Microstructural Analysis of Steel from the World Trade Center Buildings 7, & 1 or 2

Ronald R. Biederman, WPI

Higgins Armory/WPI MCSI Symposium
June 5, 2006

-The Role of Heat and Hot Corrosion in the Failure

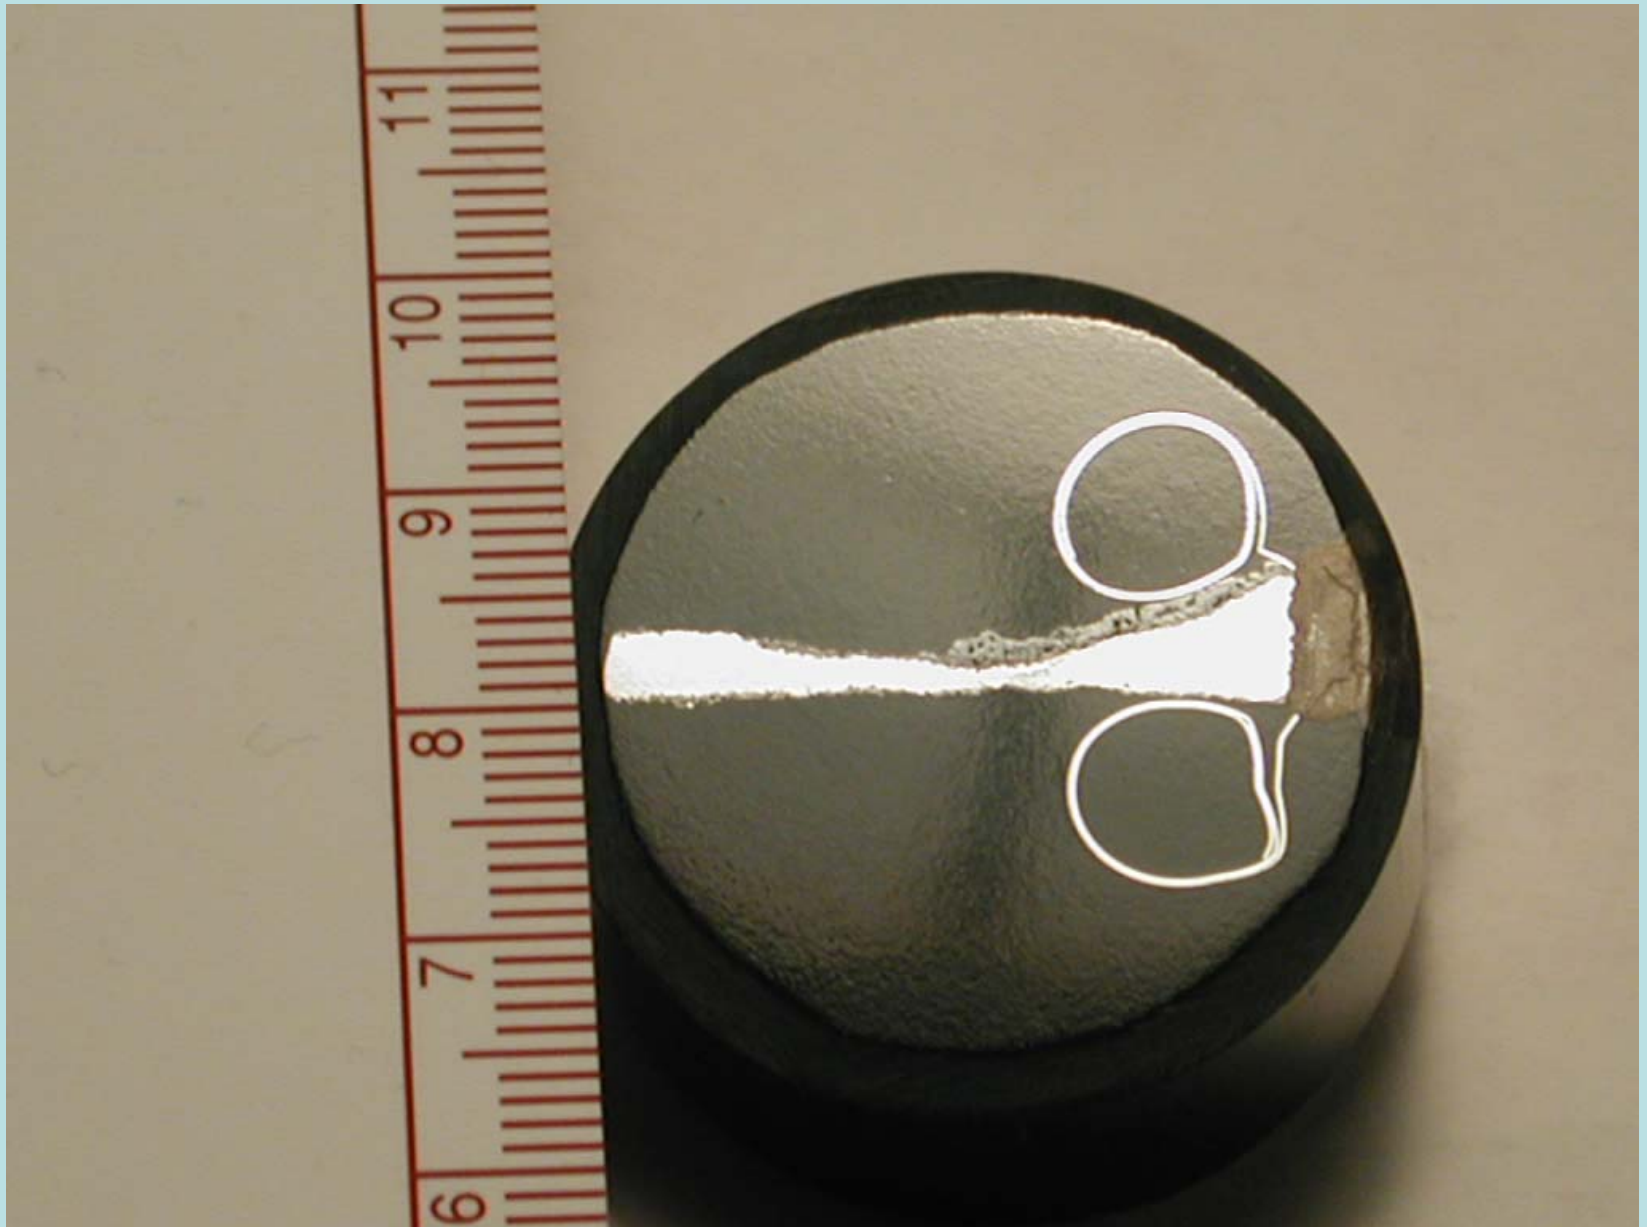
Severely Eroded $\frac{1}{2}$ " Wide Flange Beam from WTC 7

**Nominal Composition (%) of the A36 Steel Plate is:
(0.29C max, 0.80-1.2Mn, 0.04P, 0.05S, 0.15-0.3Si bal Fe)**

Typical Cross Sectional Metallurgical Mount

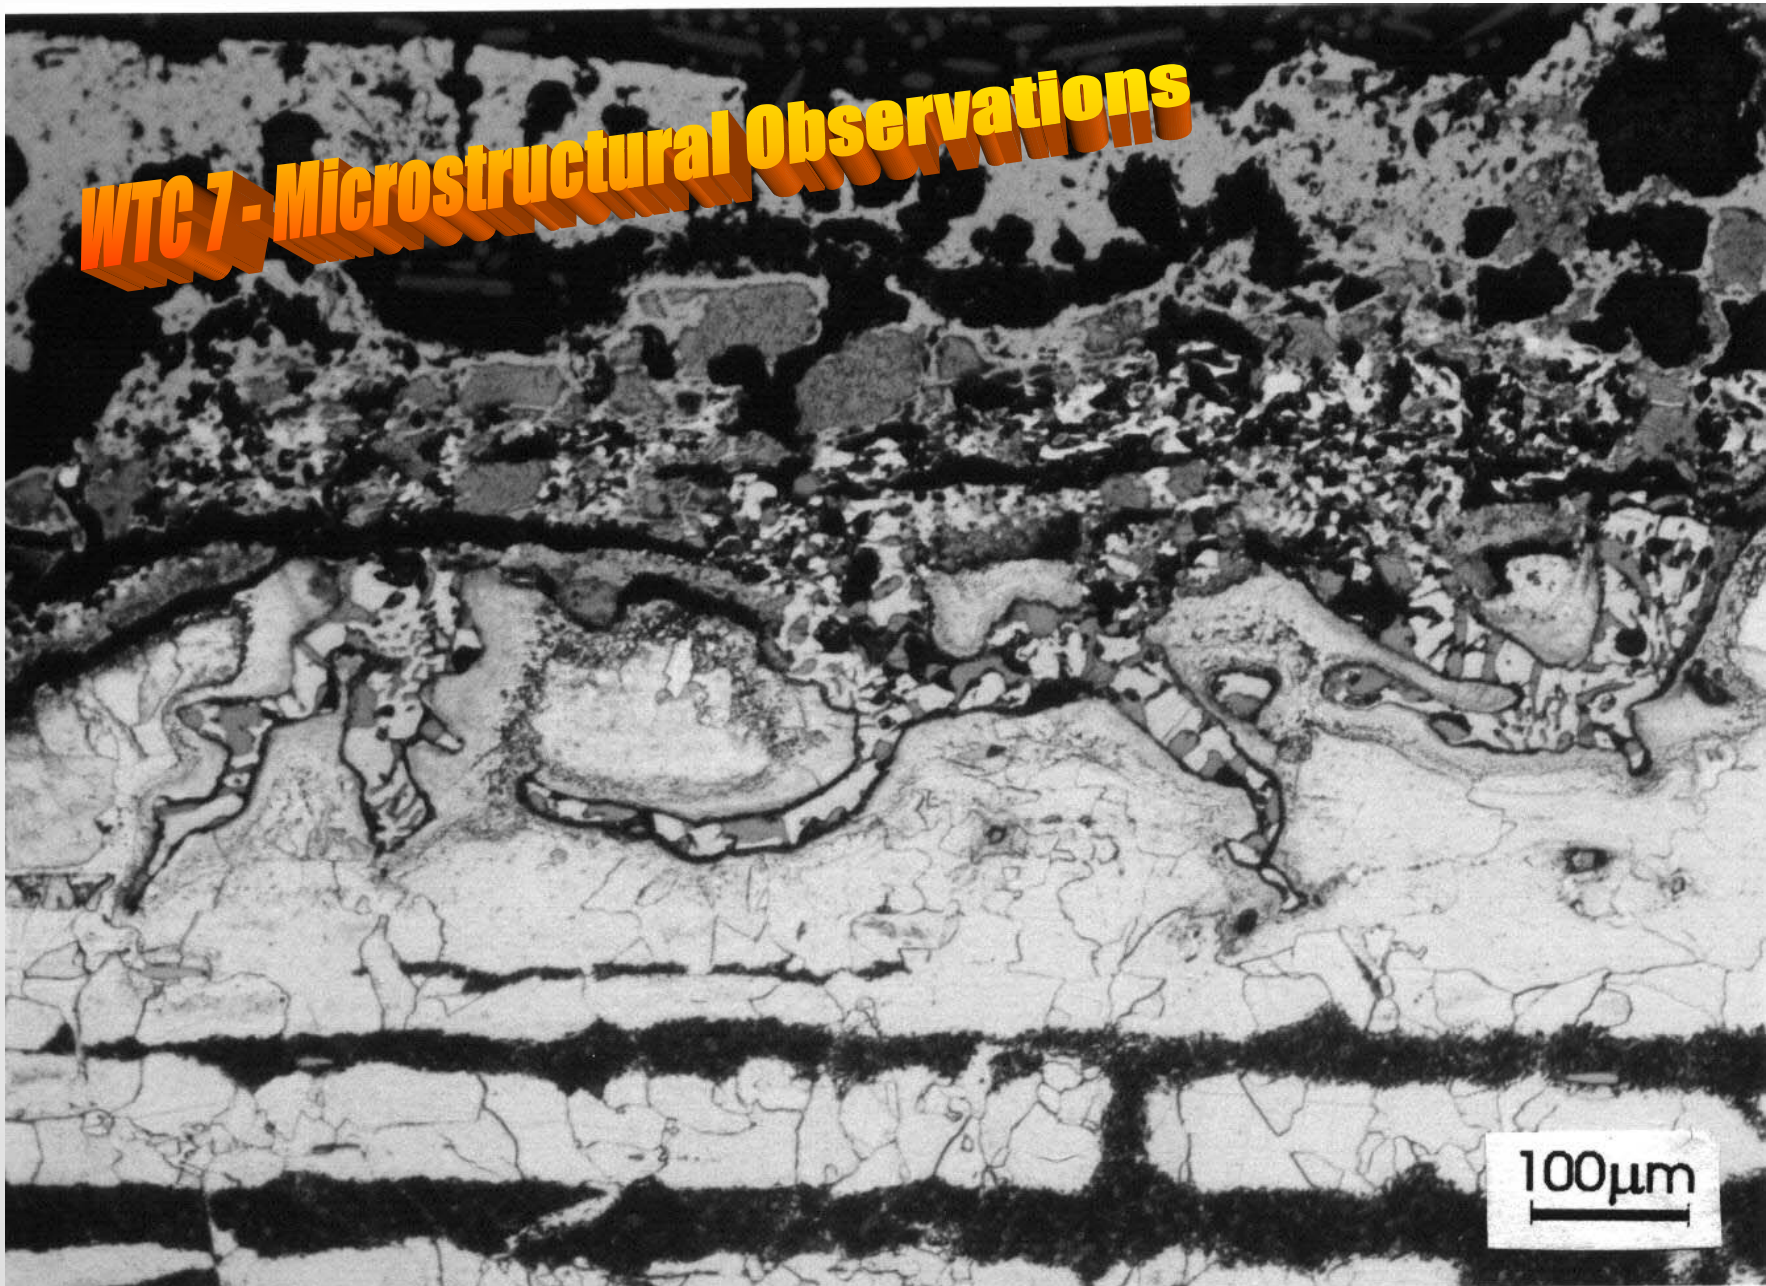
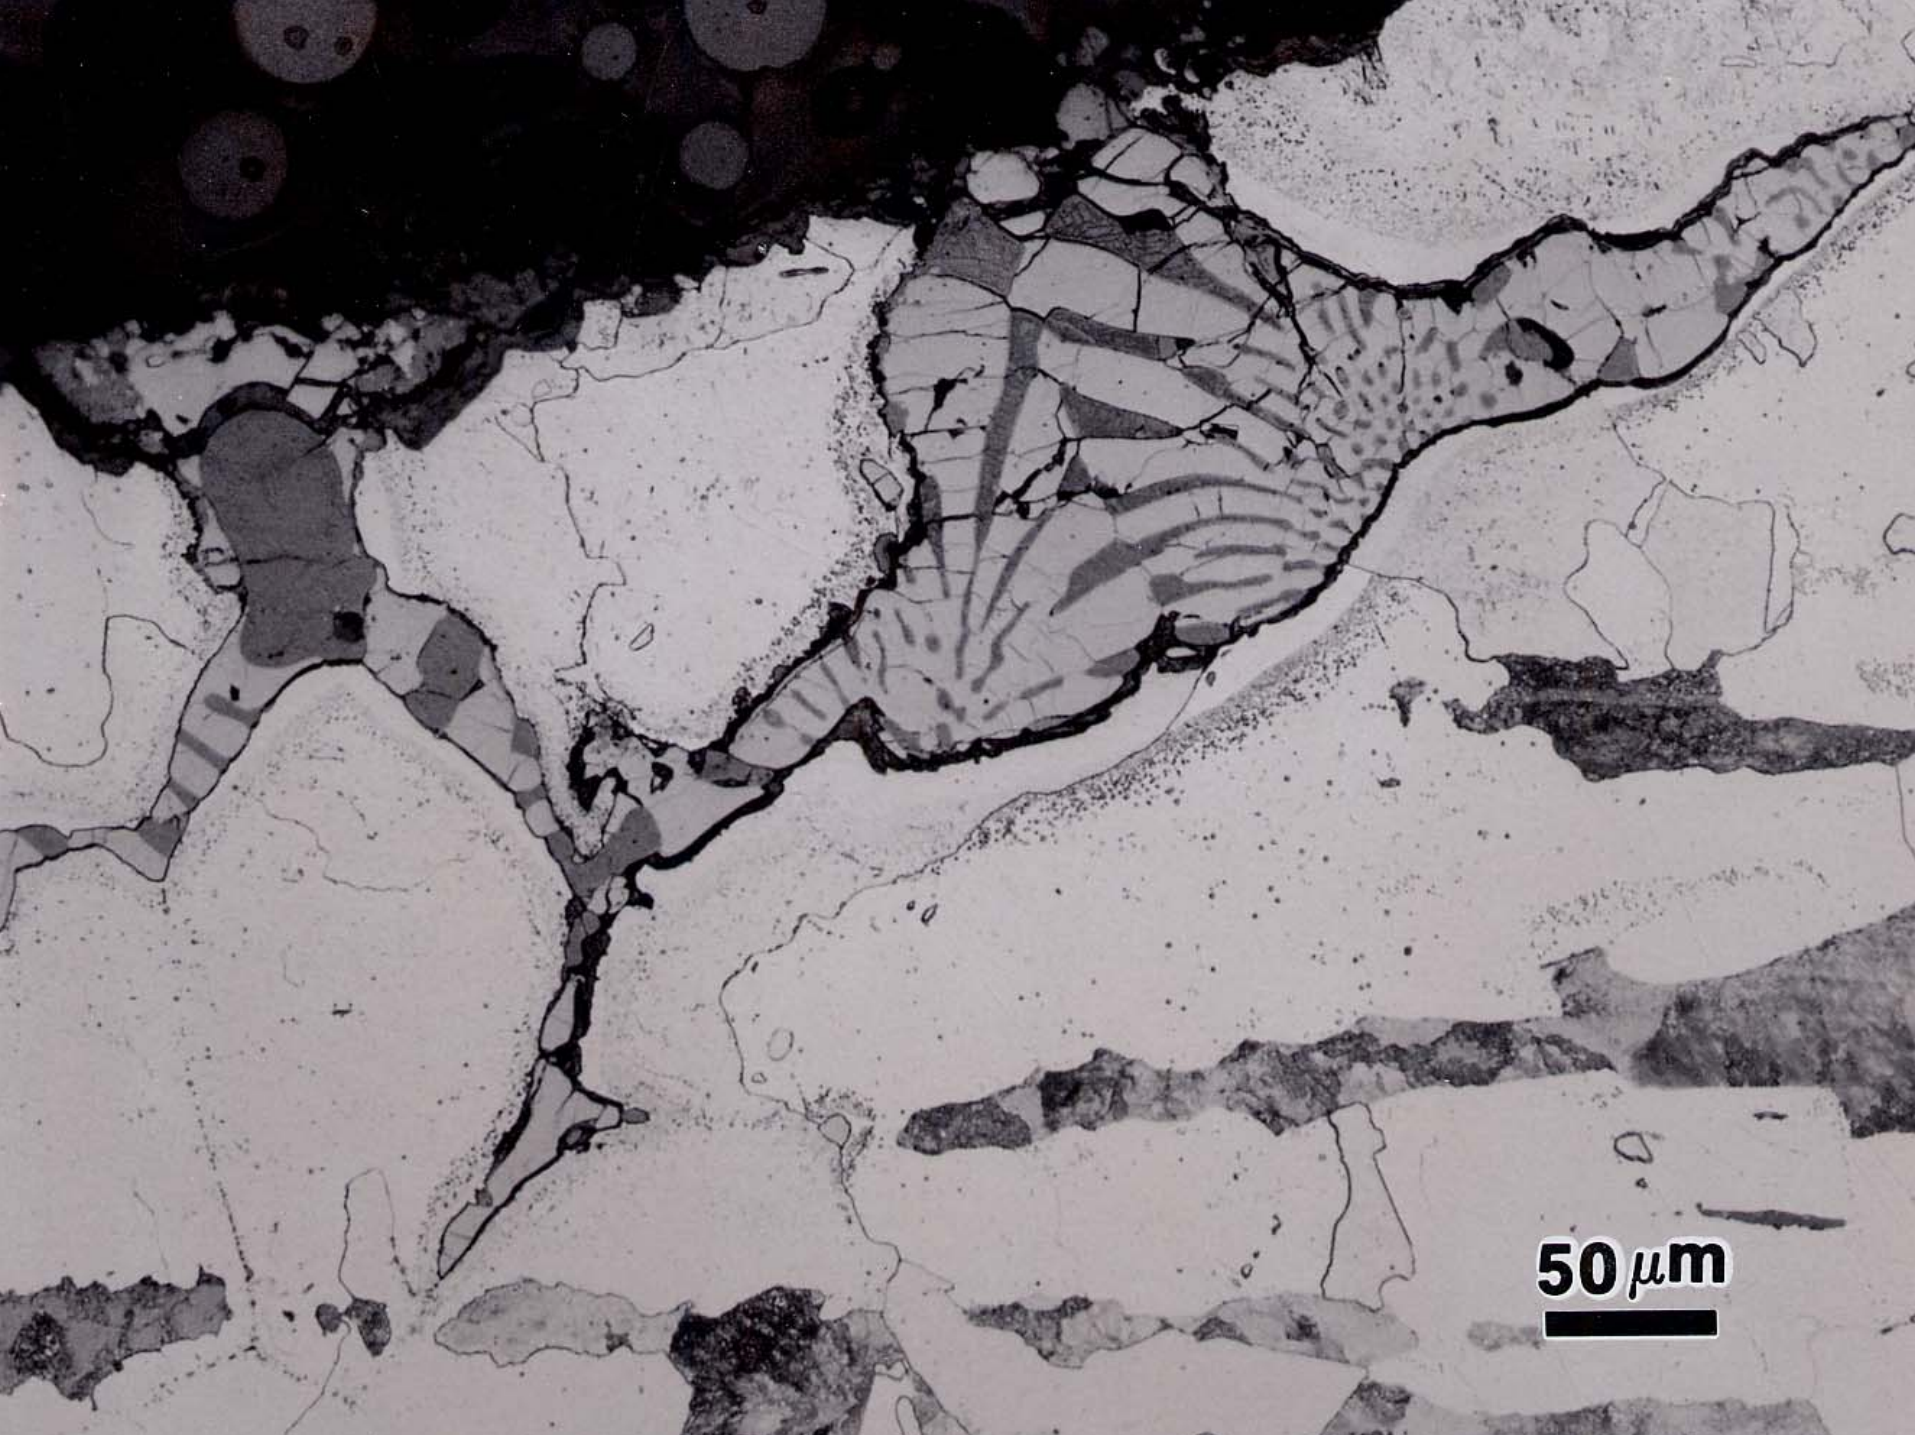
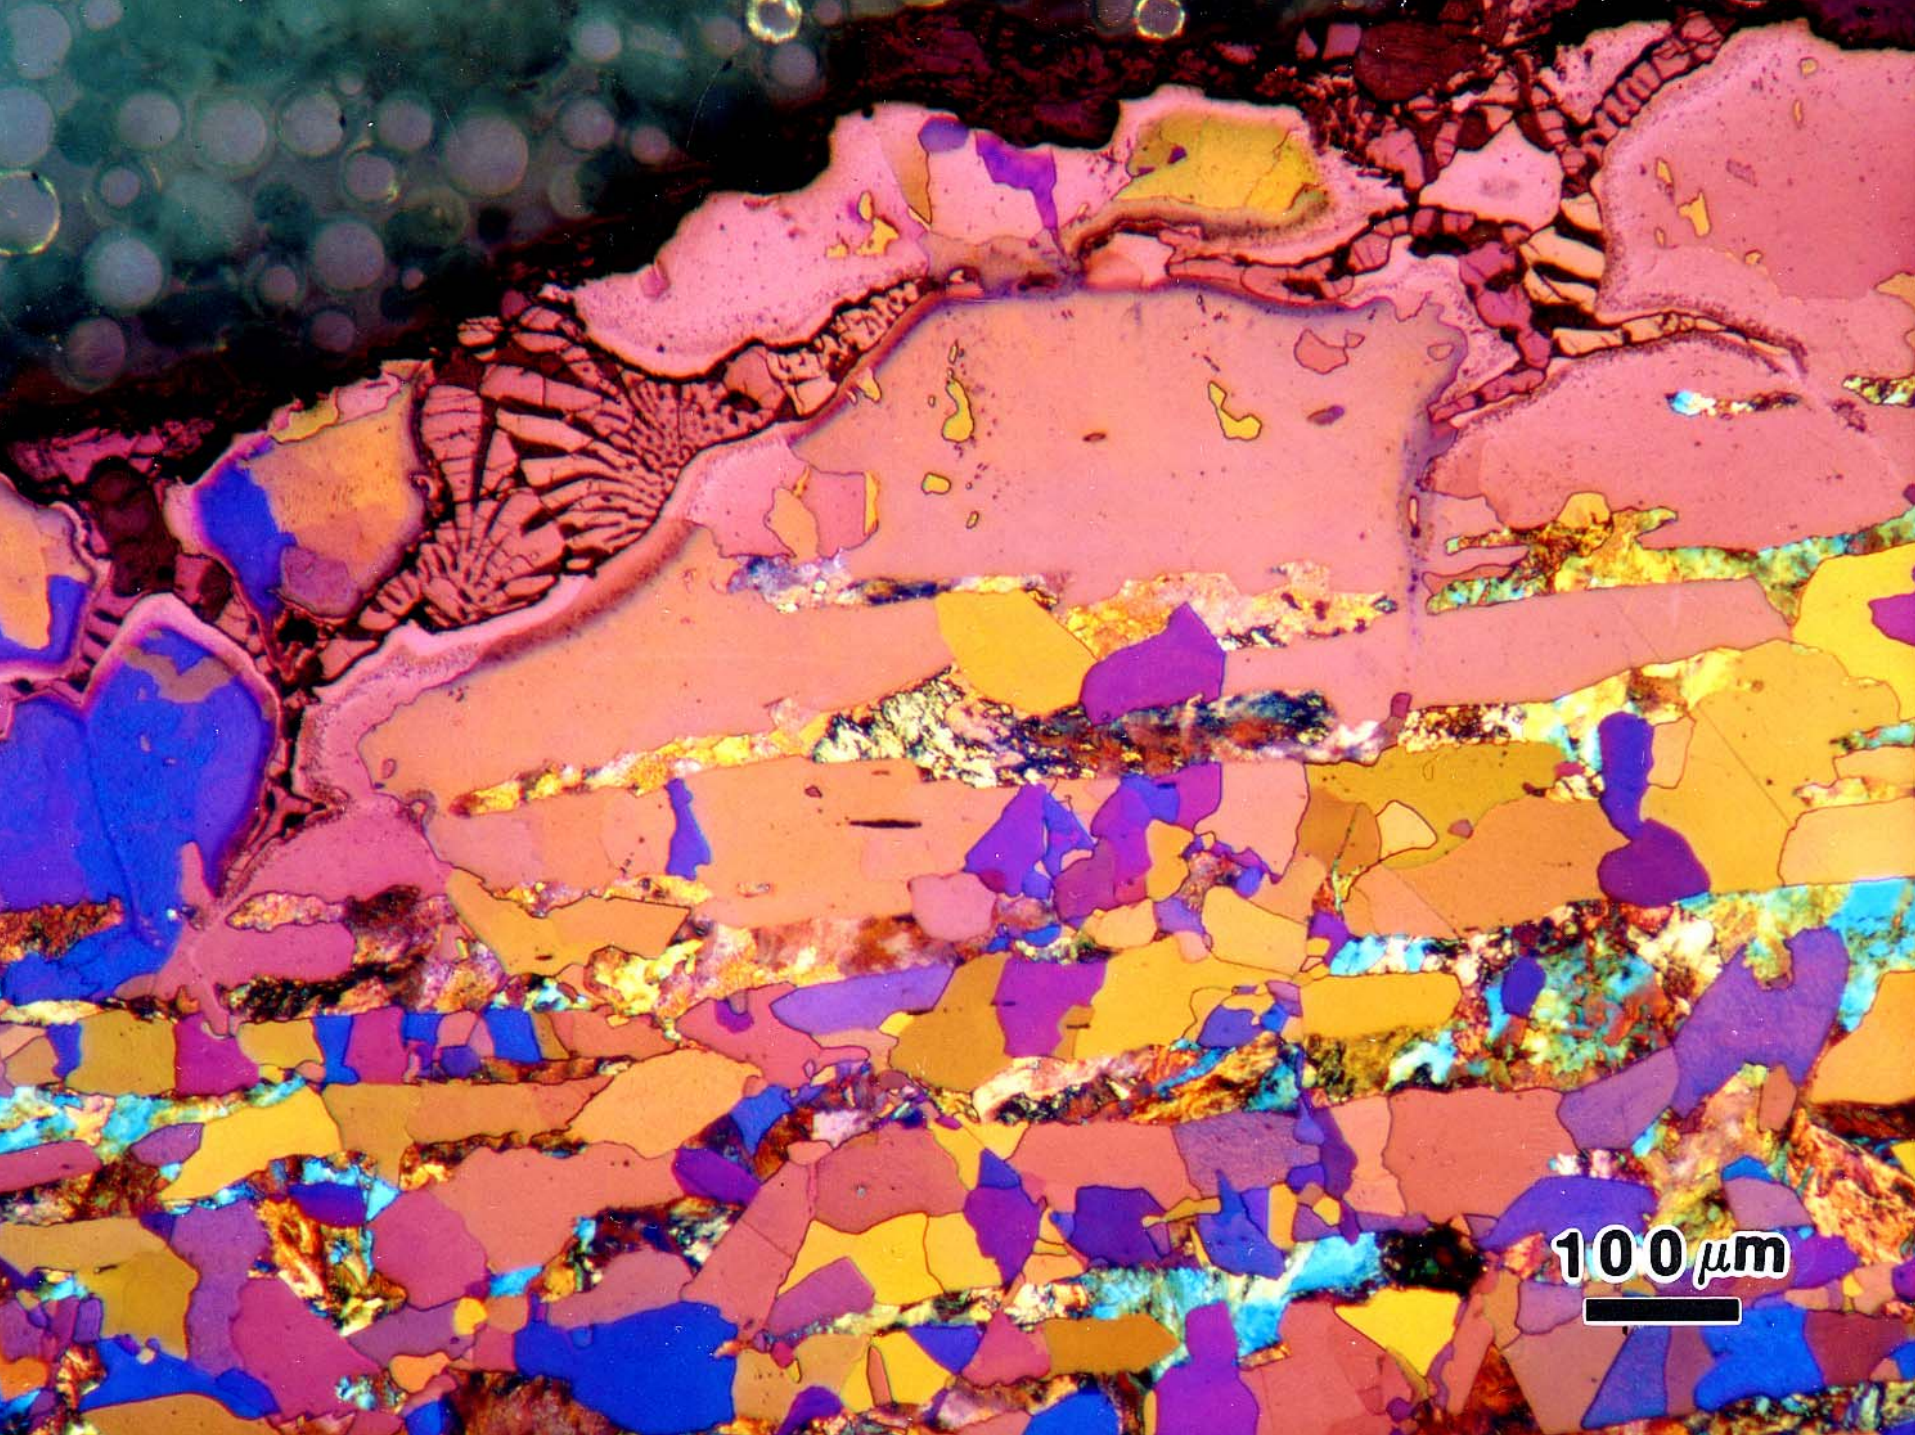
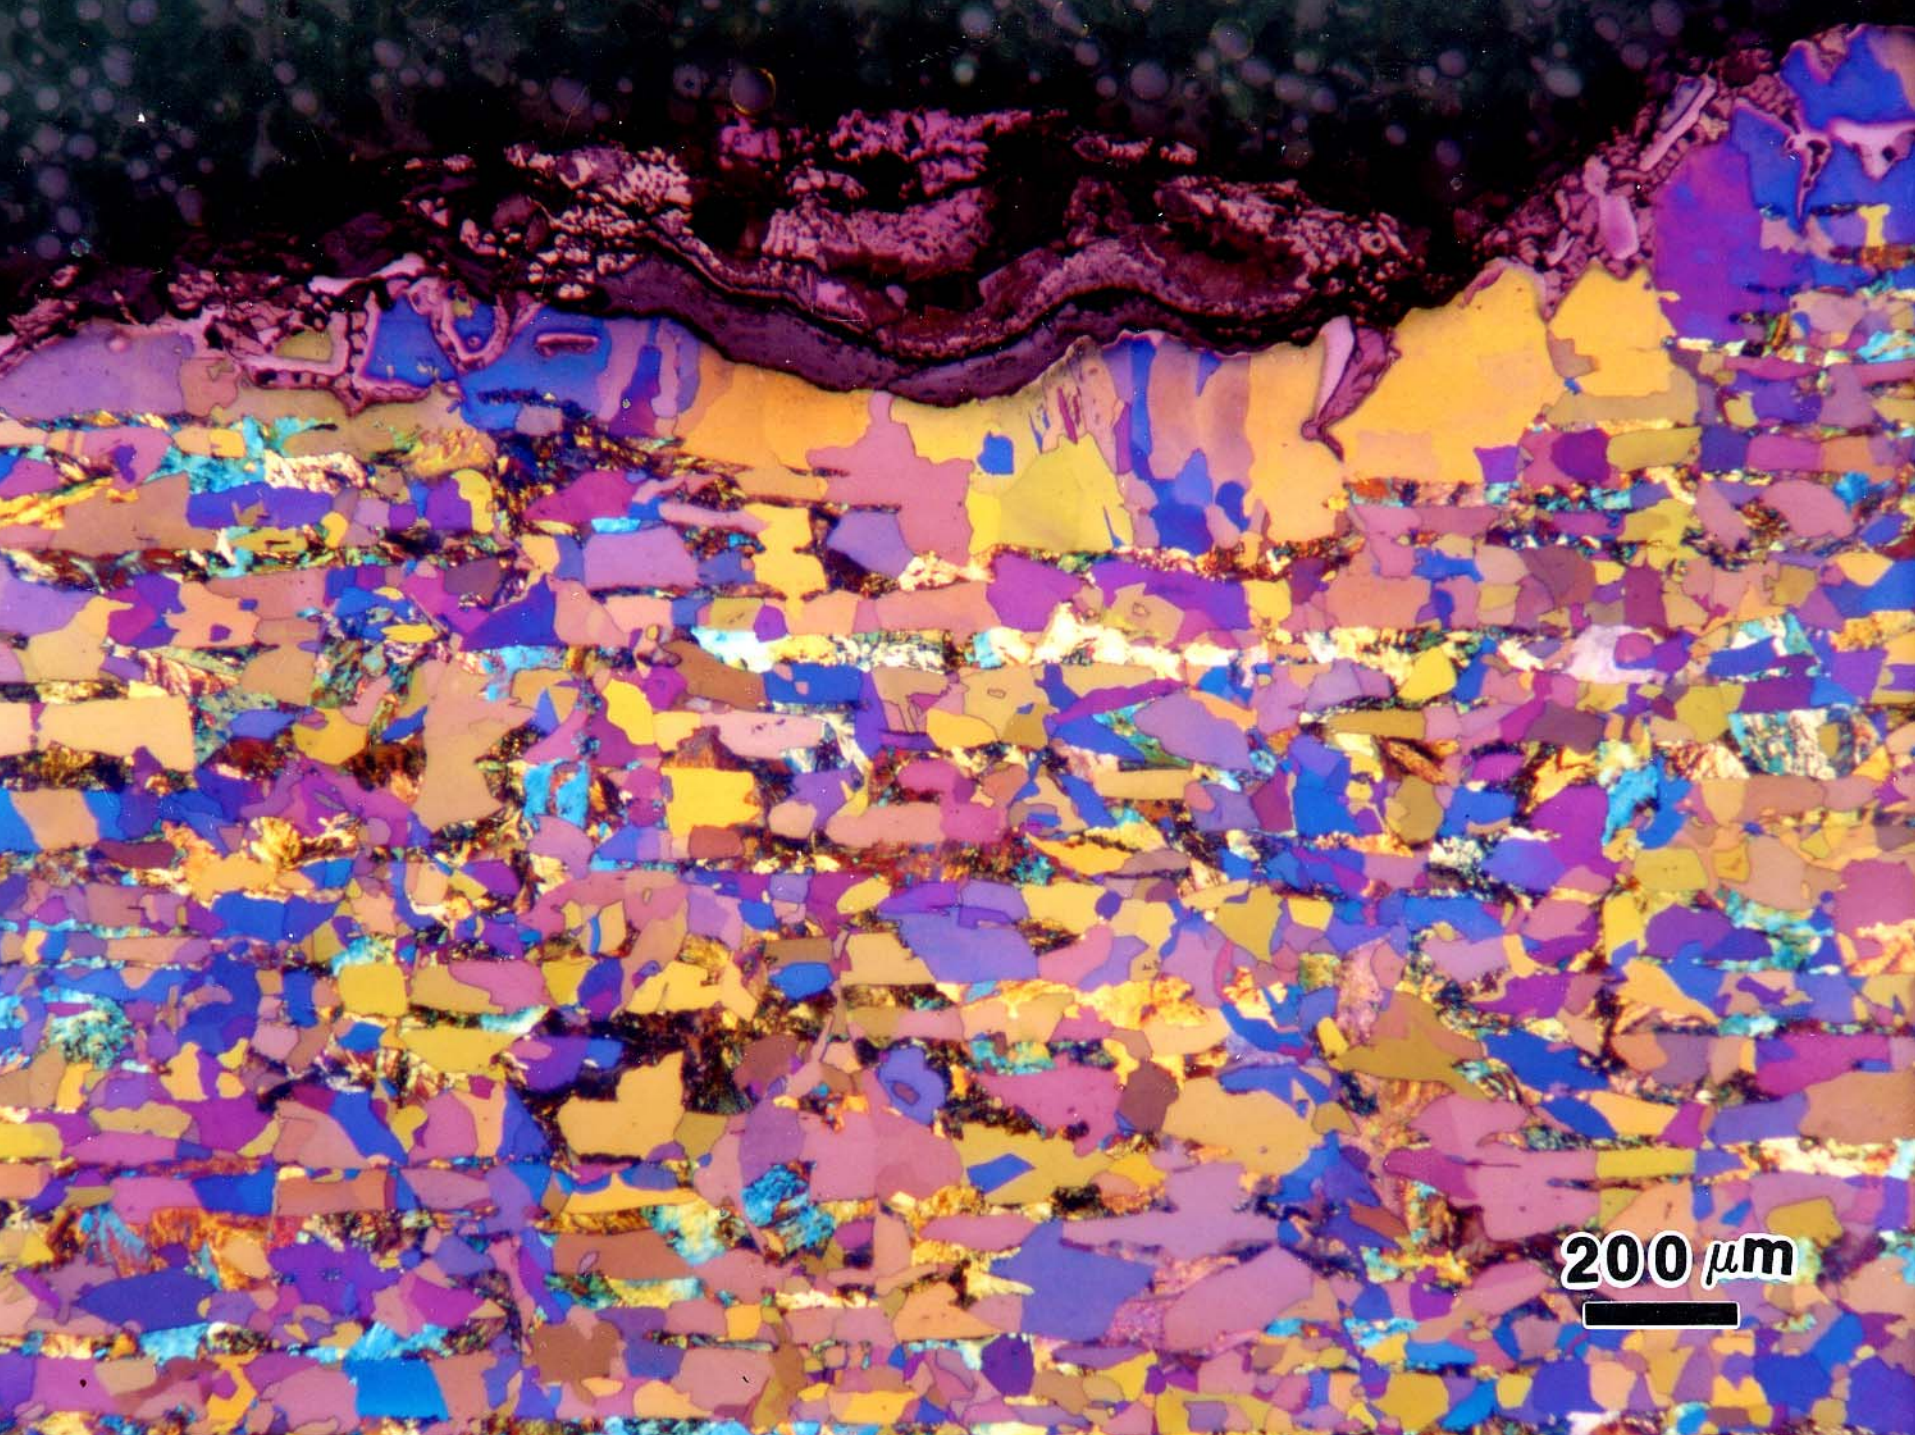
WTC 7 - Microstructural Observations

- 1. Rapid deterioration of the A36 steel was a result of hot corrosion.**

- 1. Rapid deterioration of the A36 steel was a result of hot corrosion.**
- 2. Heating in an environment containing oxygen and sulfur resulted in intergranular melting which transformed to an Iron Oxide and Iron Sulfide eutectic mixture on cooling .**

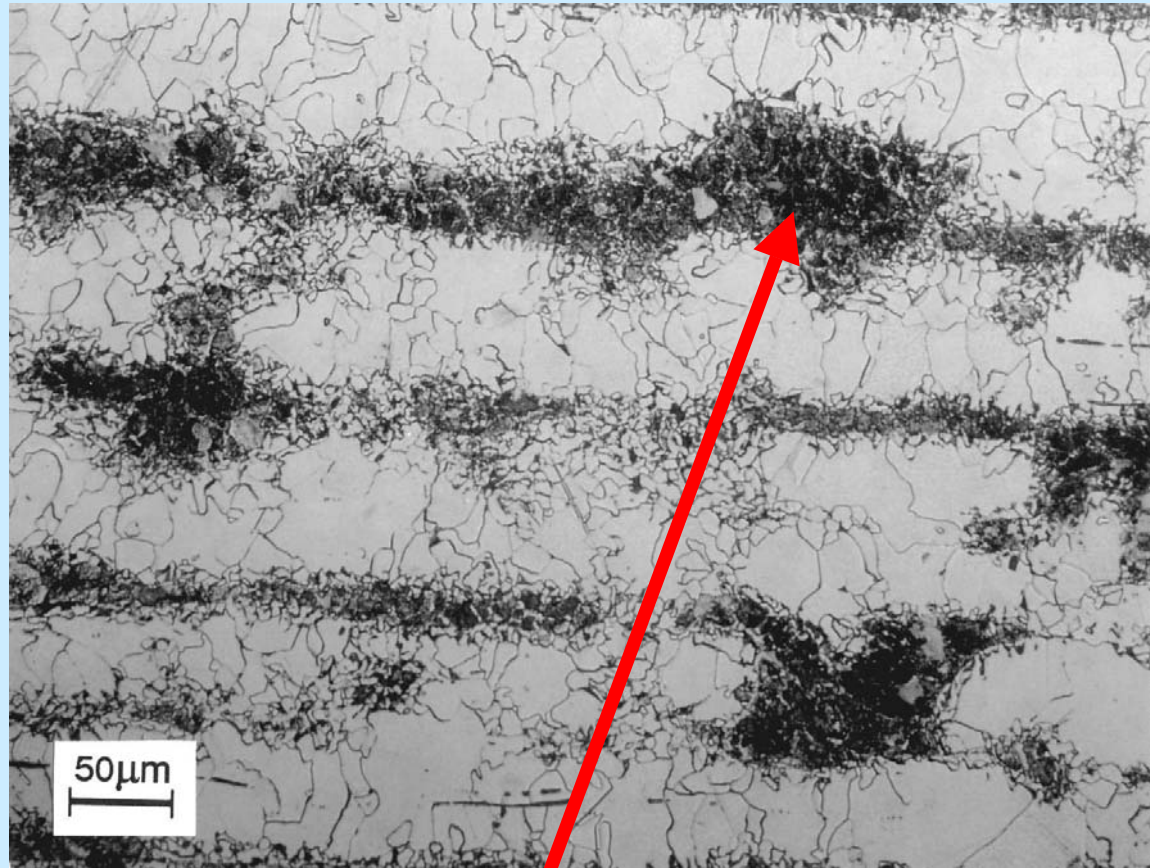
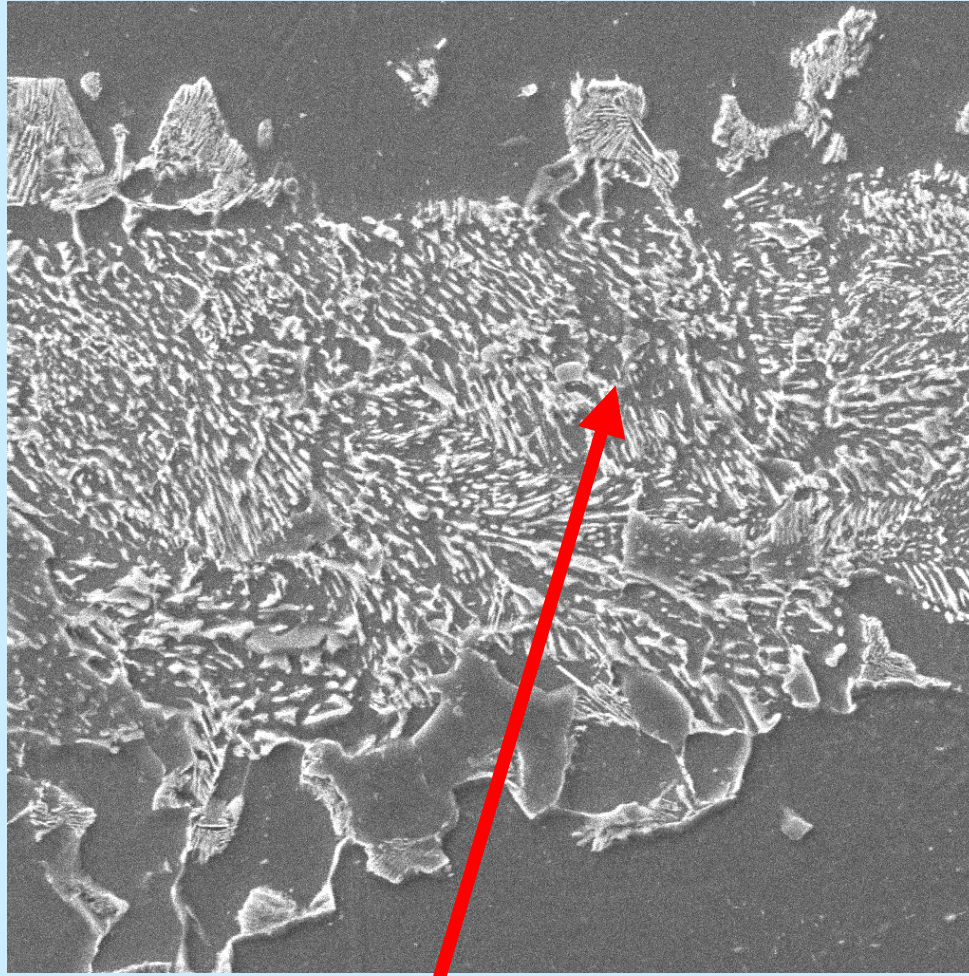
Typical Microstructural Changes That Occur When A36 Steel is Heated to the Vicinity of the Eutectoid Reaction $\sim 727^{\circ}\text{C}$ (1340°F), Held for a Short Time, and Cooled to Ambient Temperature

Partial Carbide Spheroidization

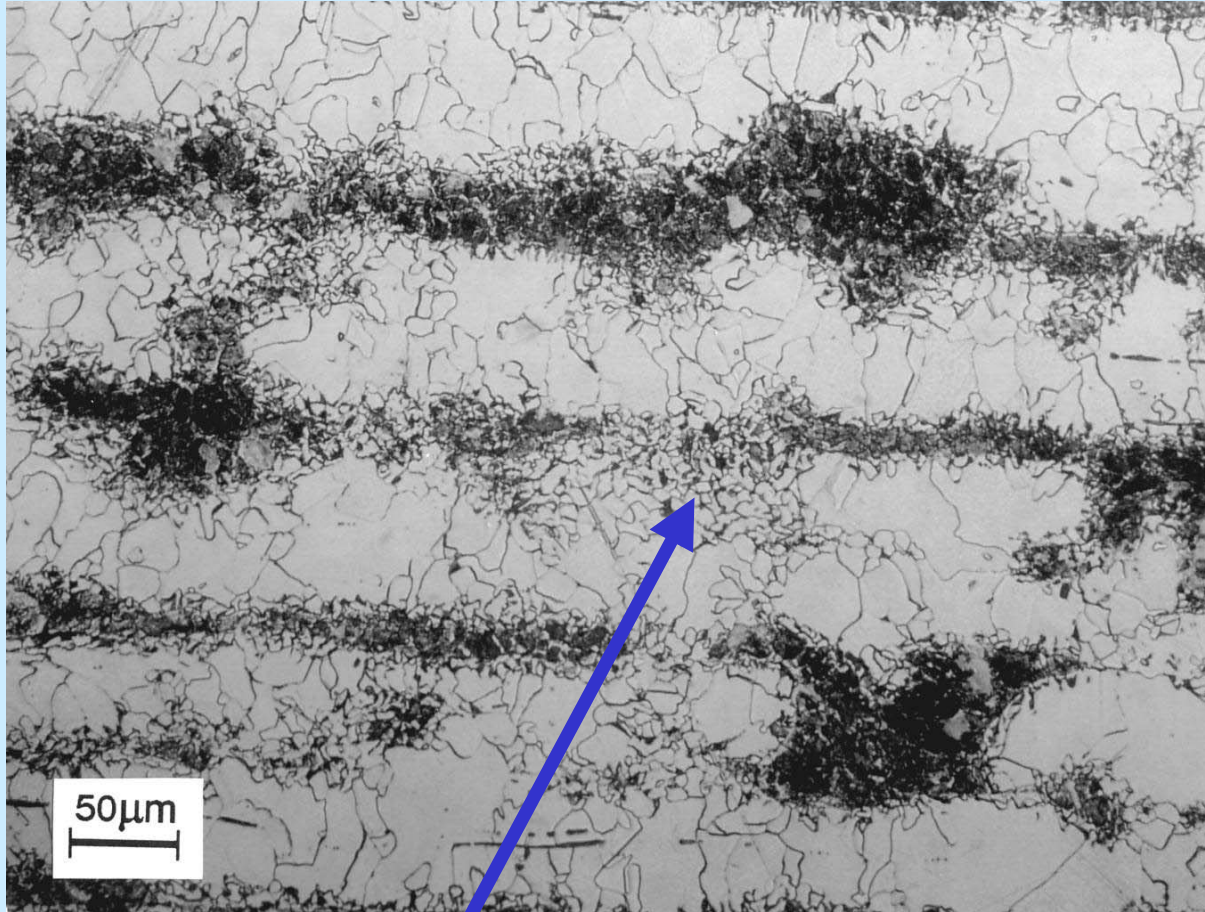
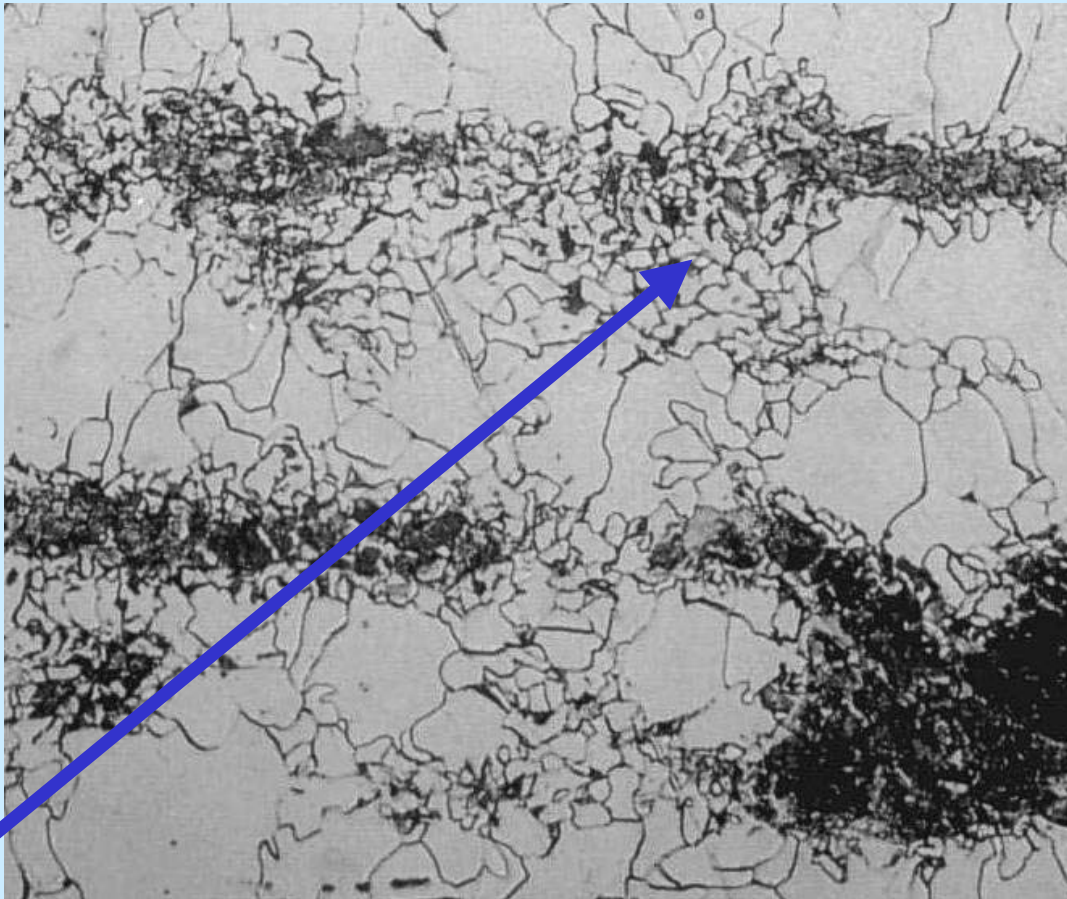
A Typical Region Where Conversion to an Austenite Matrix (on Heating) Occurred Followed by a Retransformation to a Ferrite Matrix on Cooling

Conversion to Austenite Matrix (on heating) and Return to Ferrite Matrix (on Cooling)

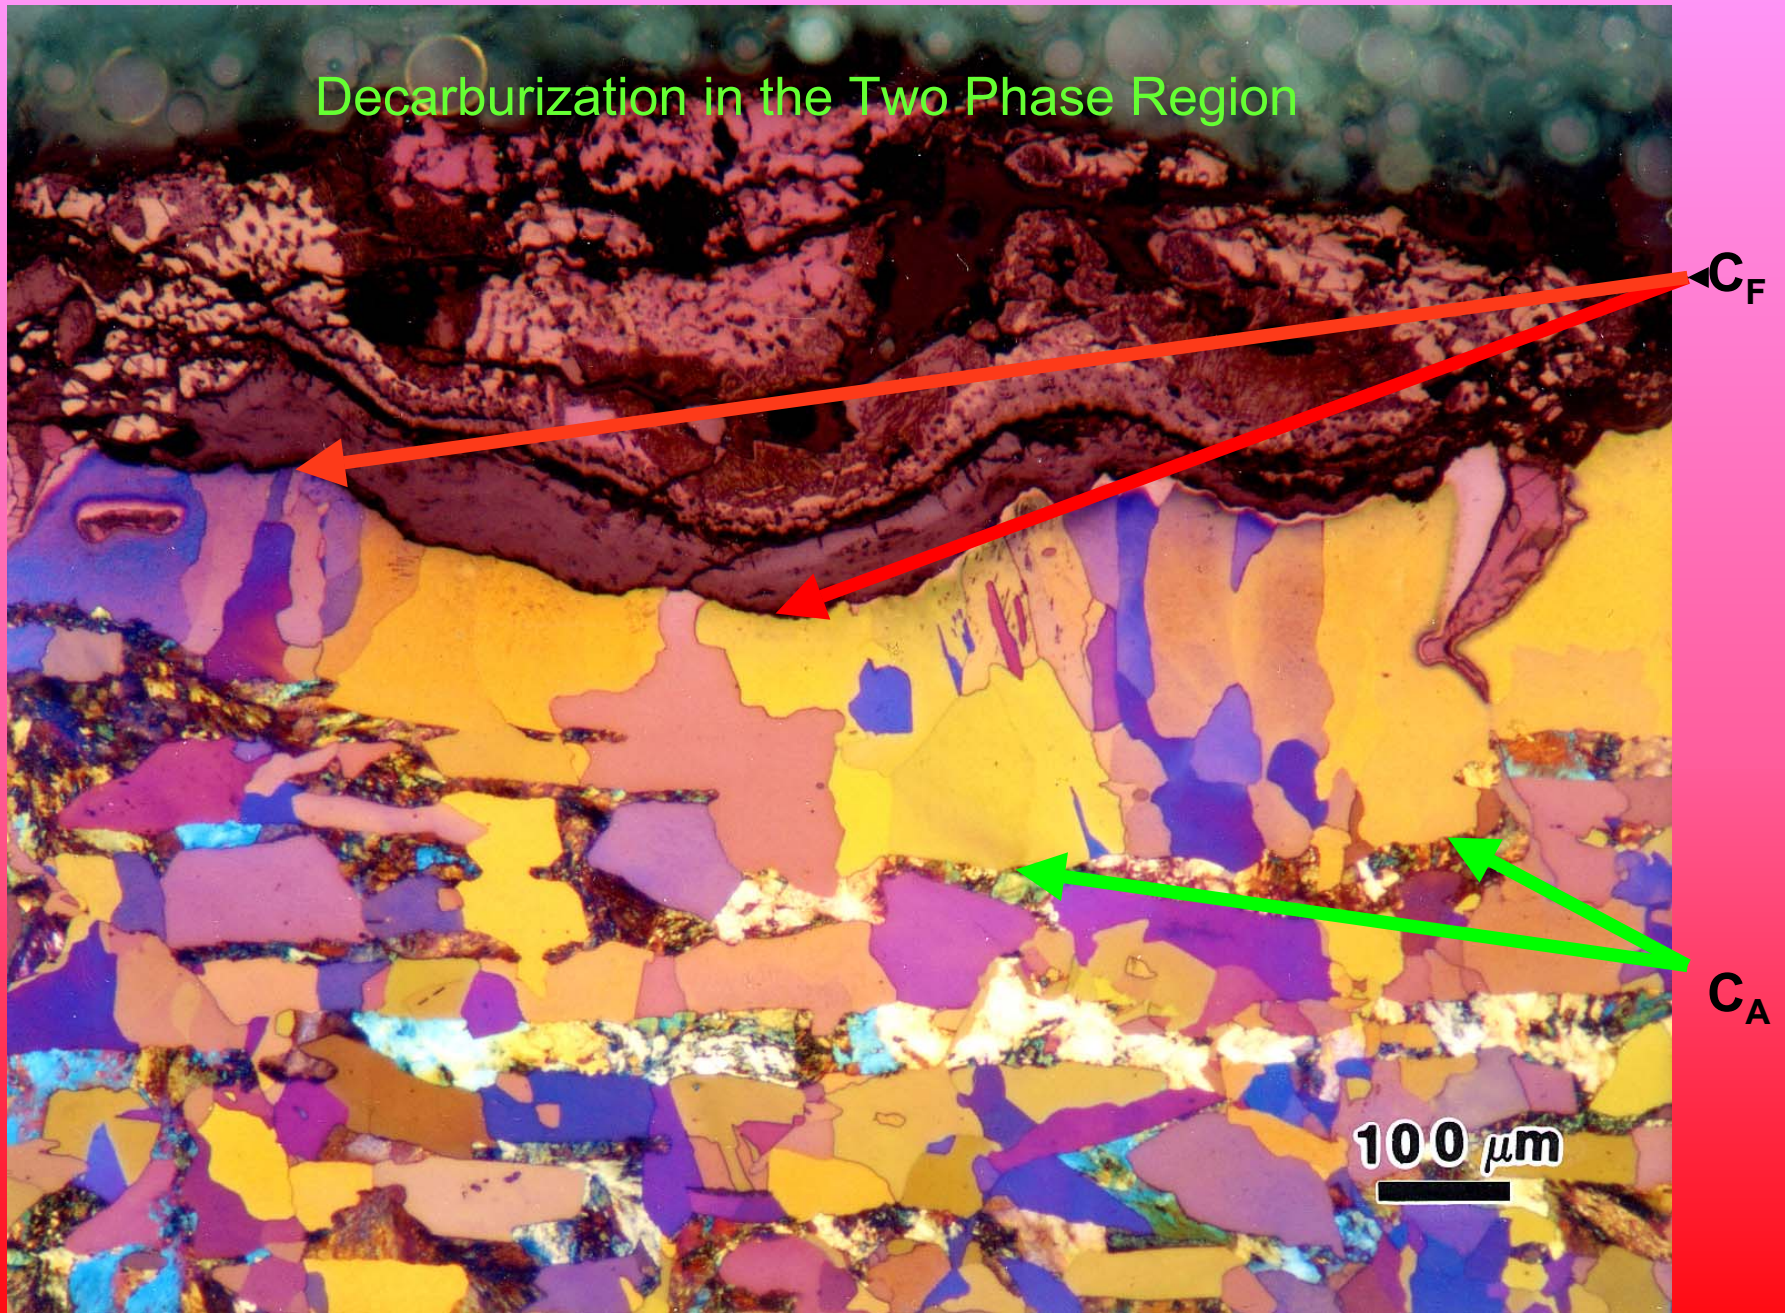
Decarburization in the Two Phase Region

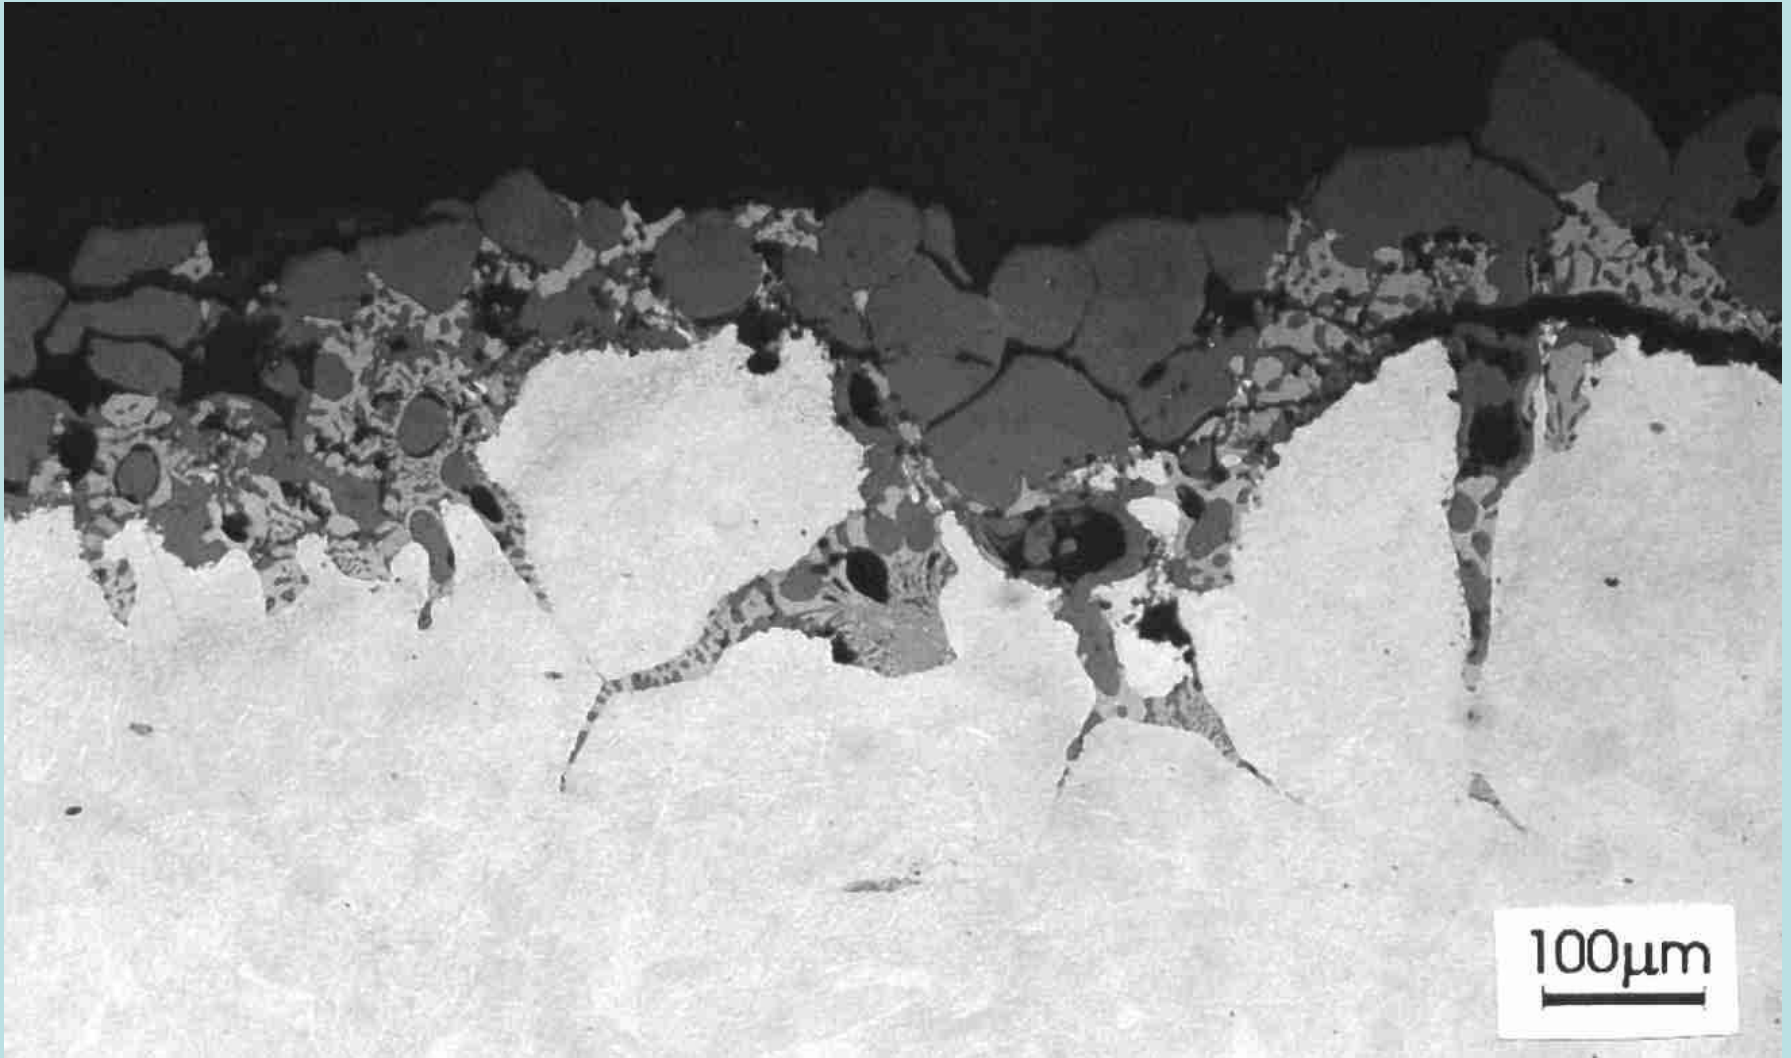
Oxidation and Intergranular Attack

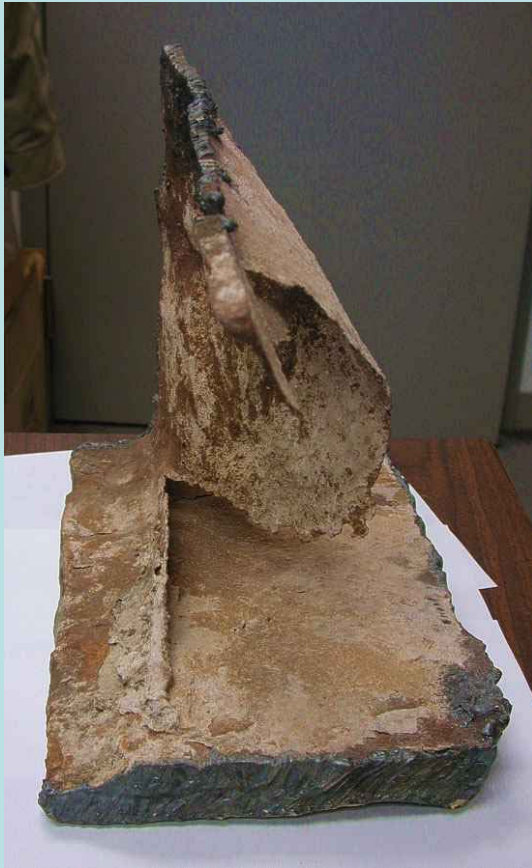
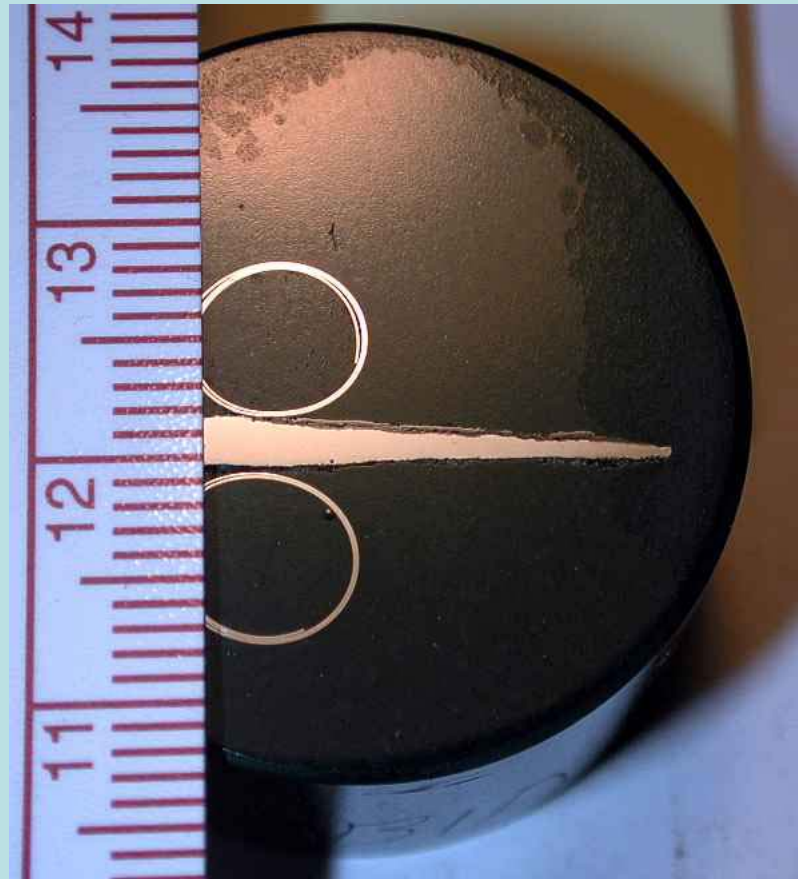
A Section from a HSLA steel Column thought to be from either WTC building 1 or 2.
