Microstructural Analysis of Steel from the World Trade Center Buildings 7, & 1 or 2

Ronald R. Biederman, WPI

Higgins Armory/WPI MCSI Symposium
June 5, 2006

-The Role of Heat and Hot Corrosion in the Failure

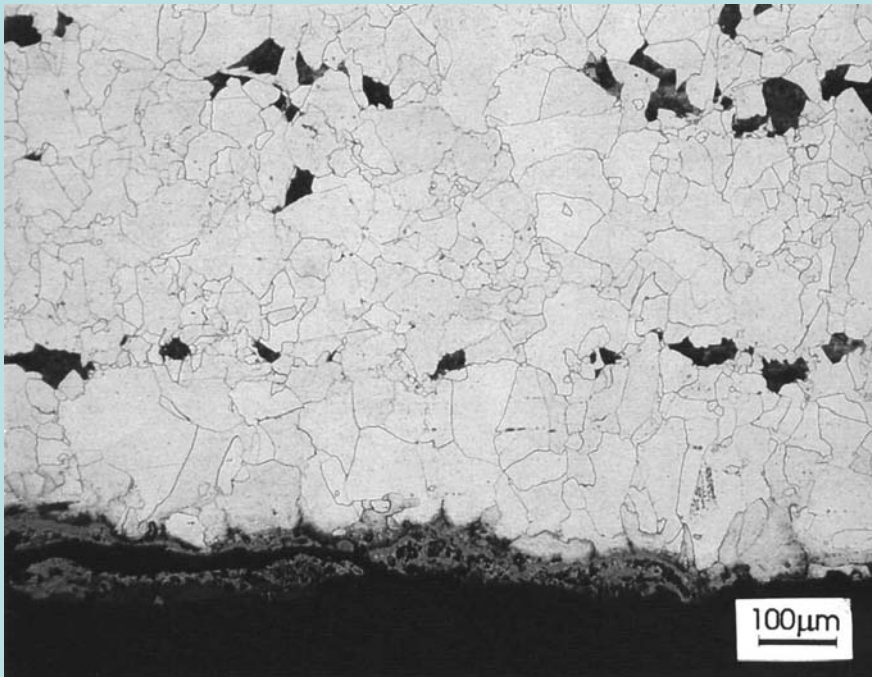
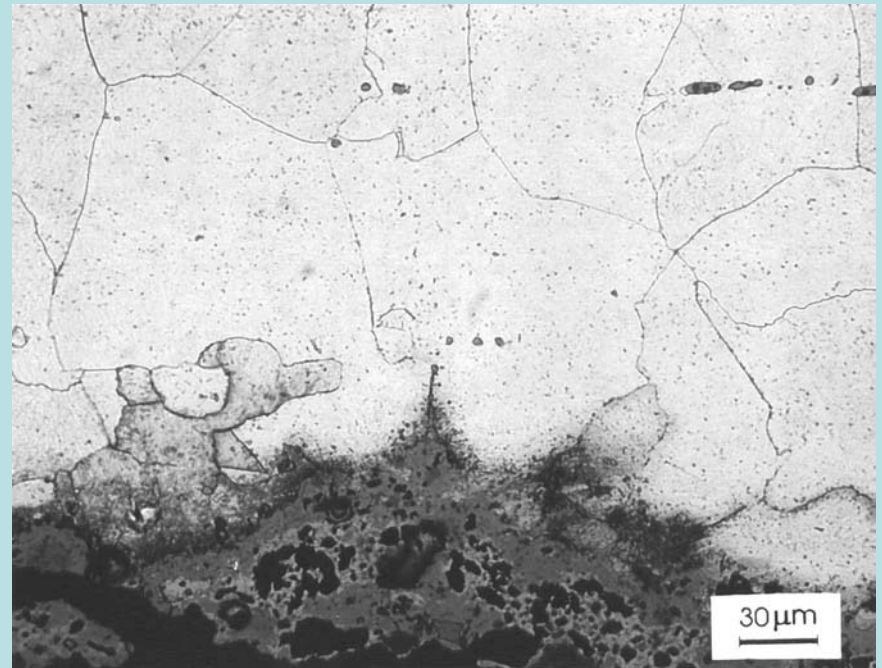
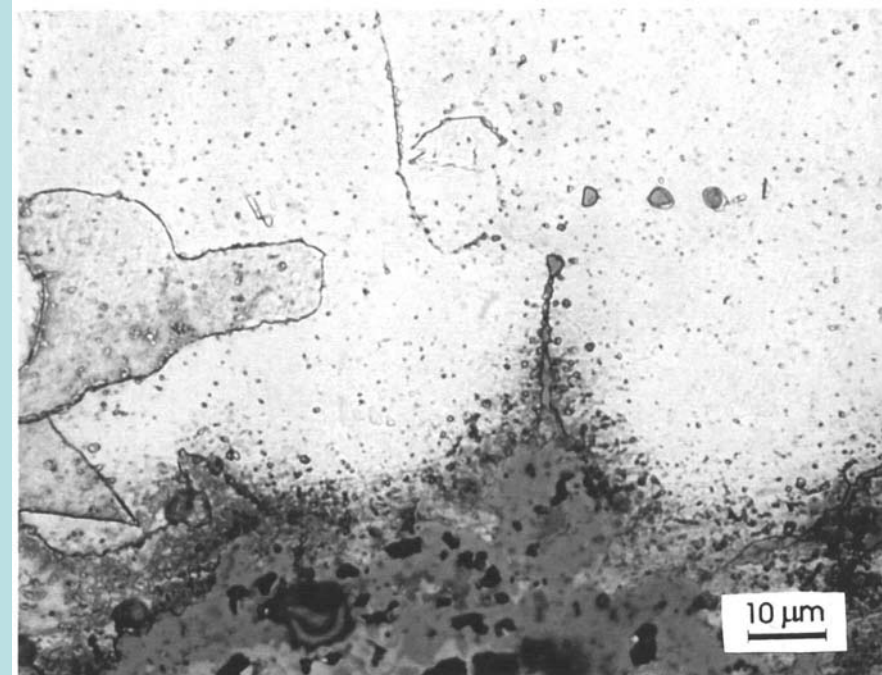
Column Section Showing Region with Severe Thinning

1. **The severe thinning of the HSLA steel occurred by high temperature corrosion due to a combination of oxidation and sulfidation.**

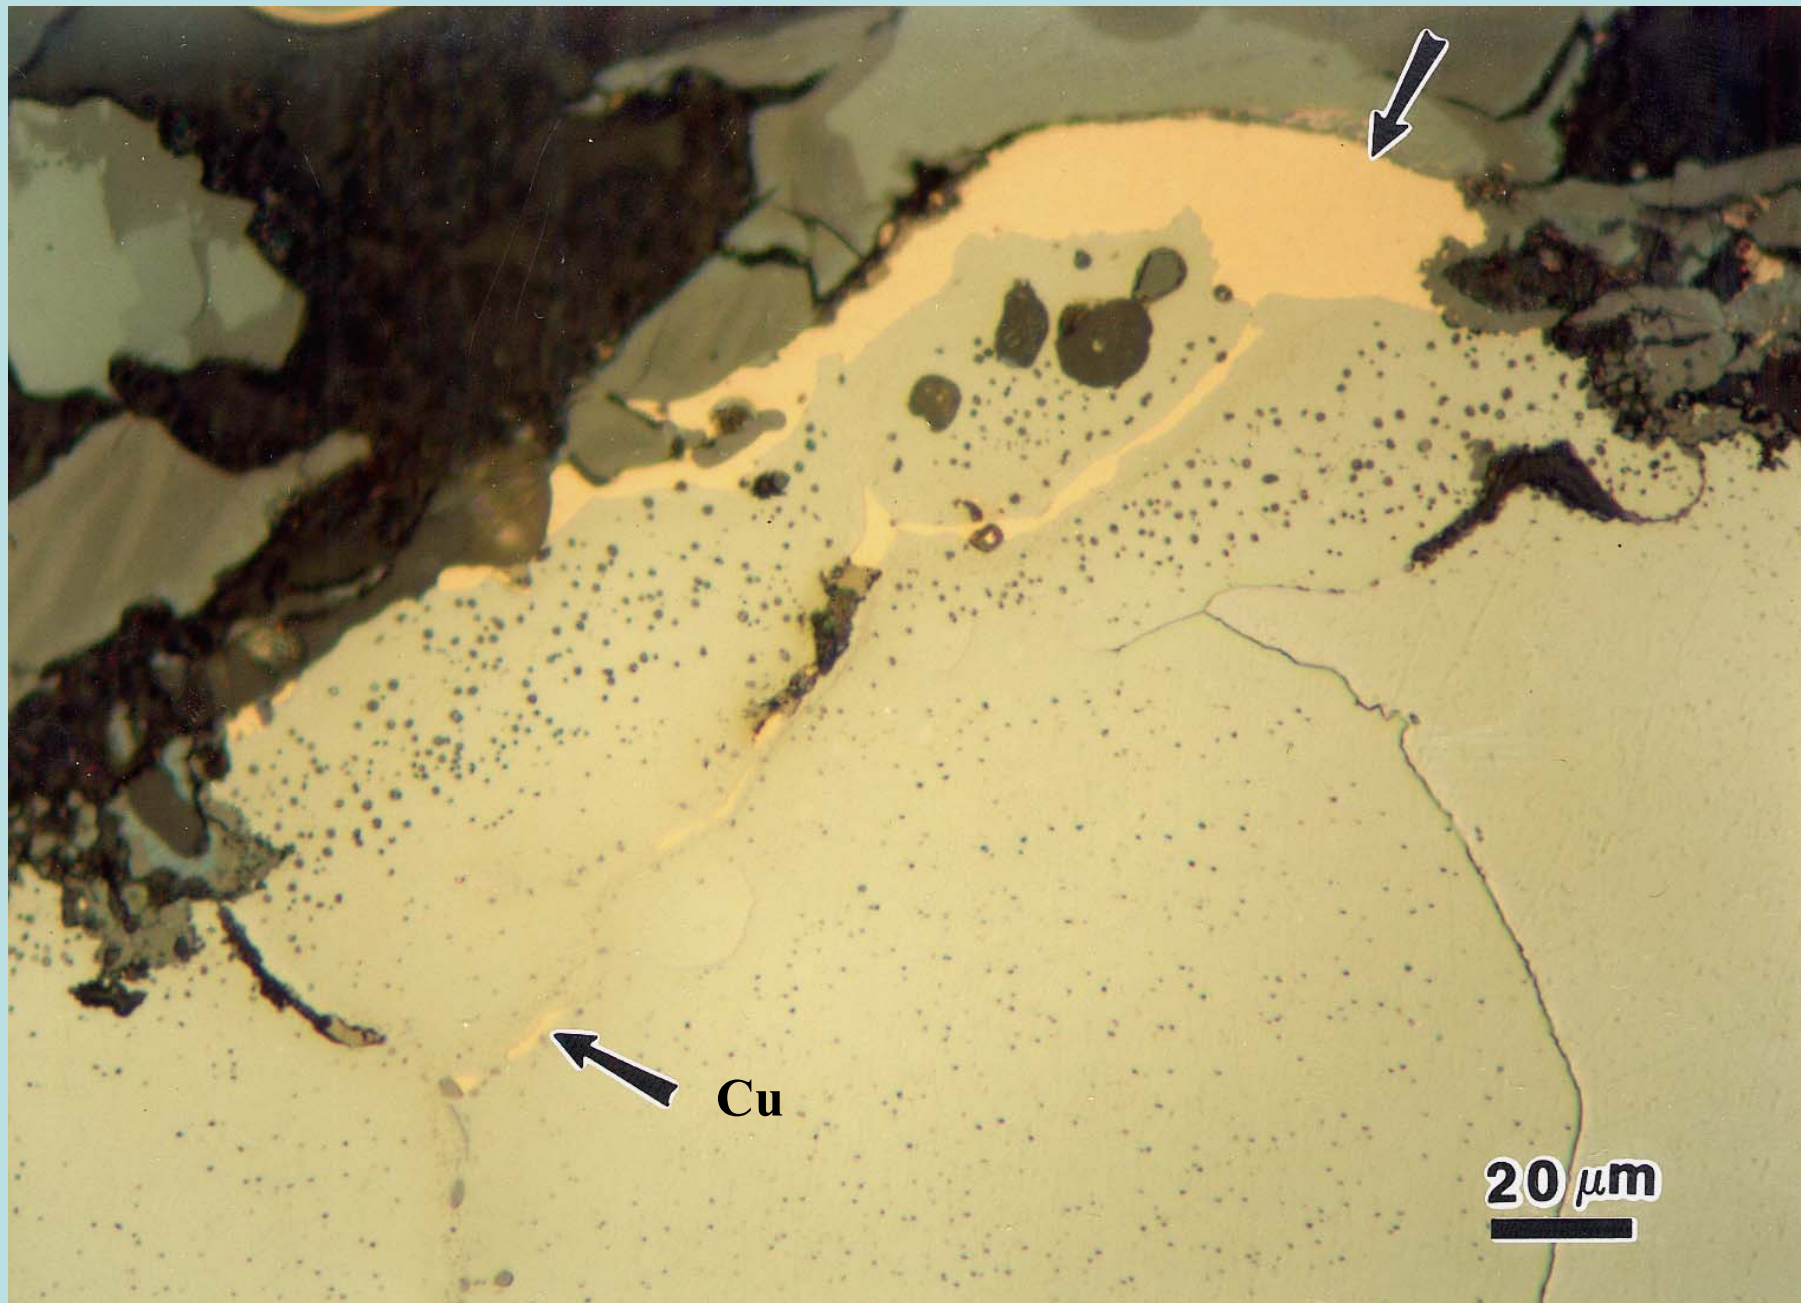
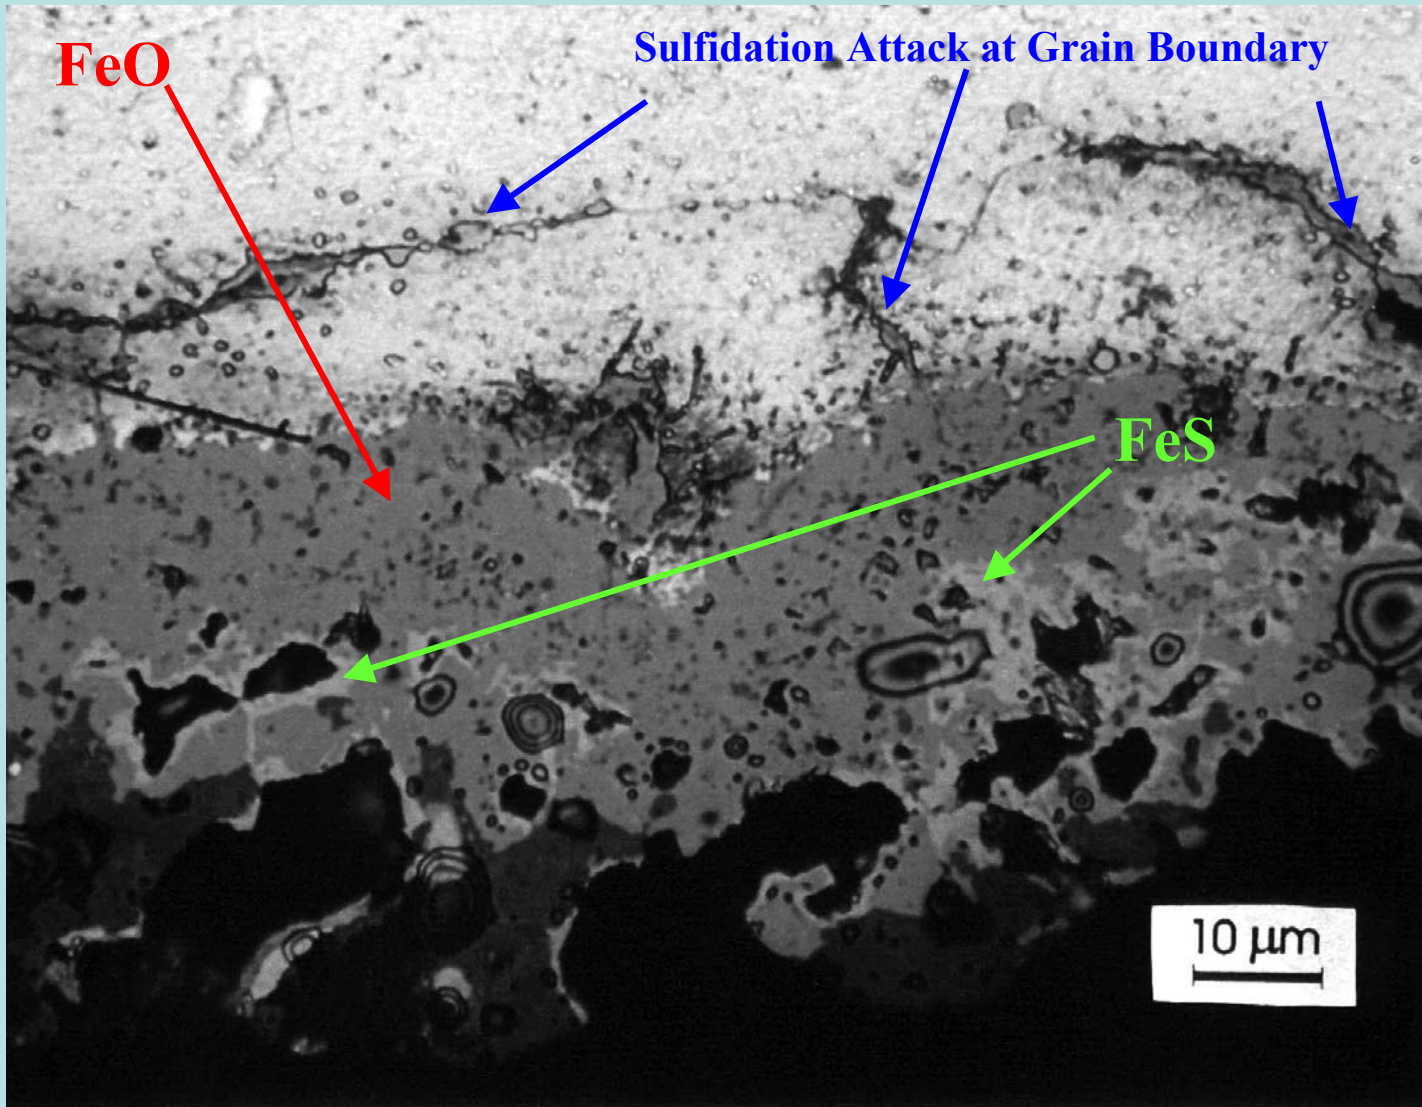
Microstructure of a Typical Region Showing the Surface and Grain Boundary Corrosion Attack of the HSLA Steel

1. **The severe thinning of the HSLA steel occurred by high temperature corrosion due to a combination of oxidation and sulfidation.**
2. **Sulfidation of the grain boundaries in the HSLA steel accelerated the corrosion and erosion of the steel.**

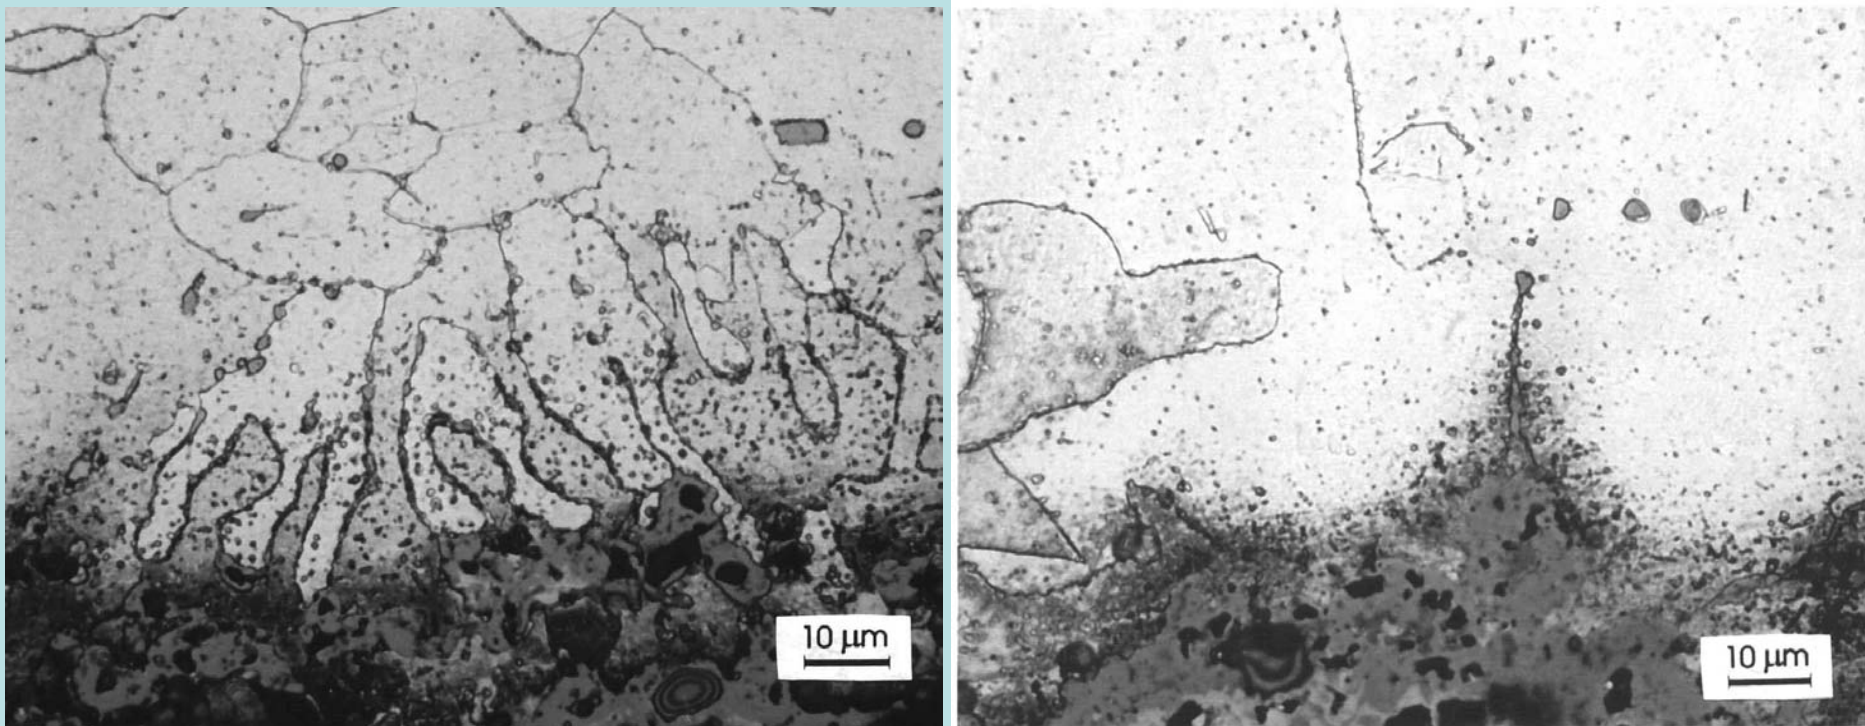
Manganese, Carbon, Silicon, Copper, and Sulfur Segregate at Interfaces where Reaction is Severe

Gradient of Sulfides into the Steel from the Oxide-Metal Interface
