5 WTC 7

5.1 Introduction

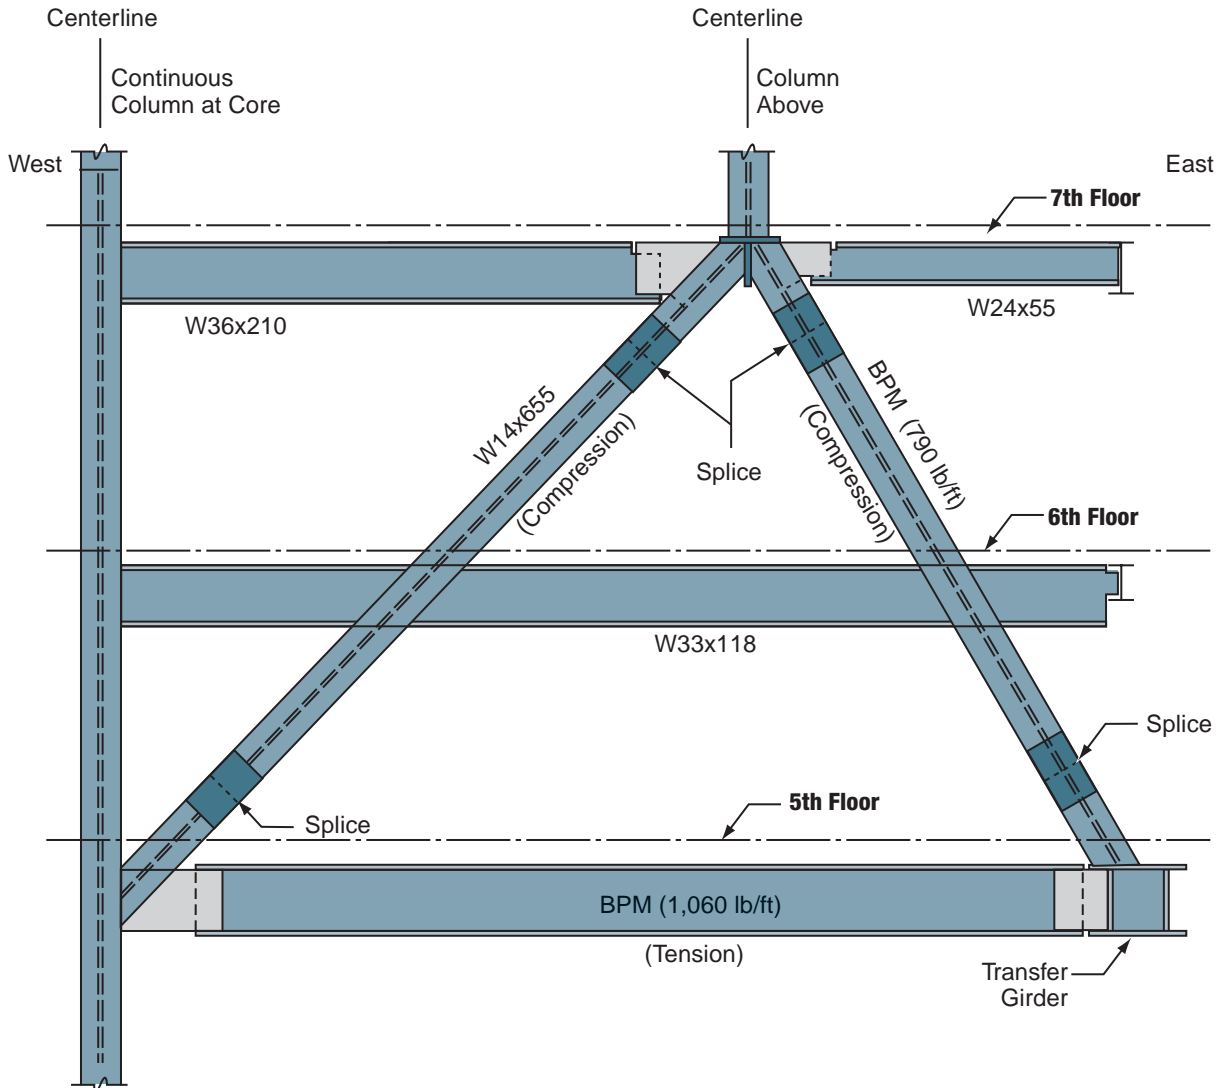
Figure 5-7 Truss 1 detail. (BPM = built-up plate member.)

Truss 1 was situated in the northeast sector of the core, and spanned in the east-west direction. As shown in Figure 5-7, this truss was a two-story double transfer structure that provided load transfers between nonconcentric columns above the 7th floor to an existing column and girder at the 5th floor. The girder then provided a second load transfer to an additional two columns. The 7th floor column supported 41 floors and part of the east mechanical penthouse. Its load was transferred through the triangular truss into a column located above an existing substation column and girder at the 5th floor. The 36.5-ton built-up double web girder spanned in the north-south direction between two new columns that started at the foundation and terminated at the 7th floor. The truss diagonals were W14 shapes and the horizontal tie was a 22-ton, built-up shape.

5th Floor Scenarios. From a structural standpoint, the most likely event would have been the collapse of Truss 1 and/or Truss 2 located in the east end of the 5th and 6th floors. These floors are believed to have contained little if any fuel other than the diesel fuel for the emergency generators, making diesel oil a potential source of fire. As noted in Section 5.4, the fuel distribution system for the emergency generators pumped oil from tanks on the lower floors to the generators through a pipe distribution system. The SSB fuel oil system was a more likely source of fire around the transfer trusses. The SSB pump is reported as a positive displacement pump having a capacity of 75 gpm at 50 psi. Fuel oil was distributed through the 5th floor in a double-wall iron pipe. A portion of the piping ran in close proximity to Truss 1. However, there is no physical, photographic, or other evidence to substantiate or refute the discharge of fuel oil from the piping system.

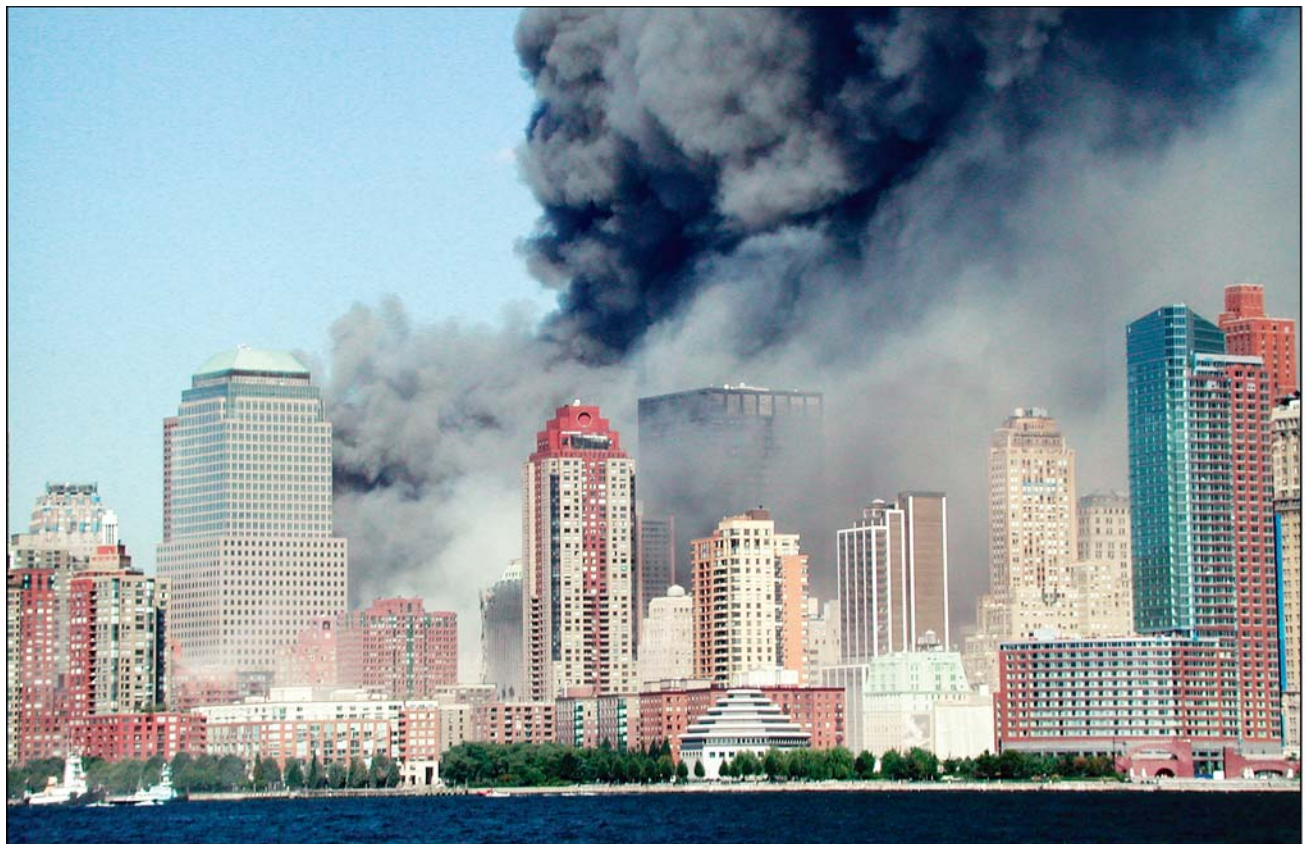
Figure 5-18 WTC 7, with a large volume of dark smoke rising from it, just visible behind WTC 1 (left). A much smaller volume of white smoke is seen rising from the base of WTC 7. Note that the lower, lighter-colored smoke (to right) is thought to be from the two collapsed towers

News coverage after 1:30 p.m. showed light-colored smoke flowing out of openings on the upper floors of the south side of the building. Another photograph (Figure 5-18) of the skyline at 3:25 p.m., taken from the southwest, shows a large volume of dark smoke coming from all but the lowest levels of WTC 7, where white smoke is emanating. The mode of fire and smoke spread was unclear; however, it may have been propagated through interior shafts, between floors along the south façade that may have been damaged, or other internal openings, as well as the floor slab/external façade connections.

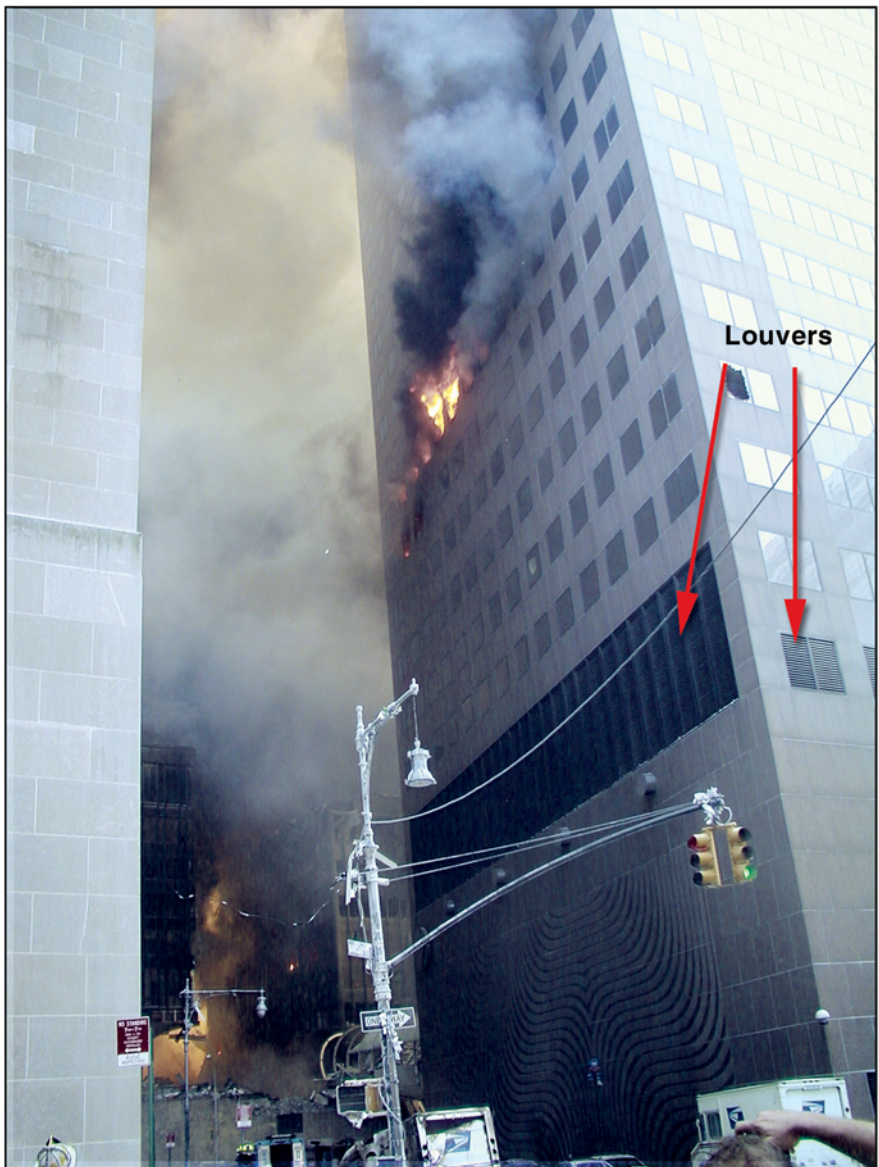
Figure 5-19
Fires on the 11th and 12th floors of
the east face of WTC 7.

As the day progressed, fires were observed on the east face of the 11th, 12th, and 28th floors (see Figure 5-19). The Securities and Exchange Commission occupied floors 11 through 13. Prior to collapse, fire was seen to have broken out windows on at least the north and east faces of WTC 7 on some of the lower levels.
