11-4403-CV

United States Court of Appeals
for the
Second Circuit

JOINT APPENDIX
Volume 13 of 16 (Pages JA-3321 to JA-3616)

In re: September 11 Property Damage and Business Loss Litigation

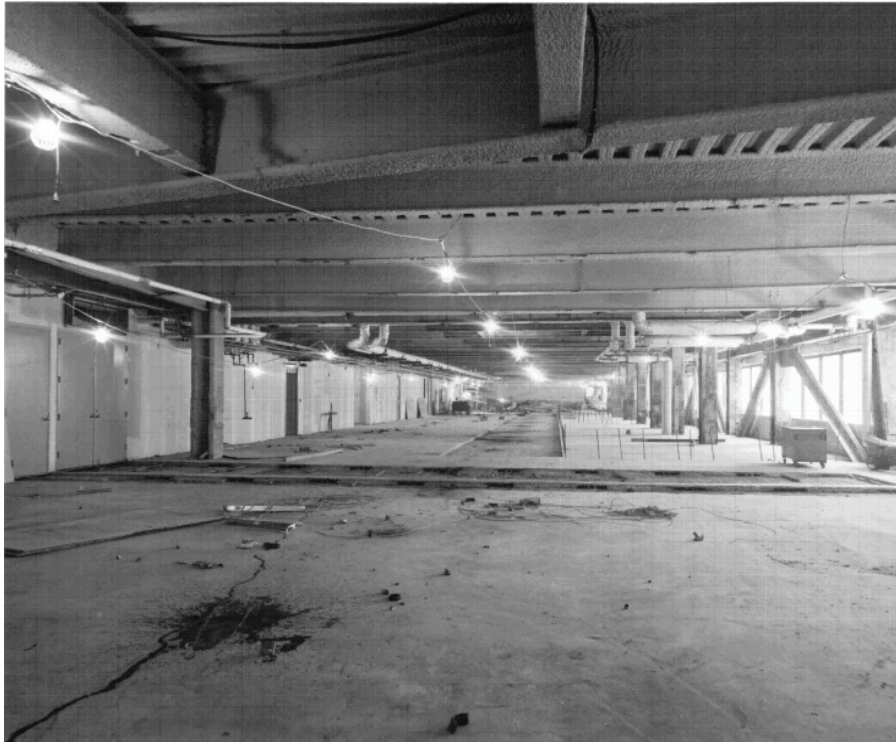
Figure 3. Photograph showing condition of fireproofing in WTC7.²
(Bernstein Photo 5-93 View: 5th floor NE→NW (BERNSTEIN0000029.01.pdf))

In summary, the WTC7 building had a number of deficiencies with respect to its fire protection. These deficiencies included:

- Improper specification of the steel framing in the building as restrained;
- An inadequate fire resistance rating of 1-hour for the floor assemblies based on an unrestrained assembly classification;
- Failure to fill the cavities between the upper beam flanges and the fluted metal decks with fireproofing material in accordance with UL requirements for floor assemblies, further reducing the actual level of fire resistance provided for the floor assemblies;
- Failure to provide a 3-hour fire separation between the standby generator spaces (Occupancy Group D-1) and adjacent spaces (generally Group E);
- Incomplete sprinkler protection, including the lack of sprinkler protection or alternative fire suppression in the SB standby generator spaces on the 5th floor.

As a result of these deficiencies, WTC7 did not meet the standards for fire protection of a Class I-B structure and consequently was more vulnerable to fire than it should have been.

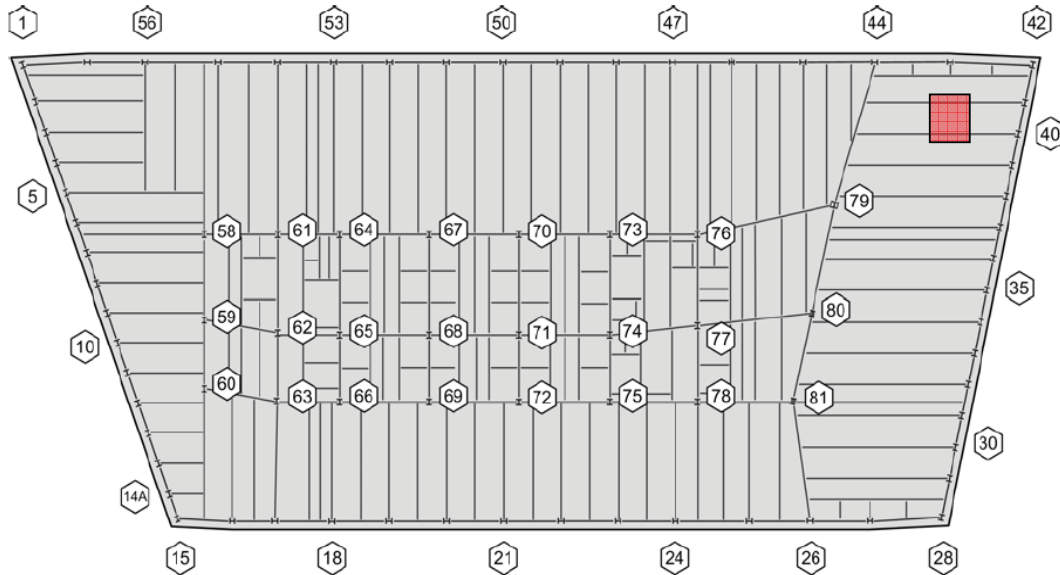
as to whether the results of this test can be extrapolated to actual floor constructions with spans that are more than 4 times longer than the test assembly, as they were in the northeast corner of WTC7. As noted in Section 4.2 of the ASTM E119 standard, "...Variation from the test conditions or specimen construction, such as size, materials, method of assembly, also affects the fire-test-response. For these reasons, evaluation of the variation is required for application to construction in the field." To illustrate this point, Figure 4 shows the approximate area of a floor test assembly superimposed as a red rectangle on a typical WTC7 floor plan.

Figure 4. Floor plan of WTC7 with approximate area of ASTM E119 test specimen superimposed (red rectangle).

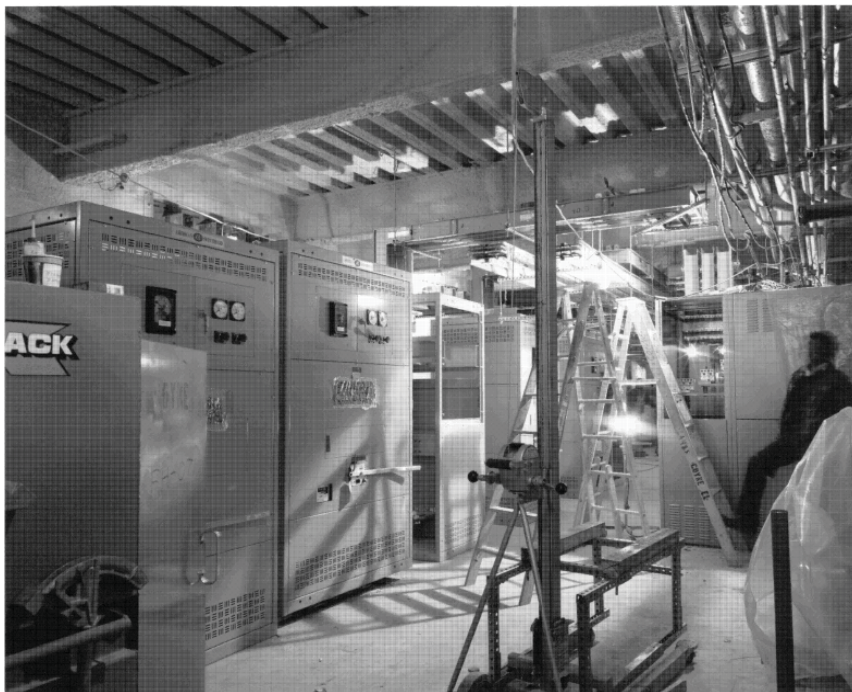
Failure to construct the WTC 7 with the flute cavities above the beams and girders filled with the fire protection material applied to the beams, as required by the UL Fire Resistance Directory listing for the selected floor assembly and the project specification, reduced the fire resistance of the beams, girders and floor assemblies below the level that would have been achieved if these cavities had been filled in compliance with the requirements of the NYCBC. Failure to fill the flute cavities with the fire protection material applied to the beams, as required, permitted the girders and beams to heat up more quickly than expected when exposed to fire conditions. This is discussed in more detail in Section 5.6 of this report and in the expert report prepared by Prof. Colin Bailey.

Figure 5a. Bernstein Photo 14-106 View: 5th FL. NE CORNER (BERNSTEIN0000093.01.pdf)

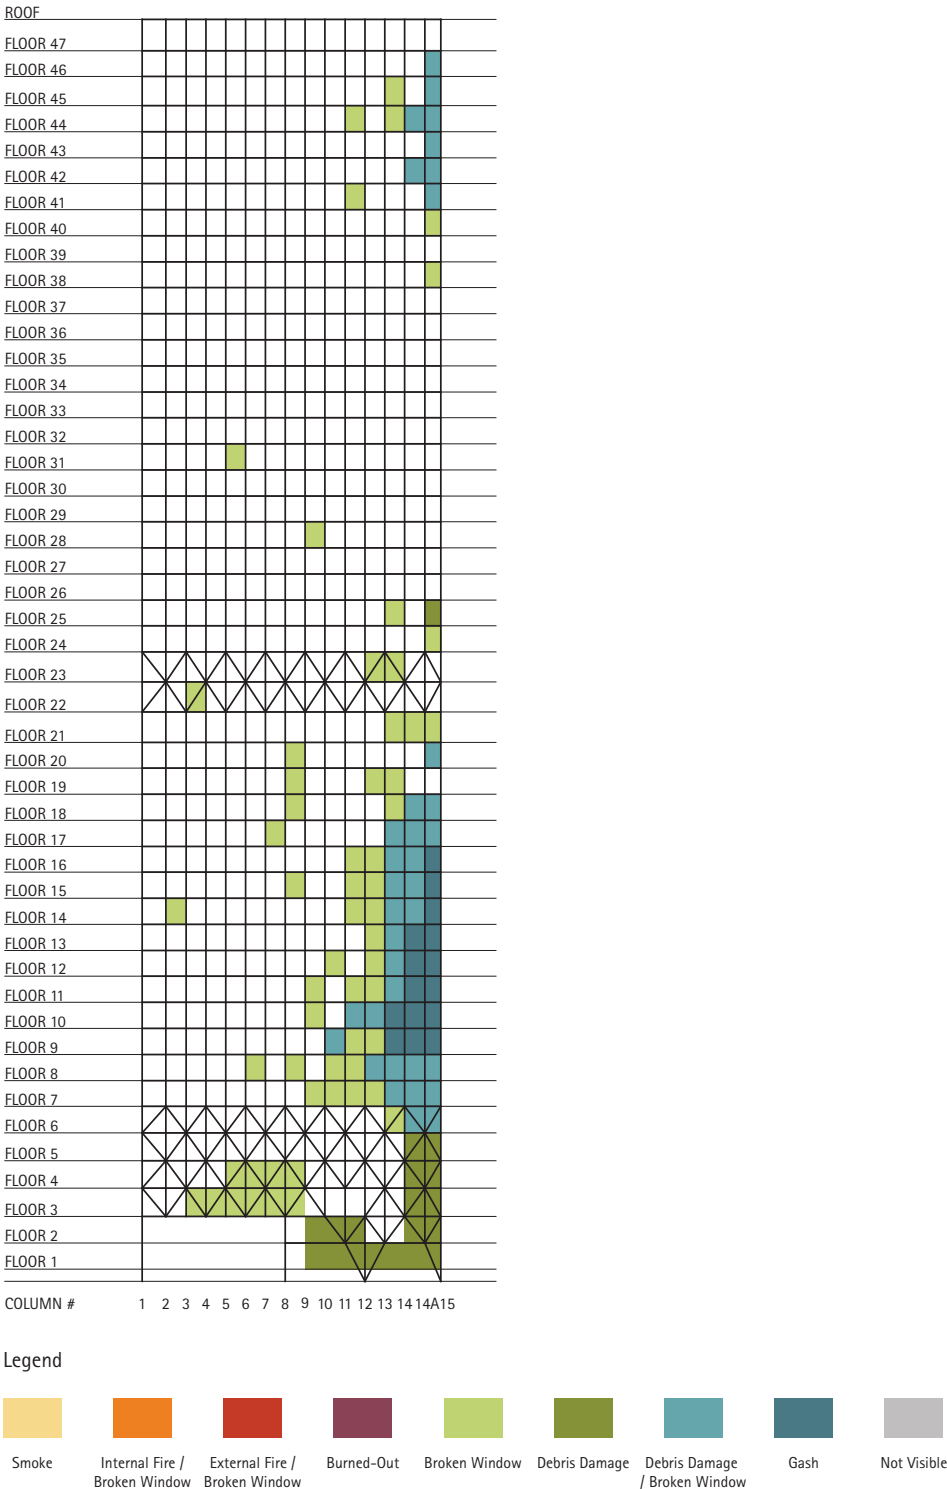
Figure 1.W.01 WTC7 West facade - Debris Damage after WTC1 collapse

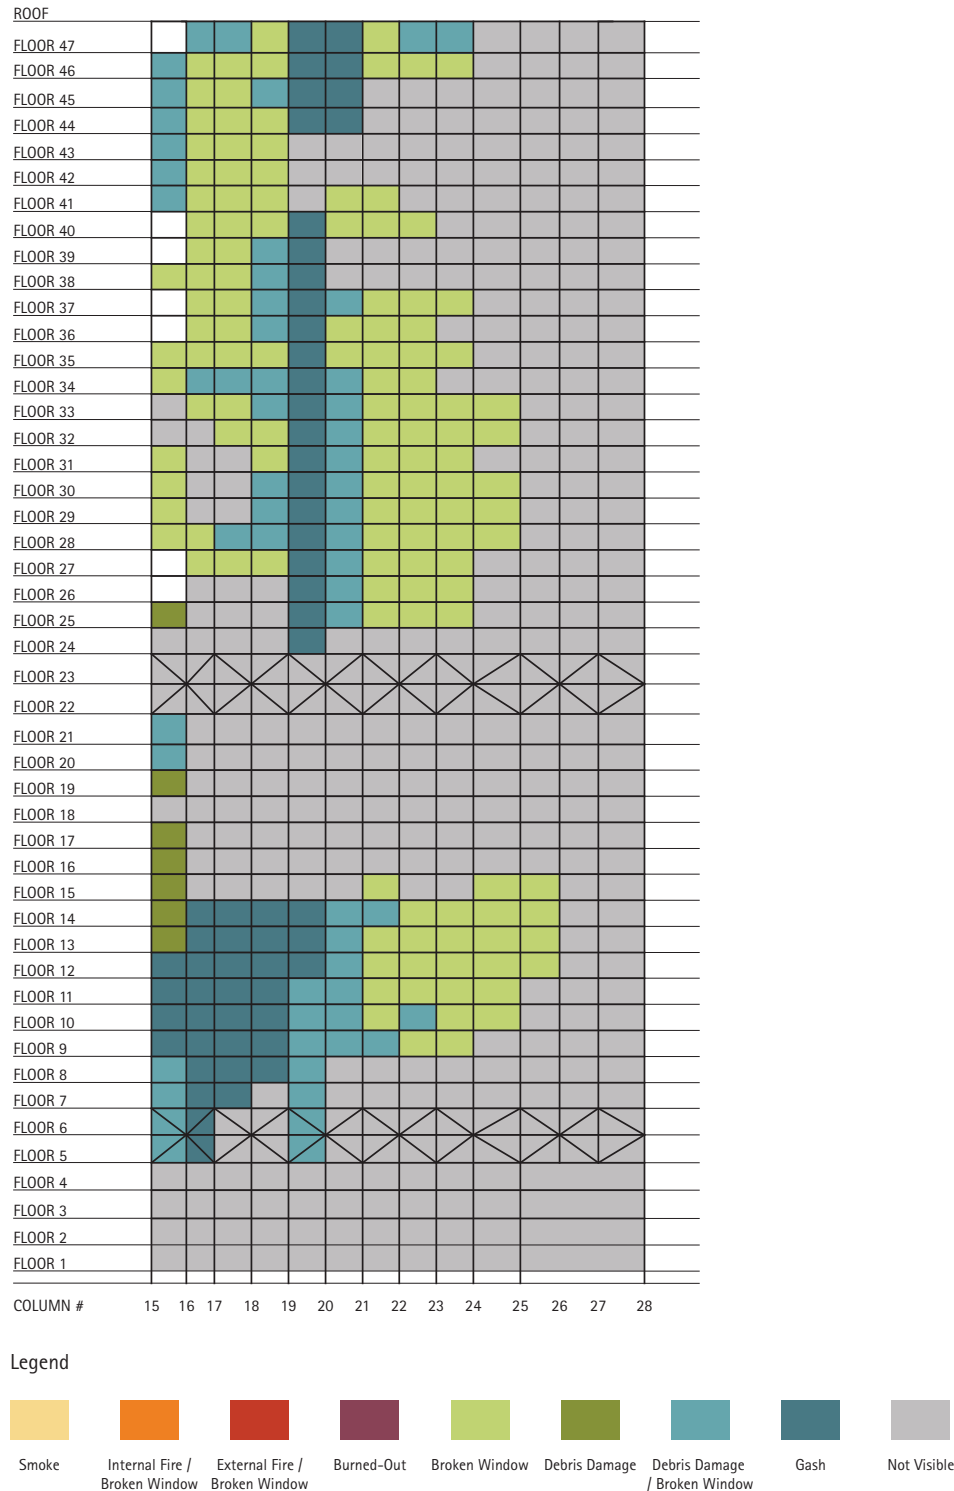
Figure 1.S.01 WTC7 South facade - Debris Damage after WTC1 collapse

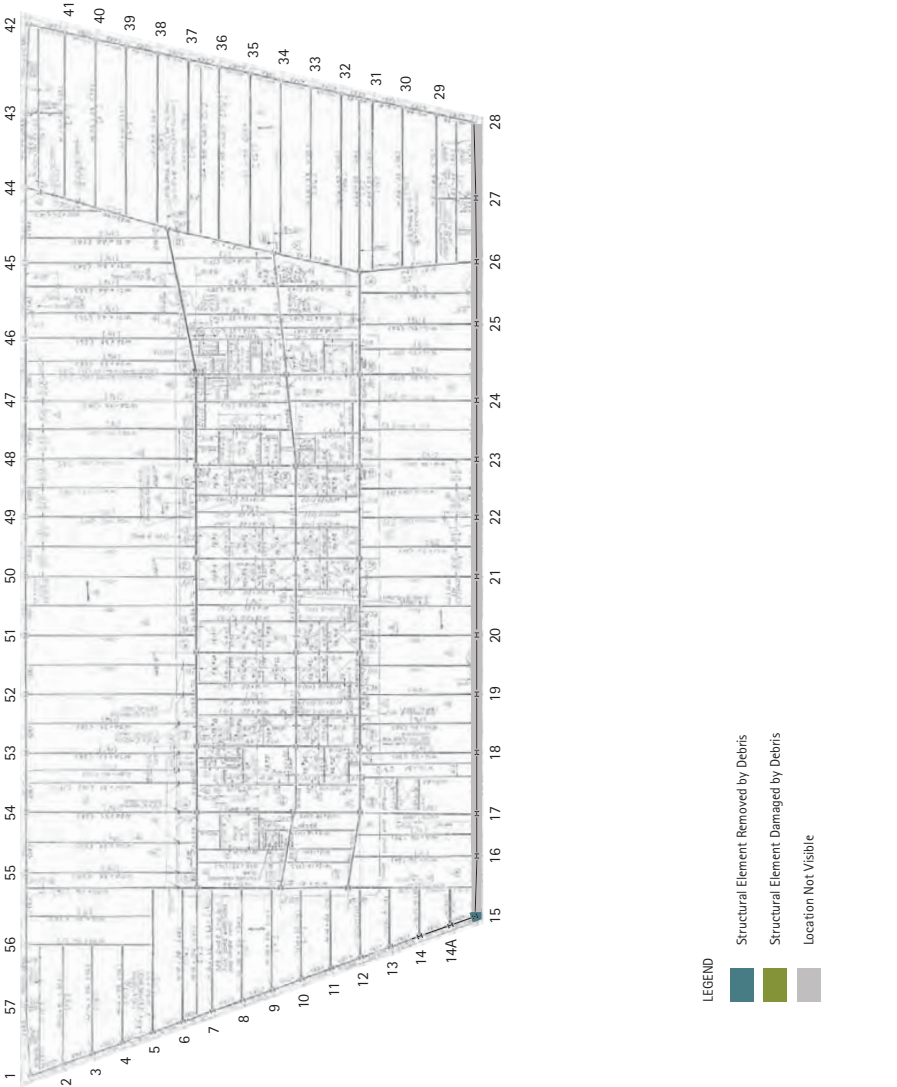
Figure 1.D.02 WTC7 Level 16 Planometric Debris Diagram

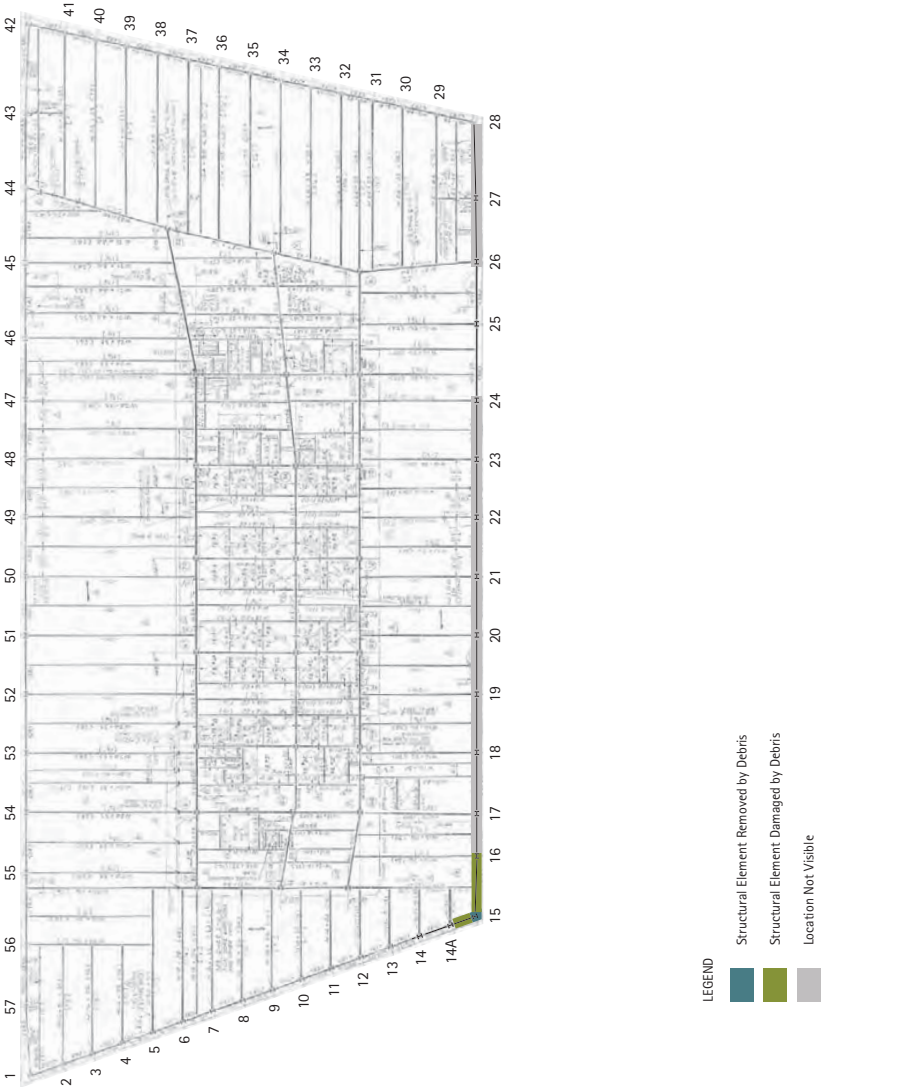
Figure 1.D.03 WTC7 Level 15 Planometric Debris Diagram

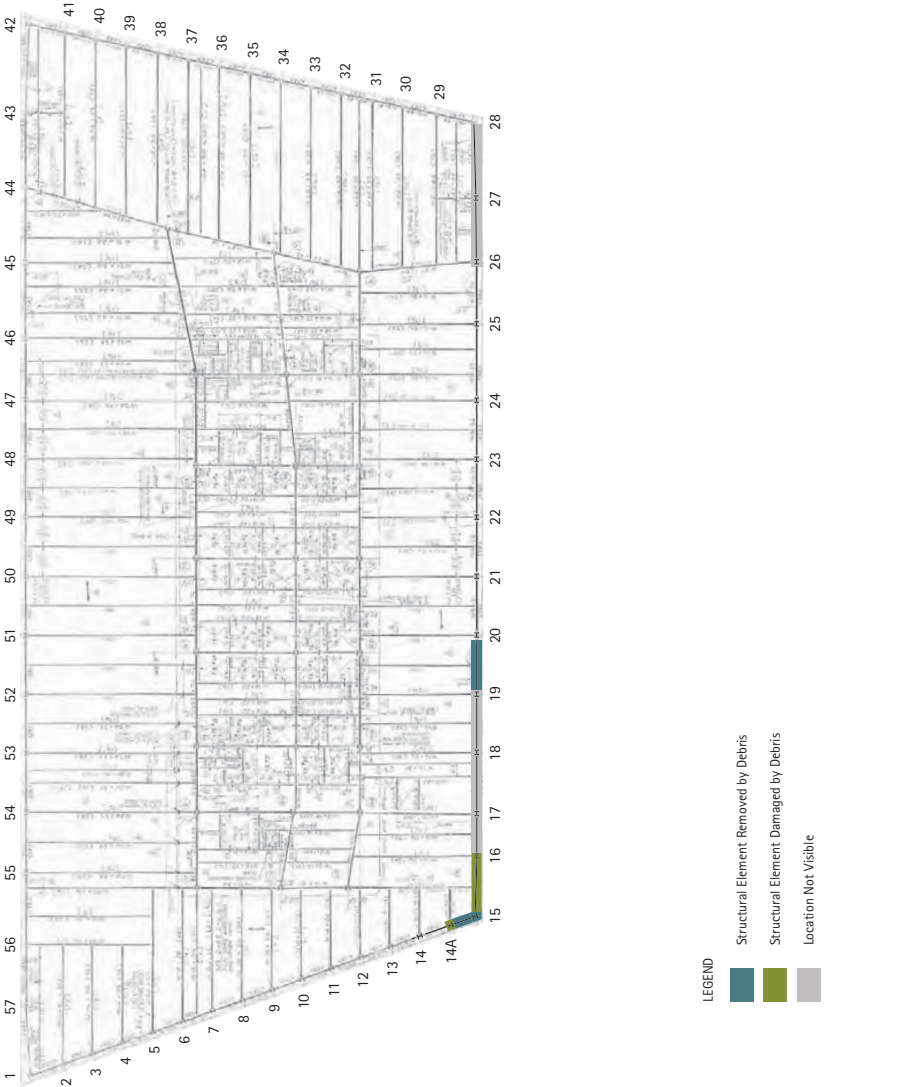
Figure 1.D.04 WTC7 Level 14 Planometric Debris Diagram

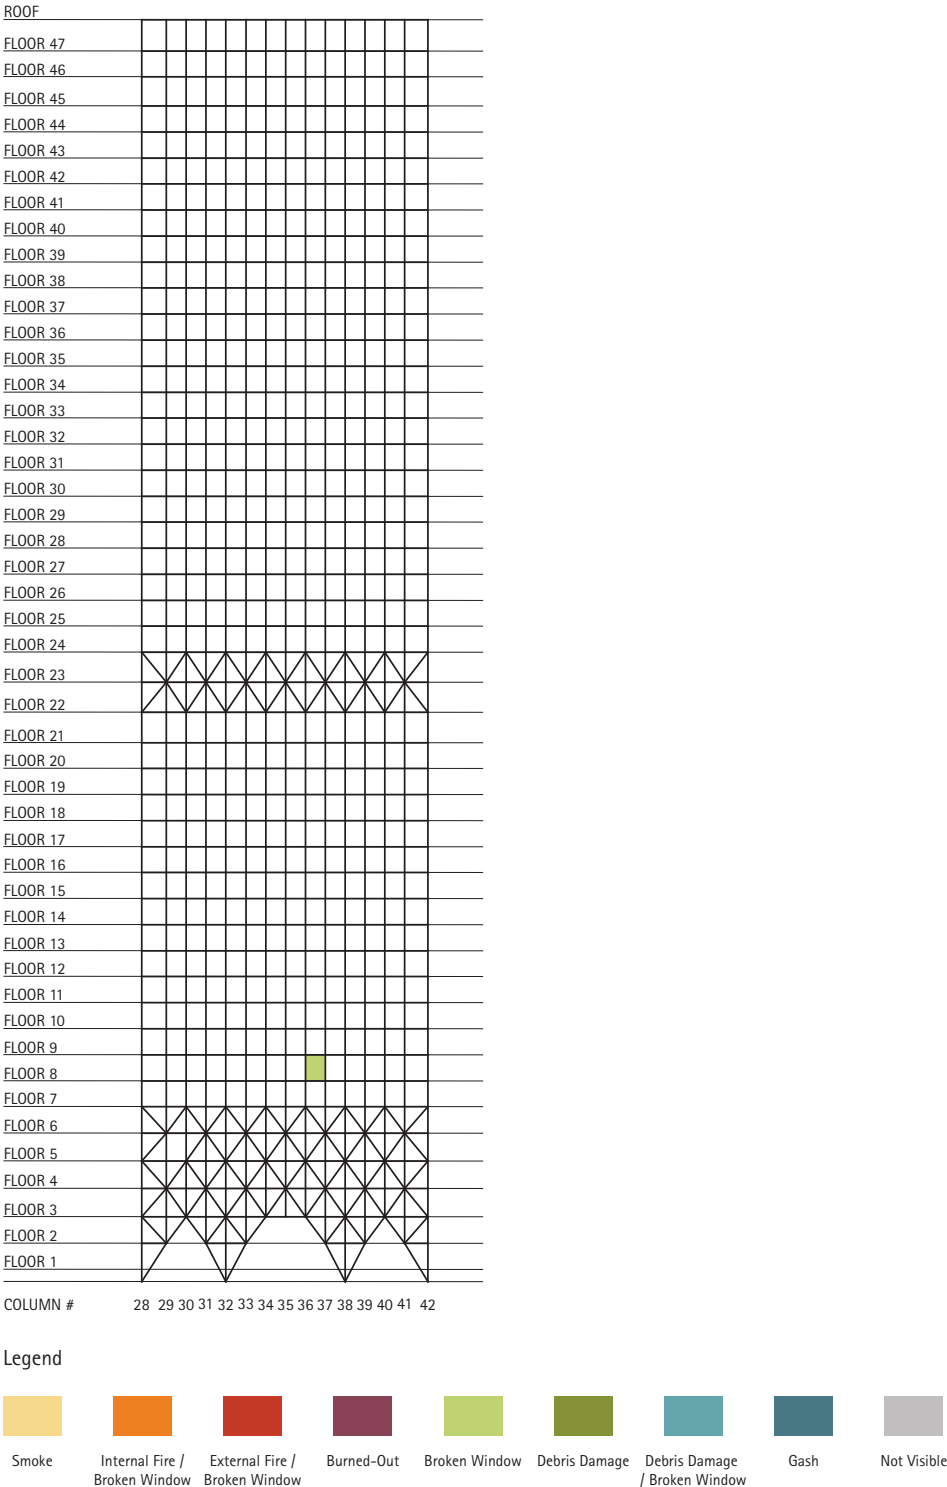
Figure 2.E.01 WTC7 East facade - Debris and Fire Damage at approximately 12PM

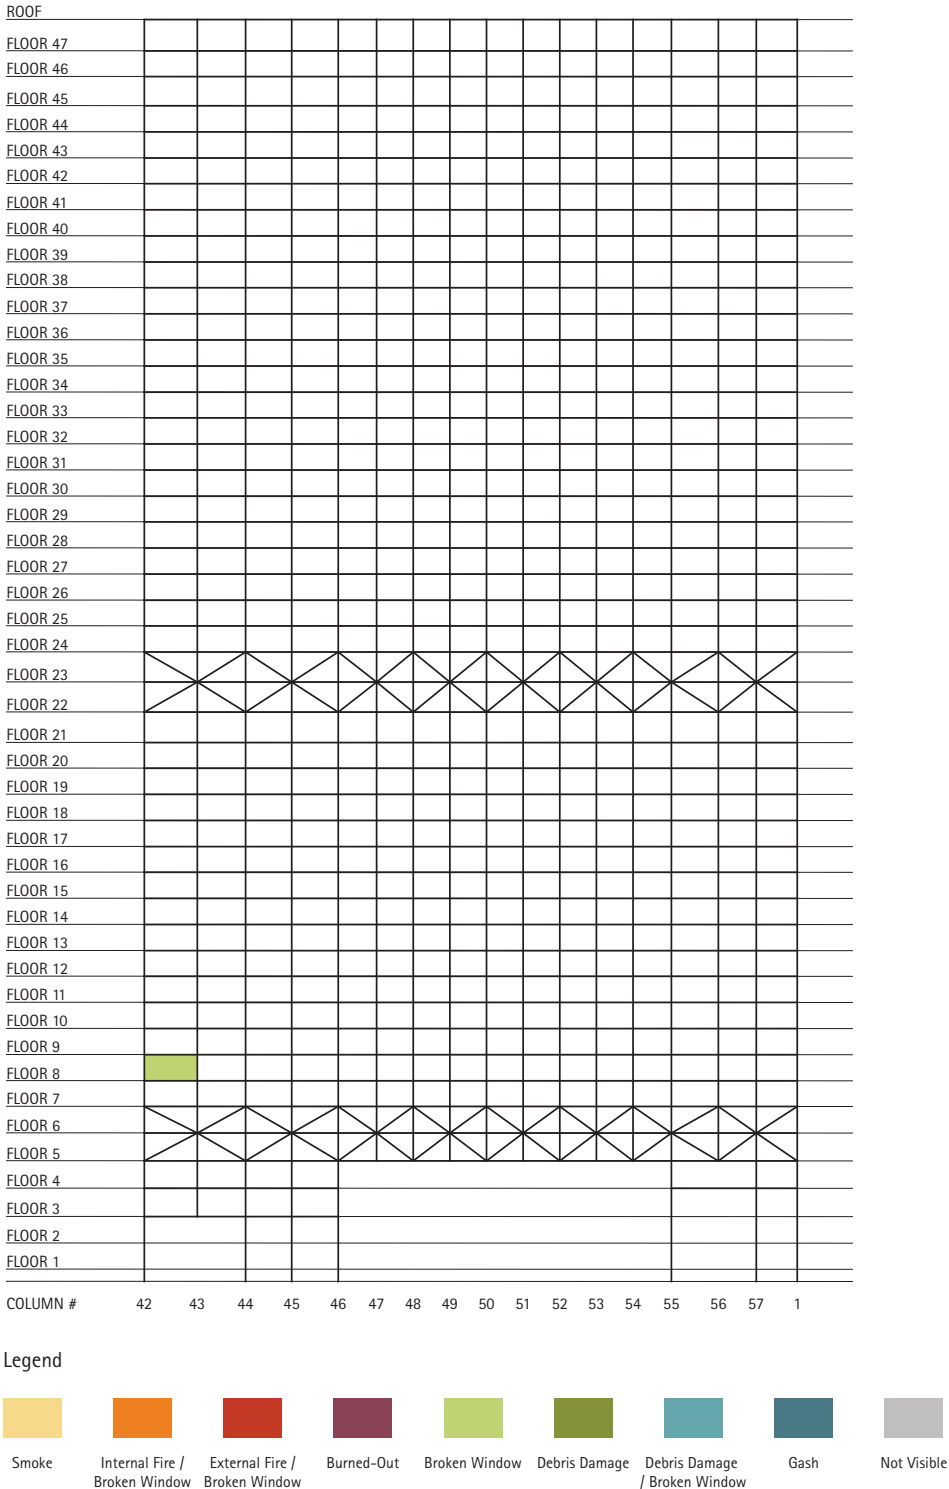
Figure 2.N.01 WTC7 North facade - Debris and Fire Damage at approximately 12PM

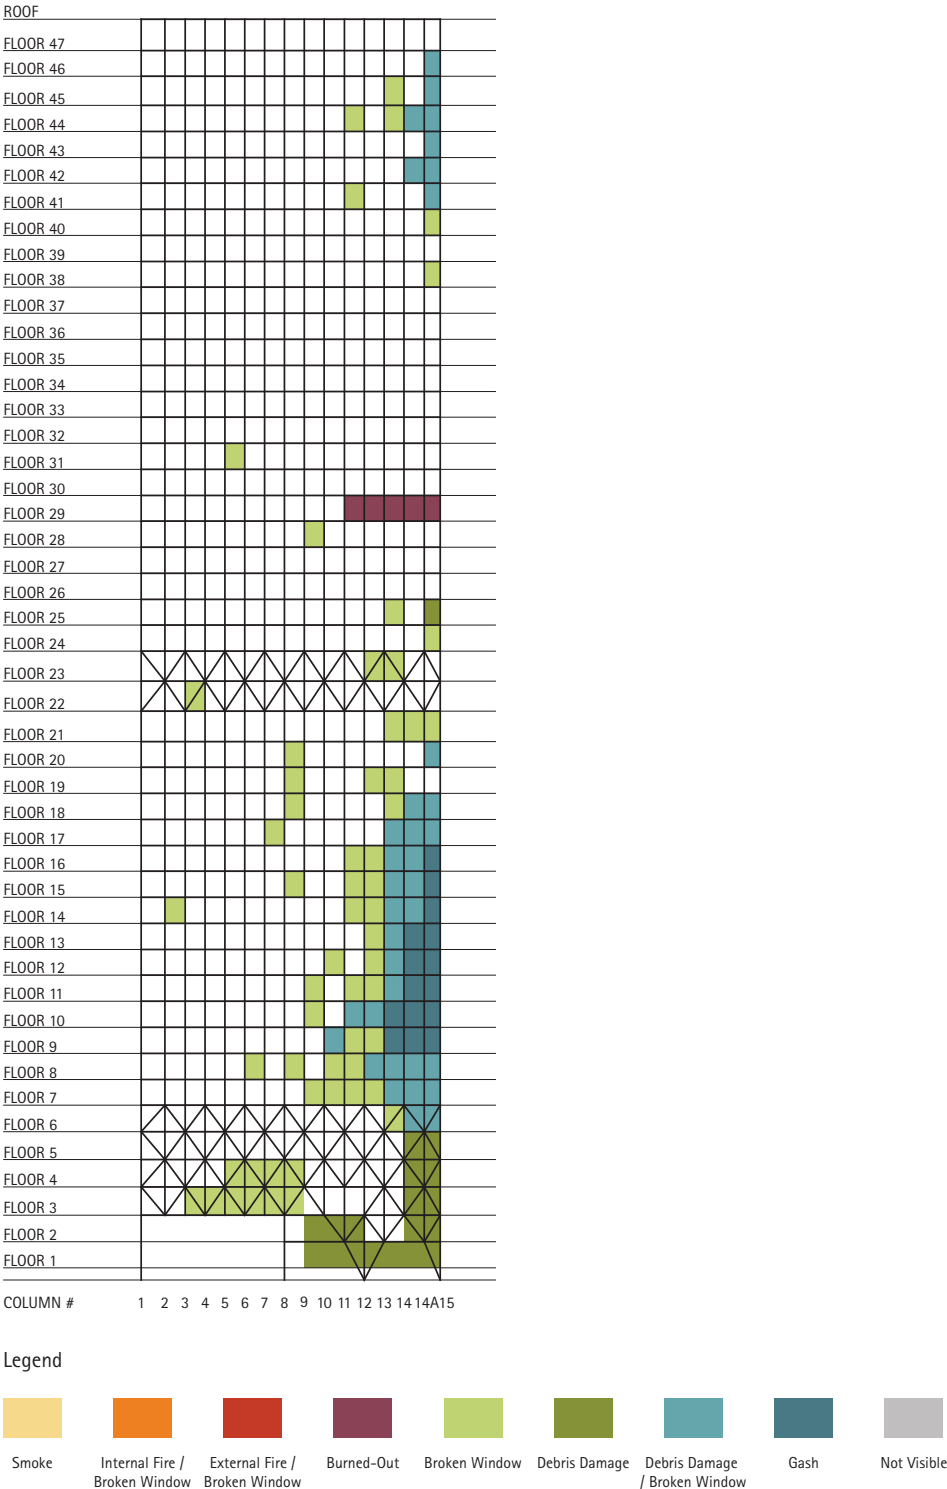
Figure 2.W.01 WTC7 West Facade - Debris and Fire Damage at approximately 12PM

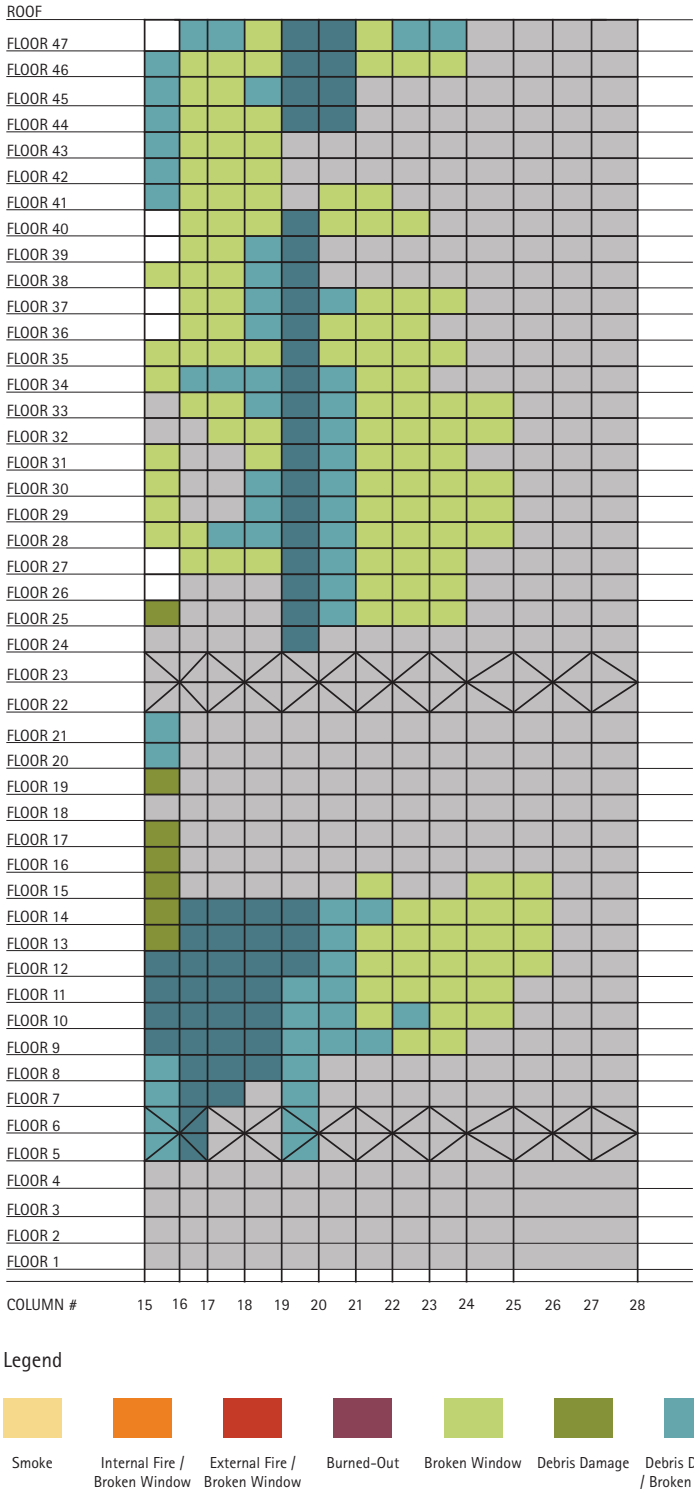
Figure 2.S.01 WTC7 South facade - Debris and Fire Damage at approximately 12PM

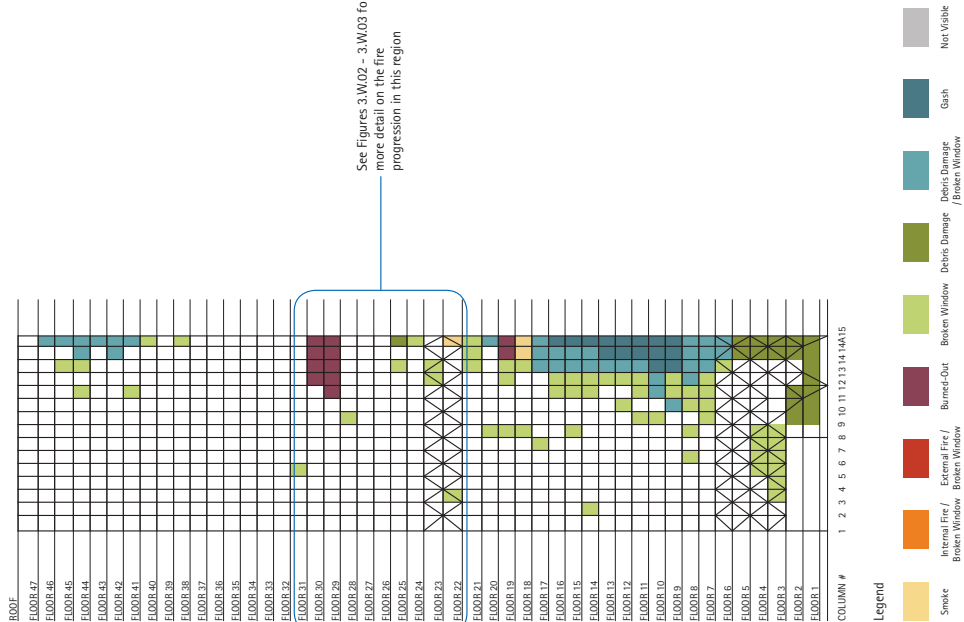
Figure 3.W.01 WTC7 West Facade - Debris and Fire Damage at approximately 1PM

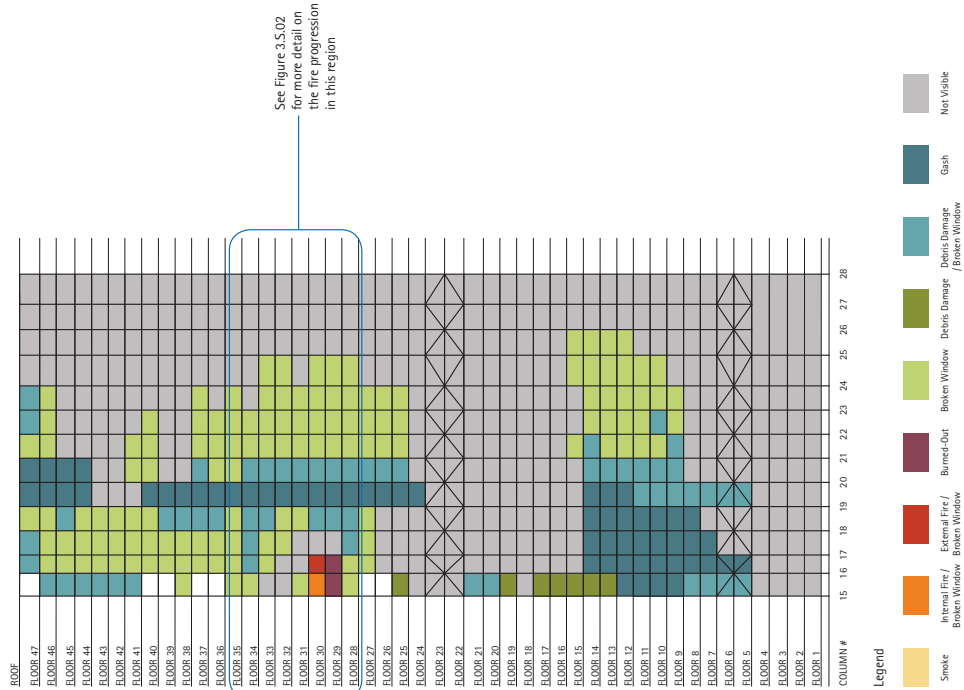
Figure 3.S.01 WTC7 South Facade – Debris and Fire Damage at Approximately 1PM

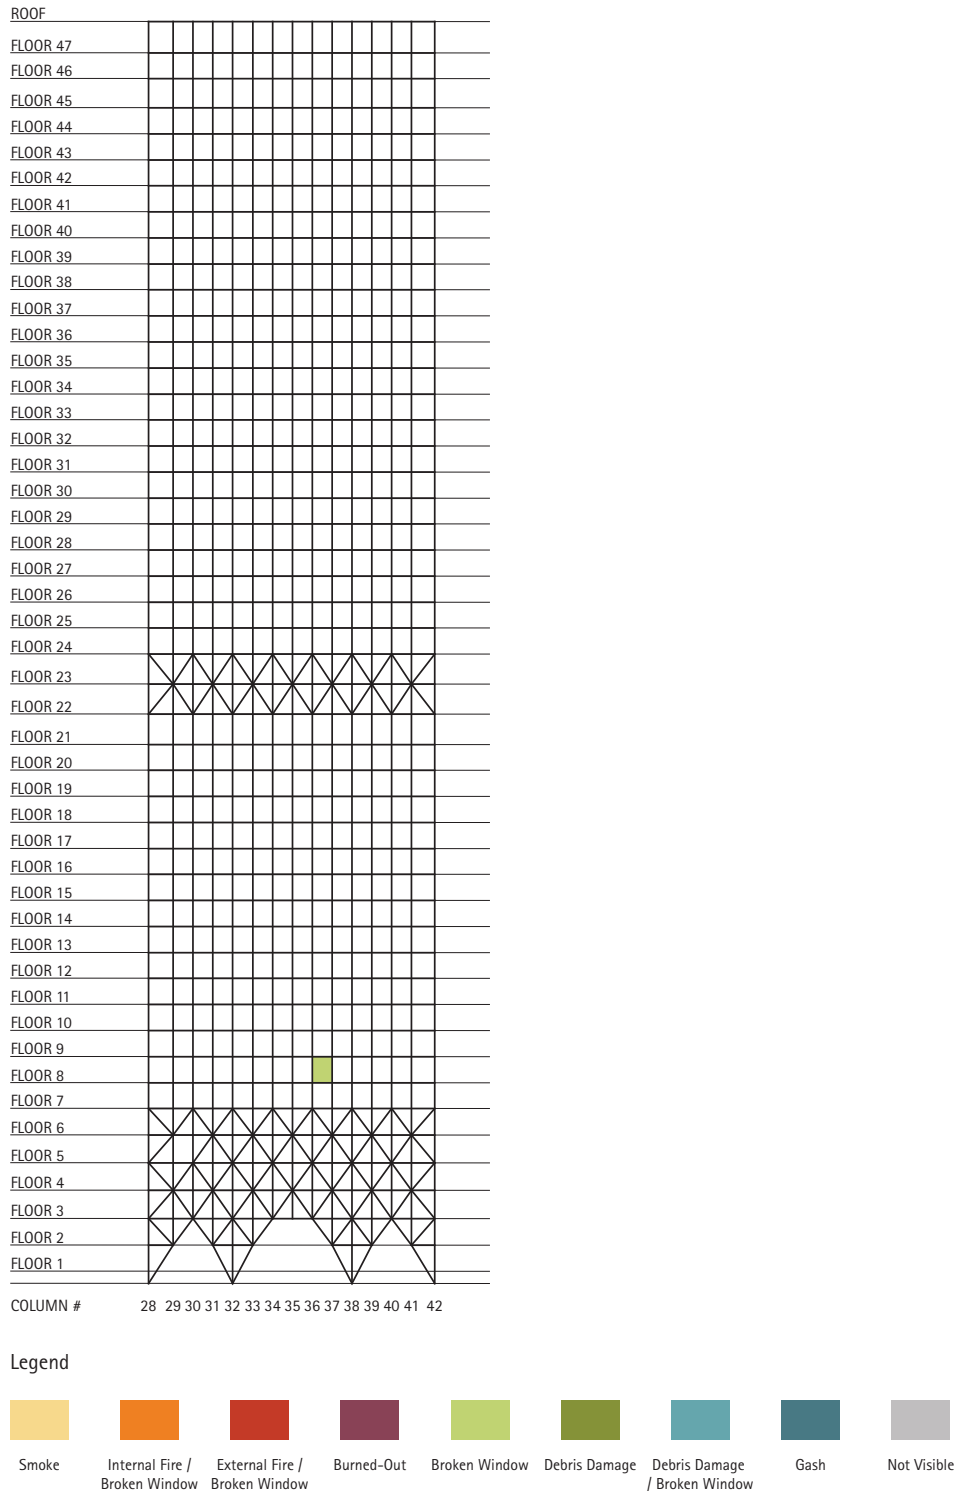
Figure 4.E.01 WTC7 East facade - Debris and Fire Damage at approximately 2PM

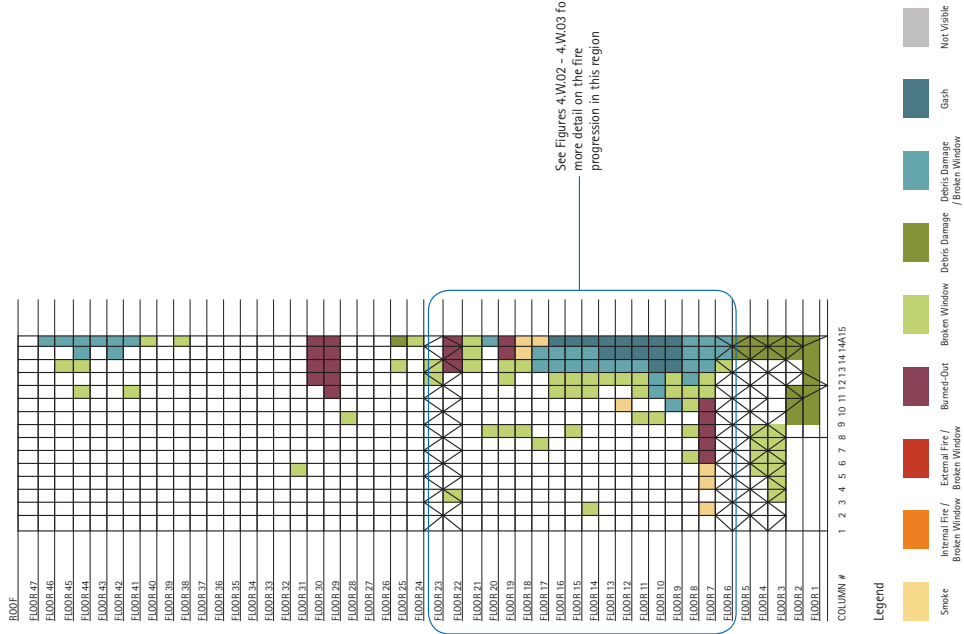
Figure 4.W.01 WTC7 West Facade - Debris and Fire Damage at approximately 2PM

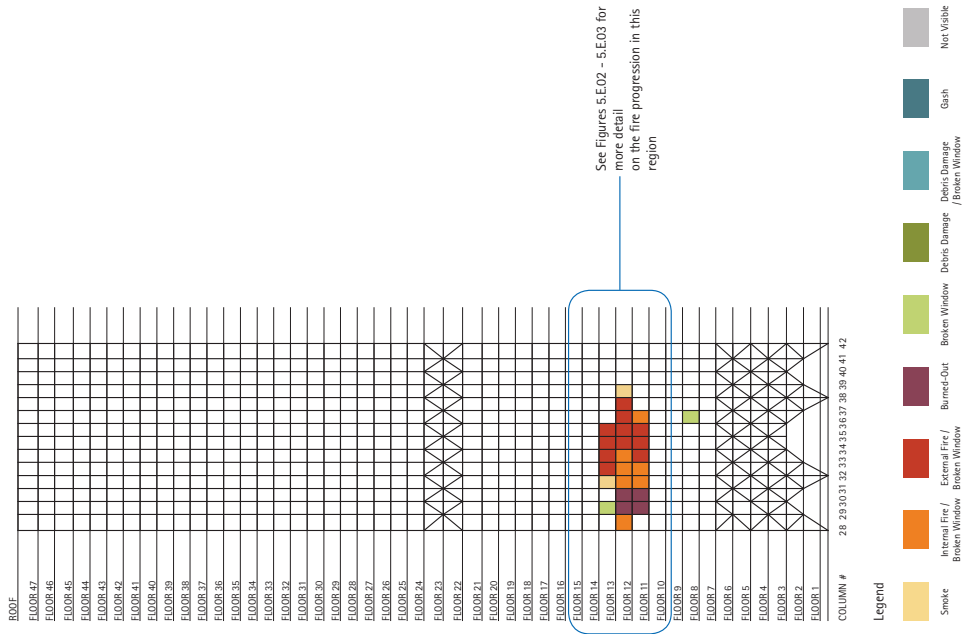
Figure 5.E.01 WTC7 East Facade - Debris and Fire Damage at approximately 3PM

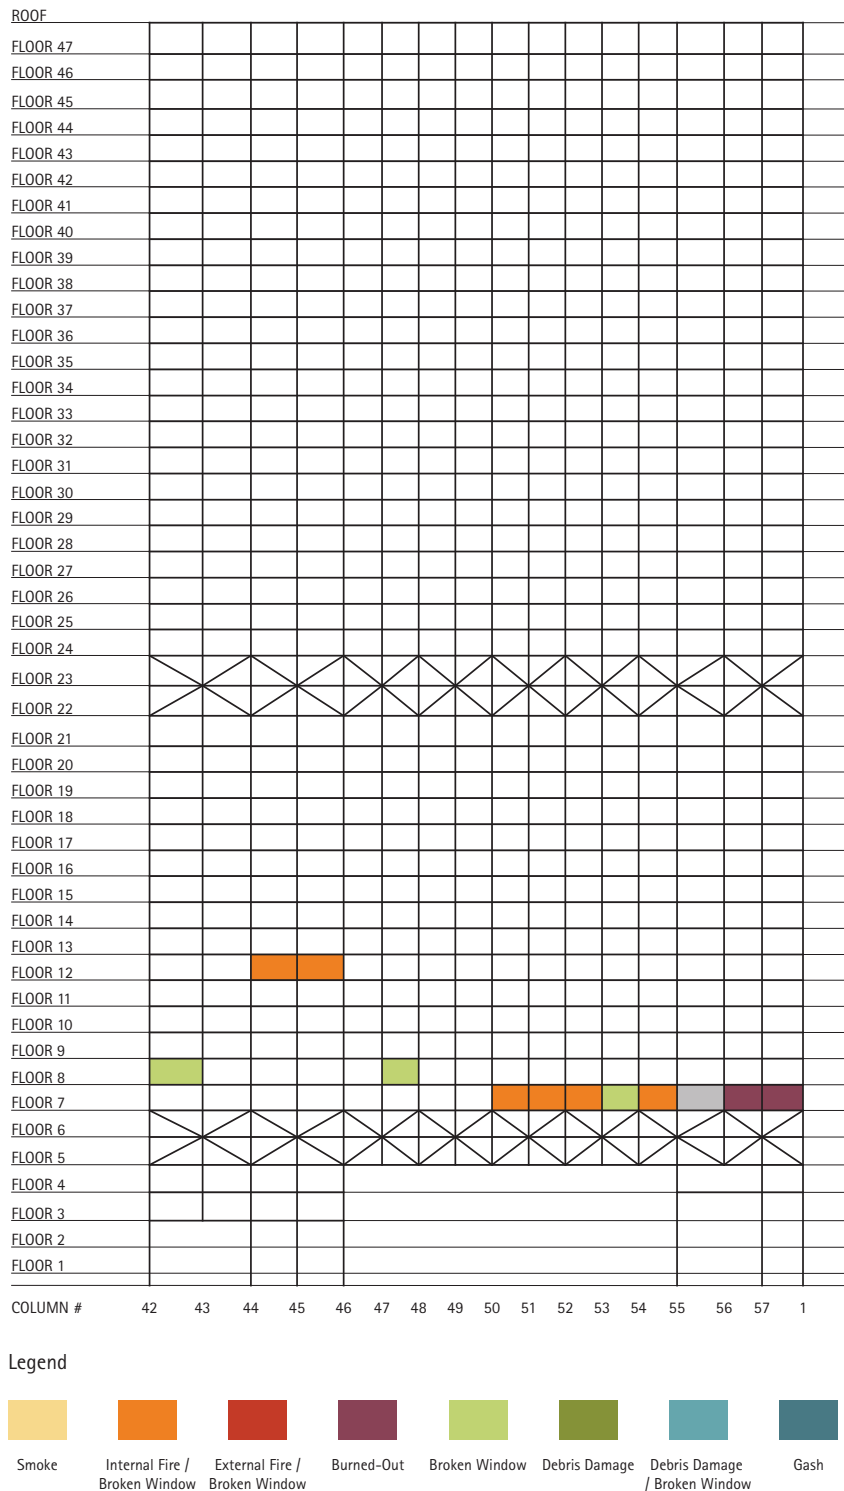
Figure 5.N.01 WTC7 North facade - Debris and Fire Damage at approximately 3PM

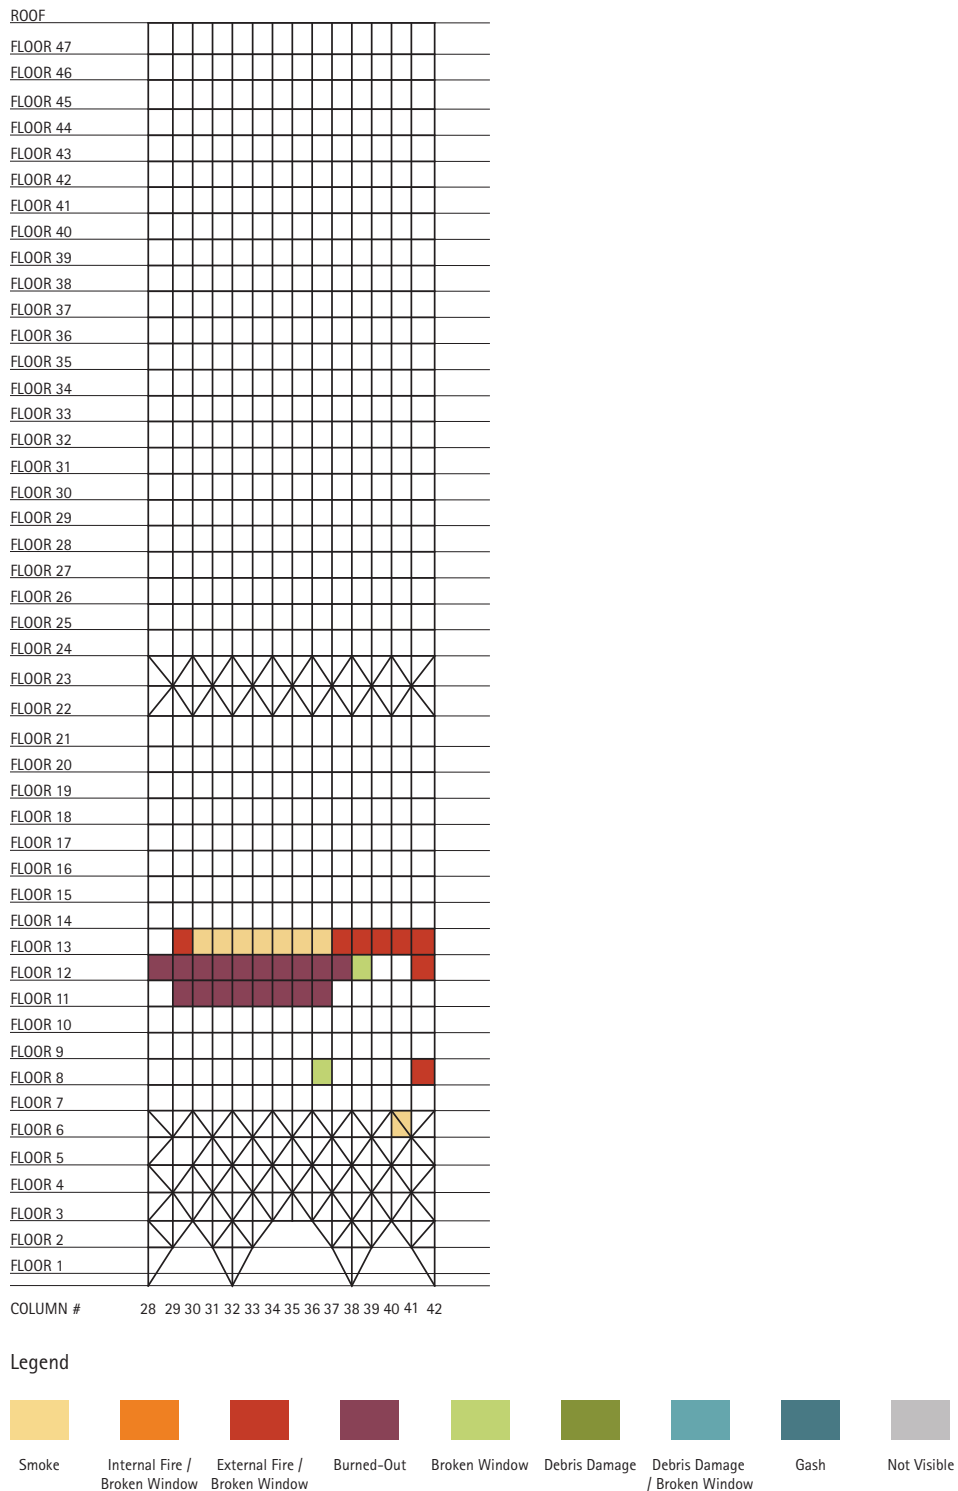
Figure 6.E.01 WTC7 East facade - Debris and Fire Damage at approximately 4PM

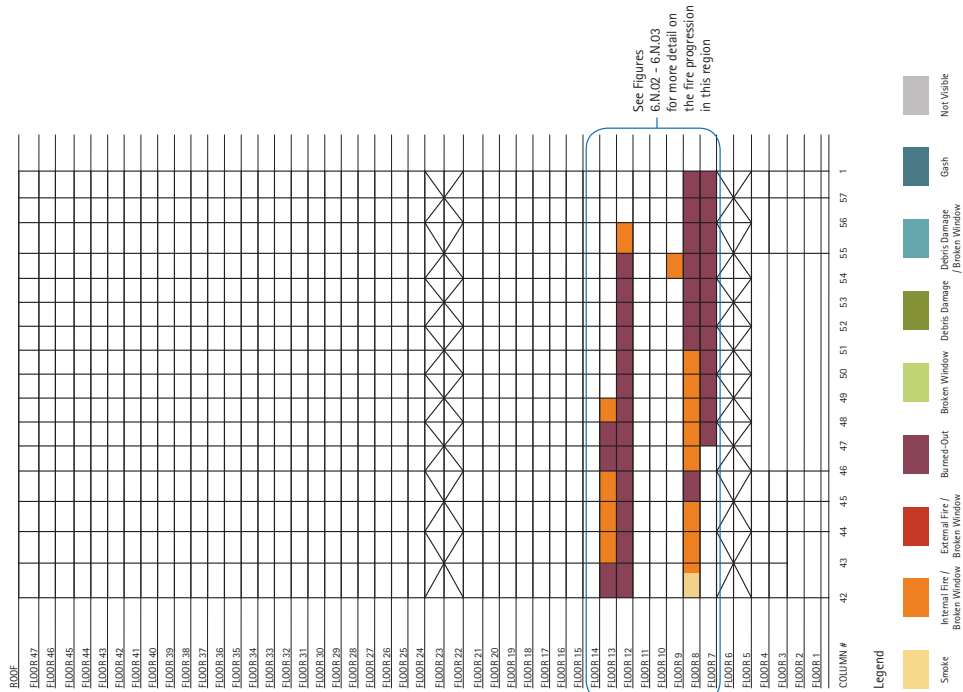
Figure 6.N.01 WTC7 North Facade - Debris and Fire Damage at approximately 4PM

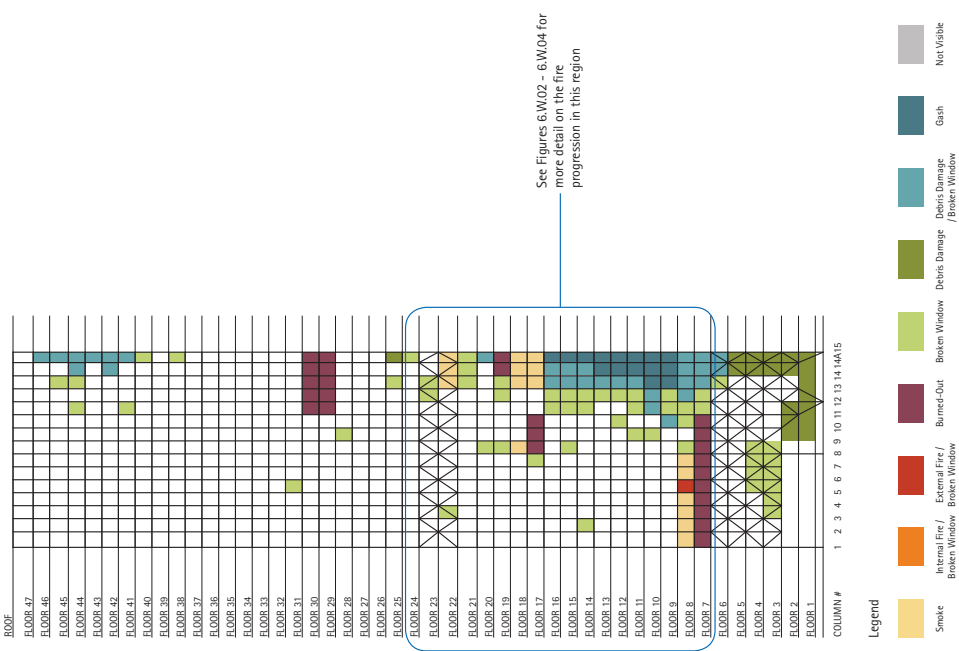
Figure 6.W.01 WTC7 West Facade- Debris and Fire Damage at approximately 4PM

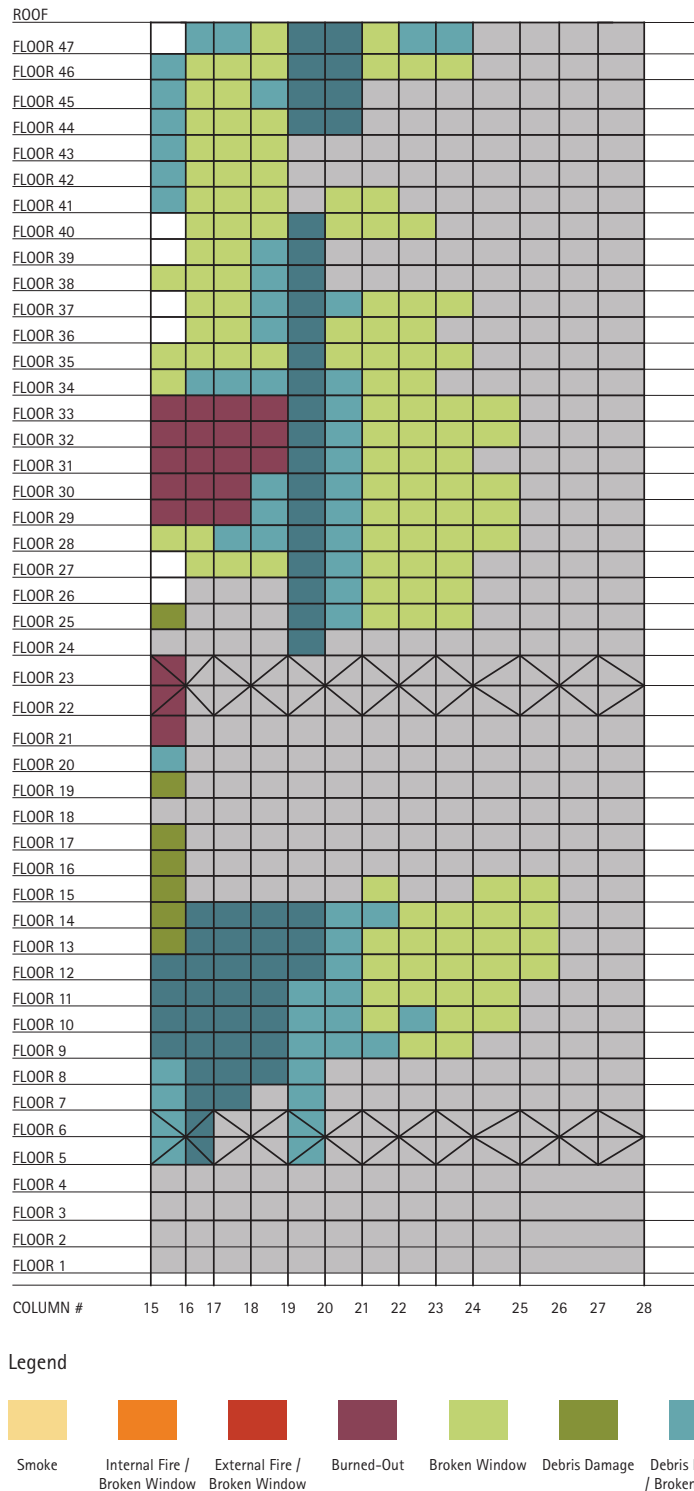
Figure 6.S.01 WTC7 South facade - Debris and Fire Damage at approximately 4PM
