Preliminary Root Causes Analysis of Failures of the Oroville Dam Gated Spillway

R. G. Bea

Center for Catastrophic Risk Management
University of California Berkeley
April 17, 2017¹

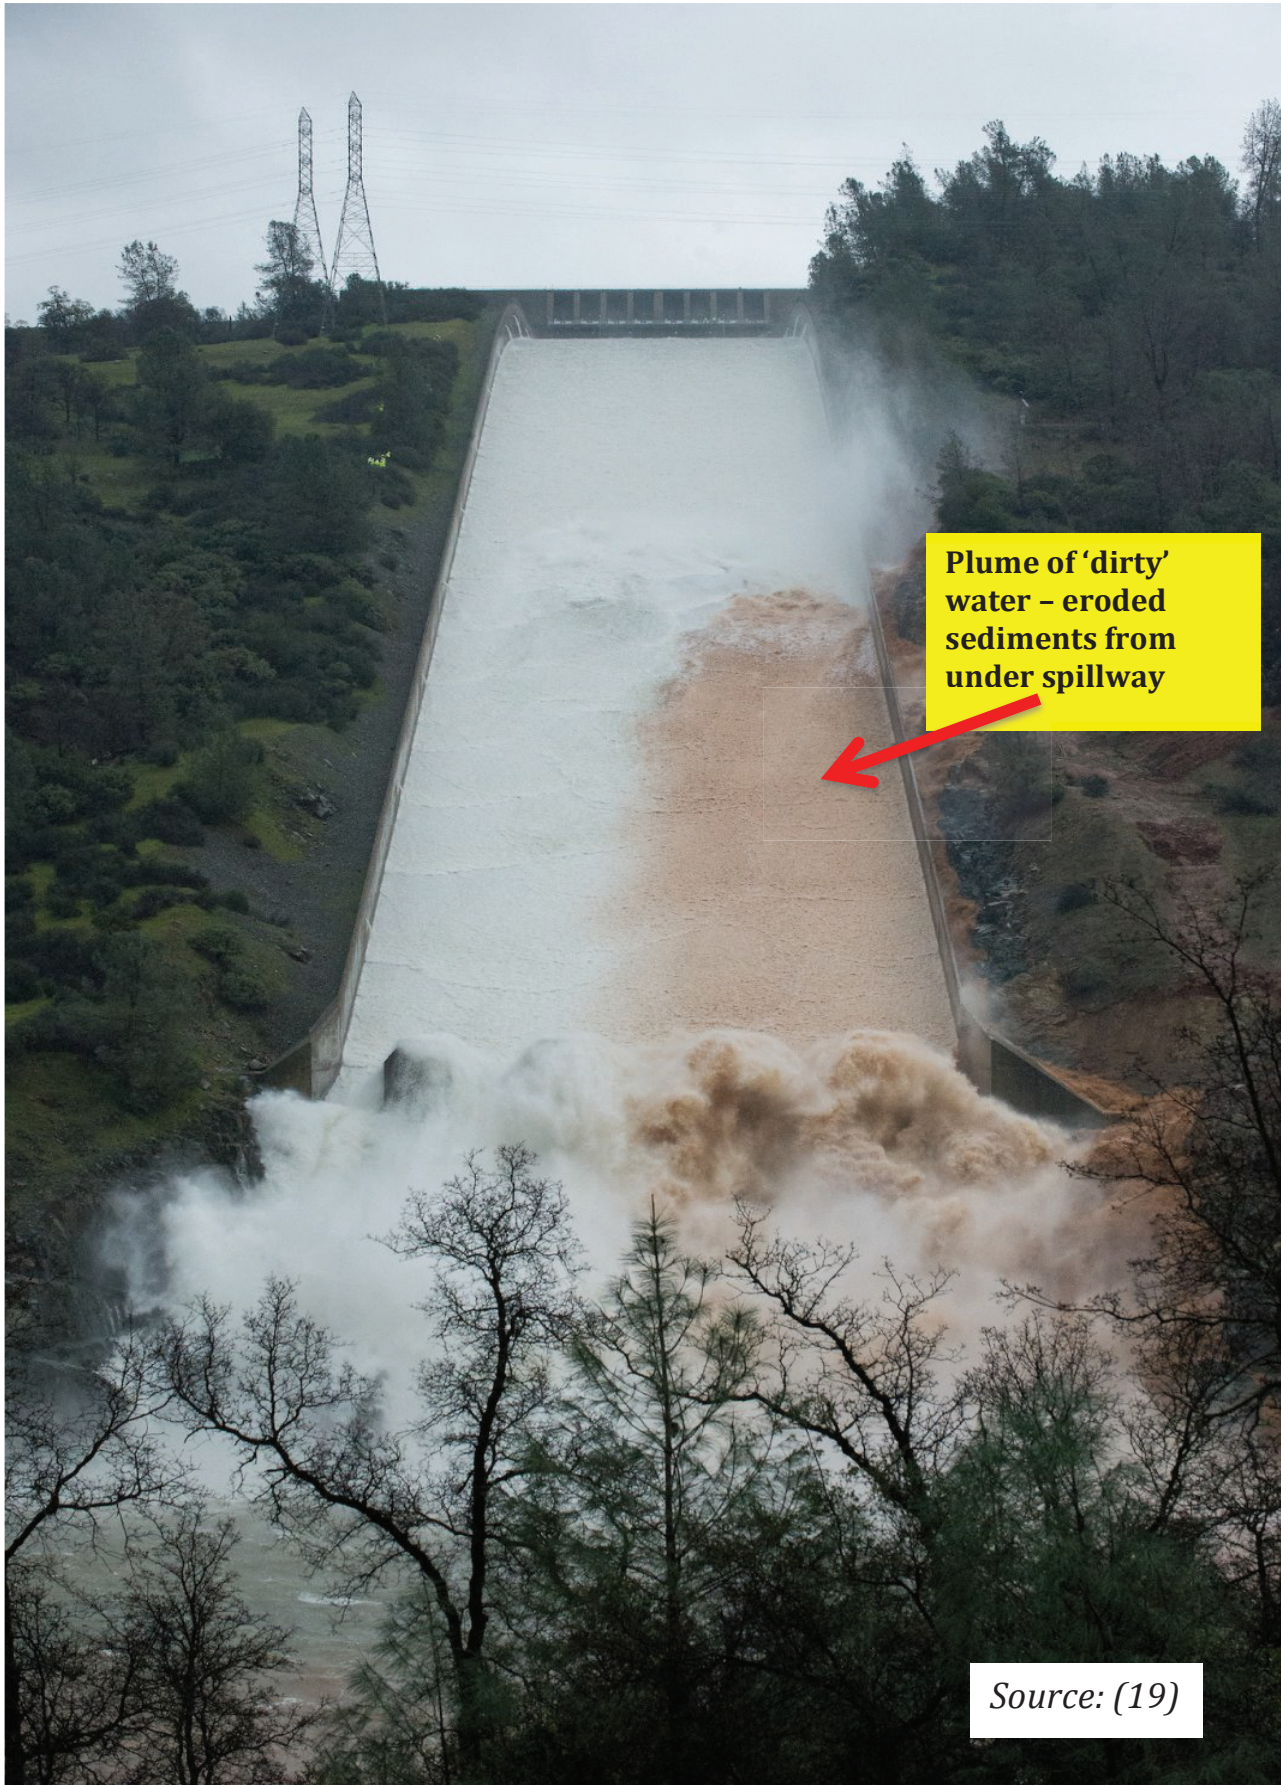
February 7, 2017 - Stage #1

Plume of 'dirty' water - eroded sediments from under spillway

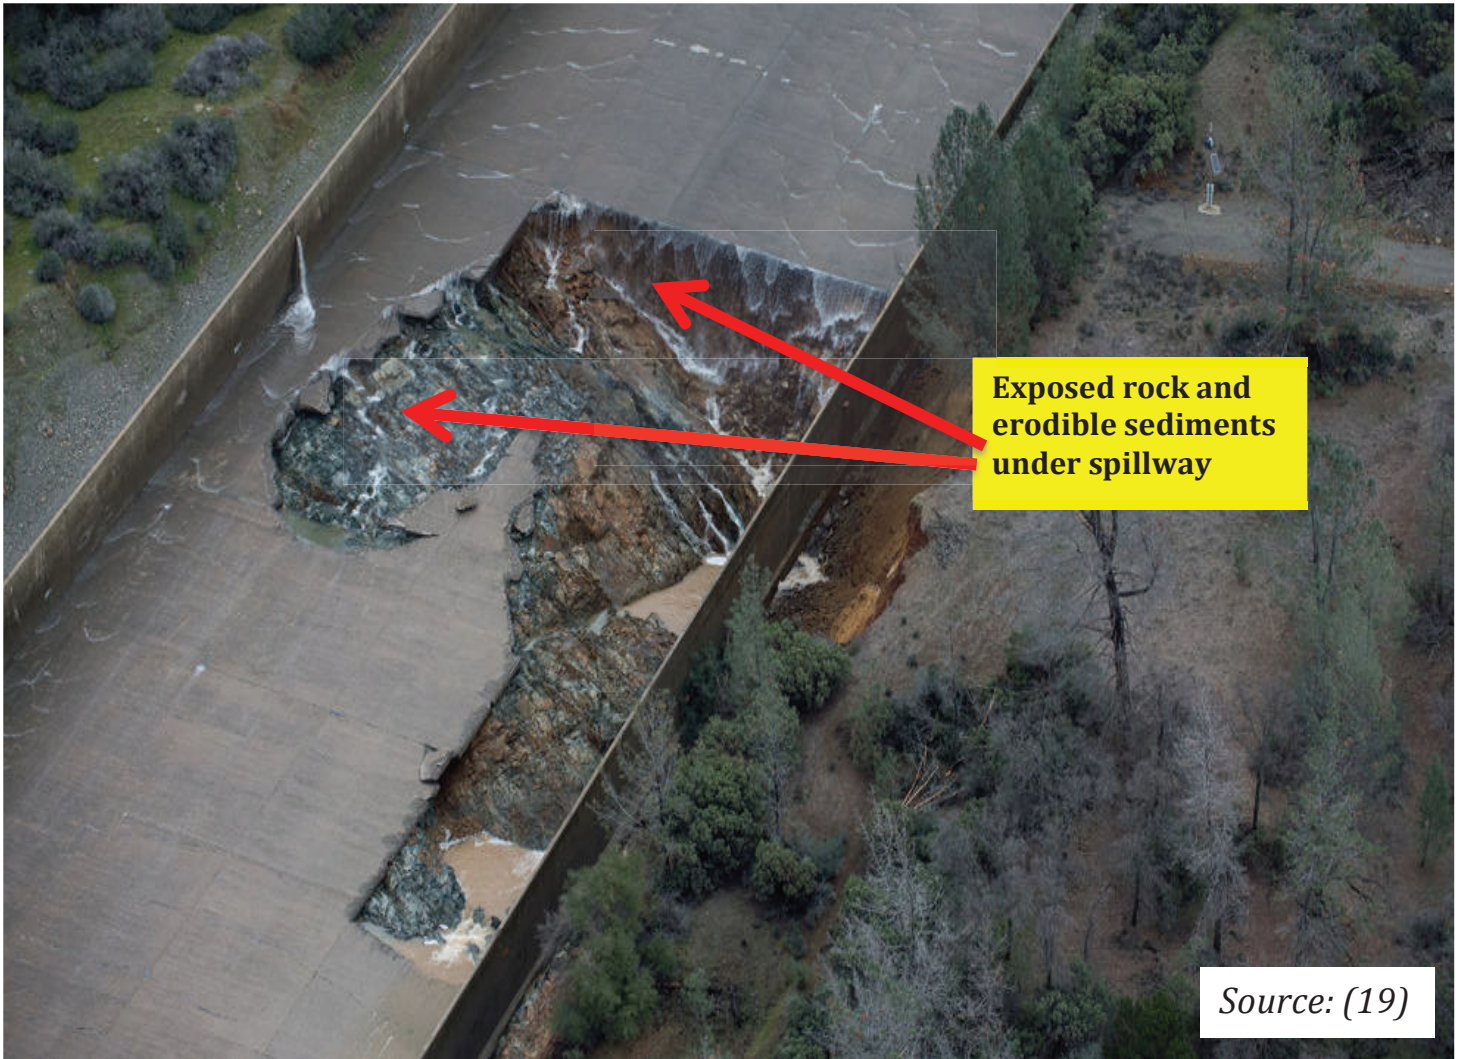
Exposed rock and erodible sediments under spillway

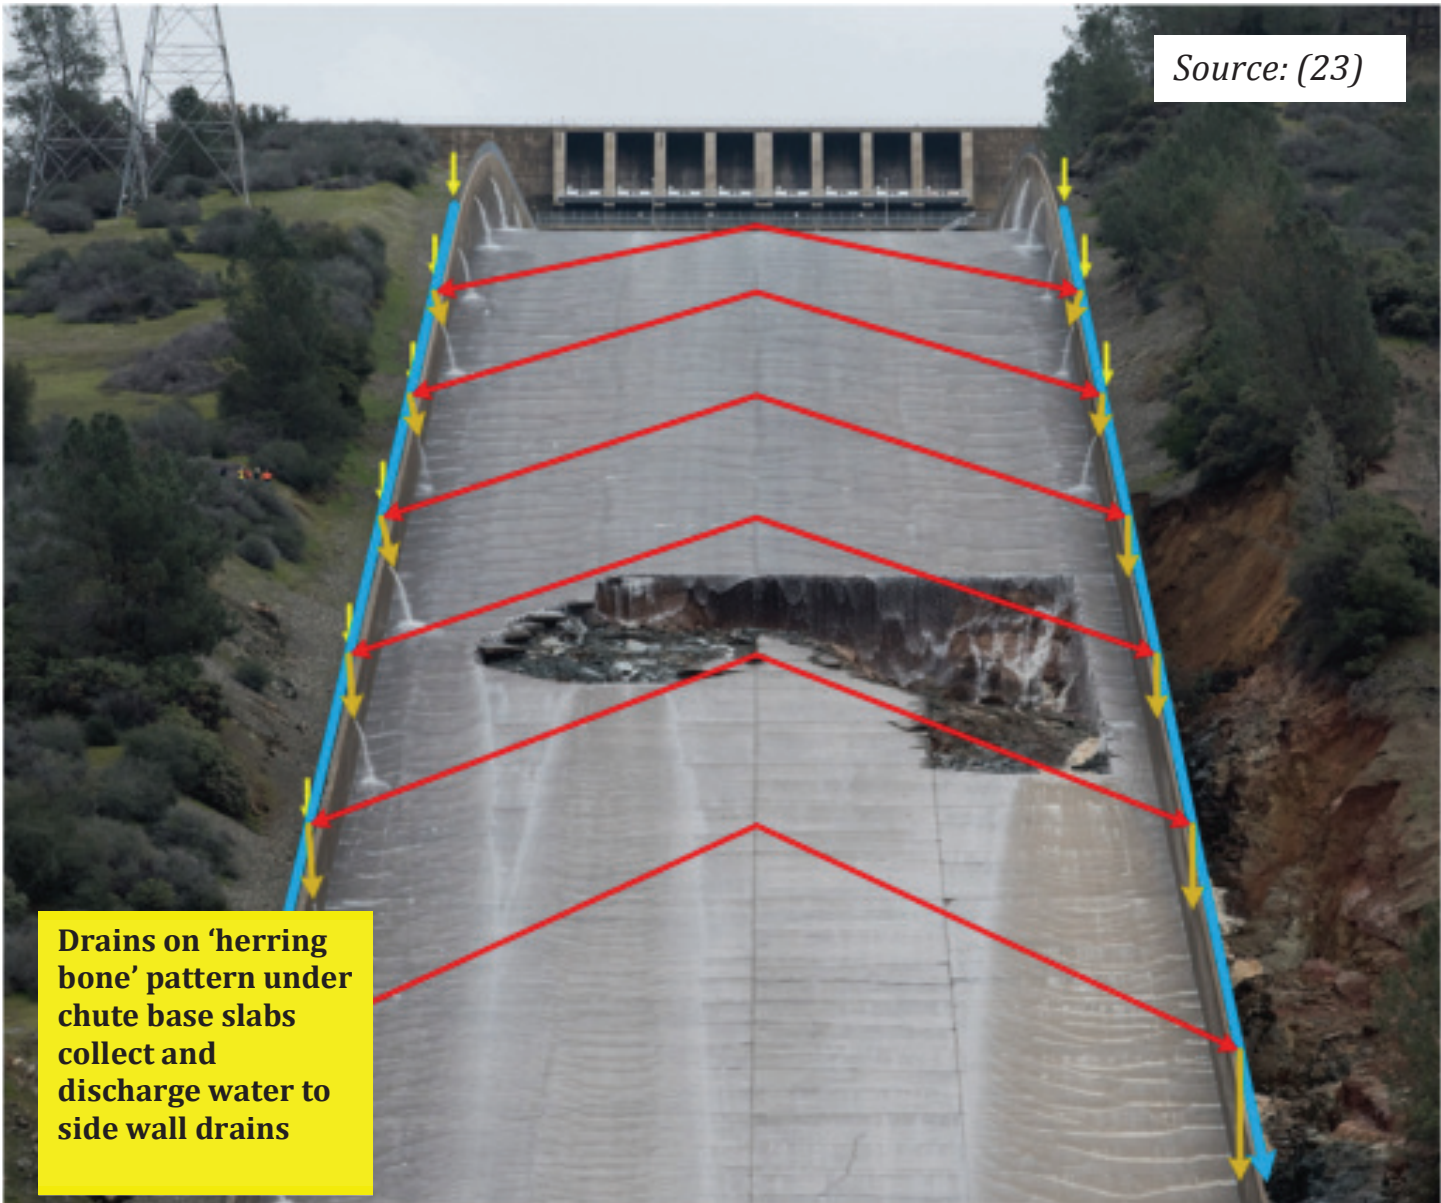
Drains on 'herring bone' pattern under chute base slabs collect and discharge water to side wall drains

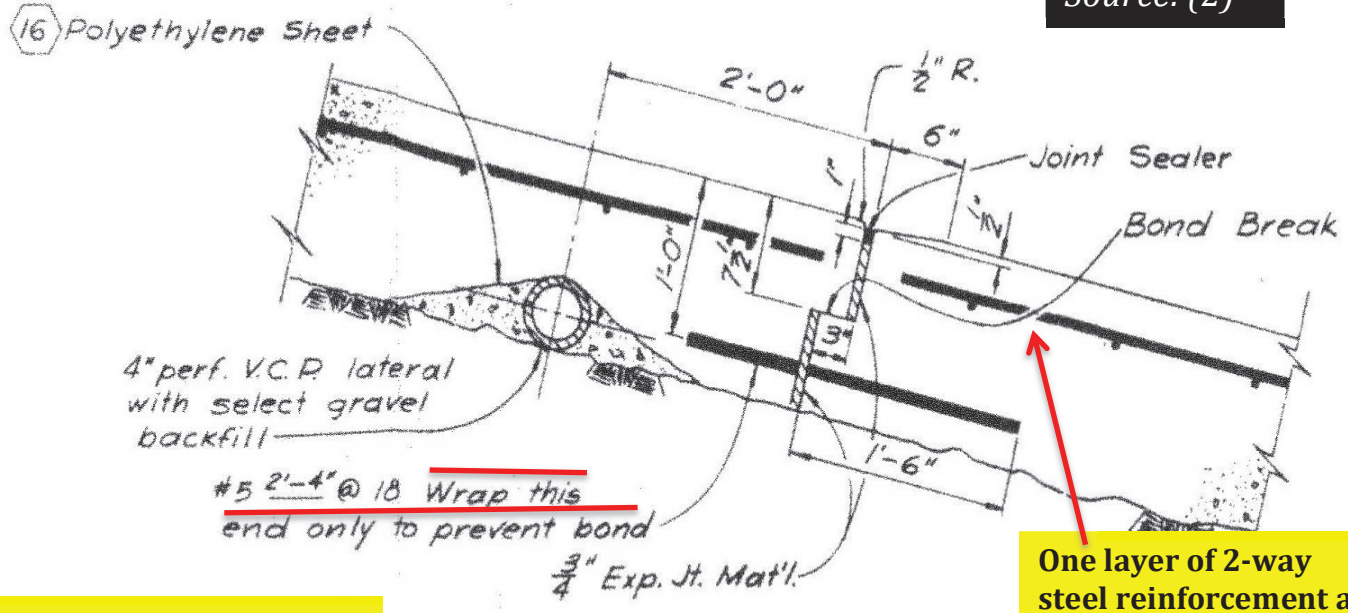
DETAIL A
LATERAL EXPANSION JOINT
Scale: 1" = 1'

One layer of 2-way steel reinforcement at top of slab

No 'continuous' steel across joint to prevent slab separation

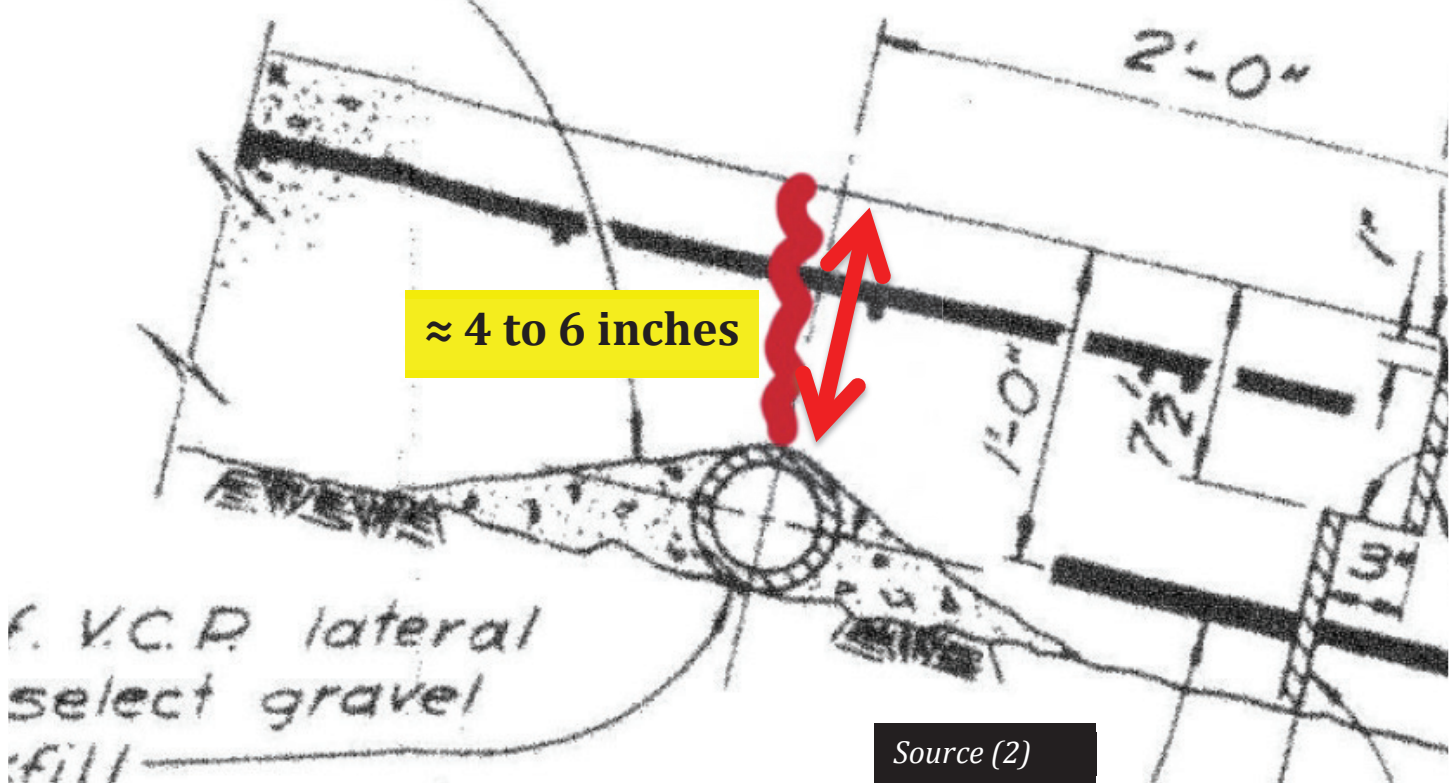
DETAIL A
LATERAL EXPANSION JOINT
Scale: 1"=1'

No steel reinforcement
across slab joints to
prevent separation

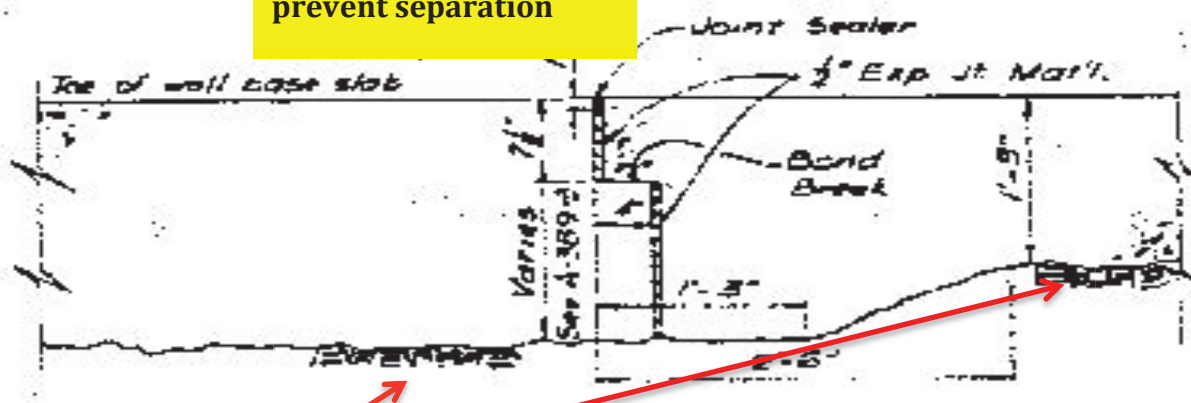
TYPICAL DETAIL
SLAB EDGE EXPANSION JOINT
Scale: 1"=1'

Chute base slabs
designed to be
constructed on 'rock'

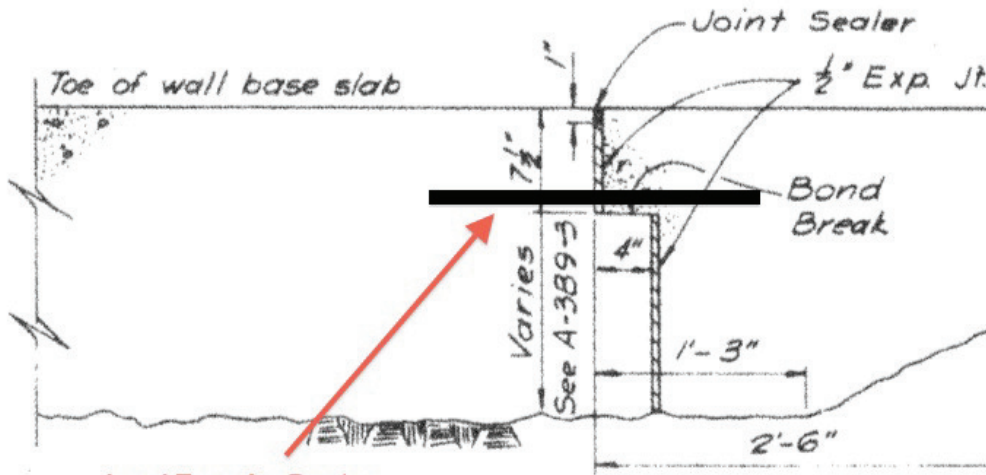
TYPICAL DETAIL
SLAB EDGE EXPANSION JOINT
 Scale: 1" = 1'

Load Transfer Bar (as constructed - not shown in diagram)

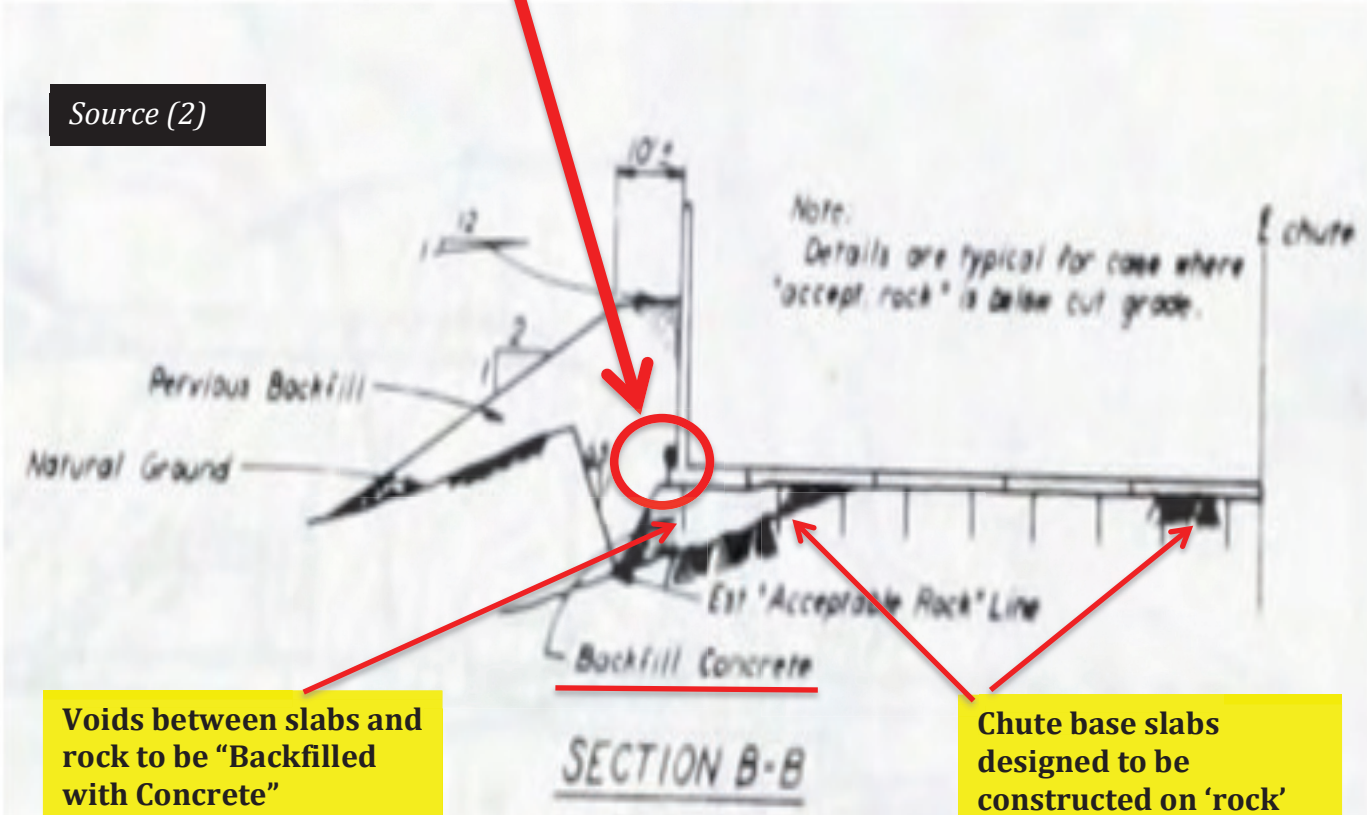
Voids between slabs and rock to be "Backfilled with Concrete"

Chute base slabs designed to be constructed on 'rock'

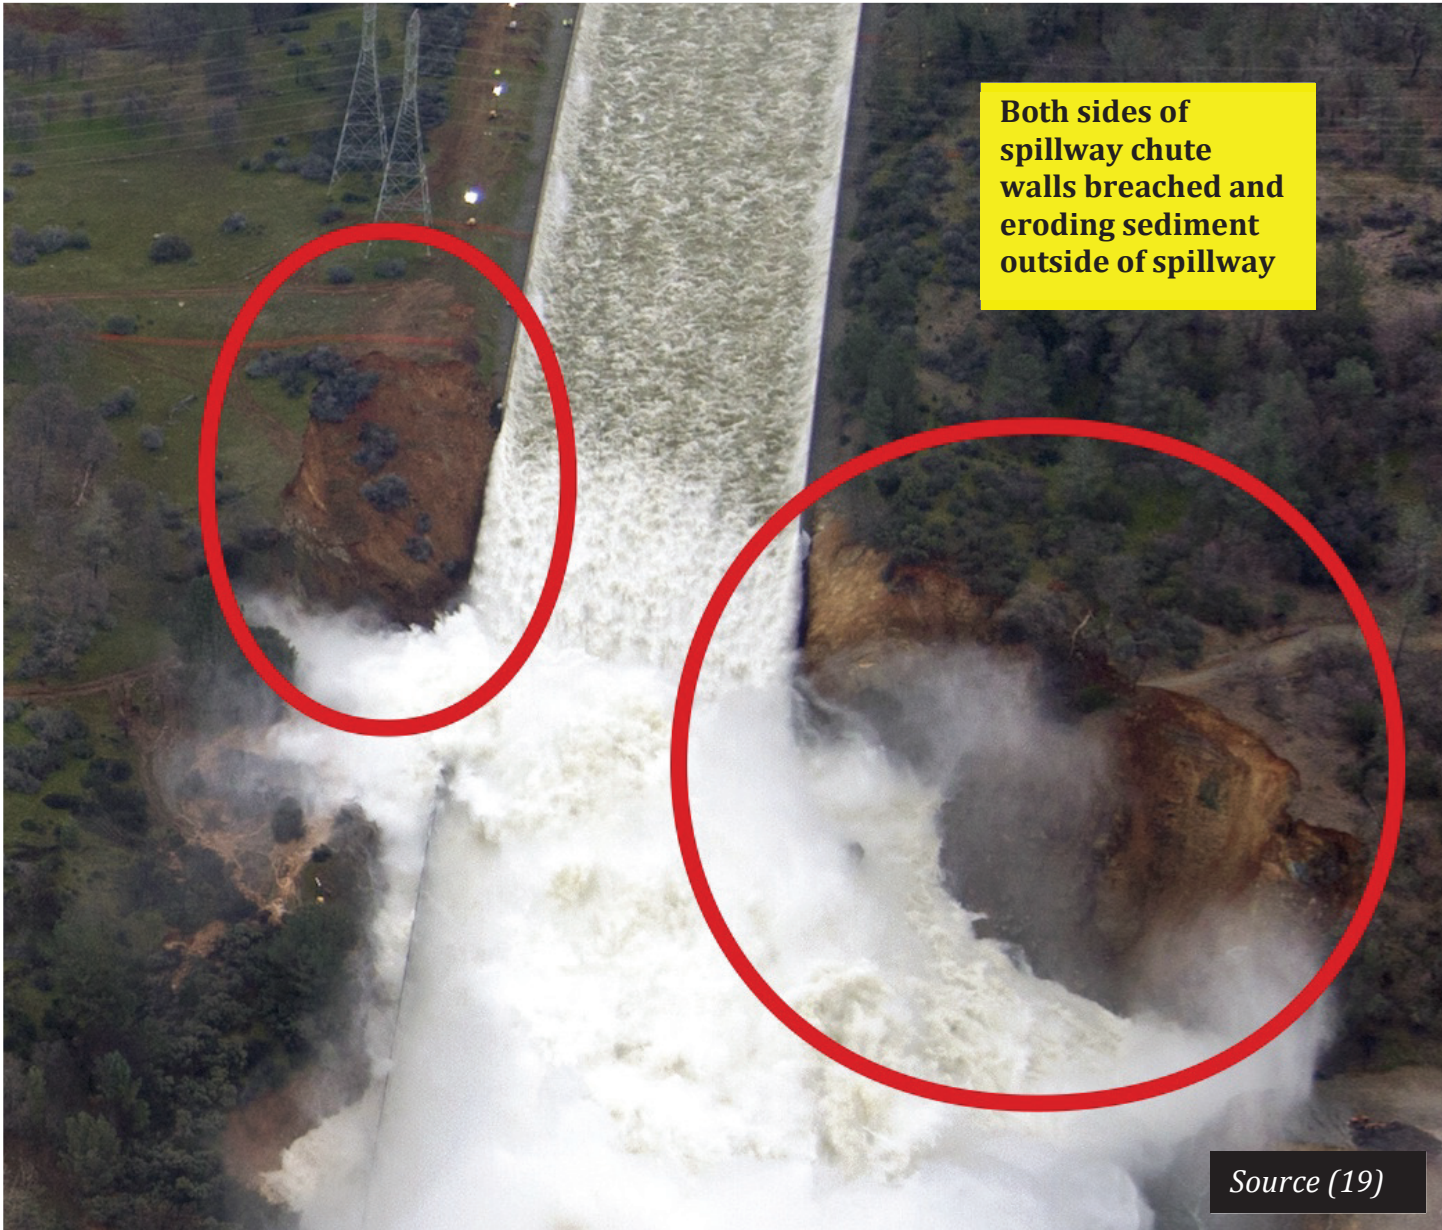
Both sides of spillway chute walls breached and eroding sediment outside of spillway

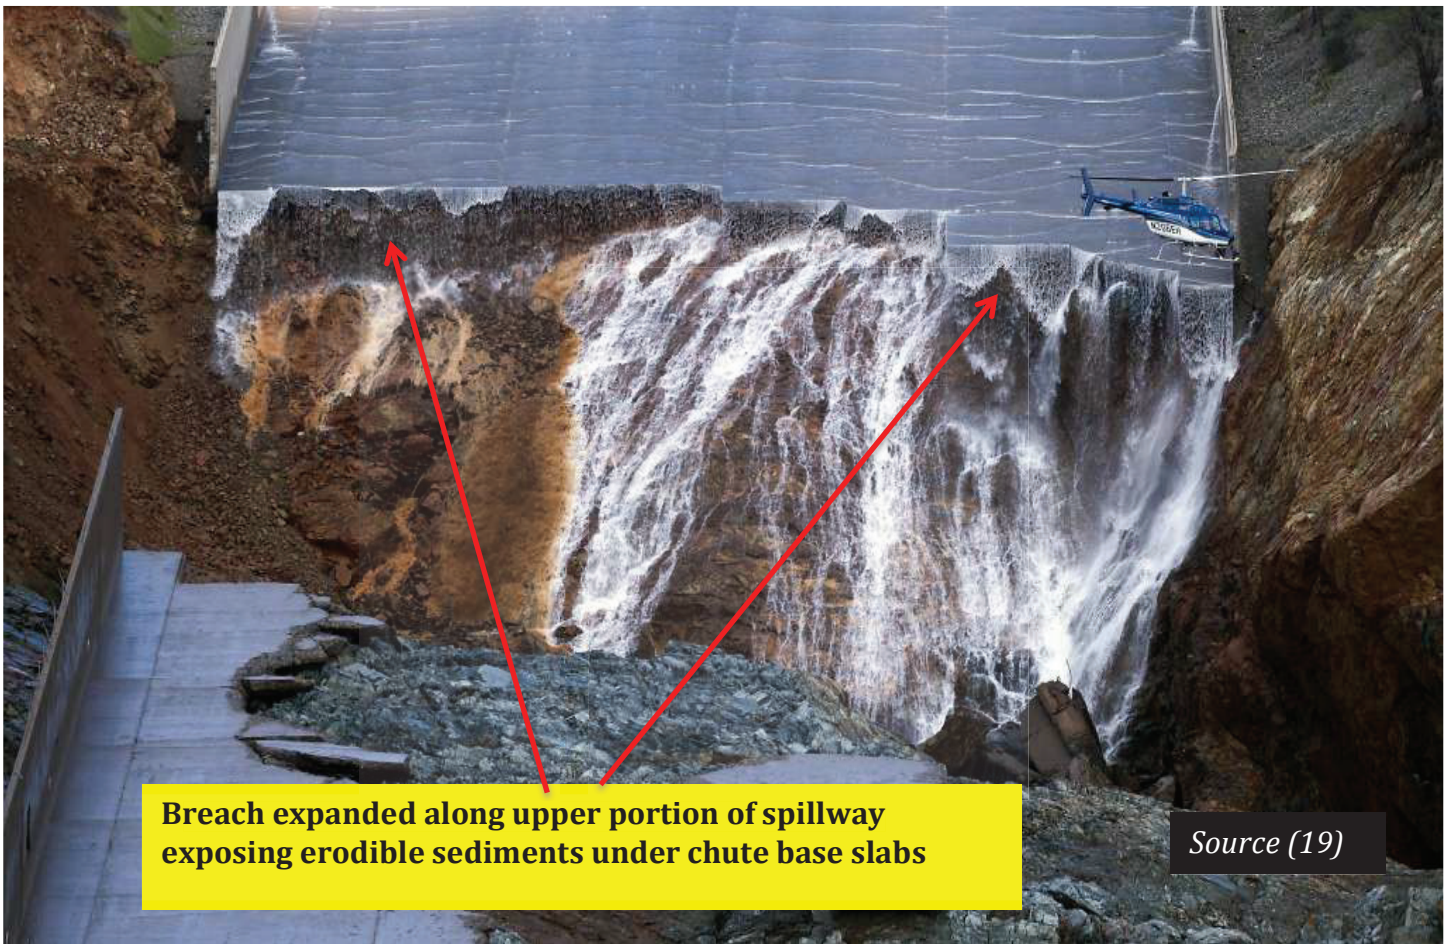
Breach expanded along upper portion of spillway exposing erodible sediments under chute base slabs

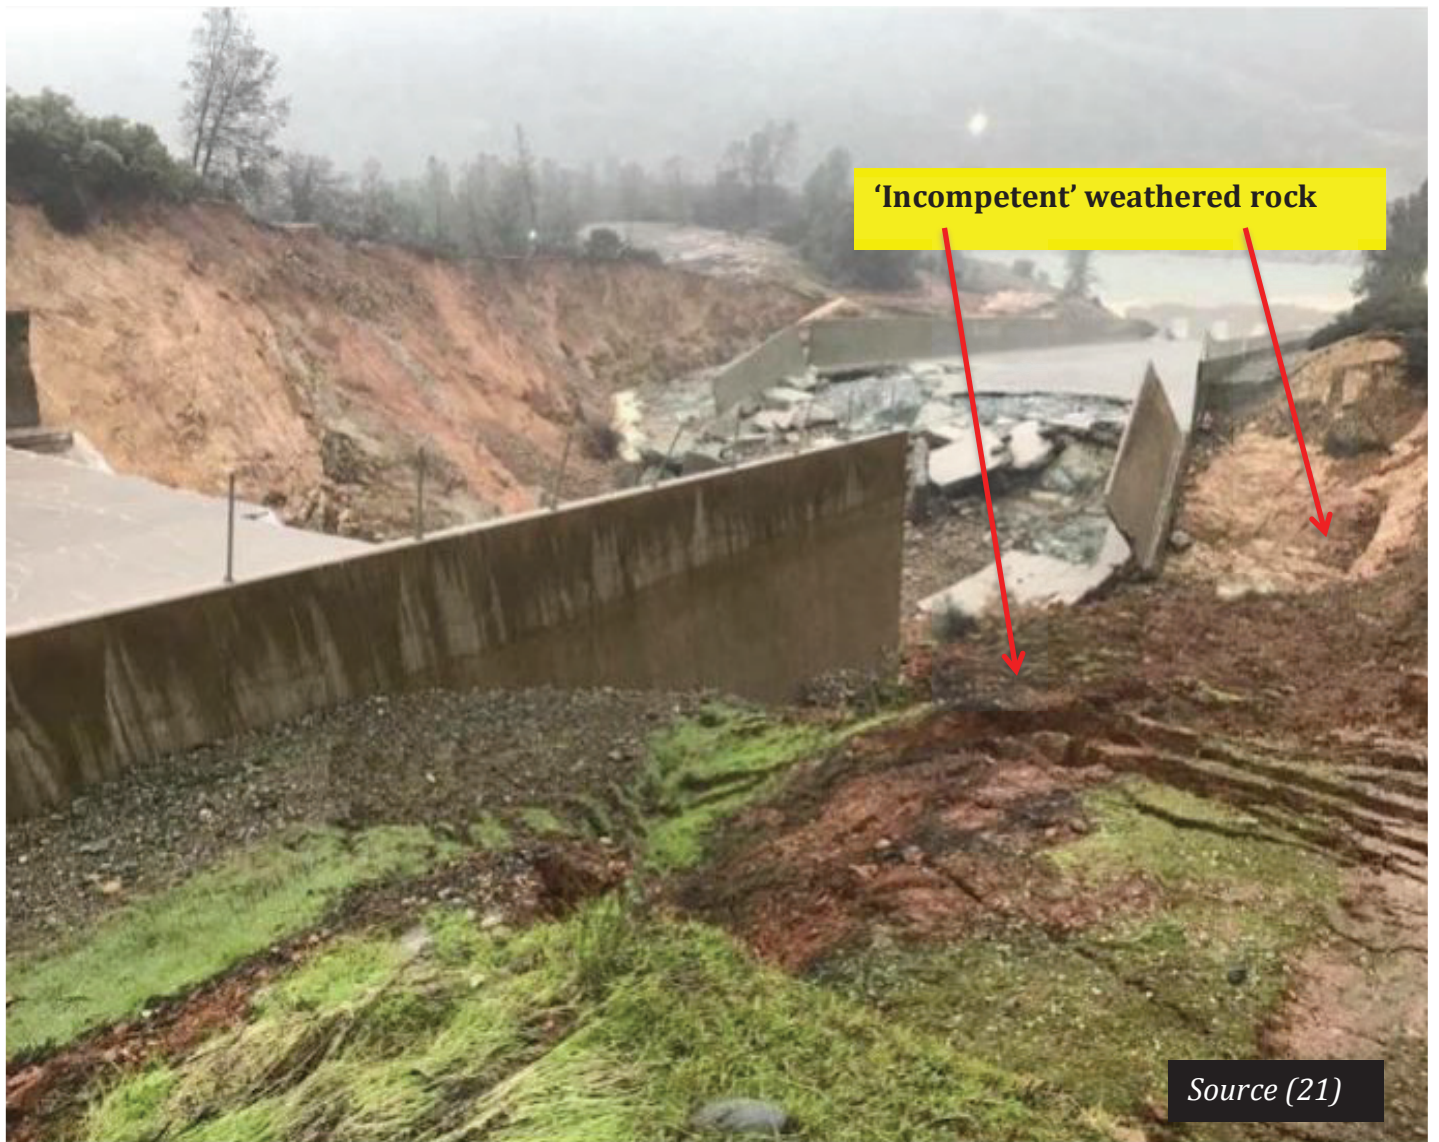
'Incompetent' weathered rock

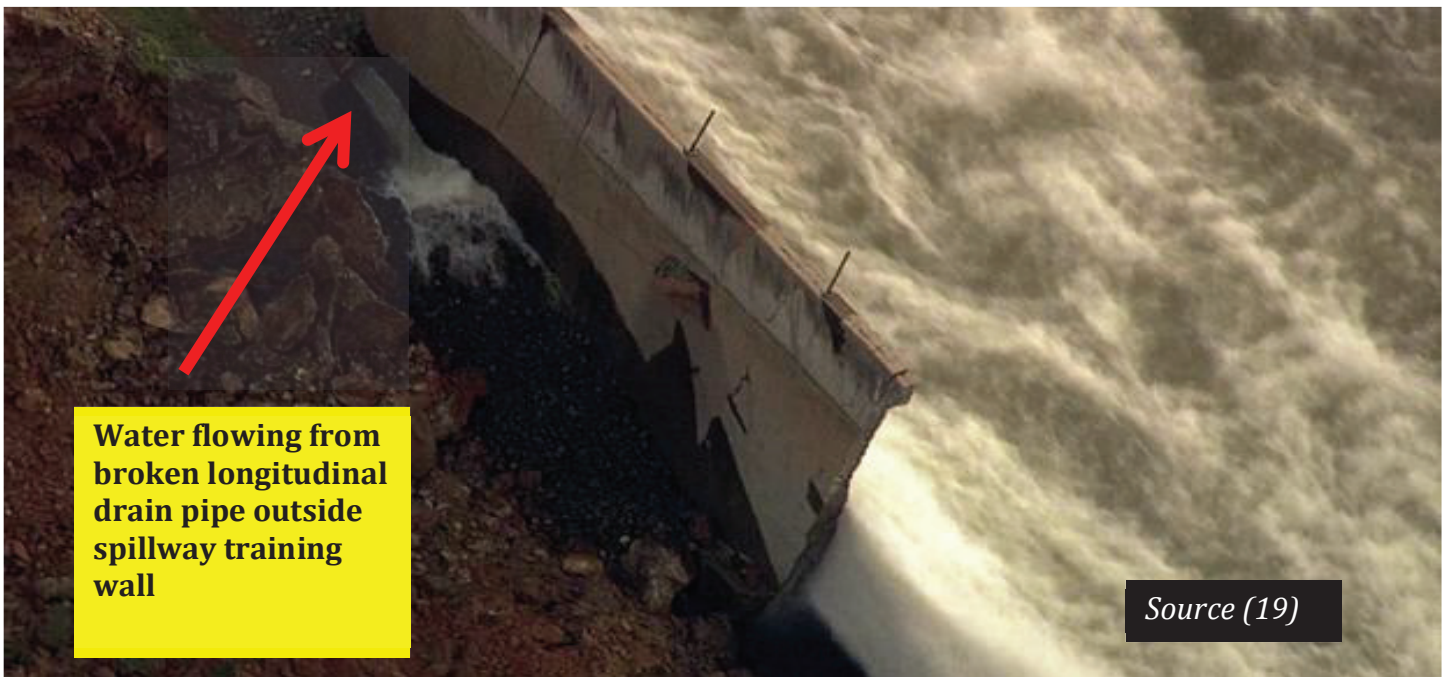
Water flowing from broken longitudinal drain pipe outside spillway training wall

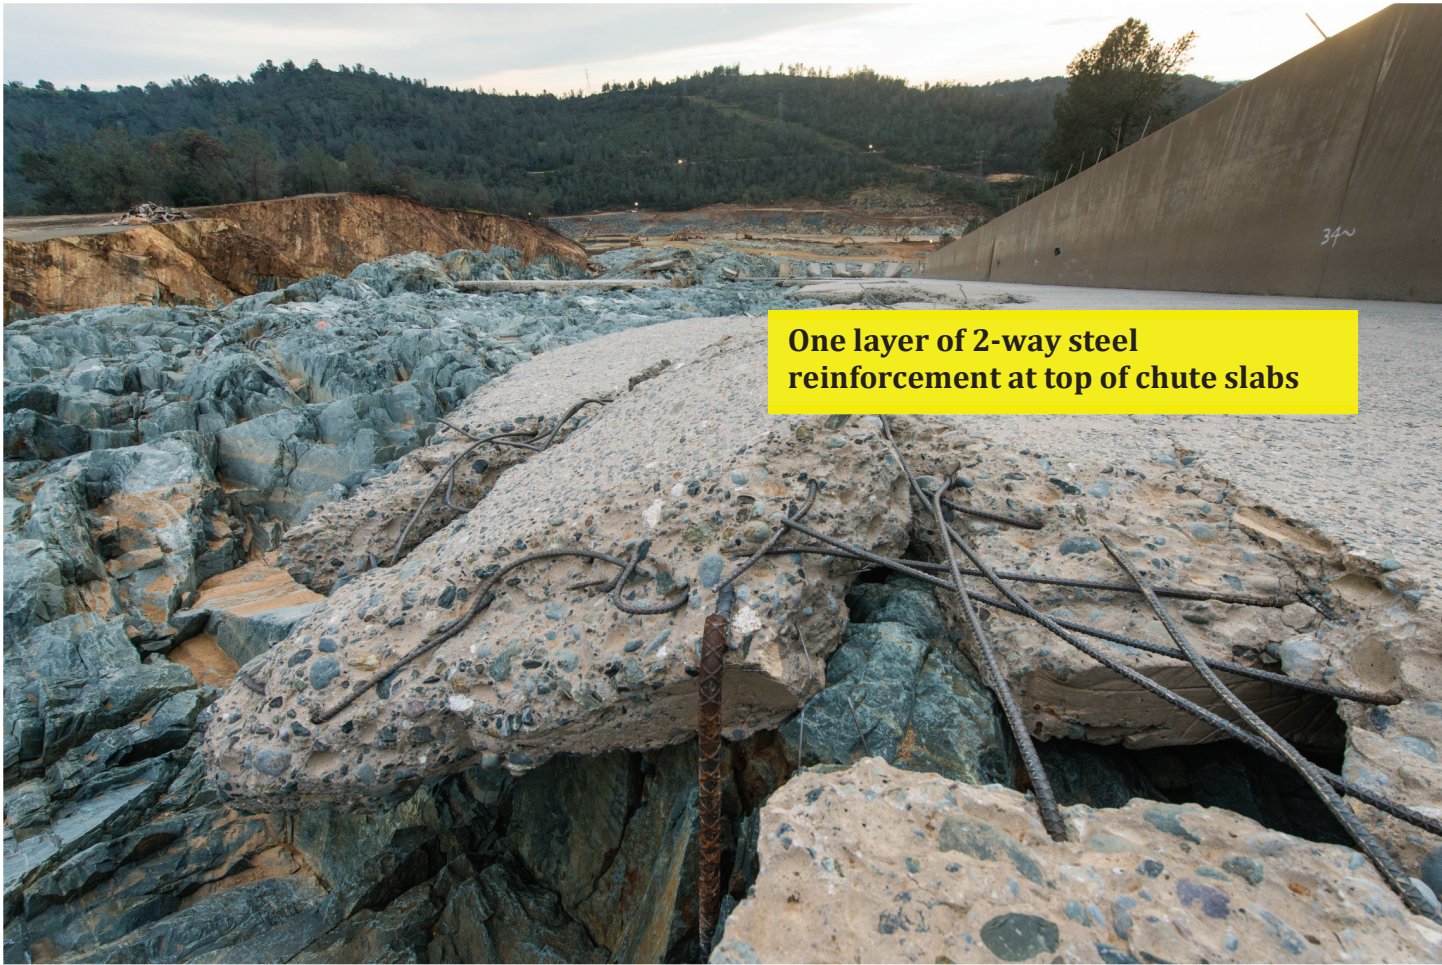
One layer of 2-way steel reinforcement at top of chute slabs

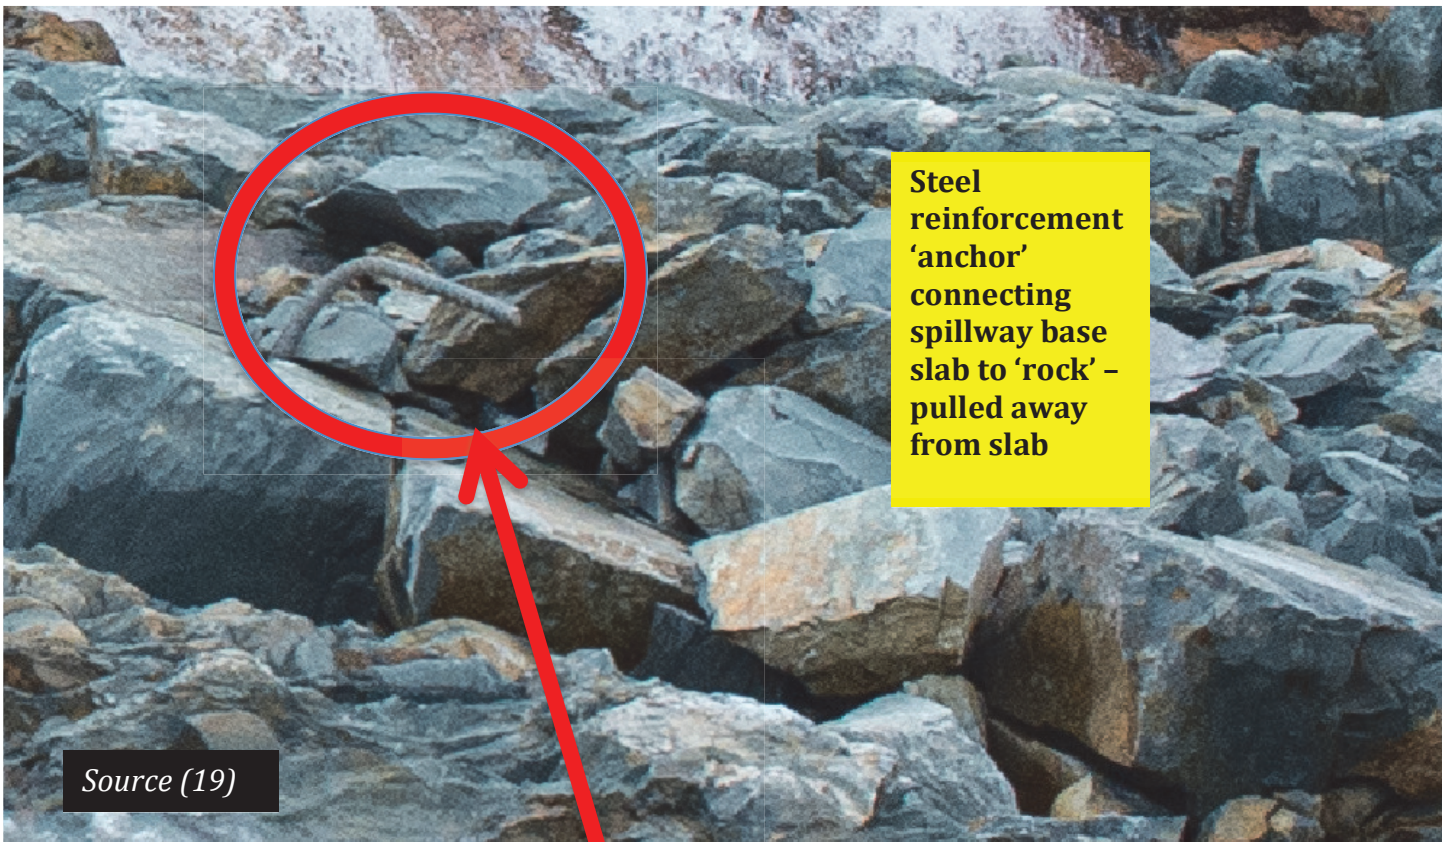
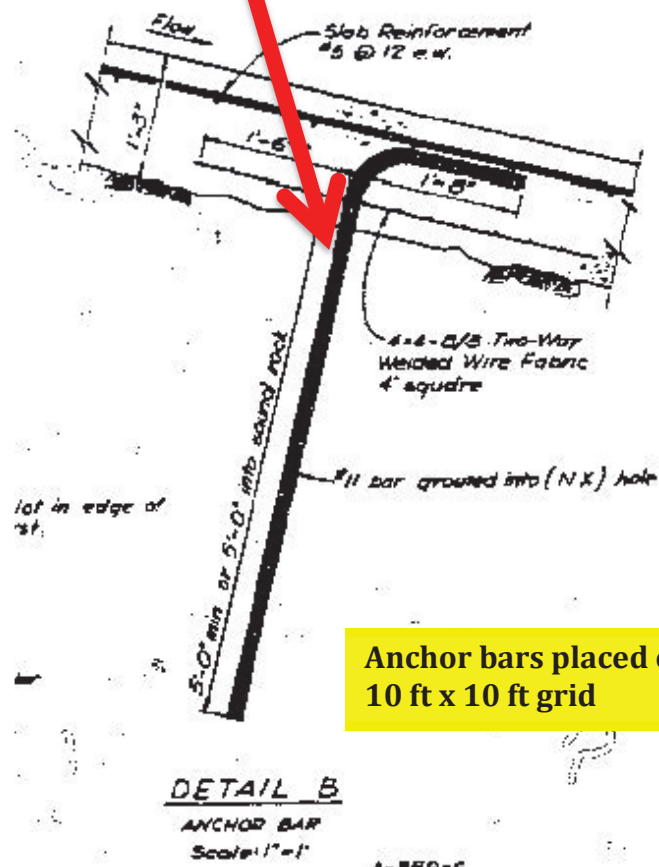
Anchor bars placed on 10 ft x 10 ft grid

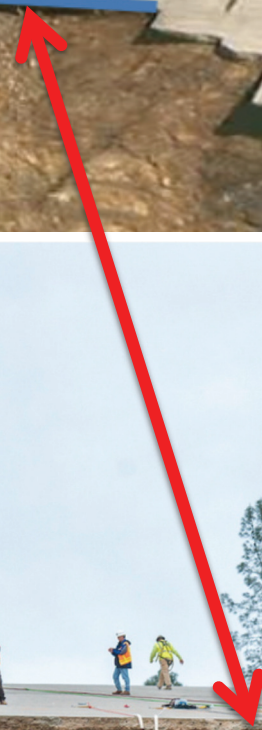
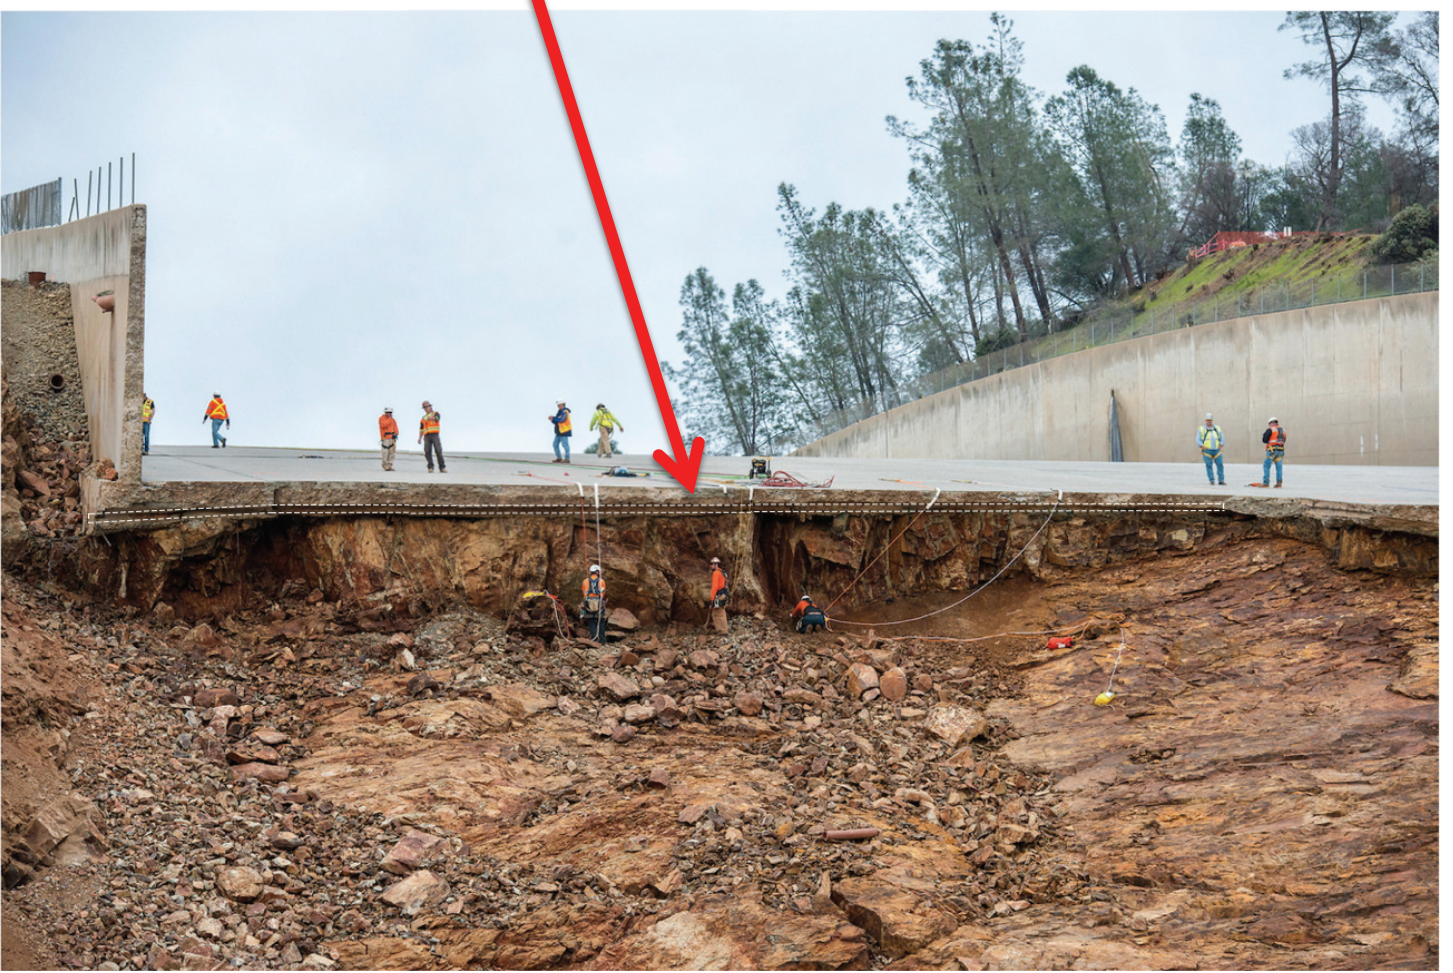
Concrete fractured along
drain pipe emplacement

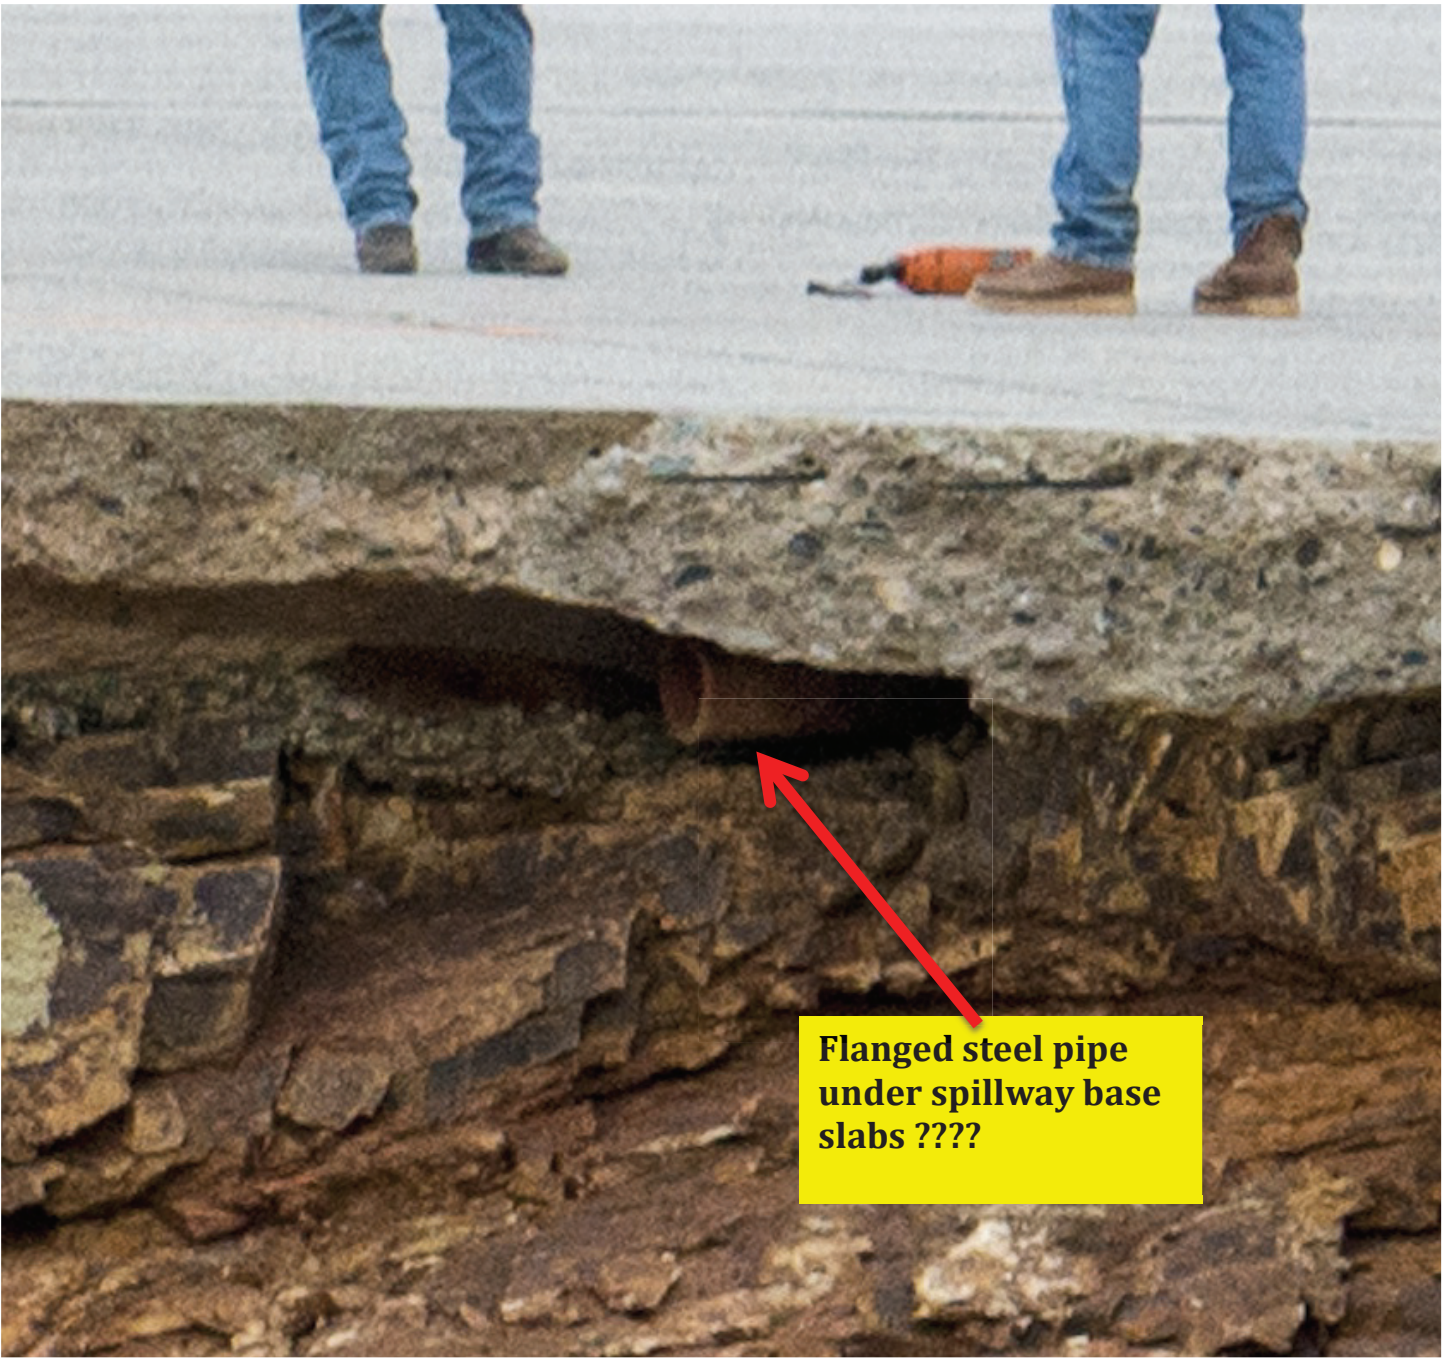
**Flanged steel pipe
under spillway base
slabs ????**
