Pre-Failure Images

**Previous inspection report photographs
(all from cited DWR inspection reports)**

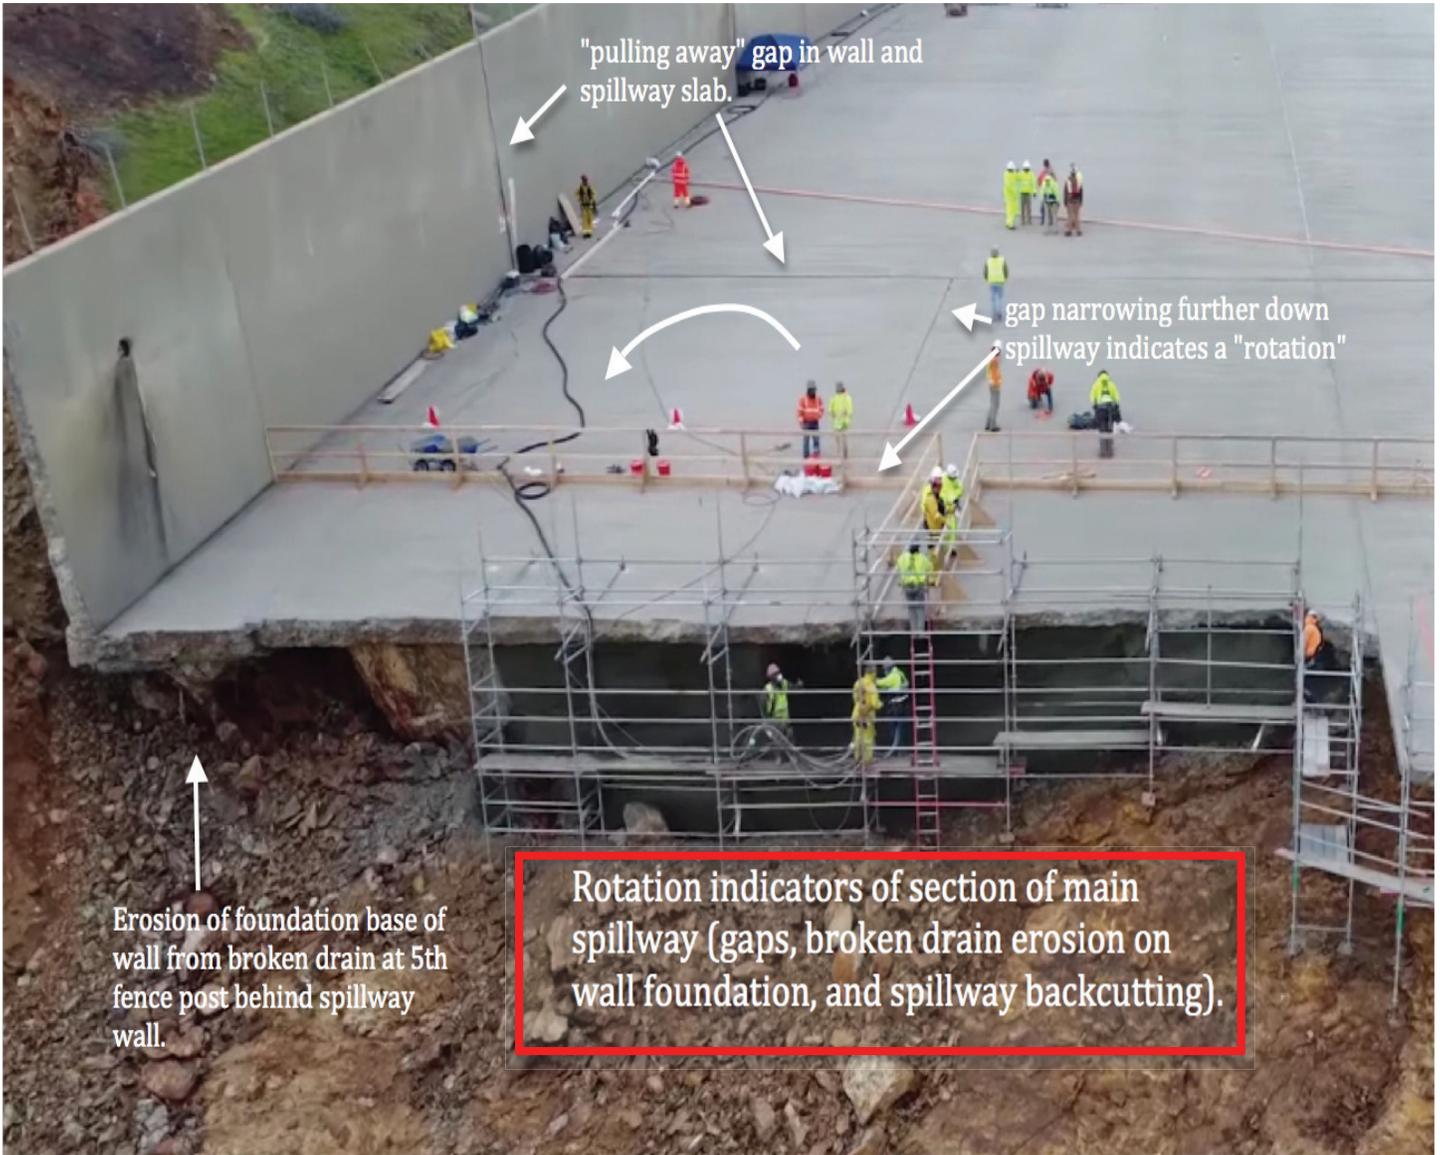
Erosion of foundation base of wall from broken drain at 5th fence post behind spillway wall.

Rotation indicators of section of main spillway (gaps, broken drain erosion on wall foundation, and spillway backcutting).

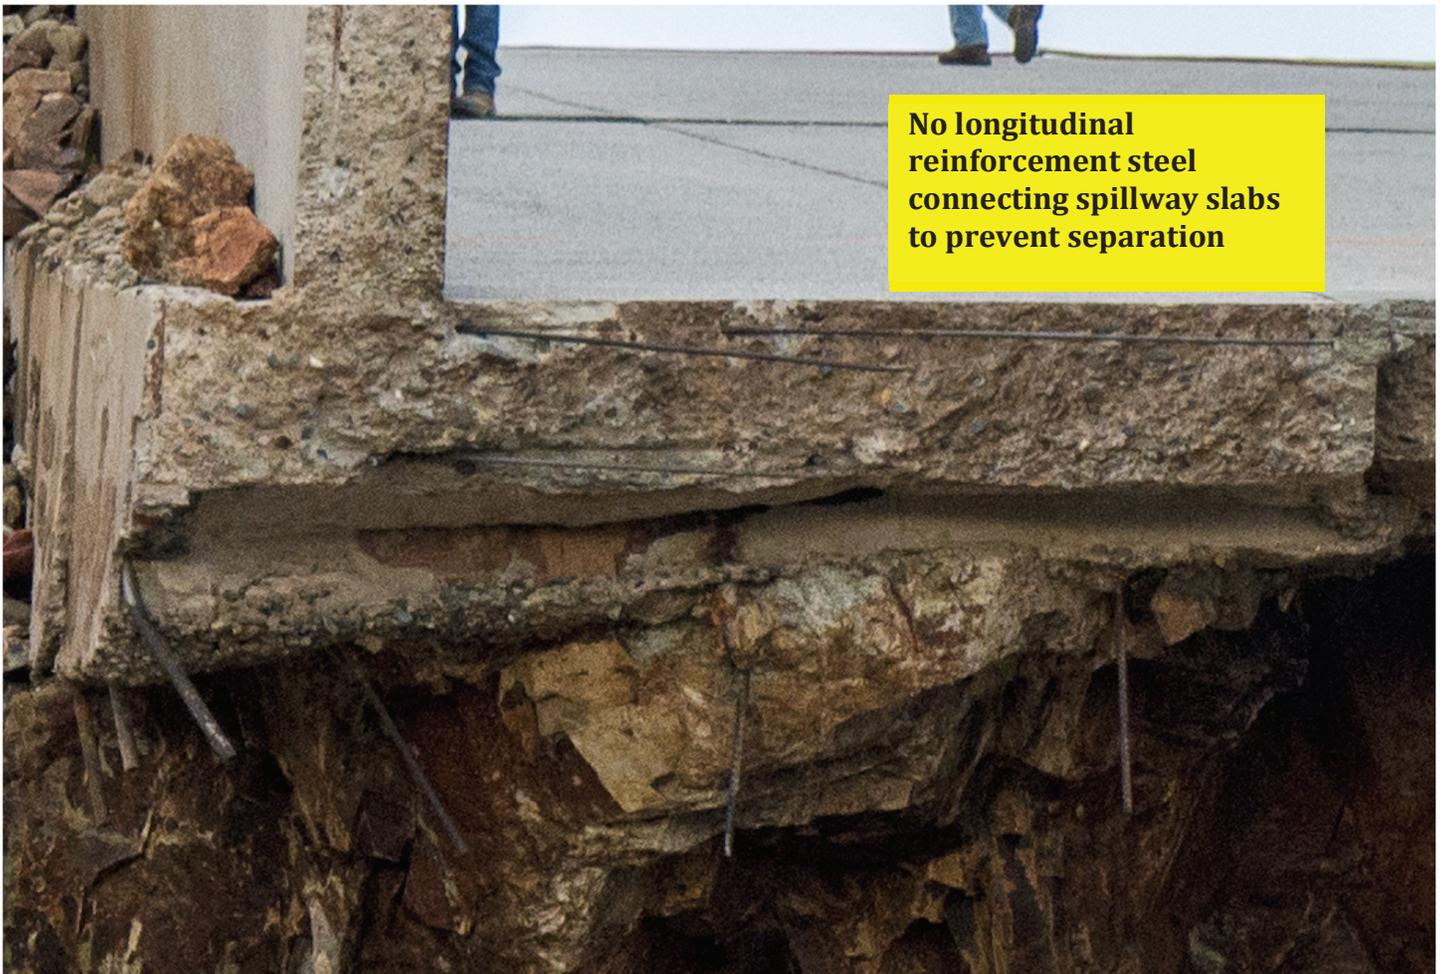
No longitudinal reinforcement steel connecting spillway slabs to prevent separation

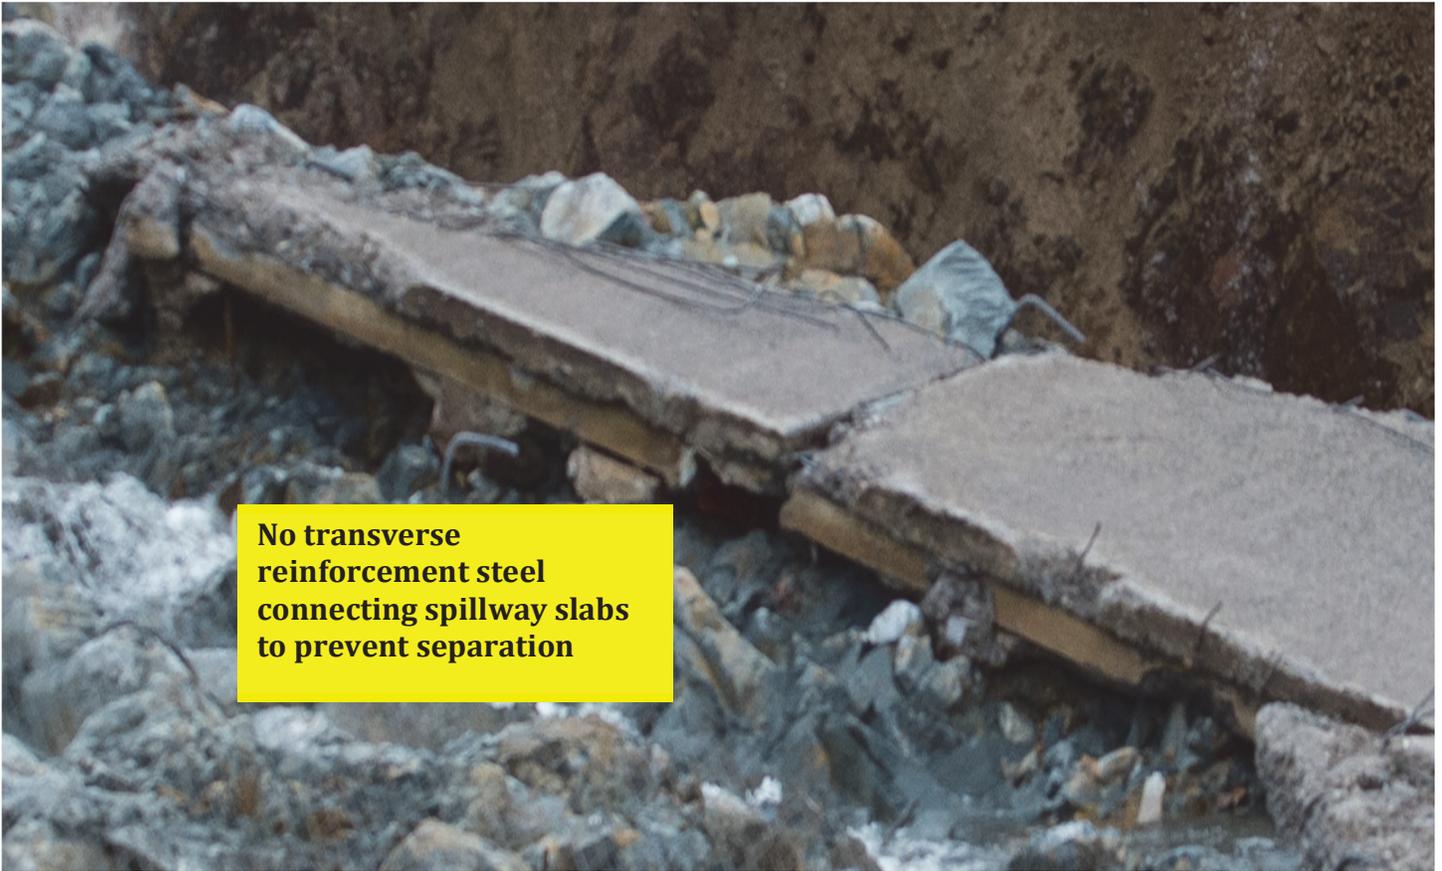
**No transverse
reinforcement steel
connecting spillway slabs
to prevent separation**

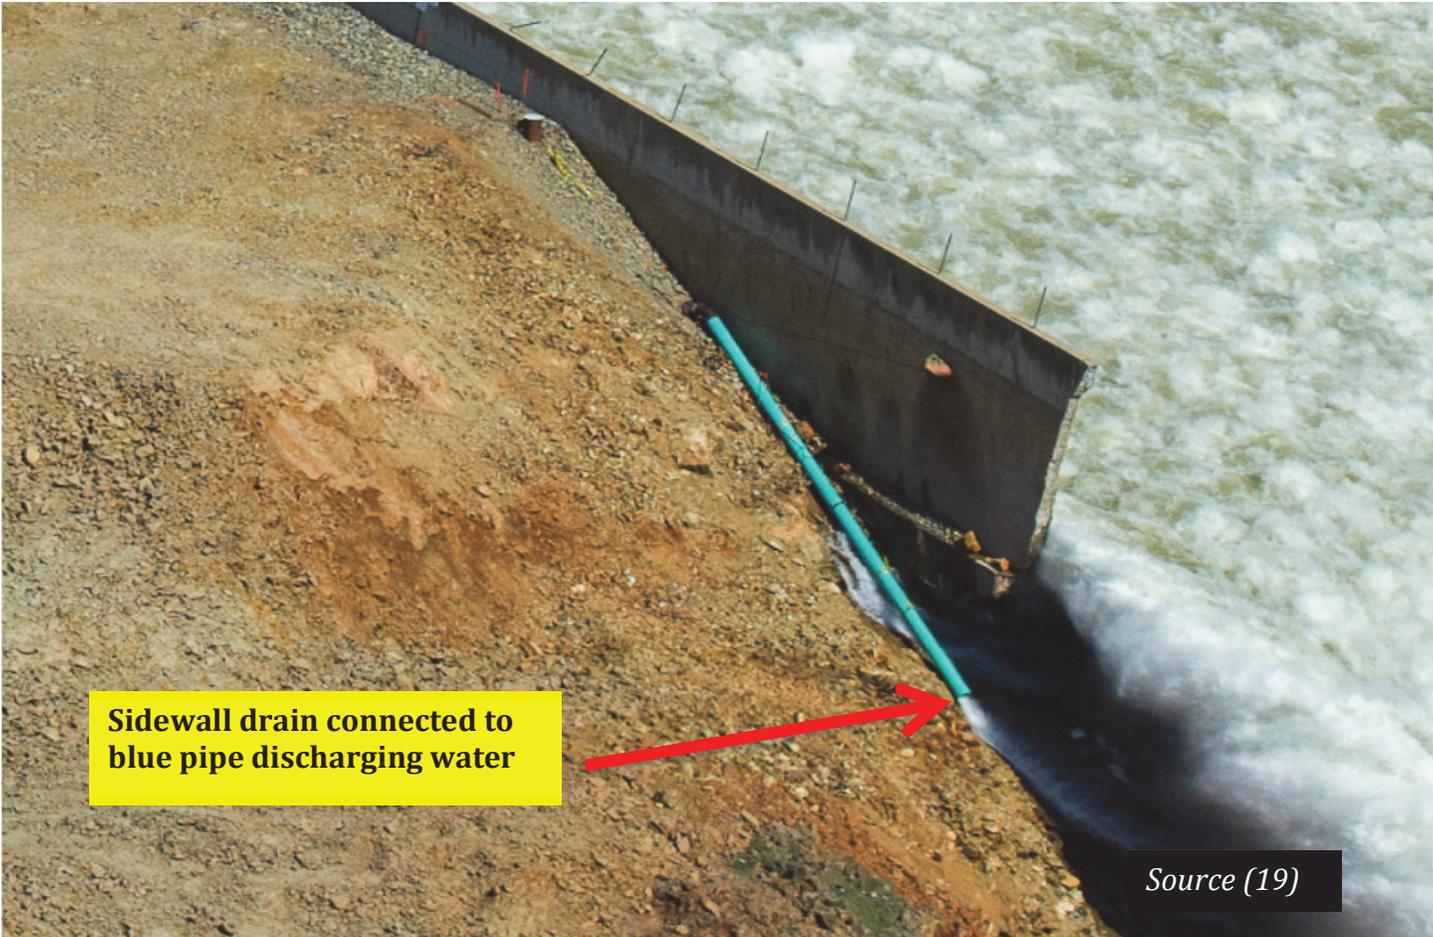
Sidewall drain connected to blue pipe discharging water

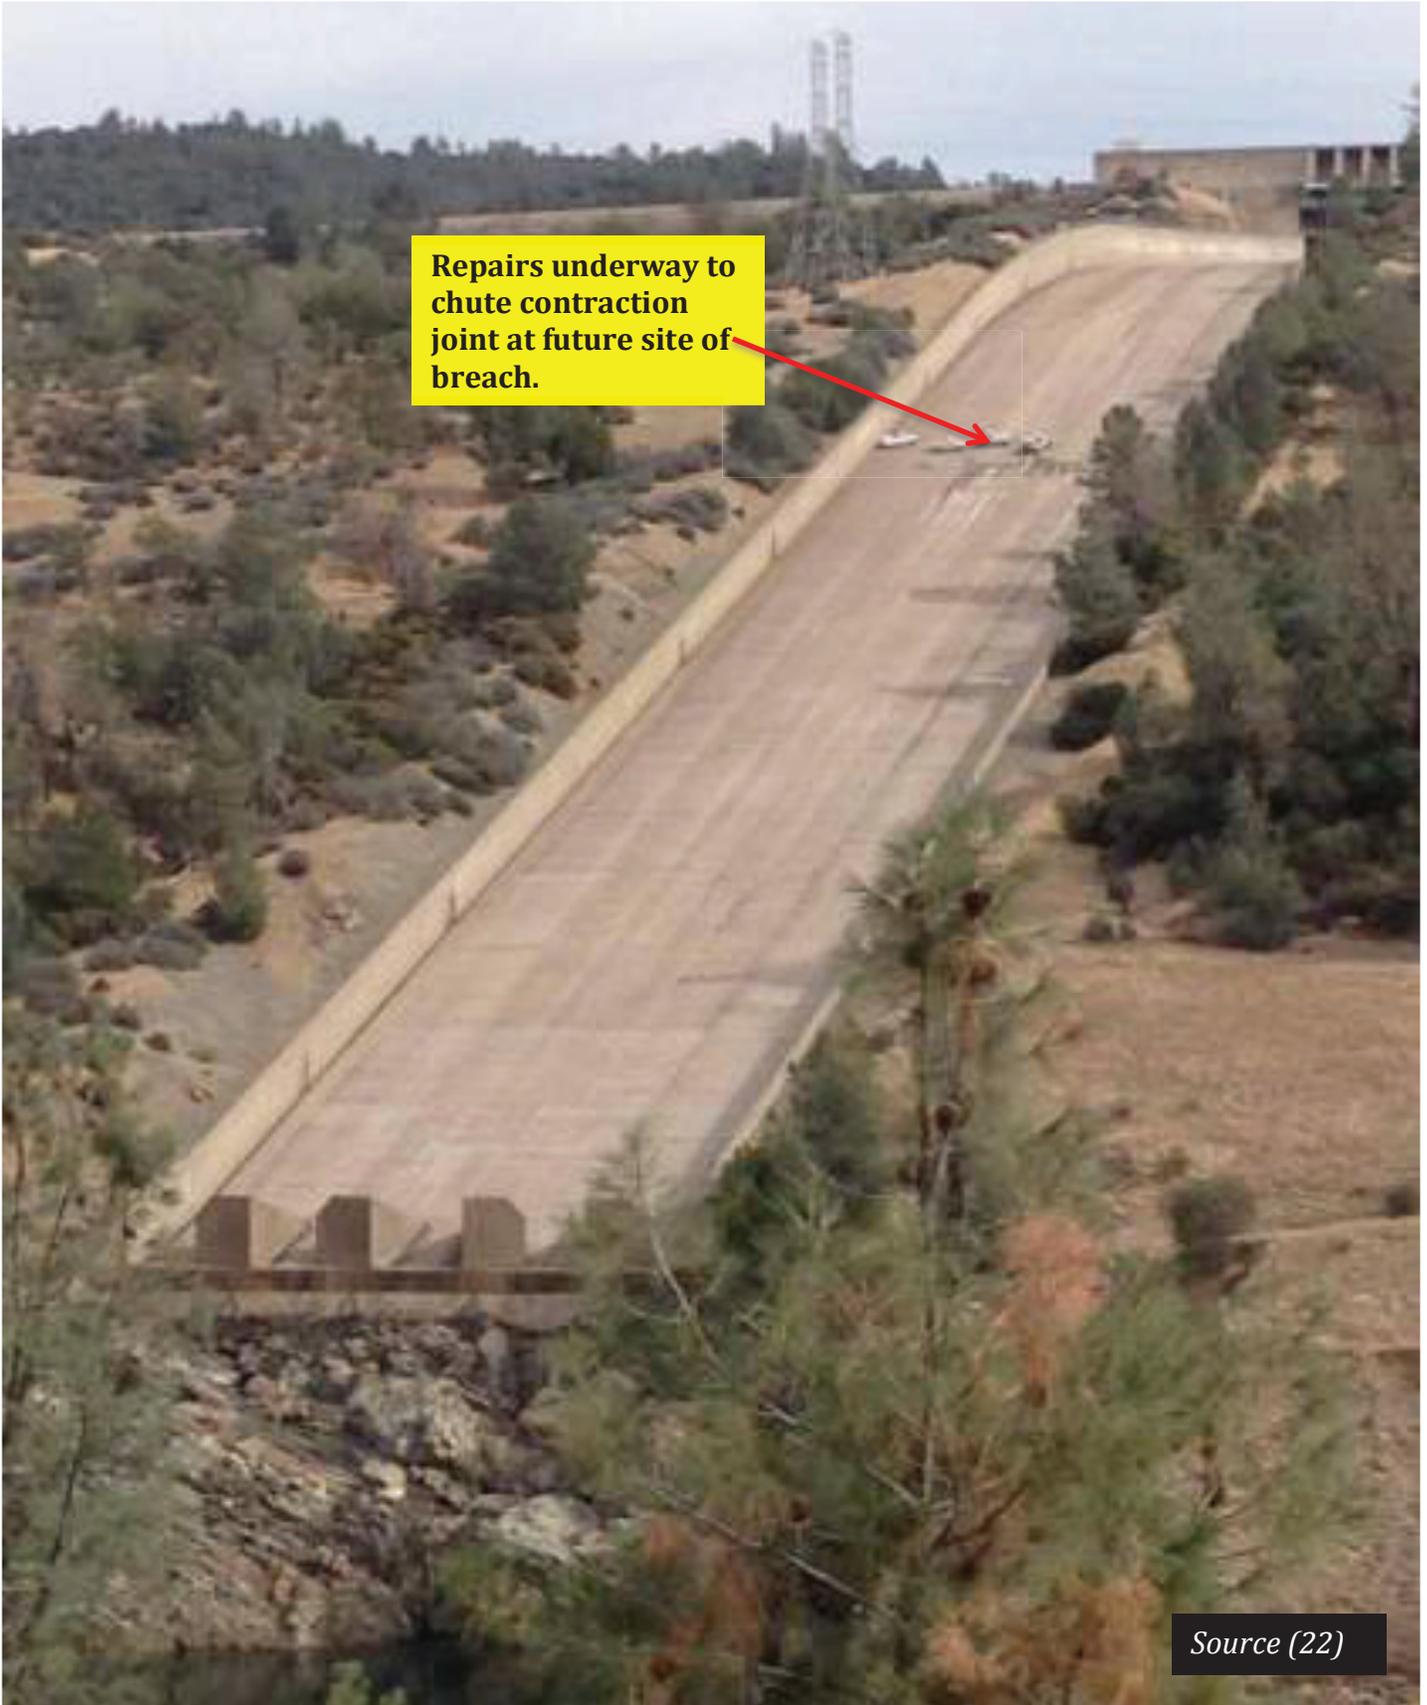
Repairs underway to chute contraction joint at future site of breach.

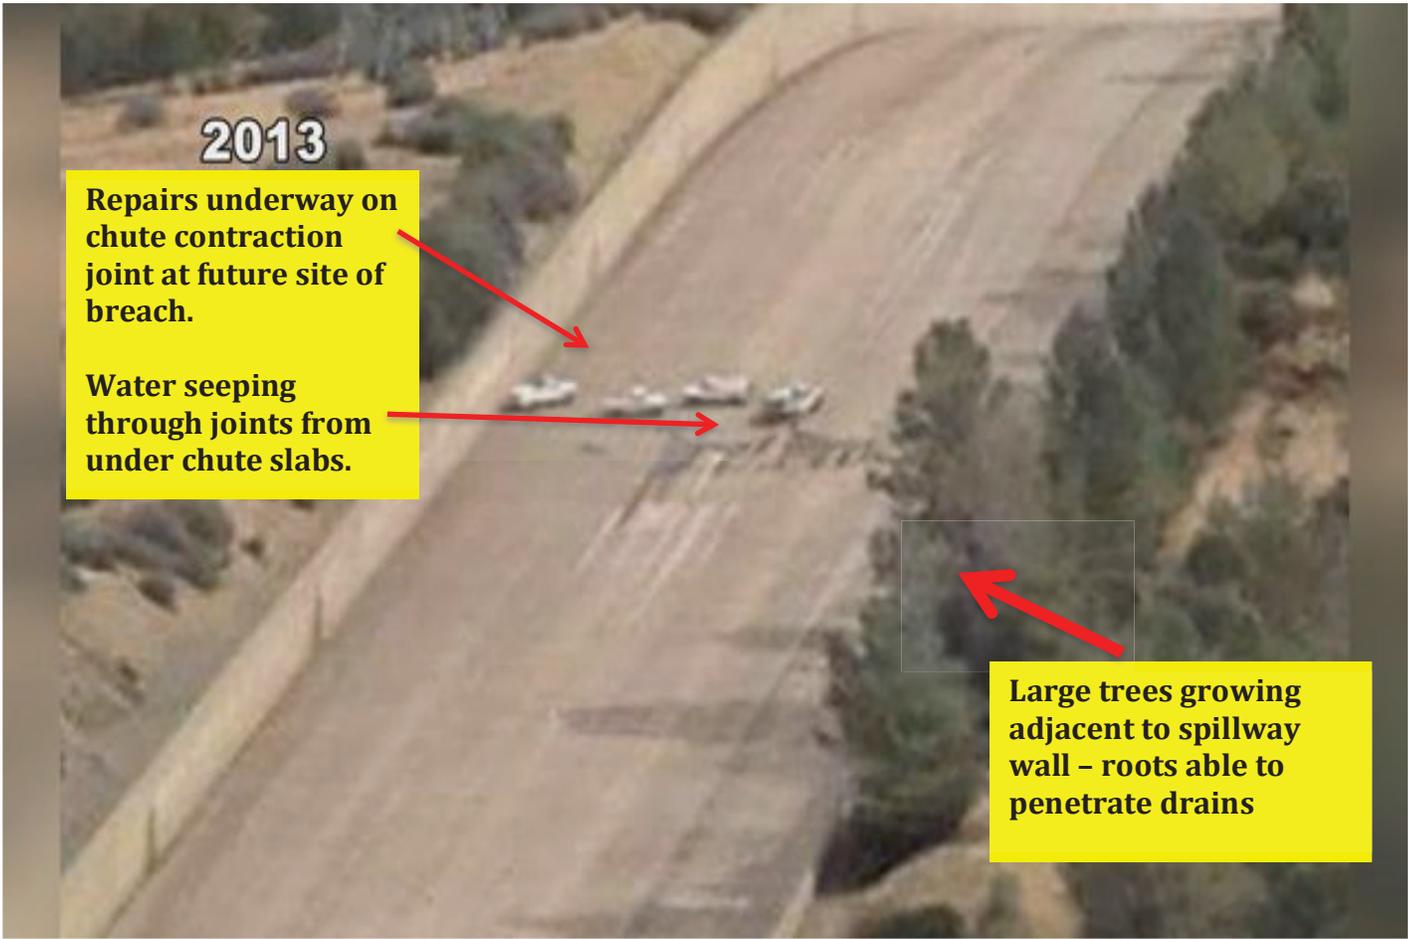
Repairs underway on chute contraction joint at future site of breach.

Water seeping through joints from under chute slabs.

Large trees growing adjacent to spillway wall - roots able to penetrate drains

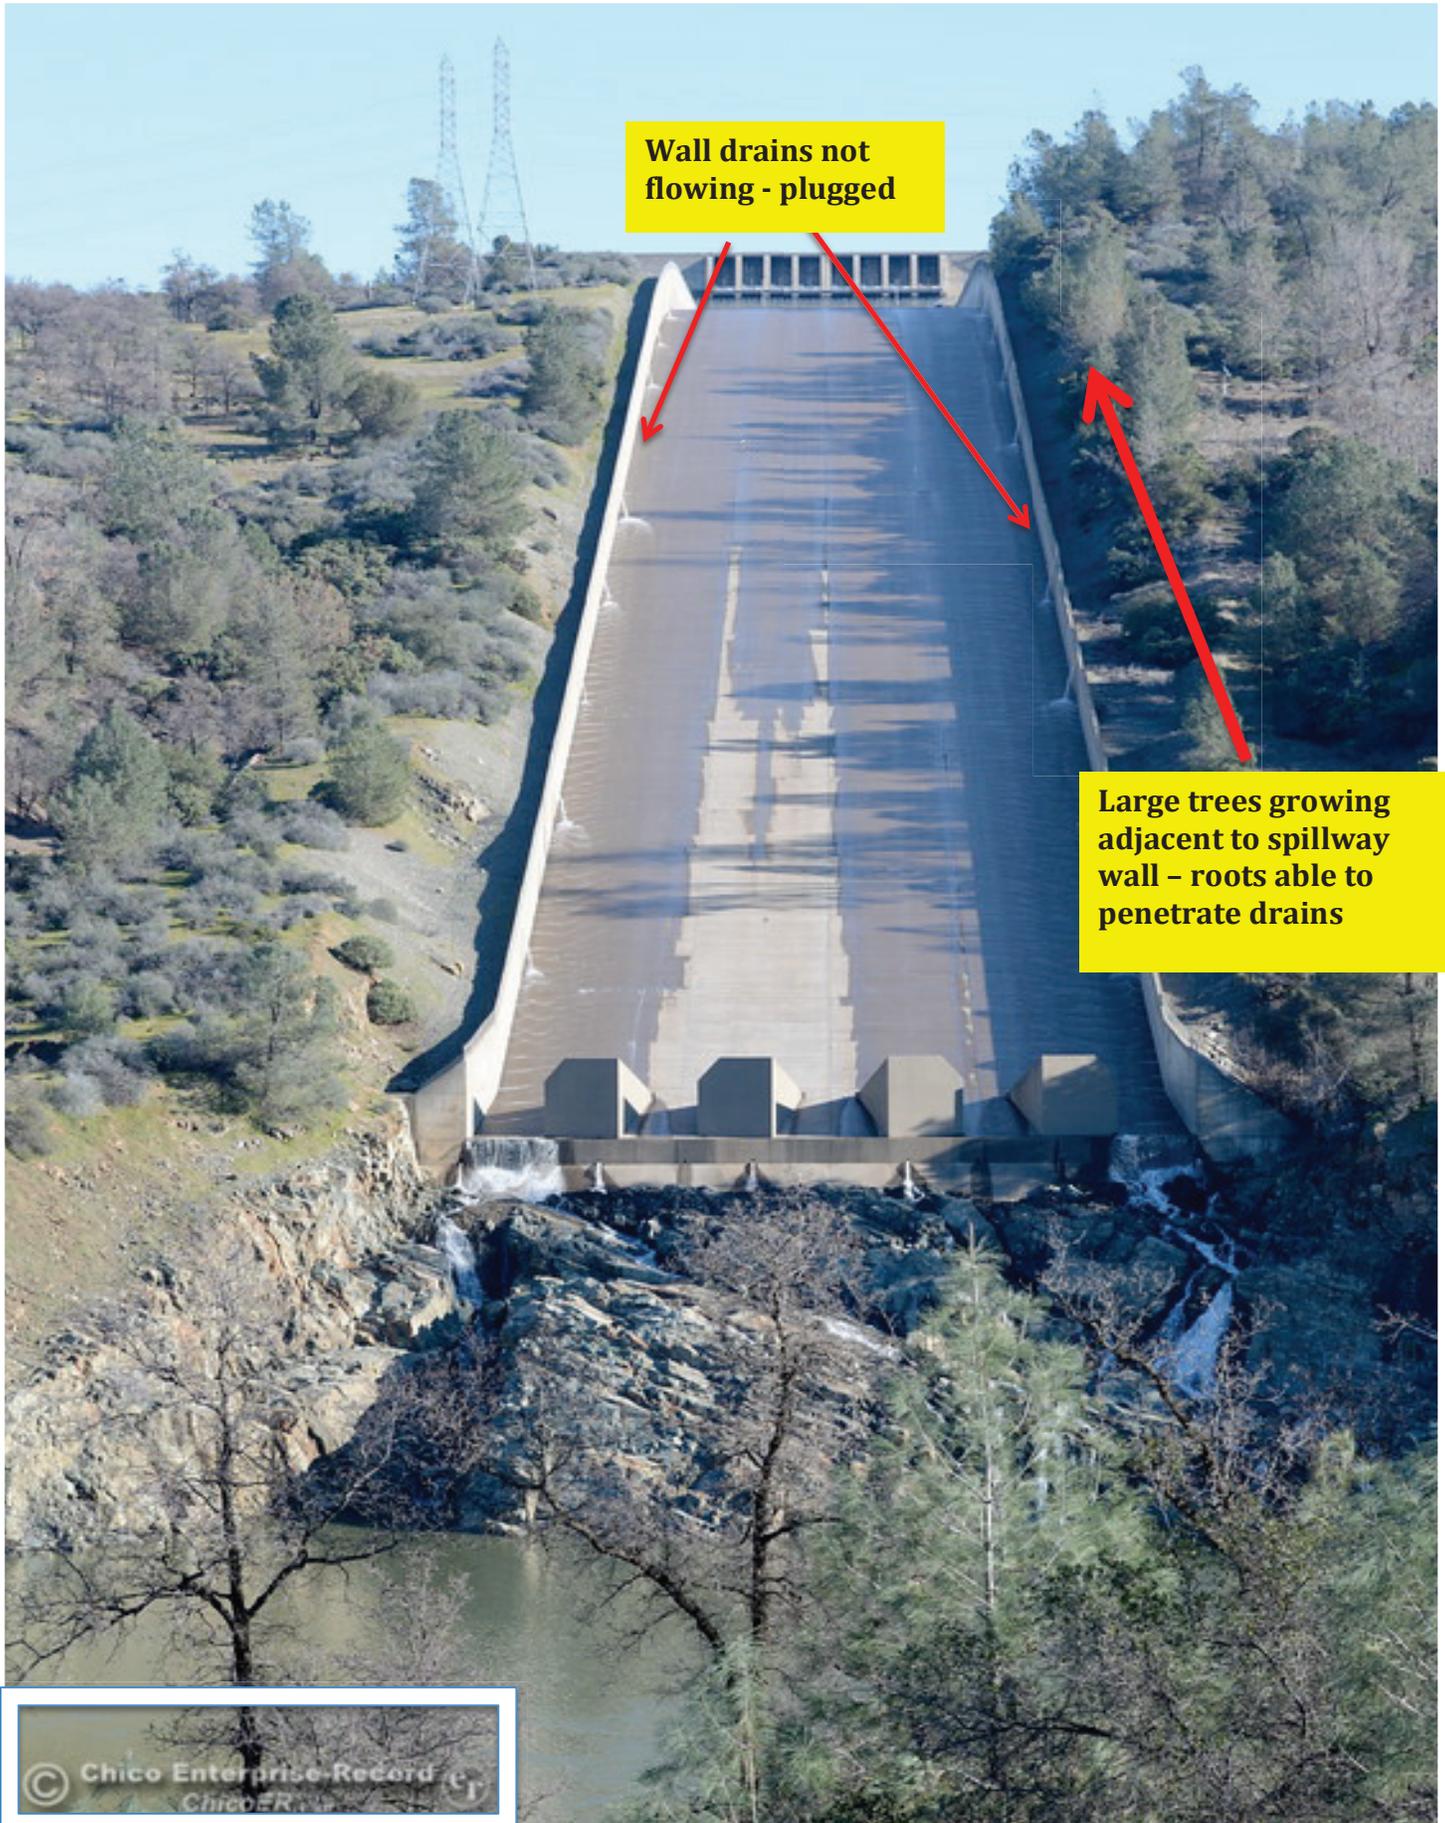
Wall drains not flowing - plugged

Large trees growing adjacent to spillway wall - roots able to penetrate drains

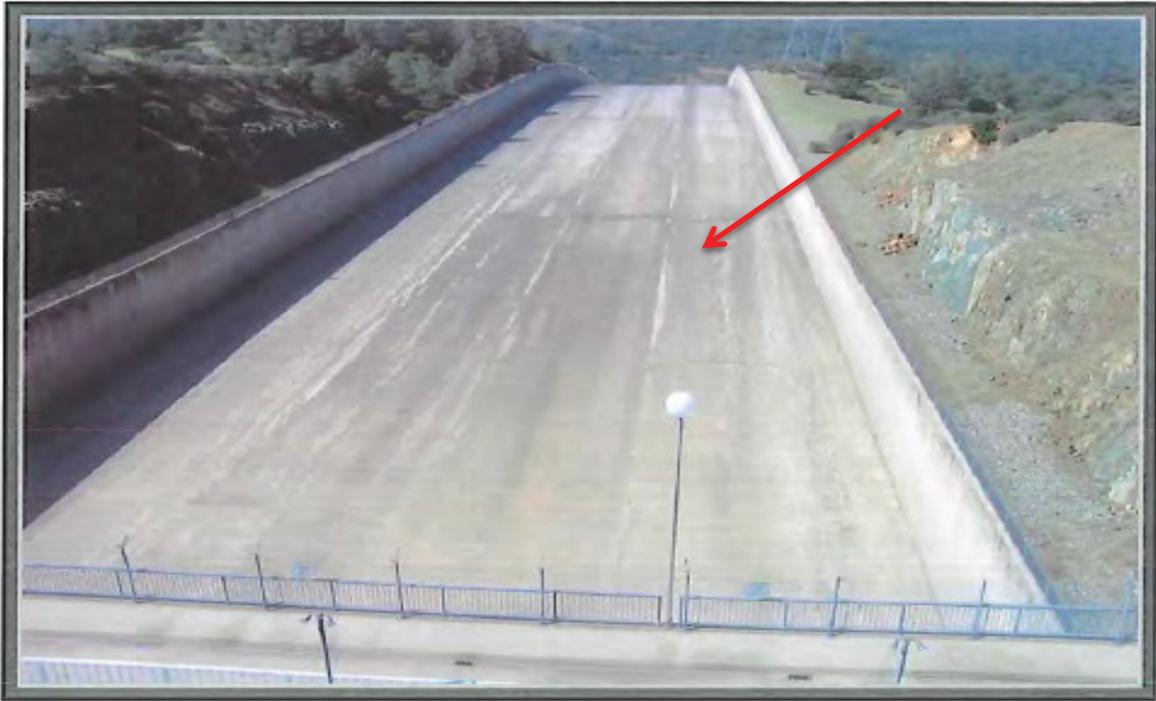
5/6/08 Inspection Report

11. The spillway at the flood control outlet remains in satisfactory condition.

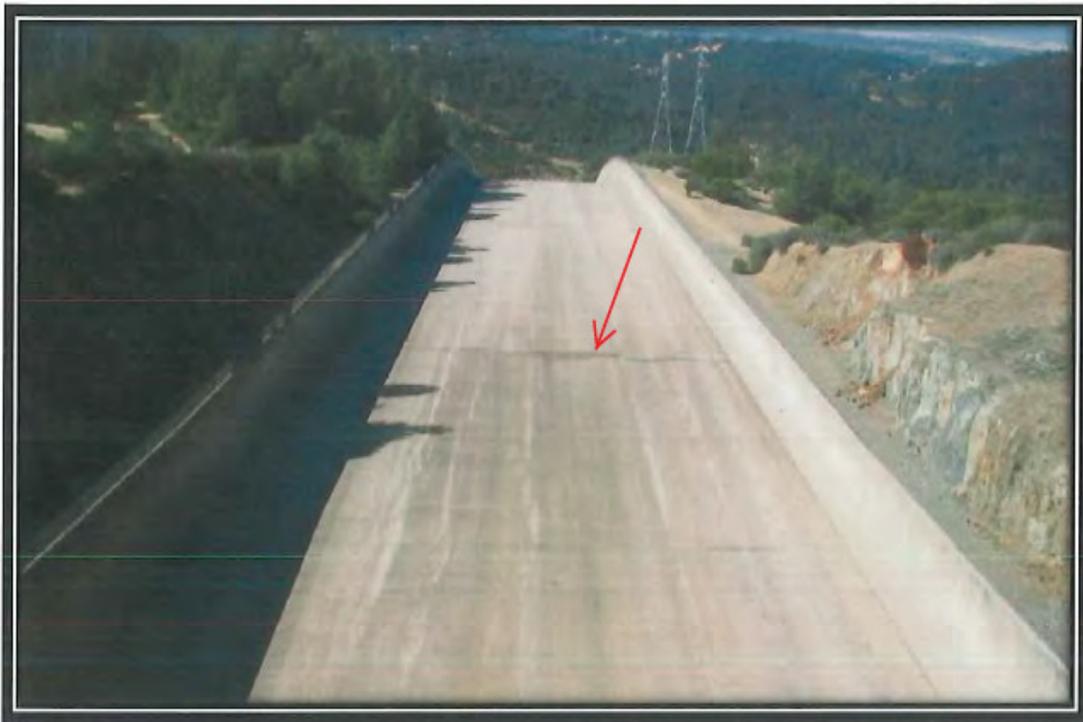
12/14/09 Inspection Report

20. This view shows the flood control outlet chute as seen from the upper deck. The walls and chute appeared to be stable and in satisfactory condition. Minor repairs along the chute floor will be completed this year.

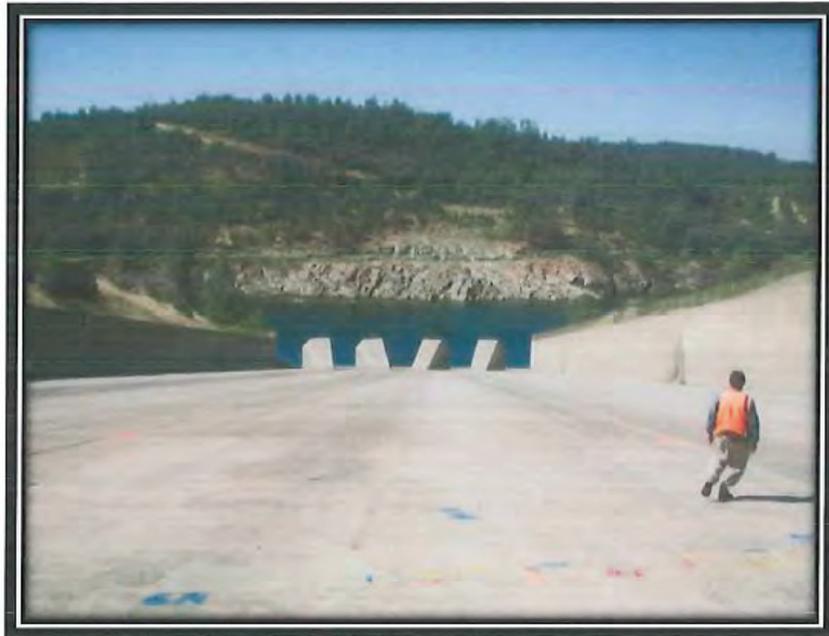
21. The lower flood control outlet chute is shown. Not the markings for the upcoming chute repairs.
6/25/10 Inspection Report

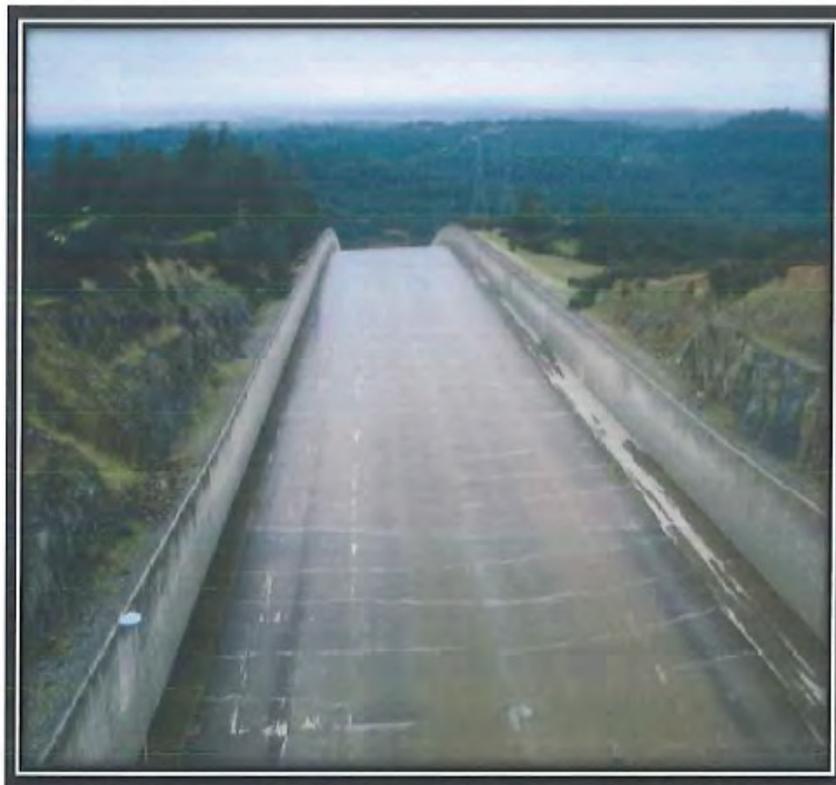
12. The concrete along the spillway chute has been repaired. The repaired herringbone crack pattern is said to reflect the underlying drain system.

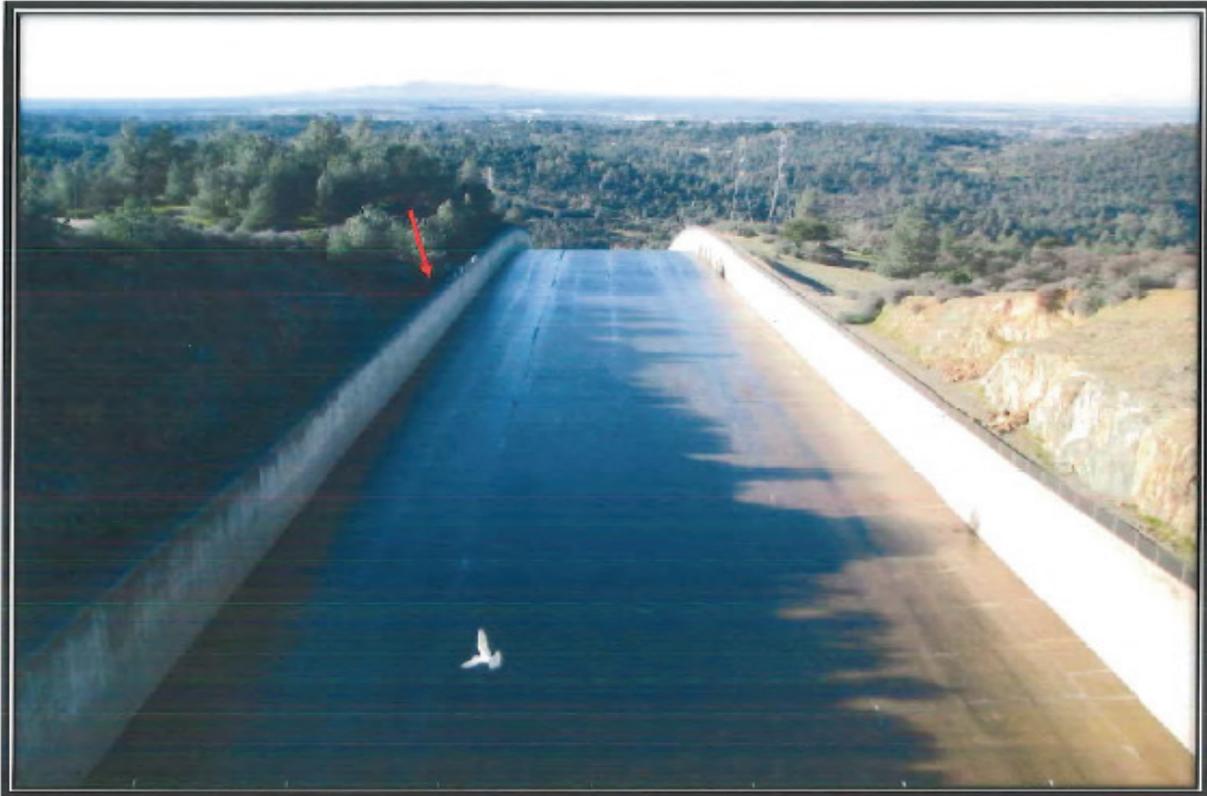
2/8/11 Inspection Report

9. The gates seals were leaking enough to keep the chute floor wet. The repaired lateral cracks in the chute floor are visible as light streaks. The brush at the arrow should be removed to prevent root invasion of the wall drain. No signs of instability were noted along the chute walls or floor. The drain holes at the end of the chute were flowing.

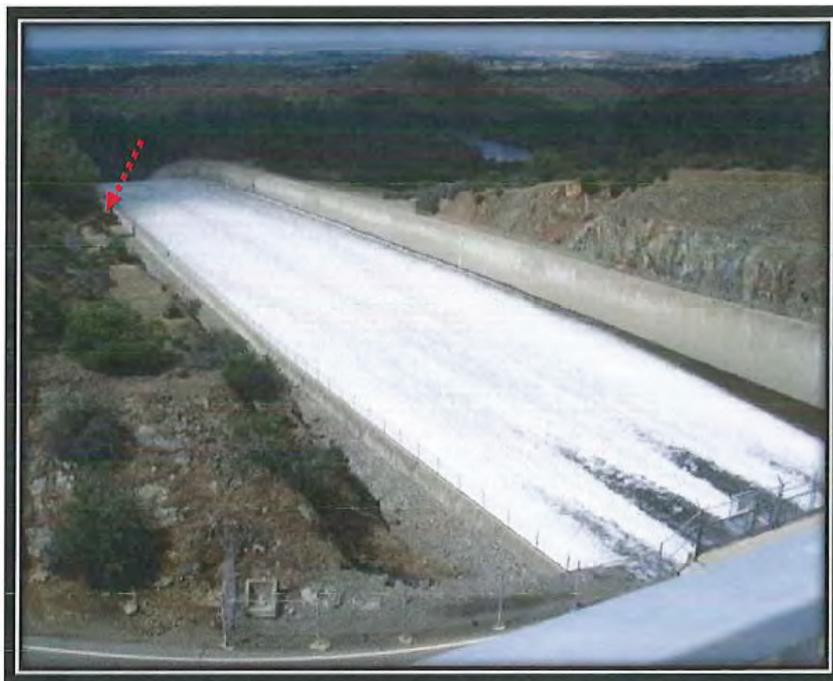
2/16/11 Inspection Report

11. The flood control outlet flow pattern was normal. The walls were well aligned and stable appearing. The drains at the vertical curve along the chute were flowing as expected. The brush growing in the backfill gravel adjacent to the left wall should be removed as previously requested. See arrow at left.

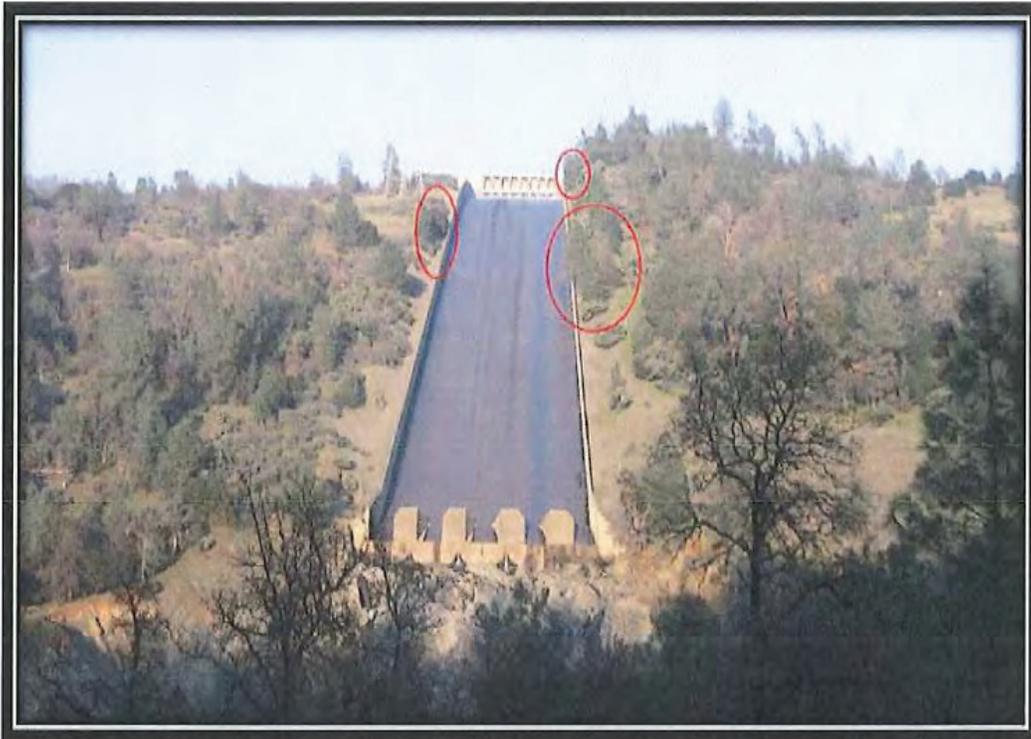
2/5/13 Inspection Report

14. The flood control outlet gate seal leakage and drain flow are visible. The trees and brush shown within the ovals should be removed by November 1, 2013. Oroville Dam, No. 1-48

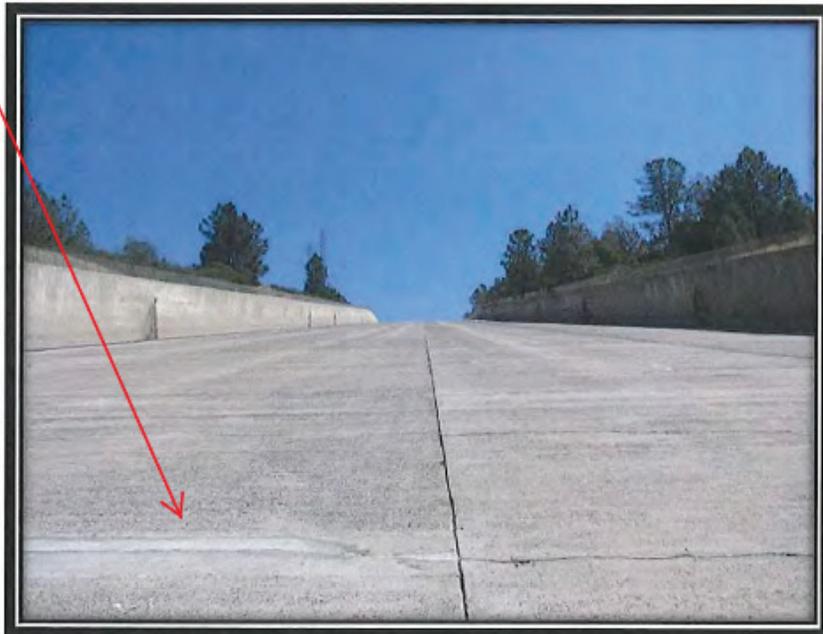
13. This view is looking upstream along the FCO channel from the dentates. Dark, vertical stains along the walls indicate the location of the drain outfalls.

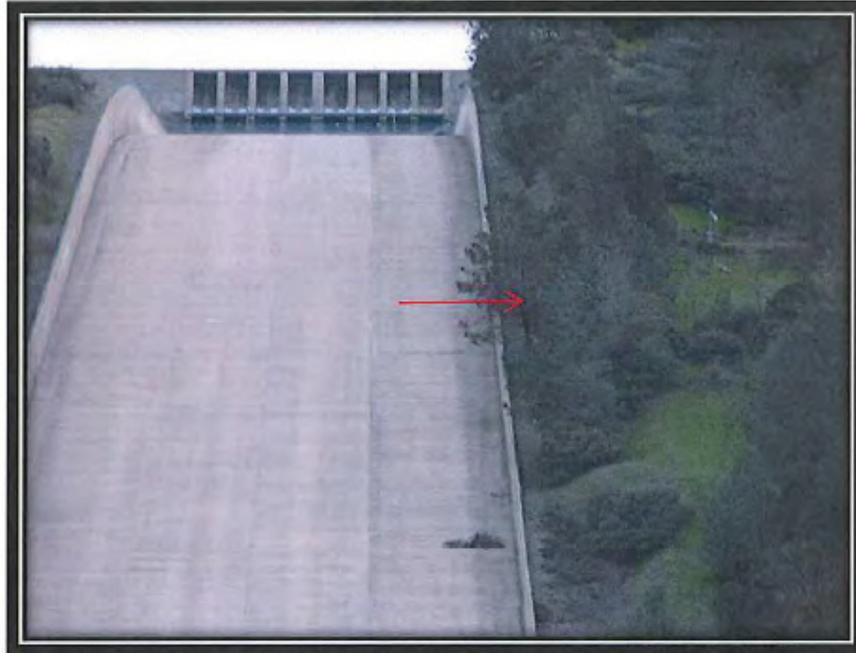
9. This view looking upstream along the FCO discharge chute shows one tree (arrow) that needs to be removed following a significant effort to remove brush along the outside of the wall.

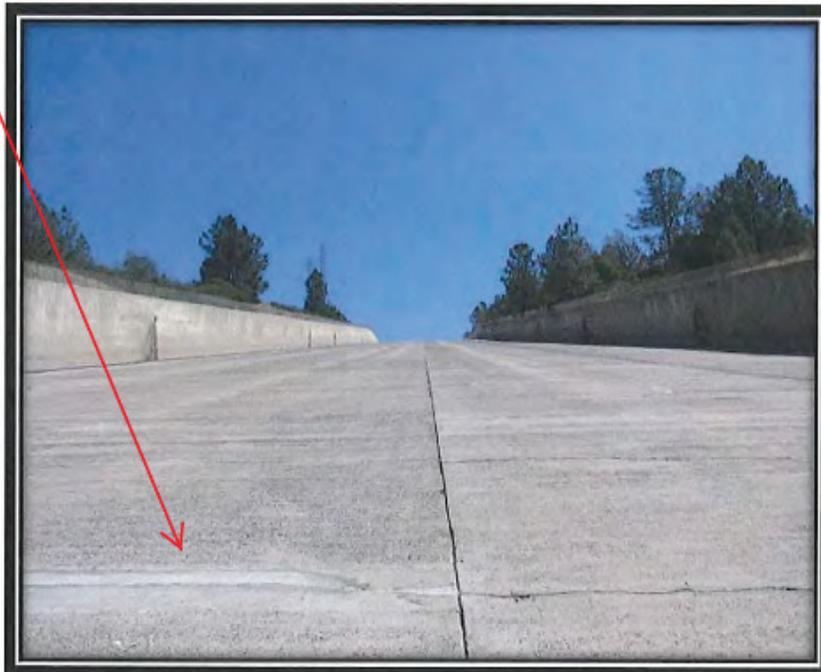
13. This view is looking upstream along the FCO channel from the dentates. Dark, vertical stains along the walls indicate the location of the drain outfalls.

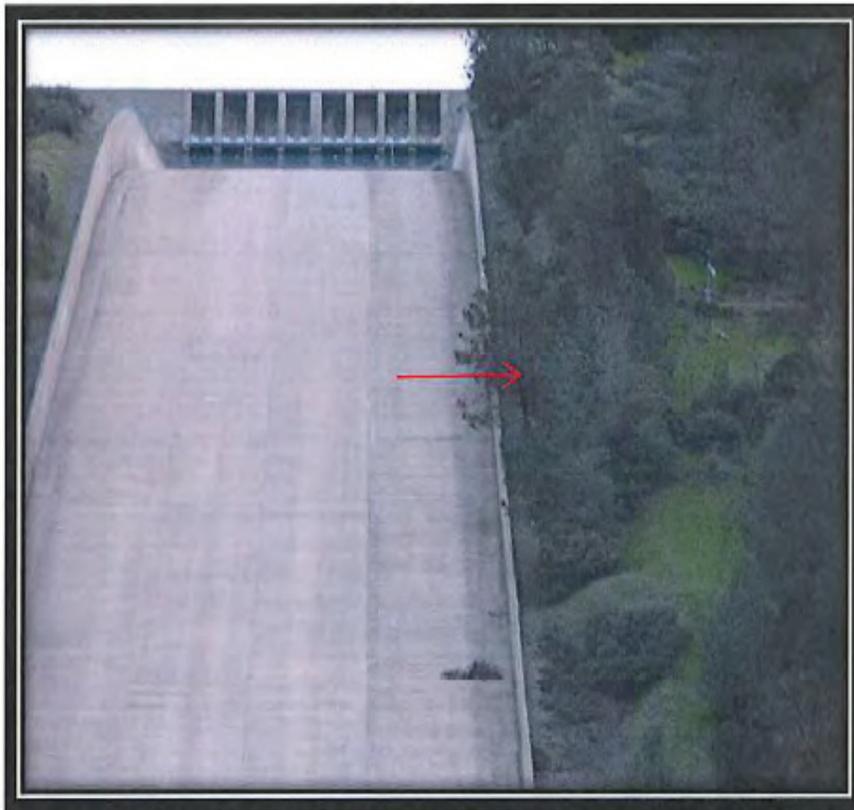
9. This view looking upstream along the FCO discharge chute shows one tree (arrow) that needs to be removed following a significant effort to remove brush along the outside of the wall.
