Preliminary Root Causes Analysis of Failures of the Oroville Dam Gated Spillway

R. G. Bea

Center for Catastrophic Risk Management
University of California Berkeley
April 17, 2017¹

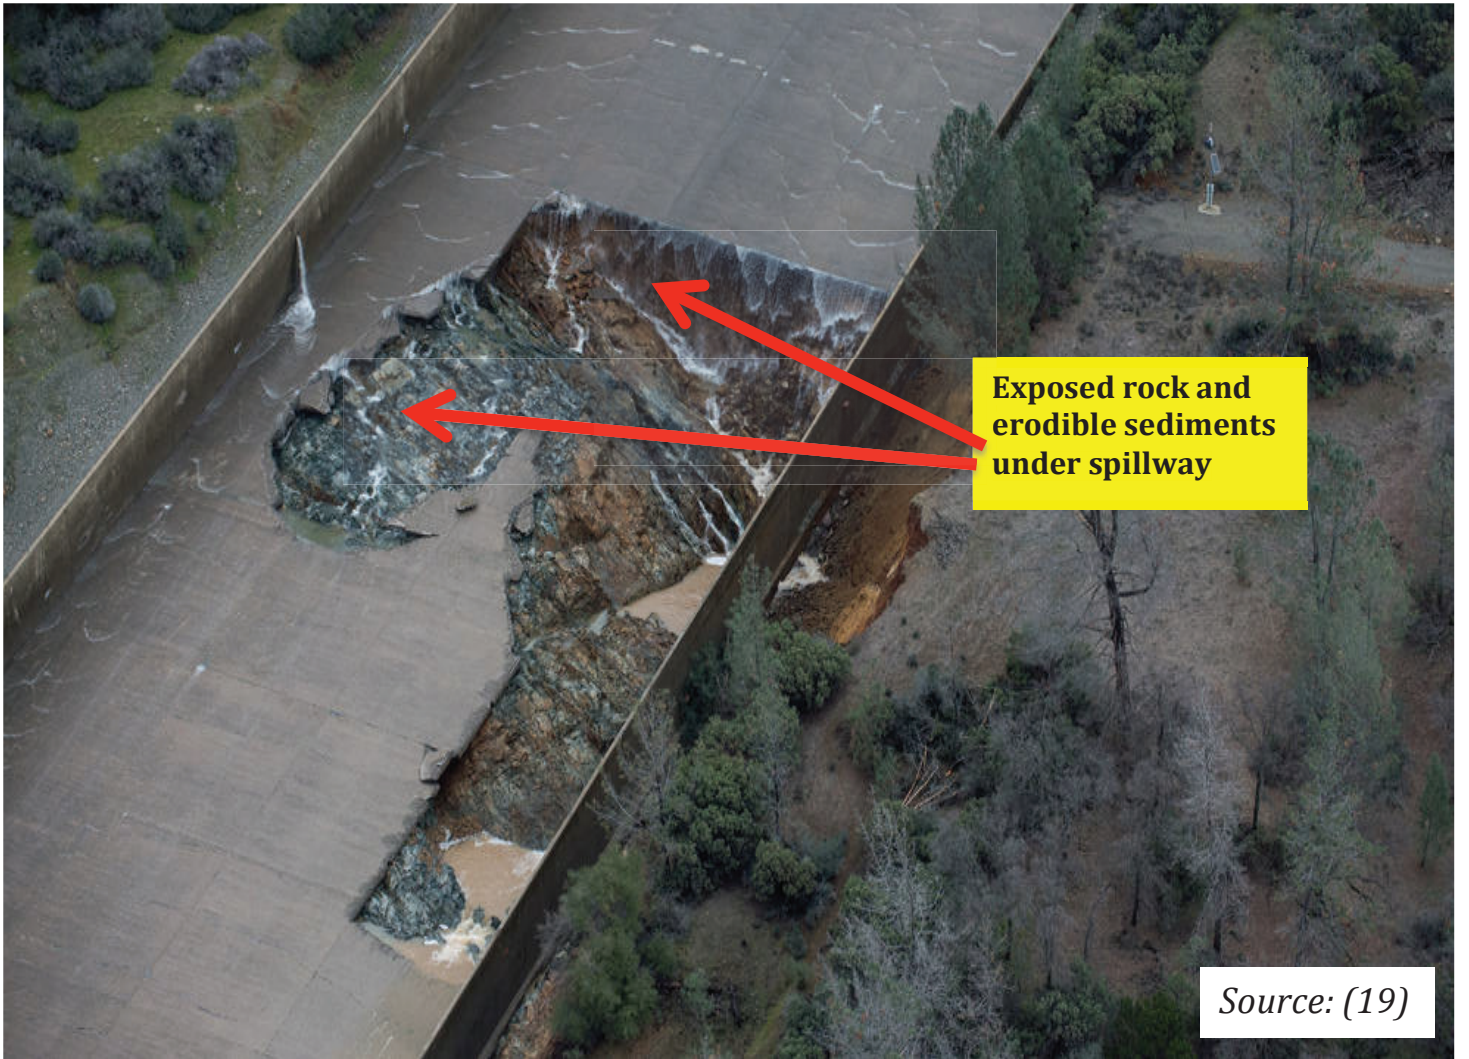
Exposed rock and erodible sediments under spillway

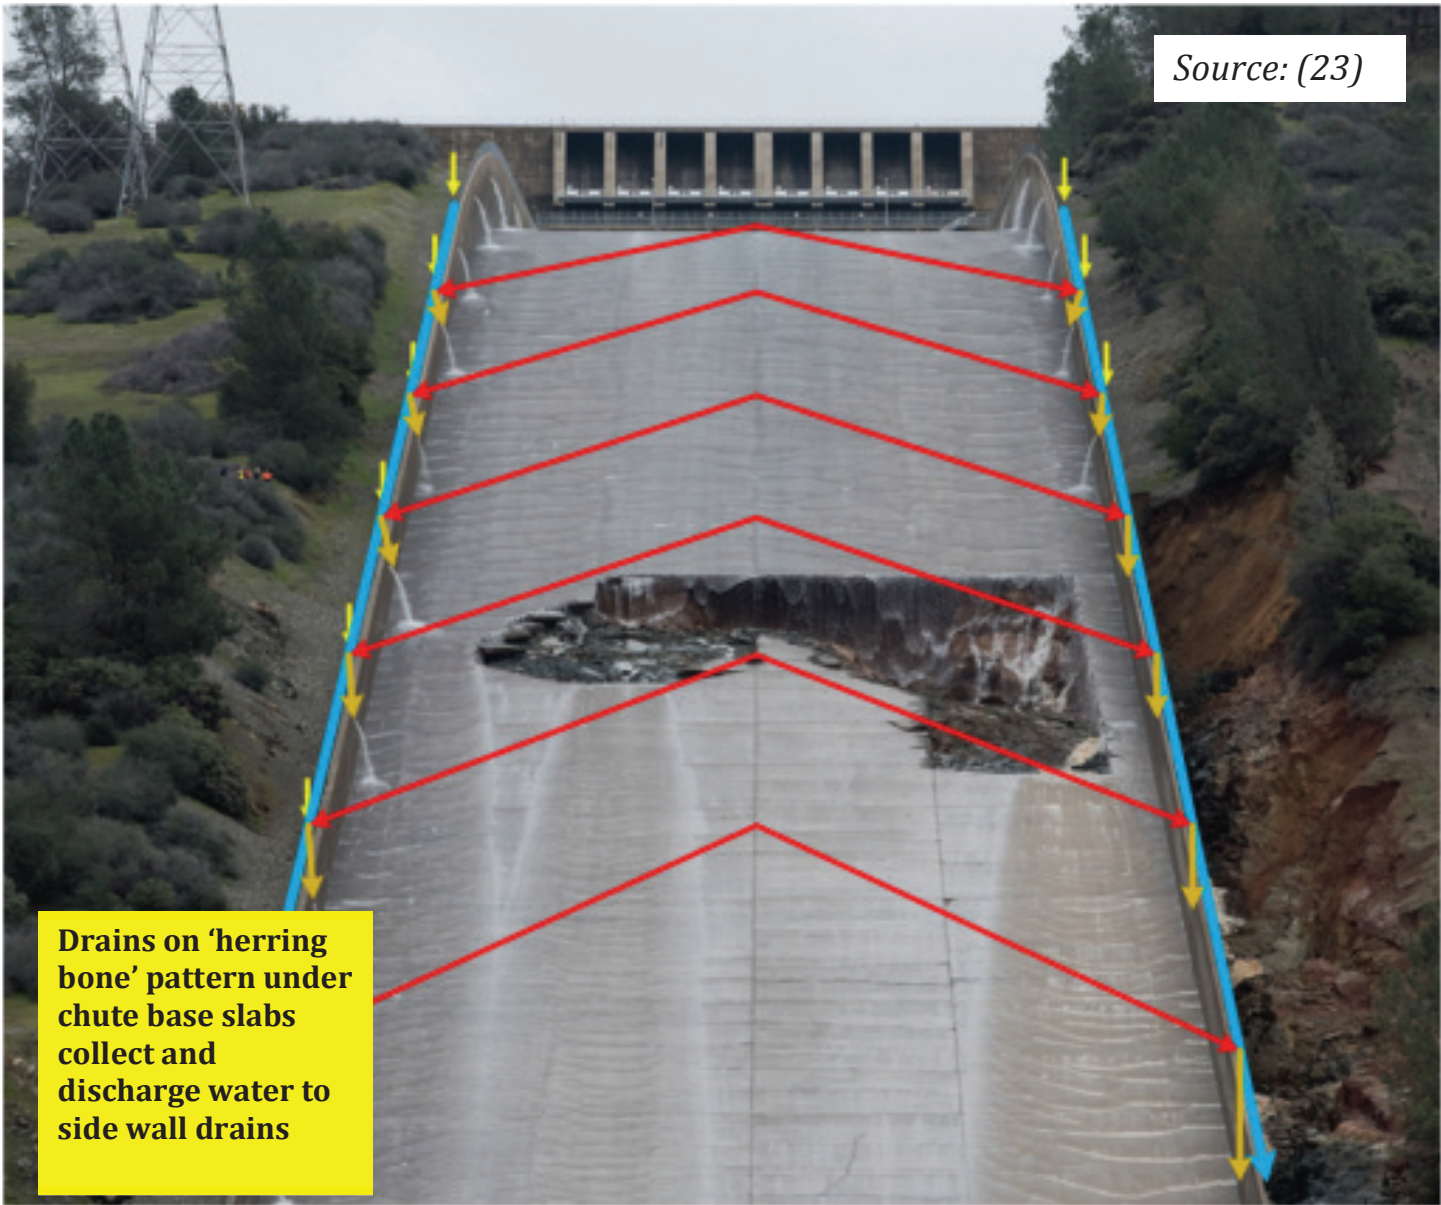
Drains on 'herring bone' pattern under chute base slabs collect and discharge water to side wall drains

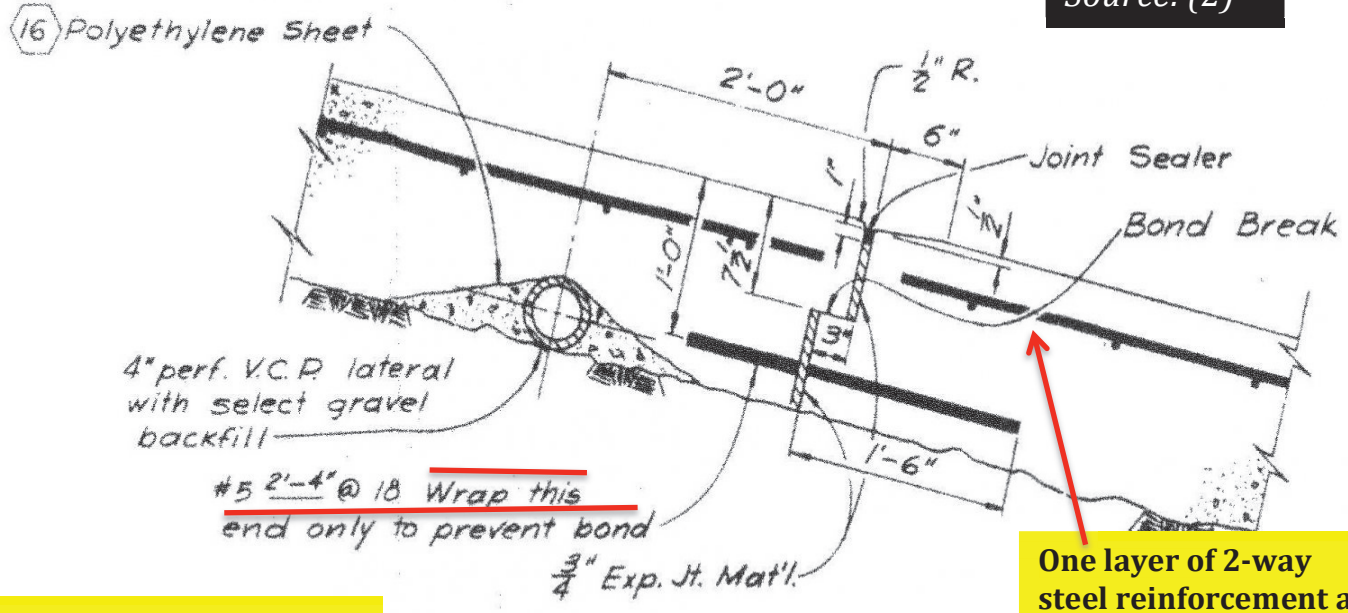
DETAIL A
LATERAL EXPANSION JOINT
Scale: 1" = 1'

One layer of 2-way steel reinforcement at top of slab

No 'continuous' steel across joint to prevent slab separation

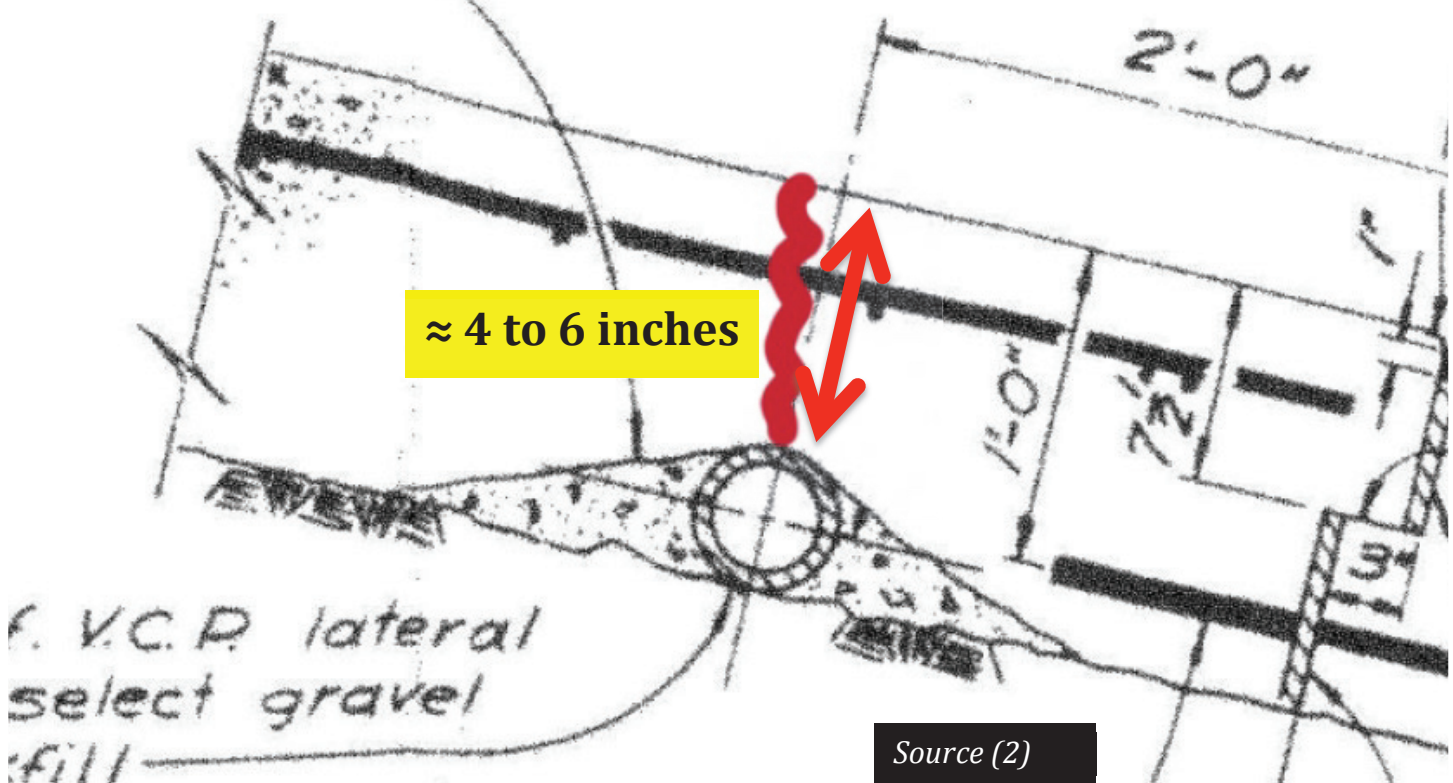
DETAIL A
LATERAL EXPANSION JOINT
Scale: 1"=1'

No steel reinforcement
across slab joints to
prevent separation

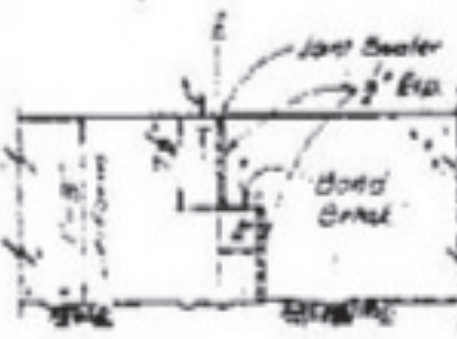
TYPICAL DETAIL
EXPANSION JOINT
Scale: 1"=1'

No steel reinforcement
across slab joints to
prevent separation

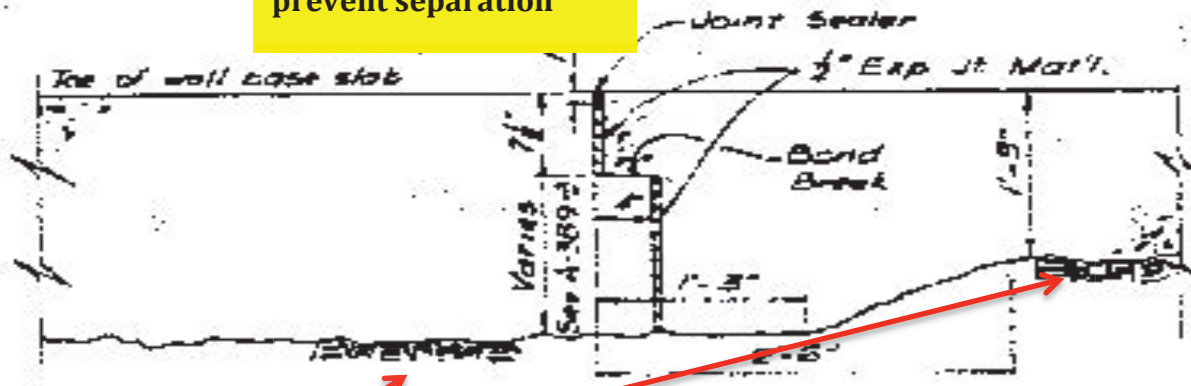
TYPICAL DETAIL
SLAB EDGE EXPANSION JOINT
Scale: 1"=1'

Chute base slabs
designed to be
constructed on 'rock'

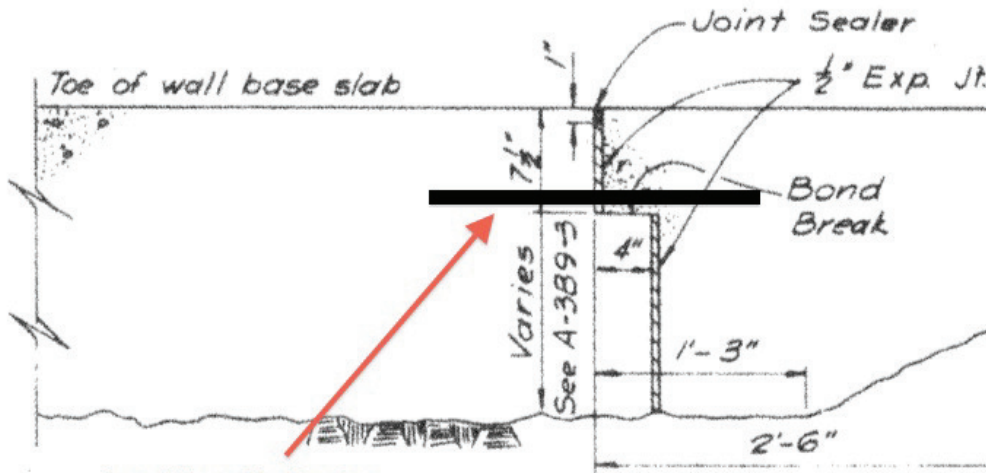
TYPICAL DETAIL
SLAB EDGE EXPANSION JOINT
 Scale: 1" = 1'

Load Transfer Bar (as constructed - not shown in diagram)

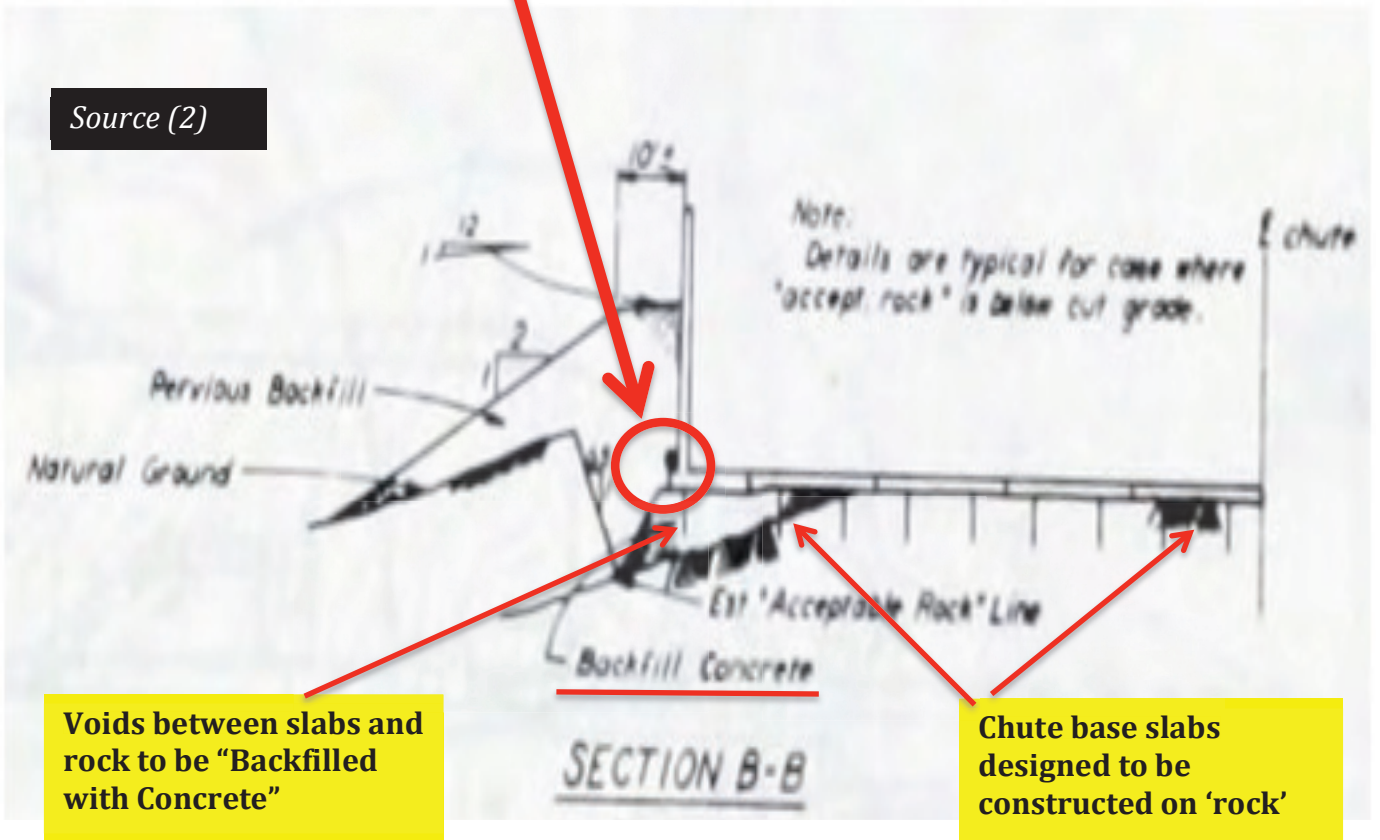
Voids between slabs and rock to be "Backfilled with Concrete"

Chute base slabs designed to be constructed on 'rock'

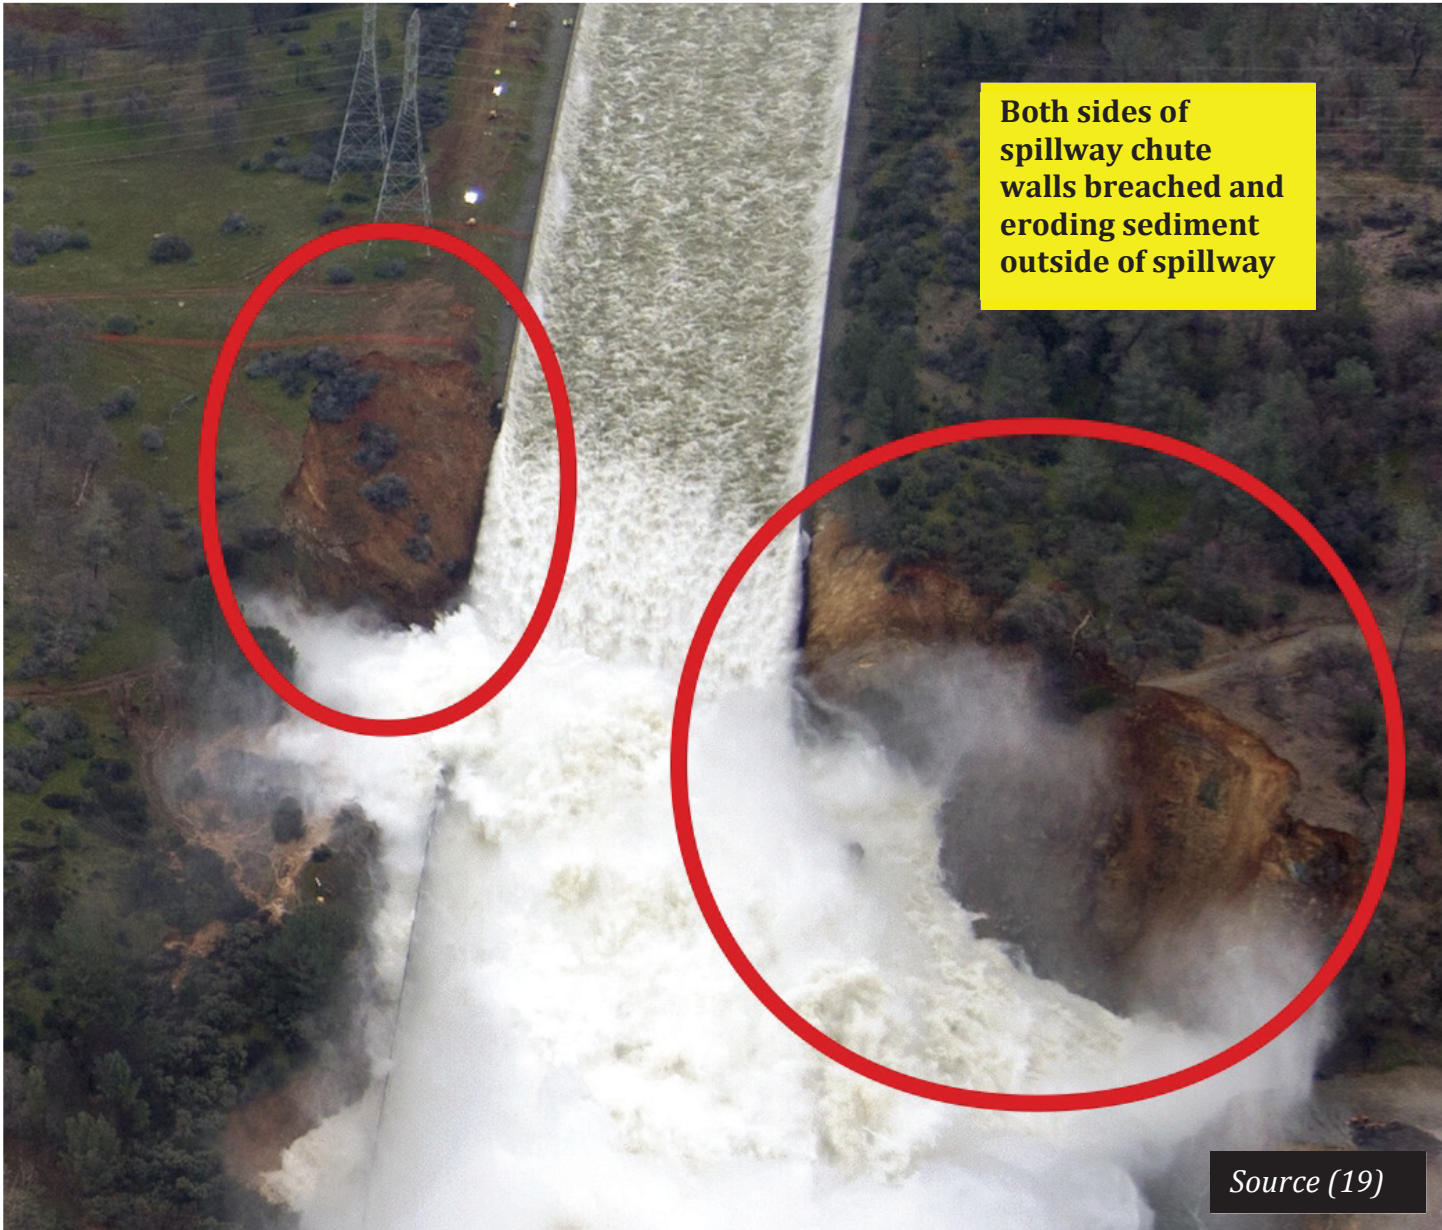
Both sides of spillway chute walls breached and eroding sediment outside of spillway

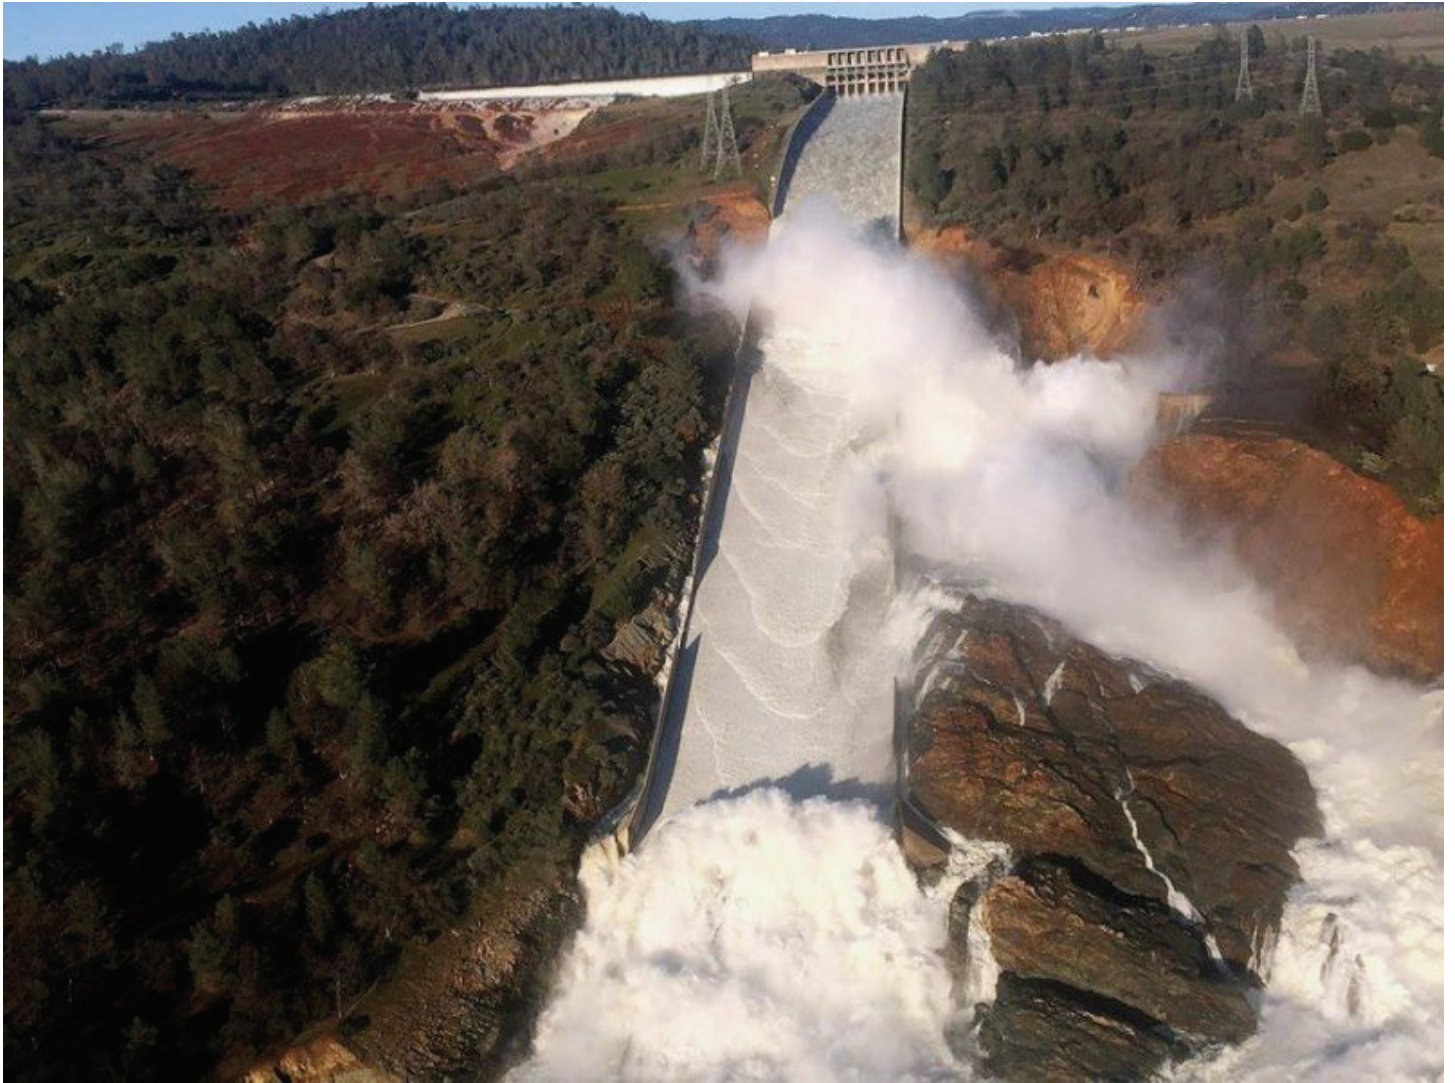
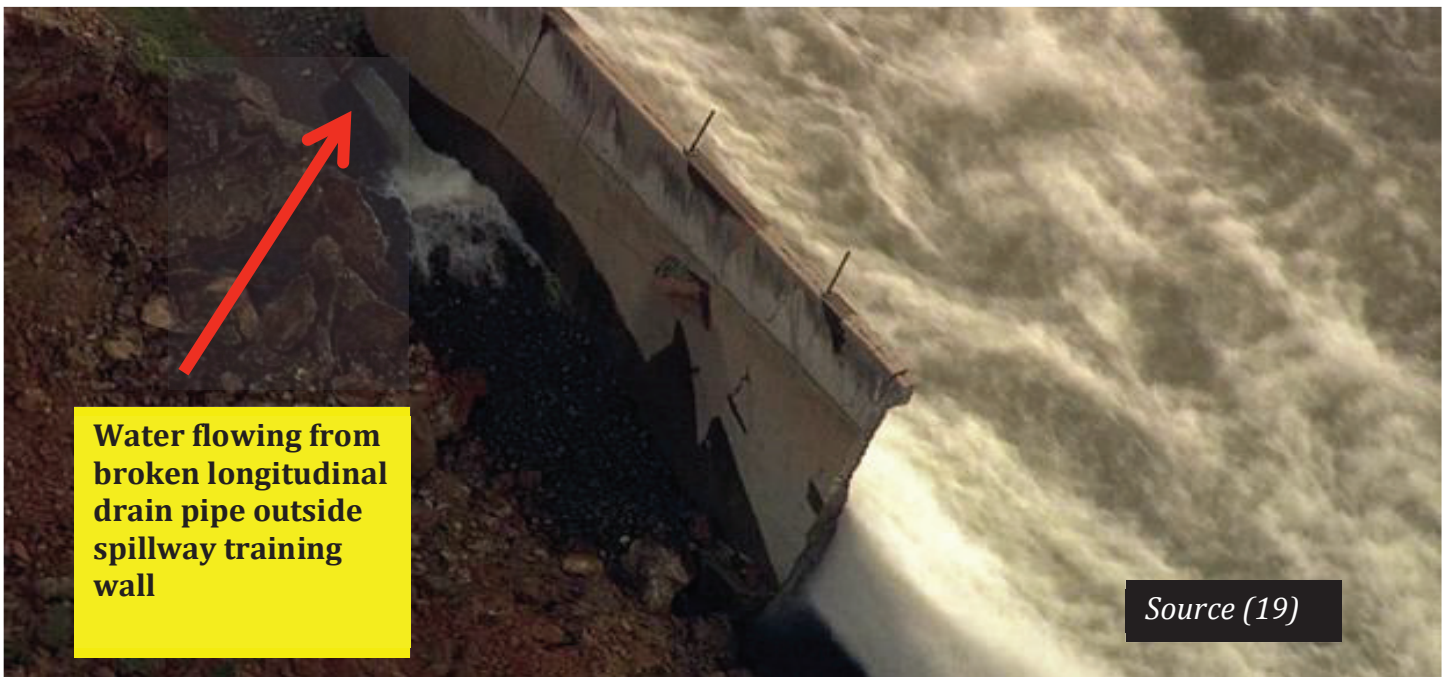
Water flowing from broken longitudinal drain pipe outside spillway training wall

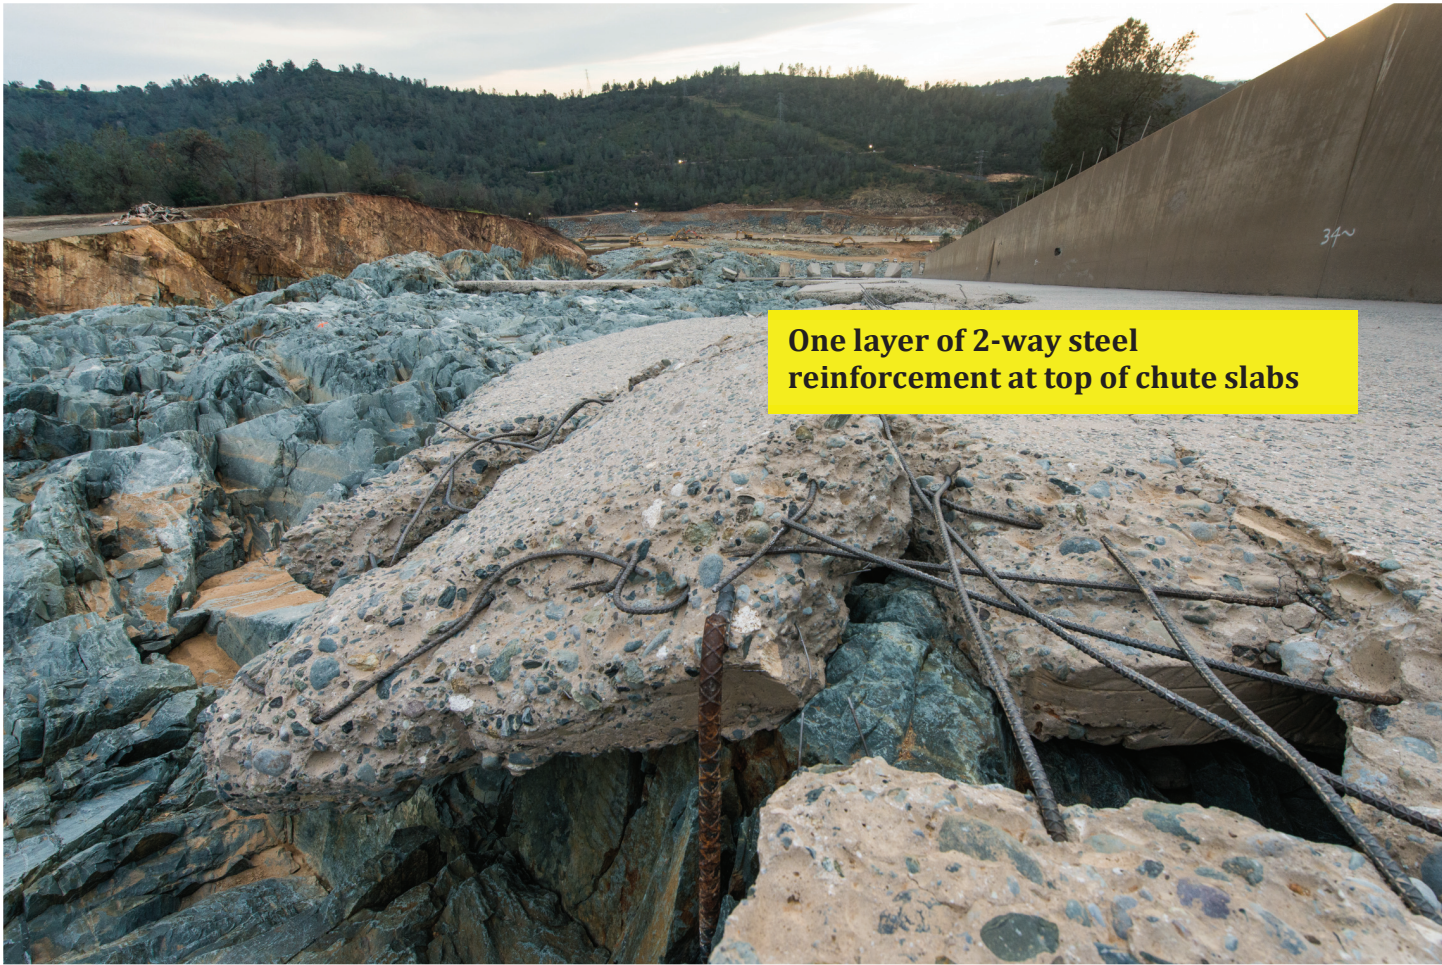
One layer of 2-way steel reinforcement at top of chute slabs

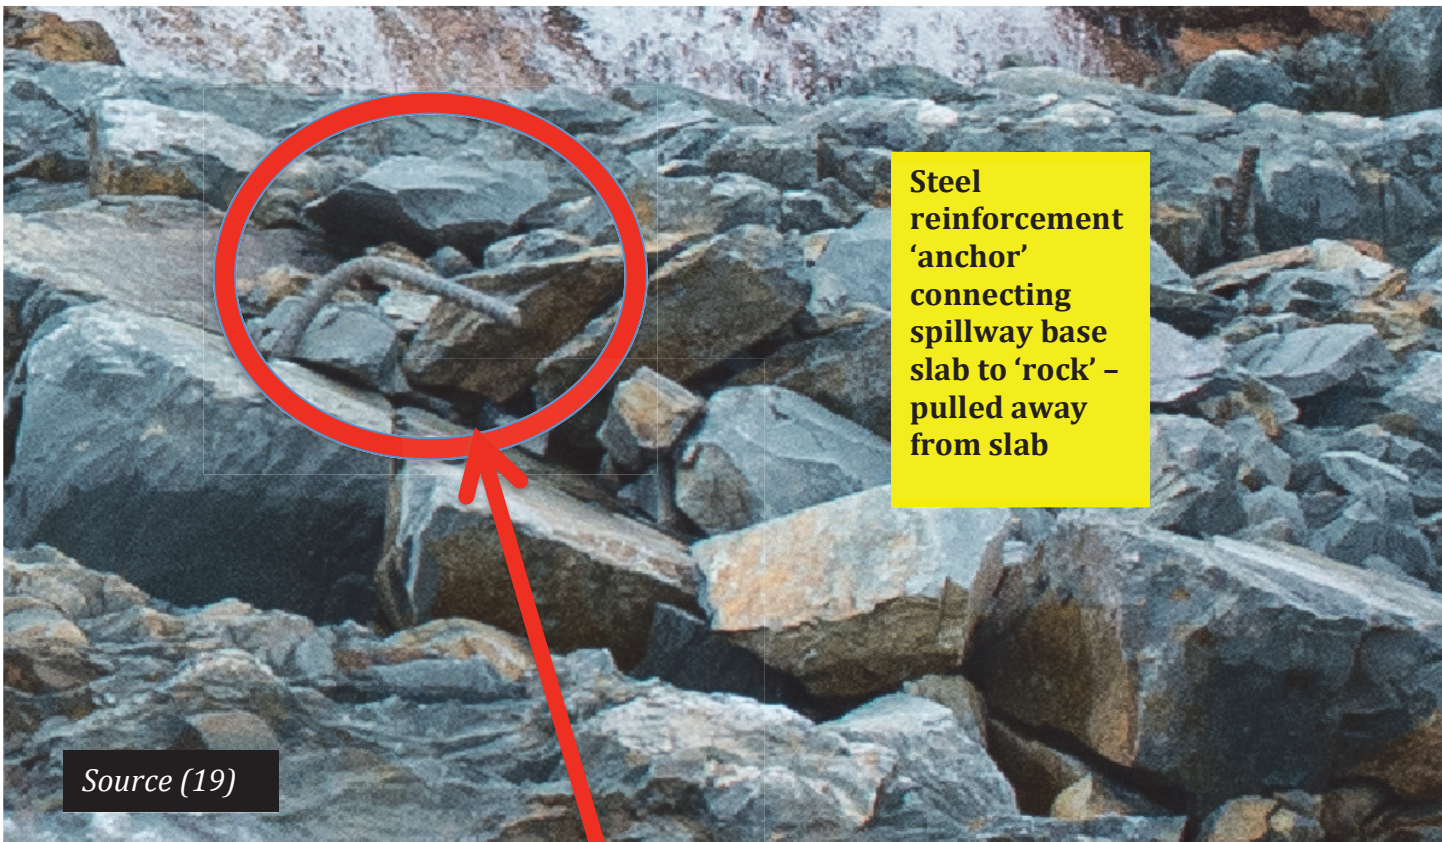
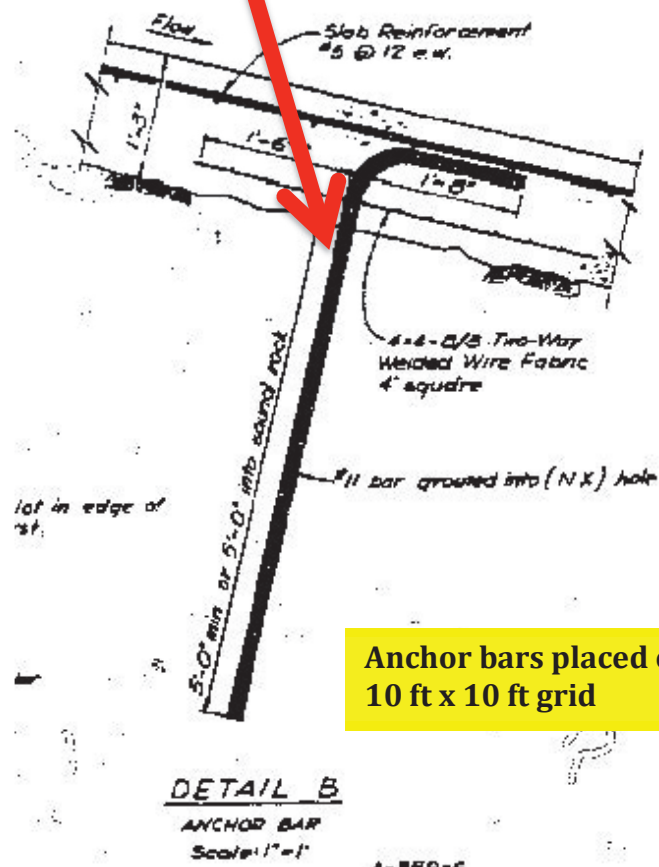
Anchor bars placed on 10 ft x 10 ft grid

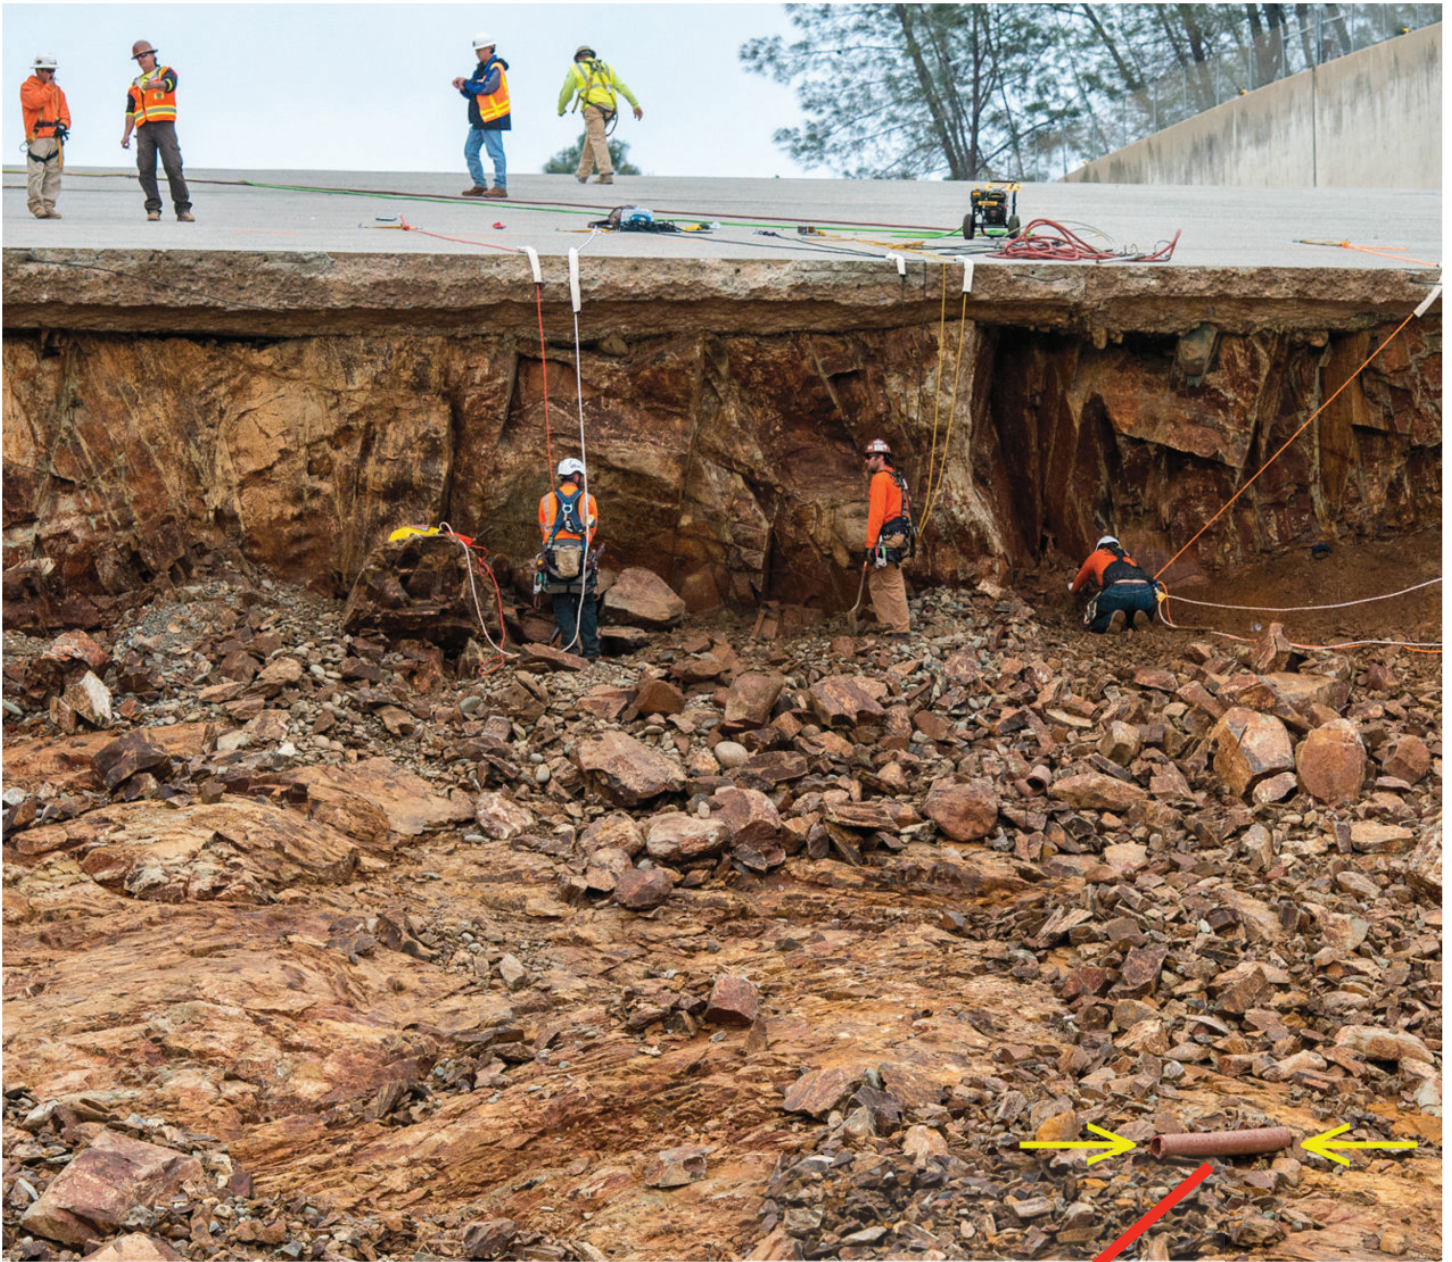
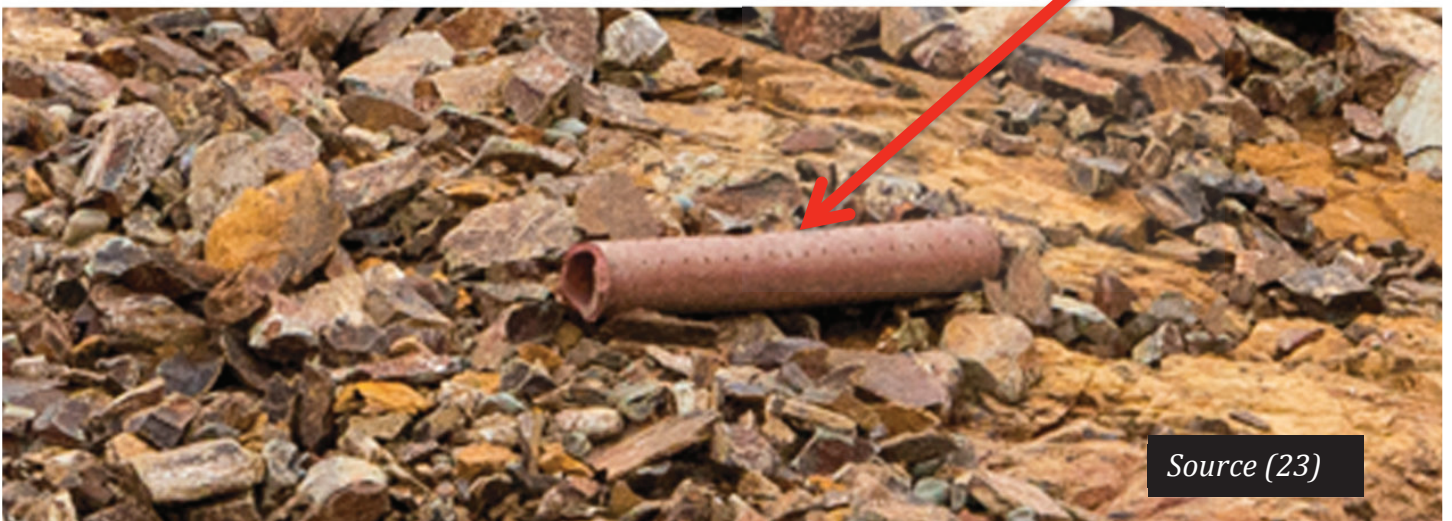
Concrete fractured along
drain pipe emplacement

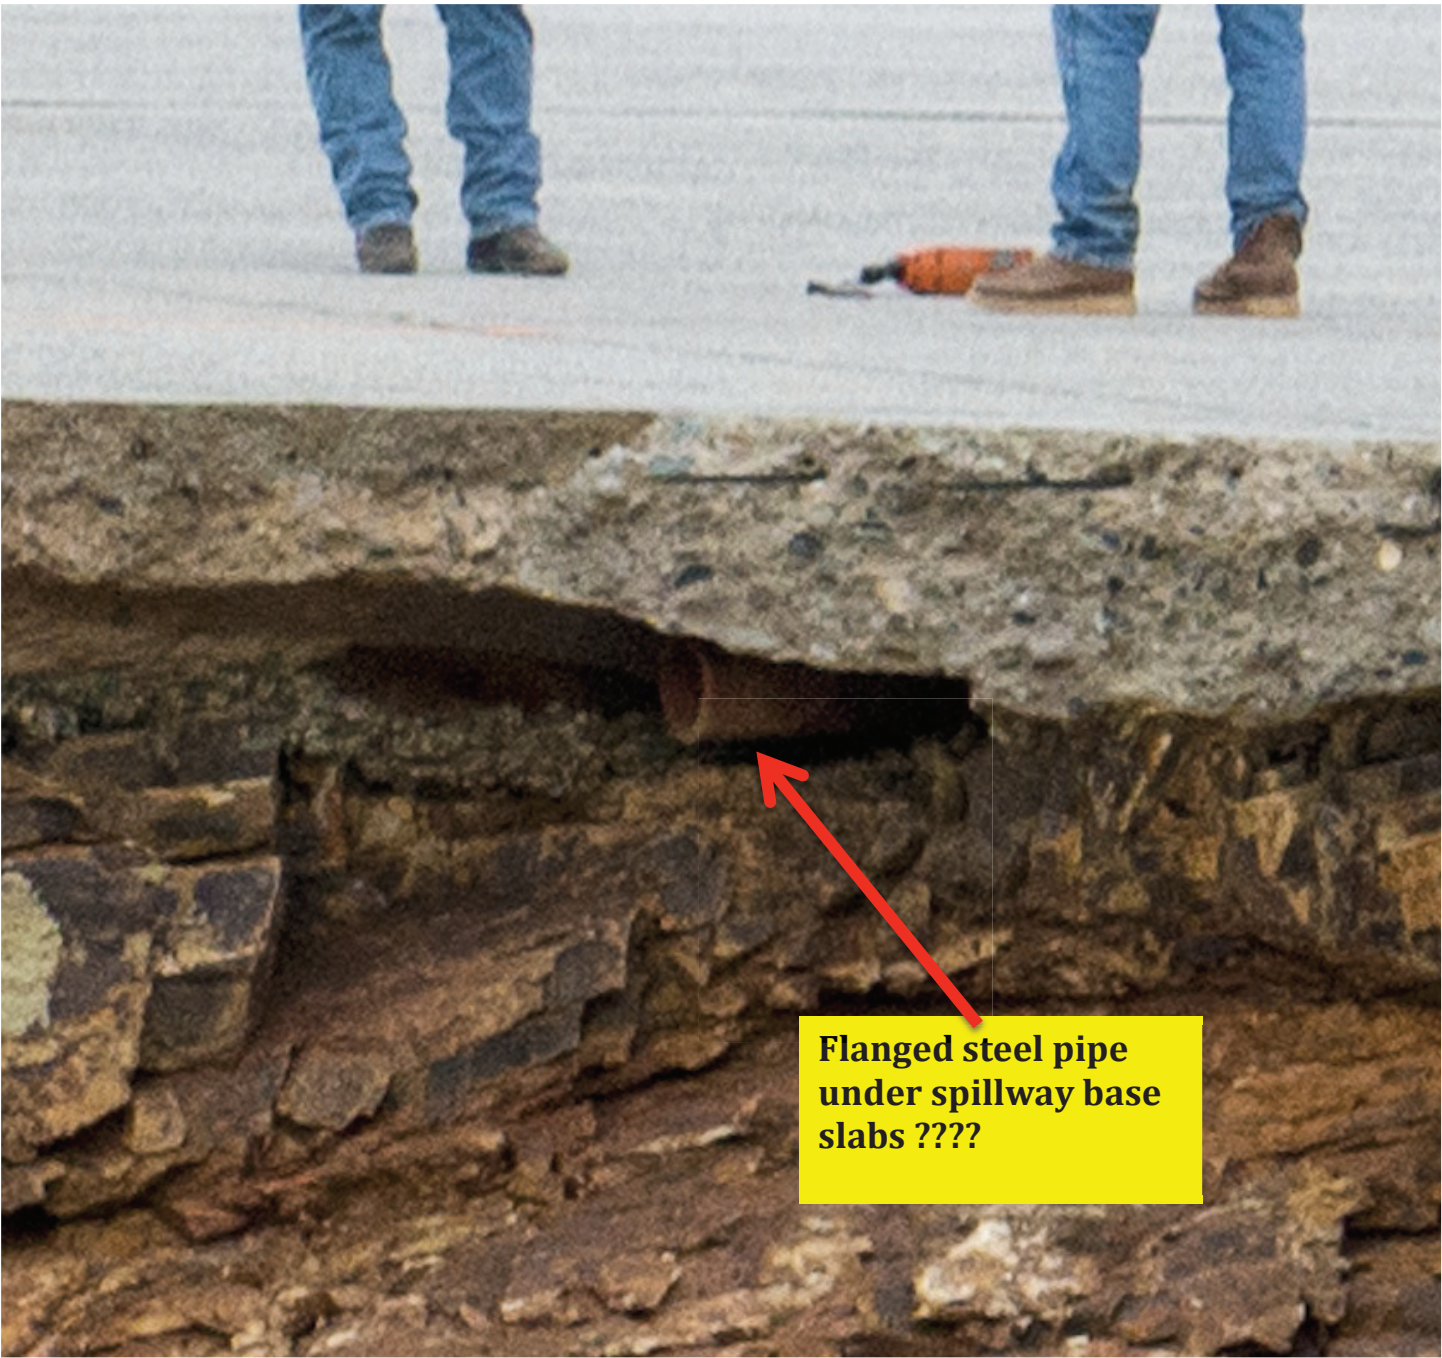
**Flanged steel pipe
under spillway base
slabs ????**
