Pre-Failure Images

**Previous inspection report photographs
(all from cited DWR inspection reports)**

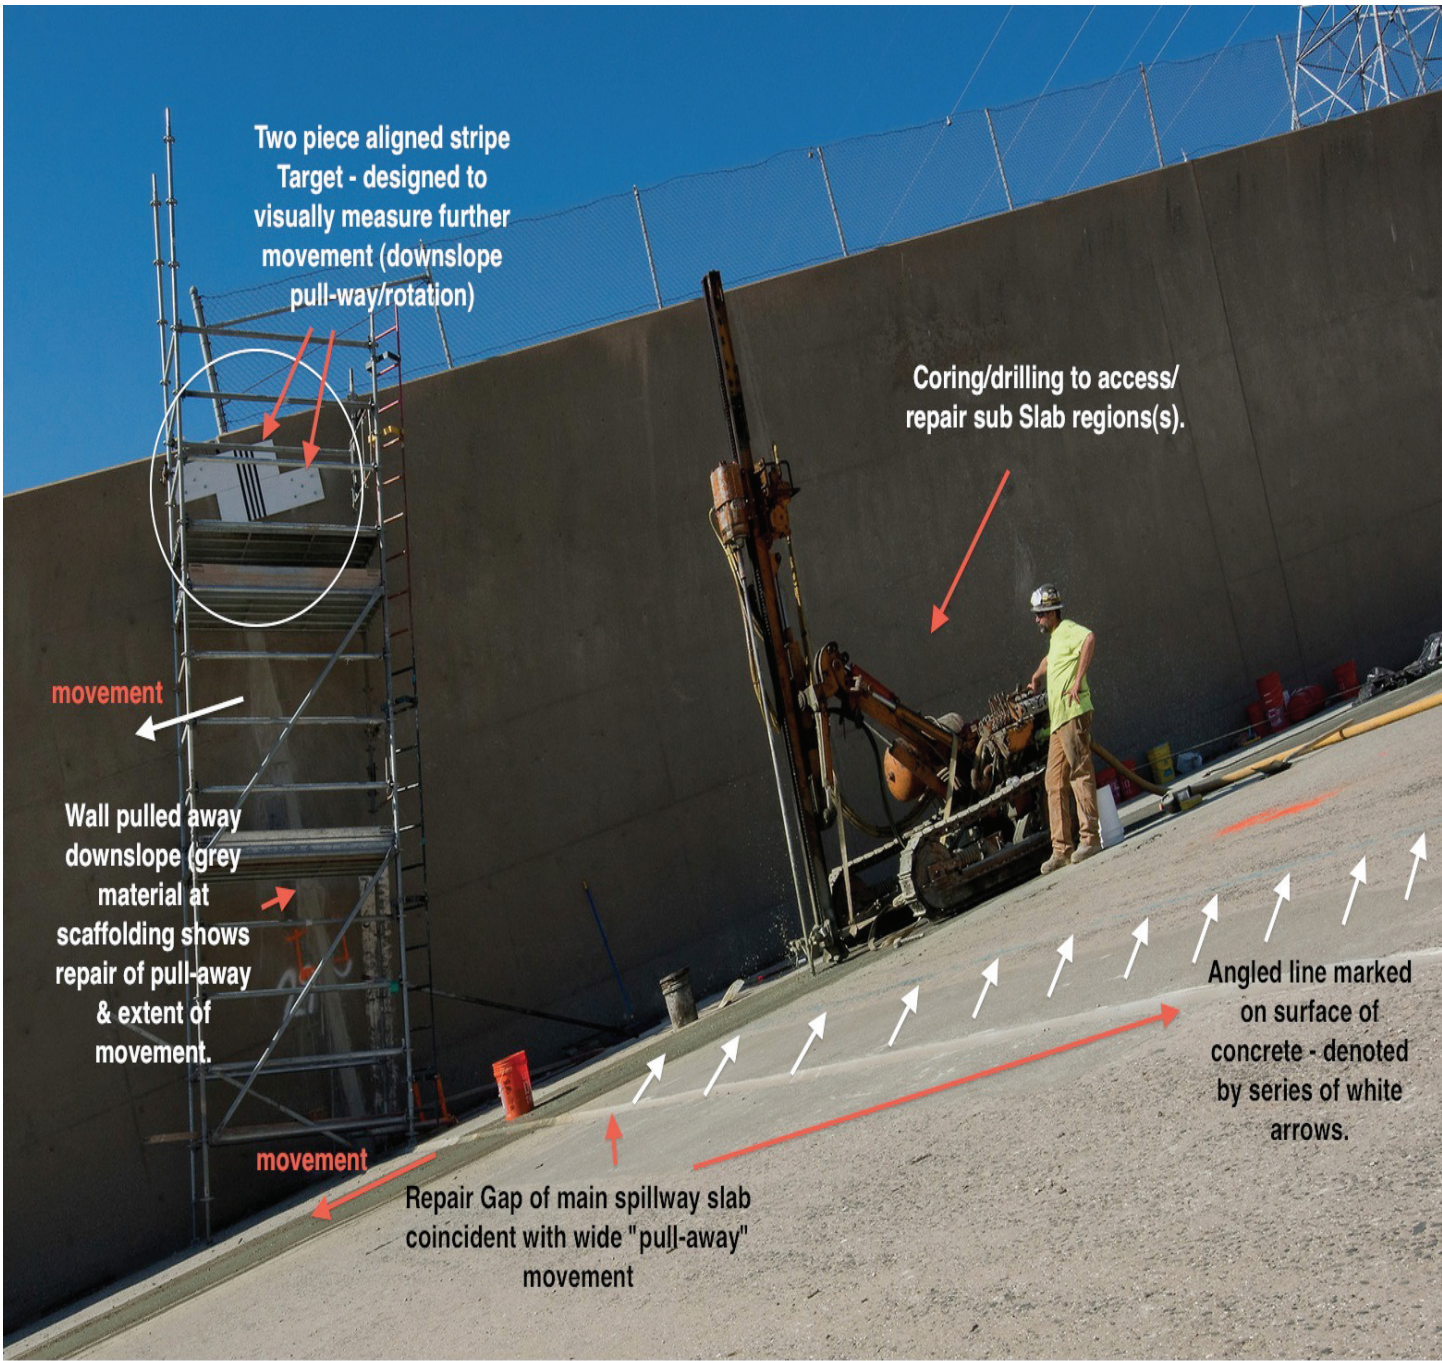
Spillway Repair - Drilled & emplaced "rock bolts" to secure concrete slabs

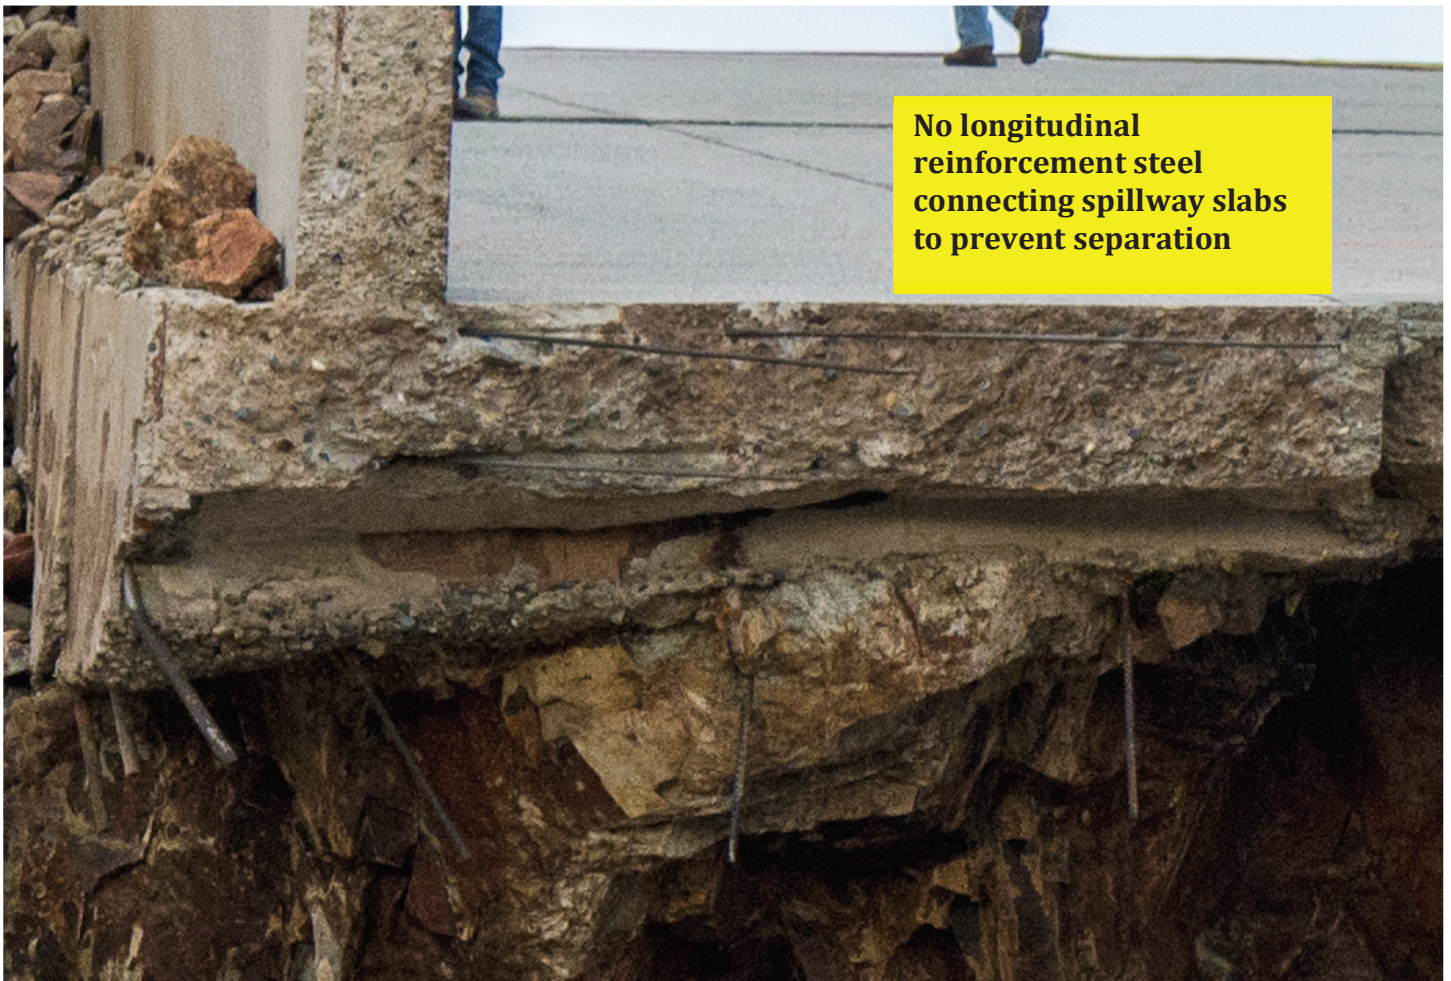
No longitudinal reinforcement steel connecting spillway slabs to prevent separation

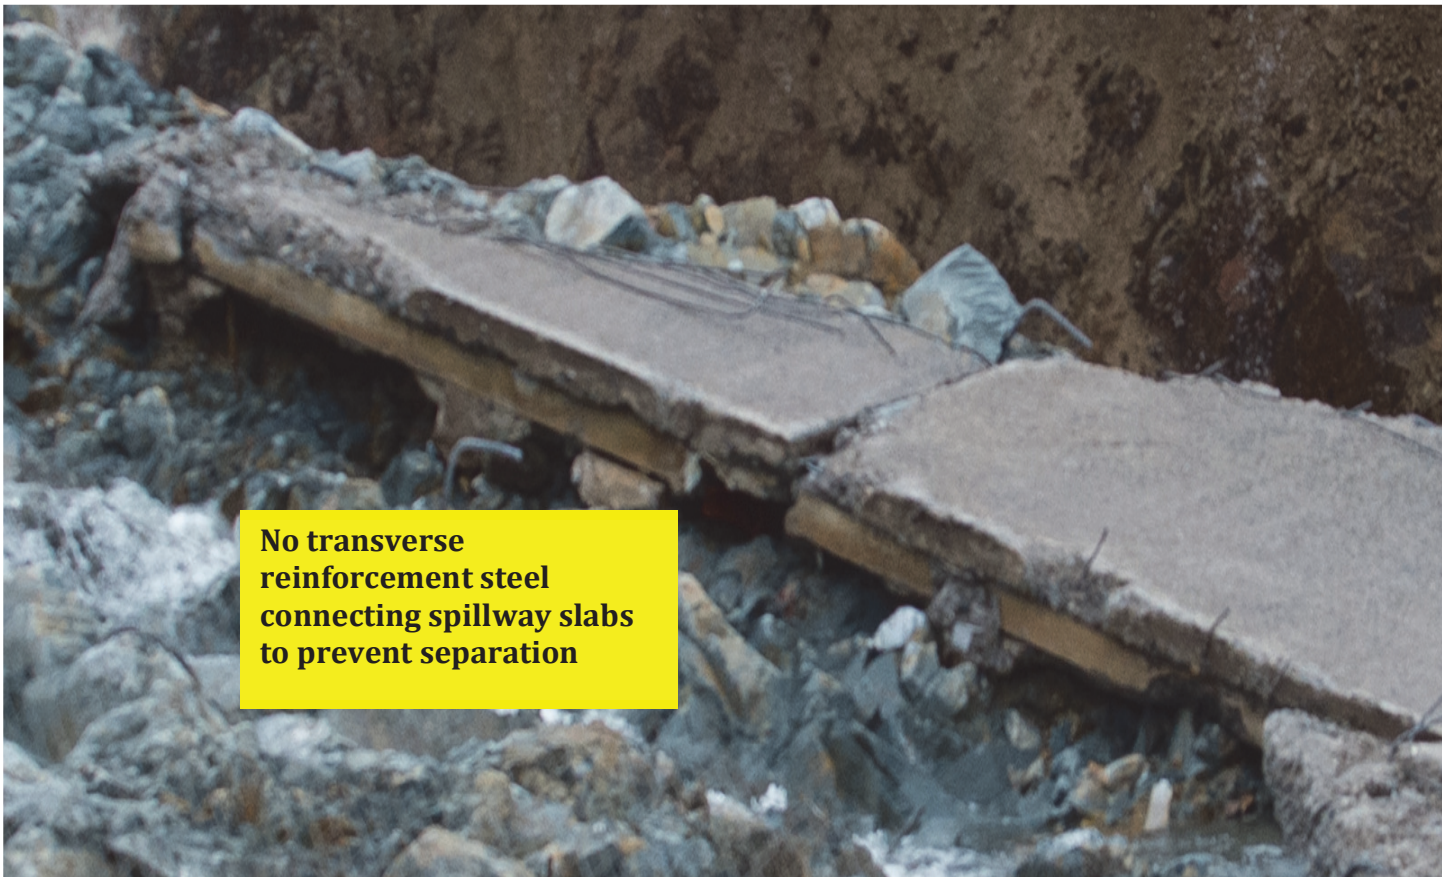
**No transverse
reinforcement steel
connecting spillway slabs
to prevent separation**

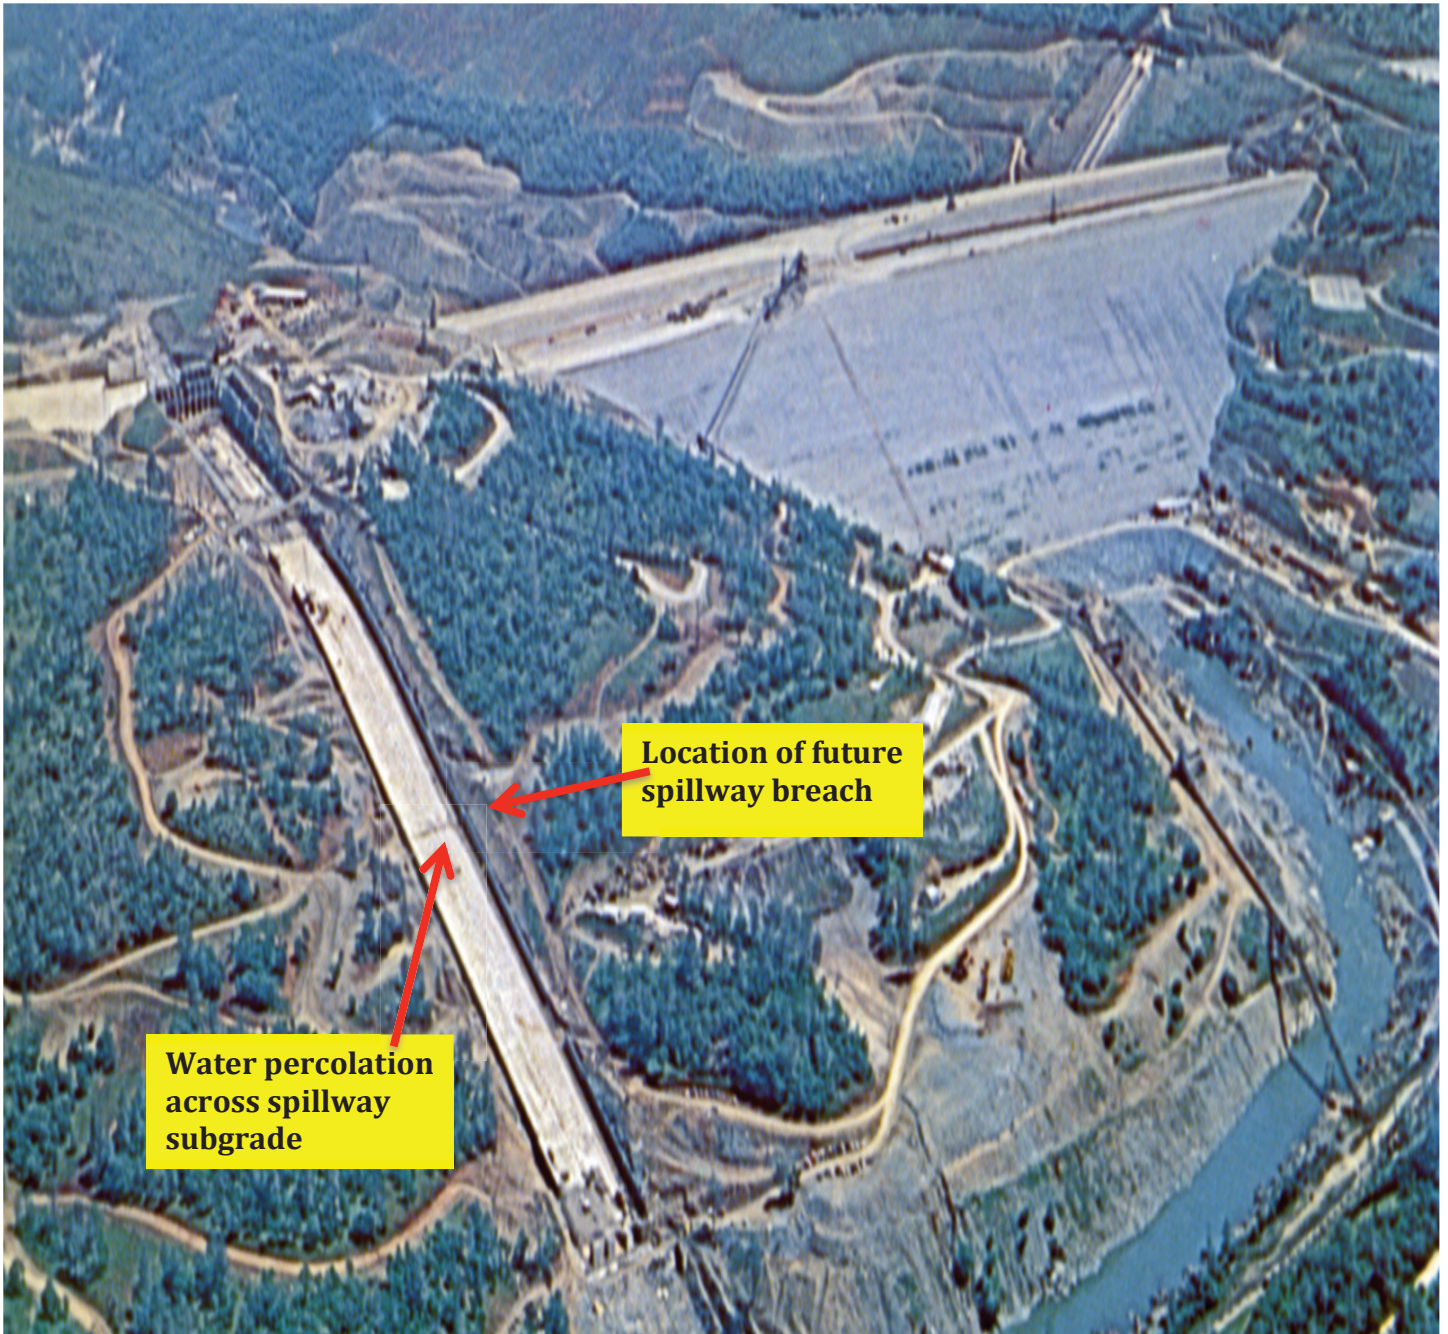
1967 - Spillway being constructed - walls being cast - chute subgrade placed

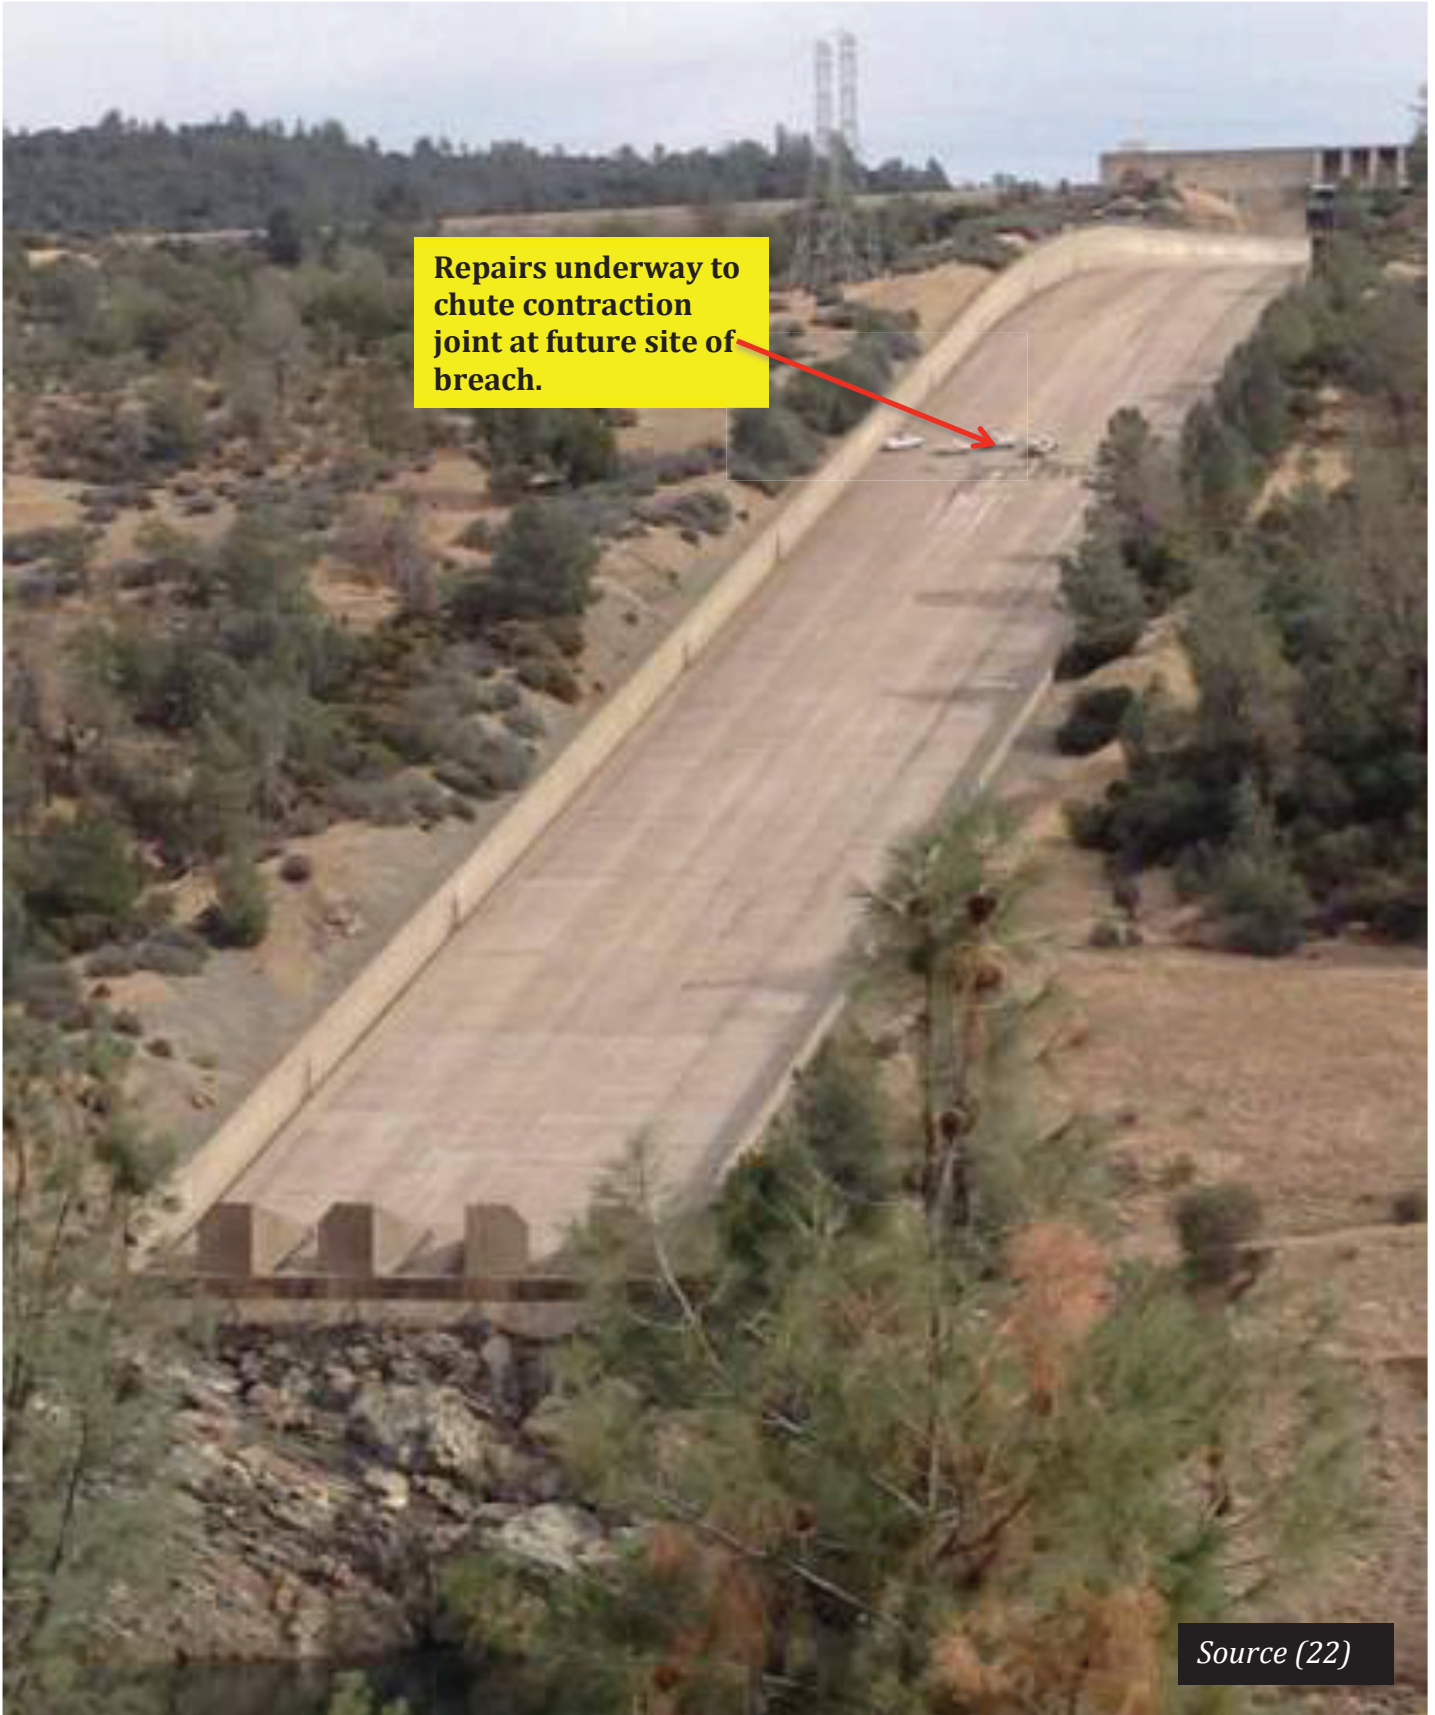
2013

Repairs underway to chute contraction joint at future site of breach.

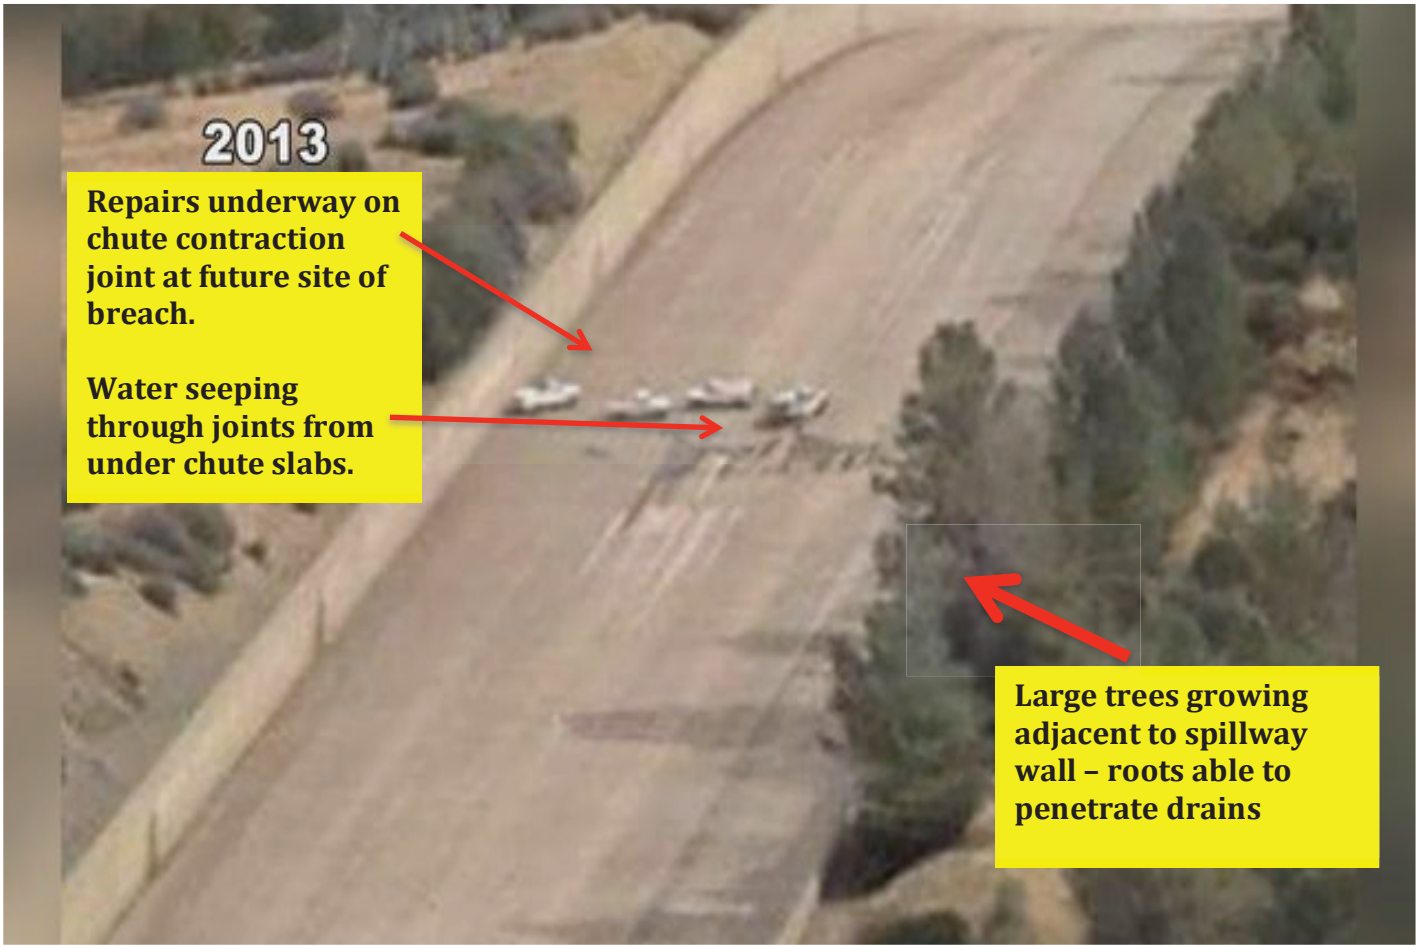
2013

Repairs underway on chute contraction joint at future site of breach.

Water seeping through joints from under chute slabs.

Large trees growing adjacent to spillway wall - roots able to penetrate drains

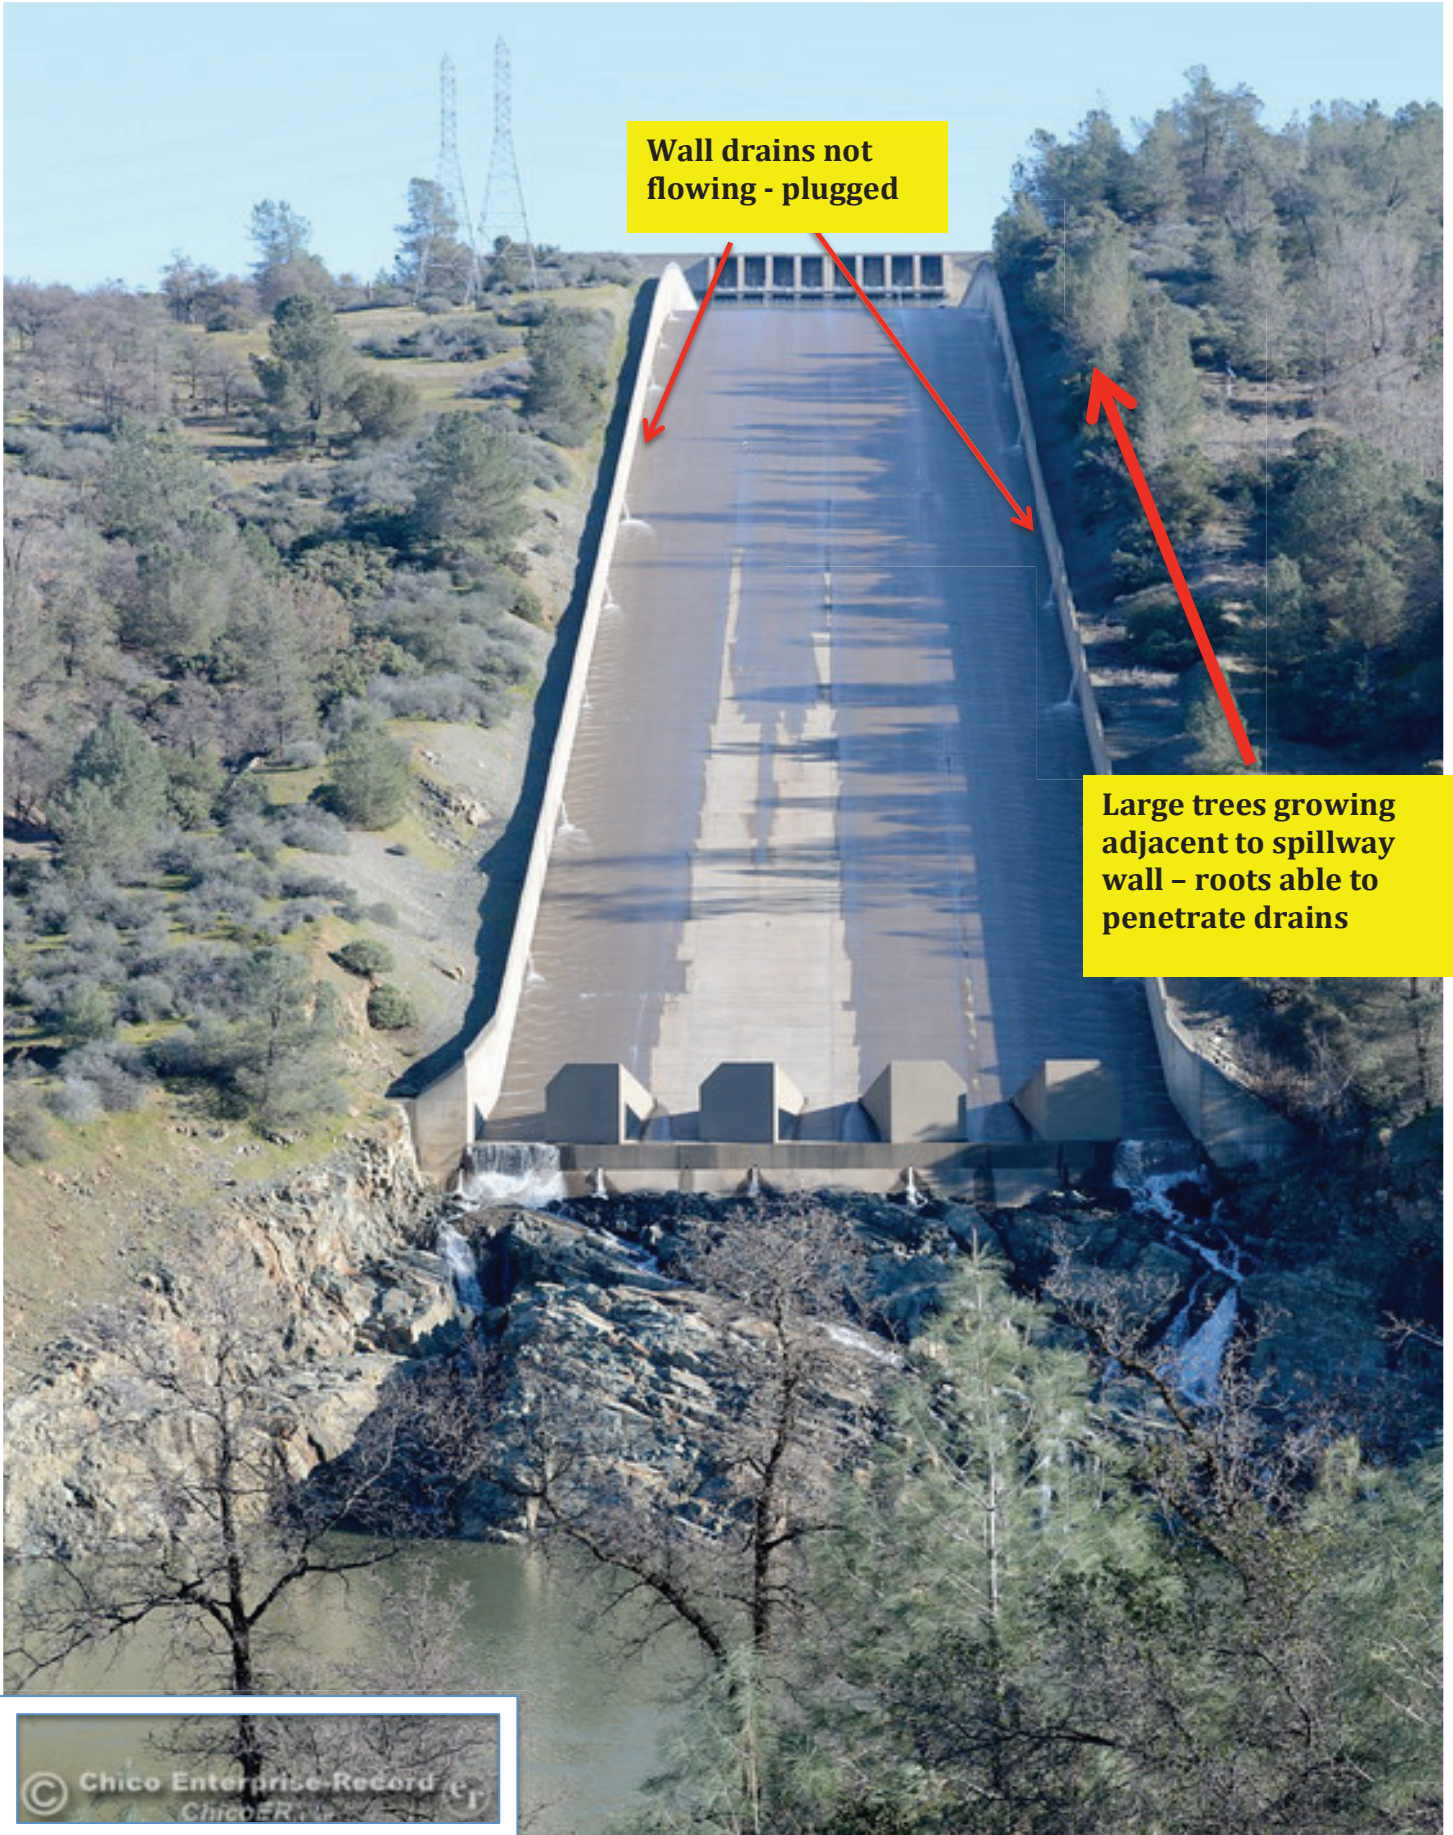
Wall drains not flowing - plugged

Large trees growing adjacent to spillway wall - roots able to penetrate drains

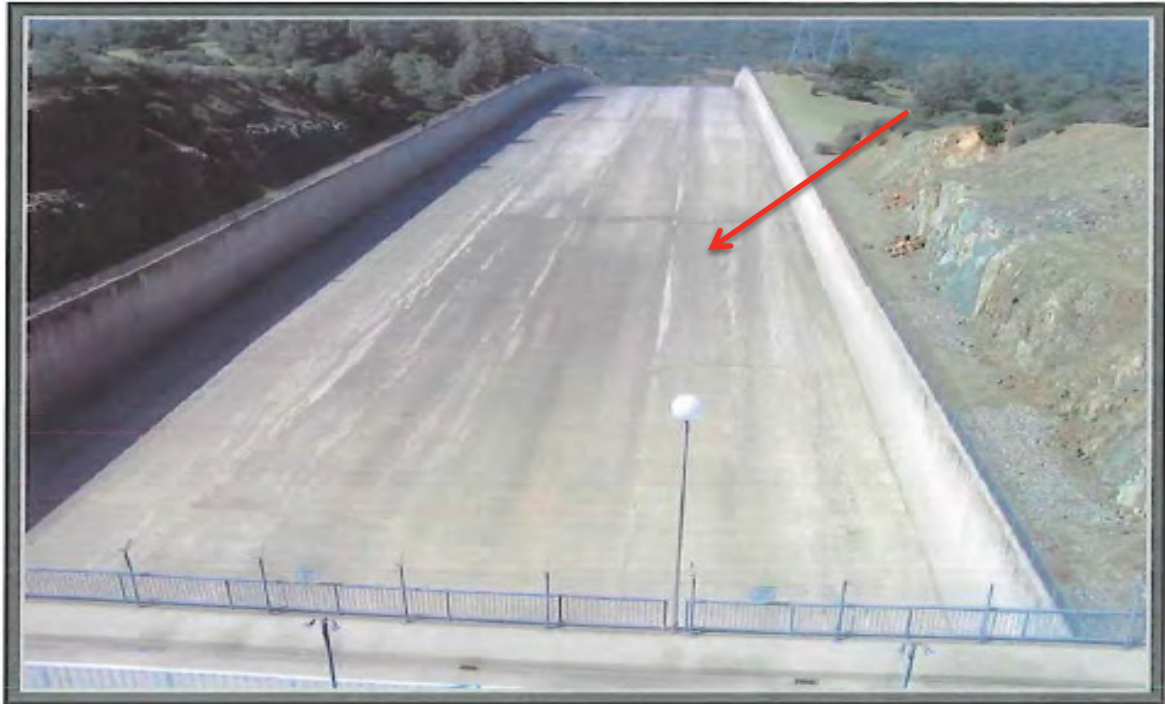
5/6/08 Inspection Report

11. The spillway at the flood control outlet remains in satisfactory condition.

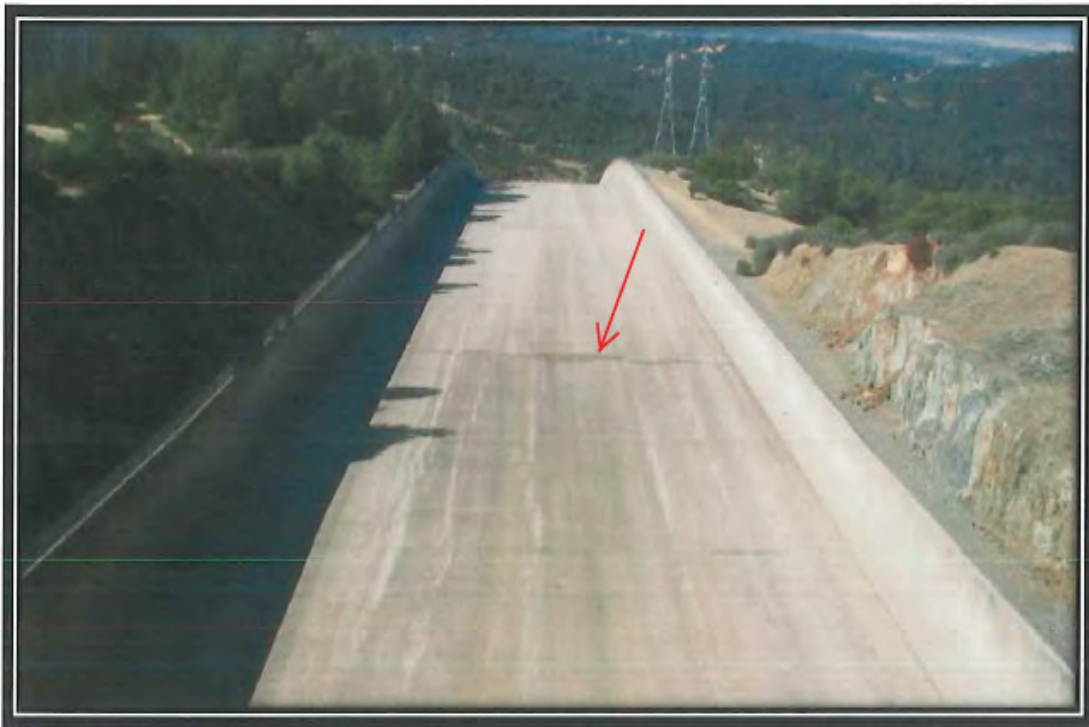
20. This view shows the flood control outlet chute as seen from the upper deck. The walls and chute appeared to be stable and in satisfactory condition. Minor repairs along the chute floor will be completed this year.

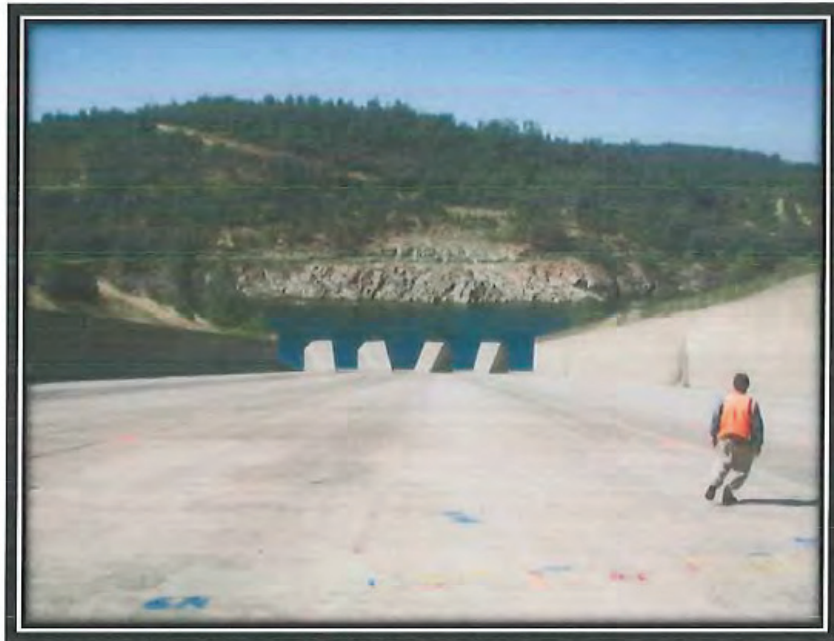
21. The lower flood control outlet chute is shown. Not the markings for the upcoming chute repairs.
6/25/10 Inspection Report

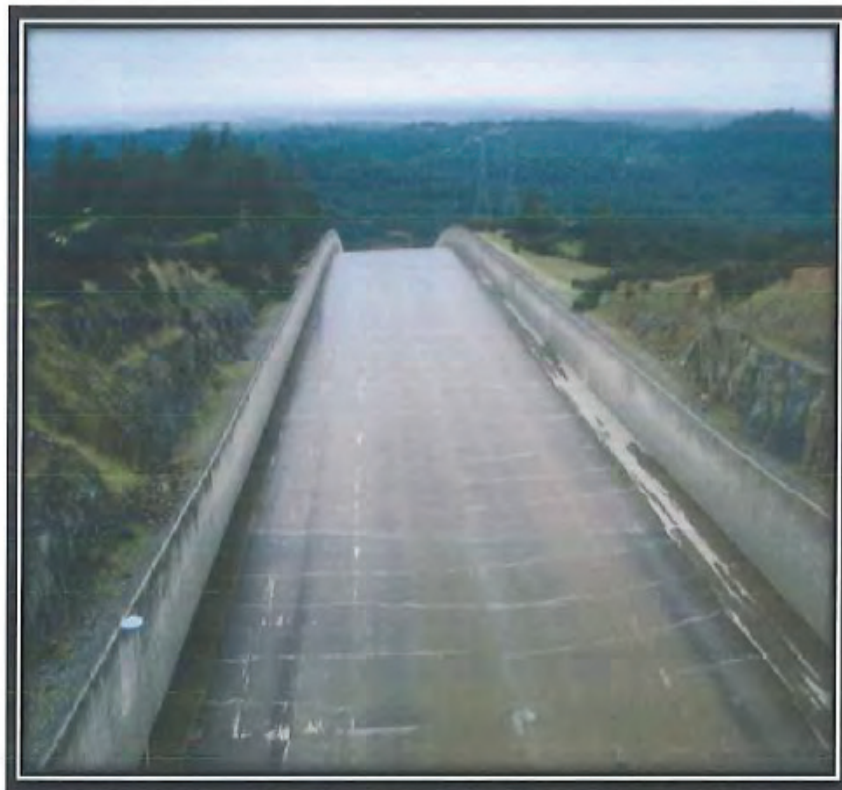
12. The concrete along the spillway chute has been repaired. The repaired herringbone crack pattern is said to reflect the underlying drain system.

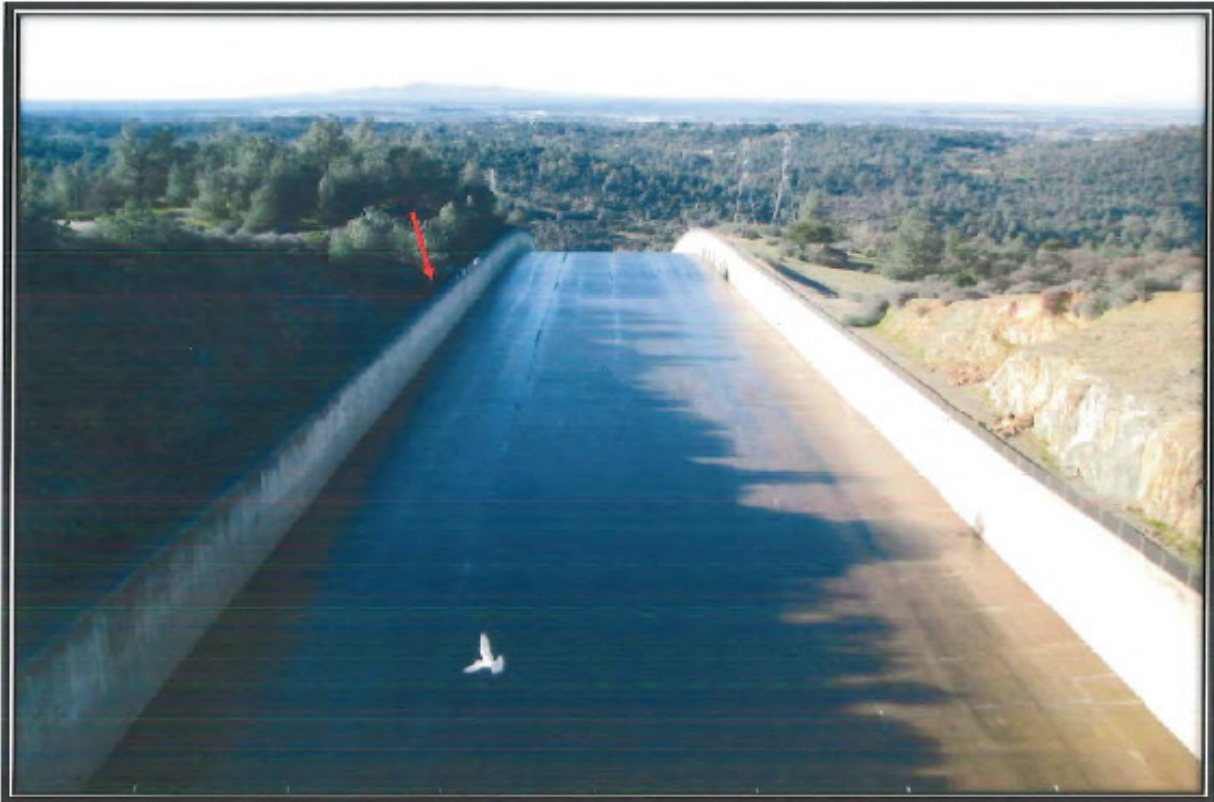
9. The gates seals were leaking enough to keep the chute floor wet. The repaired lateral cracks in the chute floor are visible as light streaks. The brush at the arrow should be removed to prevent root invasion of the wall drain. No signs of instability were noted along the chute walls or floor. The drain holes at the end of the chute were flowing.

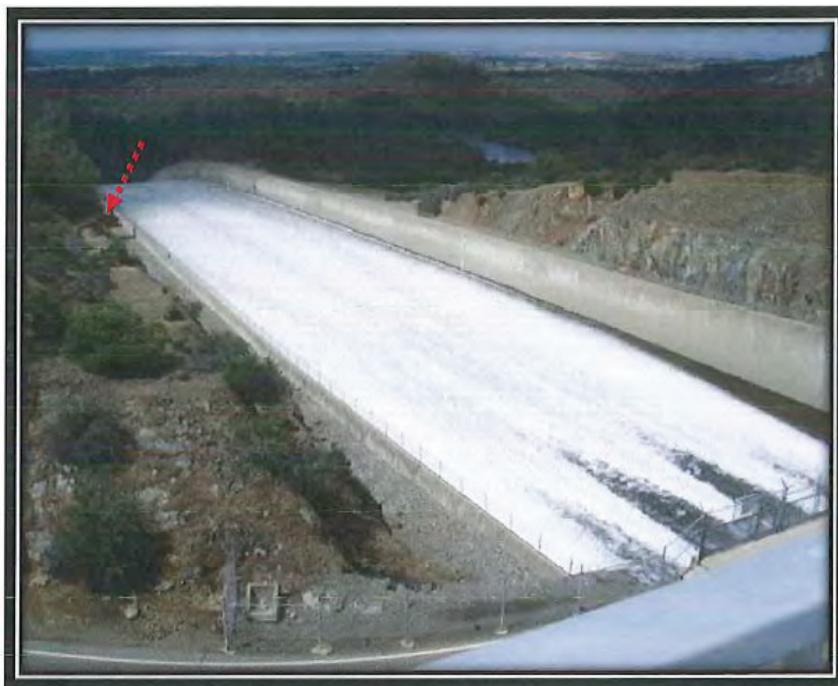
11. The flood control outlet flow pattern was normal. The walls were well aligned and stable appearing. The drains at the vertical curve along the chute were flowing as expected. The brush growing in the backfill gravel adjacent to the left wall should be removed as previously requested. See arrow at left.

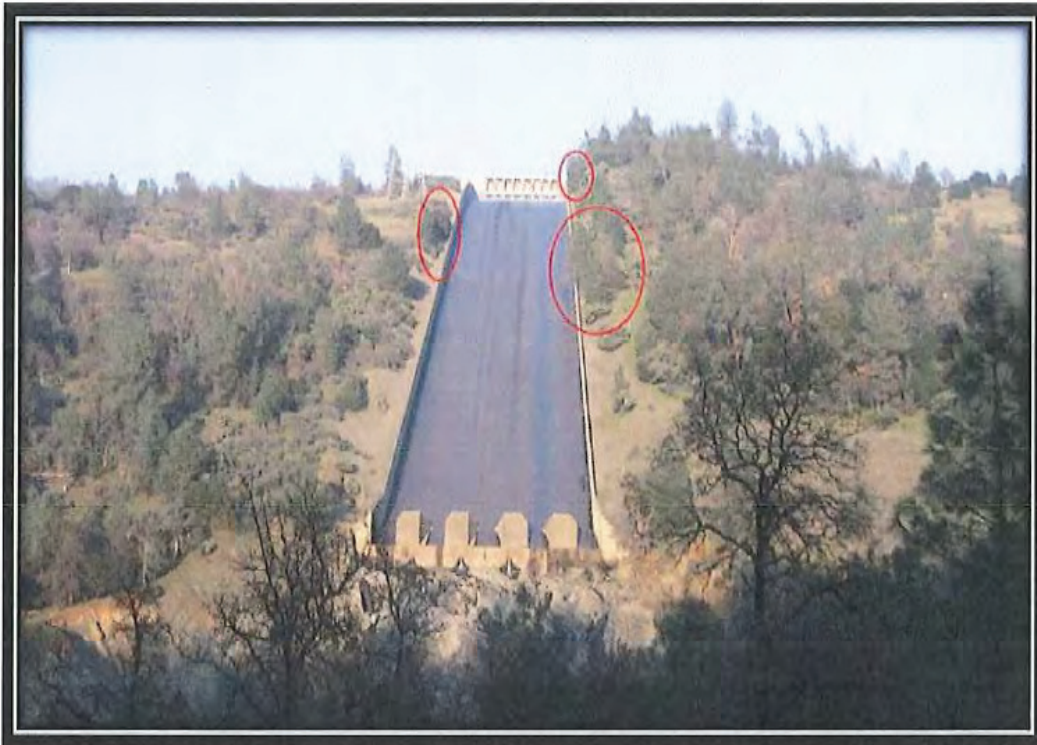
14. The flood control outlet gate seal leakage and drain flow are visible. The trees and brush shown within the ovals should be removed by November 1, 2013. Oroville Dam, No. 1-48

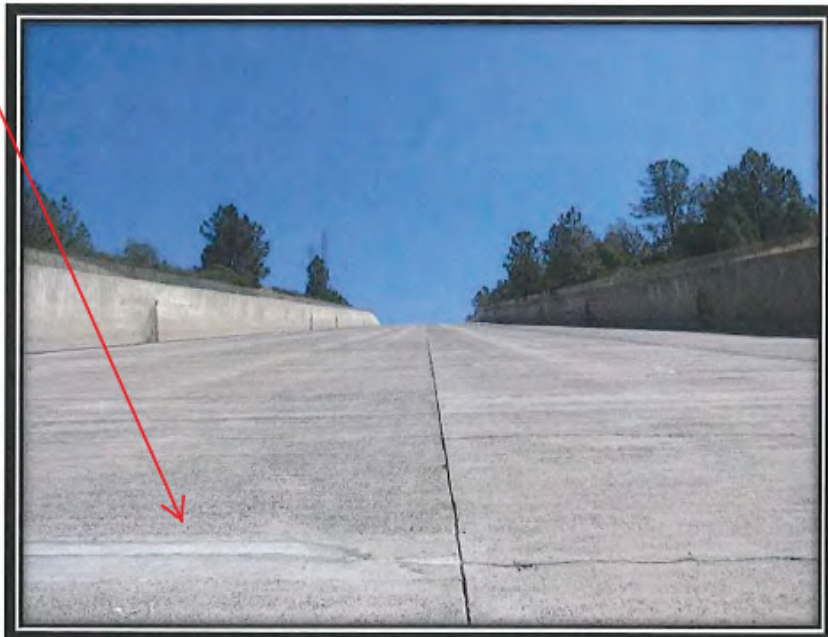
13. This view is looking upstream along the FCO channel from the dentates. Dark, vertical stains along the walls indicate the location of the drain outfalls.

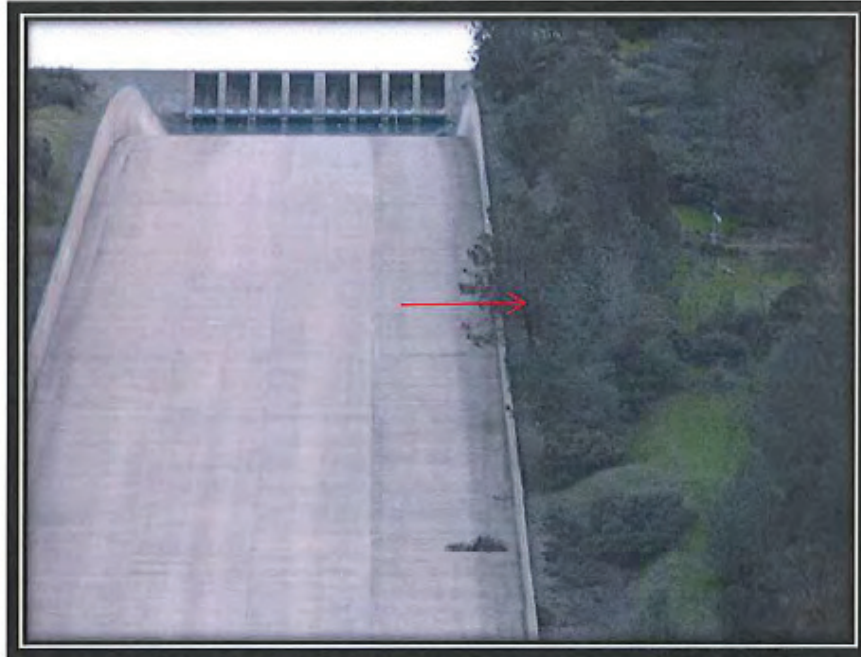
9. This view looking upstream along the FCO discharge chute shows one tree (arrow) that needs to be removed following a significant effort to remove brush along the outside of the wall.

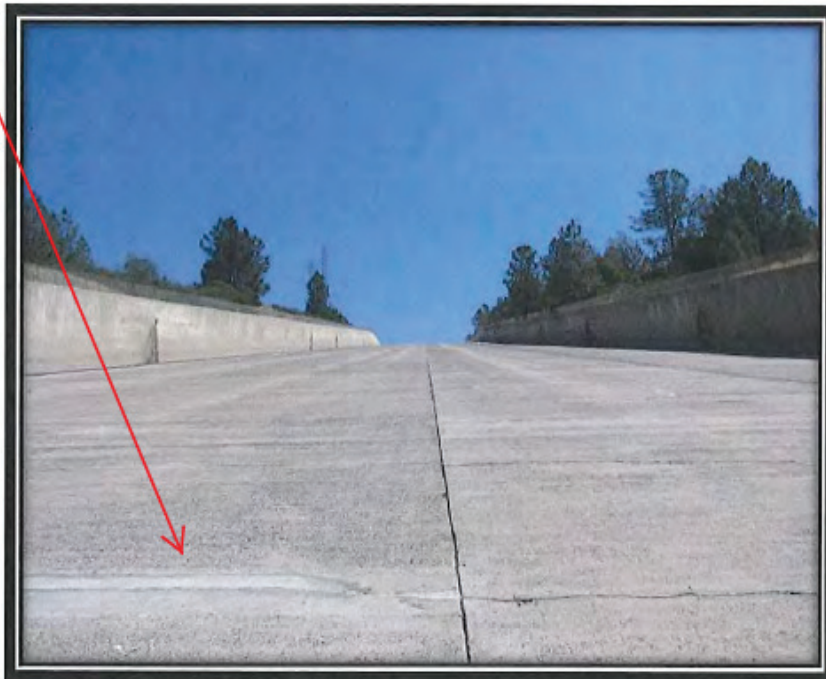
13. This view is looking upstream along the FCO channel from the dentates. Dark, vertical stains along the walls indicate the location of the drain outfalls.

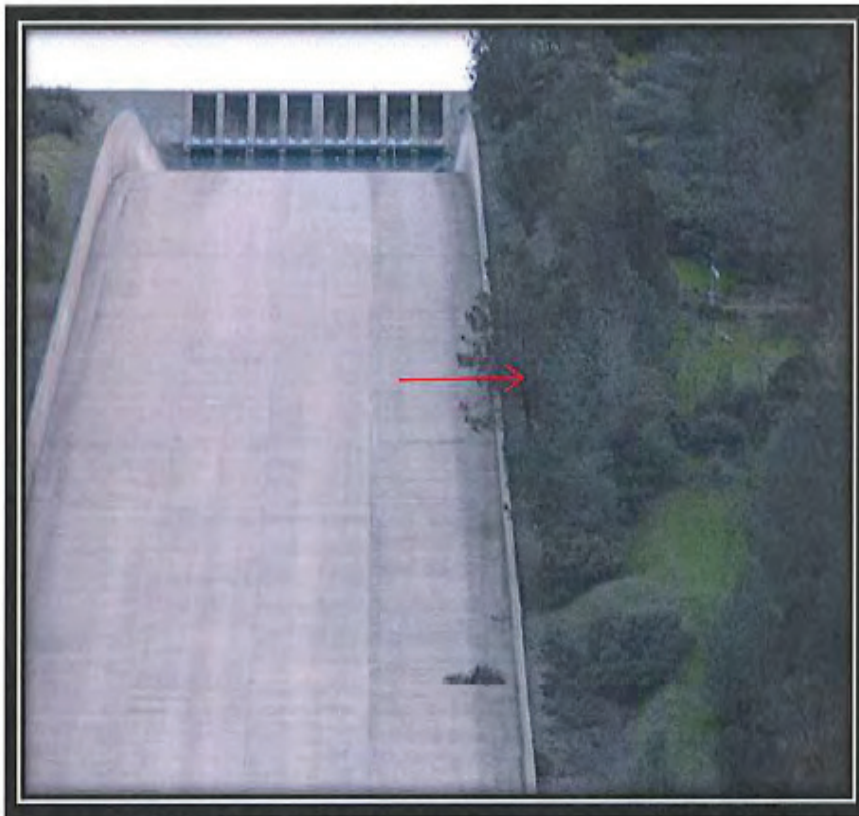
9. This view looking upstream along the FCO discharge chute shows one tree (arrow) that needs to be removed following a significant effort to remove brush along the outside of the wall.
