Collapse of the 16-Story Plasco Building in Tehran due to Fire

Abstract. On January 19, 2017 an accidental fire, which started by an electric shorting, resulted in the complete collapse of the 16-storey Plasco Building in Tehran. Twenty-two people including sixteen firefighters were killed in that incident. This paper reports the study carried out to investigate the most likely causes of the events and collapse of the structure. The information presented in this study was collected through gathering the limited amount of available information on the structure, generating as-built structural drawings, reviewing construction photographs, interviewing fire-fighters and other witnesses, frame-by-frame analysis of a number of available videotapes showing the structure during the fire as well as during the final stage of collapse. Based on these information and some engineering judgments, the paper summarizes the sequence of events from the start of the fire to final collapse, almost 3.5 h later, and the inferred scenario explaining how the structure collapsed completely. Recommendations are provided based on the lessons learned from that incident.

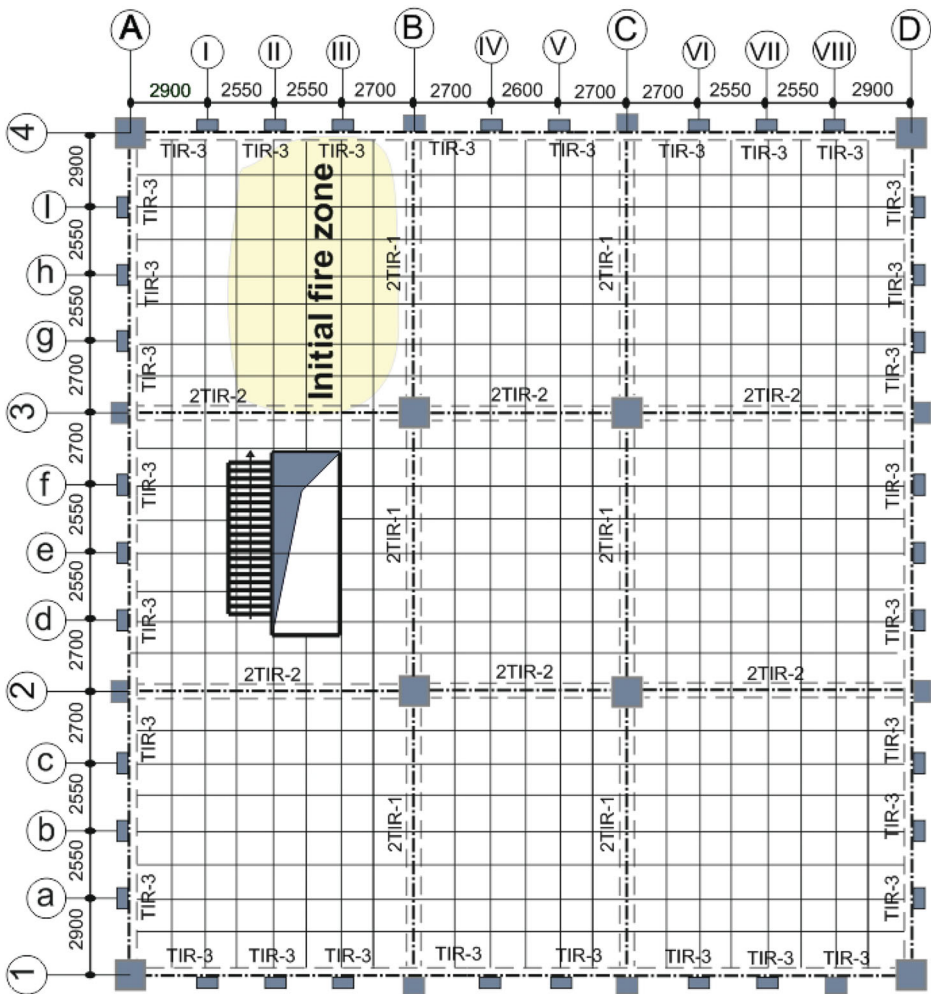
Figure 10. Fire initiation zone in the tenth storey (unit: mm).

The fire started in north-western part of the tenth storey as shown in Fig. 10 [29]. The most likely cause of fire initiation has been said to be non-standard electrical wiring and short-circuit in a shop [28]. It appears that the workers in that shop initially tried to extinguish the fire, but as it got out of control, they called the fire station with some delay. As the main focus of this paper is investigating the structural collapse of the building, details of firefighting operations are out of scope of this presentation. However, the infographic presented in Fig. 11 briefly shows the events between fire initiation and final collapse [29]. This figure was produced using the statements of the firefighters, fire department records, available videos and photographs. As seen, the first group of firefighters arrived in site after about 2 min from first contact with the fire department. It should be noted that the nearest fire station was located only about 350 meters from the building. However, for some reasons, such as the fire location at upper storeys, one-way stair case, problems with proper fitting of fire hoses and etc., firefighting operations began 22 min after the arrival of the first team. The firefighters' statements show that at that time the fire had spread in north and western parts of the 10th storey and the whole floor was full of the smoke, so the fire could not be extinguished by the existing firefighting equipment. Also, firefighters stated that at the same time,

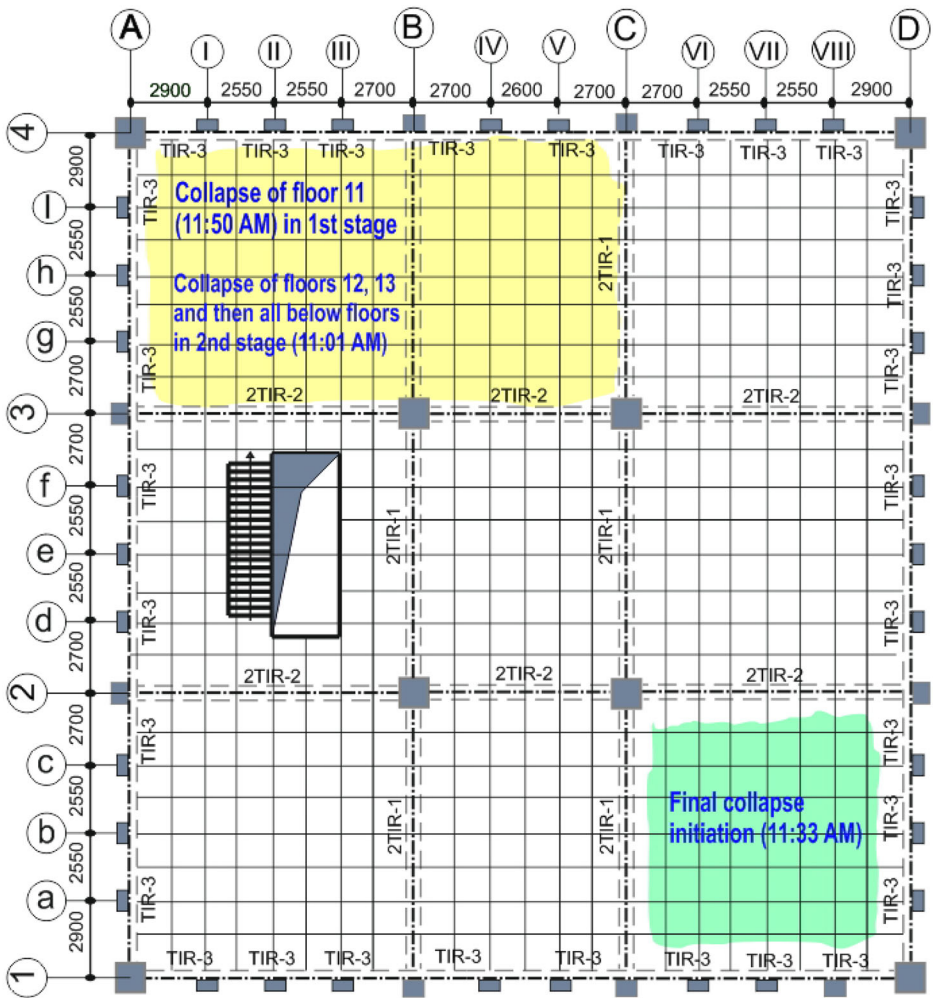
Figure 12. The collapsed area of floor 11 in the first stage (unit: mm).

The surviving firefighters stated that in the first stage of the collapse, north-western part of the floor 11 (see Fig. 12) collapsed on the floor 10. Due to persistence of fire in this area for about three hours, this collapse must have been caused by the effects of rising temperature on the structural elements of the flooring system. As explained in Sect. 3.2, the slabs were supported by open web joists and tie beams, which transferred the gravity loads to the truss type main girders. Photos of these joists and girders were presented in Fig. 9. The webs and bottom chords of these truss type members were directly exposed to fire in the space between the main slab and false ceiling without any fire protection. According to firefighters those slabs had visible deformations before collapse. From the structural point of view the final collapse of the floor in that part must have been due to failure of the connections of main girders to the columns [30].

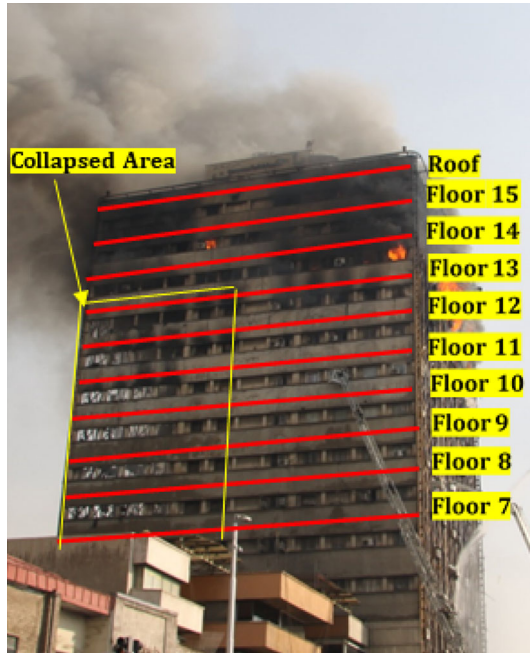
Figure 13. West elevation of the building showing the floors collapsed partially in second stage.

In the second stage, about ten minutes later, same part of the floors 12 and 13 also collapsed on floor 10. Obviously the floor structure could not support so much additional load and this caused partial collapse of the all lower floors

(Fig. 13). Consequently, the area between the axes A-B-C and 4-3 were completely destroyed below the floor 13 and so a vertical void was created in that part of the building. Figure 14 shows the western view of the building after the second collapse stage showing the failure in the northern panels. As seen in Figs. 13 and 14, the collapse of mentioned floors has made the sky behind the building visible from the windows of the western elevation. This is while the sky is not visible at upper storeys and fire and smoke coming out of the windows indicate that floors of these storeys did not collapse.

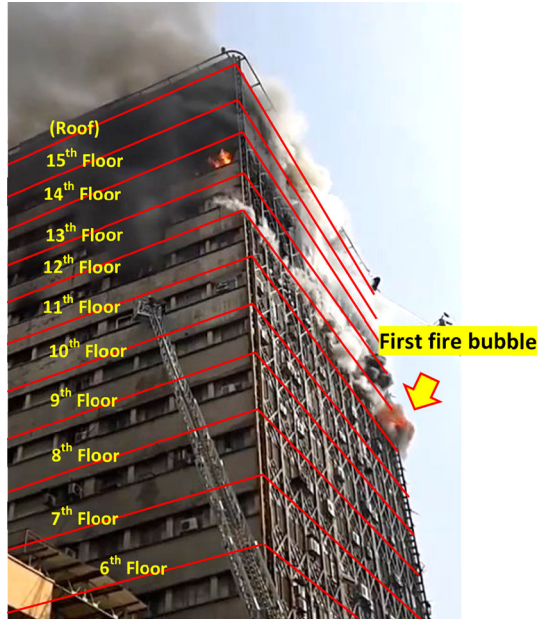
Figure 15. Appearance of the first fire bubble in the 11th storey.

The observations revealed that a few seconds before the final collapse, two fire bubbles appeared with a time interval of three seconds in south-eastern part of floor 11. Figure 15 shows that the first fire bubble burst out in this area together with dust and smoke. It seems that this phenomenon has been due to collapse of the floor 12 on floor 11 in this part of the building. After about three seconds from the appearance of the first fire bubble, the second fire bubble appeared in the same area implying that the same area of floor 13 also collapsed on floor 11 (Fig. 16).

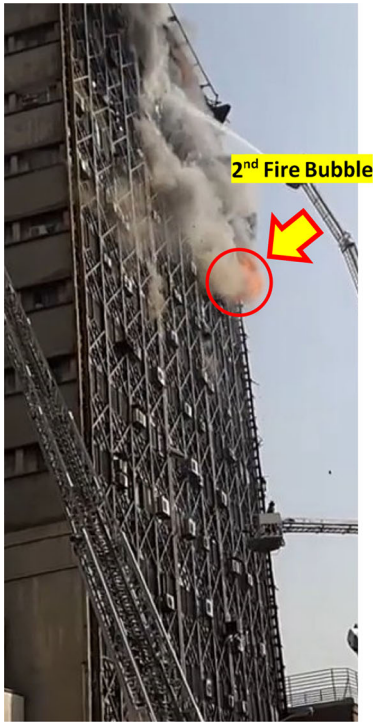
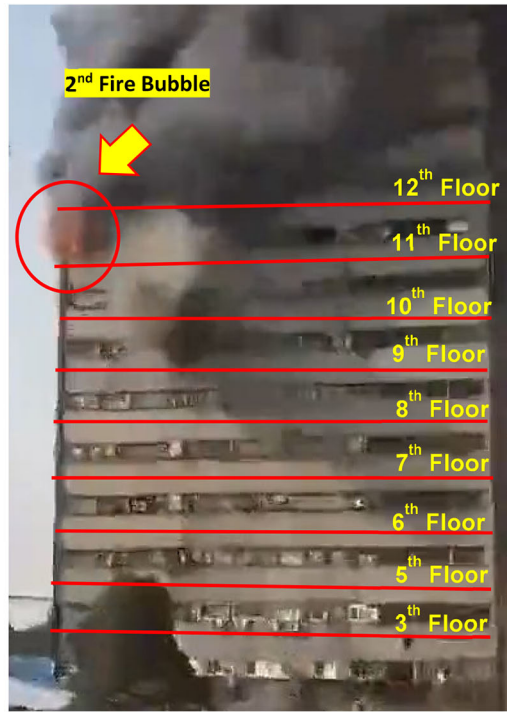
Figure 17. South and east views of the building; at the moment of the second bubble appearance.

After the local collapse in south-eastern part of floors 11 to 13, the progressive collapse of the building floors was initiated. Figure 17 presents the south and east views of the building, named E1 and S1, respectively, exactly at the time that the second fire bubble appeared.

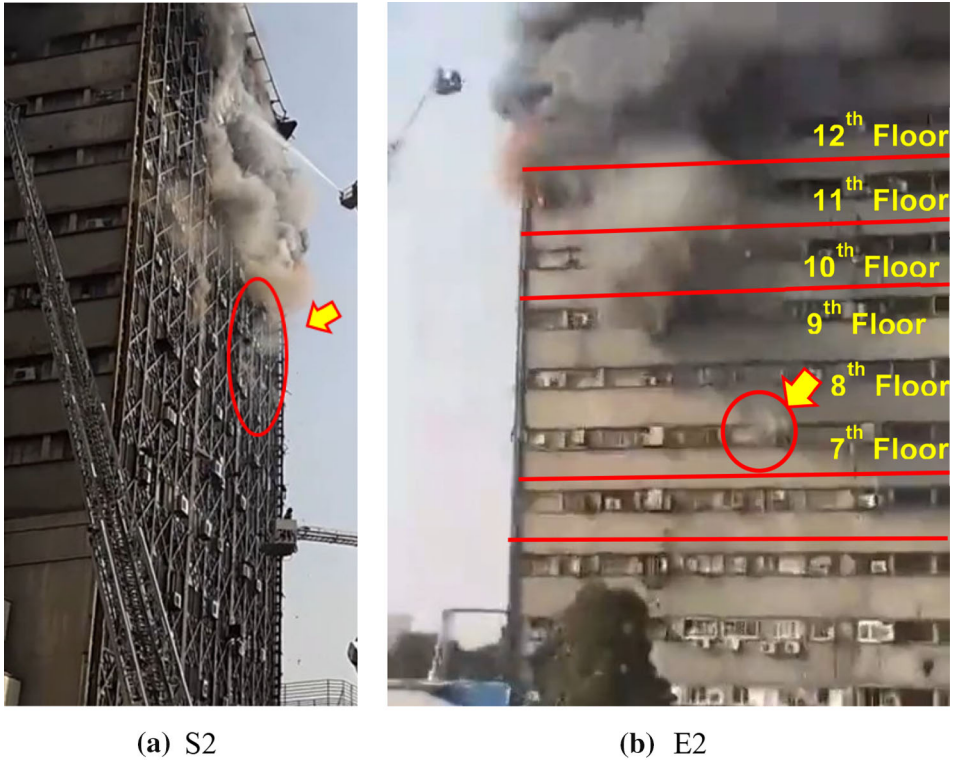
Figure 18. South and east views of the building; about 0.42 s after the second bubble appearance.

Figures 18, 19, 20, 21, 22, 23, 24, 25, 26 and 27 present the east and south views of the building at different stage of the collapse. Picture E2 in Fig. 18 shows smoke coming out of the window in floor 7, whereas no smoke or dust is observed in E1. This is related to the collapse of the floor 8th in C-D-2-3 area. It should be noted, what is seen in Fig. 17 (E1) is the smoke that has already got out of upper floors and has reached around floor 7, so it is not the dust coming out of windows of floor 7. Comparing the dusts in pictures S2 and E2, it can be understood that the collapse of the floors have likely progressed in the area between the axes C-D-2-3 and B-C-1-2. But it is unlikely that at this time, the floors have collapsed in the area between the axes C-D-1-2 in the south-eastern corner of the building.

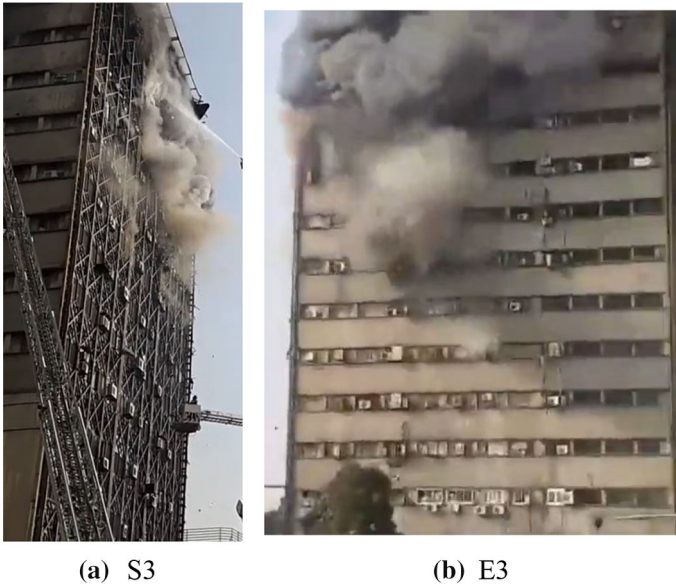
Figure 19. South and east views of the building; about 0.83 s after the second bubble appearance.

Figure 19 shows that at about 0.83 s, there was no new collapse, compared to 0.42 s.

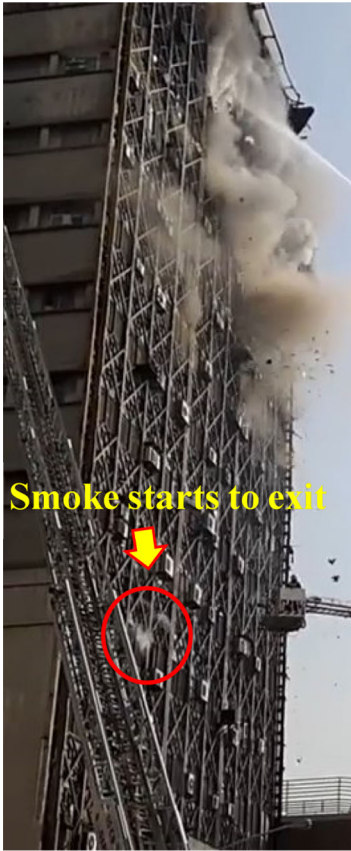
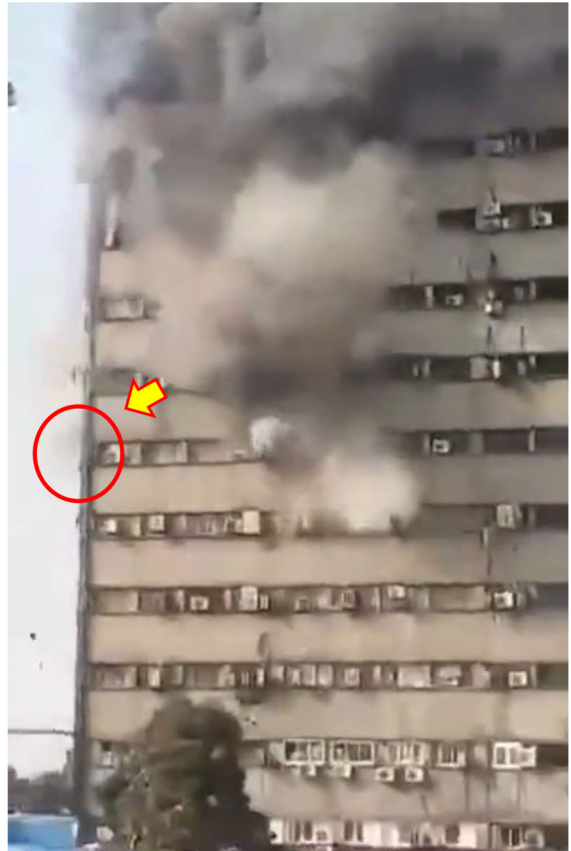
Figure 20. South and east view of the building; about 1.25 s after the second bubble appearance.

The picture E4 in Fig. 20 indicates that the collapse of the side panel of the building, (C-D-1-2), occurred in floor 8 at about 1.25 s. Simultaneously, the picture S4 shows the smoke coming out of floor 3 in the panel of A-B-1-2 but considering the conditions of the windows of west part, an absolute judgment cannot be made about the collapse of the floors in that area.

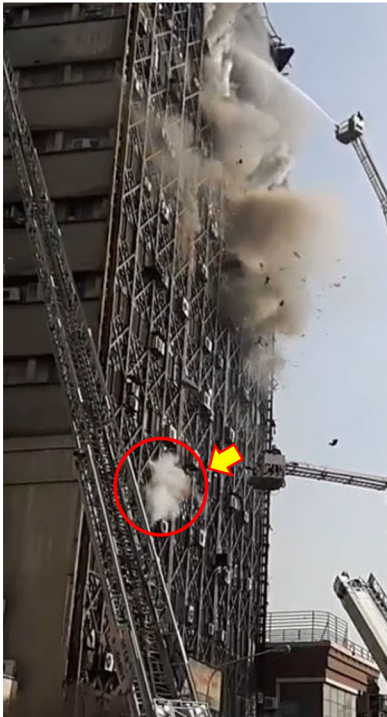
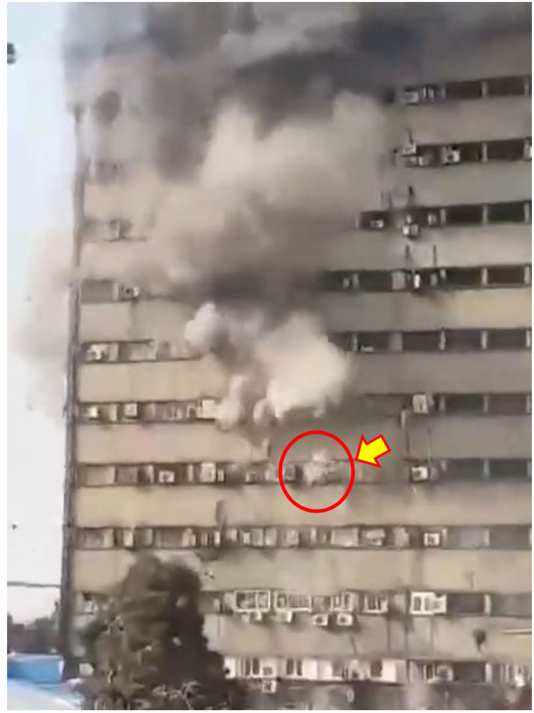
Figure 21. South and east views of the building; about 1.67 s after the second bubble appearance.

Figure 21-E5, from the east part, shows that the collapse in the middle panel, C-D-2-3, has progressed to the floor 6 and similar events have also occurred in the panel of C-D-1-2 of the floor 8. In simultaneous images of the south part, picture S5 shows the collapse in panel of A-B-1-2 on the floor 3.

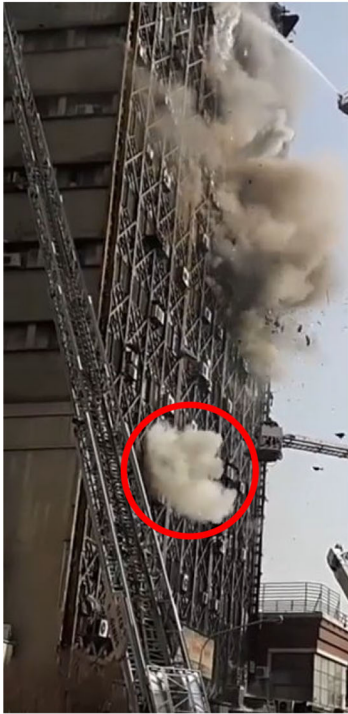
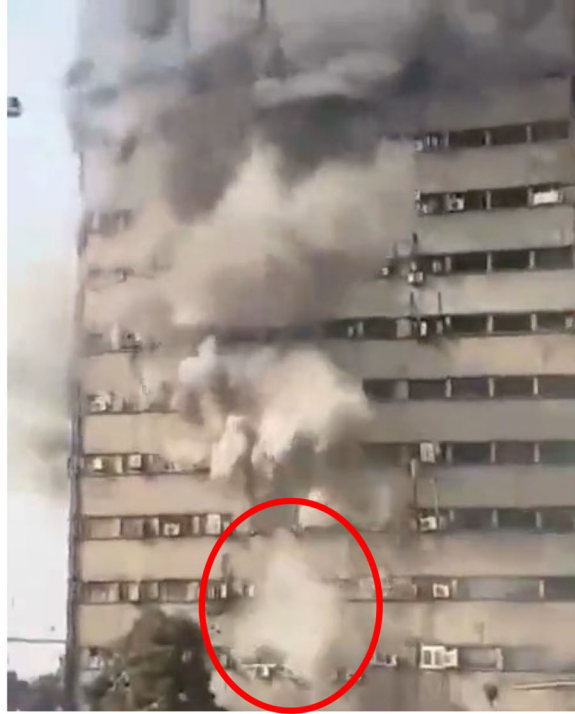
Figure 22. South and east views of the building; about 2.08 s after the second bubble appearance.

As seen in picture E6 of Fig. 22, the collapse on the east part of the building in panel C-D-2-3 has progressed to floor 4, but in the panel C-D-1-2, collapse has continued to floor 5 and the progression of collapse is still with a delay in this area. The same collapse as presented in previous photographs can be observed with greater intensity in picture S6 of Fig. 22 and no sign of a new collapse is identified.

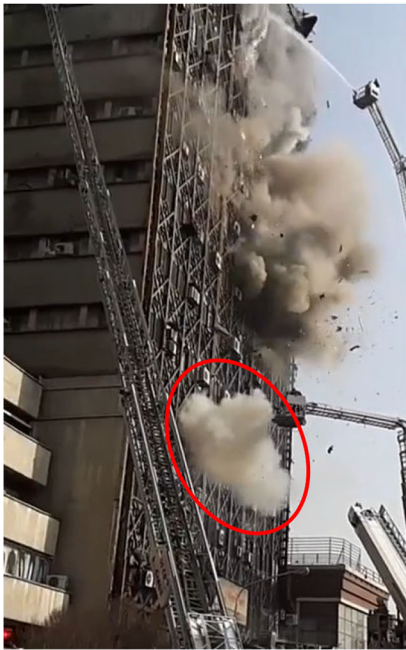
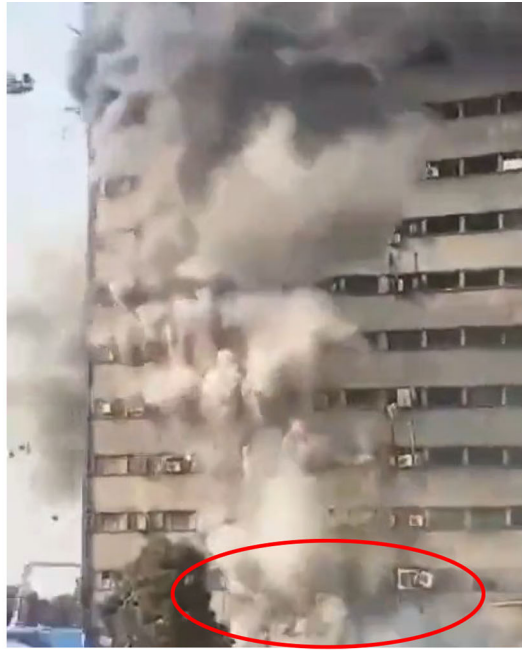
Figure 23. South and east views of the building; about 2.50 s after the second bubble appearance.

The next stage of the collapse, at about 2.50 s after the second bubble appearance is presented in pictures E7 and S7 of Fig. 23. The collapse in panel C-D-2-3 on the east side progressed to the ground floor and in panel C-D-1-2, the floors

collapsed down to floor 4. These observations confirm that the collapse of the panel C-D-1-2 occurred with the same pattern as that occurred in panel C-D-2-3 but with a delay of two floors. In the south part of the building, collapse progressed down to floor 3 at this time.

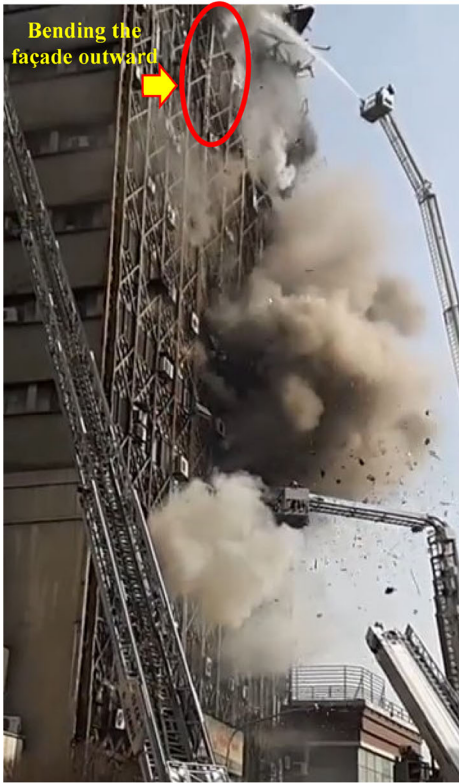
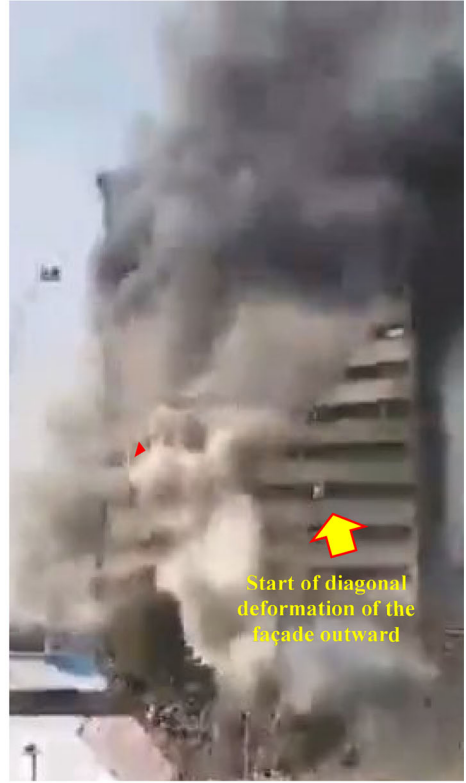
Figure 24. South and east views of the building; about 3.33 s after the second bubble appearance.

After above mentioned observations, up to about 3.33 s after the second fire bubble, no new important event was observed but at this moment, a non-uniform deformation began to form in the eastern view of the building, as shown in picture E8 of Fig. 24. This deformation implies the start of instability of the southern part of the structure. At the same time, an out-of-plane movement of the building facade occurred in the upper parts of the south side of the building, noting that the collapse had not progressed to lower floors in the south side (see picture S8 of Fig. 24). Figure 25 shows non-uniform deformation of the east elevation a few moments before the final collapse and Fig. 26 shows the final collapse of the building.

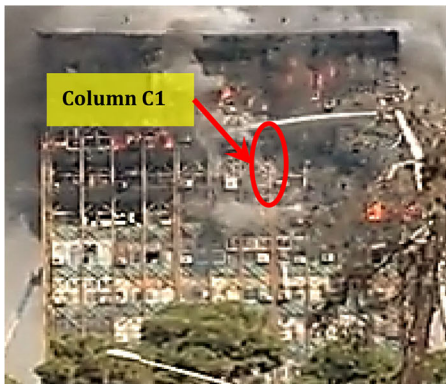
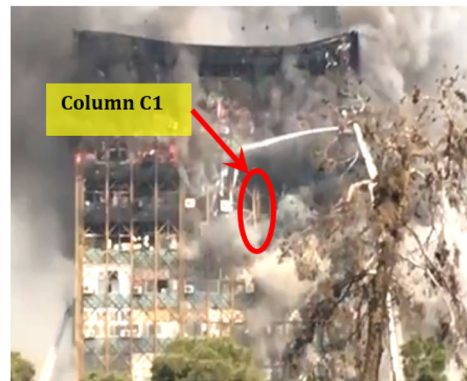
Figure 27. Southern view of the building a few moments before final collapse.

Based on above, the first and second collapse stages occurred in the north-western part of the building and the third and final stages of collapse started in the south-eastern part of the building and then propagated to the whole building. The probable mechanism of the final collapse of the building can be explained using a video file showing the moments of the final collapse from the south view of the building. Figure 27a shows the south view of the building just after the appearance of the second fire bubble, while Fig. 27b shows the same view after a few moments.

Comparing the two pictures of Fig. 27 shows that, a significant deformation has occurred in the structure just in less than three seconds. In Fig. 27b, in addition to overall deformation of the structure, a considerable deformation can be seen in column C1. Figure 28a shows the location and schematic section of this column. As seen, column C1 was a built up section composed of two welded boxes. A close look at the final progressive collapse reveals the separation and buckling of these two individual components (see Fig. 28b). In other words, the column C1 is divided into two segments with a single box section and each section has buckled instantly after the separation. These breakdowns could have occurred for several reasons. In fact, the girder of axis C-1-2 was composed of two adjacent truss beams, each of which was connected to one of the column boxes and as can be seen in Fig. 28a, these trusses have different tributary areas. As the temperature increased, simultaneous with the strength deterioration of the welds of the stitches

between the column segments, there was a significant increase in the beams deflection due to the reduction of the Young's modulus of steel materials. The excessive deflection has caused the catenary action in the truss girders. Catenary action refers to the ability of girders to resist vertical loads through formation of a catenary-like mechanism, which is associated with development of large deformations in girder so that vertical loads are mainly resisted by the vertical component of axial force developed in the girder [31]. These phenomena, along with the impacts due to the falling of the floors 12 and 13 on the floor 11, ultimately have led the truss beams to pull the column C1 inwards.

The difference in the amount of these tensile forces due to different beams tributary areas, could have created a severe shear demand in the weakened welds of the stitches. All of these events eventually led to the failure of the mentioned welds and so, the separation of the column into two individual components. It should be noted that at this time these segments have already lost their lateral bracing in the direction normal to axis 1, because of the collapse of floors 12 and 13 without losing them in plane of this axis. Dividing the column into two parts, increasing the slenderness ratio of these parts, the reduction of the mechanical properties of the materials simultaneous with the applied forces caused by the

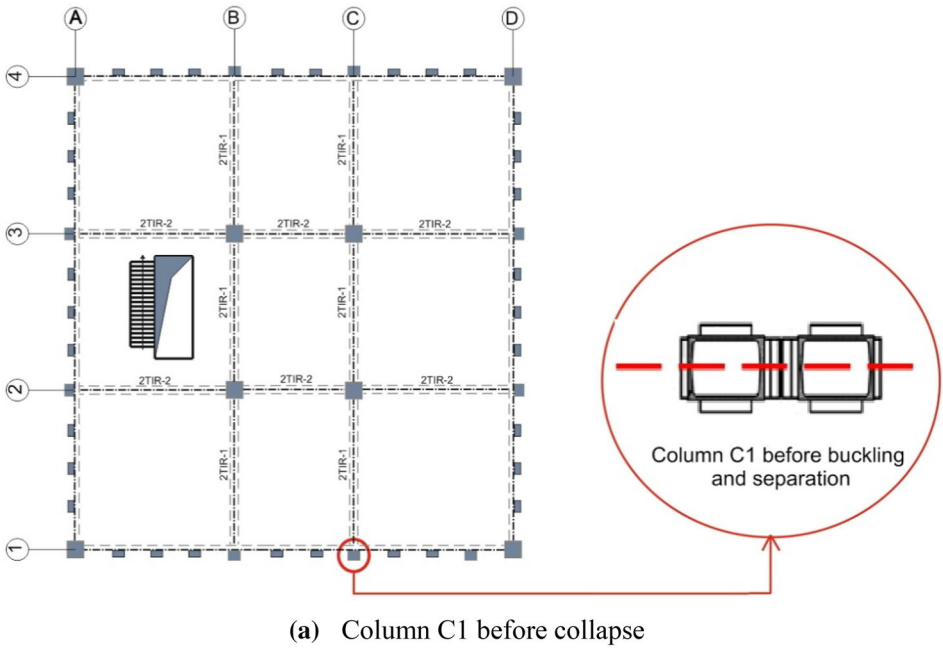
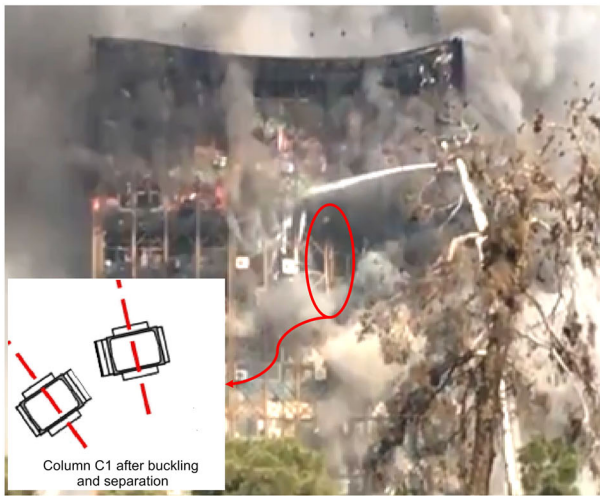
Figure 28. Damage to column C1.

catenary action resulted in the buckling of each segment of the column C1 about axis 1. Consequently, the overall instability of the structure began with this column. It should be kept in mind, since the buckling of the column C1 has occurred around axis 1 (out-of-plane the axis 1), the bending deformation of this column is less visible in the southern view shown in Fig. 28b.

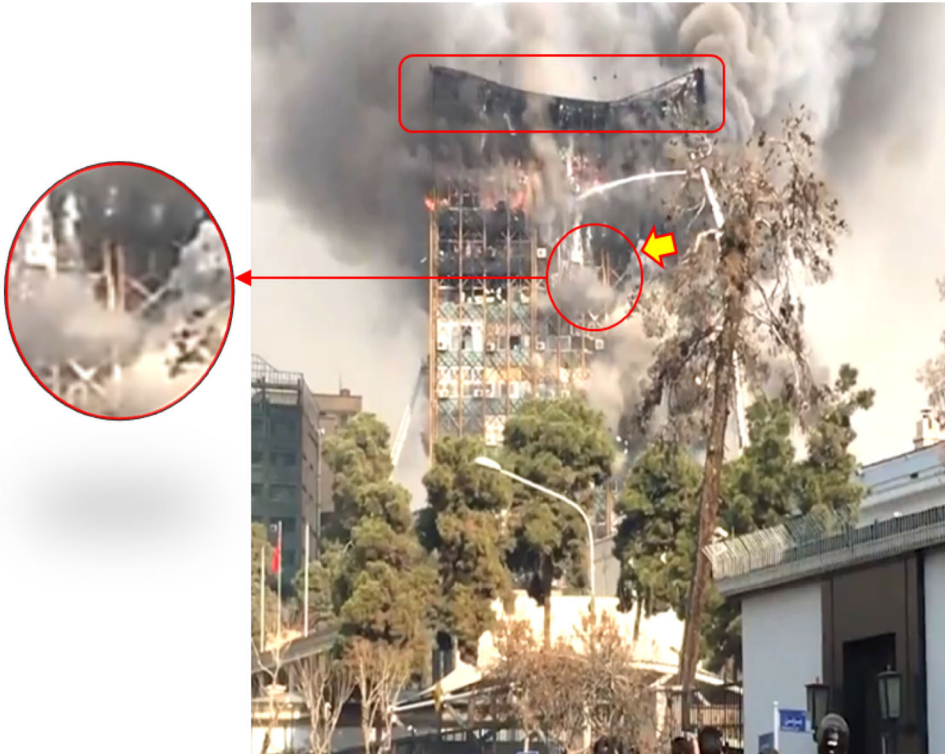
Figure 29. Progressive collapse of the south view of the building.

Figure 29 presents the damage to the perimeter columns and the collapse of the floors from the south view of the building. Examinations of the available videos showed that in the final stage of the collapse, although the floors and side walls of the building were fully destroyed, the main four middle columns of the building remained stable for few moments and then overturned one by one. Those four middle columns, namely columns C2, C3, B2, and B3, apparently did not suffer major damage till the last moments of global collapse. Figures 30, 31 and 32 show the falling sequence of the middle columns. A top view of the collapsed structure including the locations of the collapsed central columns is shown in Fig. 33.

As noted previously, the loss of lateral bracing of the perimeter columns due to the collapse of floors 12 and 13 simultaneous with the catenary action of the truss girders of floor 11 are likely to be the major sources of the buckling of the

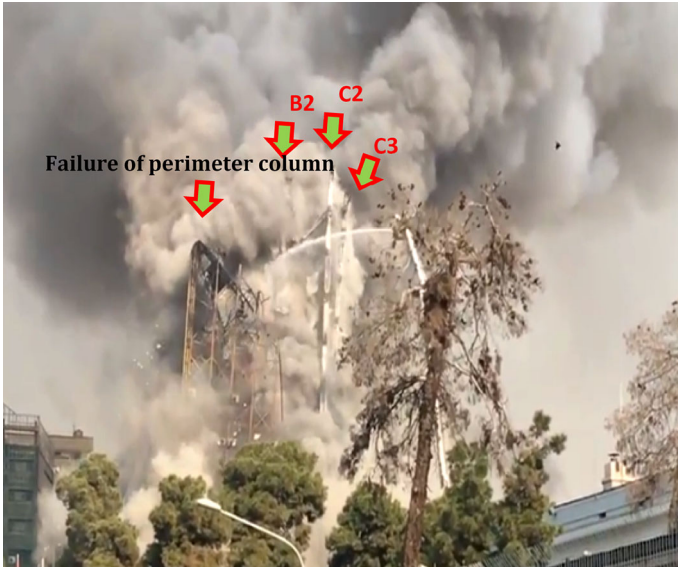
Figure 30. Appearance of the columns B2, C2, C3 and the collapse of the perimeter columns.

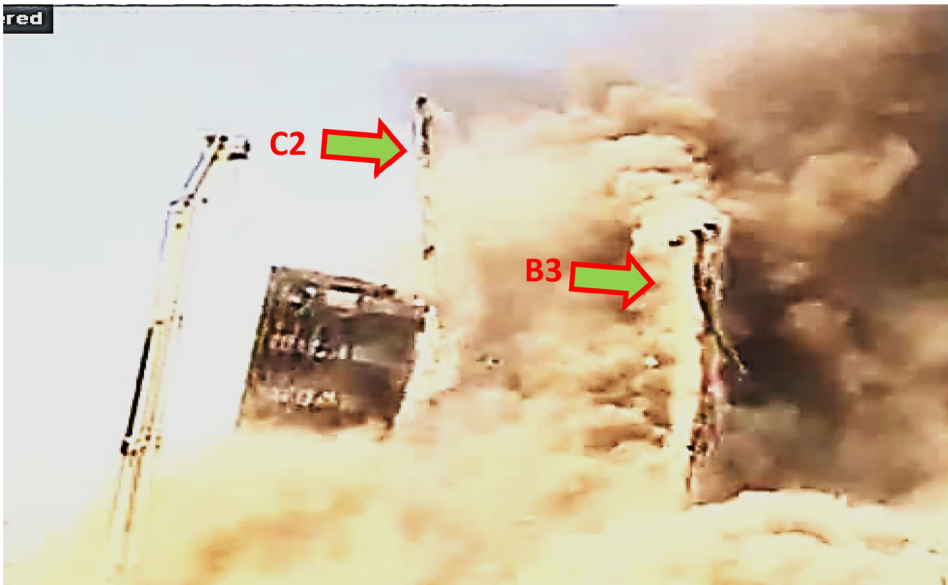
Figure 31. Overturning of column B3 to east direction while column C2 is still remained.

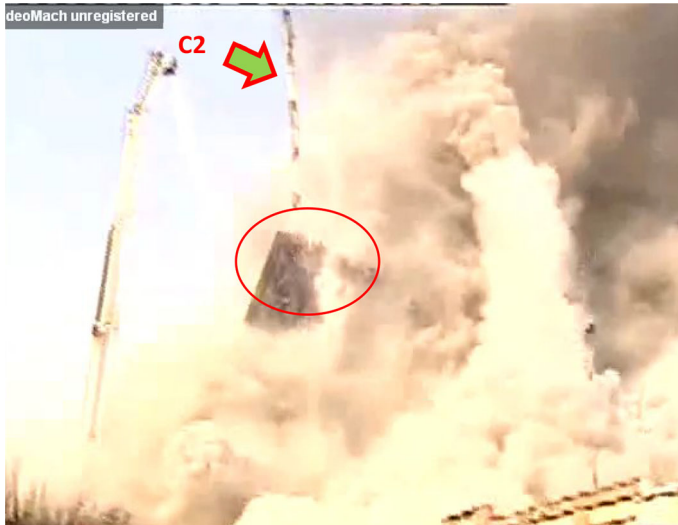
Figure 32. Overturning of column C2.

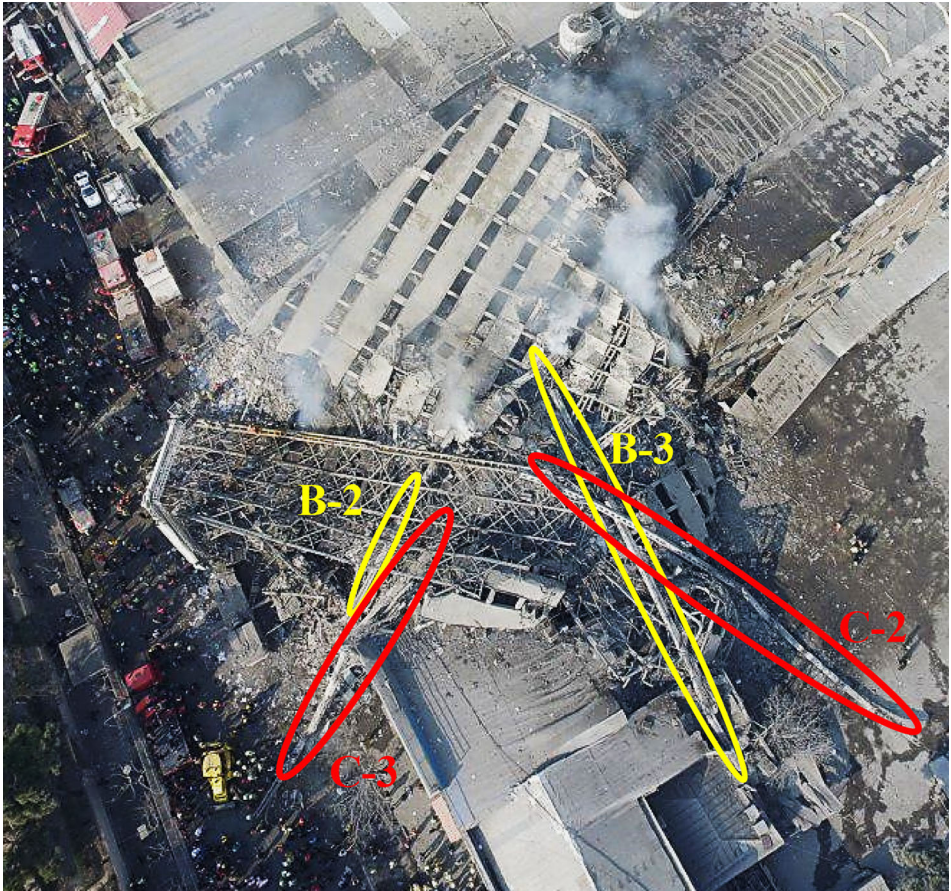
Figure 33. Top view of the collapsed building with the locations of the four middle failed columns.
