# **A Structural Reevaluation of the Collapse of World Trade Center 7**

*Draft*

**INE Report 18.17**

**September 2019**

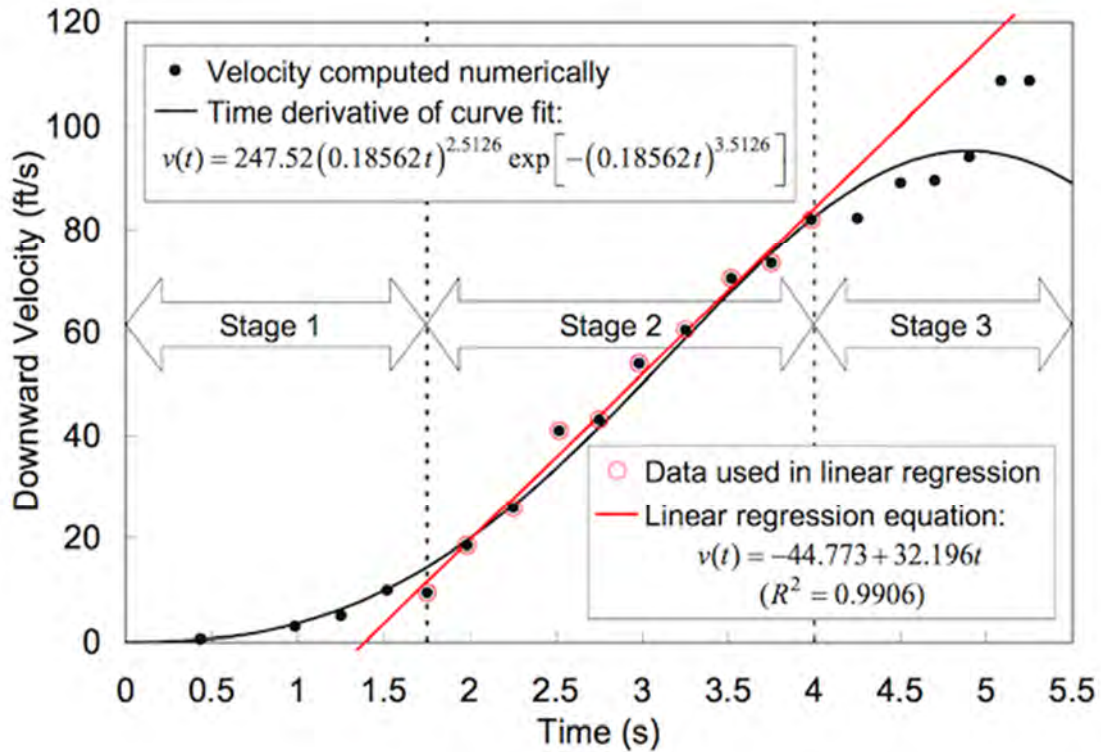
Figure 1.6 WTC 7 was in free fall for approximately 2.25 seconds over a distance of approximately 8 stories or 32.0 meters (NIST, 2008, NCSTAR 1A).

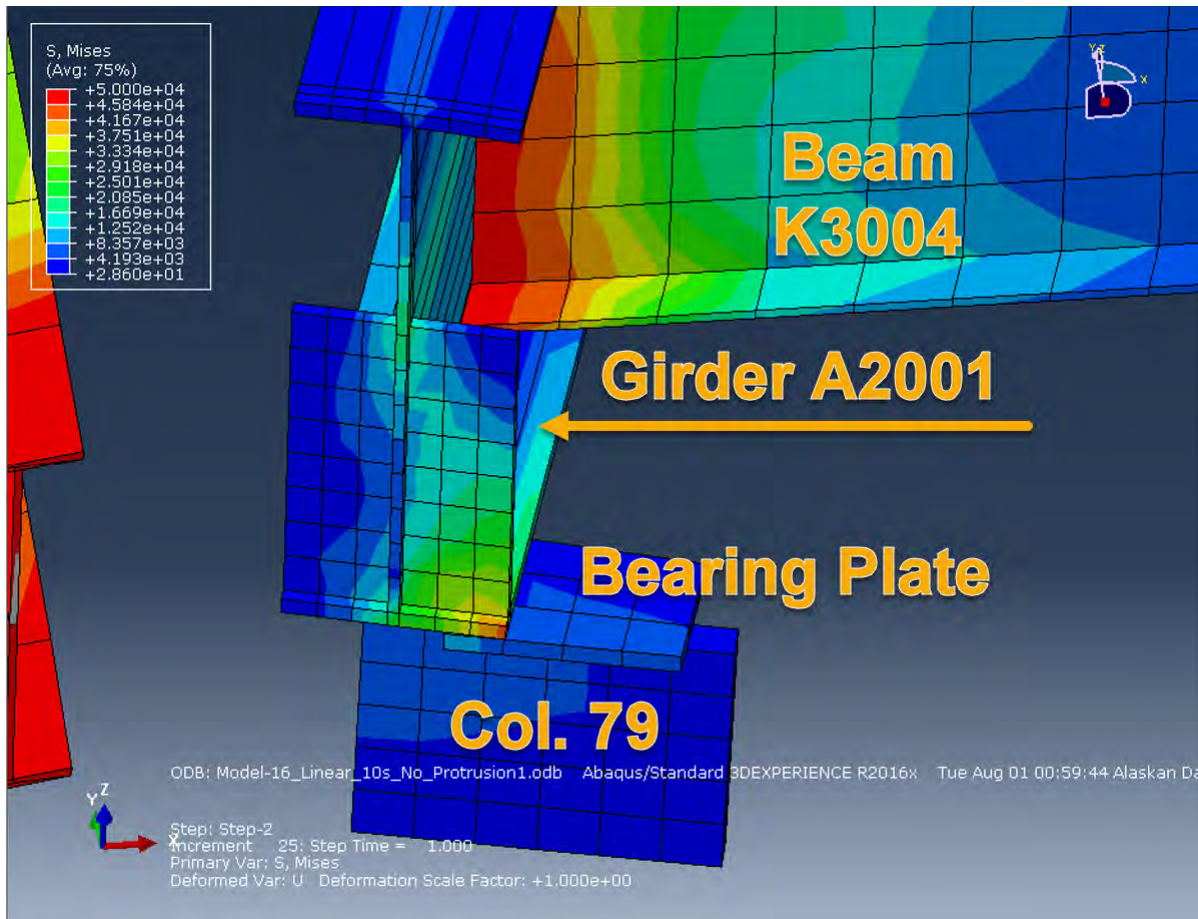
Figure 3.7 Analysis showing girder web A2001 pushed laterally past the bearing seat at Column 79. The column is removed for clarity.

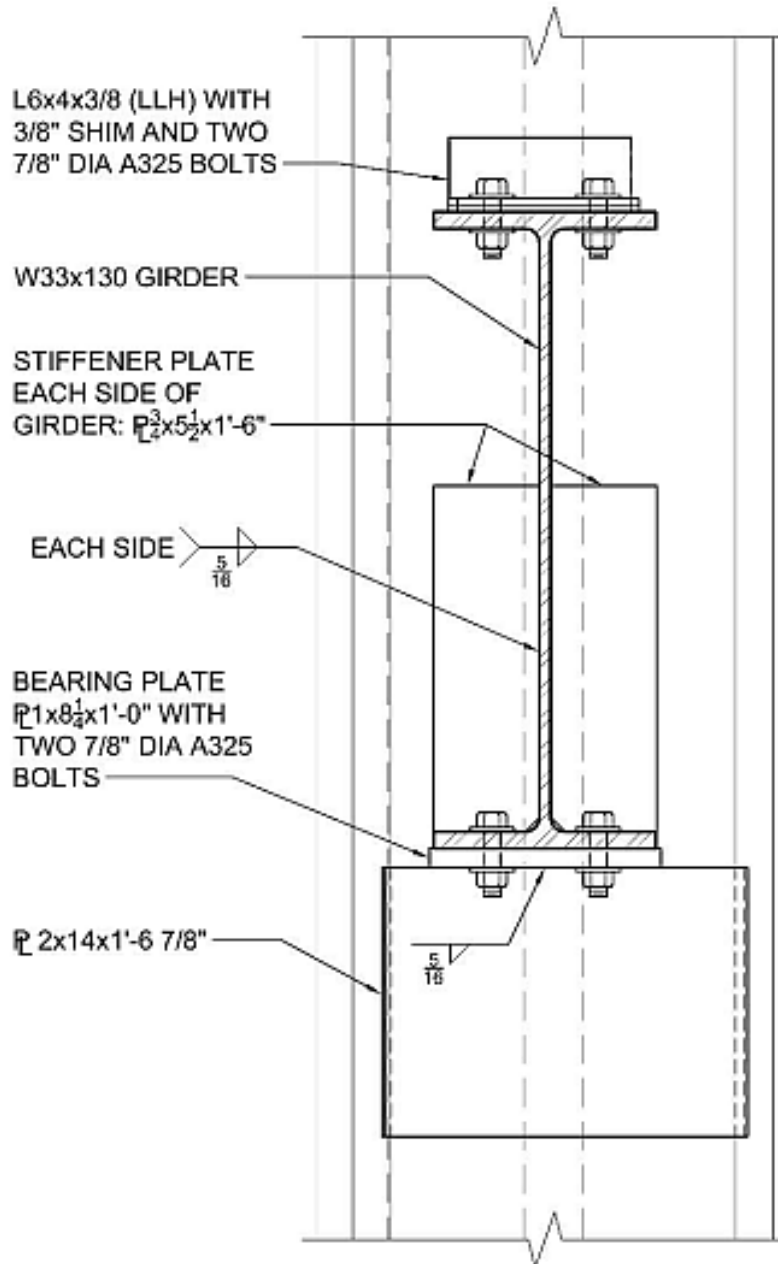
- NIST, by its own admission, did not include the partial height web stiffeners known to be on girder A2001. In addition to stiffening the web, these stiffeners significantly increase the bending resistance of the flange. In a subsequent analysis where we removed the side plate described in the previous analysis in order to allow for further westward travel of girder A2001, we found that the stresses in the girder flange and stiffener would not be sufficient to cause the flange to fail, thus preventing the girder from walking off its seat (Section 3.2.2).

Figure 3.10 Section view at Floor 13 of Column 79 and girder A2001 seated beam connection, which shows stiffener plates on girder A2001 (Data from Frankel Steel Limited, 1985, Drawing 9114; figure prepared by Brookman, 2012).

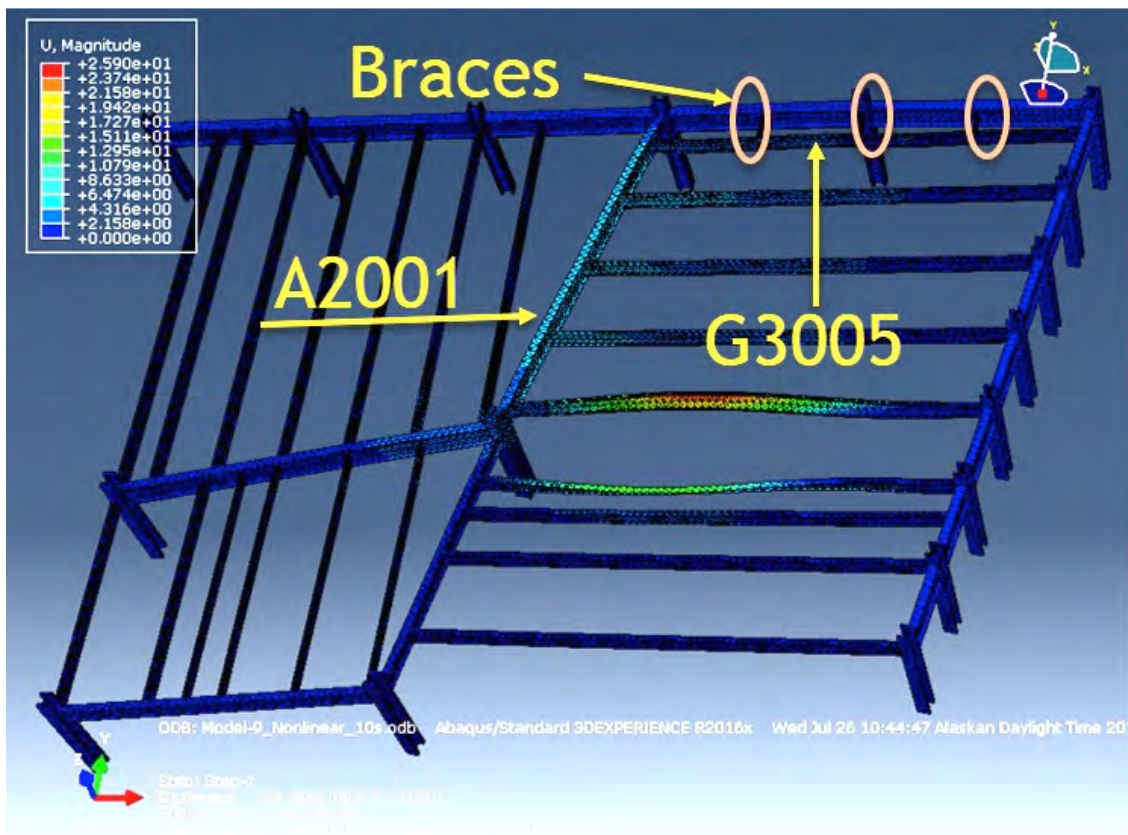
- In a preliminary collapse initiation hypothesis, NIST posited that beam G3005 buckled because its thermal expansion was restrained by girder A2001. We found that this can happen only when the three lateral support beams S3007, G3007, and K3007 spanning from beam G3005 to the north exterior wall are not included in the model. While these short beams are observed in some of the figures in the NIST report, they are missing from

Figure 3.11 UAF ABAQUS analysis shows beam G3005 does not buckle when braced by lateral support beams S3007, G3007 and K3007 (Frankel Steel Limited, 1985).

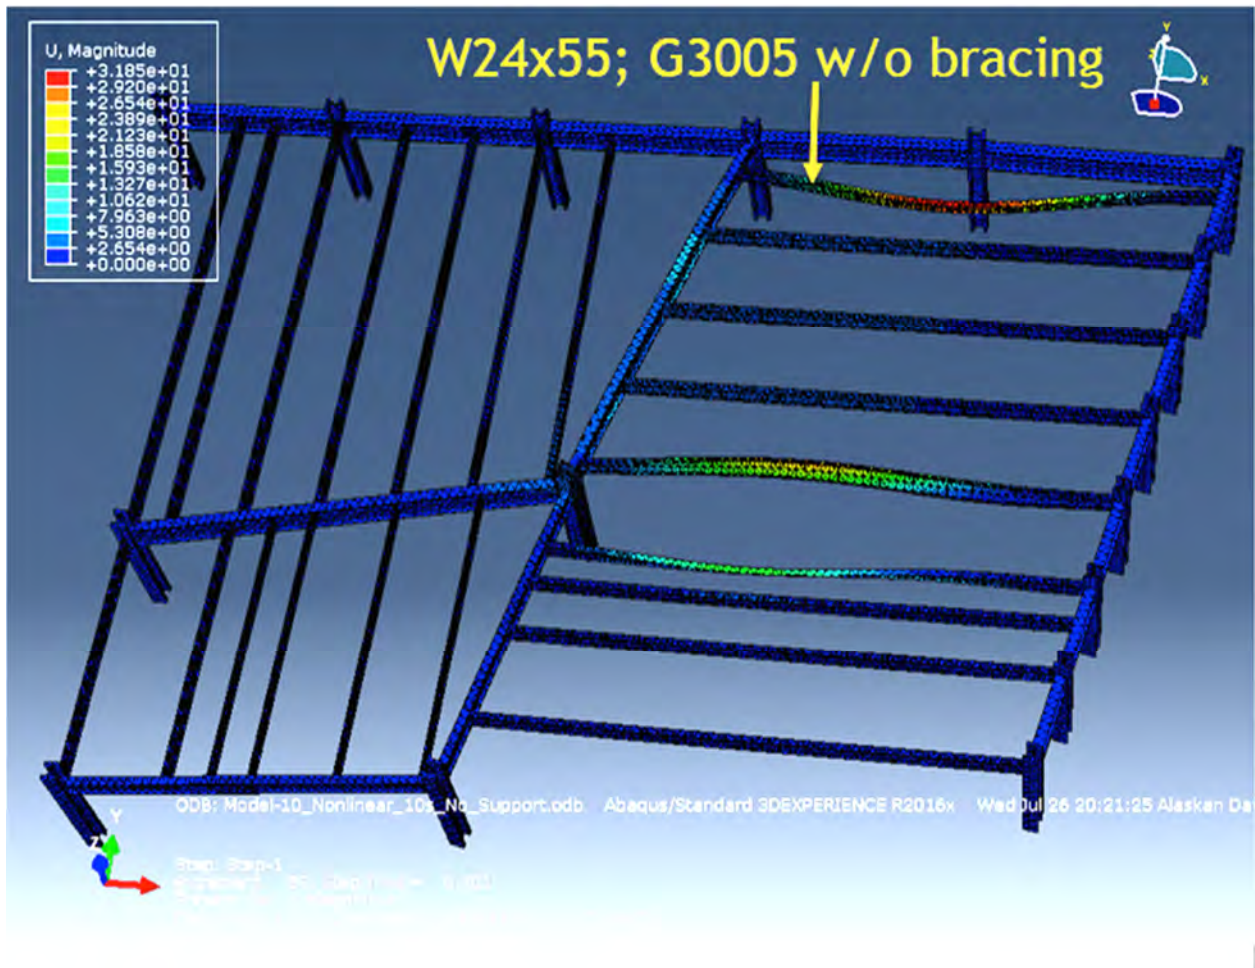
Figure 3.14 UAF analysis of the W21x44 G3005 with no lateral support beams included.

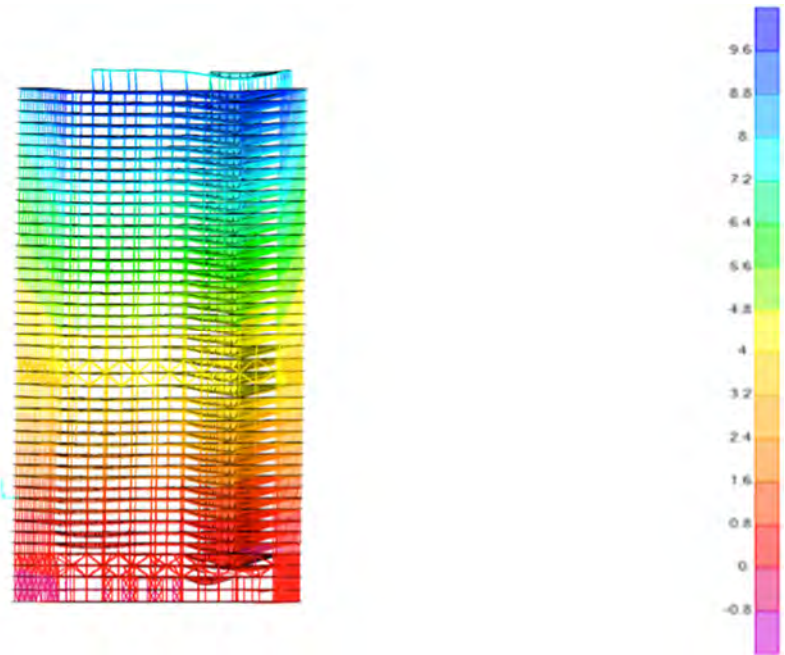
Figure 4.2: Columns 79, 80, and 81 are removed from Floor 6 to Floor 13. The building tilts to the east almost 10 inches. The penthouse does not collapse.

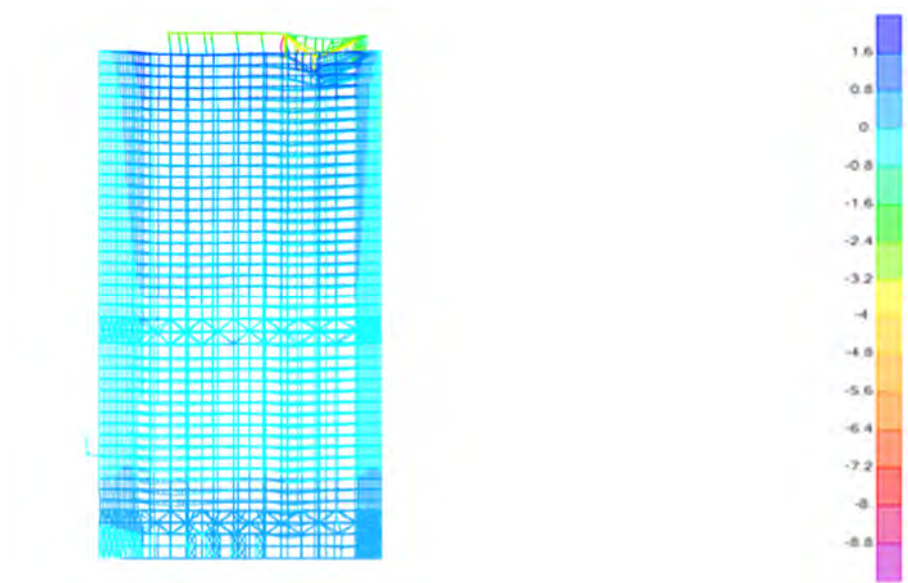
- Columns 79, 80, and 81 did not fail at the lower floors of the building, as asserted by NIST. In order to allow for the observed collapse of the east penthouse approximately 7 seconds prior to the collapse of the rest of the structure, these columns needed to have failed at the upper floors of the building all the way to the penthouse. Yet there were no documented fires above Floor 30. Therefore, fire did not cause the collapse of Columns 79, 80, and 81 nor the collapse of the east penthouse (Section 4.3).

Figure 4.7: Columns 79, 80, and 81 are removed from Floor 45 to the penthouse. Tilting of the building is now negligible. The penthouse now collapses, as demonstrated from the significant amount of deflection given in the figure.

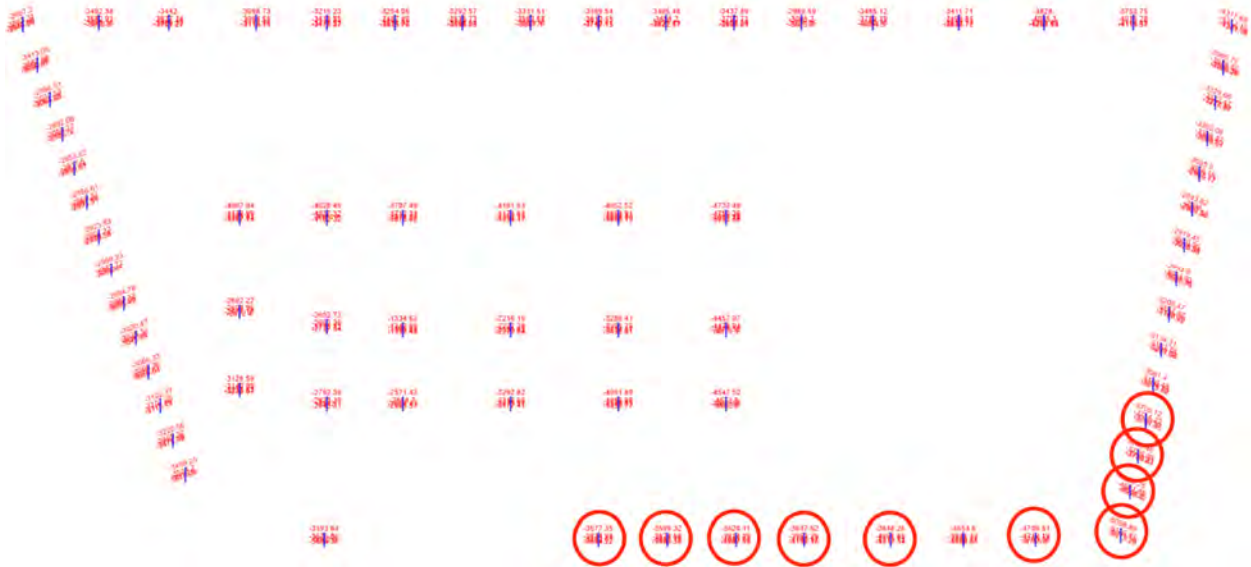
- Even if we assume the failure of Columns 79, 80, and 81 could lead to the failure of the next row of core columns, the hypothetical failure of Columns 76 to 81 would overload the exterior columns around the southeast of the building, rather than overloading the next row of core columns to the west, which would result in the building tipping to the southeast and not in a straight-down collapse (Section 4.4).

Figure 4.10: Linear static analysis results show that the failure of Columns 76 to 81 overloads 10 exterior columns (circled in red) around the southeast corner, but not the next row of core columns to the west (not circled in red).

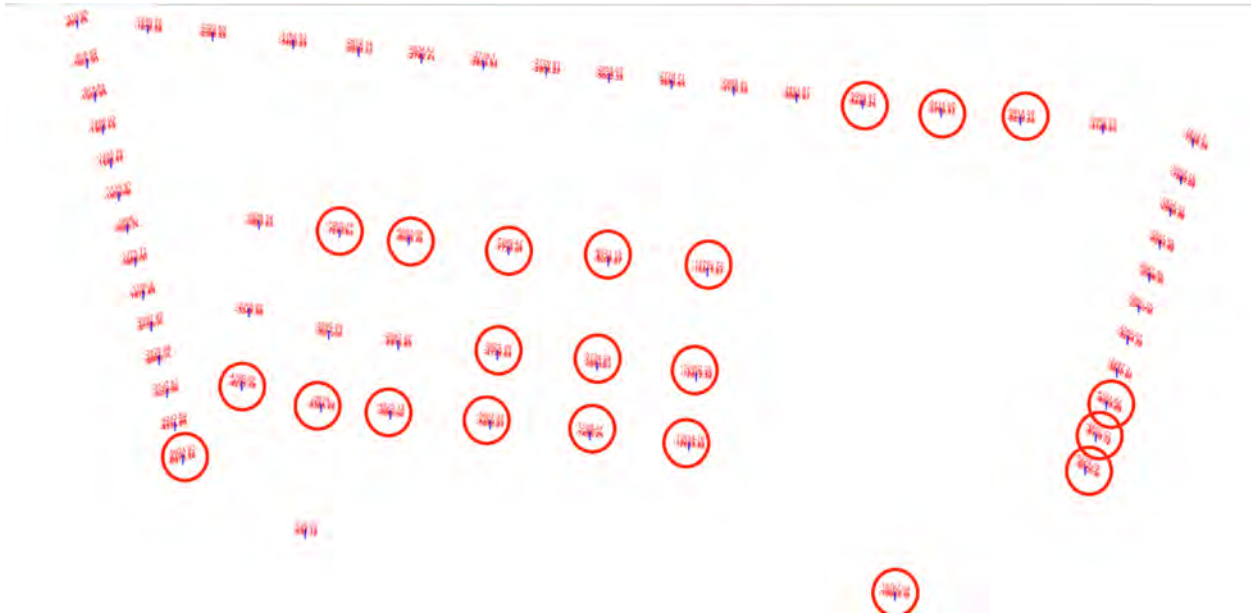
Figure 4.11: Linear static analysis results show that the failure of 10 exterior columns around the southeast corner leads to numerous core and exterior columns (circled in red) being overloaded and failing. A progressive collapse triggered by the hypothetical failure of Columns 76 to 81 is underway.

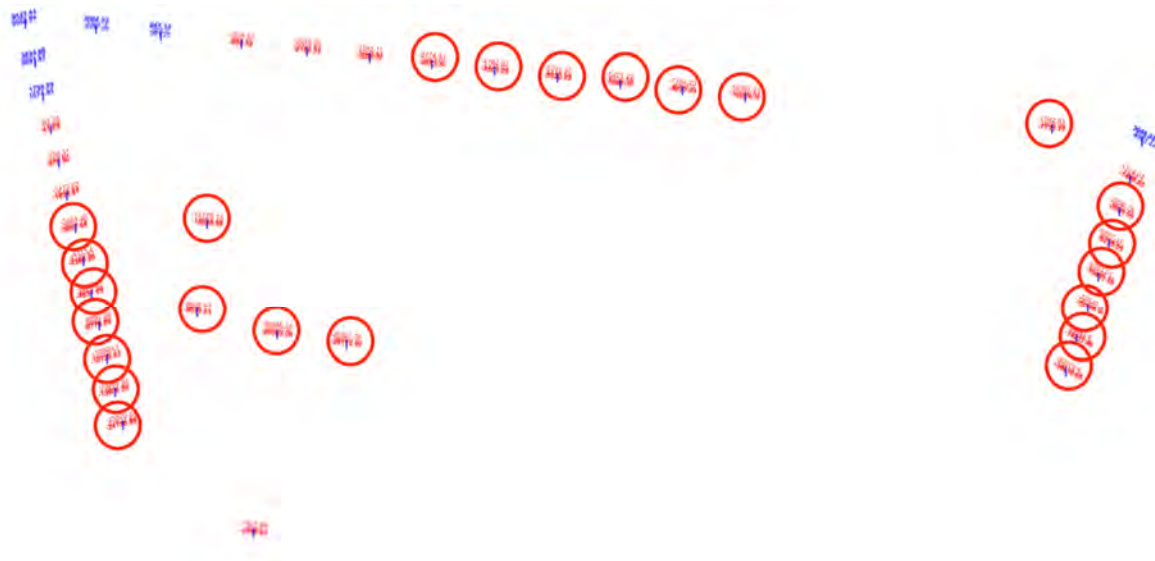
Figure 4.12: Linear static analysis results show that the failure of additional columns (shown in Figure 4.11 above) leads to the failure of the remaining core columns and many exterior columns (circled in red). The columns with blue values are in tension rather than compression, indicating the building is tipping away from those columns.

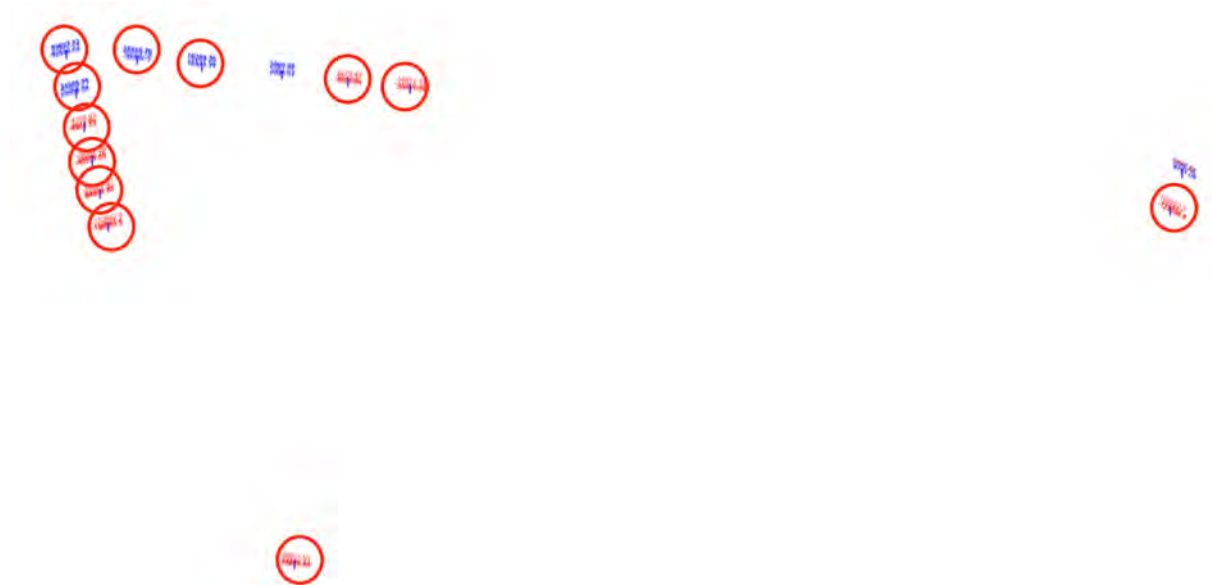
Figure 4.13: Linear static analysis results show that the failure of additional columns (shown in Figure 4.12 above) leads to the failure of nearly every remaining column (circled in red).

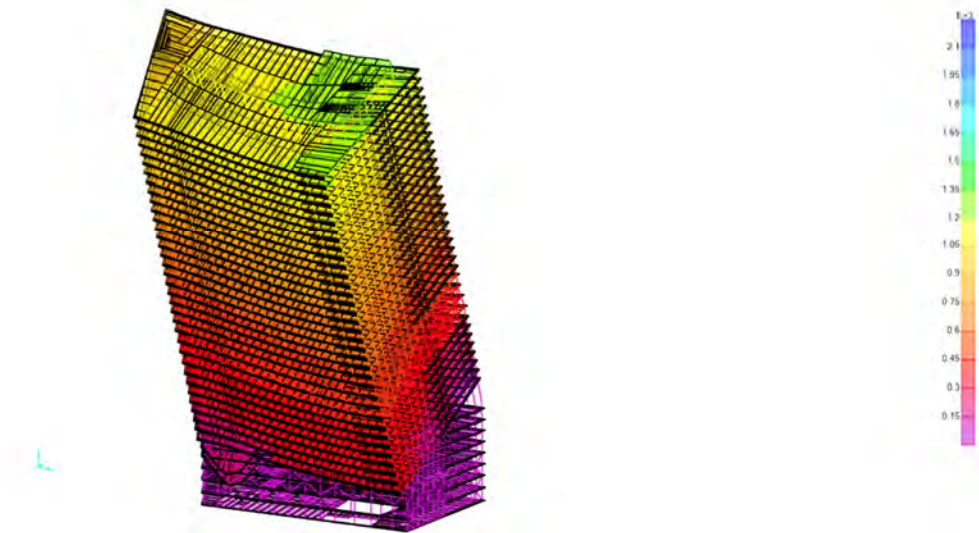
Figure 4.14: Visualization of linear static analysis, from the southeast, showing the building tipping to the southeast after the hypothetical failure of Columns 76 to 81.

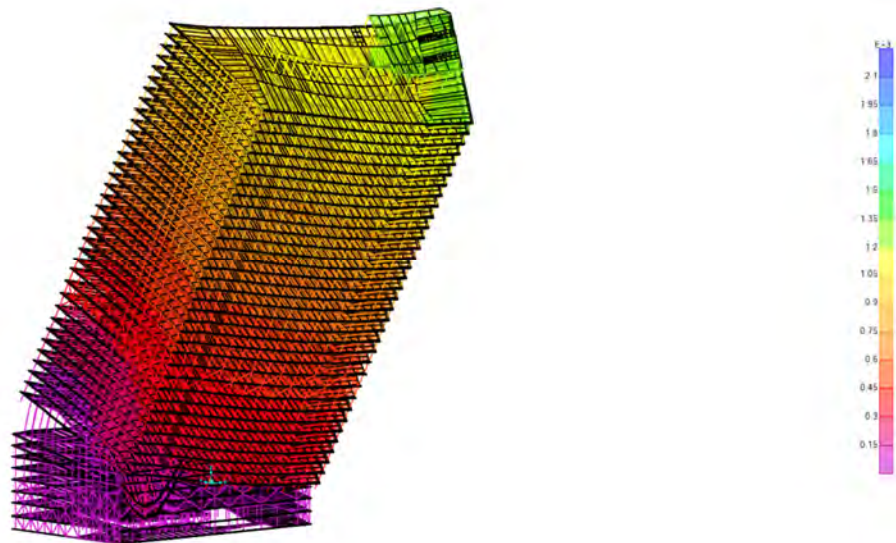
Figure 4.15: Visualization of linear static analysis, from the southwest, showing the building tipping to the southeast after the hypothetical failure of Columns 76 to 81.

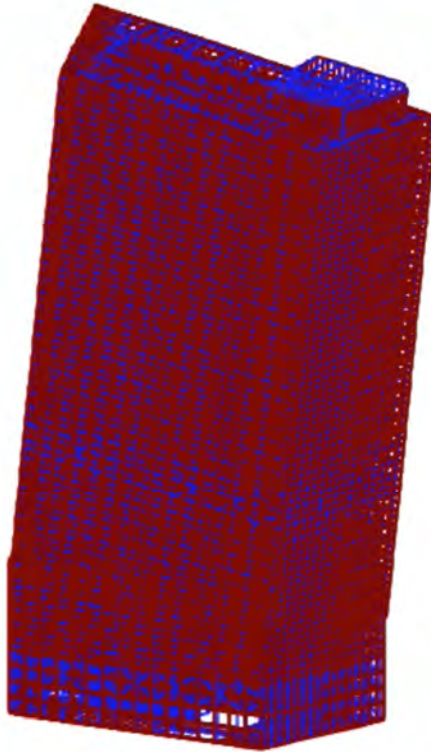
Figure 4.16: Dynamic analysis results showing the building tipping to the southeast after the hypothetical failure of Columns 76 to 81.

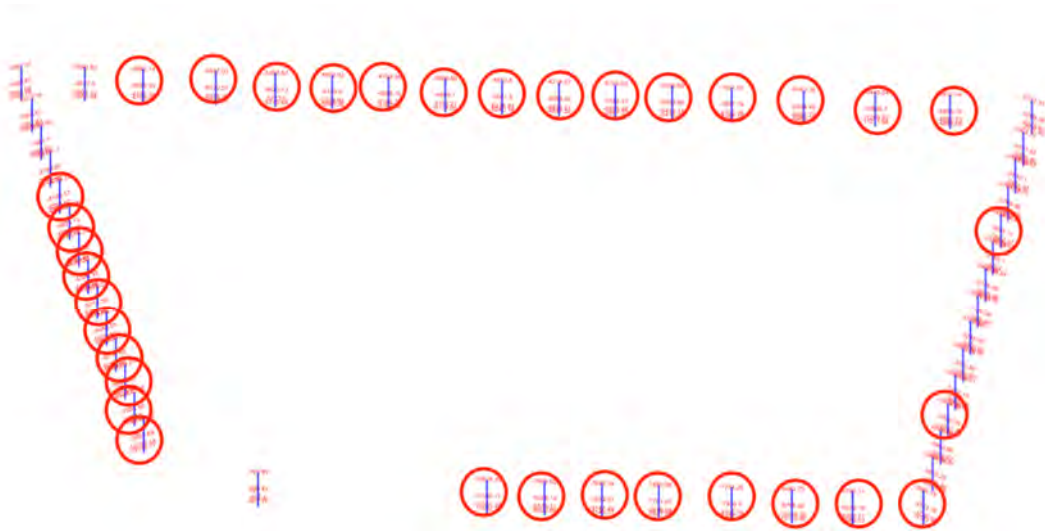
- The hypothetical simultaneous failure of all core columns (but not exterior columns) would cause the building to tip to the southwest rather than causing a straight-down collapse (Section 4.5).

Figure 4.17: Linear static analysis results show that the simultaneous failure of all core columns leads to the failure of most exterior columns, causing the building to tip to the southwest. Only columns at the northwest corner and eastern side are not overloaded.

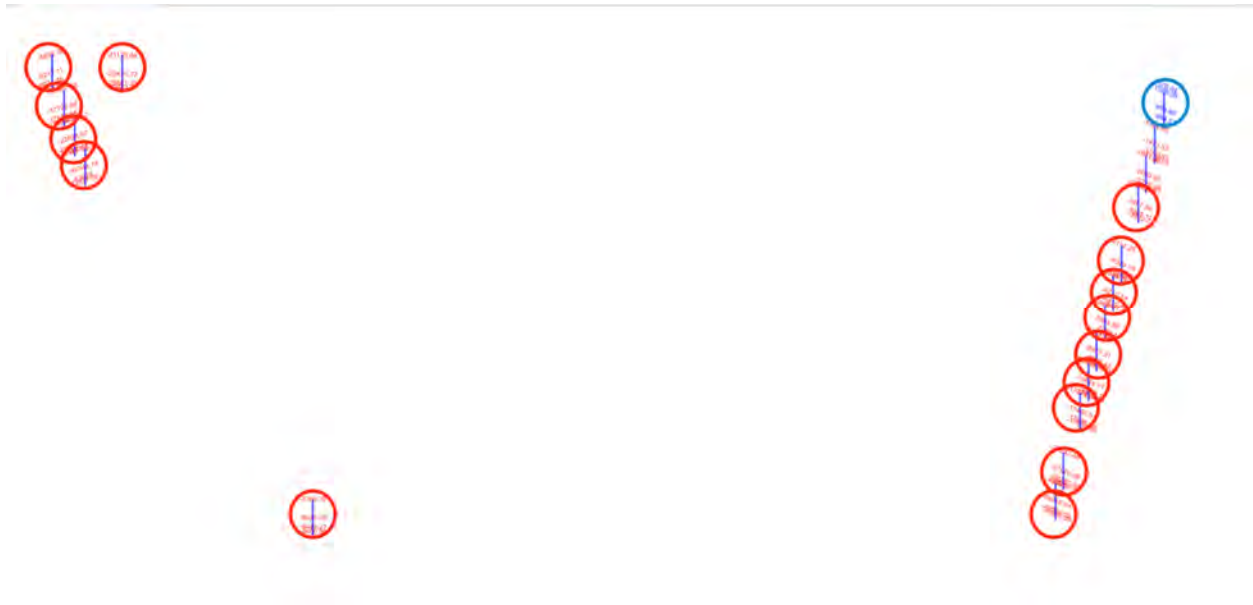
Figure 4.18: Linear static analysis results show the failure of nearly all remaining columns. The northeast column with blue values is in tension as the building tips away to the southwest.

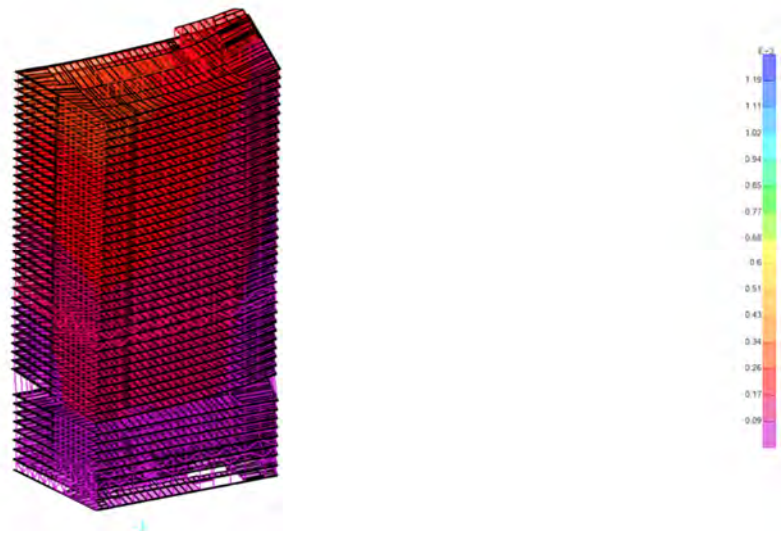
Figure 4.19: Visualization of linear static analysis, from the southwest, showing the building tipping to the southwest after the hypothetical simultaneous failure of all core columns.

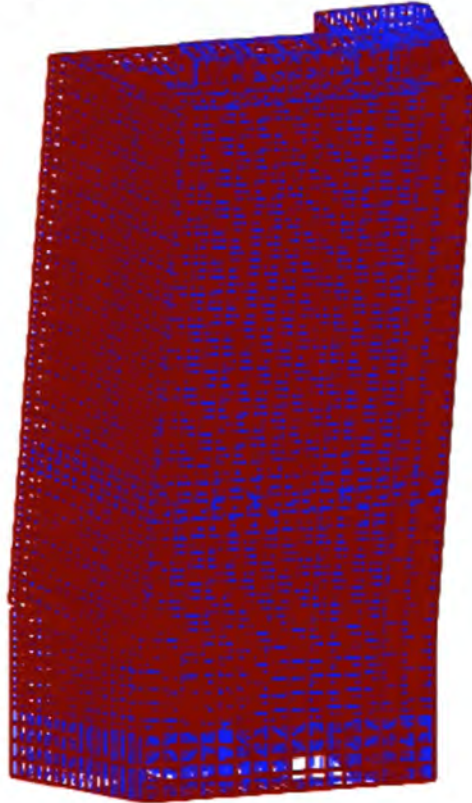
Figure 4.20: Dynamic analysis results showing the building tipping to the southwest after the hypothetical simultaneous failure of all core columns.

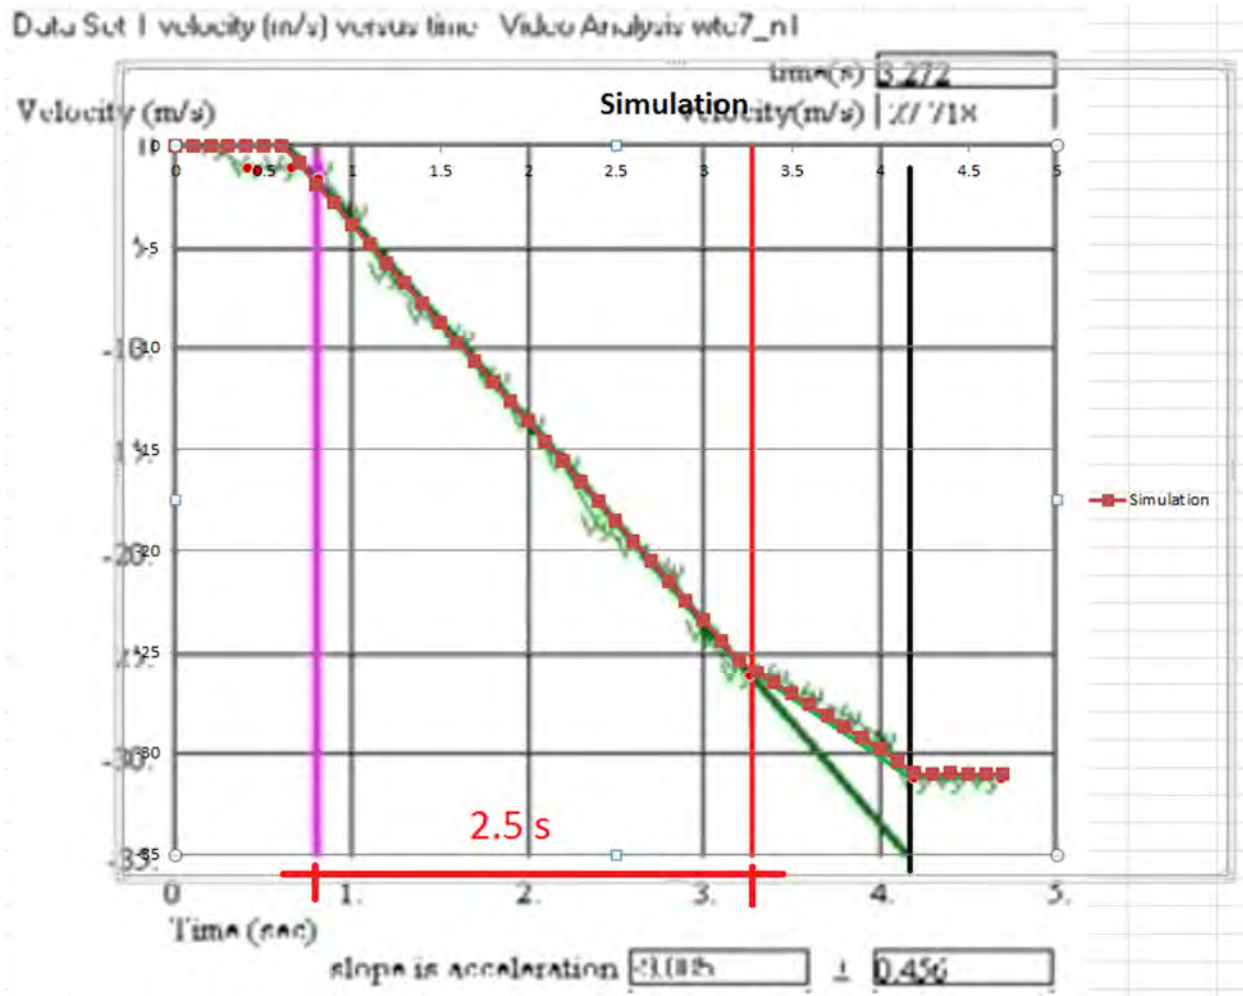
This conclusion is based primarily upon the finding that the simultaneous failure of all core columns over 8 stories followed 1.3 seconds later by the simultaneous failure of all exterior columns over 8 stories produces almost exactly the behavior observed in videos of the collapse, whereas no other sequence of failures that we simulated produced the observed behavior. We cannot completely rule out the possibility that an alternative scenario may have caused the observed collapse; however, the near-simultaneous failure of every column is the only scenario we identified that was capable of producing the observed behavior.

Figure 4.23: Velocity comparison between Chandler measurement (green plotted line) and UAF simulation (red plotted line). Bold green trend line illustrates free fall.
