2 *WTC 1 and WTC 2*

2.1 Building Descriptions

In each case, the aircraft impacts resulted in severe structural damage, including some localized partial collapse, but did not result in the initiation of global collapse. In fact, WTC 1 remained standing for a period of approximately 1 hour and 43 minutes, following the initial impact; WTC 2 remained standing for approximately 56 minutes following impact. The second event was the simultaneous ignition and growth of fires over large floor areas on several levels of the buildings. The fires heated the structural systems and, over a period of time, resulted in additional stressing of the damaged structure, as well as sufficient additional damage and strength loss to initiate the third event, a progressive sequence of failures that culminated in total collapse of both structures.

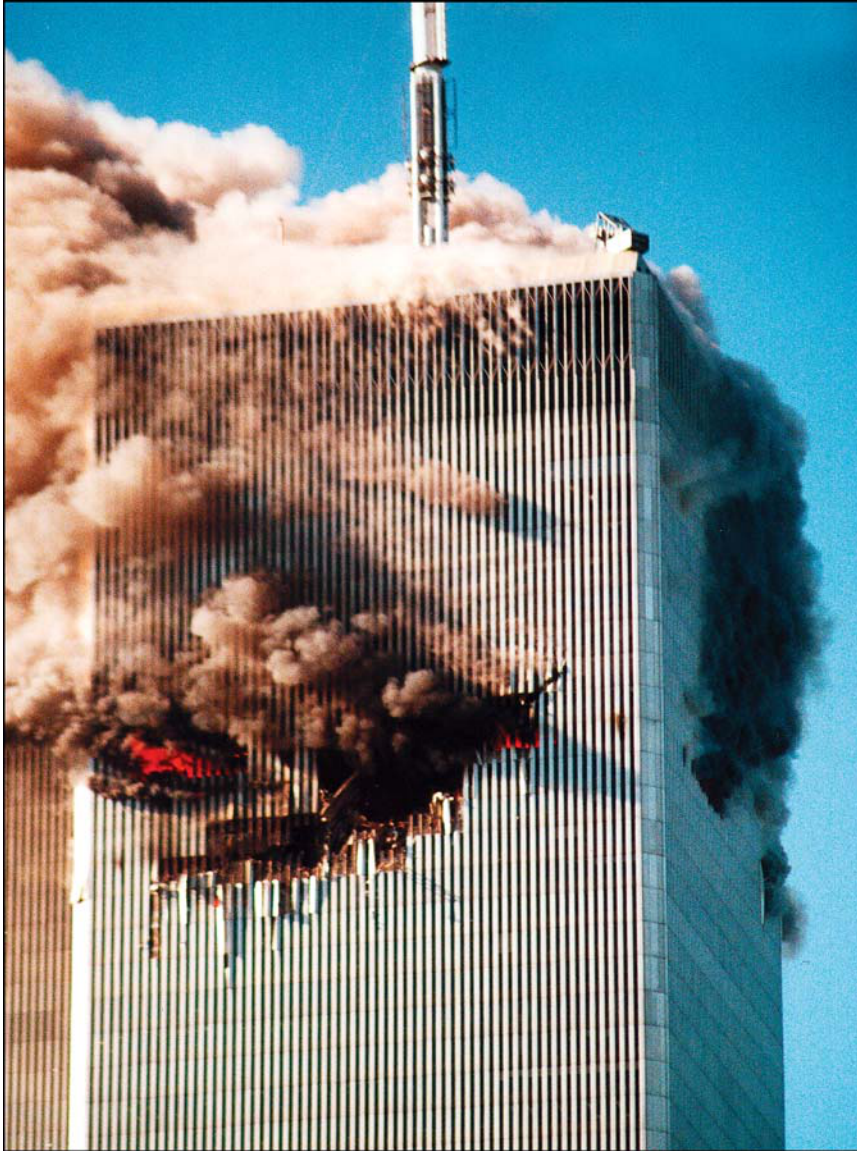
Figure 2-13 Zone of aircraft impact on the north face of WTC 1.

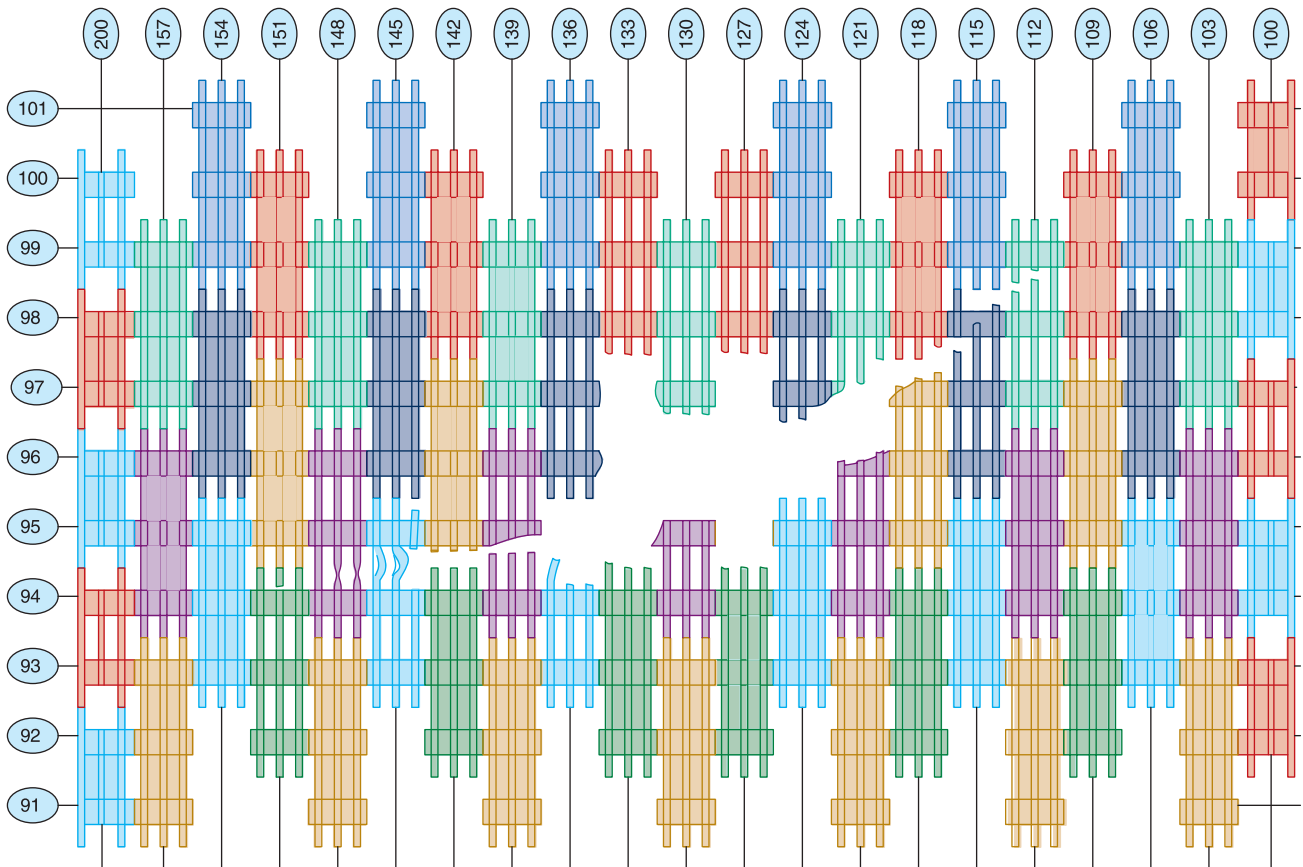
GENERAL NOTES: (1) Column damage captured from photographs and enhanced videos. (2) Damage to column lines 111-115 at level 98 is estimated.

Figure 2-16 Impact damage to exterior columns on the north face of WTC 1.

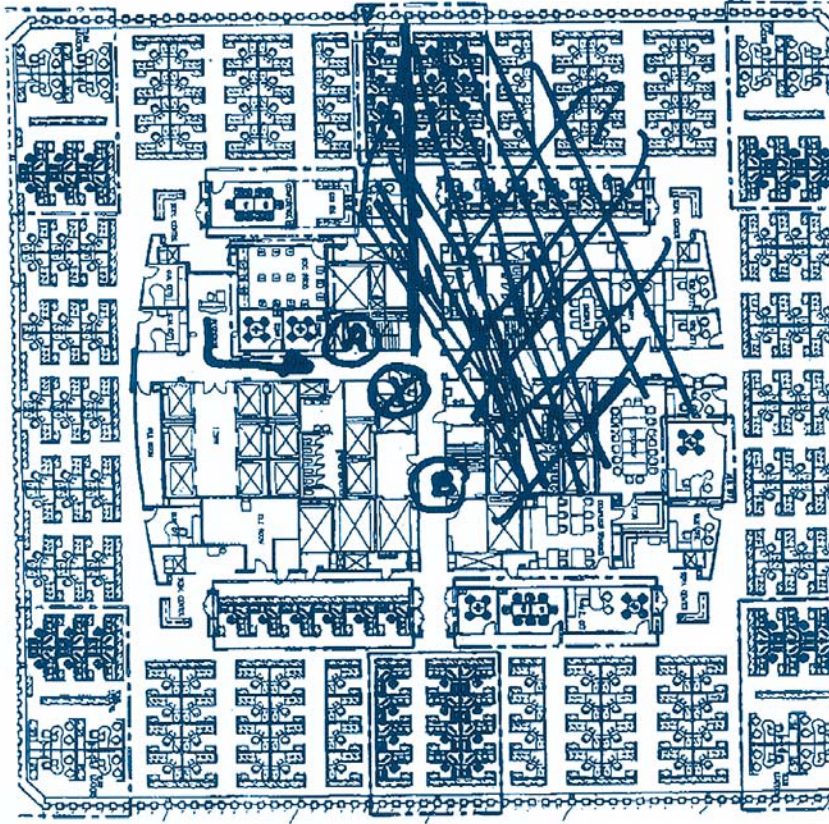
Figure 2-17
Approximate debris location on the 91st
floor of WTC 1.

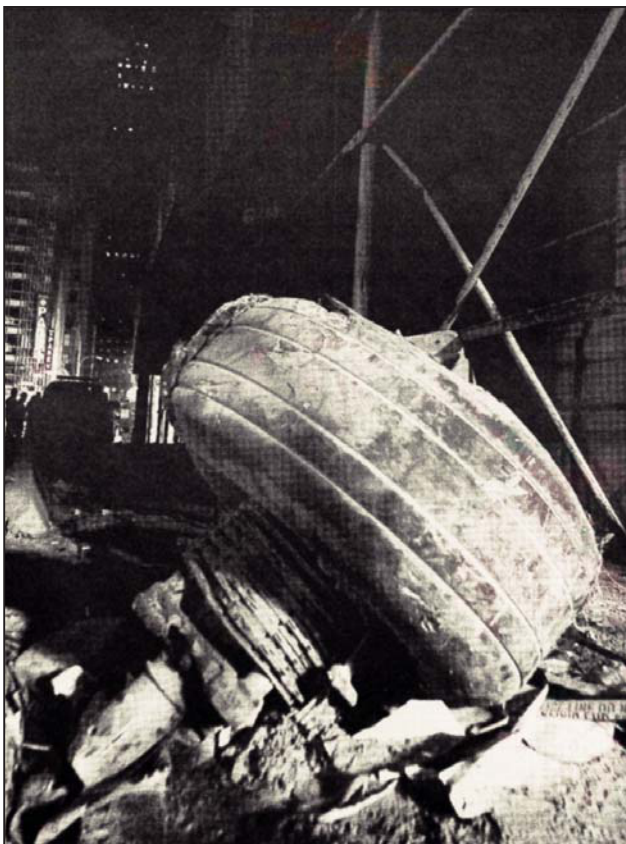
Figure 2-18
Landing gear found at the corner of West and Rector Streets.

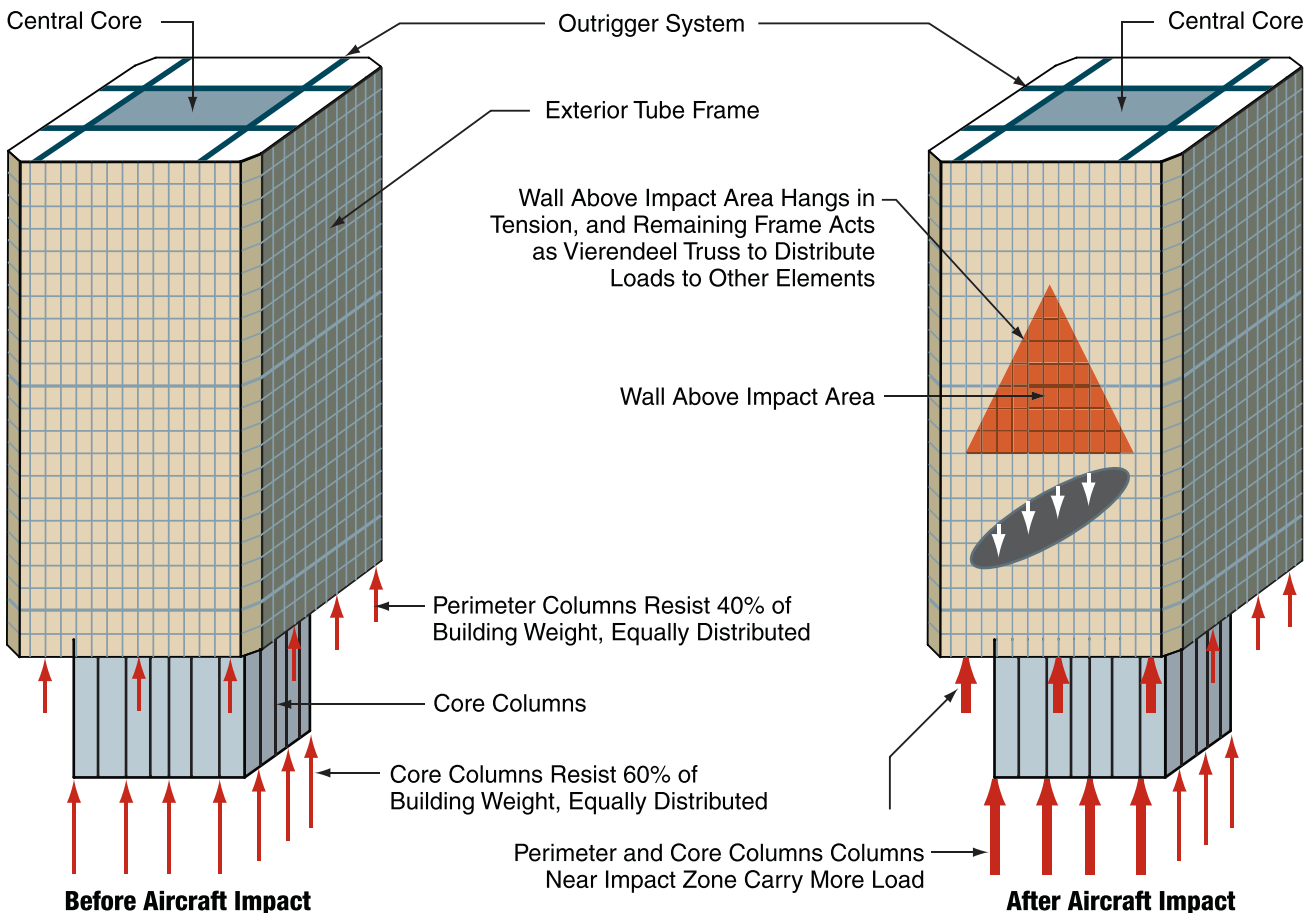
compression were successfully transferred to other load paths. Most of the load supported by the failed columns is believed to have transferred to adjacent perimeter columns through Vierendeel behavior of the exterior wall frame. Preliminary structural analyses of similar damage to WTC 2 suggests that axial load demands on columns immediately adjacent to the destroyed columns may have increased by as much as a factor of 6 relative to the load state prior to aircraft impact. However, these exterior columns appear to have had substantial overstrength for gravity loads.

Neglecting the potential loss of lateral support resulting from collapsed floor slabs and any loss of strength due to elevated temperatures from fires, the most heavily loaded columns were probably near, but not over, their ultimate capacities. Columns located further from the impact zone are thought to have remained substantially below their ultimate capacities. The preliminary analyses also indicate that loss of the columns resulted in some immediate tilting of the structure toward the impact area, subjecting the remaining columns and structure to additional stresses from P-delta effects. Also, in part, exterior columns above the zone of impact were converted from compression members to hanger-type tension members, so that, in effect, a portion of the floors' weight became suspended from the outrigger trusses (Figure 2-10) and were transferred back to the interior core columns. The outrigger trusses also would have been capable of transferring some of the load carried by damaged core columns to adjacent core columns. Figure 2-19 illustrates these various secondary load paths. Section 2.2.2.2 provides a more detailed description of these analyses and findings.

Figure 2-19 Redistribution of load after aircraft impact.

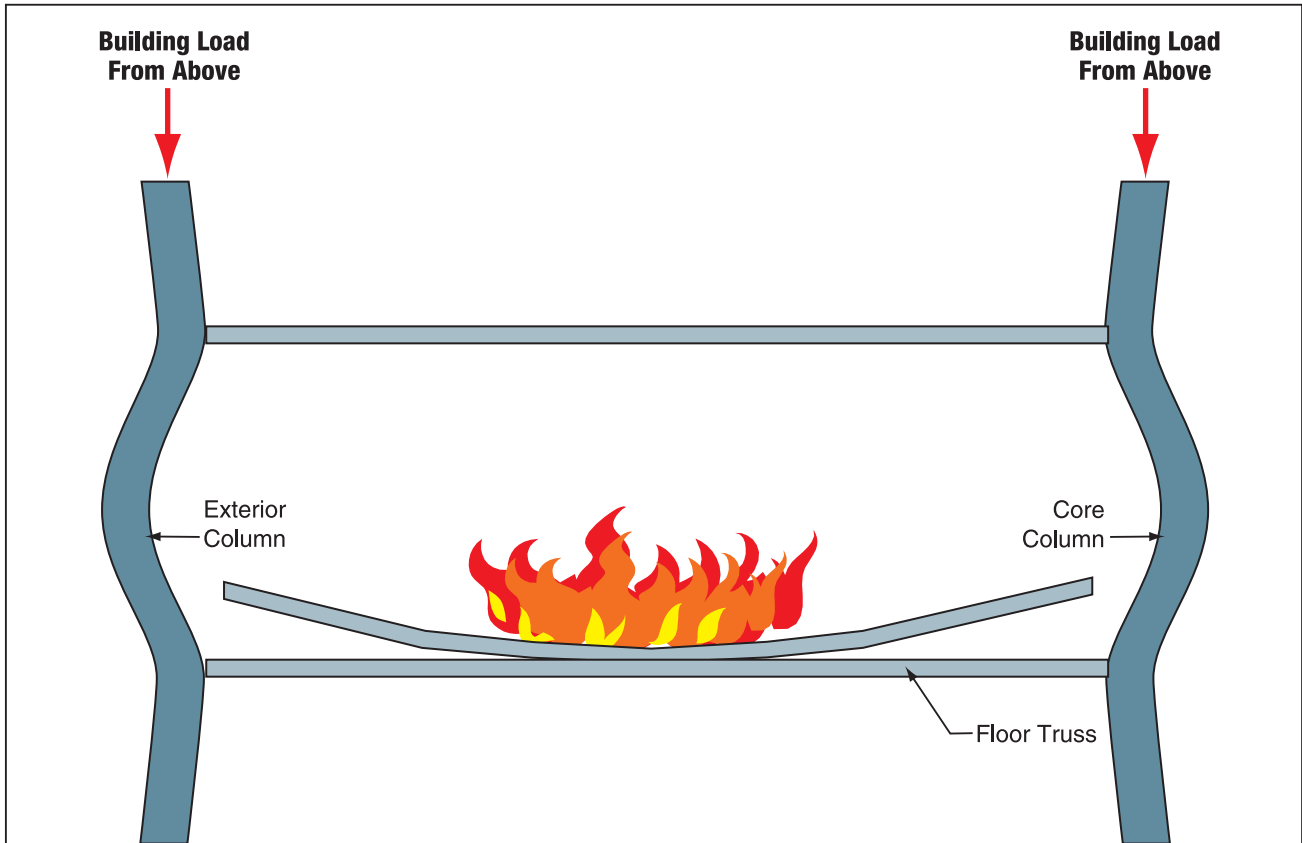
Figure 2-21 Buckling of columns initiated by failure of floor framing and connections.

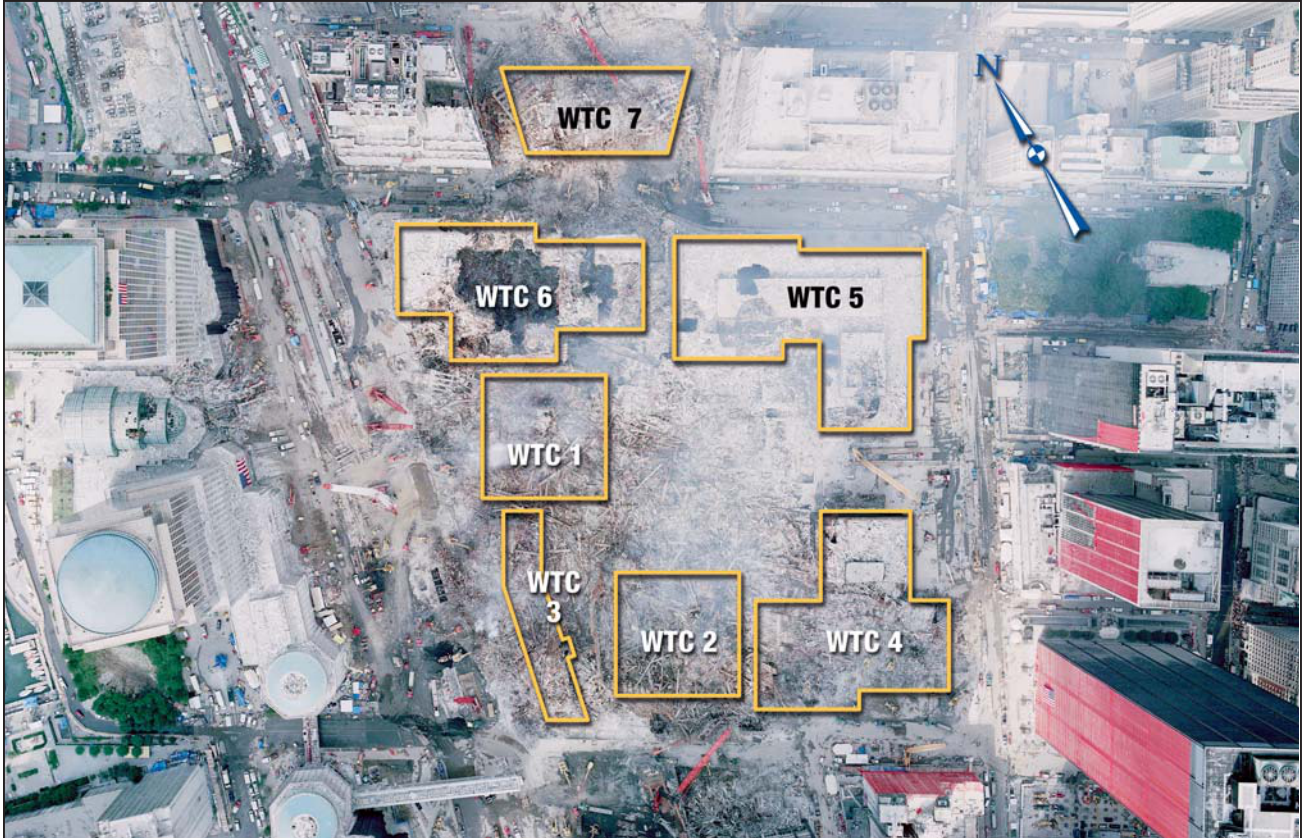
Although the building appeared to collapse within its own footprint, a review of aerial photographs of the site following the collapse, as well as damage to adjacent structures, suggests that debris impacted the Marriott Hotel (WTC 3), the Customs House (WTC 6), the Morgan Stanley building (WTC 5), WTC 7, and the American Express and Winter Garden buildings located across West Street (Figure 2-23). The debris field extended as far as 400–500 feet from the tower base.

Figure 2-23 Aerial photograph of the WTC site after September 11 attack showing adjacent buildings damaged by debris from the collapse of WTC 1.

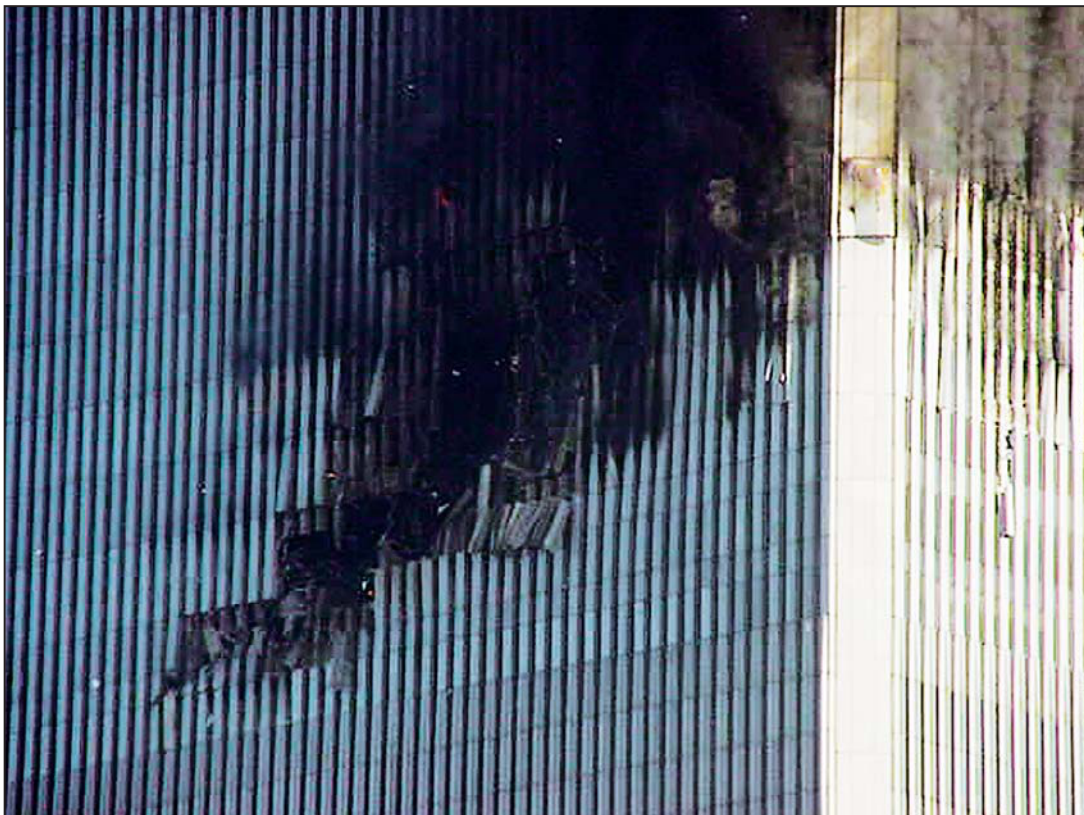
Figure 2-24 Southeast corner of WTC 2 shortly after aircraft impact.

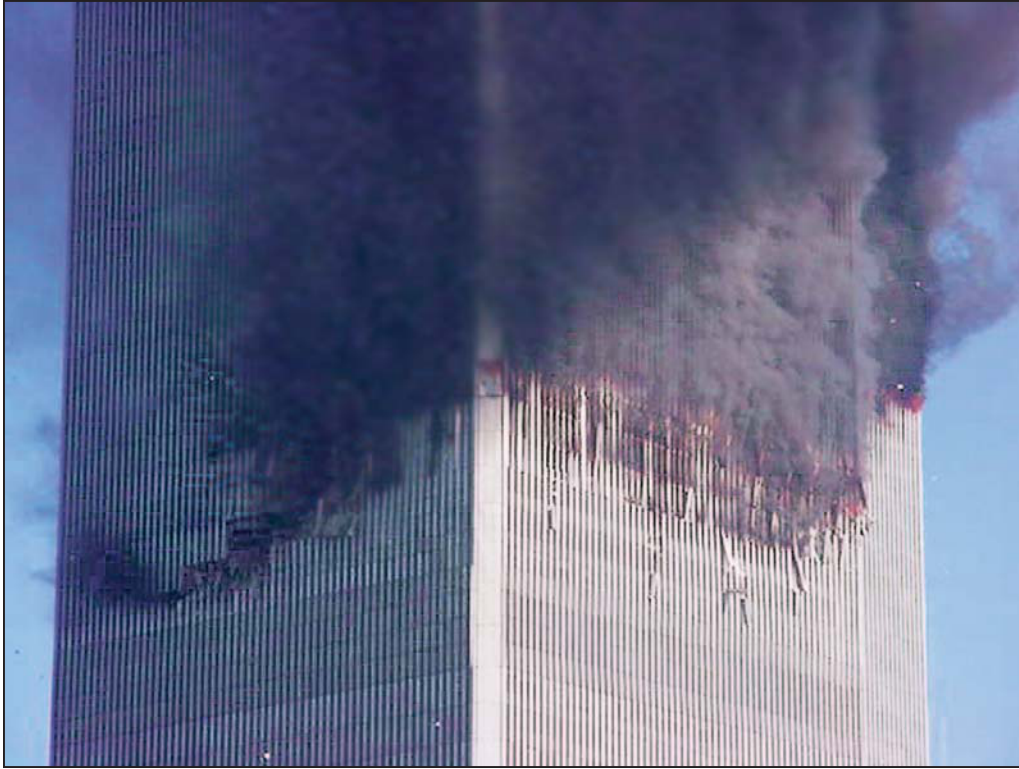
Figure 2-26 Impact damage to the south and east faces of WTC 2.

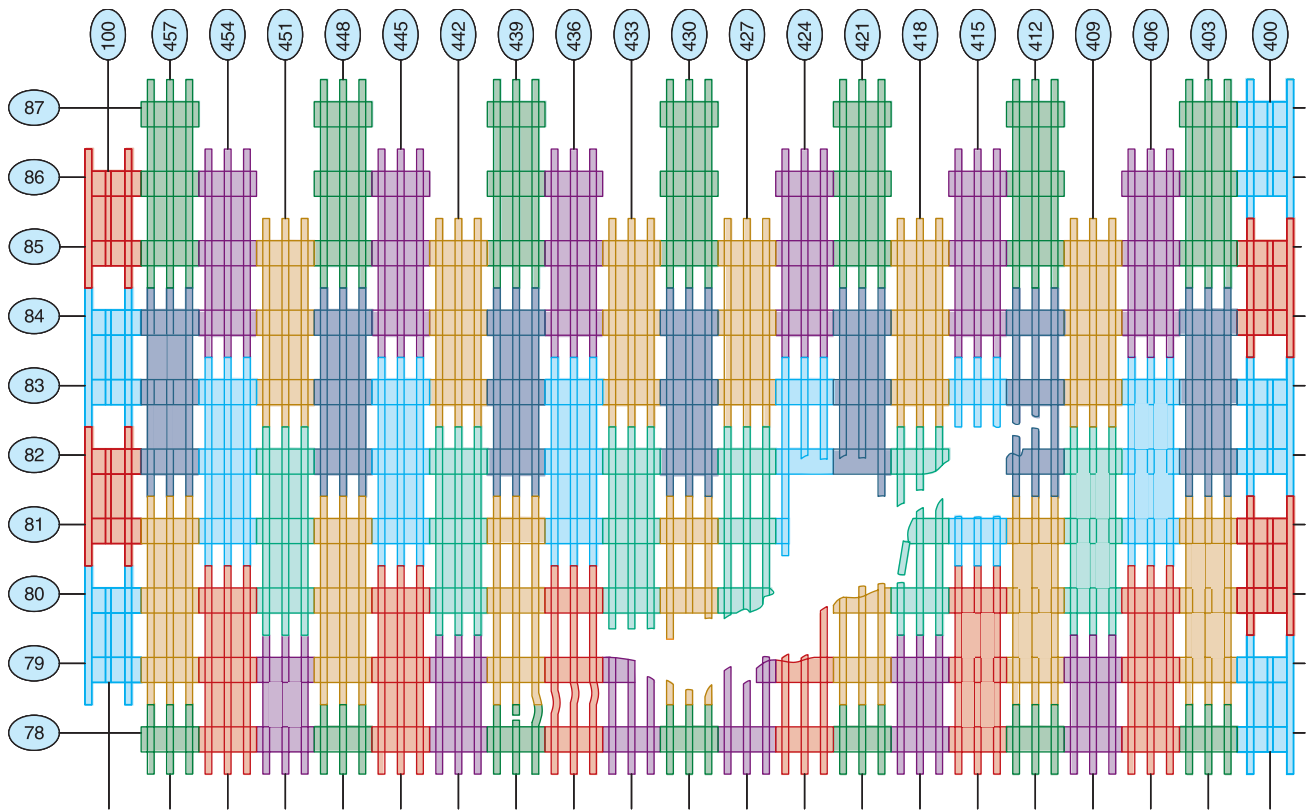
GENERAL NOTES: (1) Column damage captured from photographs and enhanced videos. (2) Damage to column lines 413-418 at levels 81 and 82 is estimated.
 (3) There is not sufficient information to detail damage to column lines 408-411 at levels 83-84.

Figure 2-27 Impact damage to exterior columns on the south face of WTC 2.

A second analysis was conducted to estimate the demands on columns immediately following aircraft impact and before fire effects occurred. Exterior columns were removed from the model to match the damage pattern illustrated in Figure 2-27. Although some core columns were probably damaged by the aircraft impact, the exact extent of this damage is not known and therefore was not considered in the model. As a result, this analysis is thought to underestimate the true stress state in the columns immediately after impact. The analysis indicates that most of the loads initially carried by the damaged exterior columns were transferred by Vierendeel truss action to the remaining exterior columns immediately adjacent to the impact area. If the floors at this level are assumed to remain intact and capable of providing lateral support to the columns, this raised the utilization ratio for the most heavily loaded column immediately adjacent to the damage area to approximately a value of 1.0. At a value of 1.0, columns would lose stiffness and shift load to adjacent columns. Based on this analysis, it appears that the structure had significant remaining margin

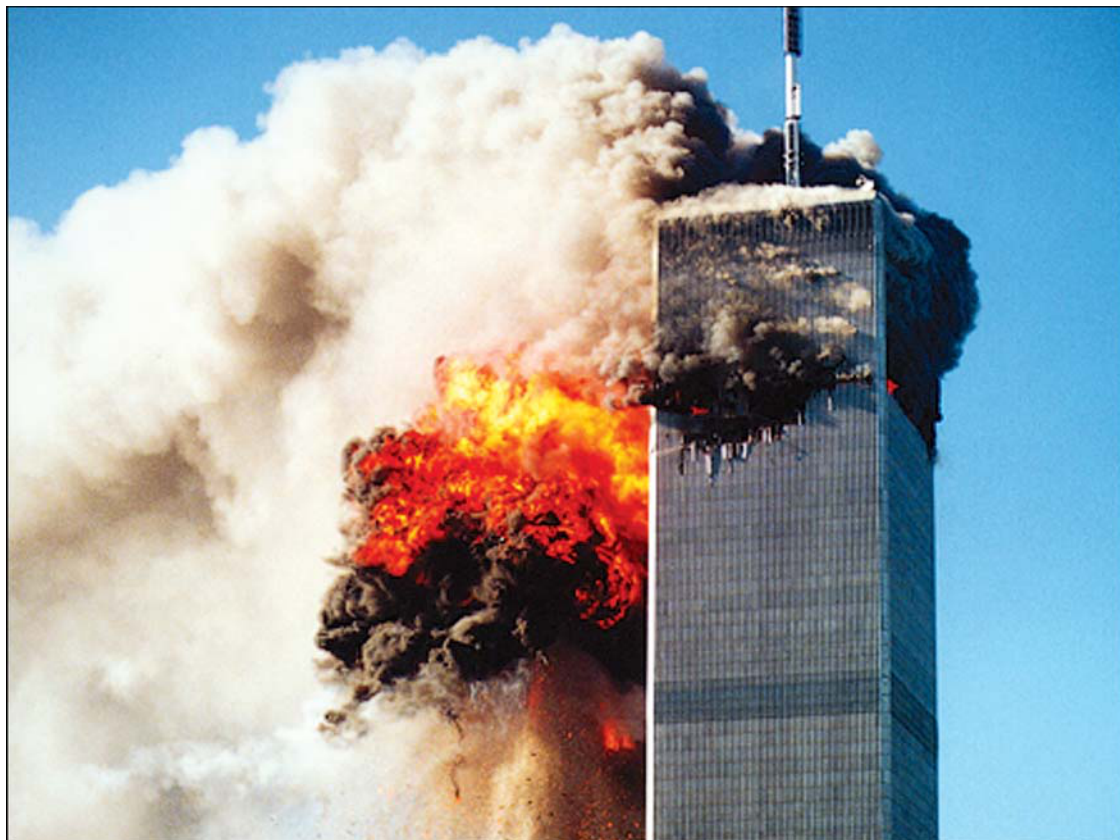
Figure 2-28 Conflagration and debris exiting the north wall of WTC 2, behind WTC 1.

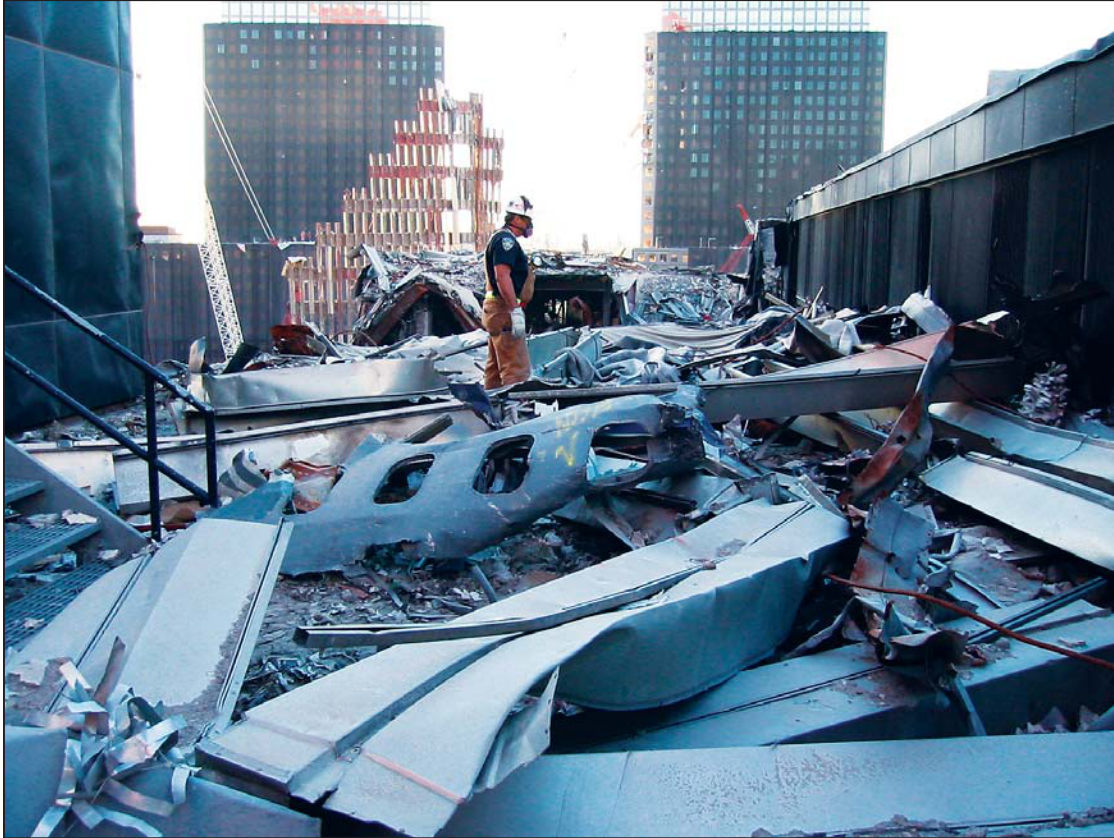
It is known that debris from the aircraft traveled completely through the structure. For example, a landing gear from the aircraft that impacted WTC 2 was found to have crashed through the roof of a building located six blocks to the north, and one of the jet engines was found at the corner of Murray and Church Streets. The extent to which debris scattered throughout the impact floors is also evidenced by photographs of the fireballs that occurred as the aircraft struck the building (Figure 2-28). Figure 2-29 shows a portion of the fuselage of the aircraft, lying on the roof of WTC 5.

Figure 2-29 A portion of the fuselage of United Airlines Flight 175 on the roof of WTC 5.

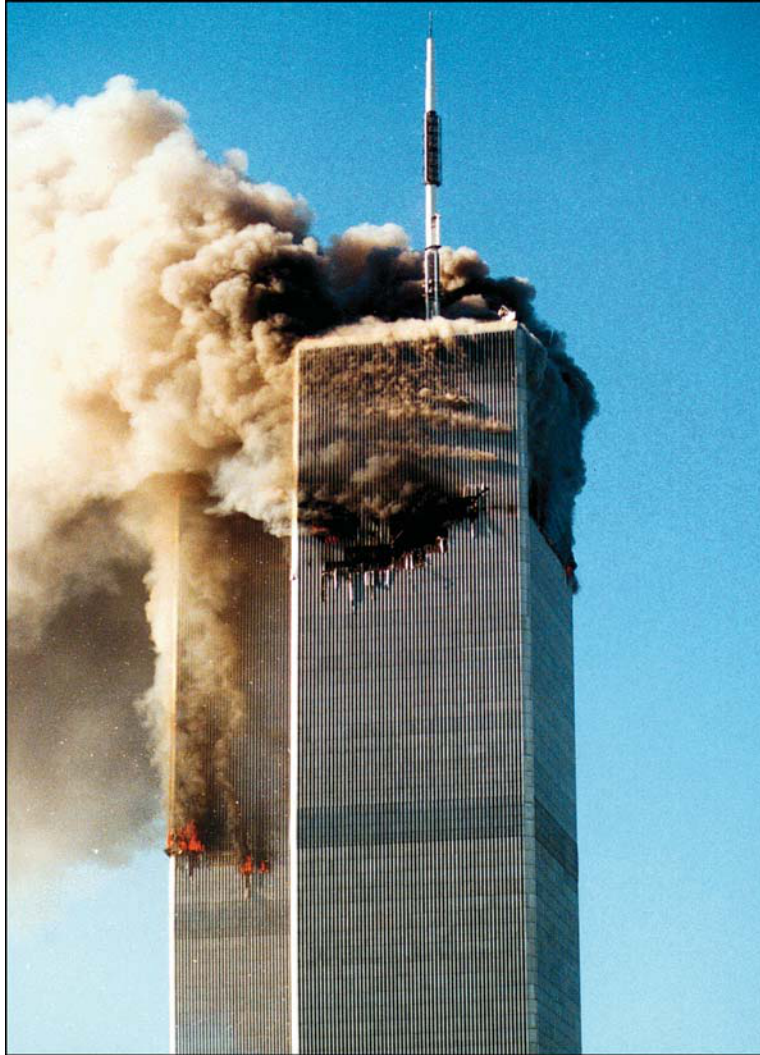
*Figure 2-30
North face of WTC 2 opposite the zone of impact
on the south face, behind WTC 1.*

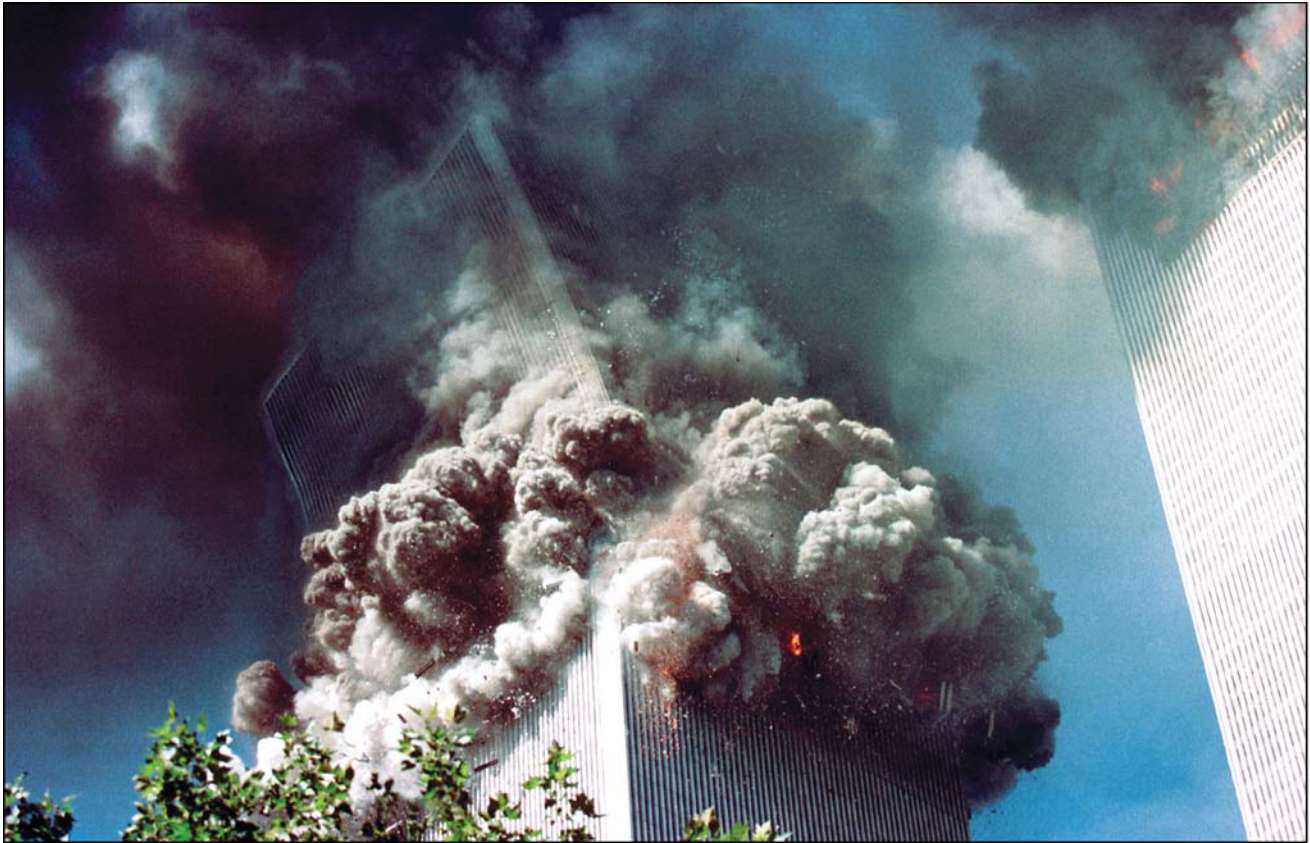
Figure 2-32 The top portion of WTC 2 falls to the east, then south, as viewed from the northeast.
