# **Interstate Bank Building Fire Los Angeles, California (May 4, 1988)**

**Investigated by: J. Gordon Routley**

**This is Report 022 of the Major Fires Investigation Project conducted by TriData Corporation under contract EMW-8-4321 to the United States Fire Administration, Federal Emergency Management Agency.**

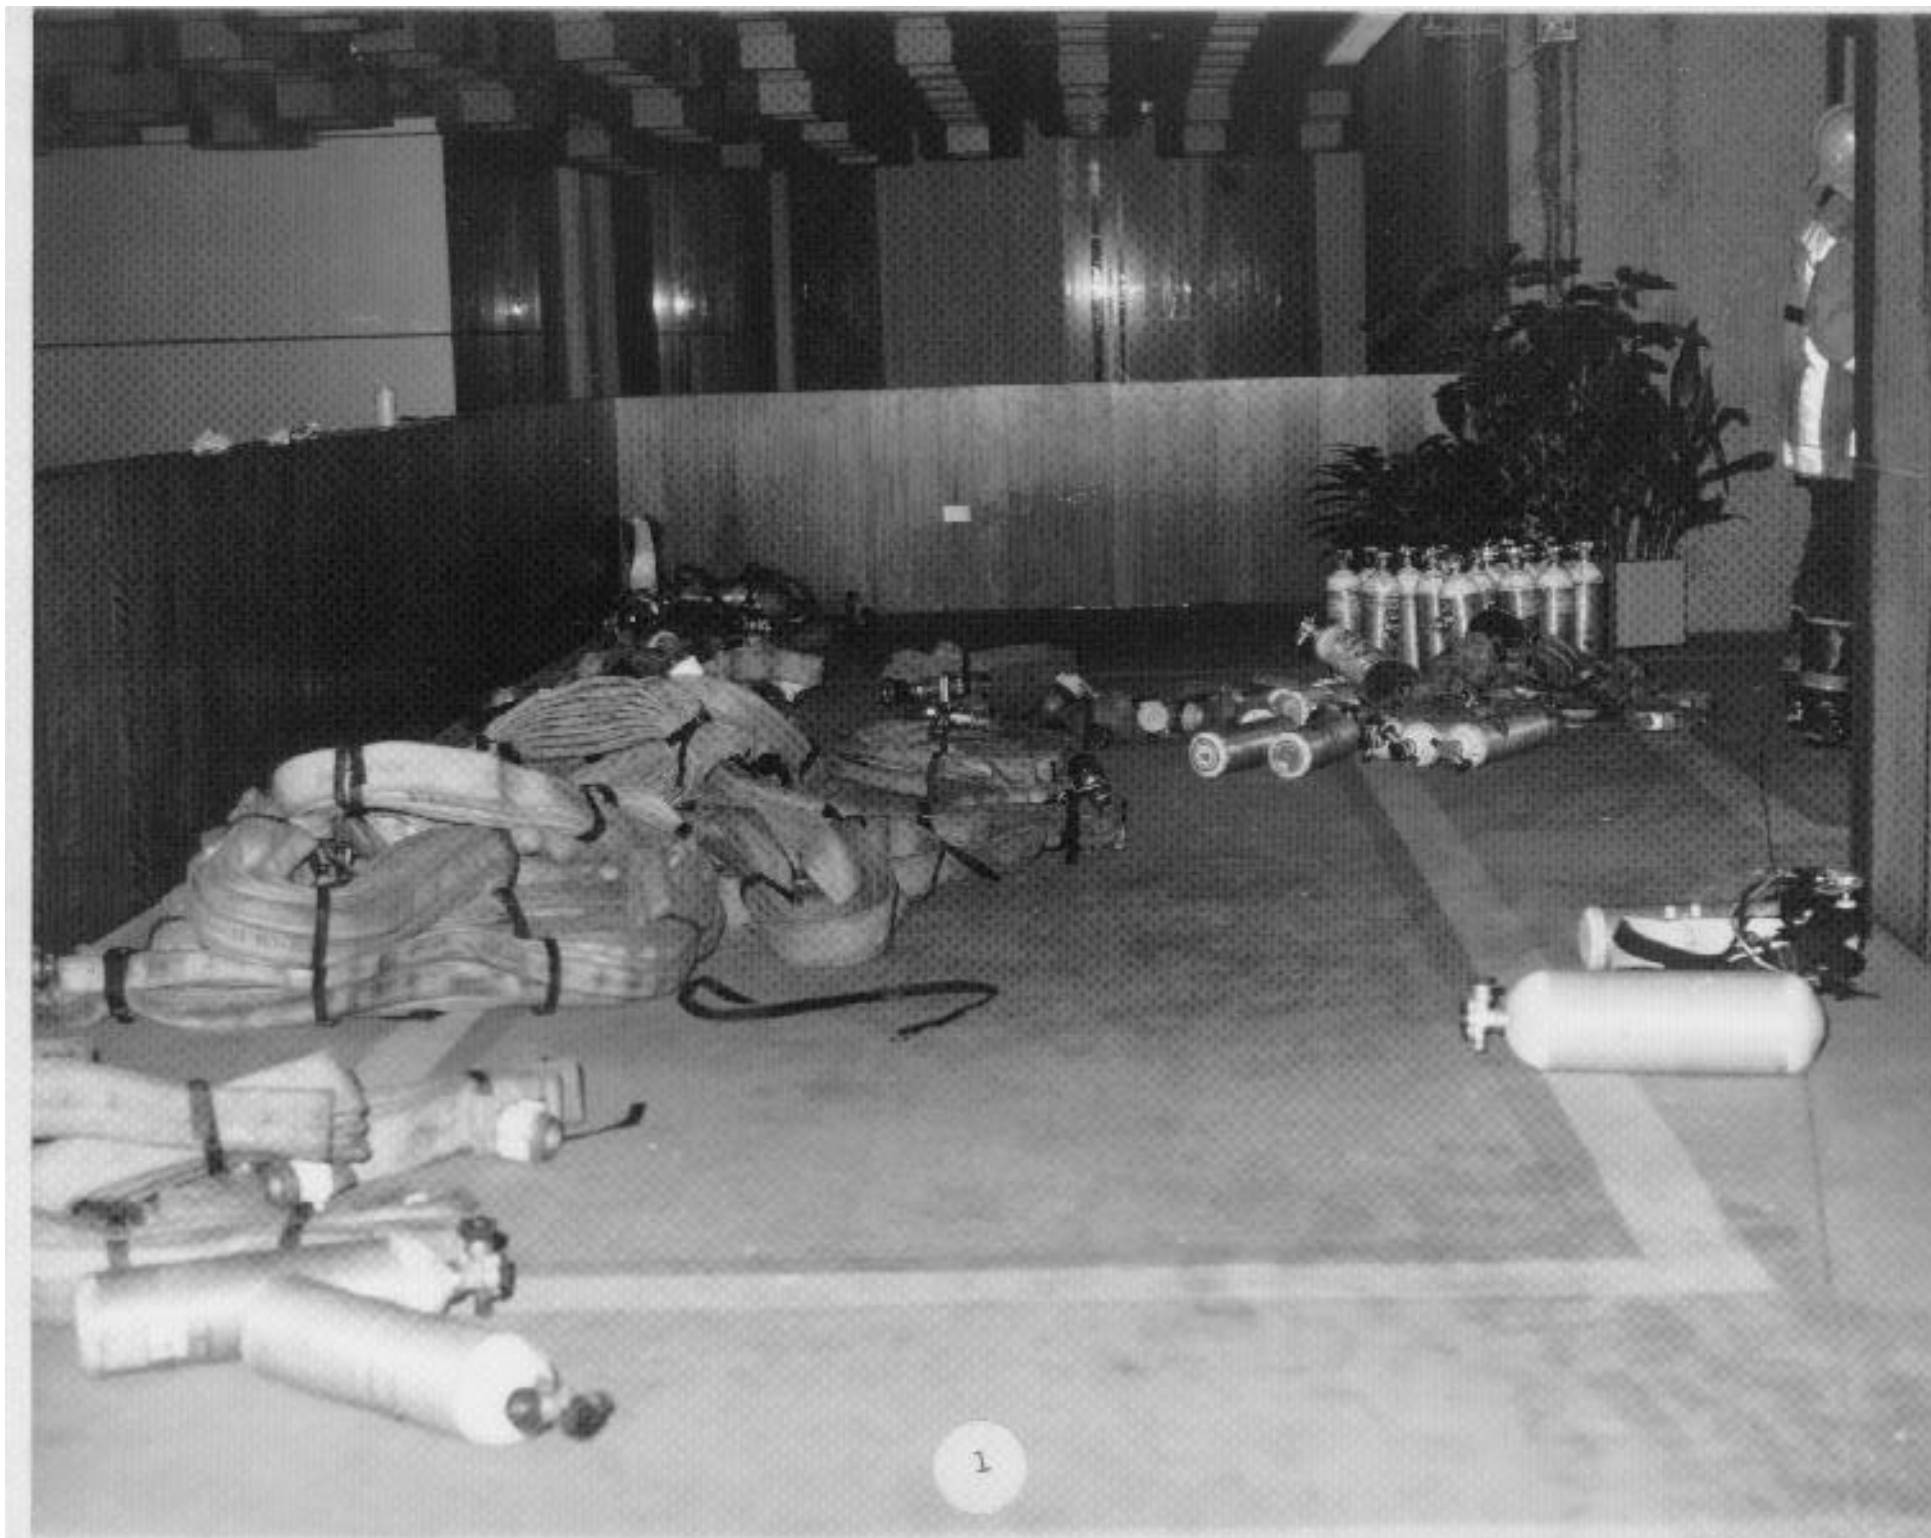
1. Lobby control equipment pool.
2. Empty air bottles in staging.
3. Task Force 15 Returning to staging  
Note hoods and water in stairwell.
4. Tenth floor staging area.
5. Helicopter searching 50th floor for  
trapped civilians.
6. Wilshire Incident Command.
7. Evidence of smoke in elevator shaft  
at 42nd floor.
8. Stairwell 6 at 22nd floor showing smoke leakage.
9. Twisted aluminum framework northeast corner of  
building.
10. Void between floor and exterior glass.
11. Plate glass windows on the 16th floor.
