Metallographic Examination of Heavily Eroded Structural Steel from World Trade Center Buildings 1, 2 and 7

R. R. Biederman¹, Erin Sullivan¹, George F. Vander Voort², and R. D. Sisson, Jr.¹

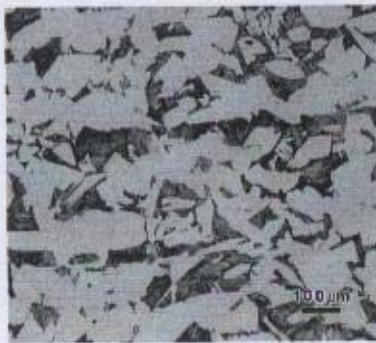
FIGURE 1 (left) Ferrite-pearlite microstructure of an unaffected A36 beam area (nital etch).

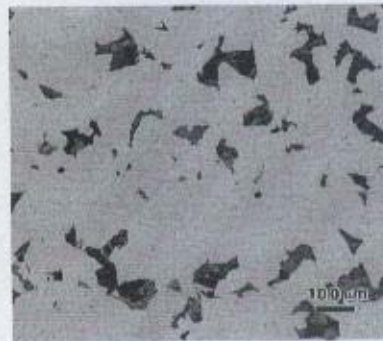
FIGURE 2 (right) Ferrite-pearlite structure of an unaffected HSLA column area (picral etch).

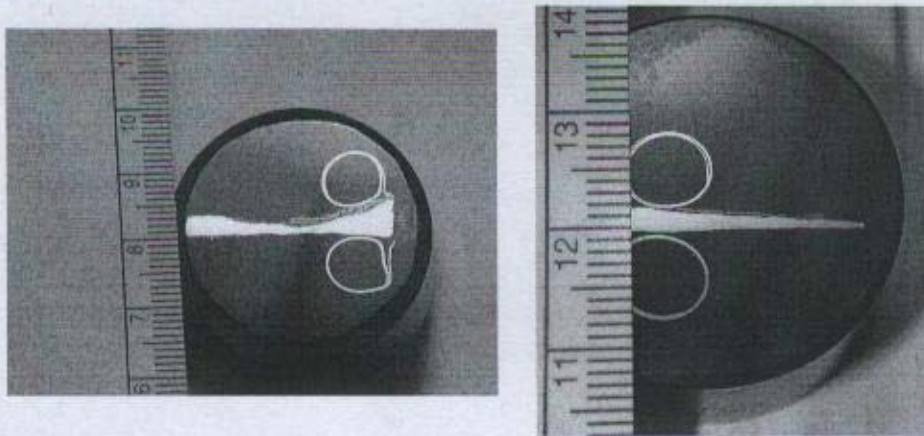
FIGURE 3 Examples of the severe loss of section thickness in the A36 beam (left) and HSLA column sections.

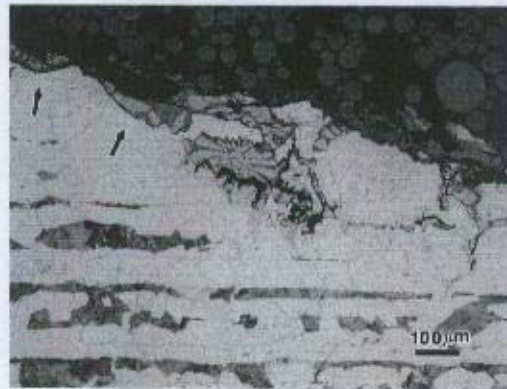
In severely “eroded” areas in the A36 steel, where the thickness had been reduced substantially, heating in a hot-corrosive environment was evident in the microstructure. Chemical reactions including oxidation, sulfidation, and decarburization occurred as well as all of the usually observed equilibrium phase transformations in the steel. An example of a typical near-surface microstructure is shown in Fig. 4. This microstructure shows the scale and slag reaction effects at the top of the photomicrograph and the normal metallurgical reactions that occurred in this steel on heating and cooling toward the bottom. As the temperature increased changes in the microstructure of the steel occurred simply as a result of heating and cooling. However, as higher temperatures occurred, microstructural, as well as chemistry changes, resulted. The interaction of heat in a corrosive fire environment resulted in making this steel susceptible to sulfidation and severe erosion.

FIGURE 4 Near-surface transformations in the A36 beam: intergranular penetration of the liquid eutectic of FeO and FeS, subsurface decarburization and dissolution of the pearlite (nital etch).

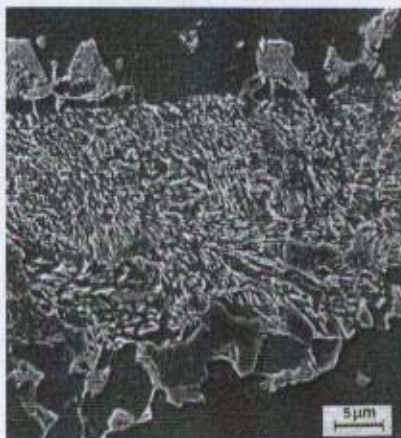
conversion from ferrite to austenite on heating followed by transformation back to pearlite and ferrite on cooling. Typical examples of these transformations are presented in Fig. 5 and Fig. 6 from pearlite banded regions near the bottom of Fig. 4. In Fig. 5 the Fe_3C in the pearlite had started to spheroidize. Also, some pearlite bands have areas where a re-austenitization had occurred and new finer grained regions of pearlite and ferrite formed on cooling as shown in Fig. 6. These observations suggest that the steel in this region had experienced temperatures in the range of 550 to 850 °C.

FIGURE 5 (left) SEM view of the start of spheroidization of lamellar cementite in the A36 steel beam (nital etch).
FIGURE 6 (right) Recrystallization of ferrite in areas where the pearlite has been partially dissolved (nital etch).

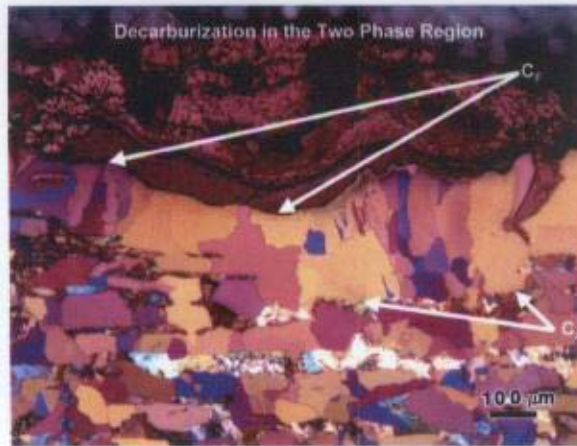
FIGURE 7 Color micrograph showing the growth of columnar ferrite grains beneath the oxidized surface (nital/Beraha's reagent).

At higher temperatures, in the ferrite + austenite phase field region, the chemical reaction rate of carbon loss to the atmosphere increases in addition to the phase transformations. Substantial decarburization can occur in this two-phase region and result in a columnar ferrite grain morphology under the scale on the steel. An example of this microstructure is shown in Fig. 7. Columnar geometry ferrite grains form in this steel as a result of loss of carbon and grain growth under a fixed compositional equilibrium requirement. This transformation likely occurred in the range of 750 to 900 °C. Toward the right side of Fig. 7 a liquid penetration into the steel had occurred when the steel was hot and transformed on cooling to the eutectic mixture of iron oxide and iron sulfide [2]. If these phases are pure FeO and pure FeS, the eutectic temperature is 940 °C [3]. However, incorporation of other elements into the liquid would likely lower the eutectic temperature.

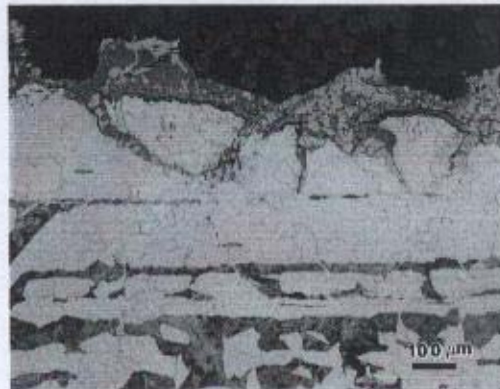
At 940 °C and higher, iron, sulfur and oxygen form a liquid (possibly a sulfate) that penetrates into the iron oxide grain boundaries forming a mixture which dissolves the iron oxide forming a semi-solid with the liquid at the eutectic composition. The semi-solid region is composed of nearly spherical solid iron oxide particles dissolving into the sulfur rich liquid. This is shown in Fig. 8.

The transformed microstructure from the section of the steel beam shown in Fig. 8 shows that the steel had reached a temperature at which it was fully austenitic and had undergone substantial grain growth. The severe erosion observed is a result of sulfidation caused by liquid penetration into the austenite grain boundaries resulting in large grain pullout of material due to a

FIGURE 8 Example of the oxide-sulfide scale and grain-boundary penetration (nital etch).

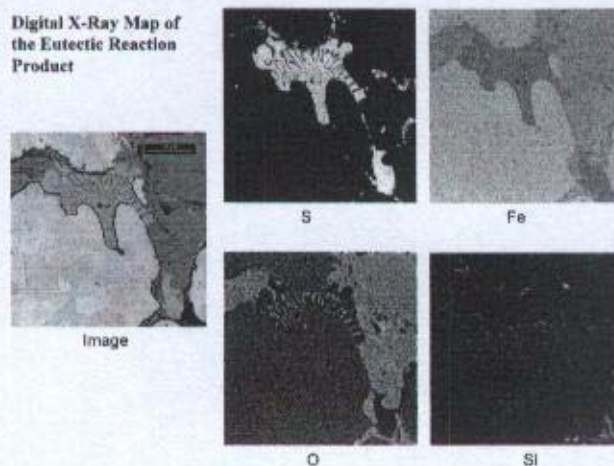
liquid intergranular attack. This liquid transforms isothermally to a two-phase eutectic product on cool-down. Digital x-ray maps for the distribution of iron, oxygen and sulfur in the eutectic reaction region are shown in Fig. 9. Sulfidation in the solid state into the austenite grains occurs much slower and is observed on cooling as a gradient of precipitated sulfides and oxides or oxidized sulfides with many of these particles containing silicon. The oxide scale in Fig. 8 is a multi-phase mixture that occurred on cooling. It can contain different mixtures of retained wustite (FeO), magnetite (Fe_3O_4) and some hematite (Fe_2O_3) depending on cooling rate effects. The amount of liquid and solid formed in the semi-solid region as well as the multi-phase oxide mixture observed suggests a maximum steel temperature near $950\text{ }^\circ\text{C}$.

FIGURE 9 SEM image and x-ray elemental maps for S, Fe, O and Si.

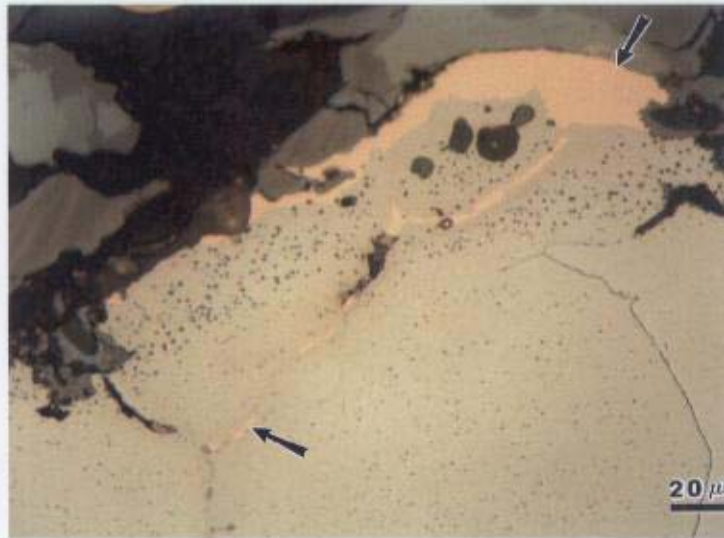
FIGURE 10 Example of the attacked surface of the HSLA column (not etched) showing copper at the steel-scale interface and in the grain boundaries with substantial sub-surface oxide/sulfide precipitation.

The microstructure of a severely eroded column section from either WTC 1 or 2 was examined using a similar approach to that used to characterize the A36 steel beam from WTC 7. The microstructure of this HSLA steel revealed corrosion reactions similar to those observed in the WTC 7 steel. However, there were substantial differences due to the lower carbon content and the copper alloy additions. A typical microstructure of the near surface damage is presented in Fig. 10. High temperature sulfidation and oxidation occurred with substantial grain boundary sulfidation under a well-bonded scale. The scale that formed on the steel was nearly continuous and contained a mixture of iron oxide, iron sulfide, and copper sulfide. The morphology of this mixture, while significantly different from that observed on the A36 steel, experienced a similar hot-corrosive attack. A gradient in sulfur penetration of the oxide scale from the atmosphere inward was observed along with the dissolution of the iron oxide into a semisolid mixture.

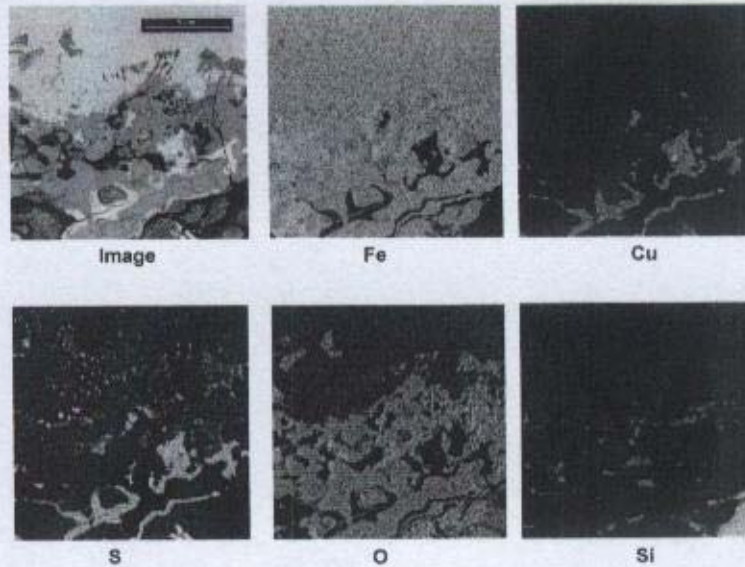
A digital x-ray map of the distribution of major elements through the scale and into the steel is shown in Fig. 11. Sulfur penetration into the oxide scale reacts to form iron sulfide and copper sulfide and a fluxing reaction occurs resulting in sulfur penetration into the steel forming predominantly manganese sulfides in many of the prior ferritic grain boundaries on cooling. It is much more difficult to detect liquid formation in these boundaries prior to cooling

FIGURE 11 SEM image and x-ray elemental scans for Fe, Cu, S, O and Si at the affected surface of the HSLA column.

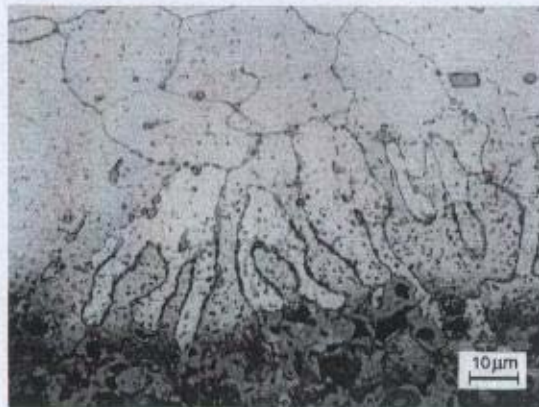
and the additions of copper and silicon complicate the formation of a simple eutectic product. However, the etching response at the grain boundaries of the steel and the formation of a columnar-grained geometry, suggests a thin film liquid corrosive penetration into the boundaries as shown in Fig. 12. More research is necessary to clarify the sulfidation reactions that occur in this HSLA steel.

FIGURE 12 Example of grain-boundary decoration by the eutectic attack in the HSLA column material (nital etch).

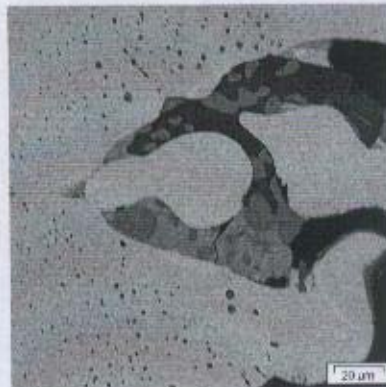
The results of a laboratory heating experiment at 1100 °C for 12 hours where an iron sulfide (FeS) powder was placed on ground and cleaned A36 steel surface prior to heating is presented in Fig.13. The microstructure that developed showed oxidation, sulfidation and eutectic liquid reactions that are quite similar to the microstructure that formed on the WTC 7 steel in the fire. This similarity suggests that when an iron sulfide phase forms on or with the oxide, intergranular attack by a liquid containing Fe, S, and O will occur if the temperature is sufficiently high.

Internal sulfidation and oxidation is also observed in Fig.13. The “dark spots” in the microstructure were found by EDS analysis to contain Mn and S, as well as Si and O. The inward concentration gradient of particles beneath the steel surface indicates a diffusion controlled internal reaction is occurring in this steel. Again, this is similar to the reactions observed in the WTC 7 steel beam. A thermodynamic analysis of the Fe-S-O system with additions of Mn, Si, and Cu is currently underway to determine the conditions that would form these sulfidation and oxidation products.

FIGURE 13 Example of eutectic attack and internal oxidation/sulfidation in the HSLA column material at the surface.
