The National Institute of Standards and Technology was tasked with the investigation to determine how the WTC 7 building collapsed to the ground on Sept. 11, 2001 in New York City. Their final report on this issue was released in November 2008. At that time the structural, erection, and shop fabrication drawings for the steel frame of the building were not publicly released, and thus those interested in the structural details of the building were not able to review them and determine the plausibility of the fire induced progressive collapse explanation given in NIST report.

The NIST WTC 7 report claims the initiating event was that a critical girder (girder A2001) in the northeast corner of the building under the 13<sup>th</sup> floor was either pushed or rocked off its seats at exterior column 44 and corner core column 79 by thermally expanding beams framing into it from the east as shown in Figure 1.

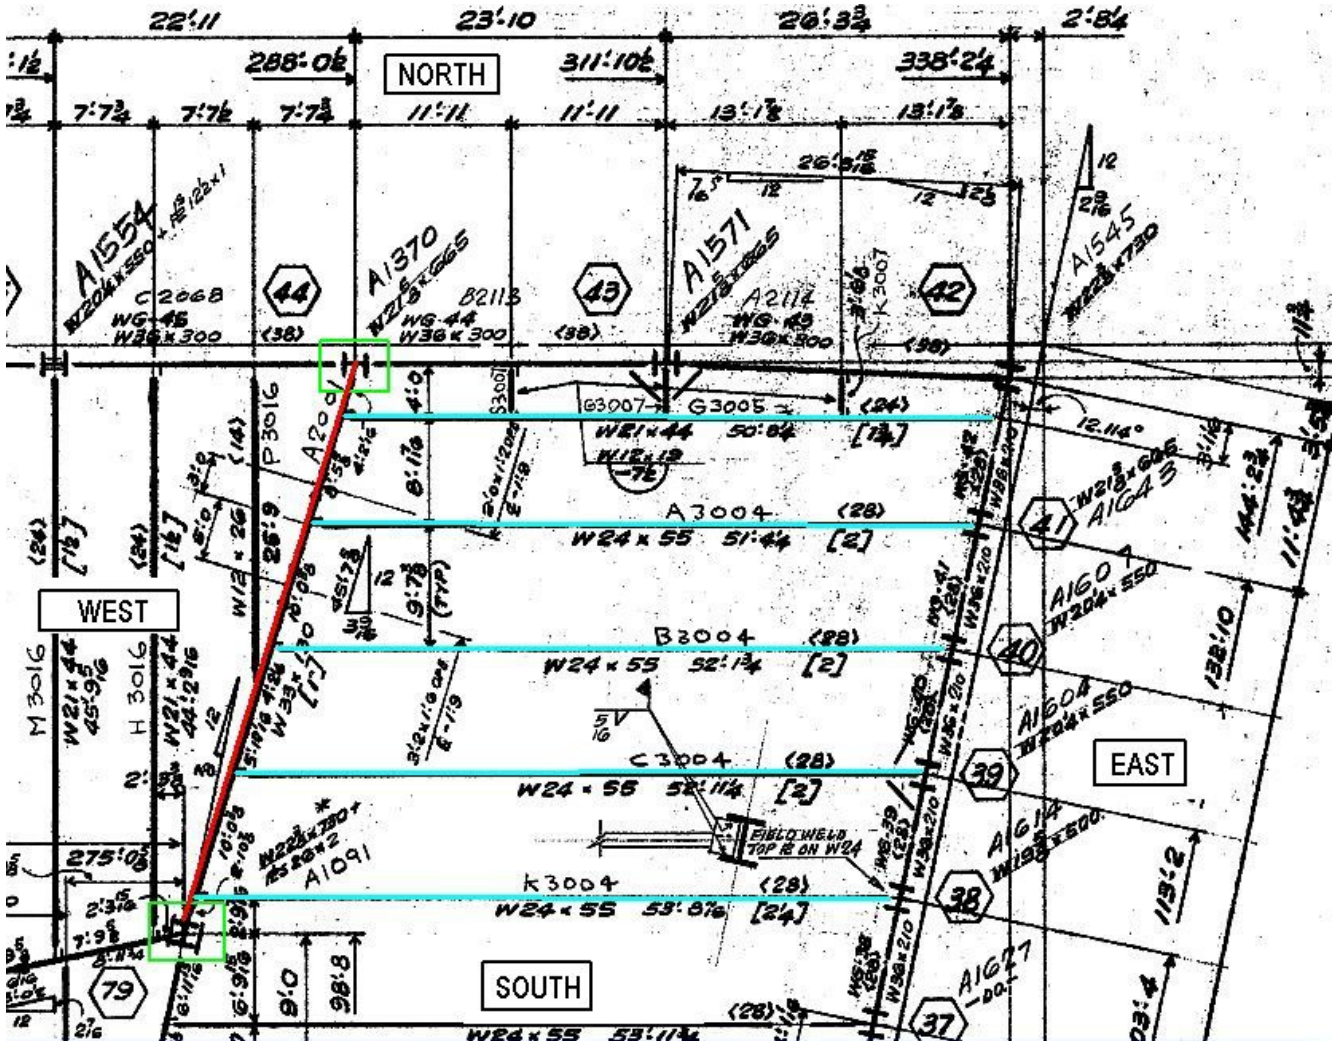
Figure 1: Framing of the northeast corner of the 13<sup>th</sup> floor of WTC 7 as shown on Frankel drawing #E12/13 with the critical girder (A2001) highlighted in red and the five beams framing into it from the east (K3004, C3004, B3004, A3004, and G3005) highlighted in blue. Columns 44 and 79, which support the girder, are outlined in green.

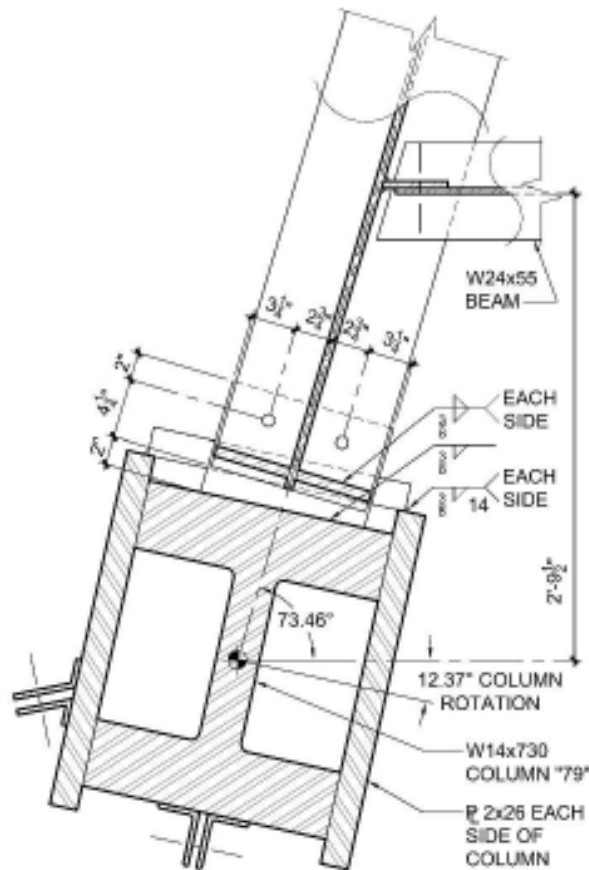
However, when calculated from the provided geometry and details of the girder and seat shown in Frankel drawings #1091 and 9114 the axial bearing length of the girder on the seat is seen to be 6.25 inches as shown in Figure 3 below.

**Figure 3: Plan View at Floor 13, Column 79 Seated Connection of Girder A2001.  
(Data from Frankel Steel Limited, 1985b)**

So it is unclear how the 5.5 inch axial travel distance for walk-off was determined as it is not related to bearing length. If it is due to when the seat would fail it needs to be stated.

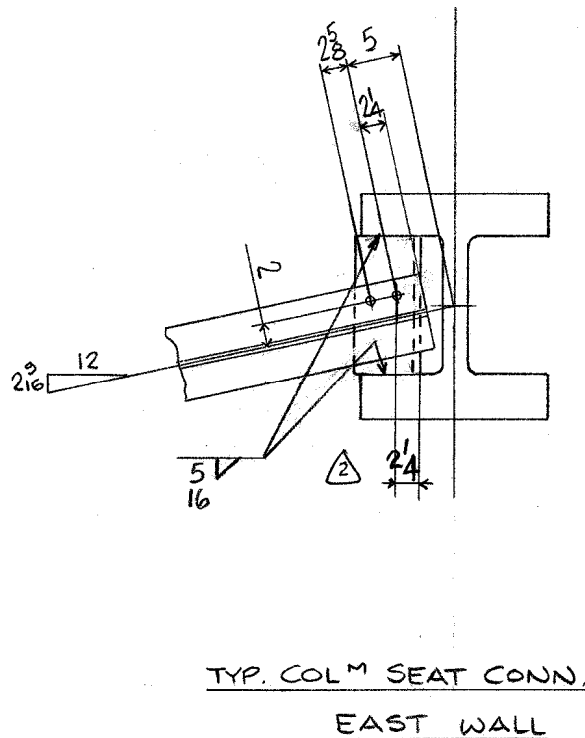
The above also assumes that all of the expansion was directed westwards, and that the four bolts of the beam connections to the columns at the east side exterior would withstand the breaking of the 28 shear studs on the beams. The beam to exterior column connections also contained clearance between the beam and the columns as shown in Figure 4, so if the bolts broke there would be at least an inch of movement to the east. This is not discussed in the NIST WTC 7 report.

**Figure 4: Plan View of east side exterior beam to column connections from Frankel drawing #9101.**

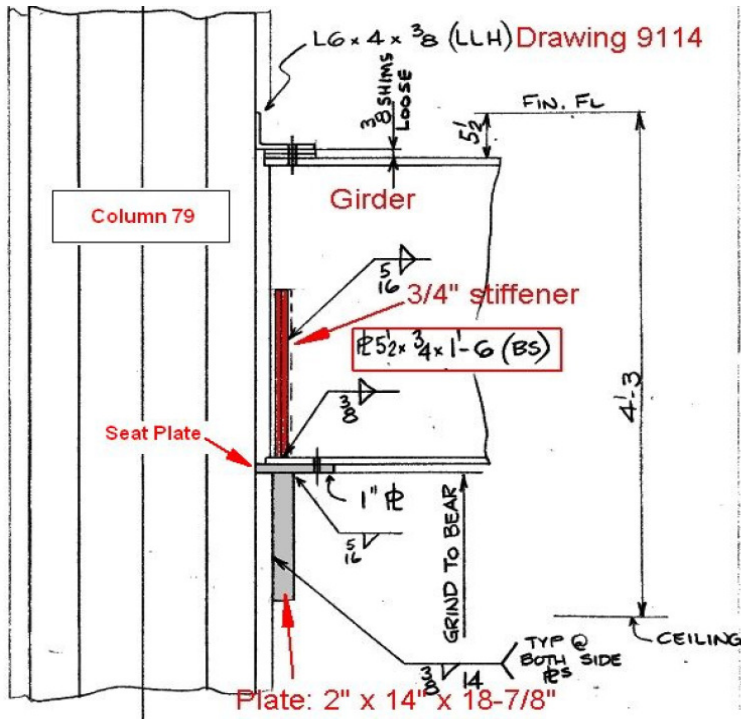
Although the shop fabrication drawing for girder A2001 has not yet been released, the stiffeners at the column 79 end of the girder are clearly shown on Frankel drawing #9114 as seen in Figure 5 below.

Figure 5: Side View of Column 79 Seated Connection of Girder A2001 on Frankel Drawing #9114.

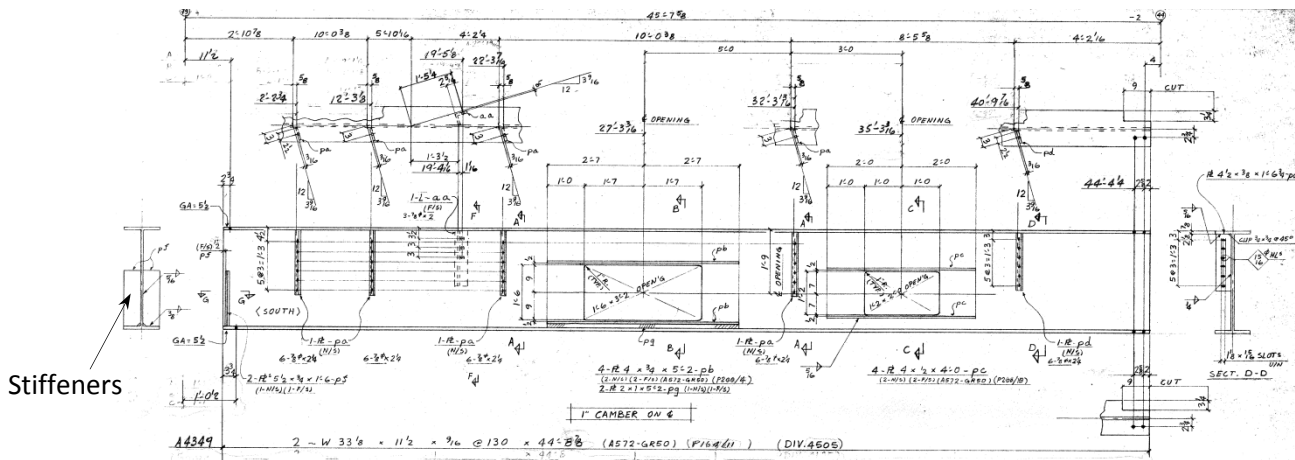
Another WTC 7 girder is shown in Figure 6 to give an illustration of a typical stiffener configuration at the end of many of the girders, which review of the drawings shows was apparently used on girders where the connection design used a narrow support plate under the seat, such as that used under the column 79 girder seat and labeled as plate “pg” on Frankel drawing #1091.

Figure 6: Typical stiffeners used on girder ends with narrow support plates under girder seat.

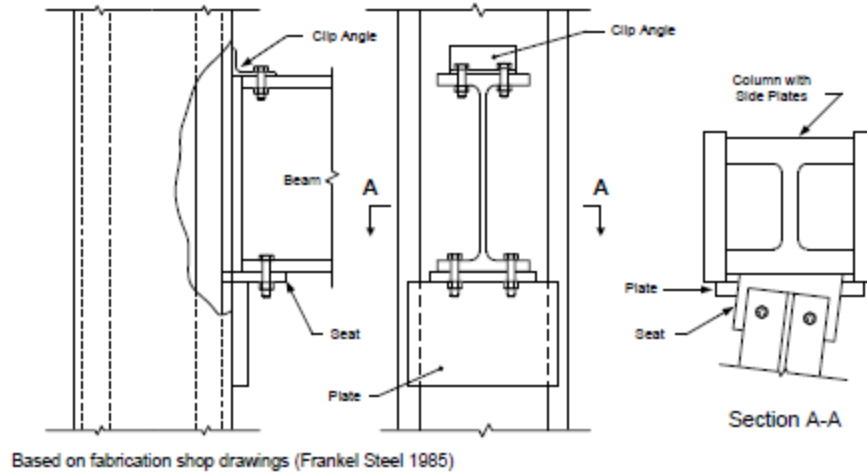
Figure 8-21. Seat connection at Column 79.

Figures 7 and 8 show how the girder was depicted without stiffeners in the NIST WTC 7 report and that the stiffeners were not included in the analysis model of the connection used to support the conclusions of the report.

Figure 7: Typical depiction of the girder end at column 79 in the NIST WTC 7 report.

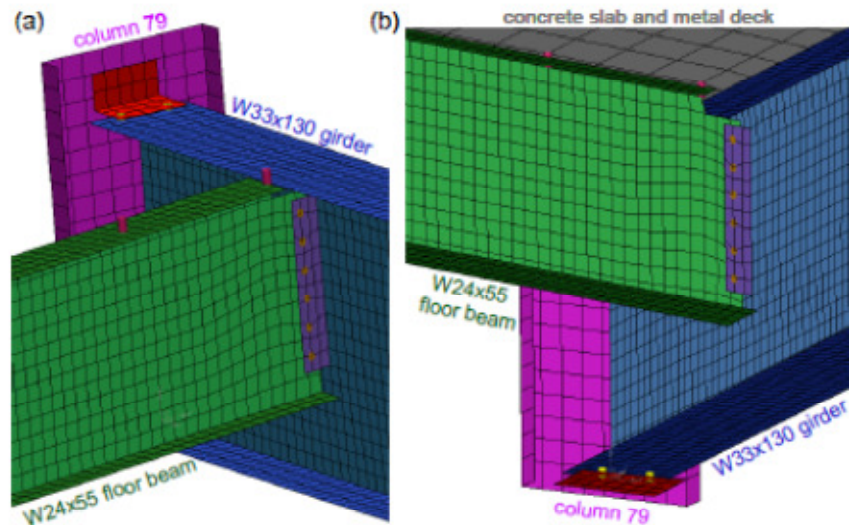
Figure 8-23. Views from northeast showing seat connection at column 79 and bolted shear plate connection of floor beam to girder

Figure 8: Analysis model provided in the NIST WTC 7 report showing the girder connection at column 79.

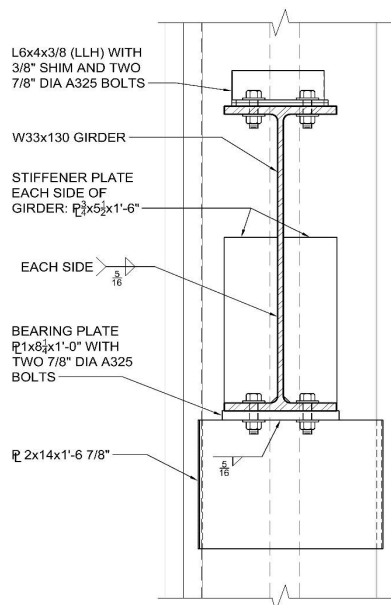
Figure 9: The A2001 girder connection at column 79 with the girder stiffeners depicted as they should have been in the NIST WTC 7 report per Frankel drawing #9114.

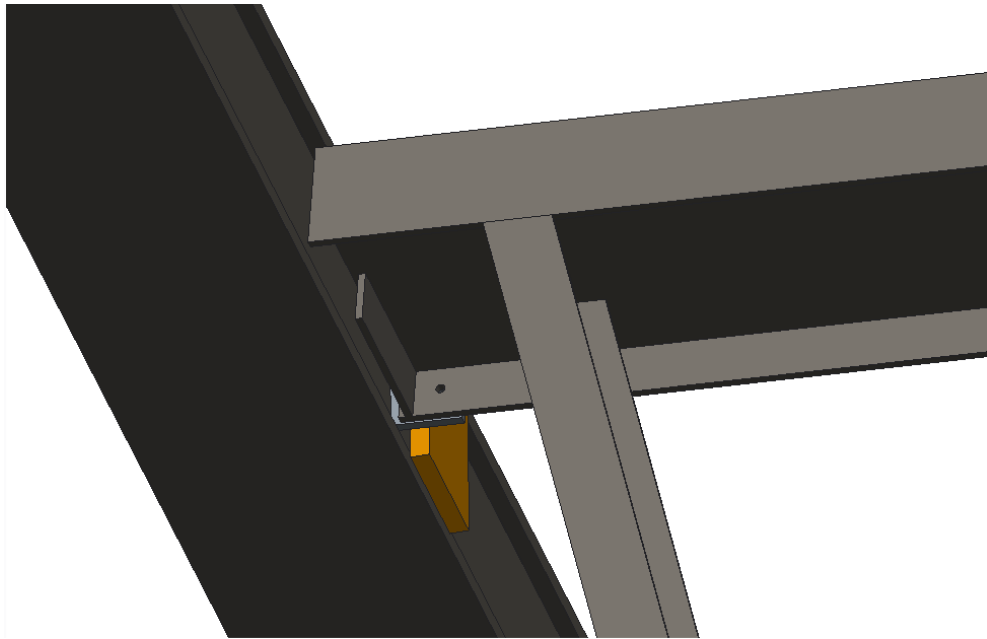
**Figure 10: Model showing how the Column 79 seated connection of girder A2001, as shown on Frankel drawing #9114, would actually appear.**

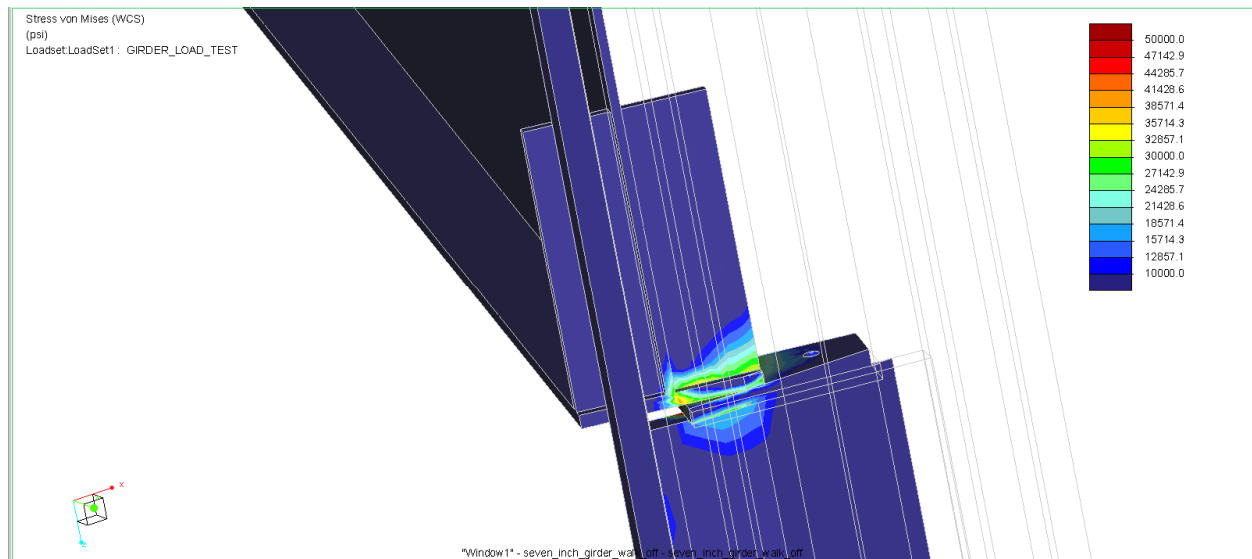
The stiffeners would have done more than simply prevent web crippling as they also strengthen and stiffen the flange. Figure 11 shows the results of an analysis with the girder web beyond the seat with stiffeners included. The stress on the flange and stiffeners is well below yield strength showing the stiffeners would prevent failure of the flange of the girder even if the web was pushed beyond the 12 inch wide seat. In reality, the centered girder web could not move beyond the edge of the 12 inch long seat due to the 5.5 inch beam expansion maximum.

**Figure 11: Analysis showing the girder flange does not fail when the girder web is beyond the seat with stiffeners installed. The above is with 6.75 inches of beam expansion.**

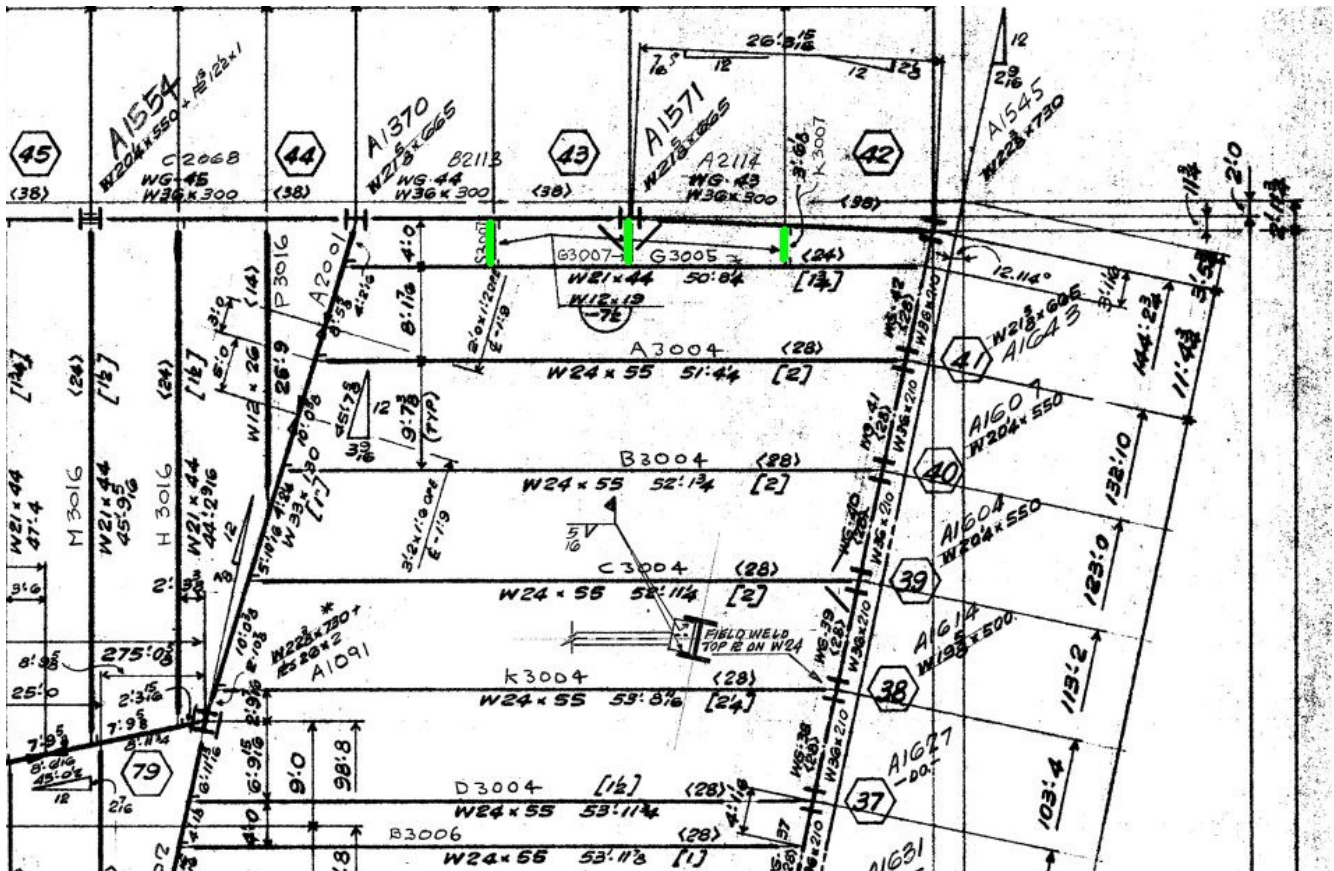
The omission of the lateral support beams from the exterior frame to beam G3005 has not yet been acknowledged, although the question concerning them was also asked in the FOIA letter to the NIST dated March 19, 2012. They can be seen in Frankel drawing #E12/13 as shown in a blow up from that drawing of the northeast corner at floor 13 in Figure 12 below.

Figure 12: Three W12 x 19 lateral support beams labeled S3007, G3007, and K3007 framing into beam G3005 are shown on Frankel drawing #E12/13 (the three beams are highlighted in green here).

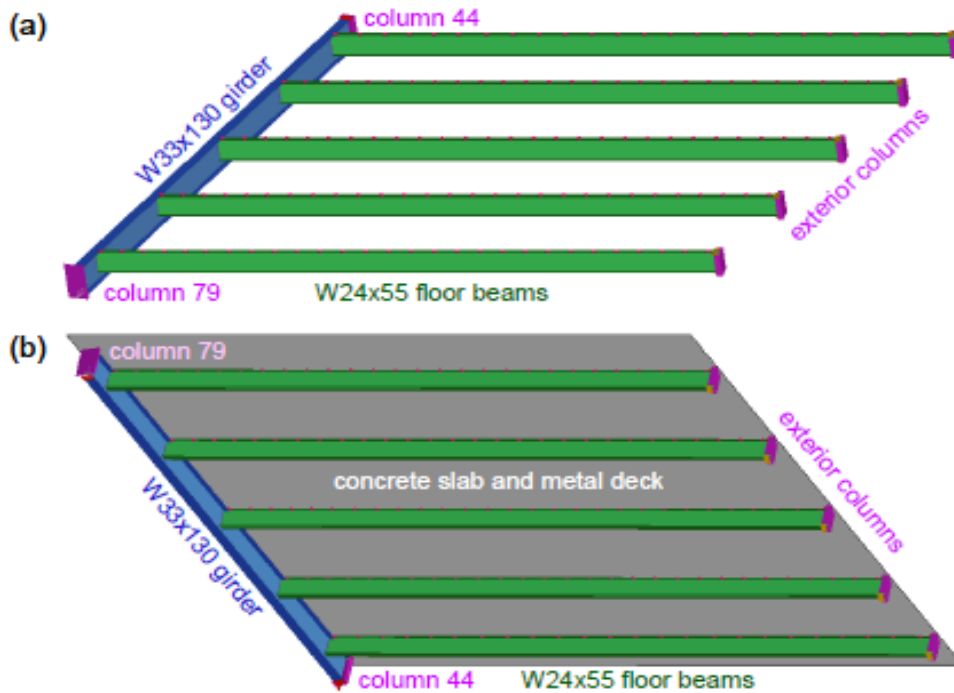
Figure 8-22. Finite element model of northeast corner as viewed from the southeast (a) Top view, with deck removed; (b) bottom view.

Figures 13 and 14 show the elements used in a second NIST analysis of the five floor beams and girder where beam G3005 is said to buckle due to its thermal expansion being restrained by girder A2001, to then lose its load carrying capacity, and subsequently cause the other four beams to buckle which then rocked the girder off its seats. While buckling of this beam, due to restraint from thermal expansion, is possible without the three lateral support beams framing into it, it is not possible when they are included. The lateral support beams drastically reduce the beam's slenderness and cause the required buckling force to be approximately 16 times greater than it is without them. The models from the NIST analyses do not include the lateral support beams.

Figure 13: Figure from the NIST WTC 7 report does not include the lateral support beams framing into beam G3005 from the exterior as shown on Frankel drawing #E12/13.

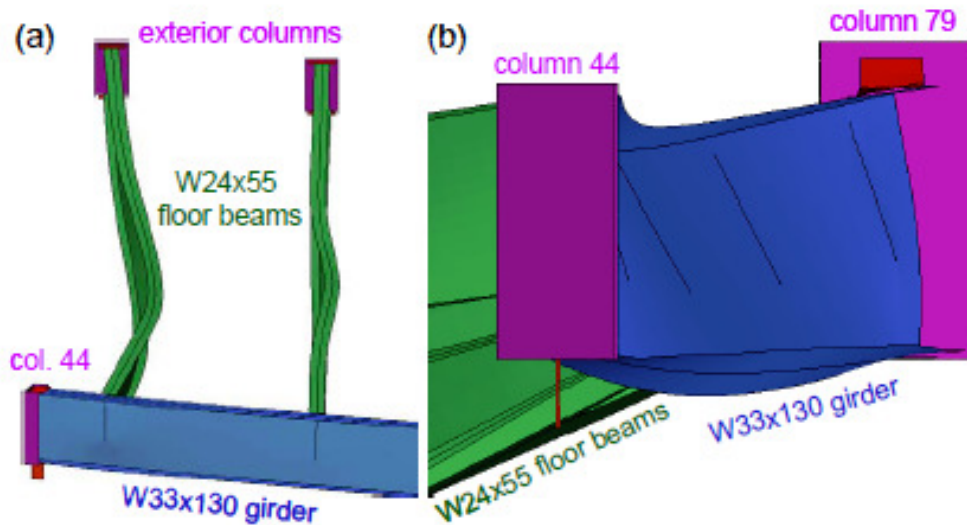
Figure 8-27. Buckled floor beams shown from above (a) and along girder (b).

Figure 14: Figure from the NIST WTC 7 report showing buckling of beam G3005 does not include the lateral support beams framing into it from the exterior as shown on Frankel drawing #E12/13.

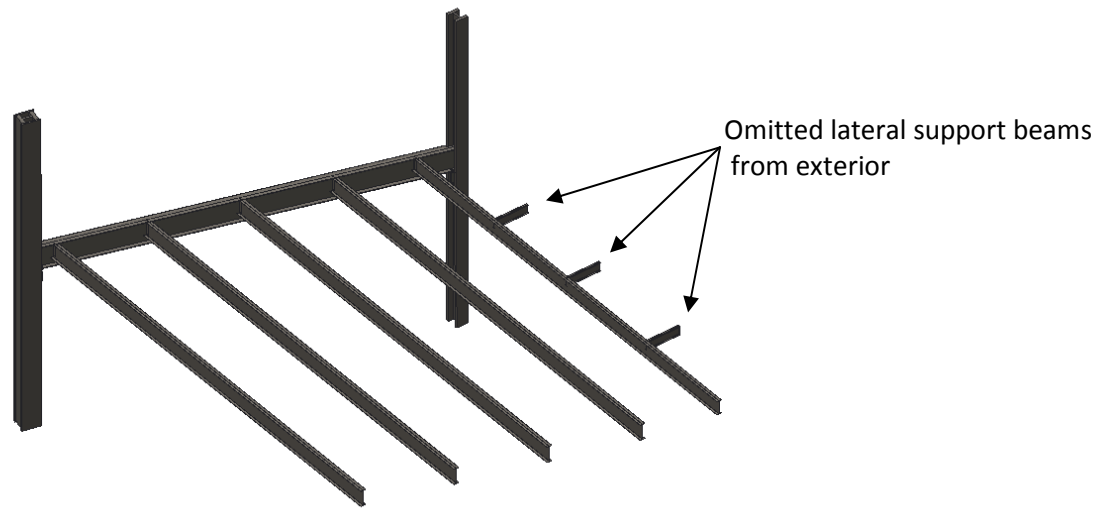
**Figure 15: Model showing the omitted lateral support beams framing into beam G3005 from the exterior as shown on Frankel drawing #E12/13.**

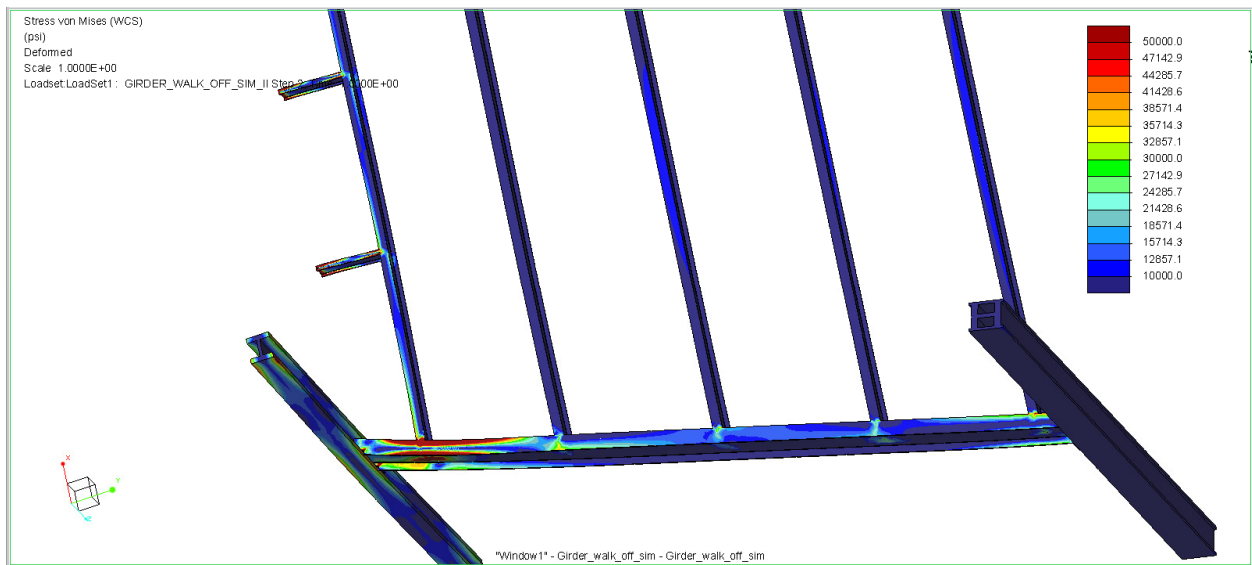
Figure 16 shows the results of an analysis performed with the lateral support beams included. They show beam G3005 does not buckle when the three lateral support beams are included. This is due to the beam's slenderness being drastically reduced by having the lateral support and requiring approximately 16 times more axial compression to cause buckling. With the lateral support beams included the axial stiffness of beam G3005 is significantly greater than the girder's lateral stiffness and thus when the beam was thermally expanded it would have simply deflected the girder.

**Figure 16: Analysis results showing beam G3005 when it is thermally expanded at 600 °C temperatures and girder A2001 heated to 500 °C temperatures per the NIST WTC 7 report.**
