**NIST NCSTAR 1**

# **Final Report** on the **Collapse of** **the World Trade Center Towers**

**NIST**

September 2005

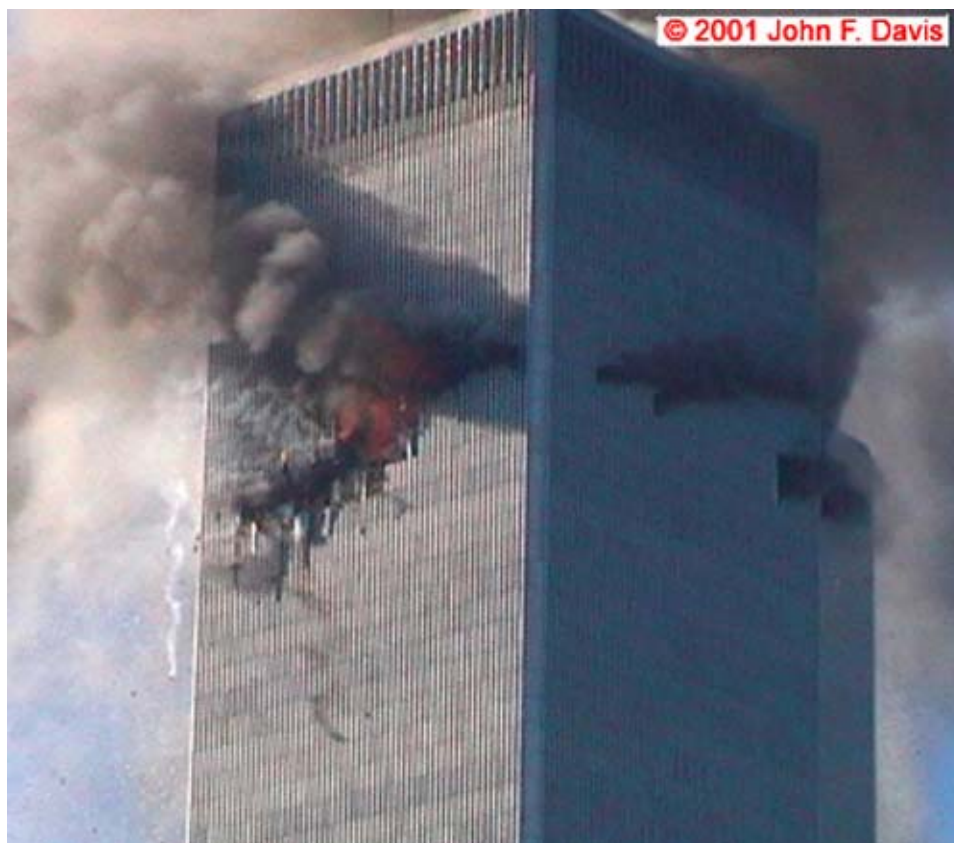
**Figure 2–2. Aircraft entry hole on the north side of WTC 1, photographed 30 s after impact.**

The aircraft did the most damage to the 95<sup>th</sup> and 96<sup>th</sup> floors. The fuel-heavy inner left wing hit the 95<sup>th</sup> floor slab, breaking it over the full 60 ft depth of tenant space and another 20 ft into the building core. The fuselage was centered on the 96<sup>th</sup> floor slab and filled the 95<sup>th</sup> and 96<sup>th</sup> floors top to bottom. The severity of the impact was clear. A wheel from the left wing landing gear flew through multiple partitions, through the core of the building, and became embedded in one of the exterior column panels on the south side of the tower. The impact severed the bolts connecting the panel to its neighbors, and the panel and tire landed on Cedar Street, some 700 ft to the south. A second wheel landed 700 ft further south. Within the two floors, 15 to 18 perimeter columns and five to six core columns were severed, and an additional one to three core columns were heavily damaged. A 40 ft width of the 96<sup>th</sup> floor slab was broken 80 ft into the building. The insulation was knocked off nearly all the core columns and over a 40 ft width of floor trusses from the south end of the core to the south face of the tower.

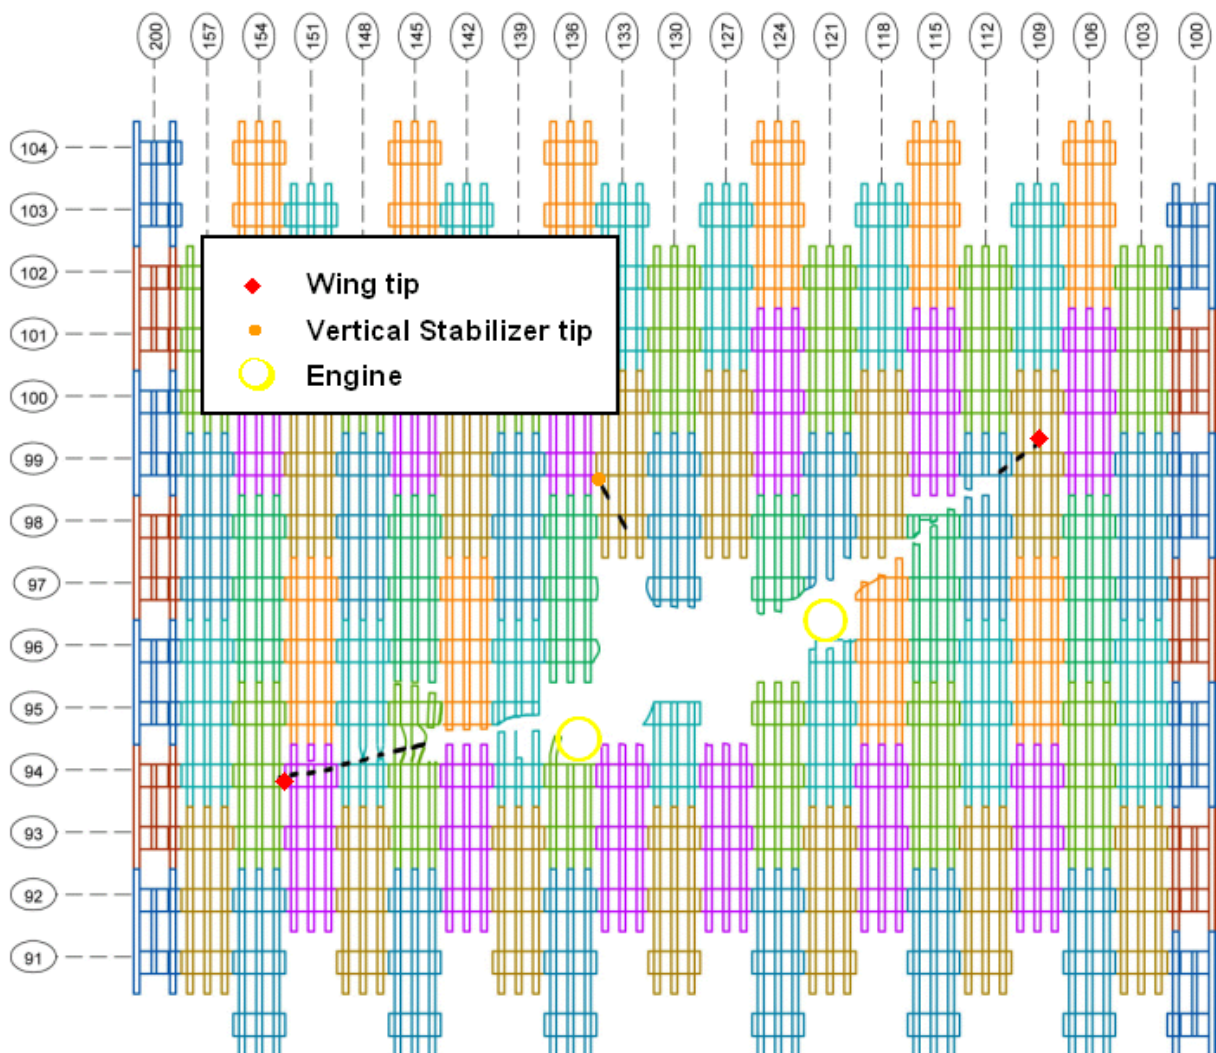
**Figure 2–3. South face damage of WTC 1 with key aircraft component locations marked.**

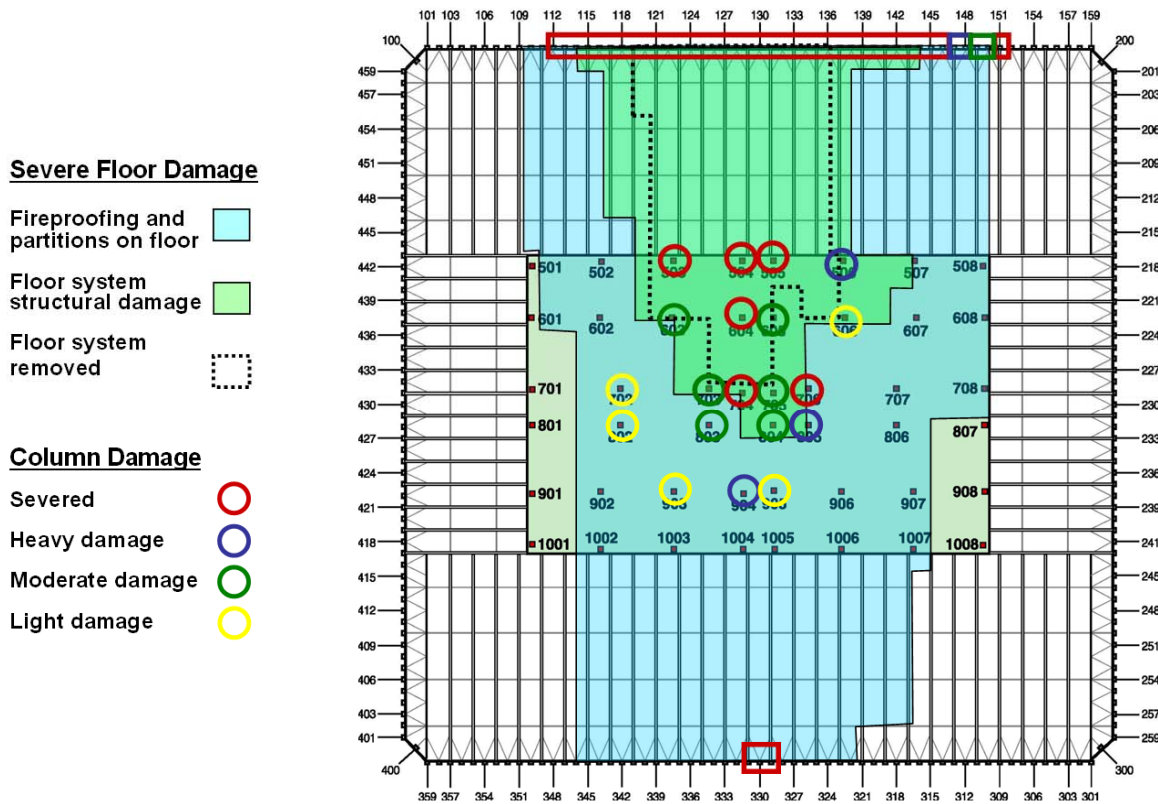
- 43 of 47 core columns stripped of insulation on one or more floors.
- Insulation stripped from trusses covering 60,000 ft<sup>2</sup> of floor area.

**Figure 2-4. Simulation of cumulative aircraft impact damage to floors 93 through 98 in WTC 1.**

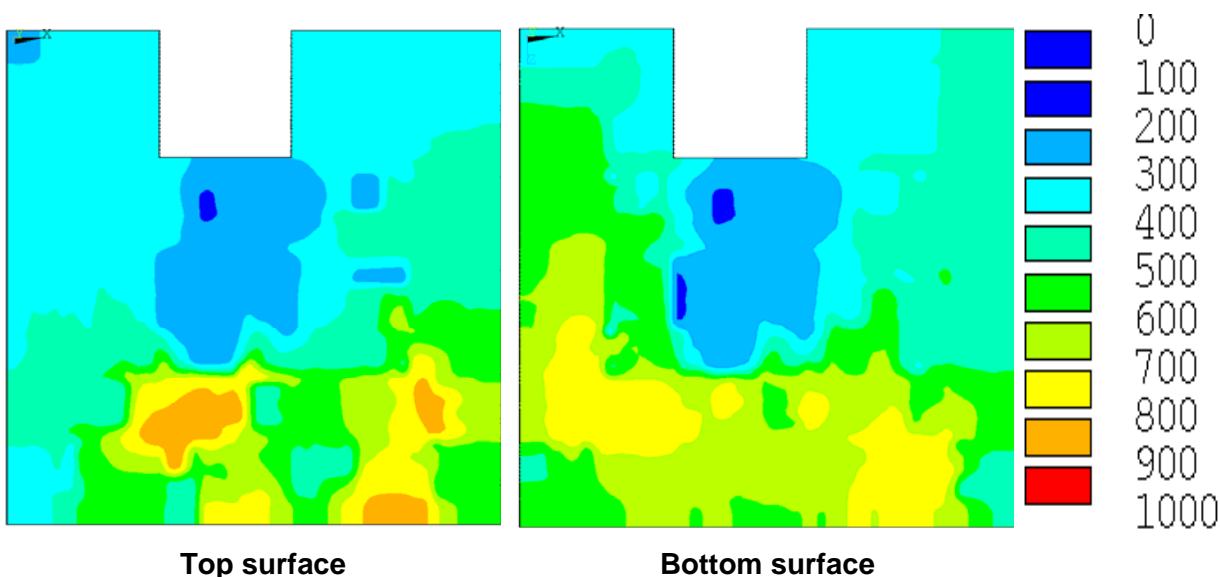
Simultaneously, the fires were creating another problem for the tower. The floors of the 93<sup>rd</sup> through the 97<sup>th</sup> stories were being heated both by the hot gases from below and by thermal radiation from the fires on the floor above (Figure 2–11). On the south side of the building, where the fires were heating the long-span trusses whose SFRM had been dislodged, the floors began to sag. In so doing, they began pulling inward on their connections to the south face and to the core columns. Pull-in forces due to the sagging floors did not fail the floor connections in most areas.

**Figure 2–11. Temperature contours (°C) on the top and bottom faces of the concrete slab (96<sup>th</sup> floor, WTC 1) at 100 min after impact. A portion of the concrete slab on the north face (top) was damaged by the impact of the aircraft.**

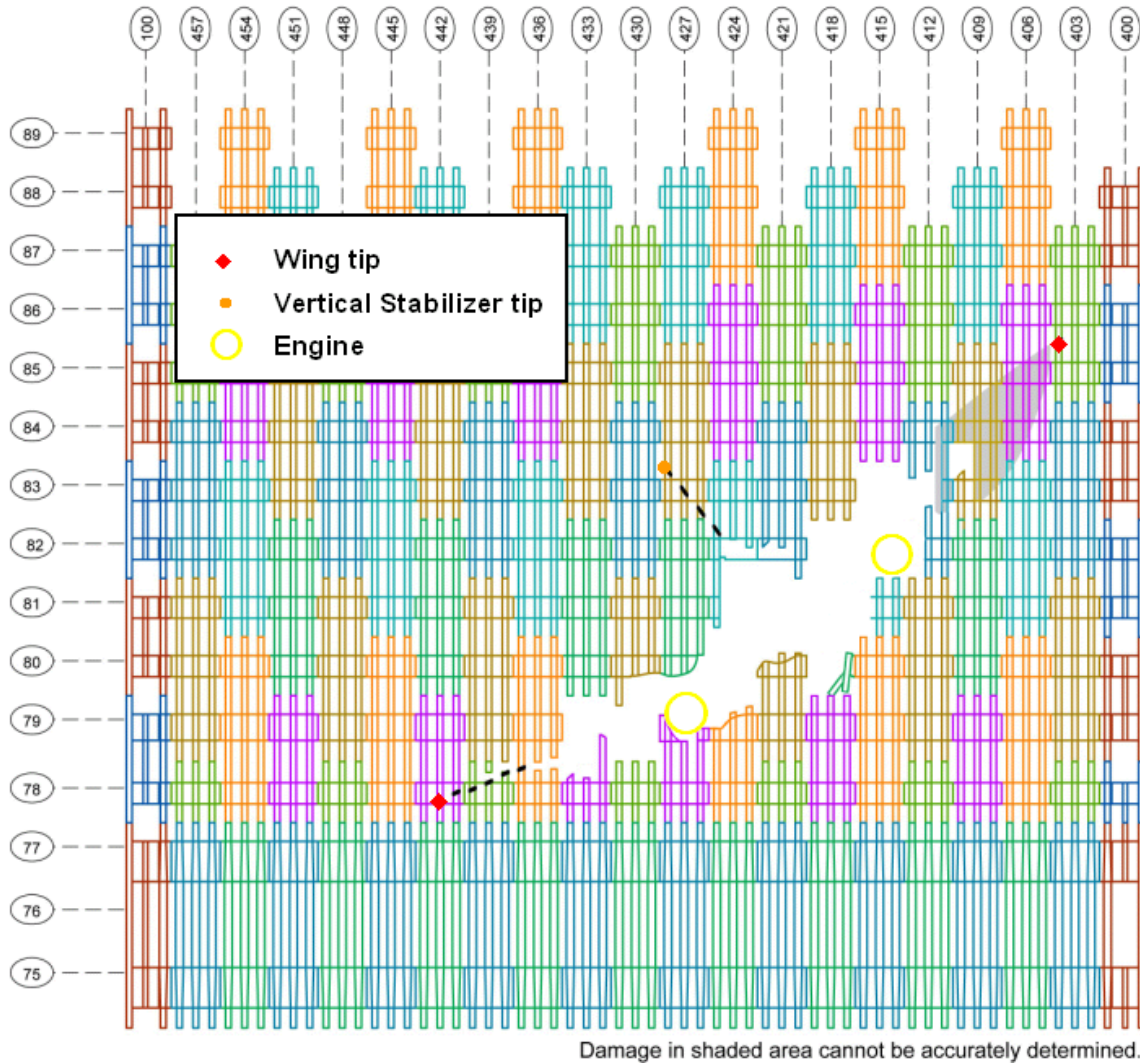
bank angle was steeper than that of AA Flight 11, this entry wound stretched over nine floors, from 77 to 85, rather than eight in WTC 1 (Figure 3–2). The occupancy of those floors is shown in Table 3–1.

Figure 3–2. South face damage of WTC 2 with key aircraft component locations marked.

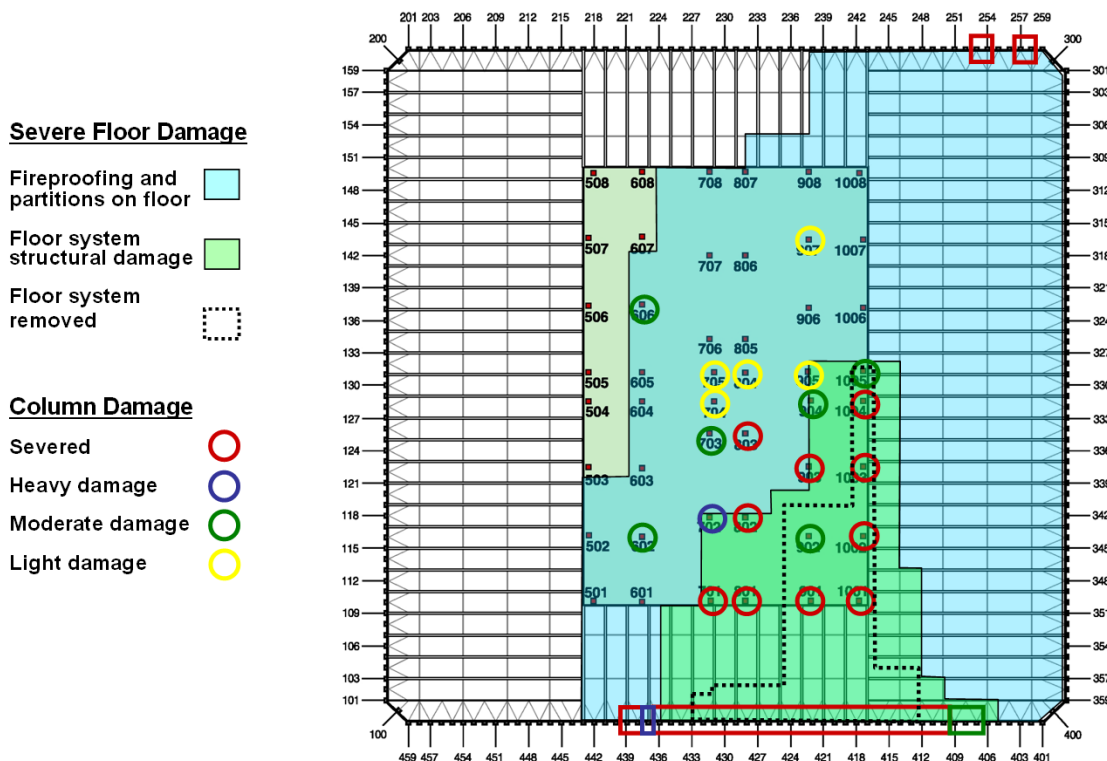
and aluminum sheet of the wing did little damage to the building structure or the SFRM on the columns and trusses on these floors. There were 433 broken windows on the north, east, and south facades.

**Figure 3–3. Simulation of aircraft impact damage to the 78<sup>th</sup> through 83<sup>rd</sup> floors in WTC 2.**

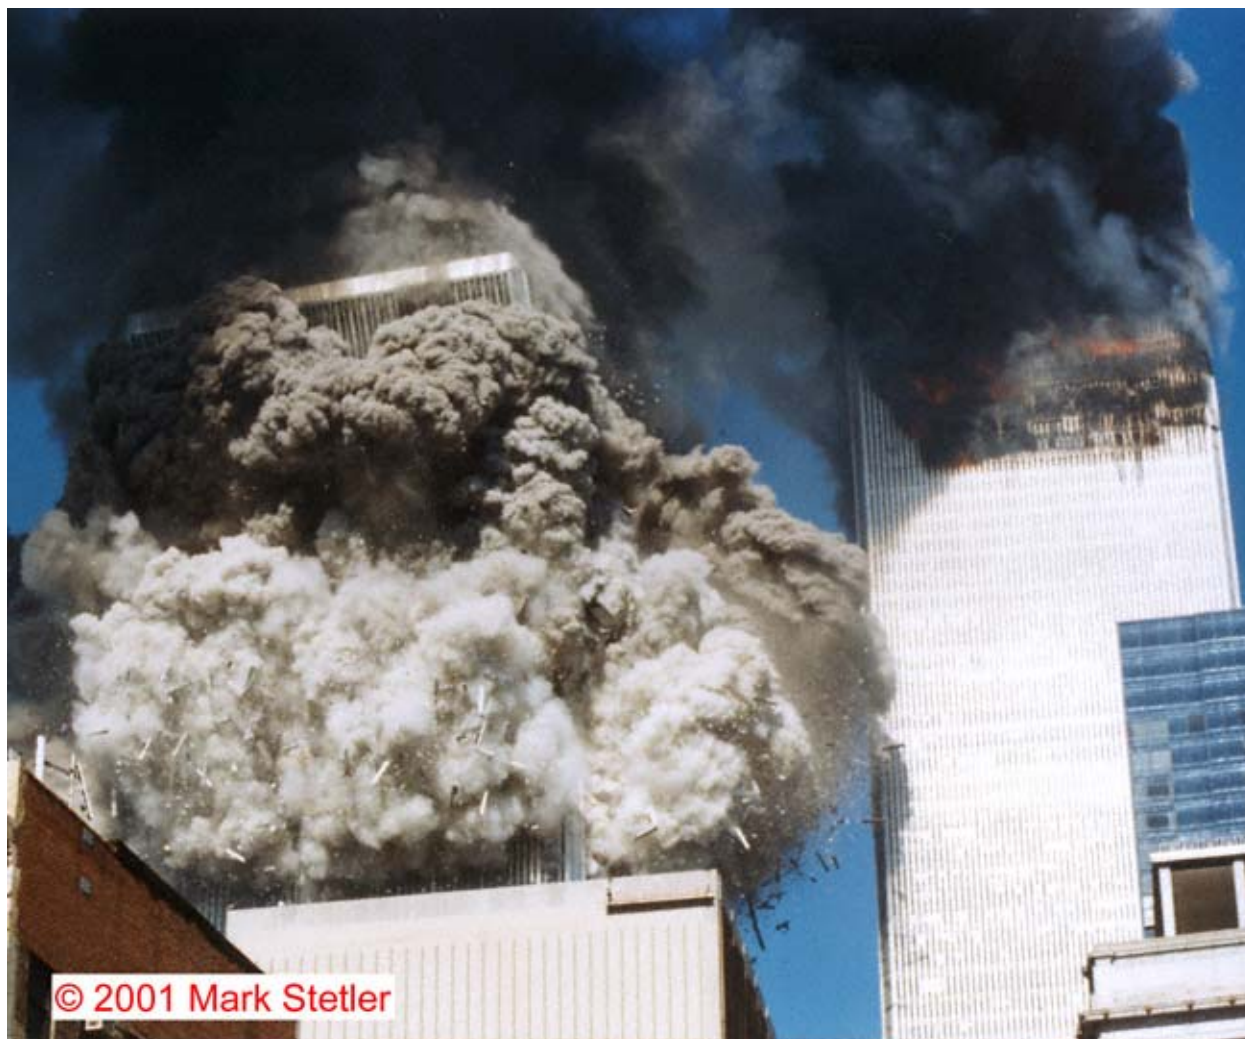
The physical condition of the tower had deteriorated seriously. The inward bowing of columns on the east wall spread along the east face. The east wall lost its ability to support gravity loads, and, consequently, redistributed the loads to the weakened core through the hat truss and to the adjacent north and south walls through the spandrels. But the loads could not be supported by the weakened structure, and the entire section of the building above the impact zone began tilting as a rigid block to the east and south (Figure 3–5). Column failure continued from the east wall around the corners to the north and south faces. The top of the building continued to tilt to the east and south, as, at 9:58:59 a.m., WTC 2 began to collapse.

**Figure 3–5. Photograph of WTC 2 tilting to the southeast at the onset of collapse.**

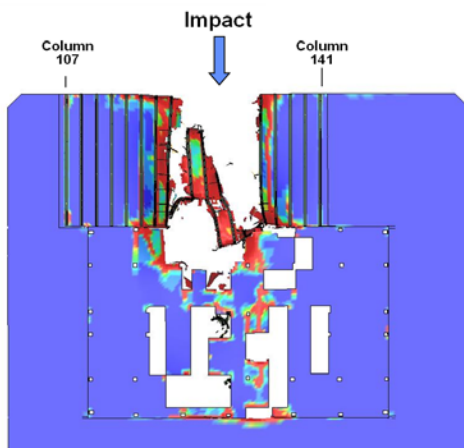
Figure 6–20. Case B damage to the slab of floor 96 of WTC 1.

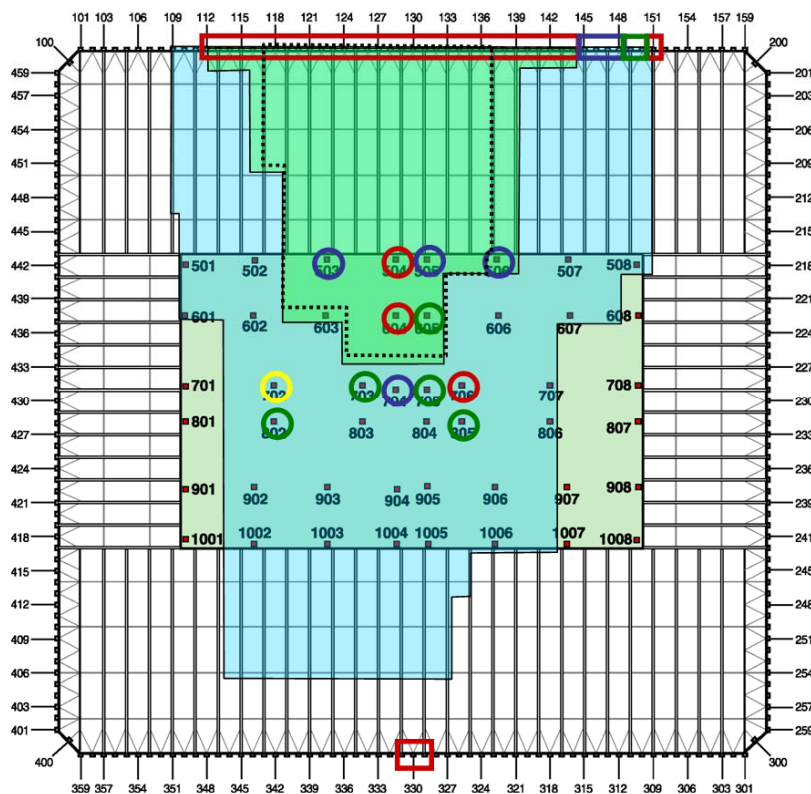
Figure 6–22. Combined structural damage to the floors and columns of WTC 1, Case A.

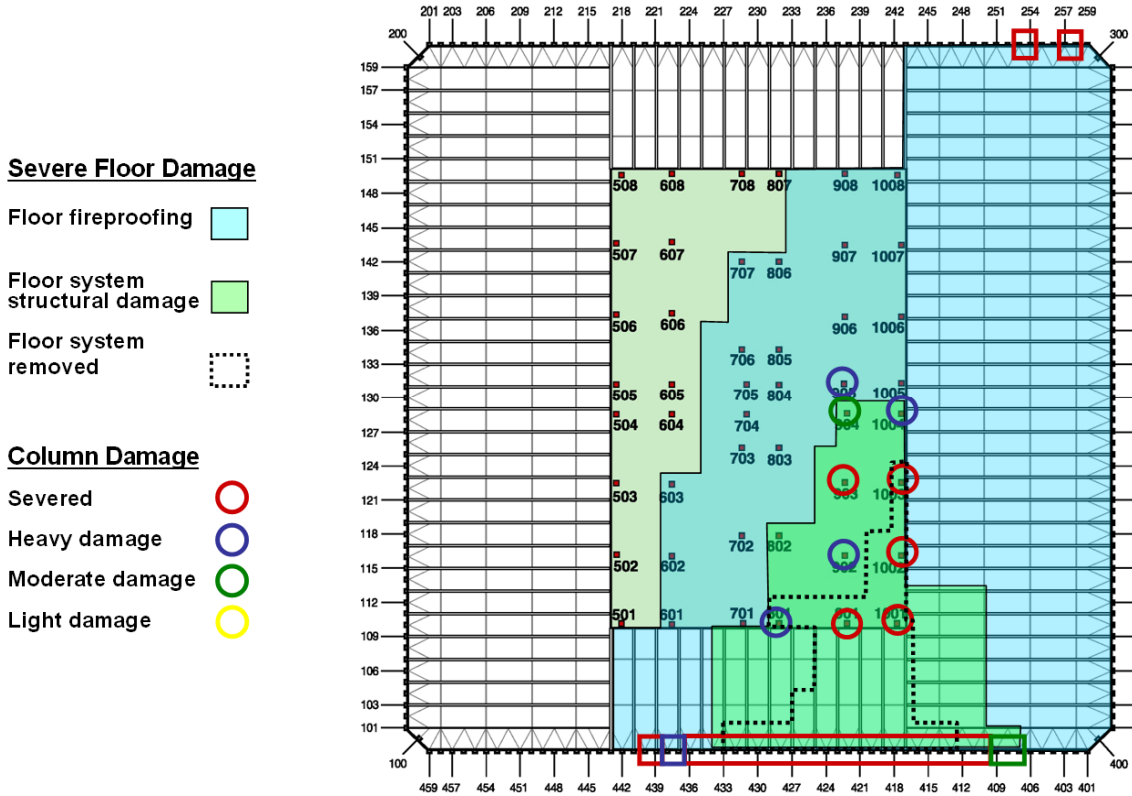
Figure 6-24. Combined structural damage to the floors and columns of WTC 2, Case C.

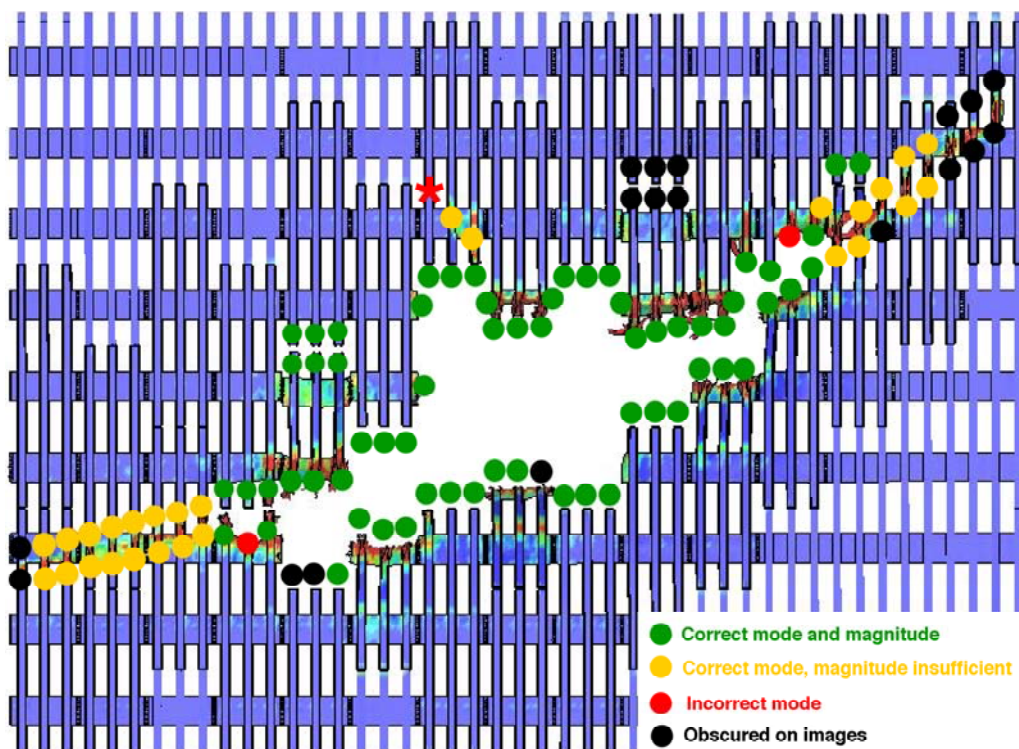
Figure 6–27. Schematic of observed damage (top) and Case A calculated damage (lower) to the north face of WTC 1.

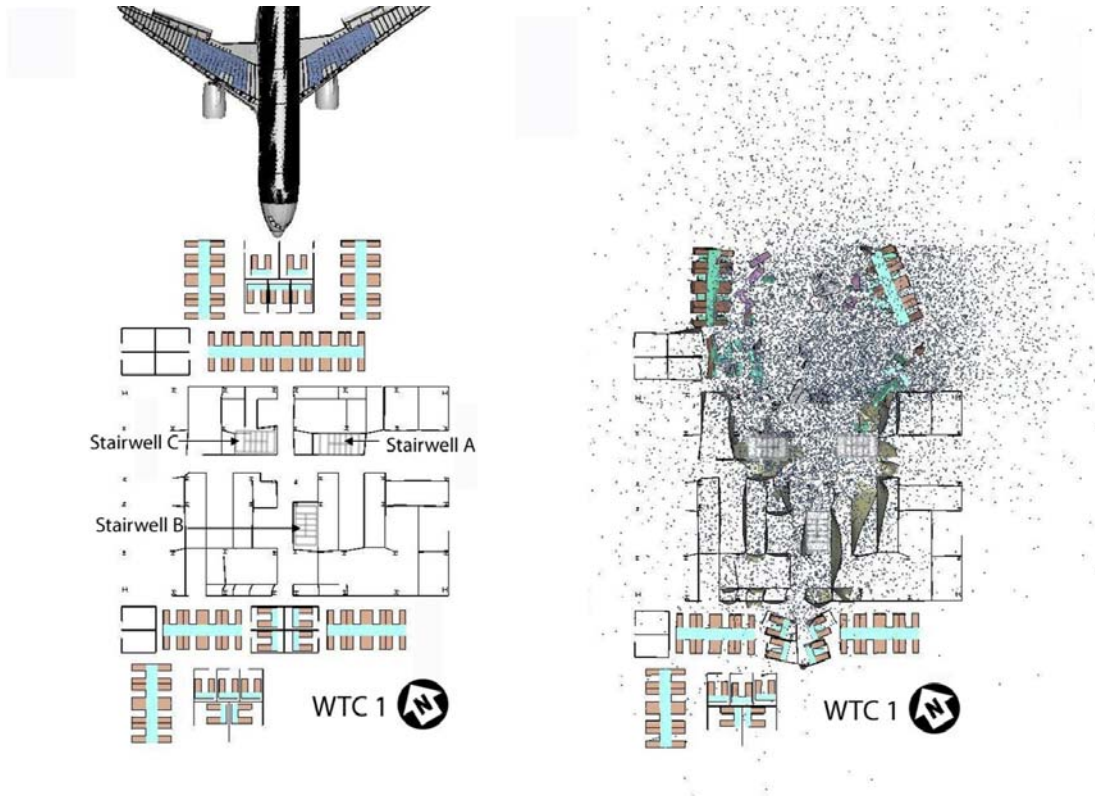
**Figure 7-1. Simulated impact damage to 95<sup>th</sup> floor of WTC 1, including stairwells, 0.7 s after impact.**

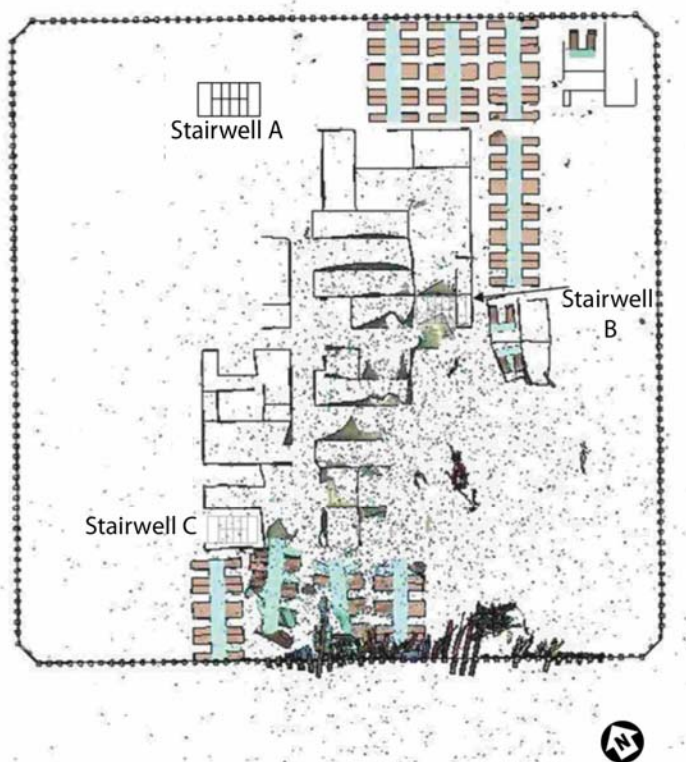
**Figure 7-2. Simulated impact damage to WTC 2 on floor 78, 0.62 s after impact.**

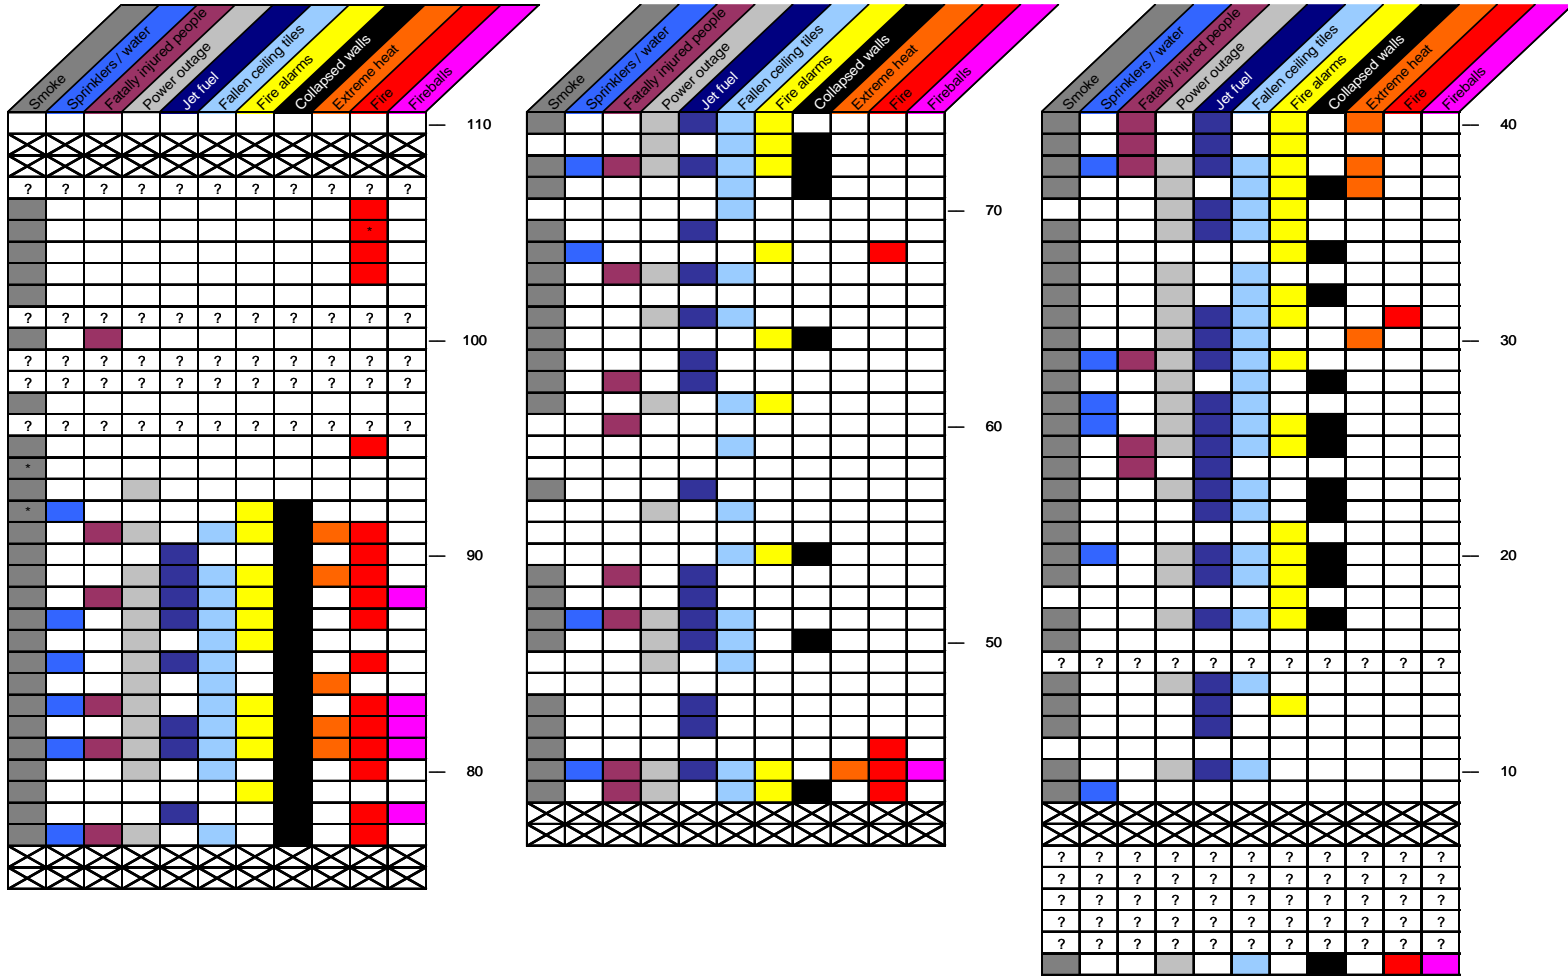
Figure 7-3. Observations of building damage after initial awareness but before beginning evacuation in WTC 1.

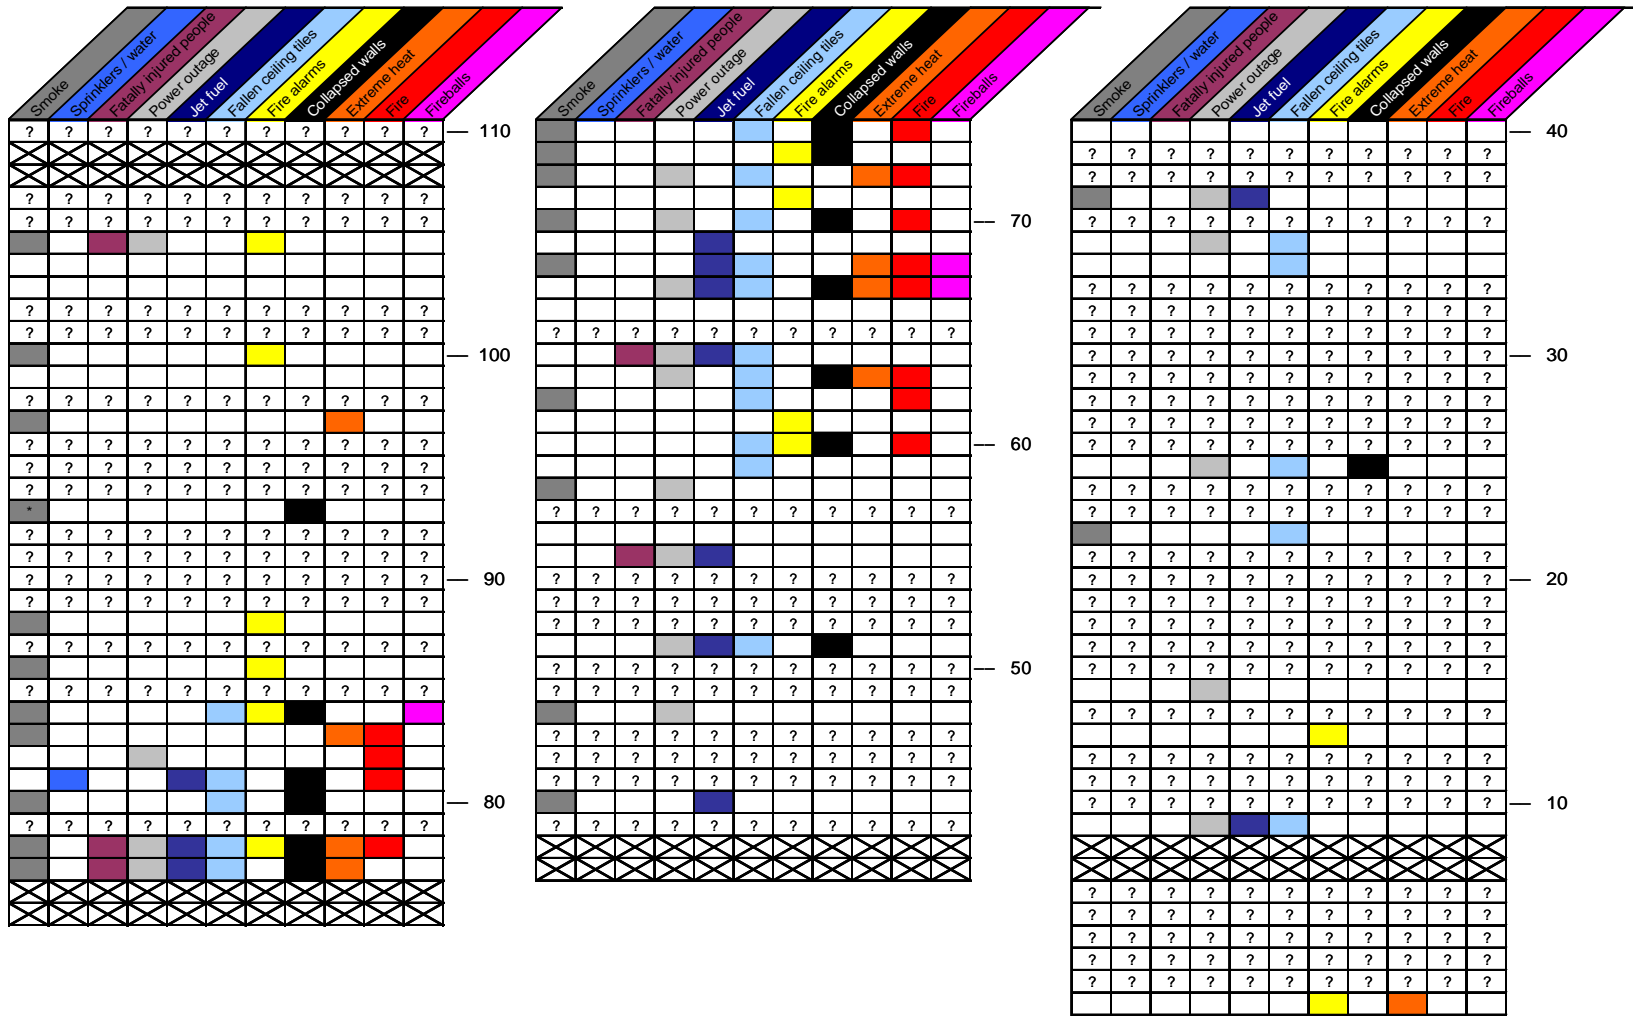
Figure 7-4. Observations of building damage from tenant spaces in WTC 2.
