# **Aircraft Impact Damage**

## **Abstract**

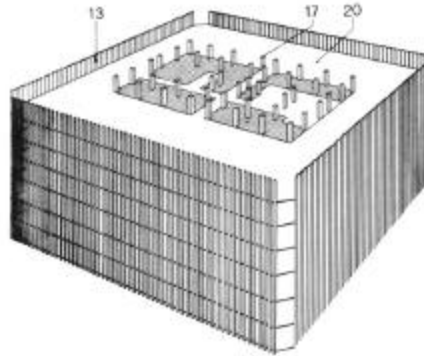
Figure 1. Double hollow tubes structures of the World Trade Center showing exterior columns (13), floors (20) and core columns (17)

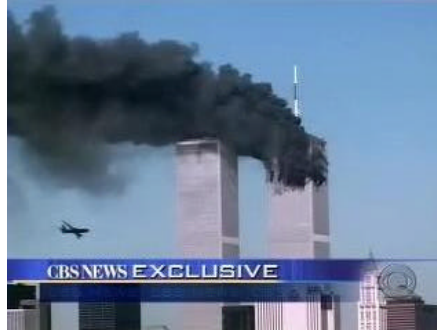
Figure 2. The aircraft approaching the South Tower

Before a structural analysis can be made, initial conditions for the impact problem must be determined. This includes: aircraft speed, aircraft trajectory, point of impact, roll angle and orientation with respect to the floors. Most of the above data can be calculated from video clips available from CBS, see Figure 2, CNN, and the Washington Post. The two airplanes crushed into the Twin Towers were Boeing 767-200ER. The main geometric dimensions of a Boeing 767-200ER are

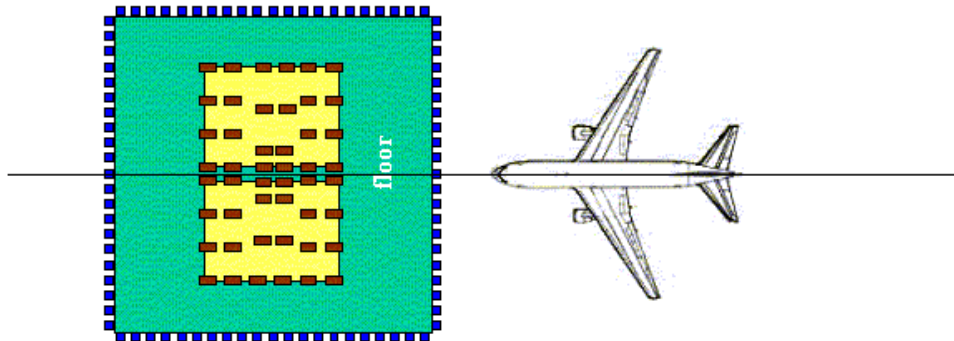
Figure 3. Orientation of North Tower head-on impact

The relative position of the aircraft with respect to the North and South Towers is shown (to scale) in Figure 3 and Figure 4 respectively.

Before colliding with the North and South Tower, the planes banked to the left and hit the Tower with a roll angle of approximately  $26^\circ$  and  $35^\circ$ . This roll angle will have significant influence on the number of destroyed floors.

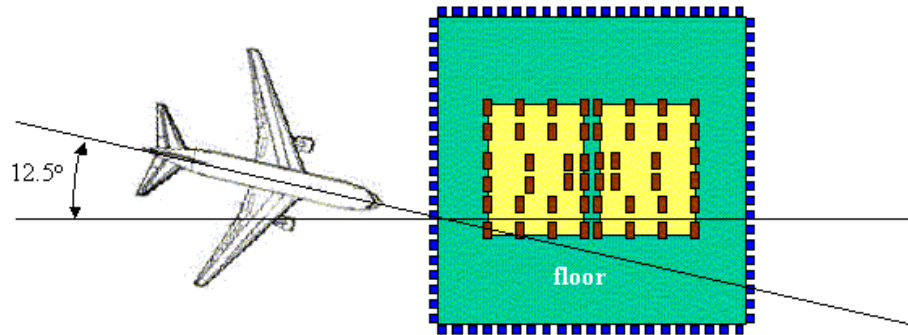
Figure 4. Orientation of South Tower oblique impact

The floor span of the South Tower impacted side is 10.7m, however for a diagonal impact, see Figure 4, the length of the damaged floors will be much larger. It is observed that the left wing traveled some 10m, while the fuselage and right wing traveled an average of 50m. Therefore, taking an average between those two, the length of the damaged floor is taken to be

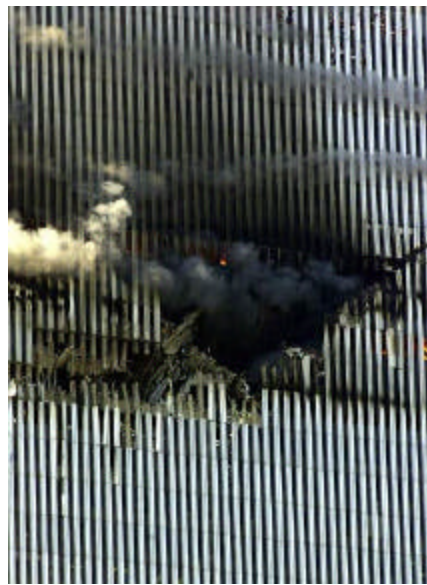
Figure 5. Damage to the exterior columns of the North Tower immediately after the impact.

The overall picture of the damage to the exterior shell is shown clearly in Figure 5. An interesting overlay of the outline of the plane on the North Towers impacted face is shown in Figure 14. One can clearly distinguish the fuselage together with the vertical and horizontal fins of the tail section, as well as two smaller holes driven by the engines. In the FEMA/ASCE report, it was estimated that the length of the damage area was approximately 31m, which is shorter than the wing span which is 47.57m. Therefore, it can be concluded that the extreme portion of the wings didn't cut through the columns but is actually deflected themselves. The damage extended over five floors, which is easily to see by counting rows of detached aluminum cladding, each one story high. From Figure 15(a) and 15(b) one can see that 33 and 23 rows of columns were cut by the impacting aircraft to the North and South Towers respectively.

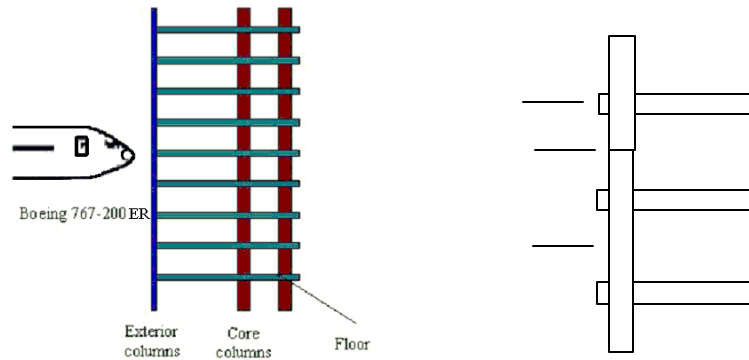
Figure 6. Relative orientation of the aircraft and the floors

The exact position of the longitudinal axis of symmetry of the plane with respect to a floor is unknown. However, we do know that the diameter of the fuselage (5.03m) was greater than the height between floors ( $l = 3.7$  m). Therefore, the fuselage will contact at least one floor, and more probably, two.

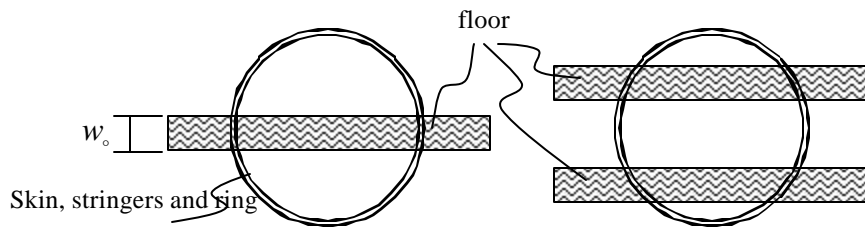
Figure 7. The 5-meter diameter of the fuselage can get engaged with one or two floors depending on the relative orientation

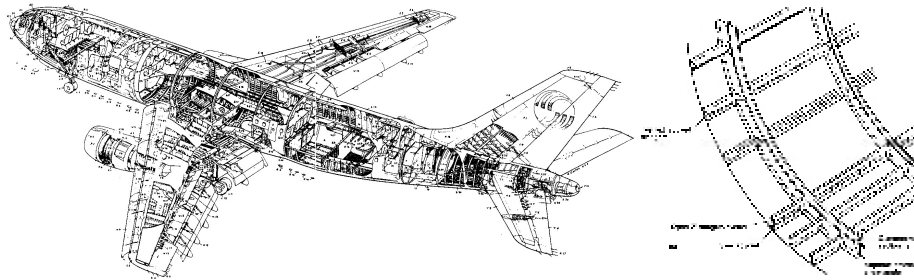
Figure 8. Internal structure of Airbus 320 (Reprinted from Ref. [25])

The fuselage consists of a system of rings and stringers attached to sheet metal. The floor separating the passenger and cargo area runs slightly below the diameter of the round fuselage. At this level of the first order engineering analysis, it is not possible to account for the individual contribution of rings, stringers, and the skin.

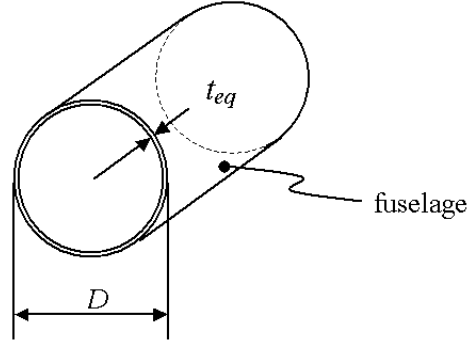
Figure 9. Simplified model of the fuselage

Instead these members are smeared into an equivalent thickness, which retains the same mass as the actual fuselage

From the above equation, it is found that for  $D = 5.03\text{m}$ , the equivalent thickness is  $t_{eq} = 18.4\text{mm}$ .

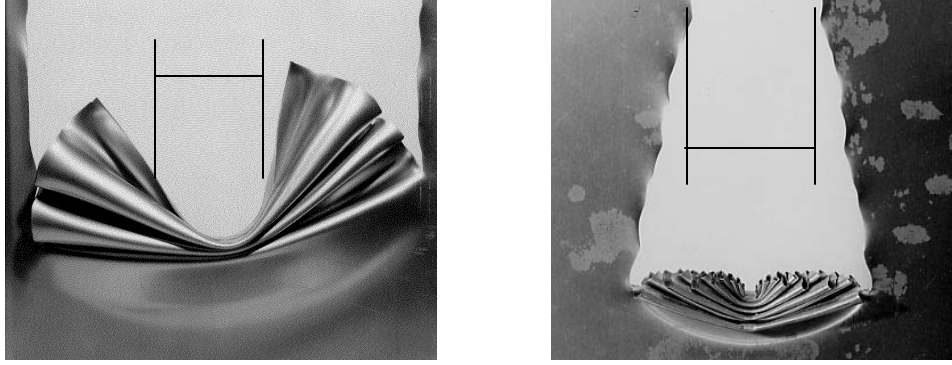
Figure 10. Concertina tearing of a sheet by a blunt object with parallel cracks (left) and diverging cracks (right)

Now the fuselage is getting engaged with one or two floors of the height  $w_o = 0.9\text{m}$  each. The floor is relatively narrow compared to the diameter of the fuselage and may in fact slice through the fuselage and cut it into two or three pieces. Wierzbicki [27] derived an approximate solution for plastic resistance of a blunt object cutting into thin sheet, such as tubular wall of the fuselage model. He identified the so-called “concertina” tearing mode, which consists of two diverging cracks enclosing a strip which progressively folds back and forth. A photograph of the damaged pattern induced by a rigid punch of width  $w_o$  is shown in Figure 10.

It is believed that the more applicable failure of floors could be the so called “concertina folding” mode, see Figure 10. The concertina mode can in fact be initiated by any blunt object such as the aircraft fuselage or wing. The failure mode consists of two parallel or diverging cracks with the plate folding back and forth between the cracks. The material is essentially piling up in front but this is not affecting the structural resistance. The solution to this rather complex problem involving combined plastic flow and fracture was given by Wierzbicki, [27]. Using realistic assumptions, he derived a very simple expression for the resisting force

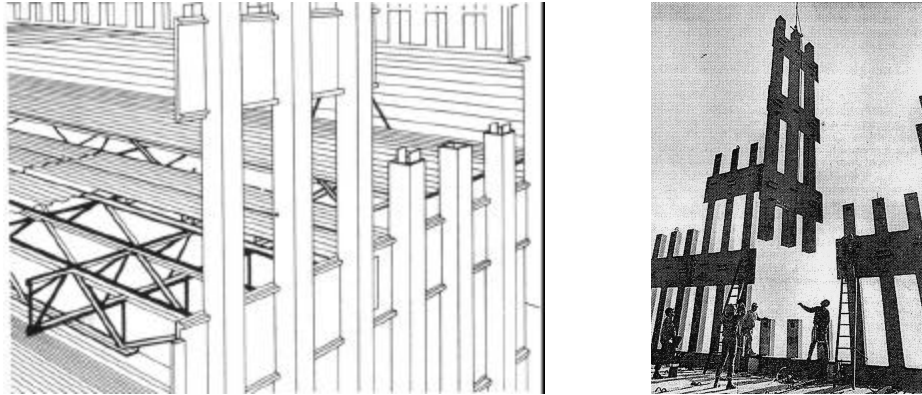
Figure 12. Assembly of the external wall units (alternately staggered in one-story heights) and floor units.

The prefabricated panel consisted of three columns connected by 3 transverse plates, called spandrels. The steel columns are of square cross-section ( $b \times b \times t = 356\text{mm} \times 356\text{mm} \times 9.5\text{mm}$ ), and they were spaced 570 mm apart from each other. The segments were staggered and bolted to their neighboring elements in every direction, Figure 12.

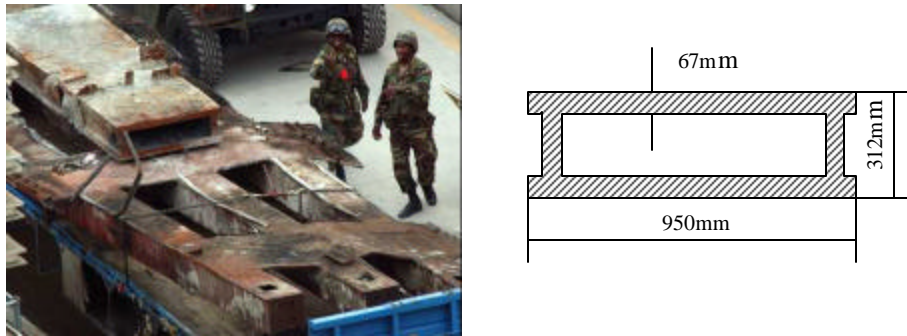
Figure 13. Relative size of core column compared to the exterior column. We have estimated the geometry of the core column from this photograph.

Inside each tower there were 44 large, concrete reinforced, steel columns, which enclosed elevators, stairways, and utility space. Again, the author's inquiries to ascertain exact values for the core column dimensions failed. However, one is able to estimate these values by comparing the size of core columns to the size of exterior columns as captured in photographs of the site, such as the one shown below. With an accuracy compromised by the poor resolution of the photographs available, we determined that each column had a thickness of 67mm, and dimensions of 950mm×312mm in rectangular cross section. It is not certain if all core columns shared identical cross section, but our calculations could easily be revisited when more precise data on their exact geometry becomes available. It is hoped that we will be able to eventually retrieve exact dimensions of core column in the course of our continuing research.

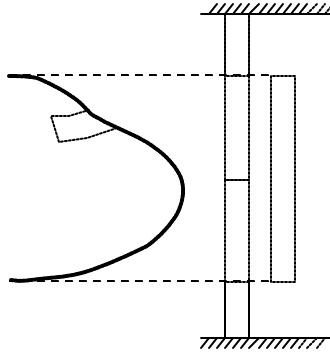
Figure 14. The shearing failure of exterior columns by the aircraft fuselage (and wings). Details given in Figure 25.

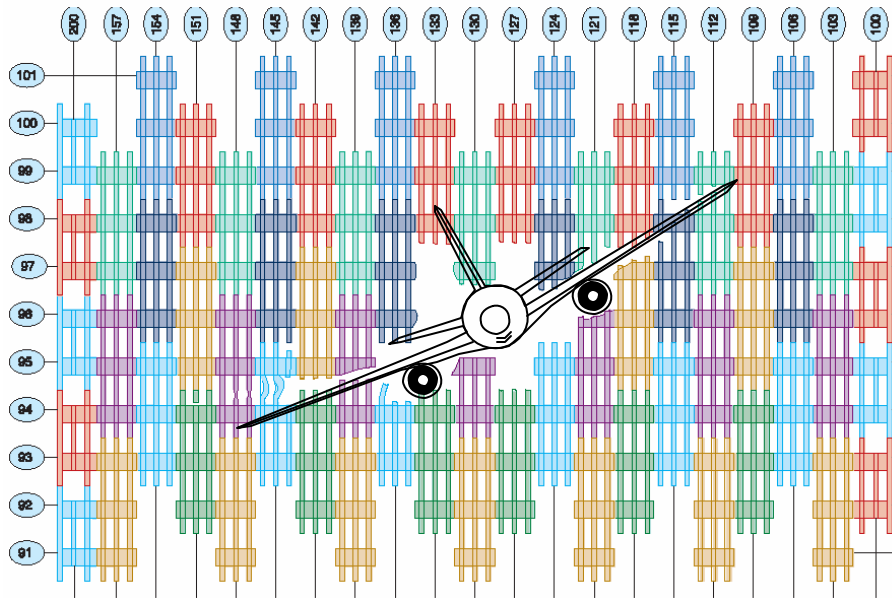
Figure 15(a). The outline of the airplane superposed on the hole driven in the exterior wall of the North Tower

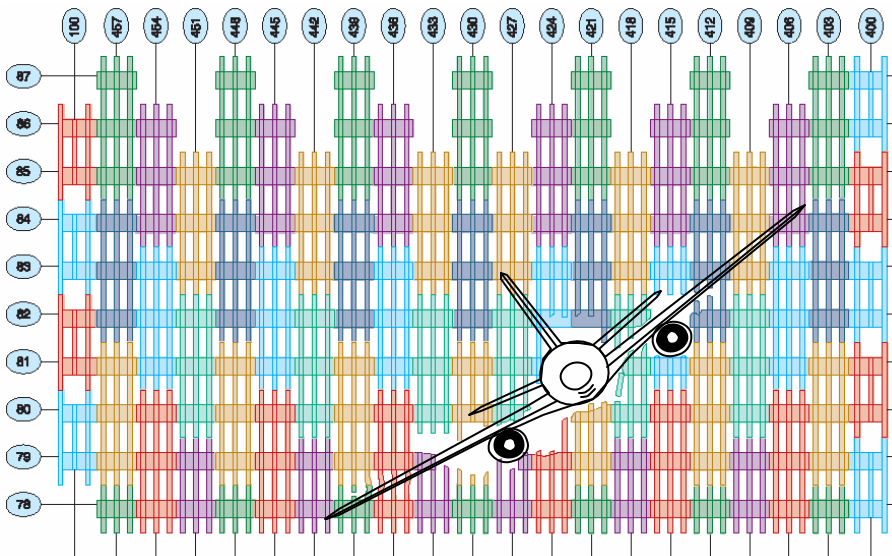
Figure 15(b). The outline of the airplane superposed on the hole driven in the exterior wall of the South Tower

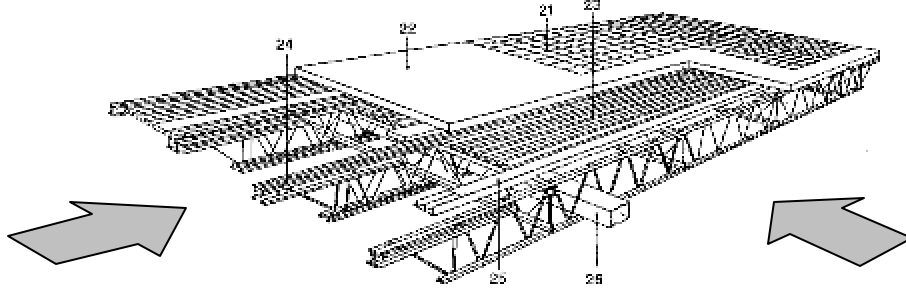
Figure 16. Aircraft impact direction with respect to the layout of floor structure

The complexity of the floor structure, as confirmed by the figure above makes the analysis very difficult. The floor structure can essentially be regarded as a longitudinally stiffened plate. Paik and Wierzbicki [29] and Braco and Wierzbicki [30] showed that a good engineering approximation for calculating resistance of such plates to crushing and cutting forces is obtained by the so called “smearing technique”. In this technique the evenly spaced steel trusses are condensed into an equivalent thickness of uniform plate. Dividing the total volume of the steel imbedded in each floor by the floor area, the equivalent thickness becomes

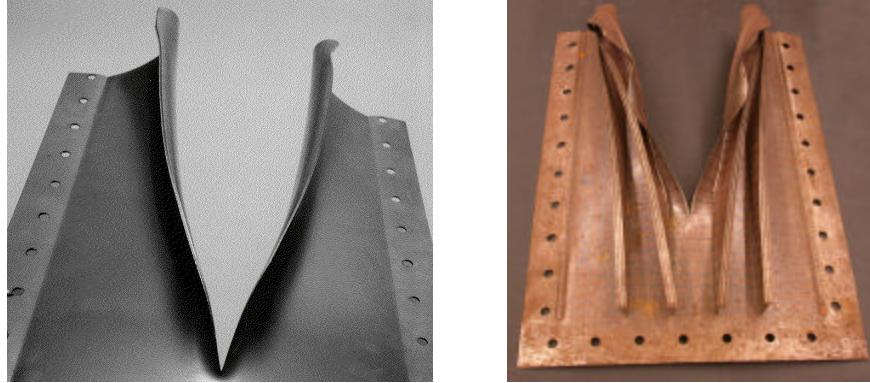
Figure 17. Unstiffened and stiffened cut by a shape wedge

damaged of oil takers and ships. Photographs of two typical failure modes are shown in Figure 17.

The pure cutting mode shown above involves one running crack followed by curling and stretching of flaps. Note that the stiffeners, if any, are deforming and curling together with the plate. The picture of damage of longitudinally stiffened plate, shown on the right could correspond more closely to the failure of the WTC tower floors in which floor trusses could be considered as stiffeners. Because this mode can only be activated by a sharp wedge, unlike a blunt fuselage, it will not be pursued any further.

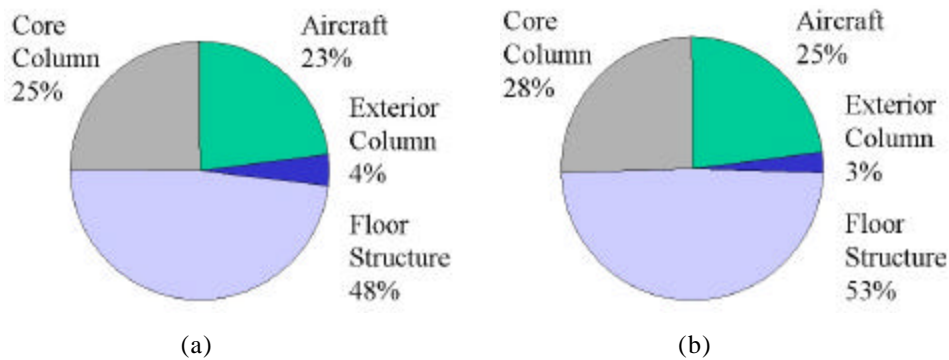
Figure 18. The contribution of various members to the energy dissipated during the initial impact. North Tower (a), South Tower (b).

According to our best estimate, the core columns absorbed  $E_{core} = 1025\text{MJ}$ , which is 52% of the total kinetic energy introduced by the aircraft. The total number of destroyed core columns is a ratio of the total energy available - core energy  $E_{core}$  to the amount of energy required to fail a single core column.

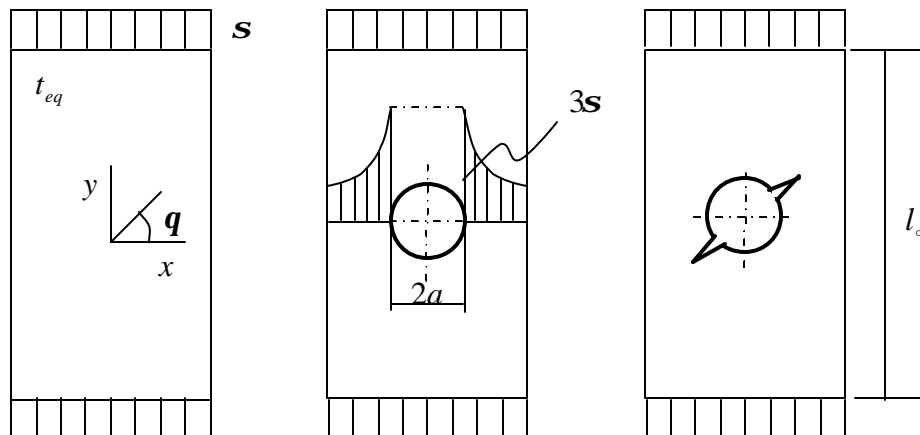
Figure 19. Stress concentration around a circular hole in a plate. Note that there is a stress singularity at the tip of any crack emanating from the hole.

Now imagine that a hole of radius  $a$  is driven into the center of the plate. The in-plane compressive stresses will be redistributed and will be concentrated near the hole. The exact elastic solution of this problem was worked out by Timoshenko [33]. The vertical component of the stress  $s_{yy}$  varies along x-axis according to

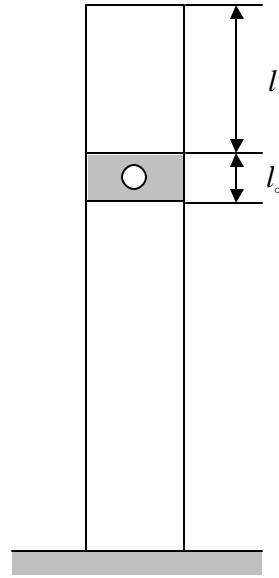
Figure 20. Stresses due to the dead weight will be concentrated around the hole

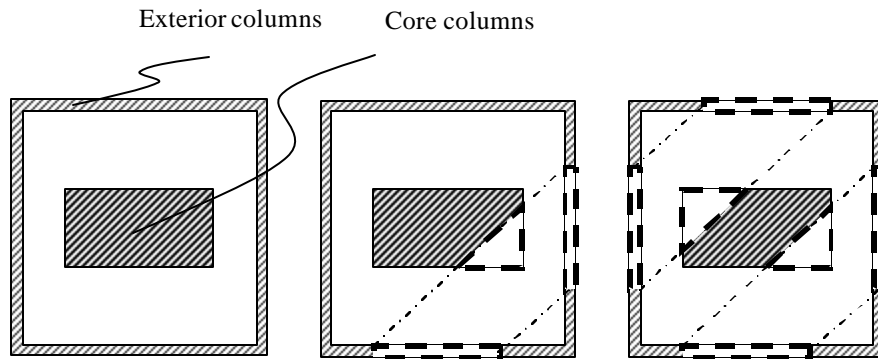
Figure 22. Conceptual sketch of the cross-section of the tower showing vertical members (left). Asymmetric damage (South Tower) removes a portion of exterior and core columns (center). Columns at mirror reflection becomes immediately inactive (right).

This example is easily generalized to encompass the actual conditions that existed in the WTC accident. A conceptual picture showing the area of active and inactive columns is shown in Figure 22. Following this generalization it is possible to graphically illustrate the location of the damaged, inactive and remaining, load-bearing columns (the shaded portions of the Figure 22) at the impact zone. In fact a photographic coverage of the onset of the global collapse (Figure 23) proves the upper part of the building tilted diagonally and felt on the low part.

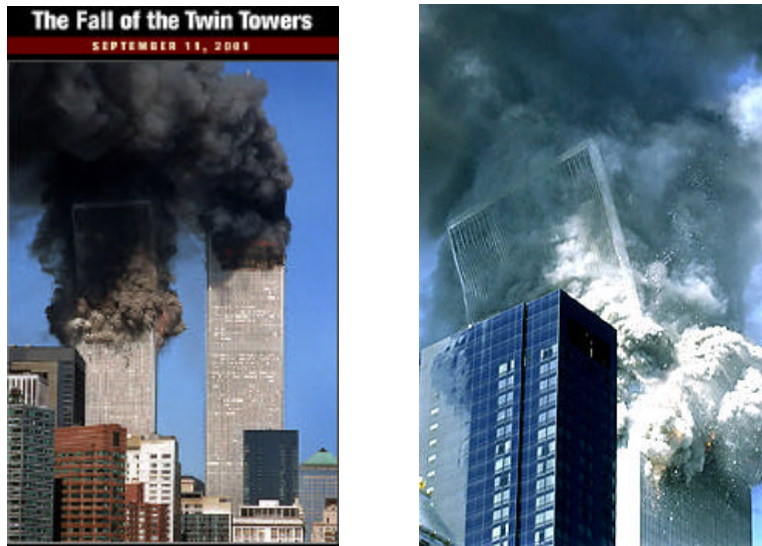
Figure 23. Few first seconds into the global destruction of the South Tower

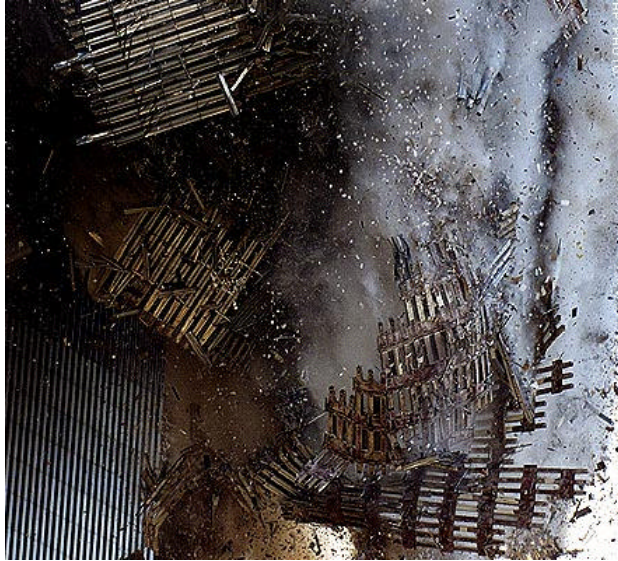
Figure 24. Prefabricated columns of the exterior wall falling to the ground completely detached from the floor structure.

What would happen if the tensile and shear strength of joints were increased by a factor of two, four, or ten? Then, the floors will keep effectively bracing inner and outer tubes, increasing the buckling strength of exterior and interior columns. Can our analysis tell what happened first: sagging of floors, which led to the detachment of floors from columns causing them to buckle, or buckling of columns causing floors to detach and fall onto one another. We think that either can be true. The impact and, thus, the damage to the North Tower were symmetric. Also, the number of destroyed core columns was fewer. It would then appear that because there was no tilting of the building, the catastrophic collapse was initiated by each floor falling into the next. This scenario would require a more prolonged effect of fire to weaken the floor trusses, which was indeed the case. The North Tower survived the initial impact for 50 minutes longer than the South Tower and then imploded.

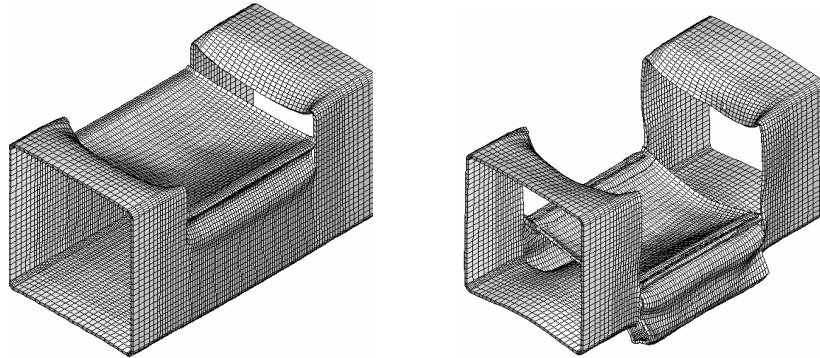
Figure 25. The problem of rigid mass (representing airplane wing) cutting through the exterior column has been solved numerically by Zheng and Wierzbicki [13].

The alternative failure mode is plastic bending of the cantilever beam but it is very unlikely that this failure mode would occur under high velocity impact because it will require the beam inertia to be activated. Recent results of the numerical study have conclusively proven that exterior columns fail by the shear type of failure, [2], see also Figure 25.
