# THE PLASCO BUILDING COLLAPSE IN TEHRAN

**A Preliminary Assessment**  
FEBRUARY 20, 2017

**ARCHITECTS  
& ENGINEERS**  
*for 9/11 TRUTH*

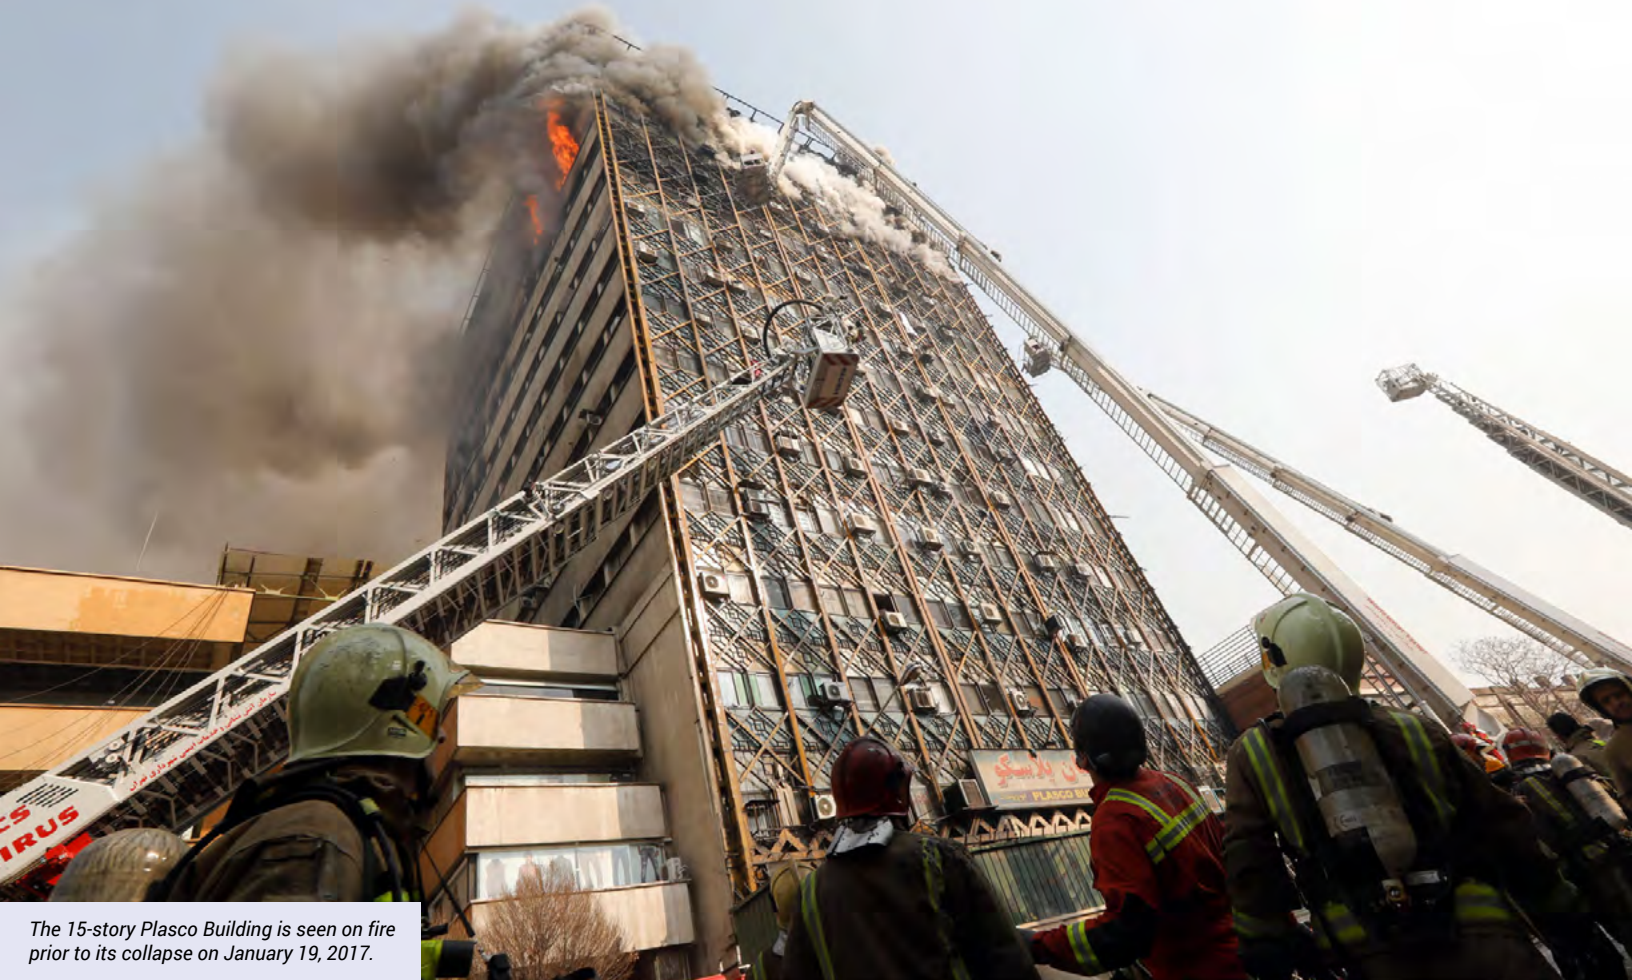
The 15-story Plasco Building is seen on fire prior to its collapse on January 19, 2017.

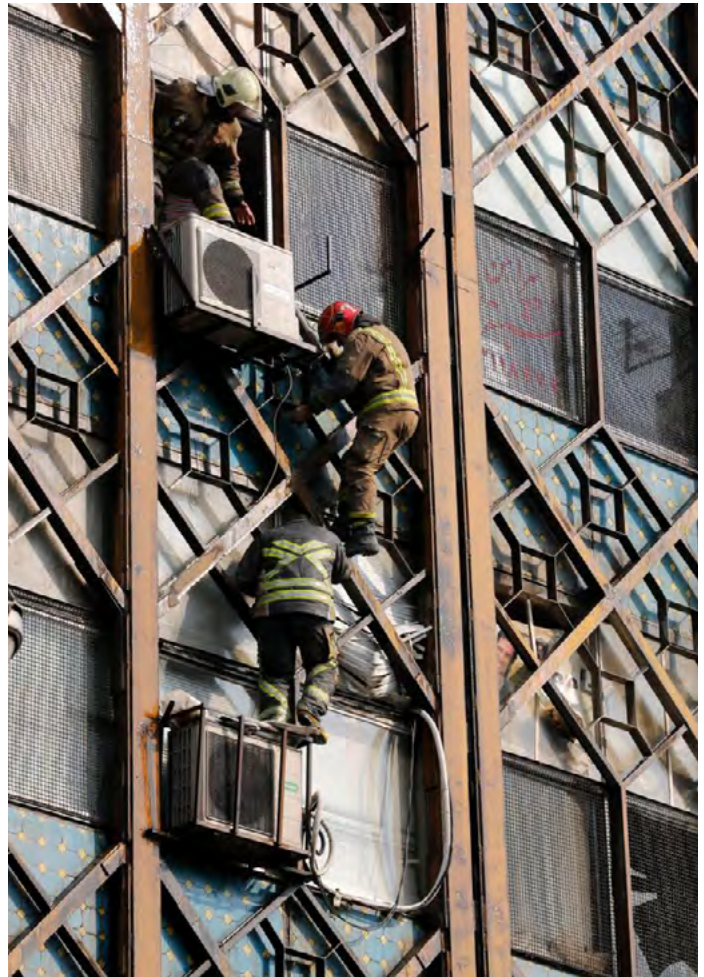
Figure 5: Firefighters are seen escaping through windows and climbing down the side of the building after a large explosion prompted the fire department to evacuate its personnel.

With regard to physical damage, the first large explosion, according to Mr. Maleki, “caused the massive destruction of the building’s windows.” Based on the fact that firefighters were attempting to escape through windows after the first large explosion, it may be that the first large explosion destroyed the stairwells and elevators as well. Alternatively, severe fires and smoke, perhaps caused by the explosion, may have prevented the firefighters from exiting through the stairwells.

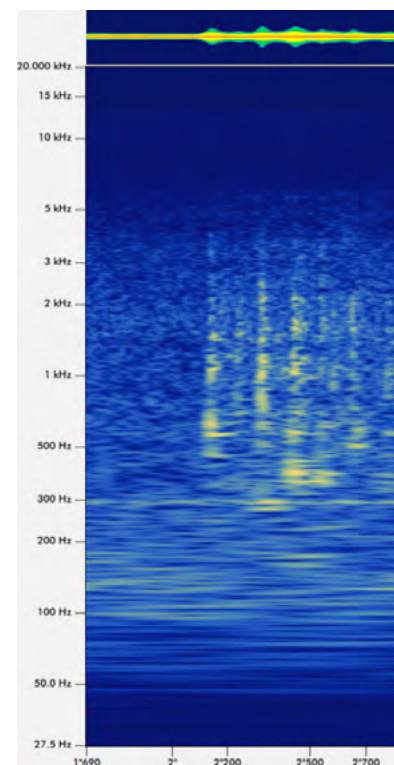
*Figure 6: Audio analysis visualization. Y-axis: audio frequency. X-axis: time elapsed in the video.*

The occurrence of seven separate impulses is consistent with video of the south face taken directly from the south,<sup>12</sup> which does not show an explosion emanating from one point. Rather, it shows a number of explosions emanating along the same floor from the center of the south face to the east side of the south face.

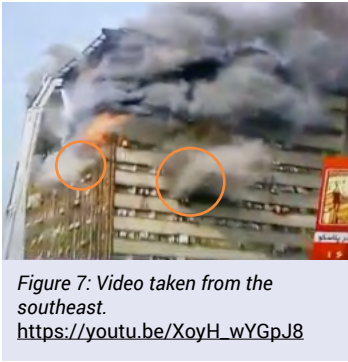
Figure 7: Video taken from the southeast.  
[https://youtu.be/XoyH\\_wYGpJ8](https://youtu.be/XoyH_wYGpJ8)

Video taken from the southeast (Figure 7) shows two energetic plumes rapidly emanating from the south and east faces approximately two seconds before the roof began to cave in along the south face. Then, just as the roof began to cave in, we see two series of expulsions run down the eastern side of the south face and down the middle of the east face, roughly below where the first energetic plumes occurred.

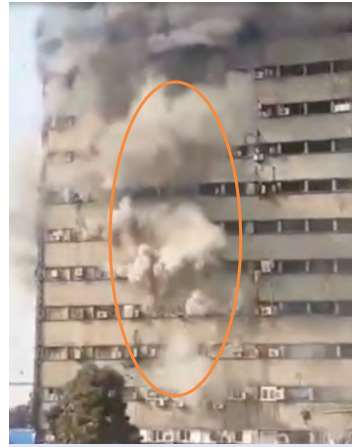
Figure 8: Video taken from the east.  
[https://youtu.be/\\_MgJTa7SDaY](https://youtu.be/_MgJTa7SDaY)

Video taken directly from the east (Figure 8) shows the same series of expulsions running down the middle of the east face.

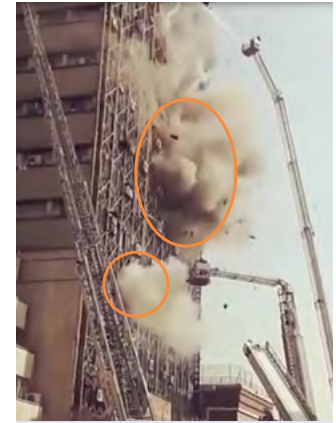
Figure 10: Video taken from the southwest closer to the building.  
<https://youtu.be/jzB-QE8Emt0>

Video taken from the southwest, much closer to the building (Figure 10), shows the two separate series of expulsions that ran down the eastern and western sides of the south face. In this video we also see an isolated expulsion that occurs closer to the bottom of the building on the western side—at the same time that the first series of expulsions begins to travel

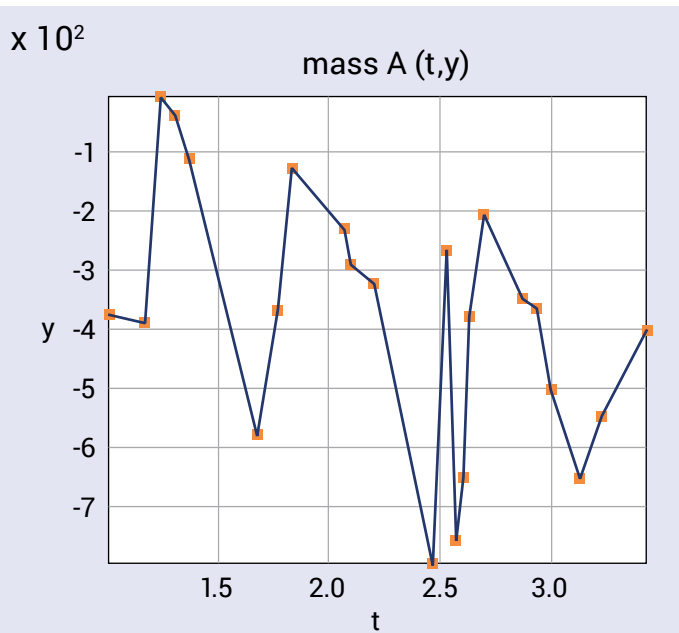
Figure 12: Map of east face expulsions. Y-axis: Location of expulsions relative to each other vertically. X-axis: time elapsed in the video ([https://youtu.be/\\_MgJTa7SDaY](https://youtu.be/_MgJTa7SDaY)).

5. A careful analysis of the series of expulsions that appear to travel down the east face of the building in a somewhat neat pattern reveals that, in fact, the expulsions occur in a disorderly sequence. As shown in Figure 12, which maps the time and vertical location of each expulsion on the east face, we see expulsions occurring high and low in the building, with no apparent order. We also see expulsions occurring seconds apart on the same floor. If the expulsions were caused by floor-wide air compression from

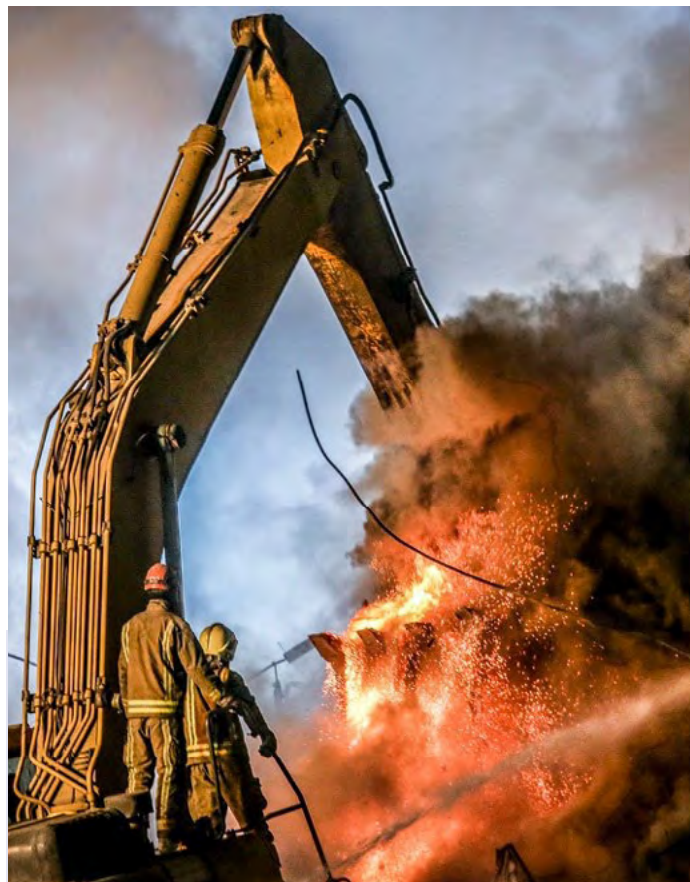
Figure 13: An excavator scooping up molten metal from the scene of the Plasco Building incident.

Fires in open air cannot achieve temperatures above 1,800°F (1,000°C). Iron and steel melt at approximately 2,750°F (1,510°C). The fires that occurred in the Plasco Building, therefore, cannot account for the observed molten metal.

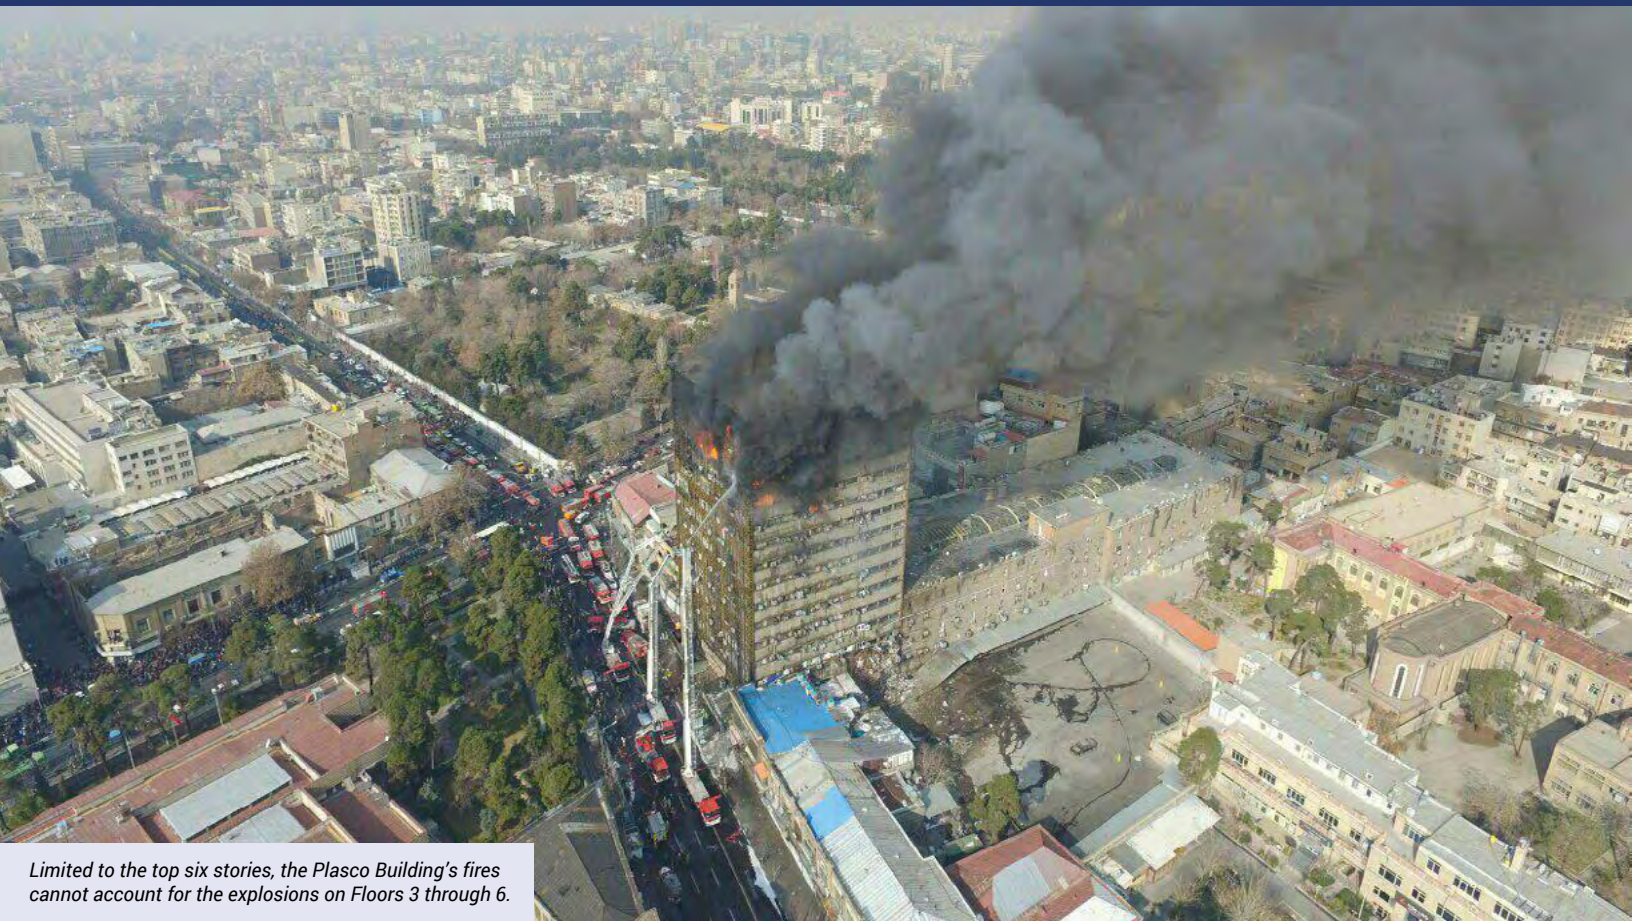
Limited to the top six stories, the Plasco Building's fires cannot account for the explosions on Floors 3 through 6.

Also, as we established in Section 2.1, fires could not have been the ignition source for the explosions that occurred before the collapse at the northeast corner on Floors 3 through 6, because the fires were limited to Floors 9 through 15. This fact alone appears to rule out the hypothesis that the explosions were caused by fire.
