Engineers Assess the Truth in AE911Truth

September 2021

David M Scott Hon AIA, FStructE, FEng, FRSE
Ron Hamburger, PE, SE, MStructE.

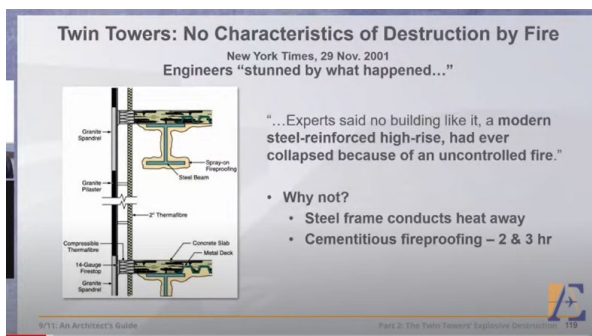
When describing WTC 1 and 2 and why structures don't fail, Ref 2-27:30 shows floor beams and says:

- "Steel is very dense. It conducts heat away from its source."
- "So, the steel beam rarely gets to its critical temperature, 1200 degrees Fahrenheit, at which it would lose half of its strength."
- "We put cementitious fire proofing on these, four to six times more than we ever need."
- "A robust connection to the perimeter frame."

Ae911truth slide on WTC 1 & WTC 2

Engineers and architects who know about the Twin Towers are quick to see that these statements are inaccurate and misleading. The floor system of the Twin Towers was a bar joist system, not a beam system. And bar joist floors are known to be particularly vulnerable to fire conditions:

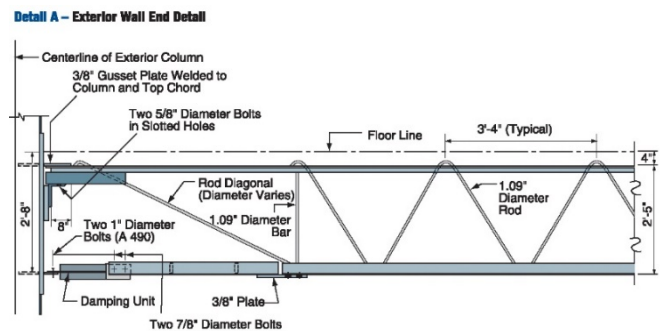
Floor Structure of WTC 1 & 2

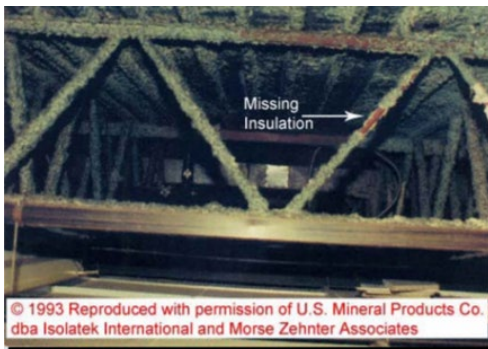
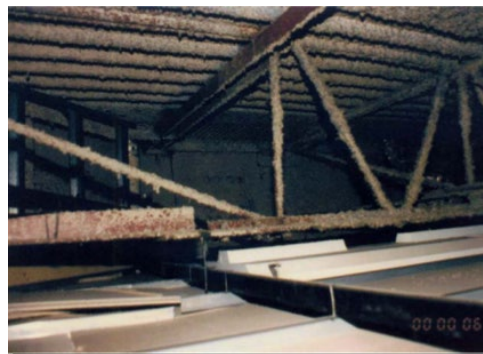
Images taken from NIST report

There are other factors that contributed to a fire/impact collapse of the Twin Towers:

1. The aircraft impacted and transited through the exterior wall. It disintegrated, creating a large debris cloud that abraded off fireproofing from many members.
2. We know the impact destroyed multiple core columns and multiple floor trusses. This caused massive overstress to some of the floor trusses above and below the impact, as well as very high stress to both the columns adjacent to the severed columns and the hat truss which was now supporting columns hanging below it.
3. We know that debris, including the failed floors, the weight of the planes, engines etc. will have overloaded some of the damaged floors.

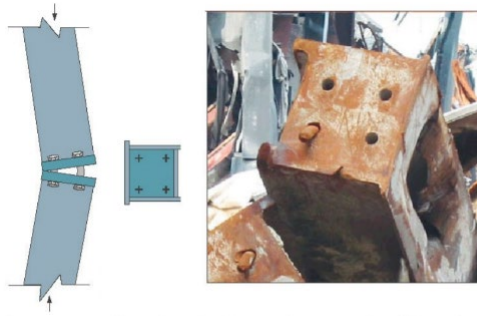
Tall buildings are never demolished with explosives at every level; why would they do it here? With thousands of explosives, surely there would be a high risk of one picture of a cutter charge. But there is a much simpler form of evidence that shows there was no line of explosives and that is the damage to the perimeter wall. The connections are much weaker than the columns and the wall failed at the connections. The connections are staggered in three-storey segments. So, there was no lines of damage. The segments are seen in the debris and in the collapse videos. The connections were studied extensively Ref 7.

Figure 2-37 Illustration of column splice connection failure, due to out-of-plane bending, in the World Trade Center Towers [FEMA, 2002].

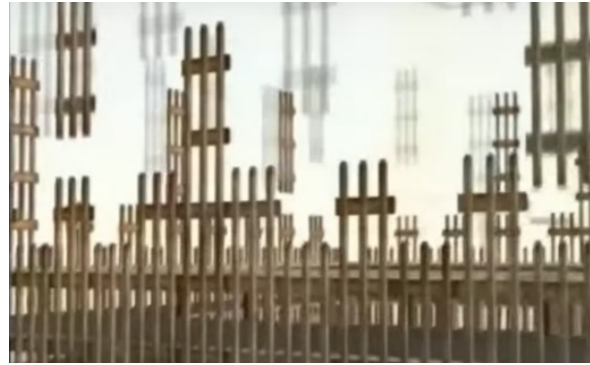
Another major problem with the hypothesis is that it doesn't take into account the air in the building. NIST has explained that there were massive volumes of air pushing out of the tower as a result of the progressing collapse. Fifty million cubic feet of air comes out of each tower in 14 seconds. The columns in the perimeter wall are at 40-inch centres and glass spanning 25 inches between them. The glass is many times stronger than normal high-rise windows. Where does the air go in the conspiracy hypothesis? And how does it not create the very ejections that conspiracy advocates see as explosions?

The air pressure also pushes the external walls out at some levels and contributes to the unpeeling. As we have seen the connection of the wall to the floors has only two bolts at each joist. The air pressure also causes the squibs and ejections, and they look natural from a progressive collapse perspective. The weakest windows break, releasing some pressure, and air and contents blast out. From the start of the collapse, the piston is pushing the walls out and pushing air out the building.

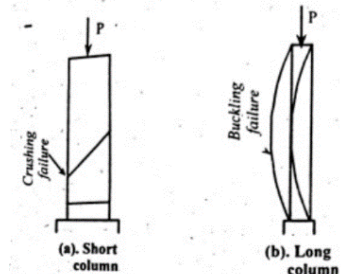
“Crushing” is a vague term in engineering. A crushing failure in engineering refers to a confined compression failure. Engineers use the diagram opposite to describe it. There were no crushing failures on 9/11; all the failures were buckling failures, tension failures, shear failures, or connection failures.

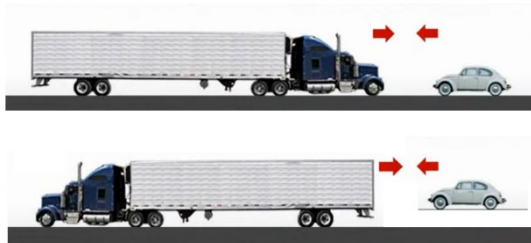
This is correct but is a misleading analogy. A better analogy of what happened on 9/11 is to turn the truck the other way round. The VW could then disappear into the trailer, much in the same way that the top section disappeared into the bottom. Taking that analogy further, the VW becomes a piston, helping to blow out the walls of the trailer.

Which image better describes the failures of WTC 1 and 2?

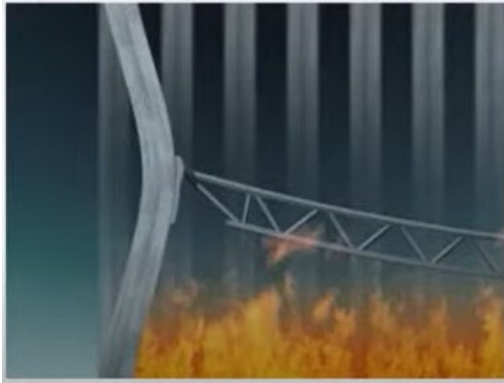
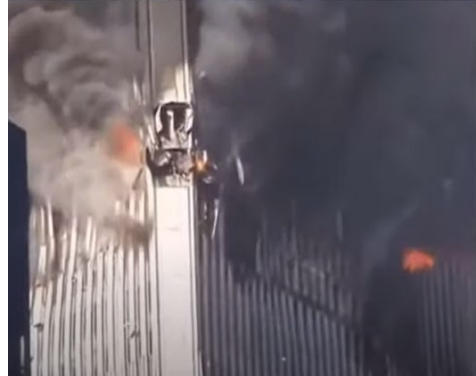
However, the top of the tower does appear to crush into the tower below which is where the term originates. Ref 1- 37 to 43 briefly describes buckling behaviour but does not mention that if the floors fail then the column capacity is reduced massively. He does not mention that the bolted connections on WTC 1 and 2 had a tiny percentage of the buckling capacity of the columns, explaining why most of the perimeter columns failed at their connections into straight 37-foot long segments; these sections are familiar to all the SEAoNY team who worked on the rescue/recovery but also to anyone who studied the videos.

Ae911truth Presentation showing column buckling Ref 2 49:40

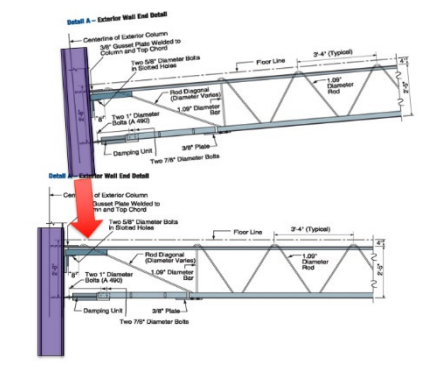
In descriptions of the explosives, theorists point out that the South Tower is leaning at an angle of 20 degrees as it descends into the section below. They then go on to explain how they see explosions at every level below that. But quite frankly what is the point of the explosives? The tower will continue to fall as the bar joists cannot resist the weight of the falling mass. And at each level below, the floor comes down, the air pushes everything out, causing the walls to unpeel and the collapse to continue. There is no need for explosives and the apparent explosions that are seen (from the air escaping), are what is expected.

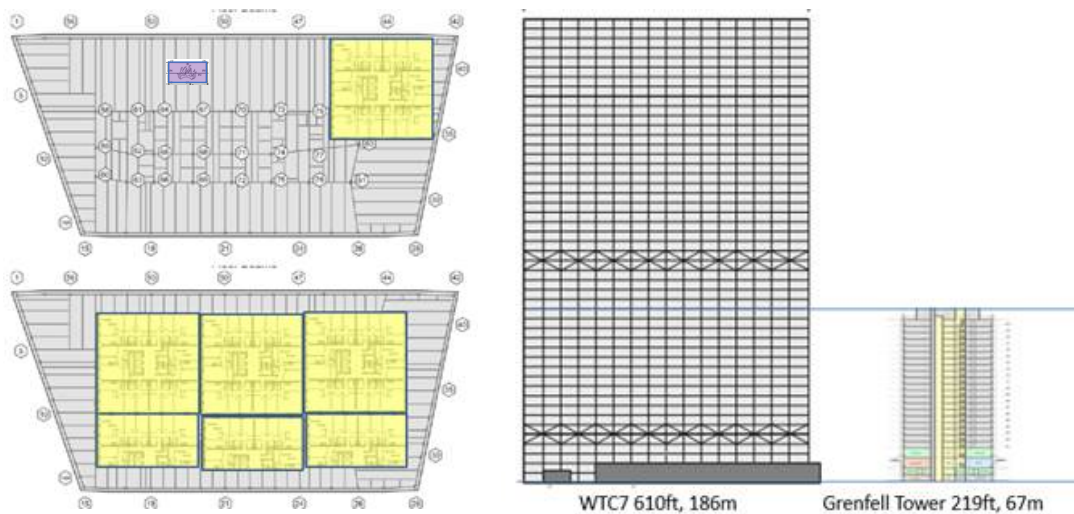
And we should not forget the scale. WTC7 was a massive building. The diagram below shows Greenfell Tower, which was a very large London fire, overlaid onto WTC7. And on WTC 7 we know what the fire was doing on the outside but not on the inside.

Plan and sections showing Grenfell (yellow) & Cardington Fire test floor grid (purple) overlaid on WTC7.

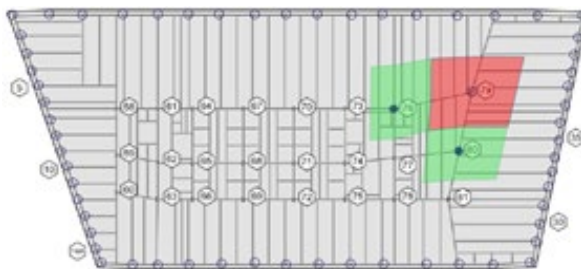
Plan showing loaded areas on Col 79 and adjacent columns

You can see that the load on Col 79 supports an area highlighted in red above, which is approximately the same size as the whole Grenfell tower.

Engineers will look at the WTC 7 plans and see that Col 79 supports a substantial area. Its removal would put a massive load on the adjacent columns, let alone the potential risk of the adjacent columns being damaged by debris. Engineers can see that there is a risk of the collapse progressing. Especially considering that adjacent columns Col 78, 77, and 80 are supported by transfer trusses which in turn support multiple columns. If these trusses were damaged by overloading or debris, then multiple core columns would fail and these in turn would immediately try to transfer their loads to adjacent columns.

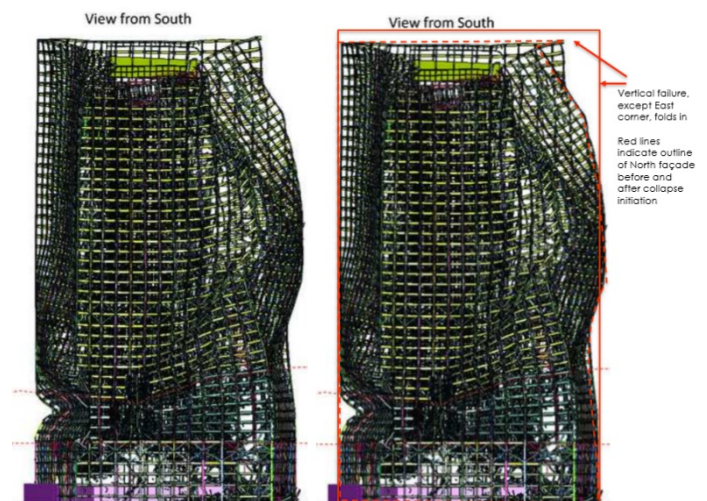
Controlled demolition theorists frequently mock the NIST model and say it looks nothing like the WTC 7 controlled demolition. If you look at the model on the right the theorists appear to be correct; it doesn’t look anything like the collapse. But architects and engineers are trained to read models like this. They know that the building isn’t transparent, that you can’t see through floors, and that the façade is much more solid than the steel frame. They know the model is a view taken from the south, and we are only interested in the top of the building and only interested in the north façade, because the south was covered in smoke from the fires.

If you look at the north façade it is remarkably rectangular. On the north-east corner of the north façade, NIST analysis shows a corner being folded south. This was not seen. The building behind is extensively damaged and is pulling down the north façade. Rather than educating the public on how to read the NIST report, theorists chooses to mislead them by not pointing out to the similarities between the NIST analyses.

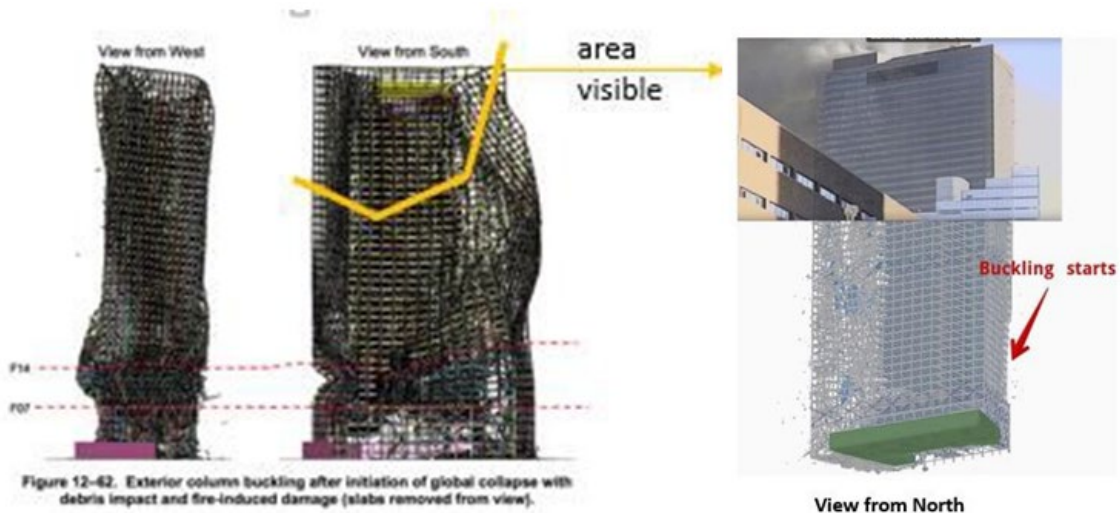
We should not forget that the failure initiated well below the line of visible structure. In the iconic video of WTC 7 only a very small part of the north-west façades can be seen, as shown below. There are other angles which show more of the north façade, up to 90 percent of the top 20 floors.

NIST could not get their simulation to match the failure, mainly because the north façade of the tower only starts moving after 18 seconds of the initiating event. NIST correlates the time to within fractions of a second. These models run in millisecond increments and every action affects all the subsequent actions, so there will be multimillion interactions captured in the NIST analysis. NIST explain this of course and those familiar with non-linear time history dynamic analysis will understand this challenge.

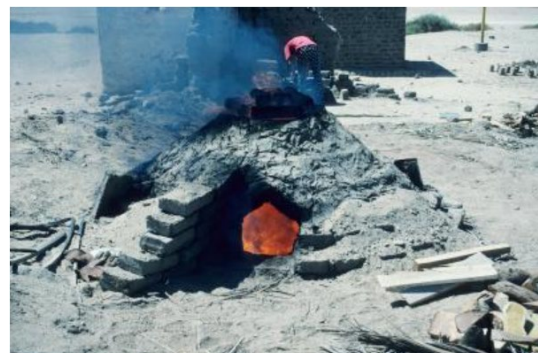
The image on the right is a recreation of an ancient Egyptian kiln. It achieves temperatures of 2100 degrees Fahrenheit/ 1150 degrees Celsius.

Now, imagine something like this but 100 times bigger, with firemen walking over the top, dousing the thick dust and concrete that insulated the fires below. That's what the WTC tower collapse piles were like, and every time a section of frame was pulled out there would be a little a local flare up. The expected temperatures would be extreme and the contents were incinerated. They were more than enough to melt aluminium and a lot of other metals and create the extreme temperatures that were measured at Ground Zero.

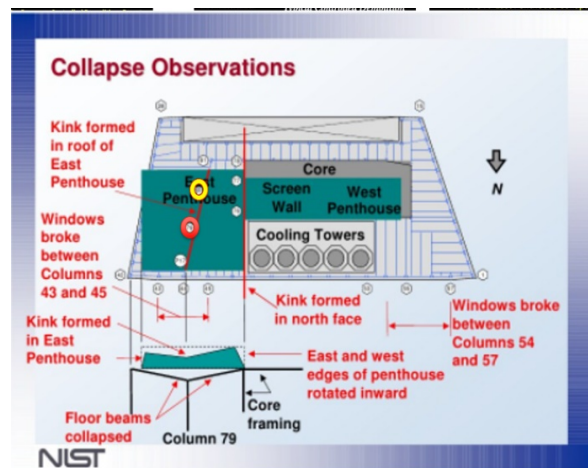
NIST time-matched their analysis to the failure times and observations, from the initial shuddering, indicating some local failures to the collapse. However, a key part of that evidence was the collapse of the East Penthouse which sank slowly into the building seven seconds before the more global collapse. For the East Penthouse to sink into WTC7 requires Column 79 to fail, which happens several seconds before the main collapse. Column 79, circled in red opposite.

It is very challenging to imagine how the building would stand up after column 79 failed. Not only is there a massive redistribution of load, but there would be the dynamic effects from the floors collapsing, as well as the potential for debris to impact or damage other columns and supports. And column 80, circled in yellow, is supported by a transfer structure, which in turn support four main columns.

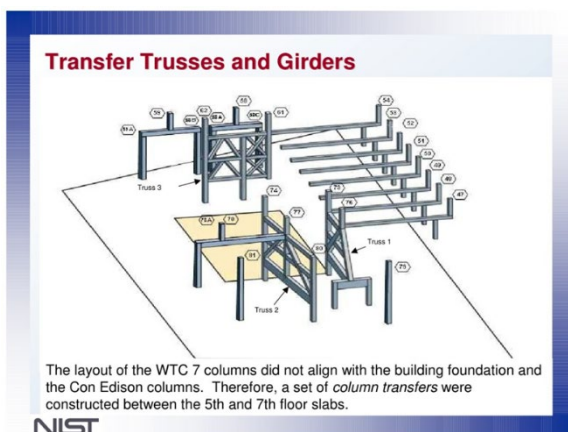
NIST states that the collapse of WTC7 was due to the progressive collapse following failure of a single column.

NIST is saying that the failure of Col 79 leads to a total progressive collapse of WTC7. As shown above it is a large steel column with 4.9-inch 125-millimeter flanges, supporting a massive area. (They also looked at the minimum size of charges needed to take the column out, with pre-cutting.)

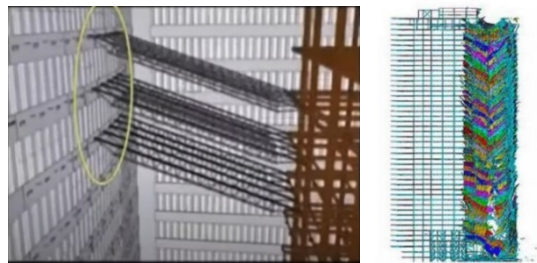
Engineers understand this hypothesis well, and Ref 2-48:13 shows an image of it, when describing the North Tower failure. The load of the interior transfers to the outside and global collapse follows. The figure on the far right is an extract from the Thornton Tomasetti analysis of the WTC7 collapse, Ref 7.

There is little change in the volume of a floor between the condition when the floor is flat and when it is inclined, so if the internal columns failed many floors below you would not see windows blown out violently. This is consistent with what happened at WTC7.

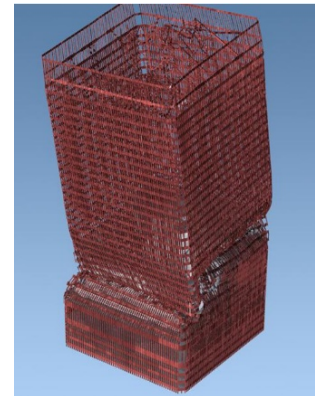
Engineers understand that there has already been extensive analysis of the three towers, which is essentially ignored by the controlled demolition conspiracy theories. An example of the WTC 1 and 2 failure analysis is shown on the figure on the right (Ref 7) which shows the failure of the top of the South Tower.
