Microstructural Analysis of Steel from the World Trade Center Buildings 7, & 1 or 2

Ronald R. Biederman, WPI

Higgins Armory/WPI MCSI Symposium
June 5, 2006

-The Role of Heat and Hot Corrosion in the Failure

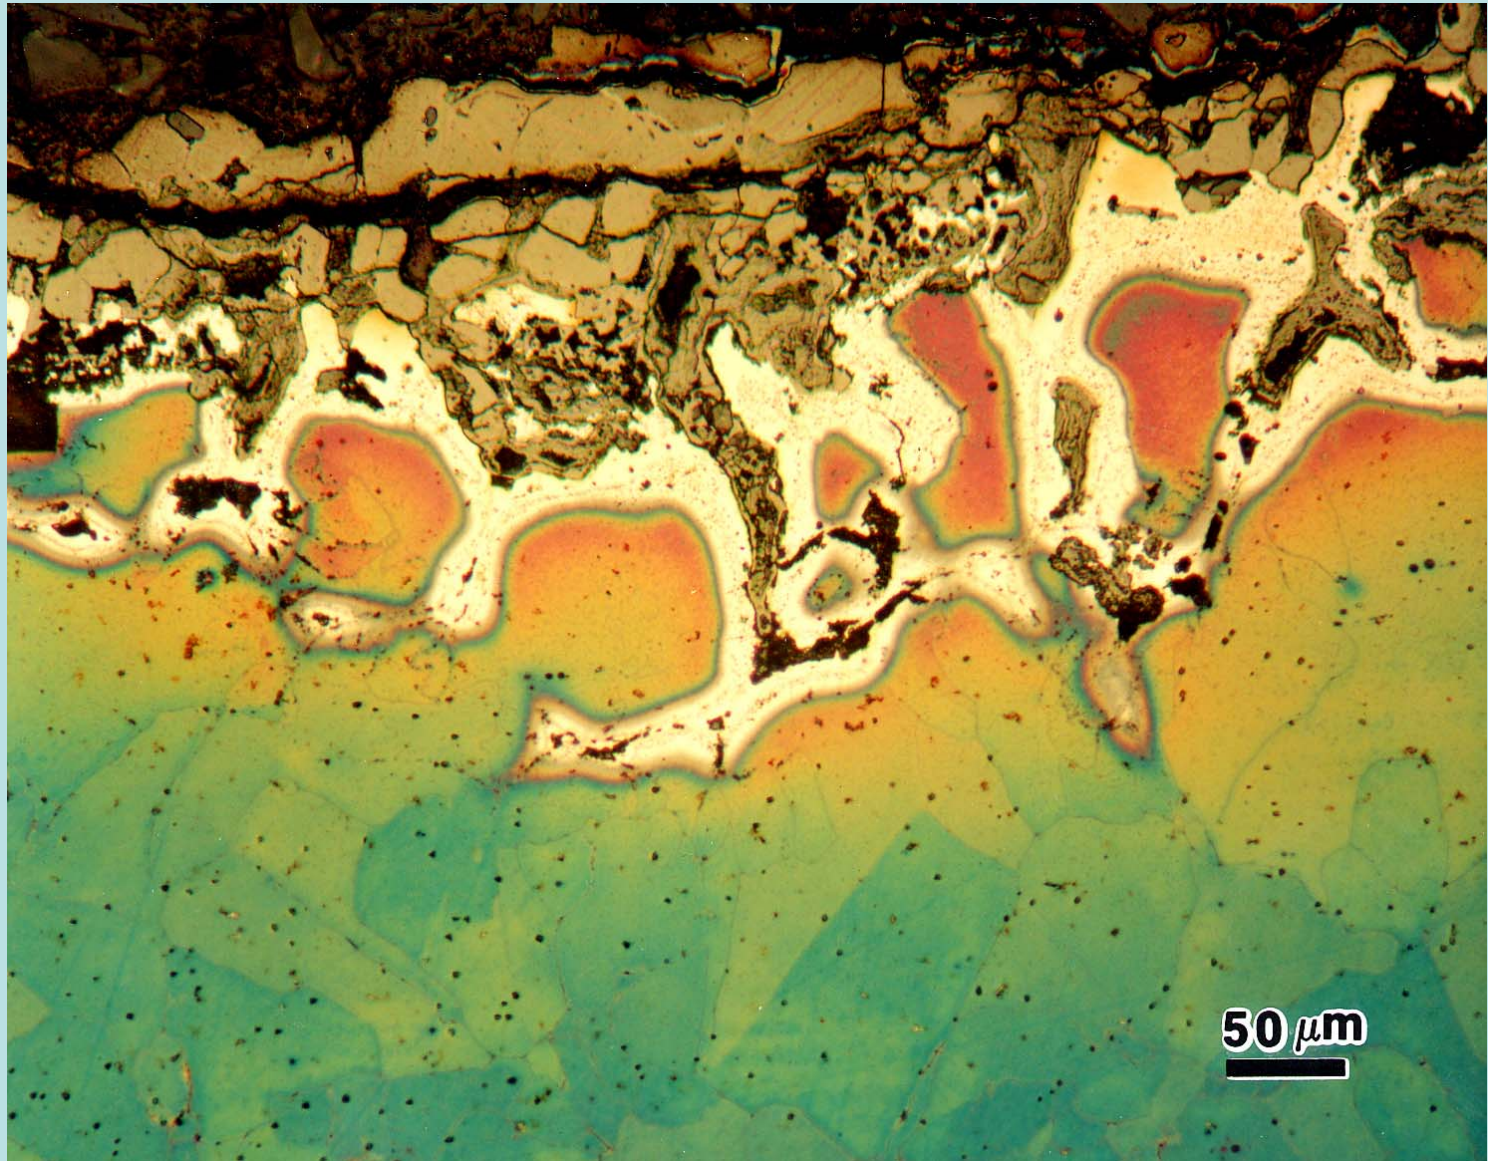
Oxidation and Intergranular Attack

Unetched

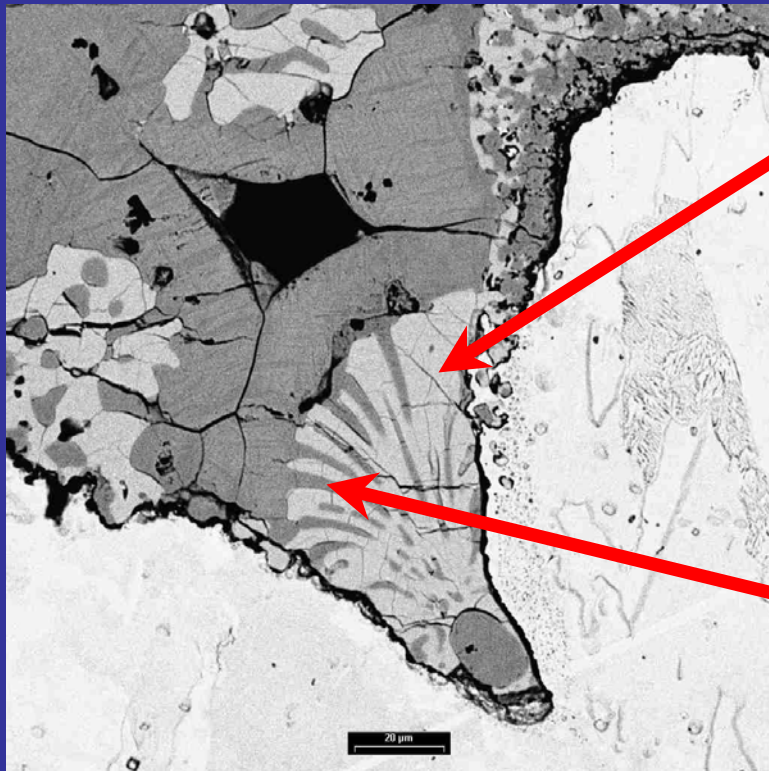
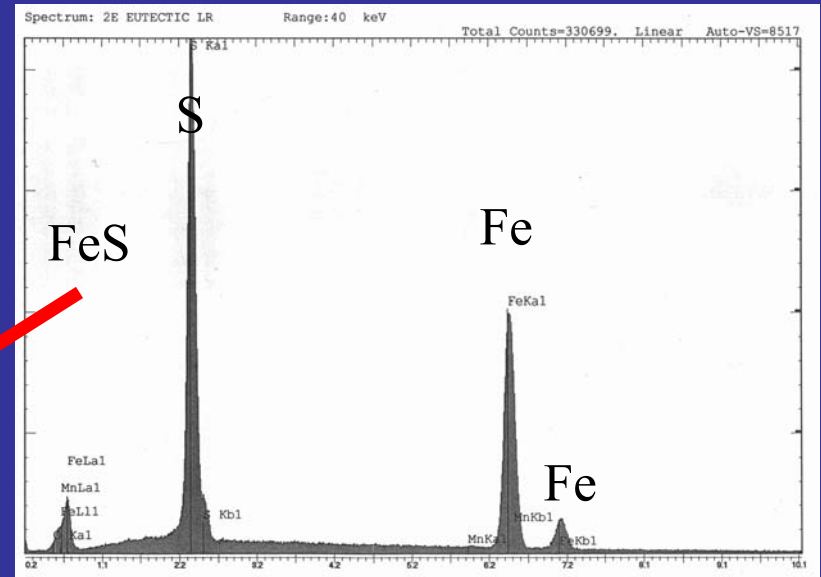
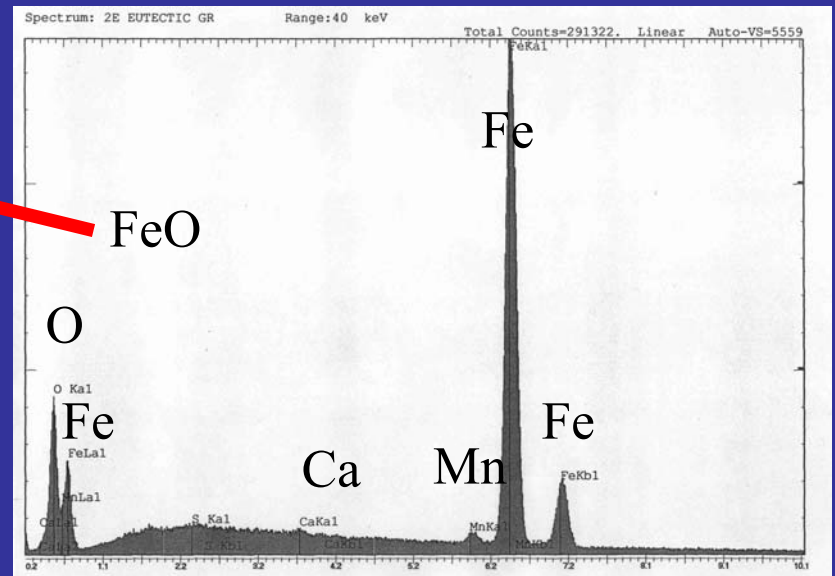
EDX Analysis of Eutectic Region

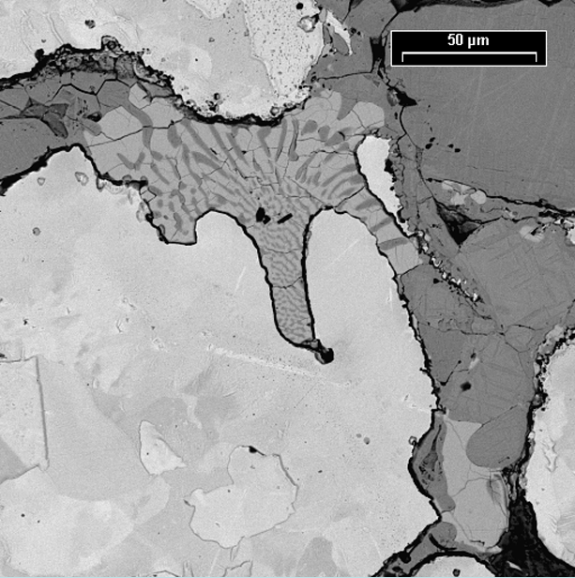
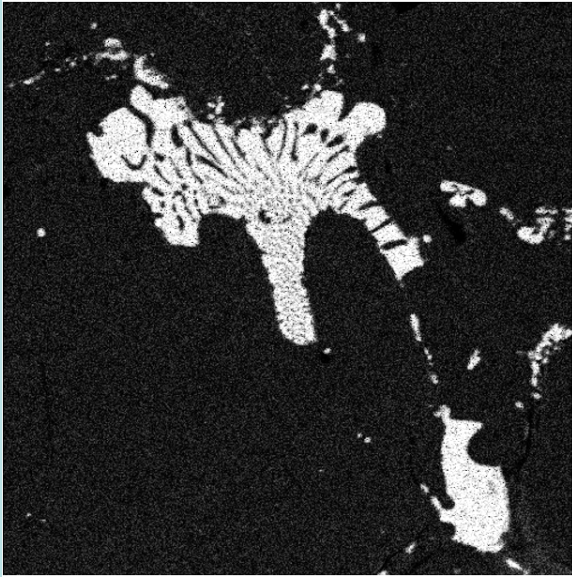
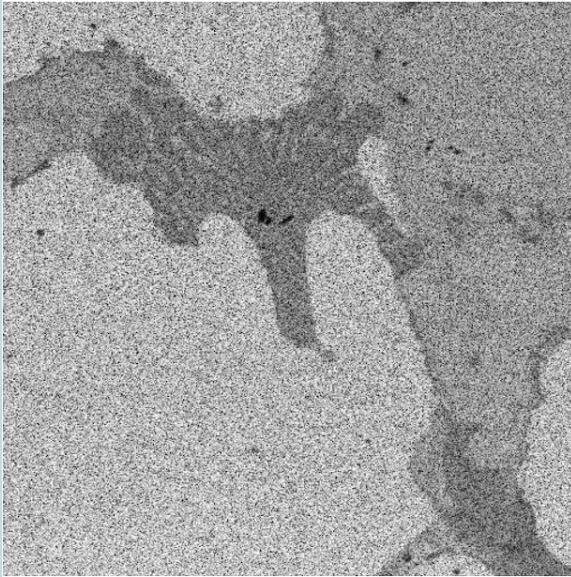
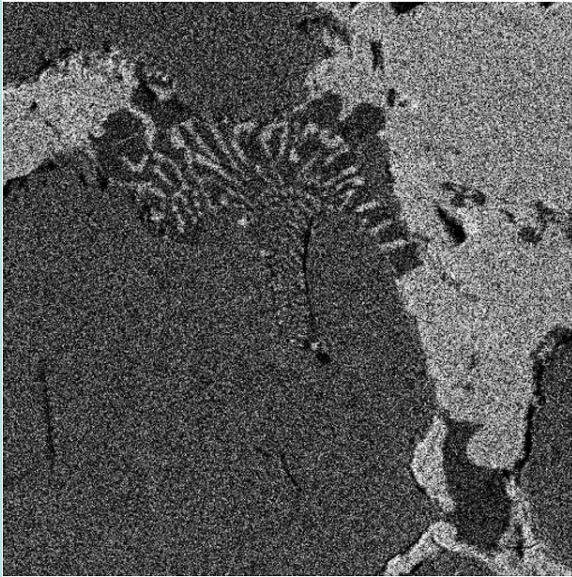
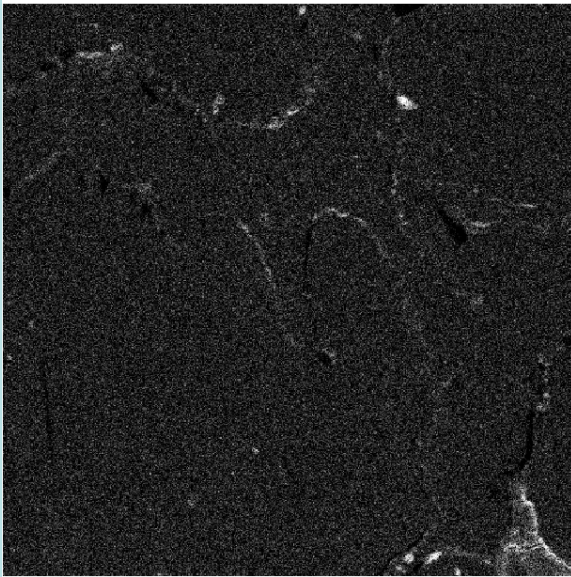
Digital X-Ray Map of the Eutectic Reaction Product

- 1. Rapid deterioration of the A36 steel was a result of hot corrosion.**

- 1. Rapid deterioration of the A36 steel was a result of hot corrosion.**
- 2. Heating in an environment containing oxygen and sulfur resulted in intergranular melting which transformed to an Iron Oxide and Iron Sulfide eutectic mixture on cooling .**

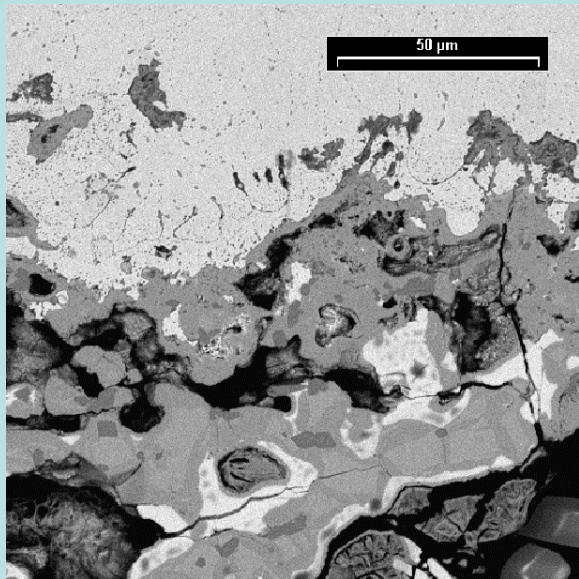
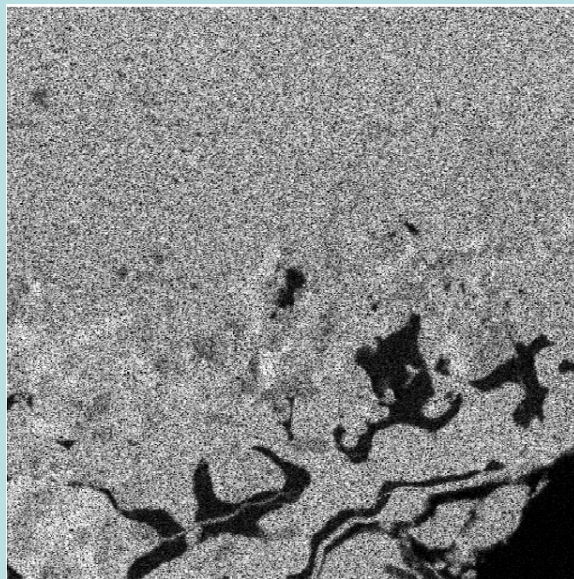
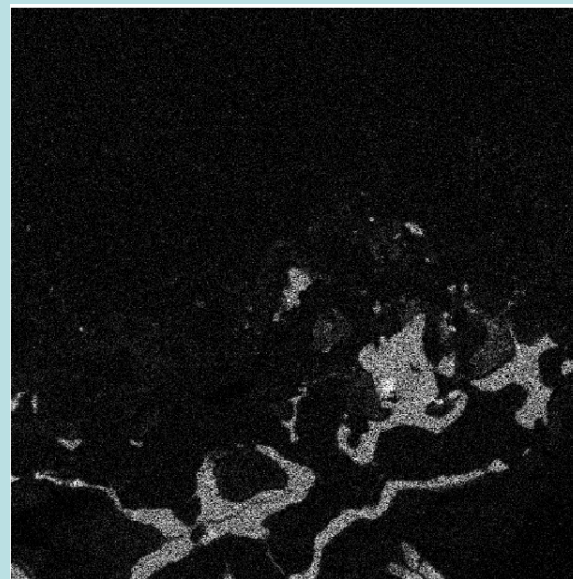
Higher Magnification of the Surface Reaction Region

1. **The severe thinning of the HSLA steel occurred by high temperature corrosion due to a combination of oxidation and sulfidation.**

1. **The severe thinning of the HSLA steel occurred by high temperature corrosion due to a combination of oxidation and sulfidation.**
2. **Sulfidation of the grain boundaries in the HSLA steel accelerated the corrosion and erosion of the steel.**

- 1. The severe thinning of the HSLA steel occurred by high temperature corrosion due to a combination of oxidation and sulfidation.**
- 2. Sulfidation of the grain boundaries in the HSLA steel accelerated the corrosion and erosion of the steel.**
- 3. The high concentration of sulfides in the grain boundaries in the corroded regions of the steel occurs due to copper diffusing from the HSLA steel combining with iron, manganese and sulfur making both discrete and continuous sulfides in the steel grain boundaries.**

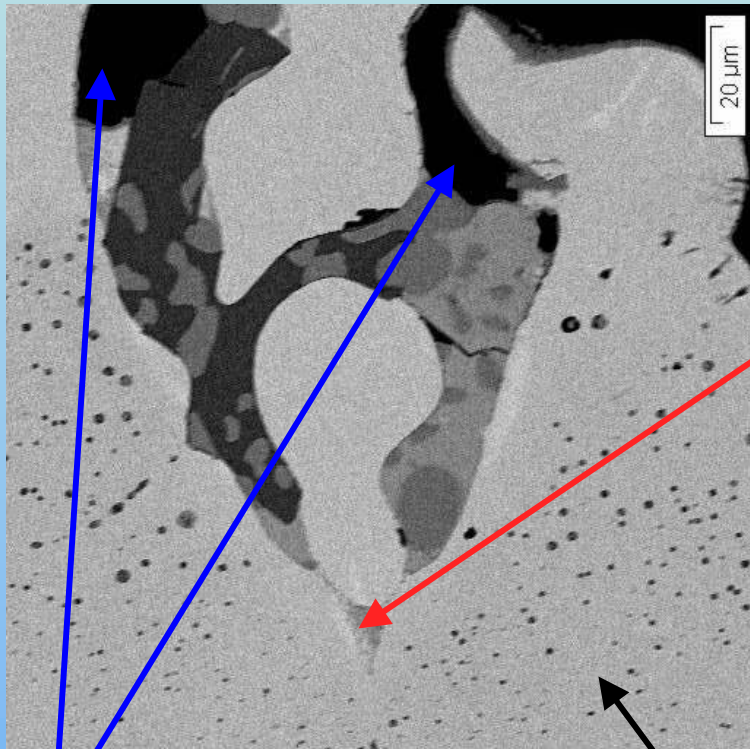
Voids
