5 WTC 7

5.1 Introduction

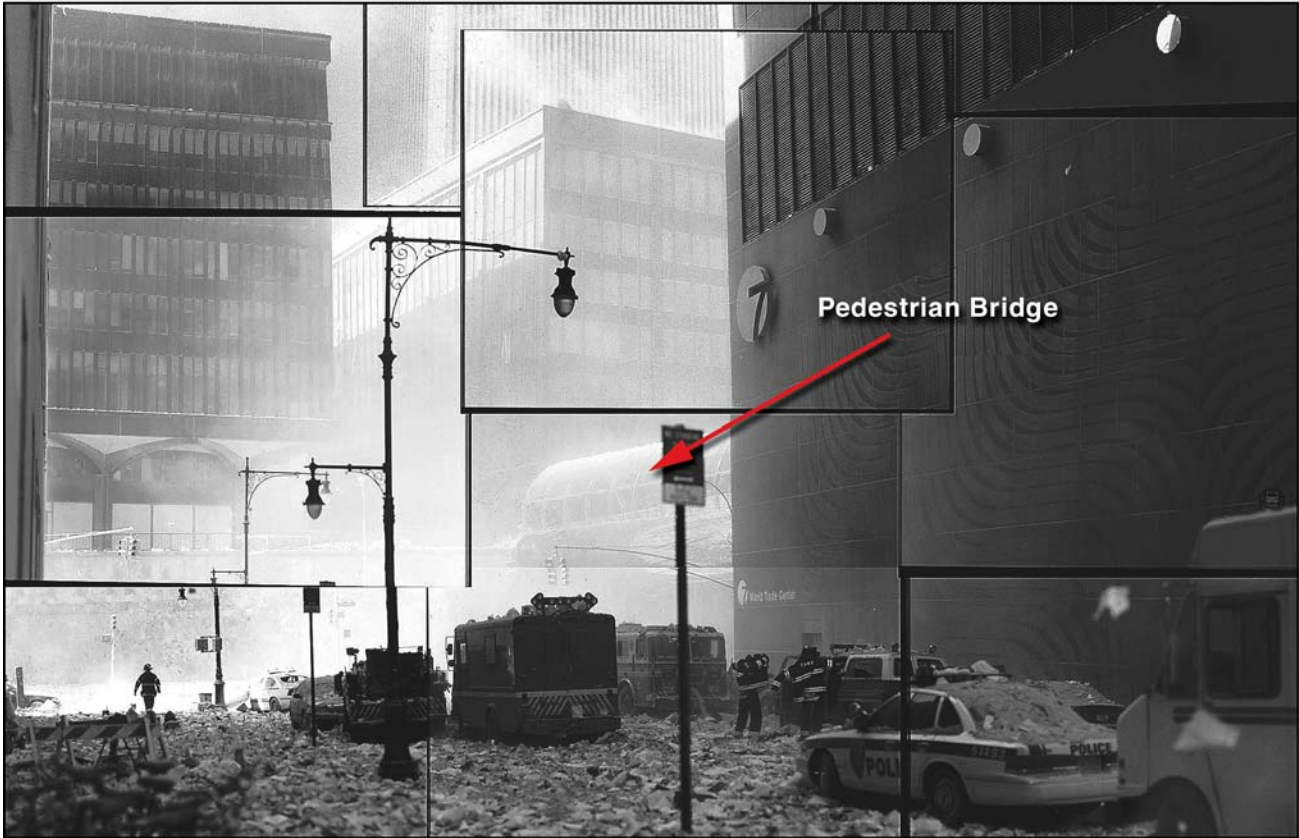
Figure 5-13 Pedestrian bridge (bottom center) still standing after WTC 2 has collapsed, sending substantial dust and debris onto the street, but before WTC 1 (top center) has collapsed.

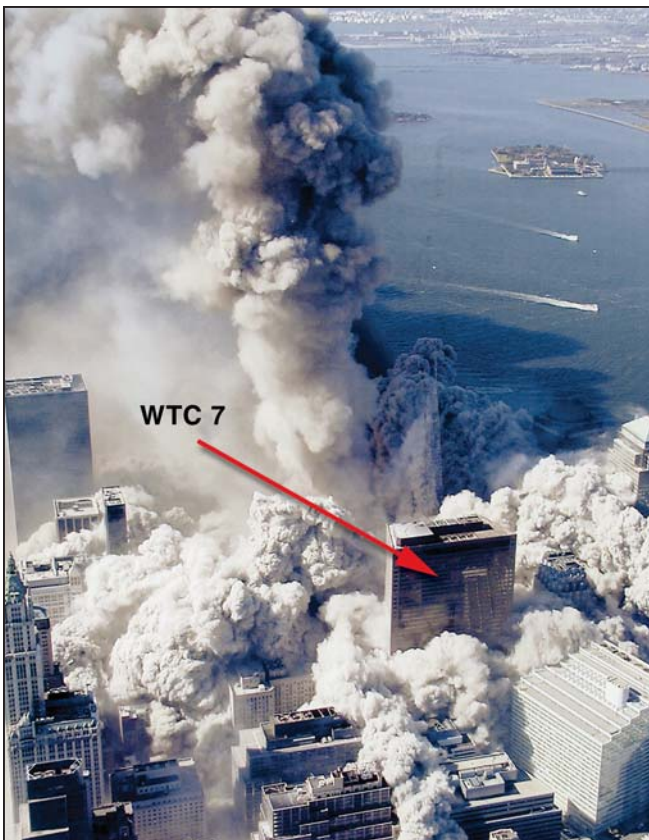
Figure 5-14 View from the north of the WTC 1 collapse and the spread of debris around WTC 7. Note the two mechanical penthouses of WTC 7 are intact.
