Preliminary Root Causes Analysis of Failures of the Oroville Dam Gated Spillway

R. G. Bea

Center for Catastrophic Risk Management
University of California Berkeley
April 17, 2017¹

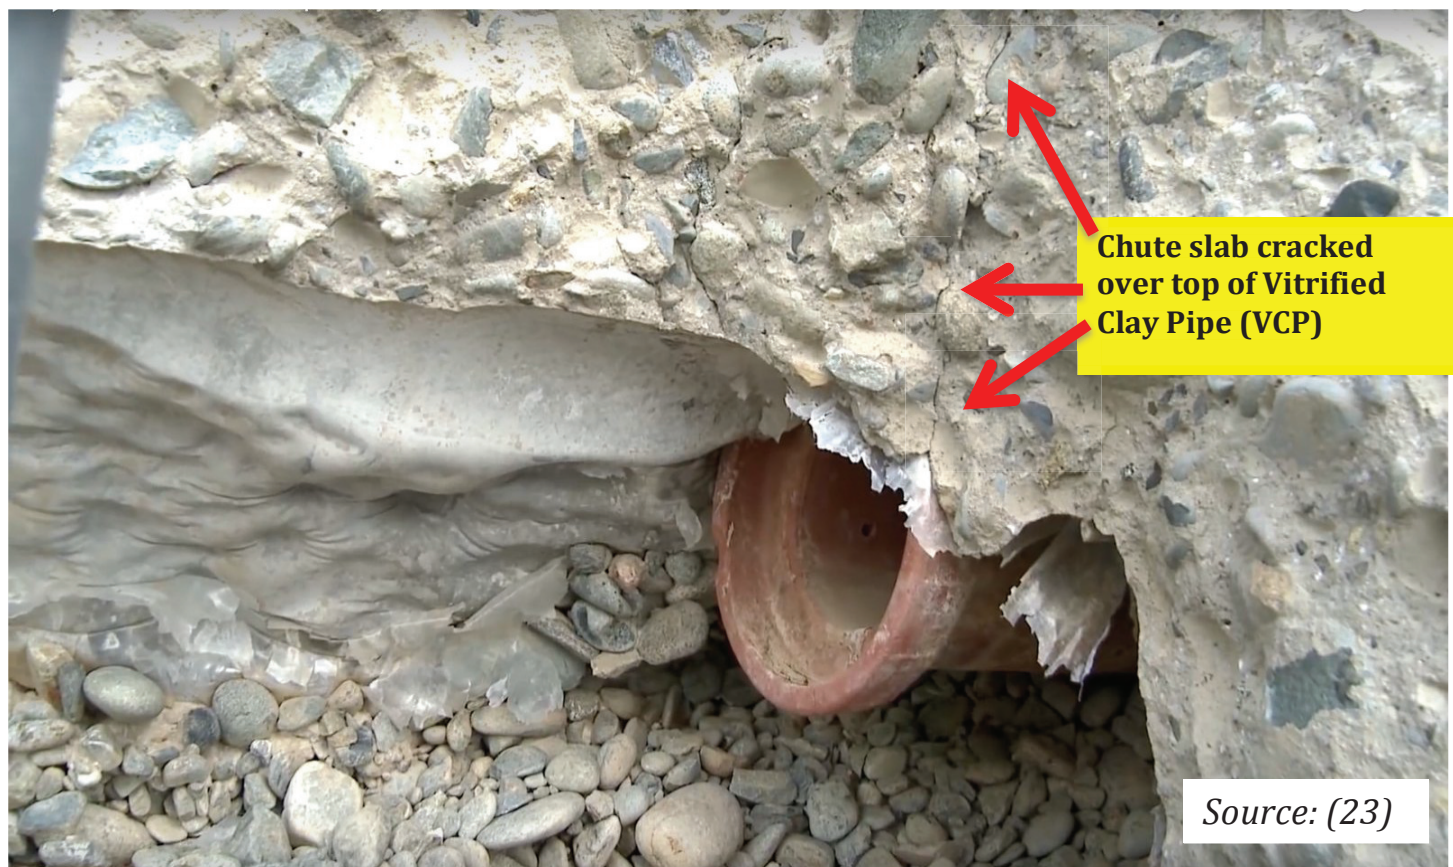
DETAIL A
LATERAL EXPANSION JOINT
Scale: 1" = 1'

One layer of 2-way steel reinforcement at top of slab

No 'continuous' steel across joint to prevent slab separation

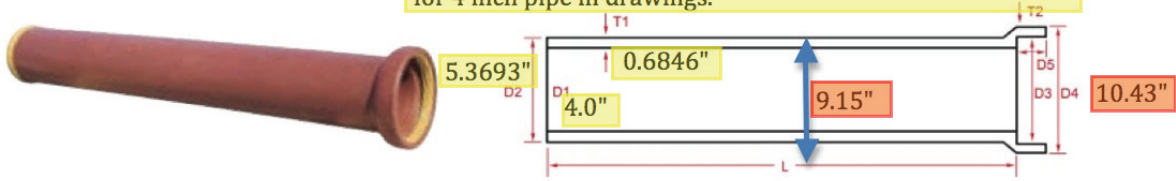
Standard Bell & Spigot

Oroville Design 1"=1' dwg dimension scale converted values for 4 inch pipe in drawings.

Spillway DESIGN Changed to 6" I.D. Drain Pipe: New dimensions should be very close to this table (6" D1, 7.87" D2, 10.43" D4)

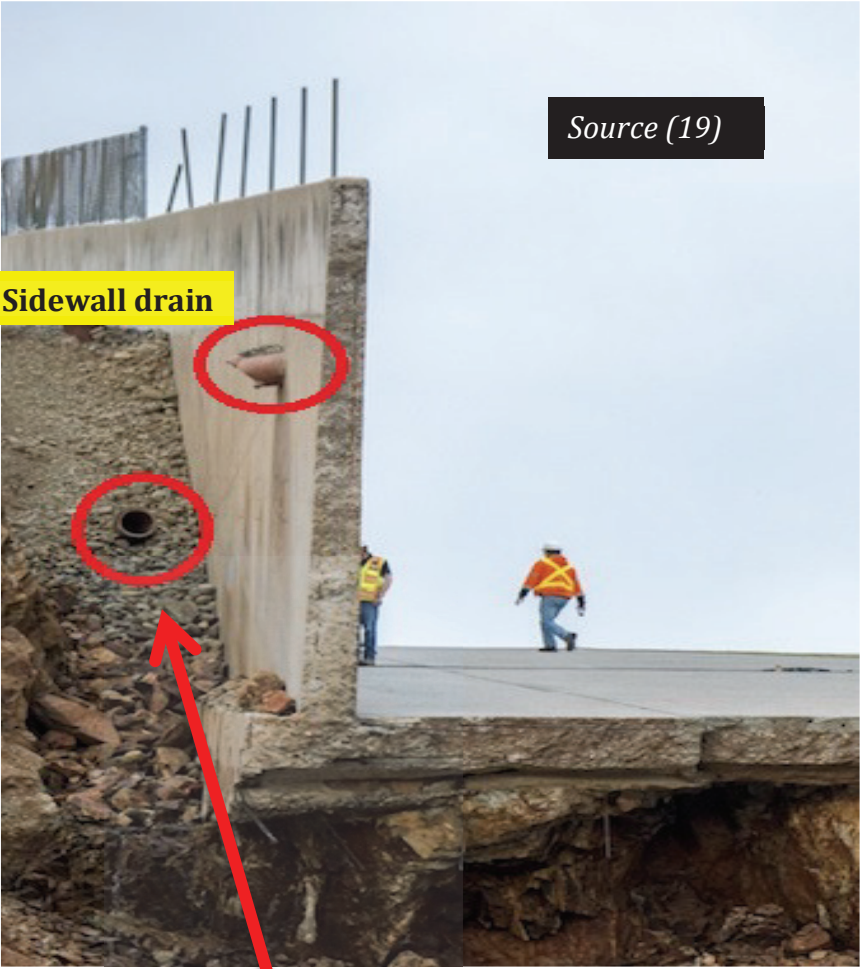
Sidewall drain

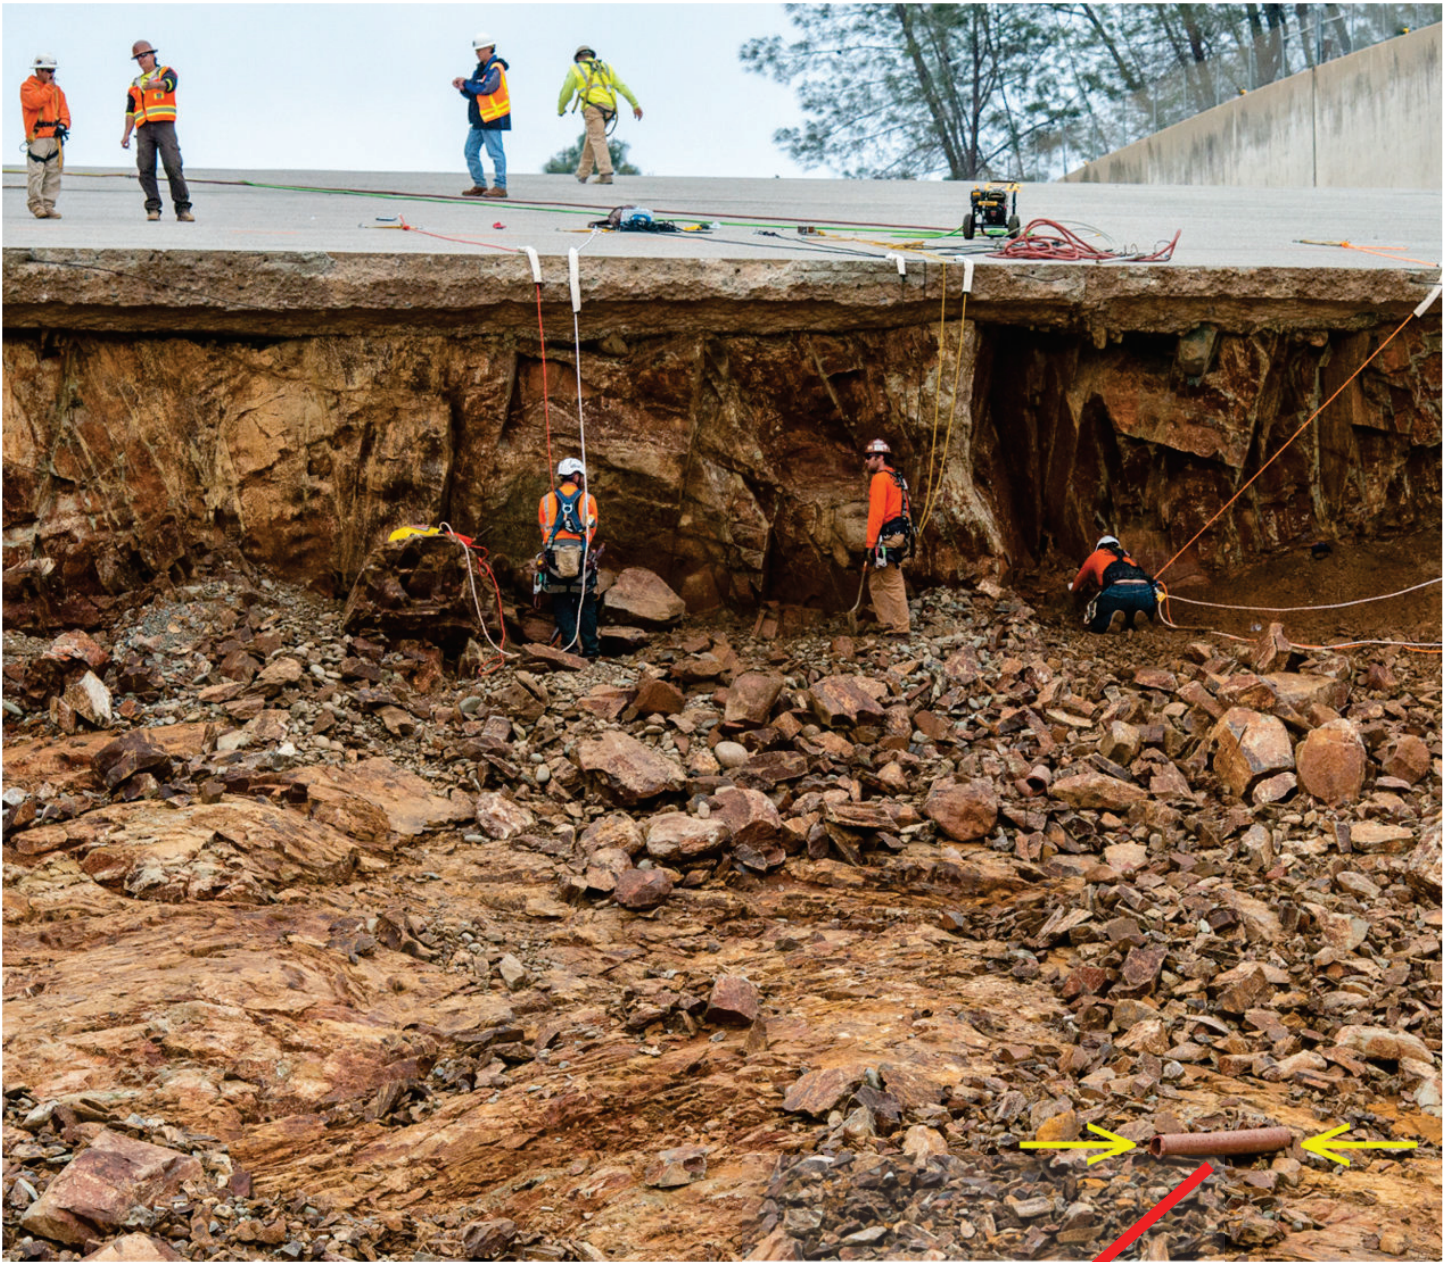
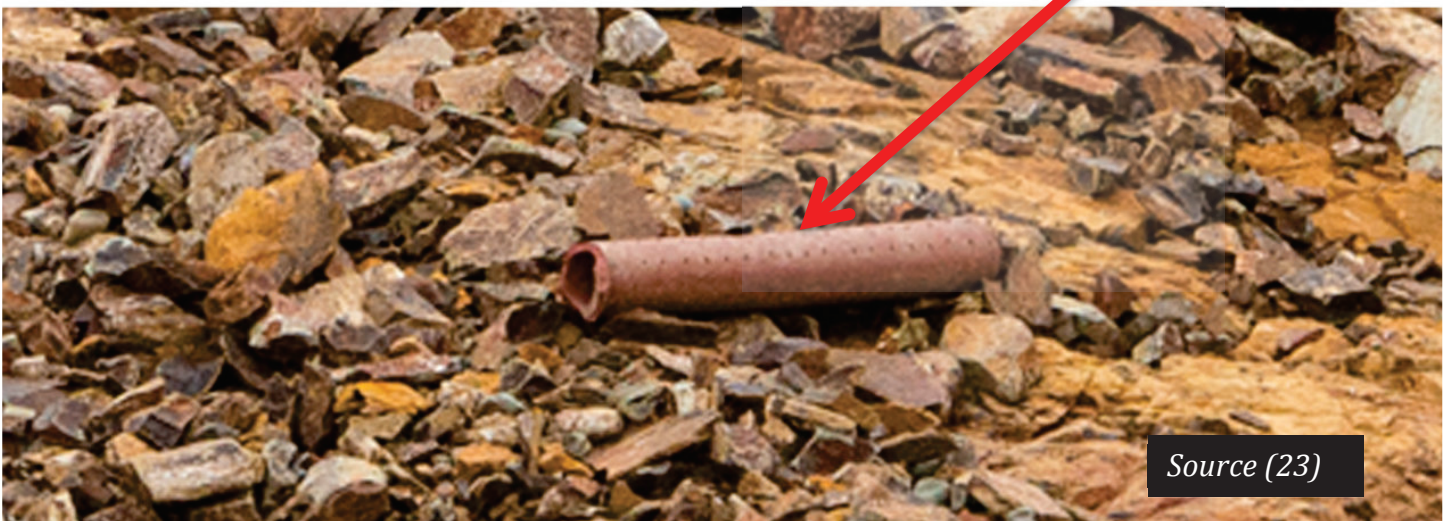
Concrete fractured along
drain pipe emplacement
