Collapse of the 16-Story Plasco Building in Tehran due to Fire

Abstract. On January 19, 2017 an accidental fire, which started by an electric shorting, resulted in the complete collapse of the 16-storey Plasco Building in Tehran. Twenty-two people including sixteen firefighters were killed in that incident. This paper reports the study carried out to investigate the most likely causes of the events and collapse of the structure. The information presented in this study was collected through gathering the limited amount of available information on the structure, generating as-built structural drawings, reviewing construction photographs, interviewing fire-fighters and other witnesses, frame-by-frame analysis of a number of available videotapes showing the structure during the fire as well as during the final stage of collapse. Based on these information and some engineering judgments, the paper summarizes the sequence of events from the start of the fire to final collapse, almost 3.5 h later, and the inferred scenario explaining how the structure collapsed completely. Recommendations are provided based on the lessons learned from that incident.

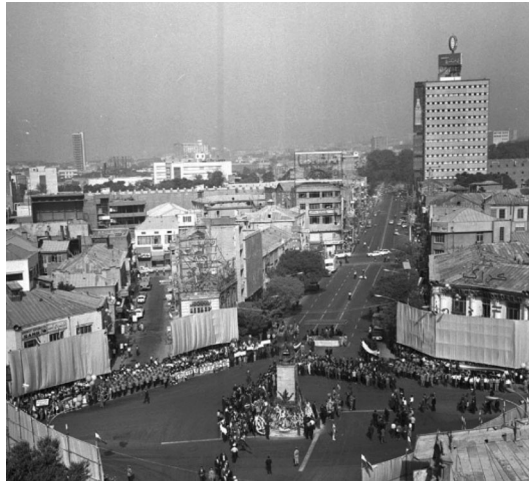
Figure 1. Plasco building in 1962.

The 16-storey Plasco building located in Tehran, the capital city of Iran, was known as the tallest steel building of the region, when its construction finished in 1962 (see Fig. 1). This building consisted of several retail shops, clothing workshops, and some restaurants.

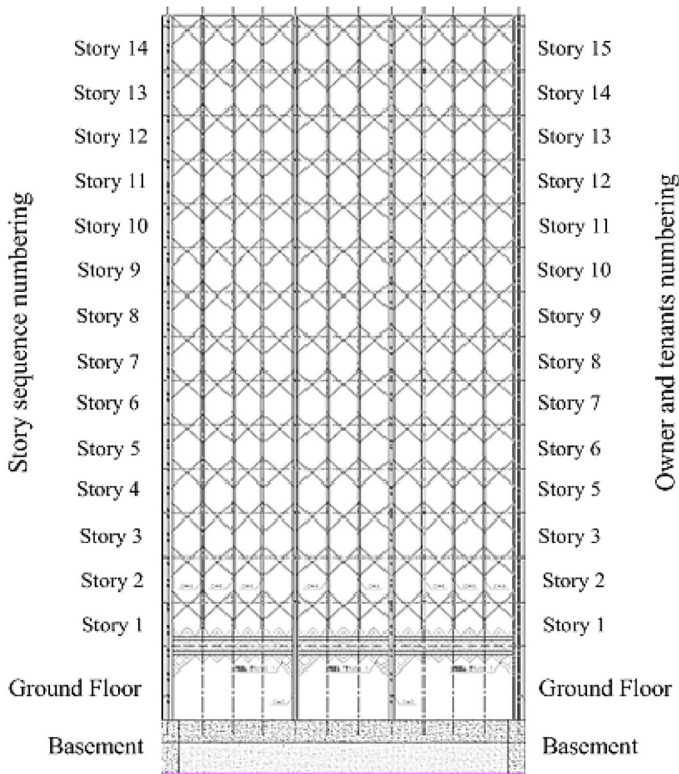
Figure 3. Storey numbering in Plasco building.

The Plasco tower consisted of 16 storeys including an underground floor, a ground floor, and fourteen storeys above the ground. Figure 3 shows the elevation view of the building. On the left side of the figure, floors are labeled based on their sequence. However, the owner and tenants used a different numbering to designate the floors, as shown on the right side of this figure. In this numbering the basement, ground floor, and three storeys above it had the same number, but

due to the existence of some units on the roof of the building located in the north of tower, the fourth storey of the tower was called Storey No. 5. Since all the reports published in media refer to the latter numbering, when the fire events are described, this numbering is used in this paper.

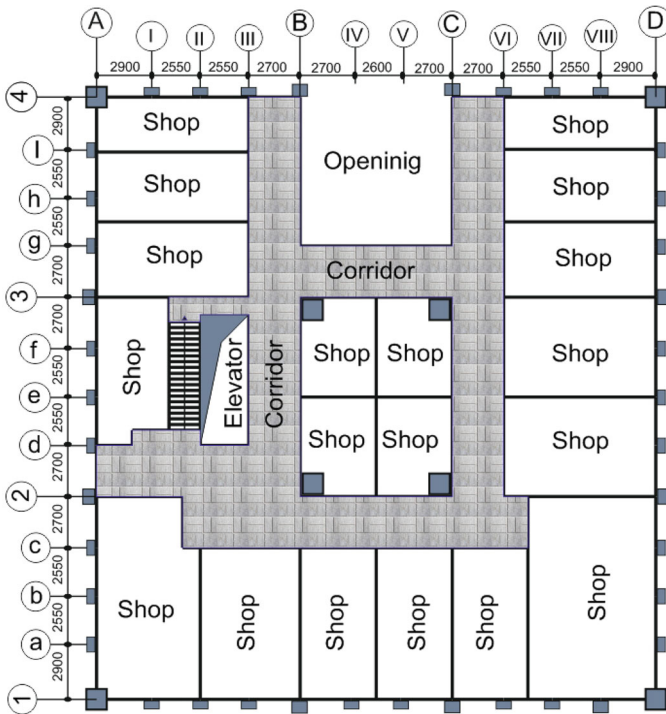
Figure 4. Architectural plan of the second storey (unit: mm).

The building had a fairly simple architectural plan. Figures 4 and 5 show the plans of second and sixth storeys as the typical lower and upper floors, respectively. In the lower floors, which were used as shops, there was an opening in the center and continuous corridors existed around that opening for access to the shops. But in the fifth storey and all storeys above, which were used mainly as clothing workshops, there was no opening except for the staircase and lift shaft. Access to the storeys was provided by a stair and lifts located at the western part of the main tower. As it can be seen in the Figs. 4 and 5, the stair was a one-way ramp and its width was 1.6 m.

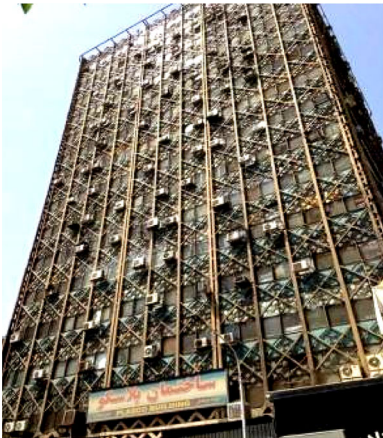
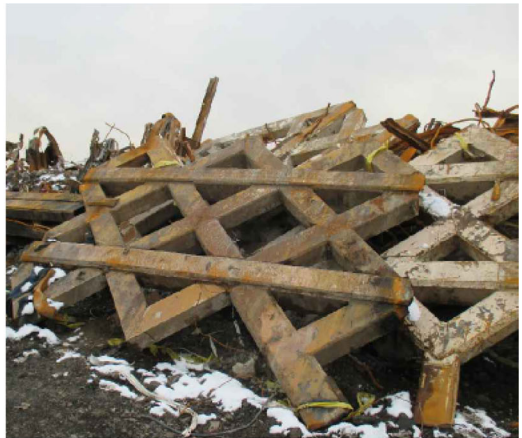
Figure 6. Steel structure facade in south face of the building.

The exterior sides of the building were covered by steel structure facades in northern and southern sides and cement facade in western and eastern sides. The steel structure facade contained heavy steel members in various dimensions. The southern facade is shown in Fig. 6.

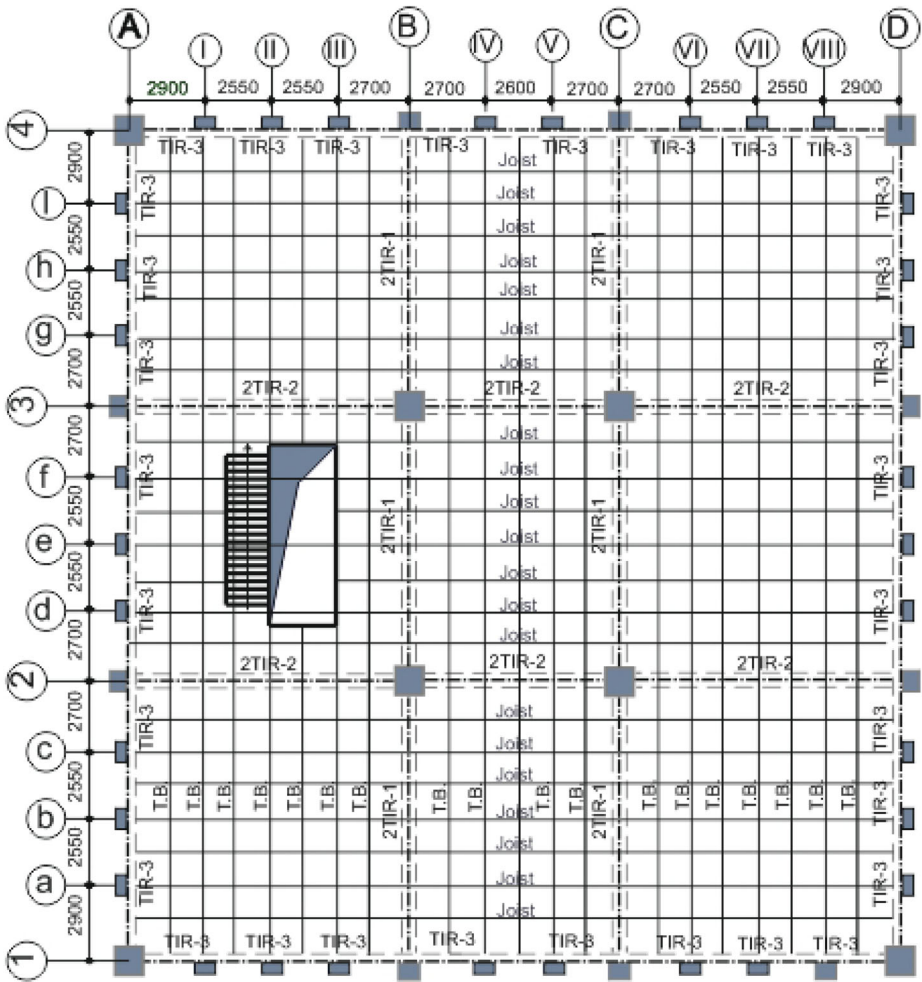
Figure 7. Typical plan of the structure (unit: mm).

Figure 7 shows a typical plan of the building. The framing of structure consisted of concrete members in the basement and steel members at all storeys above the ground. Concrete columns and beams in the basement had square and rectangular cross-section respectively reinforced with plain bars. Built-up sections were used in all steel members of the structure. Each corner column section consisted of four double channel sections. Steel box members were used to connect double channel sections of the corner column. The perimeter columns, which were located on the main axes of the building, consisted of two double channel sections, whereas other perimeter columns consisted of one double channel section only. The sections of the interior columns also composed of four double channel sections with a differ-

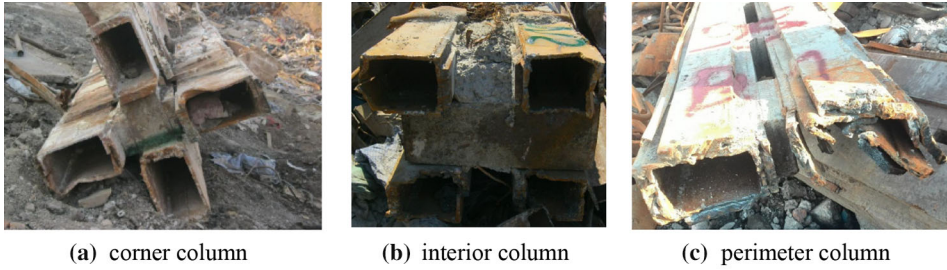
Figure 8. Column sections.

ent configuration compared to corner columns. The section of the diagonal braces also consisted of double channel sections. The photographs of the corner, perimeter, and interior column sections are presented in Fig. 8.

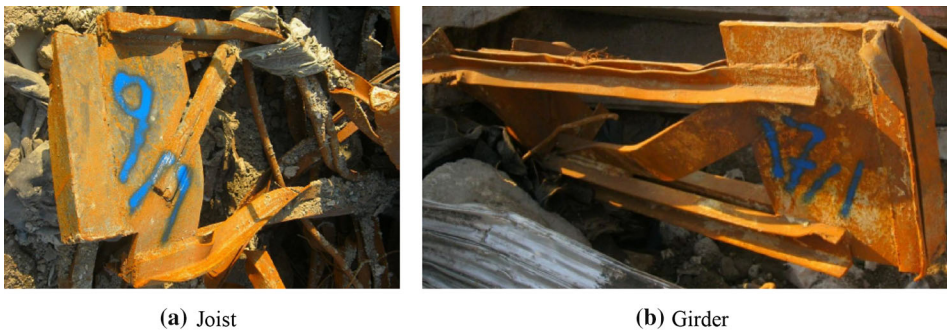
Figure 9. Floor joists and girders.

The floors contained a 13-cm thick concrete slab. The slabs were supported by open web joists and tie beams, which transferred the gravity loads to the truss type main girders. The global structural system was a semi framed-tube system consisting of only 4 interior columns and a number of closely spaced columns (see Fig. 6) with diagonal braces on the exterior face of the structure. The column spacing in the exterior tube ranged from 2.5 m to 2.9 m. In total, there were 46 perimeter and corner columns in the structure. Figure 9 shows photographs of typical joists and girders used in Plasco building. Both chords of the joists consisted of double angle sections. The joists also contained diagonal double bars, and vertical plates as the web. In the main girders, which were generally similar to the joists, the diagonal double bars and the double angle sections in bottom chord were replaced by diagonal plates and double channel sections, respectively.

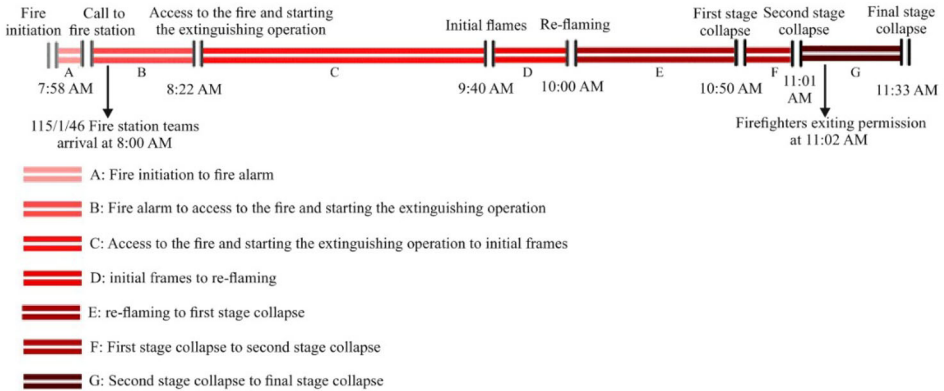
Figure 11. Timeline of the incident.

As indicated in Fig. 11, the building collapsed in three stages. This section tries to present an interpretation of these stages. Different steps described in this section are based on the evidences and engineering judgment. However unfortunately there is no evidence of what happened inside the building during the final stage of the collapse.

The surviving firefighters stated that in the first stage of the collapse, north-western part of the floor 11 (see Fig. 12) collapsed on the floor 10. Due to persistence of fire in this area for about three hours, this collapse must have been caused by the effects of rising temperature on the structural elements of the flooring system. As explained in Sect. 3.2, the slabs were supported by open web joists and tie beams, which transferred the gravity loads to the truss type main girders. Photos of these joists and girders were presented in Fig. 9. The webs and bottom chords of these truss type members were directly exposed to fire in the space between the main slab and false ceiling without any fire protection. According to firefighters those slabs had visible deformations before collapse. From the structural point of view the final collapse of the floor in that part must have been due to failure of the connections of main girders to the columns [30].

In the second stage, about ten minutes later, same part of the floors 12 and 13 also collapsed on floor 10. Obviously the floor structure could not support so much additional load and this caused partial collapse of the all lower floors
