# **A Structural Reevaluation of the Collapse of World Trade Center 7**

*Draft*

**INE Report 18.17**

**September 2019**

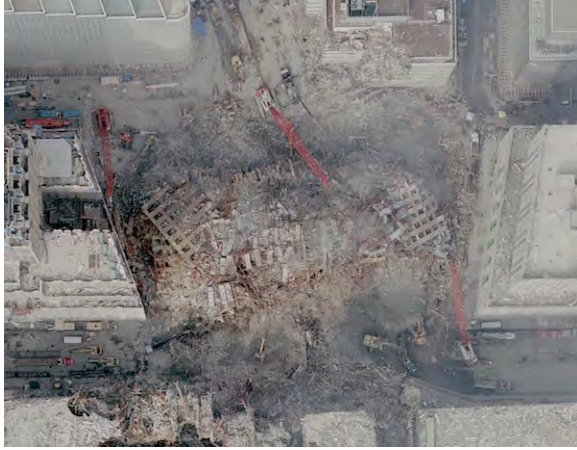
Figure 1.7 WTC 7 debris pile (NOAA, September 23, 2001).

2. The debris pile of WTC 7 was contained mostly inside the building's footprint. Furthermore, it did not have large pieces of concrete flooring or intact structural framing that would be expected in a building collapse (see Figure 1.7).

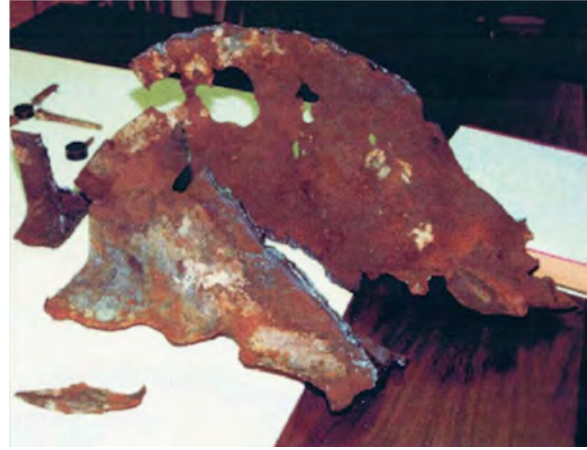
Figure 1.8 Steel from WTC 7 that experienced oxidation and sulfidation (FEMA, 2002).

3. According to Appendix C of FEMA's May 2002 report, a steel member recovered from WTC 7 was found to have experienced corrosion due to a combination of oxidation and sulfidation at 1,000°C, resulting in the formation of a liquid eutectic (see Figure 1.8). Researchers have hypothesized that the presence of thermate, which is a form of thermite

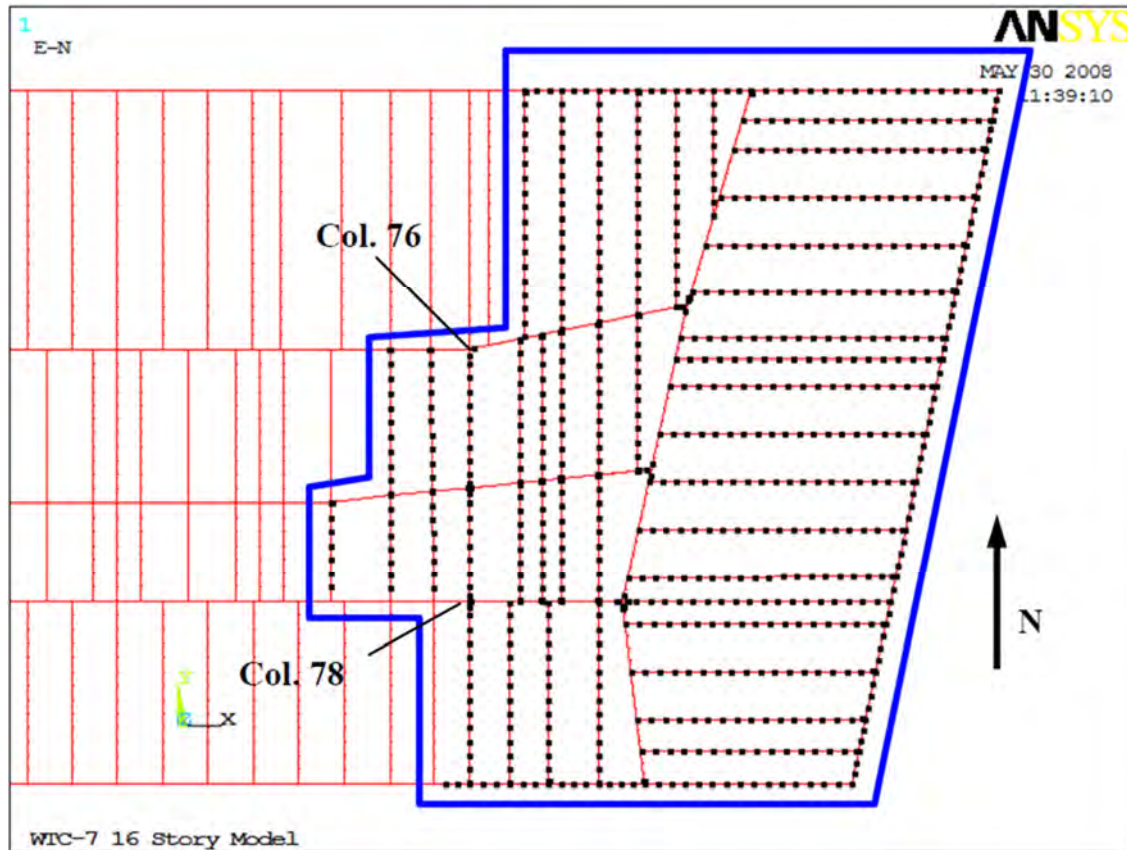
Figure 2.4 Area of floor where connection failure was modeled by NIST

In the NIST investigation, the failure of the floor-framing connections and the shear studs was modeled with break elements on Floors 8 to 14. Outside the selected area in Figure 2.4 shown below, structural damage — such as buckling of the steel frame and crushing and

cracking of the concrete slab — was modeled over the entire floor, but connection failures were not modeled over the entire floor. Connections were also not modeled in the exterior moment frame, as no failures were observed there prior to the onset of global collapse (NIST, 2008, NCSTAR 1A).

First, by not modeling connections in the outside frame, NIST overestimated the rigidity of the outside frame. That assumption and inconsistent modeling for the framing connections resulted in the stiffness of the east side of the building being different than that of the west side. This resulted in the stiffness being compromised across the plan of the building.

The NIST simulation of the collapse illustrated that the west side of the building acted differently from the east side. The structural response to failure would more closely resemble the actual collapse if the connections had been accounted for throughout the structural frame. By not modeling the connection failures outside the selected area shown in Figure 2.4 above, NIST appears to have reduced the stiffness in the area outside the selected area and separated its progressive collapse simulation into two parts (see Figure 2.5).

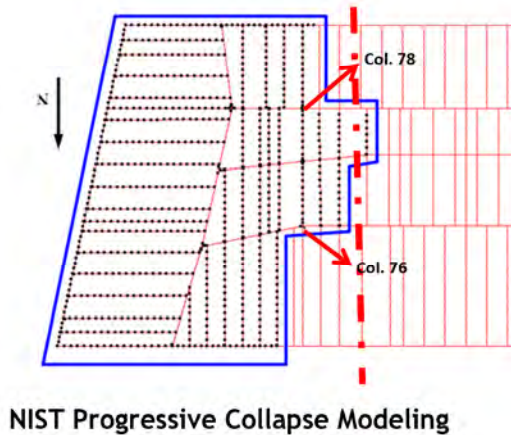
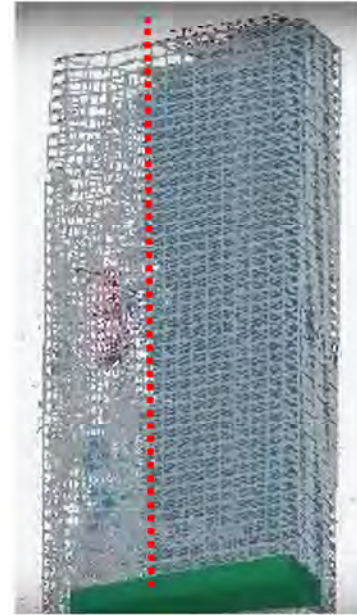
Figure 2.5 Progressive collapse separated into two parts.

**Connections were not modeled; outside selected blue space.**

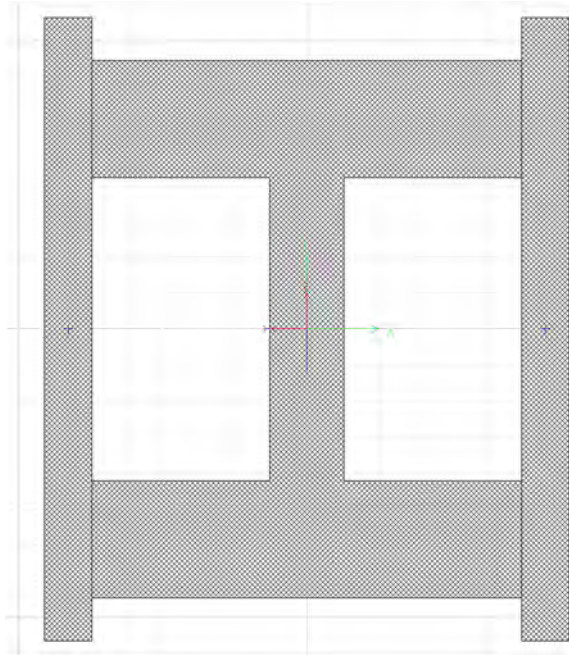
Figure 2.15 Cross section of Column 79.

Column 79 at Floor 13 was a built-up column consisting of W14×730 and two steel plates 2 inches thick by 26 inches wide welded on the sides. Figure shows the cross section of Column 79. Figure 2.16 shows the mechanical properties of steel against temperature (Engineeringtoolbox, 2011). A buckling analysis was conducted for Column 79 according to the AISC Steel Construction Manual (AISC, 2011). Figure 2.17 shows the load capacity of Column 79 versus the effective length at different temperatures assuming a pinned-pinned condition. The two red lines mark the effective length of 12 feet 9 inches and 25 feet 6 inches. The two effective lengths are the single floor height and the double floor height. The loading capacity of Column 79 at double floor height (25 feet 6 inches) would be the load capacity of the column during the fire if Column 79 were to lose its support on one floor.

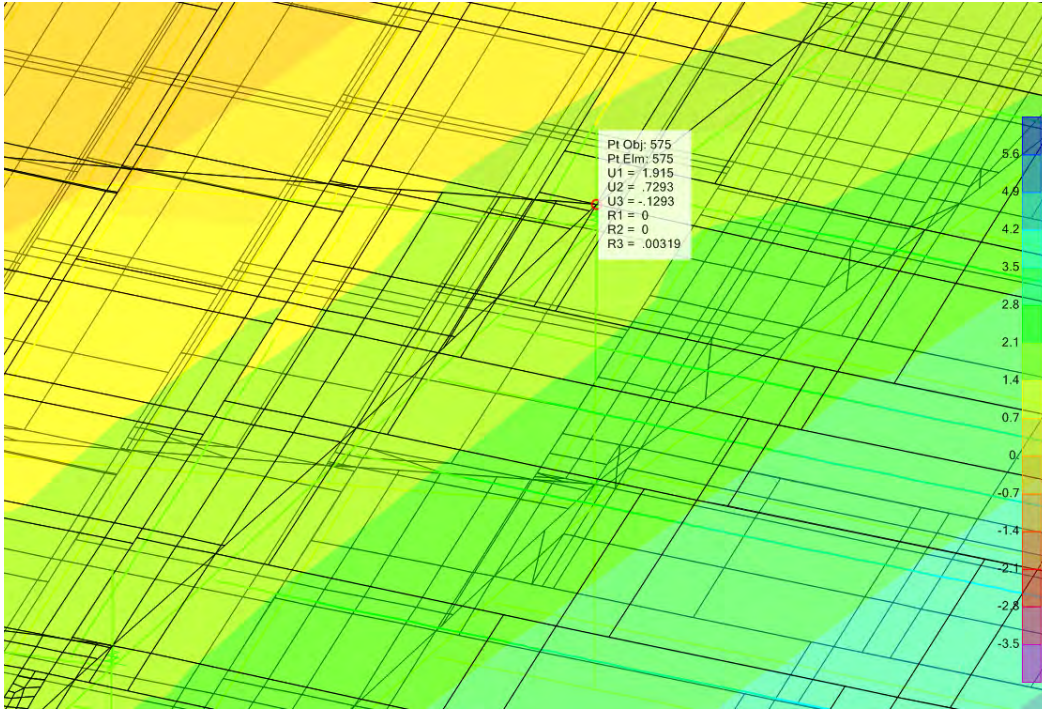
Figure 2.58 Displacement (inches) of the floor system surrounding Column 79.

Figure 2.58 shows the displacement of the floor system surrounding Column 79. The displacement at Column 79 in the  $x$ -direction was 1.915 inches east (and not west), and the displacement at Column 79 in the  $y$ -direction was 0.7293 inches. Note that this is the overall displacement of the floor system. The westward displacement of girder A2001 relative to Column 79 was found to be less than 1 inch, which differs substantially from the 6.25 inches of westward movement of girder A2001 reported by NIST. We believe this is because NIST treated

the exterior frame as infinitely stiff and fixed it against horizontal movement. Our analysis was based on using the actual external frame stiffness, which was very flexible.

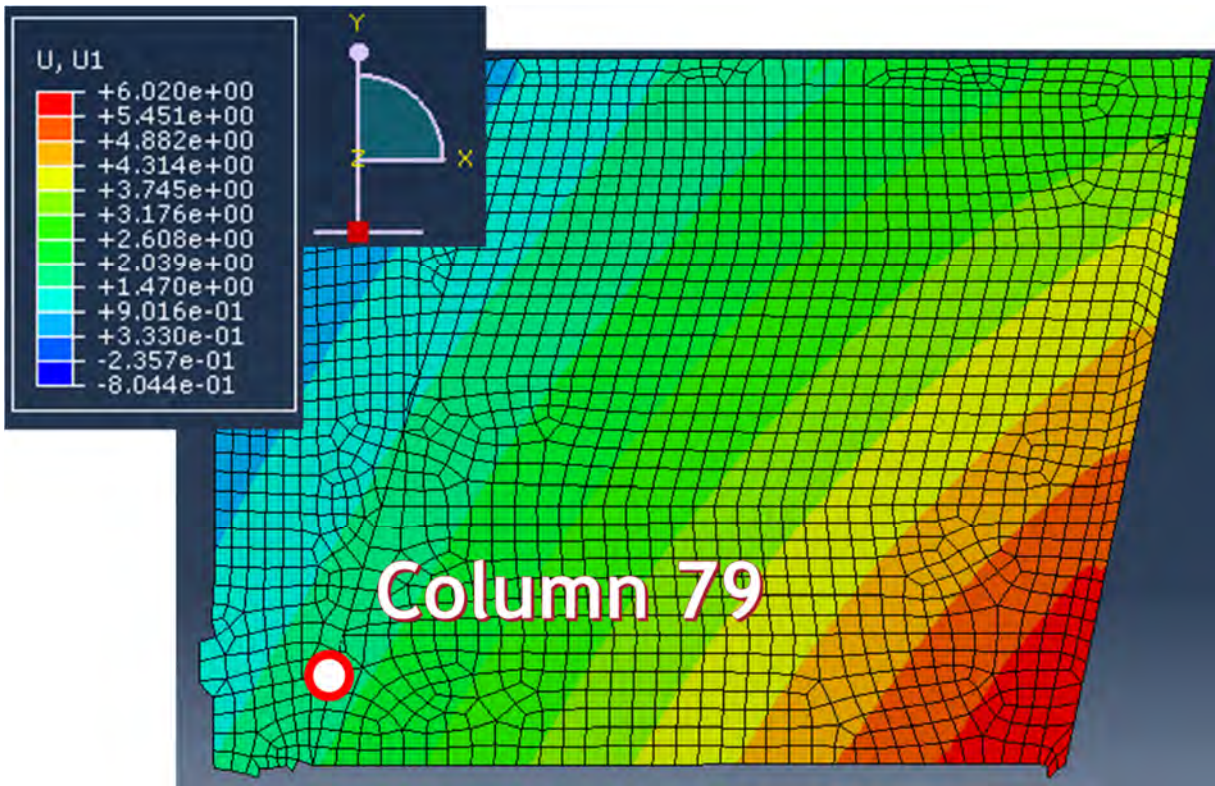
Figure 2.62 Movement in x-direction at Floor 13 around Column 79.

According to NIST, the initiating failure occurred at the connection between Column 79 and girder A2001 at Floor 13 due to a relative displacement of girder A2001 of 6.25 inches. Our ABAQUS analysis corroborated the findings of our SAP2000 analysis, showing that girder A2001 would undergo less than one inch of westward displacement relative to Column 79 under the worst-case fire condition. Examining all possible conditions, our analysis found that the westward movement of girder A2001 relative to the base plate on Column 79 was 3.68” for non-composite, 2.18” for partially composite and less than 1” for composite behavior (the condition at time of the fire).

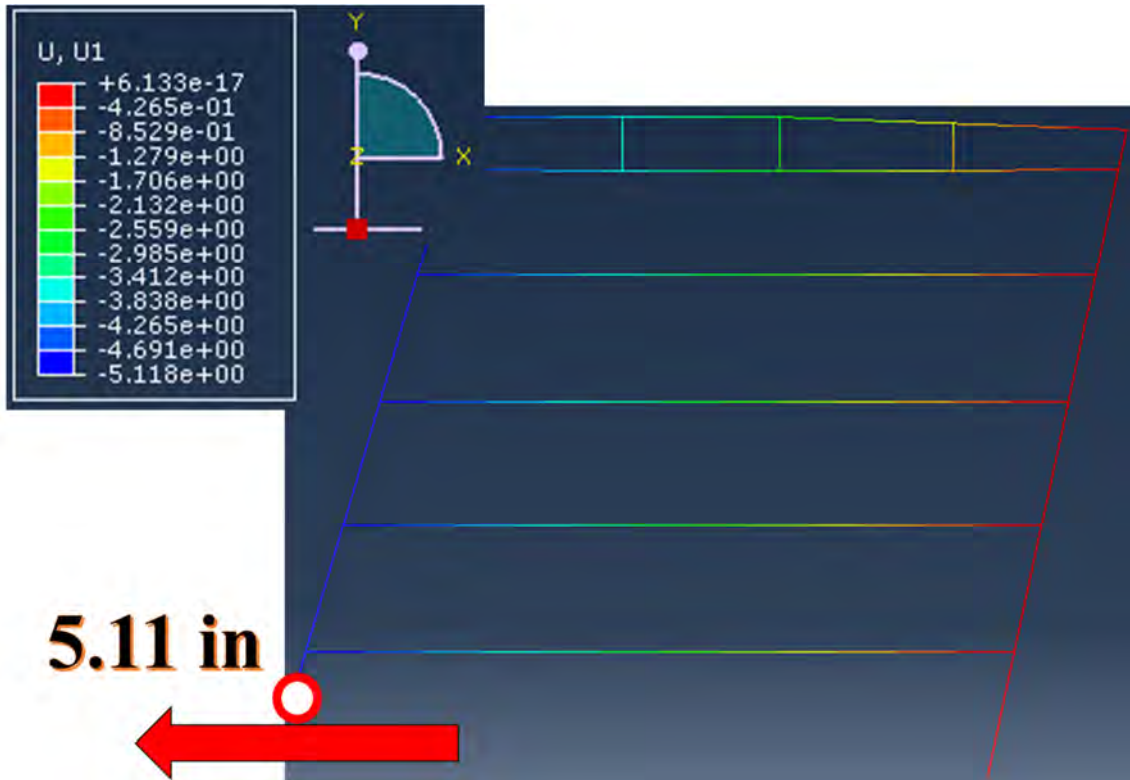
Figure 2.65 Transverse displacement at the end of A2001 using the NIST assumptions.

Figure 2.65 shows our calculation of the transverse displacement of the steel frame assuming the boundary conditions used by NIST. The horizontal displacement at the end of girder A2001 and Column 79 was calculated by our team to be 5.11 inches in the west direction. As stated above, it is important to note these boundary conditions, which were chosen by NIST, do not reflect the actual boundary conditions for Floors 12 and 13. The exterior frame is actually flexible and not fixed. The thermal point of zero movement is actually near the elevators where the building framing is stiffer. Furthermore, as stated above, all restrictions caused by other frames, columns, and the deck were excluded from this analysis.

When we incorporate NIST's boundary conditions and remove all restrictions to lateral movement, such as the Column 79 side plates, we find that the westward displacement of girder A2001 relative to Column 79 is 5.11 inches, which is a full inch less than the 6.25 inches of westward relative displacement reported by NIST, and nearly an inch less than the 6 inches westward displacement required to push the web of girder A2001 past its 12-inch seat at Column 79.

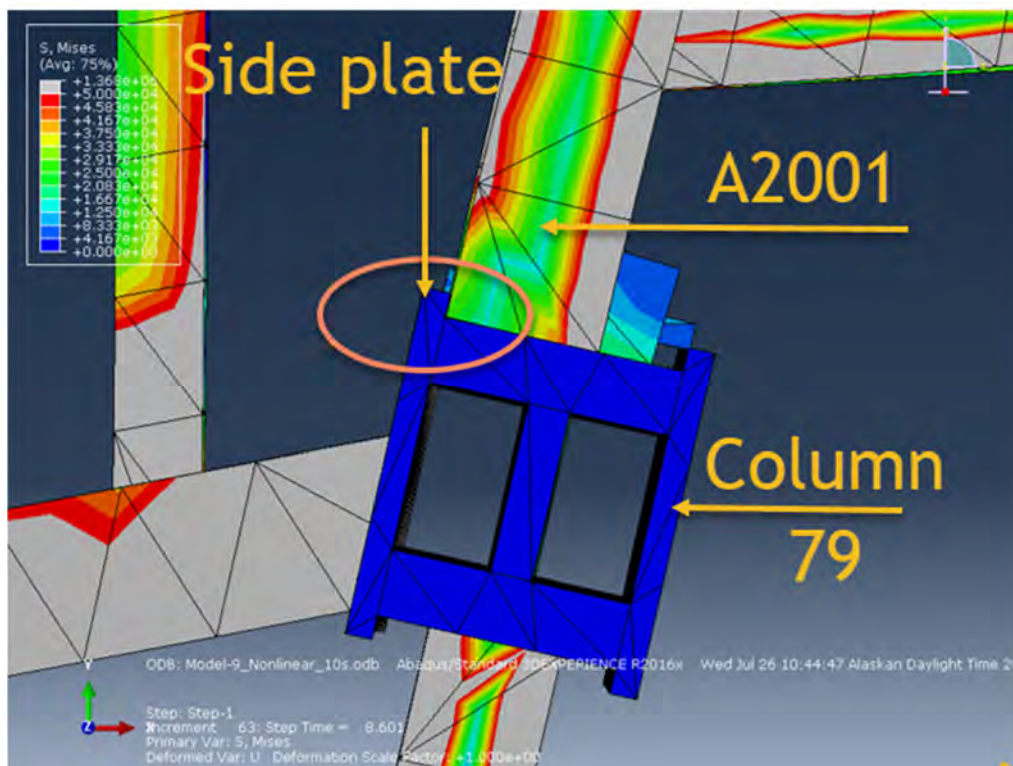
Figure 3.4 Plan view showing girder A2001 trapped by the Column 79 side plate.

First, we found that when girder A2001 is heated, it expands such that it becomes trapped behind the side plate on the western side of Column 79 as it is pushed to the west by thermally expanded beams K3004, C3004, B3004, A3004, and G3005 (see Figure 3.4).

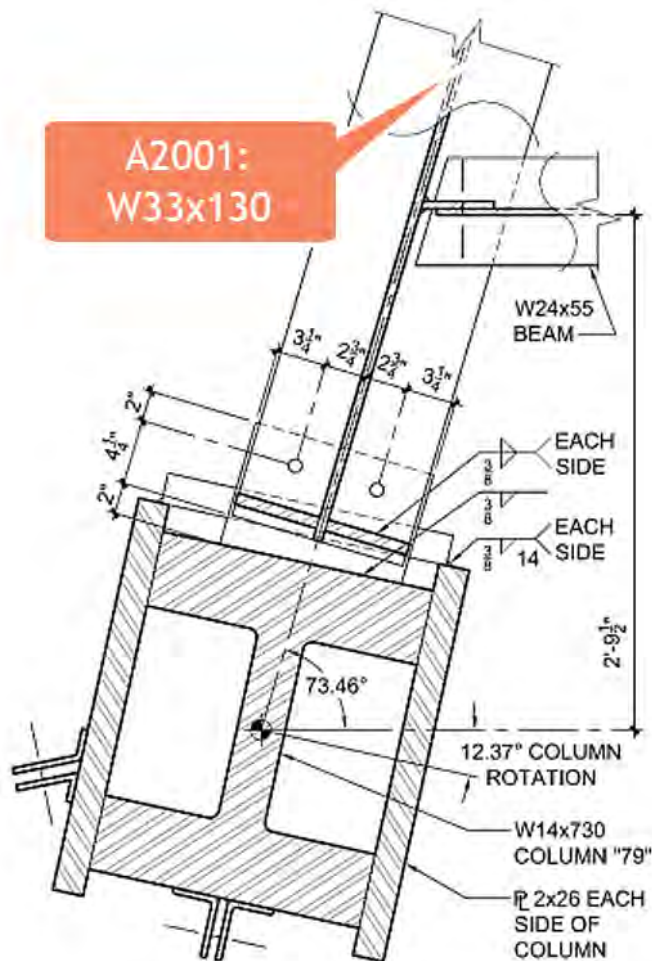
Figure 3.5 Plan View for Floor 13 at Column 79 and girder A2001 seat connection (Data from Frankel Steel Limited, 1985, Drawing 9114; figure prepared by Brookman, 2012).

Figure 3.5 shows the girder bearing seat at Column 79 is 12 inches wide. The flange width for W33 x 130 girder A2001 is 11.510 inches wide and centered on the seat; its web is 0.580 inches thick. This would require a lateral travel distance of 6.290 inches for the web to be beyond the seat. However, the distance between the column side plates is 17.89 inches. The girder and bearing seat are slightly off center to the east, with just 3.678 inches between the girder's western edge and Column 79's western side plate. Thus, the side plate prevents the girder's web from traveling beyond the bearing seat.

Given that the Column 79 side plate prevents the girder's web from traveling beyond the bearing seat, it appears that the structural analysis performed by NIST either minimized the side plate protrusion on Column 79 (nominally 1.79 inches) or ignored it altogether.

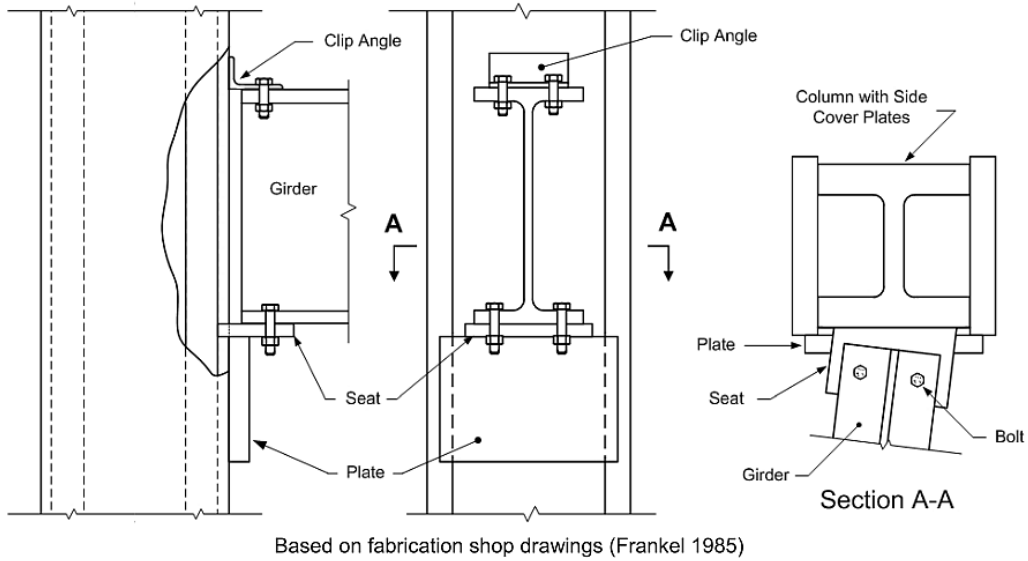
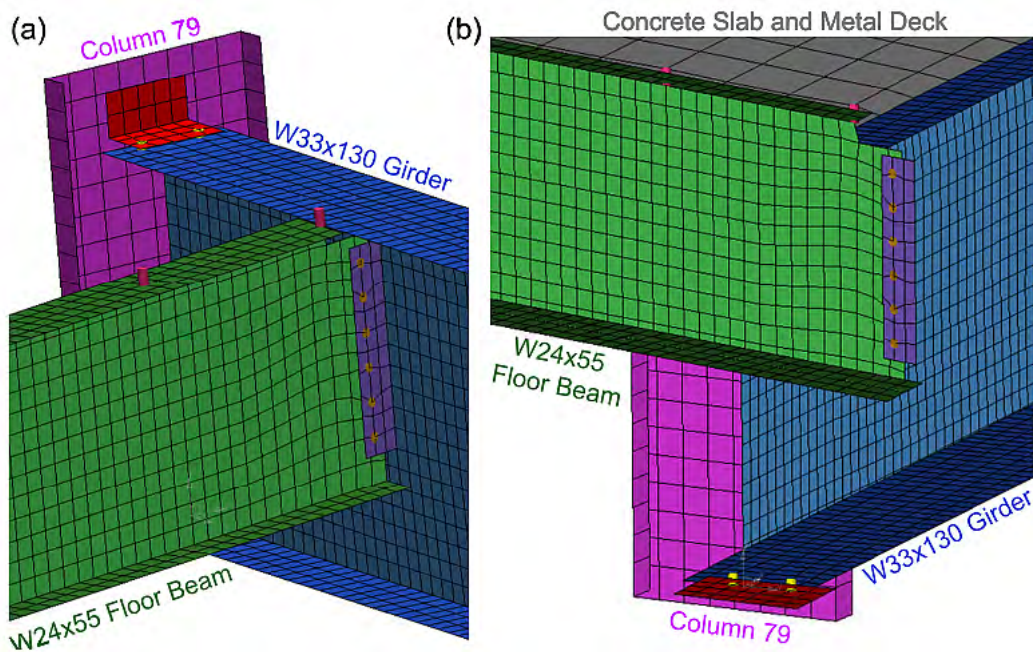
It is important to note that the analysis performed by NIST did not include the  $\frac{3}{4}$  inch thick x 5.5 inch wide x 18 inch high partial height web stiffeners on girder A2001. Released fabrication shop drawing Frankel 9114 shows that the stiffeners were part of that structural member (Frankel Steel Limited, 1985). In addition to stiffening the web, these stiffeners significantly increase the bending resistance of the flange and would have prevented it from failing due to flexure (assuming the girder were somehow able to bypass the column side plate). Note that the small amount of high stress on the corner of the girder's flange is not in a load bearing area. This stress is due to the girder flange being slightly compressed in the axial direction by its contact with the column flange when the girder is thermally expanded. Figure 3.7 shows that the stresses in the girder flange and stiffener are not sufficient to cause the flange to fail.

Figures 3.8 and 3.9 below, which are from the NIST report, show that the NIST report's drawing and analysis figures omit these web stiffeners. Figure 3.10 shows the actual configuration.

Figure 3.8 Drawing of Column 79 and girder A2001 seated beam connection shown in Figure 8-21 of the NIST report.

Figure 3.9 Figure 8-23 of the NIST report showing NIST's finite element analysis of the Column 79 and girder A2001 seated beam connection.

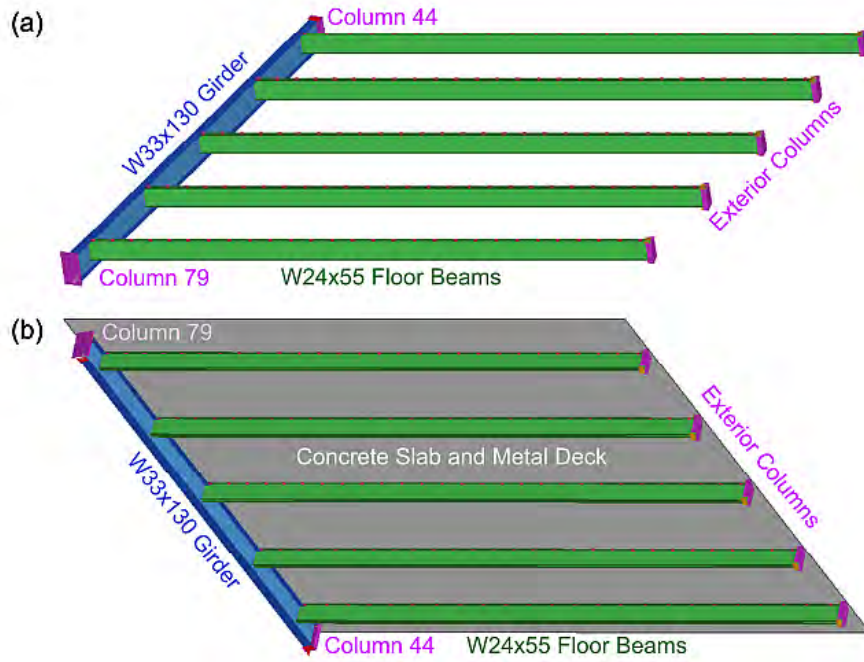
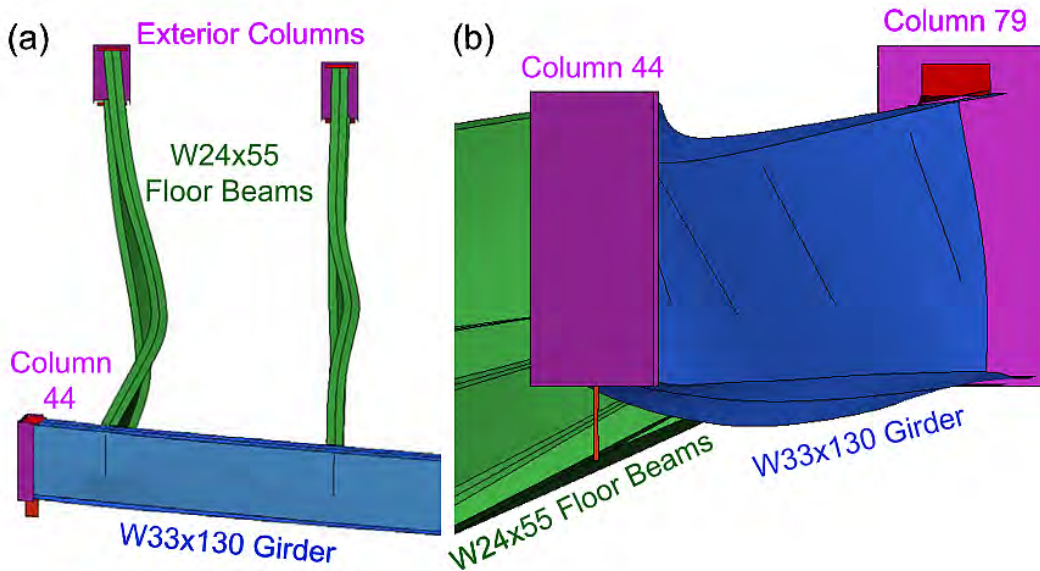
Figures 3.11, 3.12, 3.13, and 3.14 show our evaluation of NIST's preliminary hypothesis, which NIST used to determine whether the shear studs on the floor beams would fail when the floor system was heated. The NIST report posits that beam G3005 buckled because its thermal

expansion was restrained by girder A2001. Our analysis found that this can only happen when the three lateral support beams S3007, G3007, and K3007 spanning from beam G3005 to the north exterior wall are not included in the model. While these short beams are observed in some of the figures in the NIST report, they are missing from the model(s) used in the thermal and structural analyses shown in the report. It is important to realize that the lateral support beams have a significant effect and therefore should not have been omitted from the model(s).

Figure 3.12 Figure 8-22 in the NIST report shows analysis results for G3005 with no lateral bracing condition (NIST, 2008, NCSTAR 1-9, Vol. 1, Page 350).

Figure 3.13 Figure 8-27 of the NIST report shows results of a finite element analysis where lateral support beams connecting to G3005 were not included (NIST, 2008, NCSTAR 1-9, Vol. 1, Page 354).

When the NIST constraints are followed, our analysis showed that beams D3004 and K3004 would have also buckled (see Figures 3.11 to 3.14). The NIST results were based upon erroneously selected boundary conditions, wherein NIST assumed the east exterior wall was extremely stiff and acted as a fixed restraint against thermal movements. As discussed previously, this was not the case.

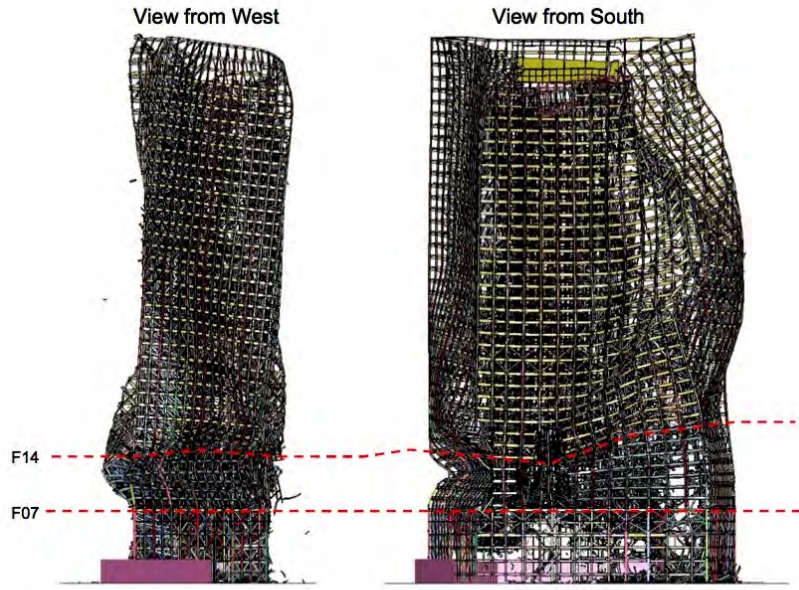
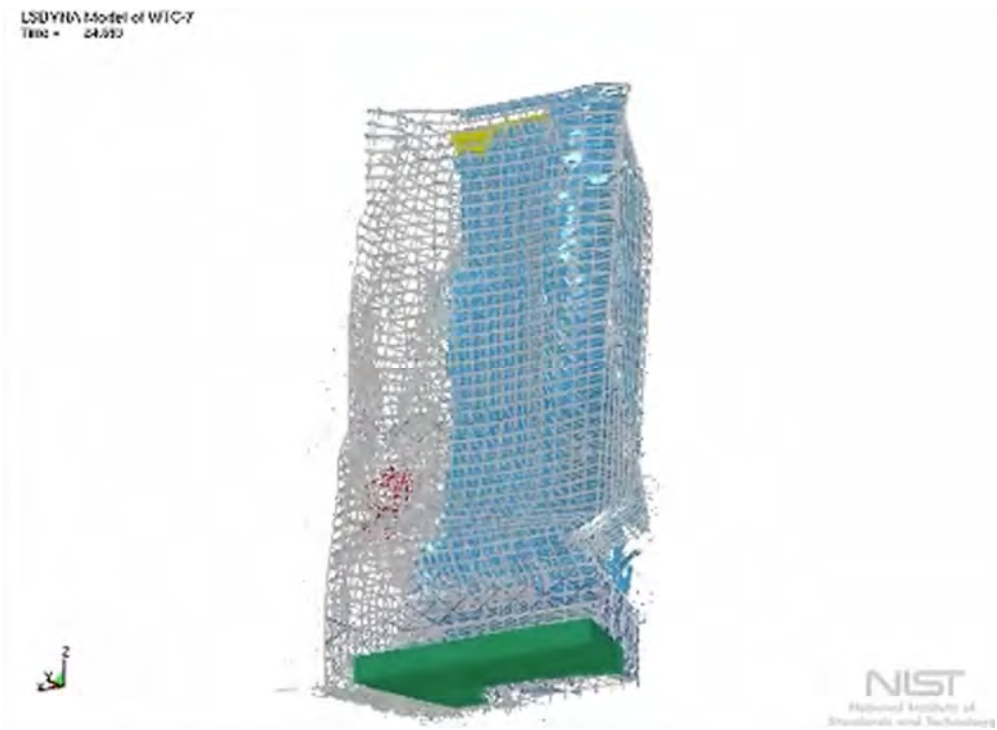
Figure 4.1 NIST’s progressive collapse simulation.

During our nonlinear connection study (Section 2.1.3.2), wherein we examined NIST's modeling of WTC 7's structural connections and its effect on NIST's progressive collapse simulation, we also observed that NIST's progressive collapse simulation did not closely resemble the observed collapse. While NIST's progressive collapse simulation does show the three key features listed above, it also predicts significant differential movements in the exterior, both before and during the fall of the roofline, that were not observed in the video (see Figures 4.1a and 4.1b). Such differential movements in the exterior would be extremely likely to have caused window breakage, cracking of the façade, and exterior deformation, none of which were observed. A major goal of our analysis was to identify failure mechanisms that would predict the minimal differential movement of the exterior seen in videos of the collapse.

(a) Illustration of NIST’s progressive collapse simulation showing significant differential movements in the exterior (NIST NCSTAR 1-9).

(b) NIST’s progressive collapse simulation showing significant differential movements in the exterior (NIST NCSTAR 1A).

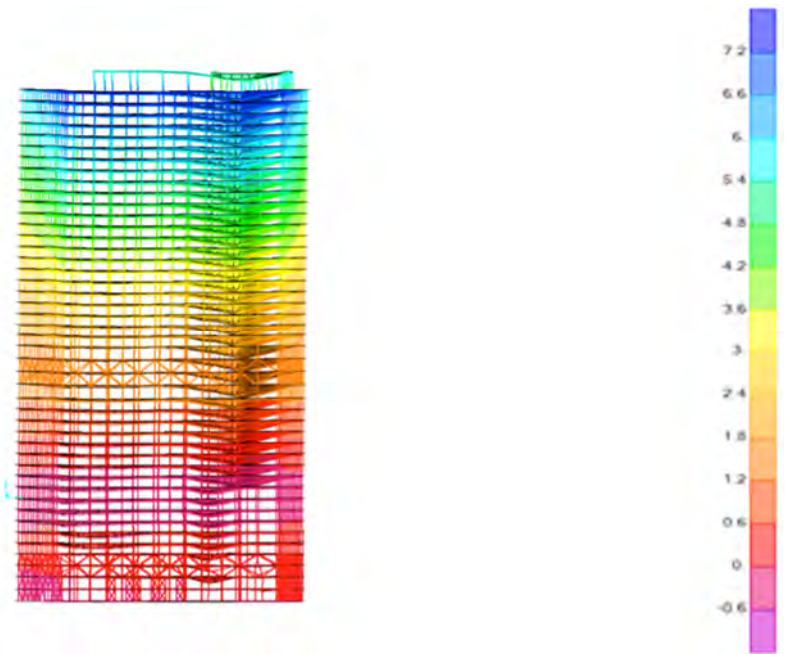
Figure 4.3: Columns 79, 80, and 81 are removed from Floor 13 to Floor 21. The building tilts to the east 7.2 inches. The penthouse does not collapse.

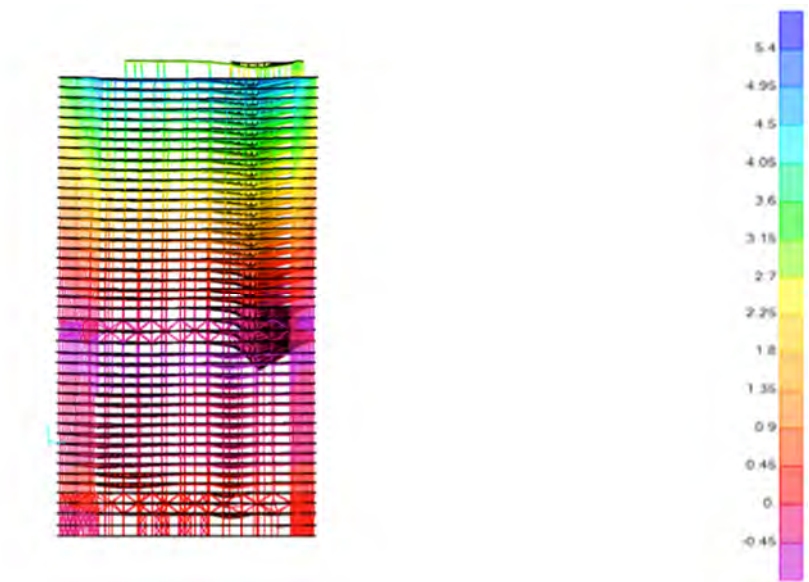
Figure 4.4: Columns 79, 80, and 81 are removed from Floor 21 to Floor 29. The building tilts to the east 5.4 inches. The penthouse does not collapse, though penthouse deflection increases.

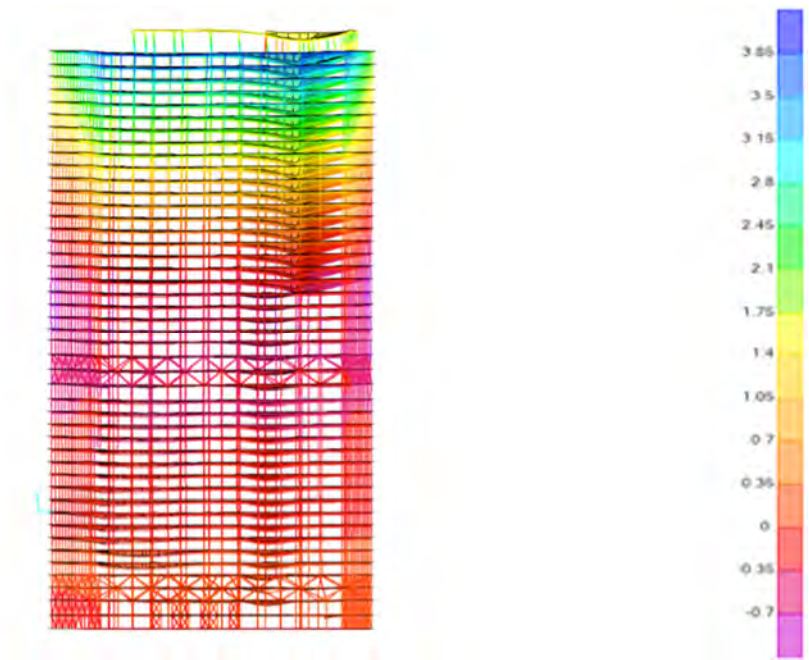
Figure 4.5: Columns 79, 80, and 81 are removed from Floor 29 to Floor 37. The building tilts to the east 3.85 inches. The penthouse does not collapse, though its deflection increases.

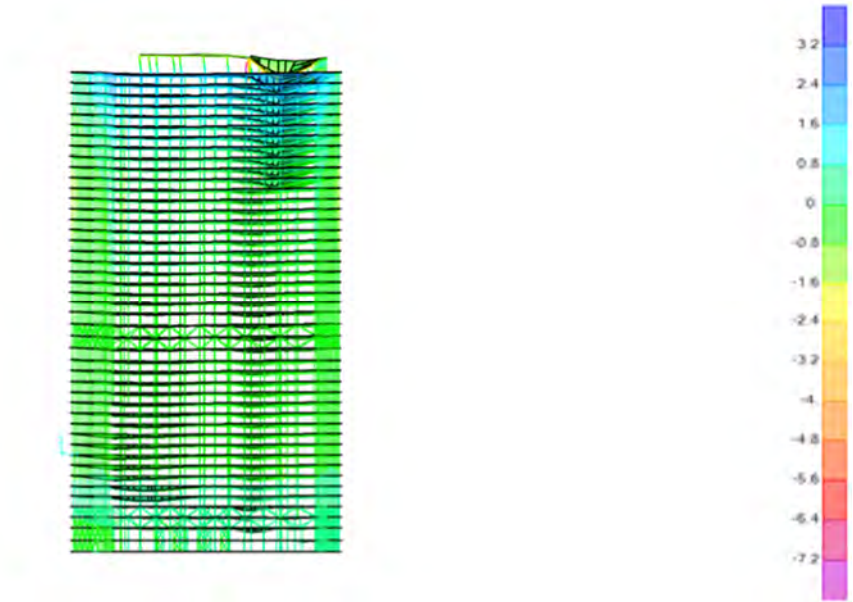
Figure 4.6: Columns 79, 80, and 81 are removed from Floor 37 to Floor 45. Tilting of the building is now negligible, whereas the deflection of the penthouse is now much greater.

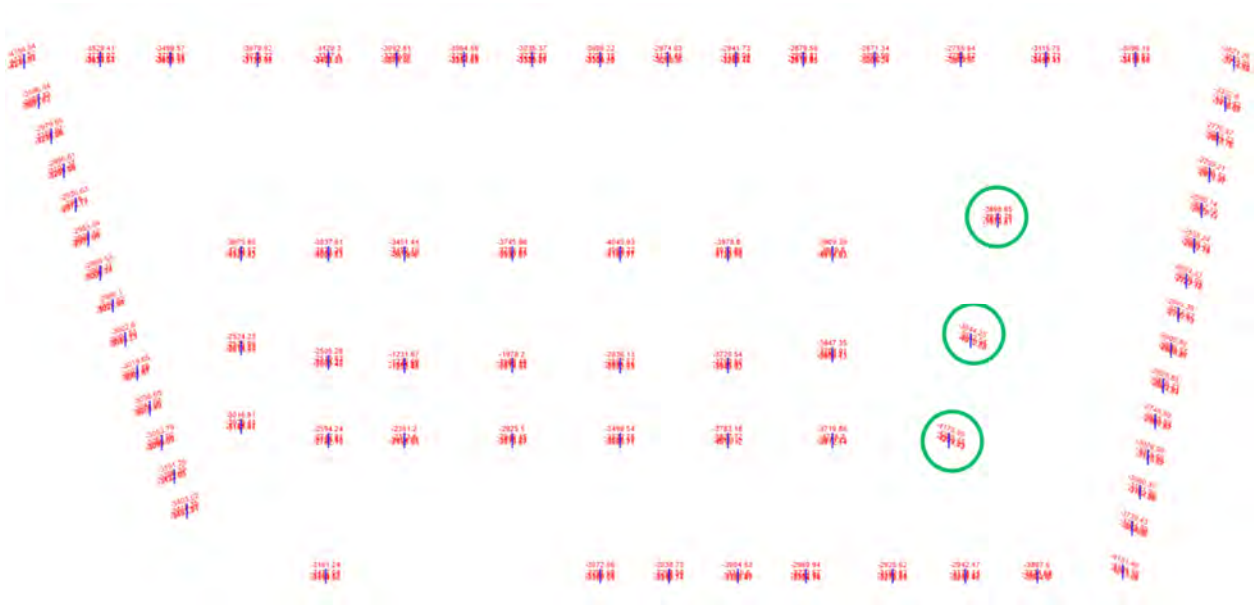
1. A horizontal progression of core column failures — starting with Columns 79, 80, and 81 — was not feasible. Therefore, the hypotheses of NIST, Arup/Nordenson, and Weidlinger that the buckling of Column 79 could trigger a progressive collapse of the entire building are invalid.
2. Even if we assume the failure of Columns 79, 80, and 81 could lead to the failure of the next row of core columns — Columns 76, 77, and 78 — the loss of these columns along with the loss of Columns 79, 80, and 81 would overload the exterior columns around the southeast corner of the building rather than overloading the next row of core

columns to the west, which would result in the building tipping to the southeast and not in a straight-down collapse.

Figure 4.8: Linear static analysis of Columns 79 to 81 (circled in green) being removed.

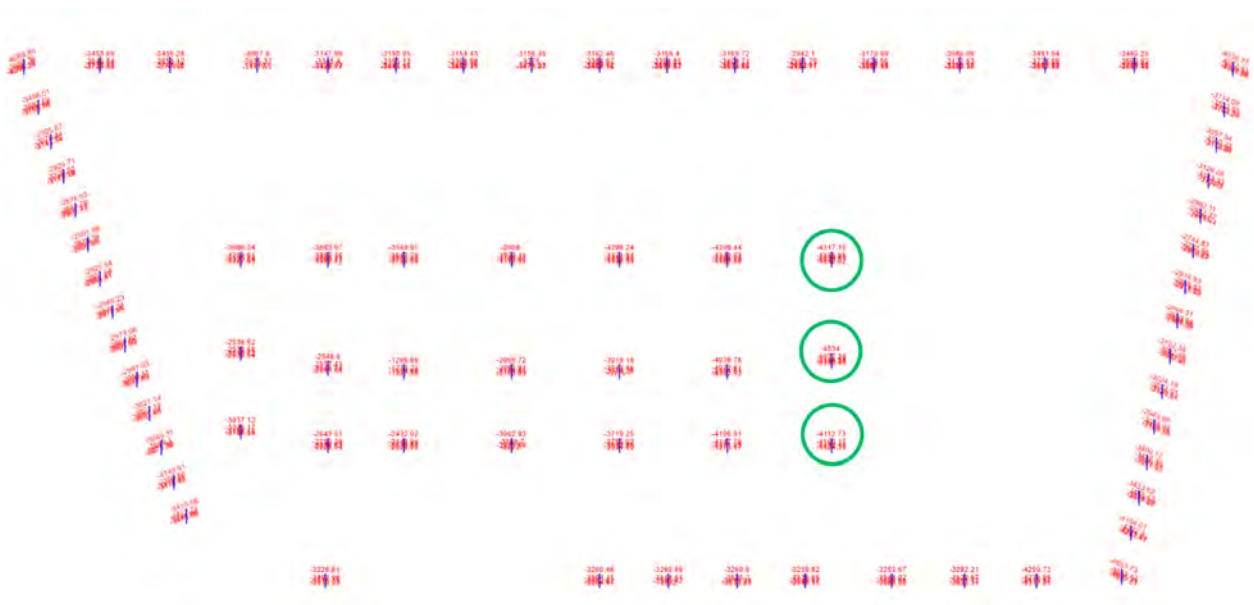
Figure 4.9: Linear static analysis of Columns 76 to 81 (circled in green) being removed.

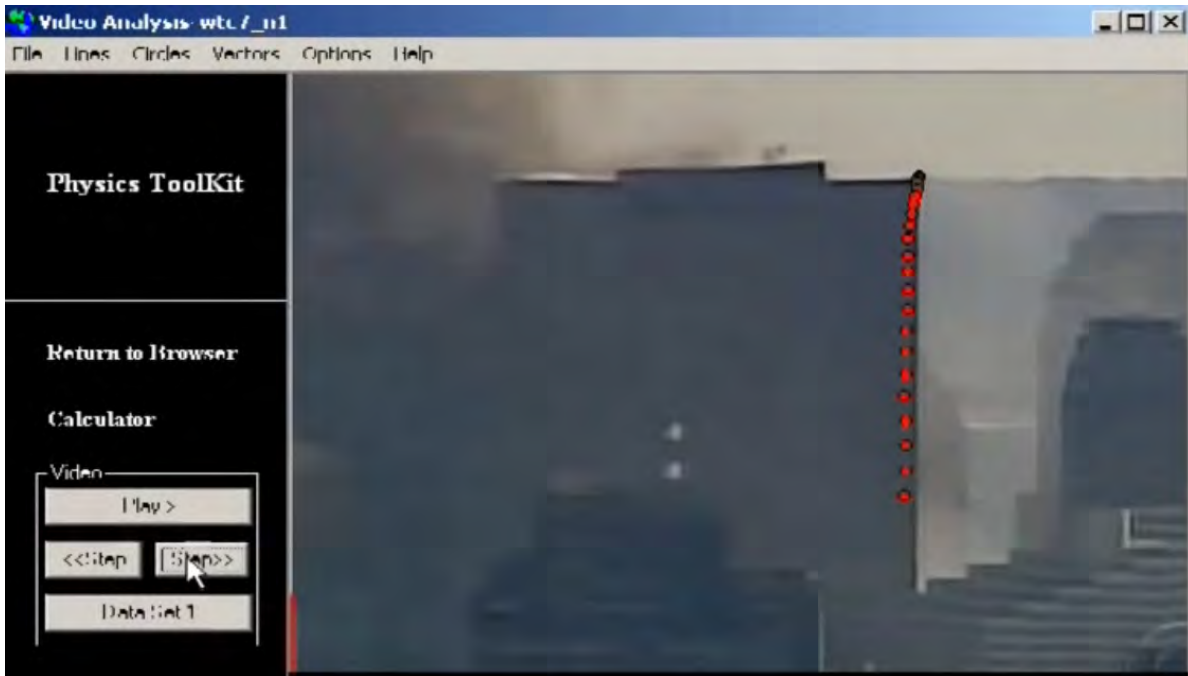
Based on this analysis, we found that the simultaneous failure of all core columns followed by the simultaneous failure of all exterior columns produces almost exactly the behavior observed in videos of the collapse. Specifically, the simulated velocity and acceleration of the building in our SAP2000 model matches almost exactly with the motion measured by David Chandler (Chandler, 2010), including the approximately 2.5 seconds of free fall, shown in Figures 4.21, 4.22, and 4.23 below.

Figure 4.21: Velocity analysis by David Chandler (Chandler, 2010).

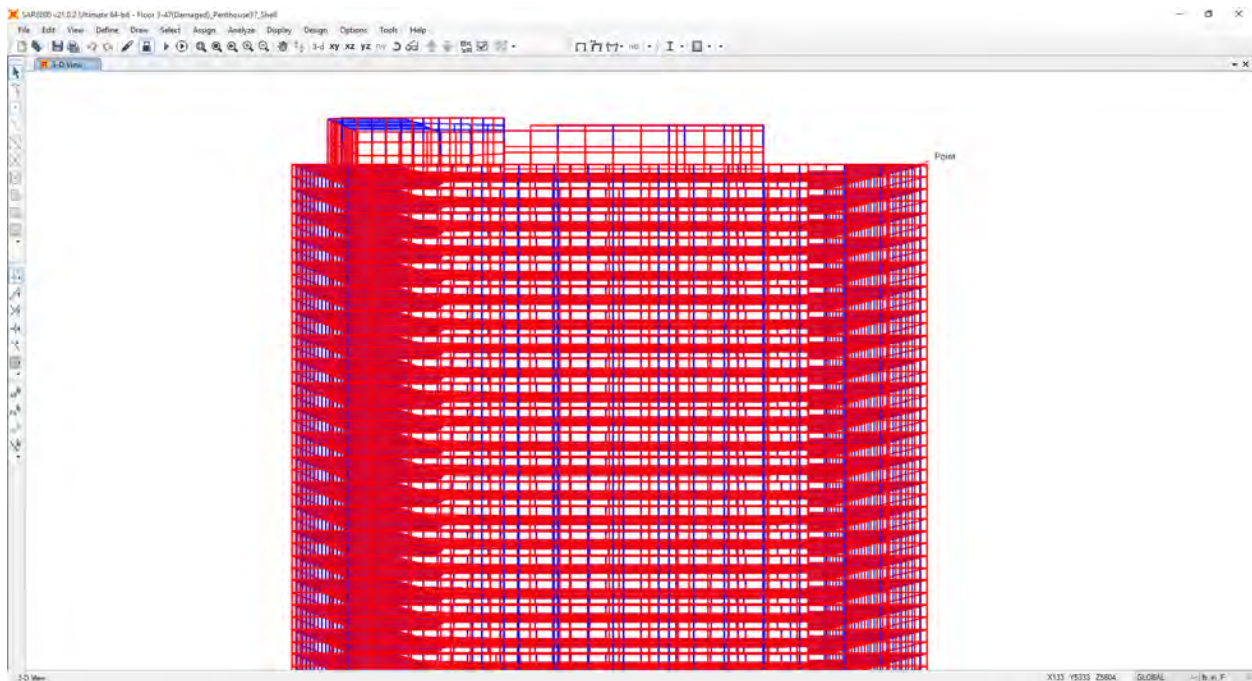
Figure 4.22: Simulation of core column-exterior column failure scenario.

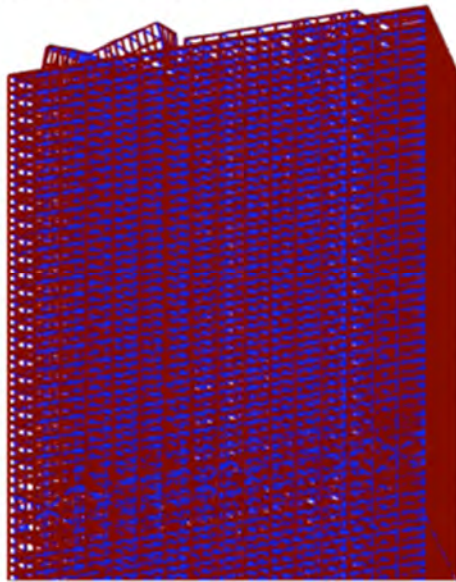
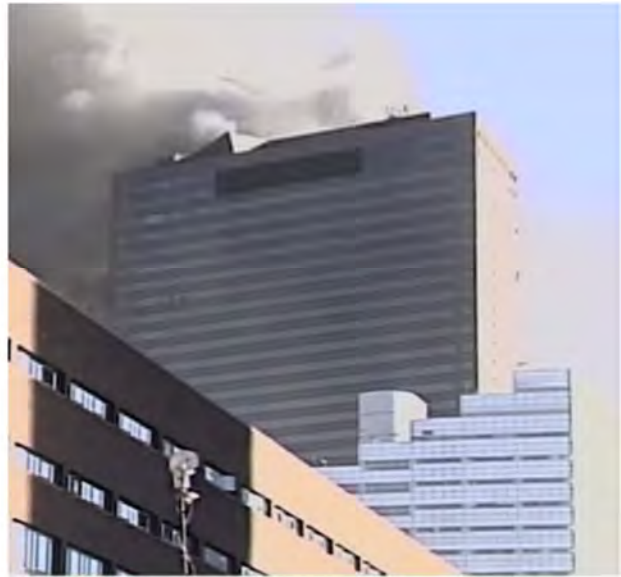
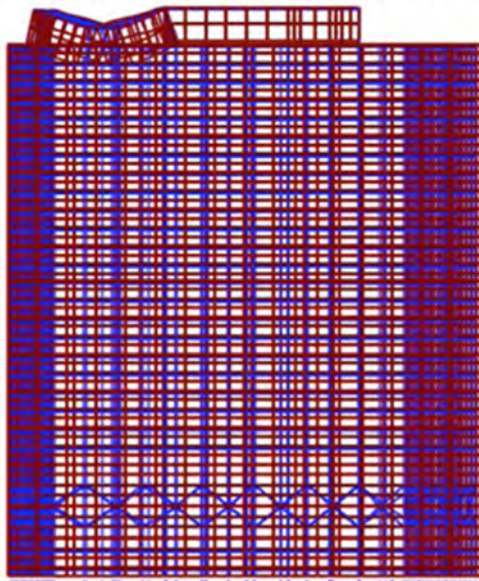
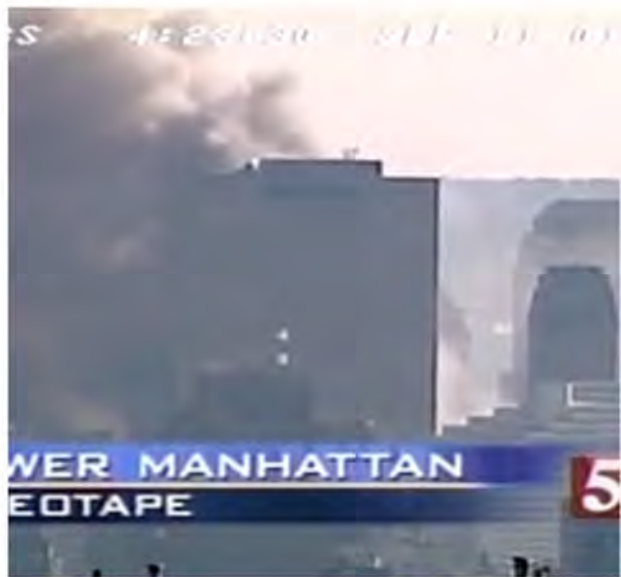
The simulated collapse was examined in two different perspectives to match the perspectives of video captured from two separate angles. Figure 4.24 below shows the UAF simulation side-by-side with the two videos of the collapse.

Figure 4.24: (a) Comparison of simulated collapse to perspective 1; (b) comparison of simulated collapse to perspective 2.

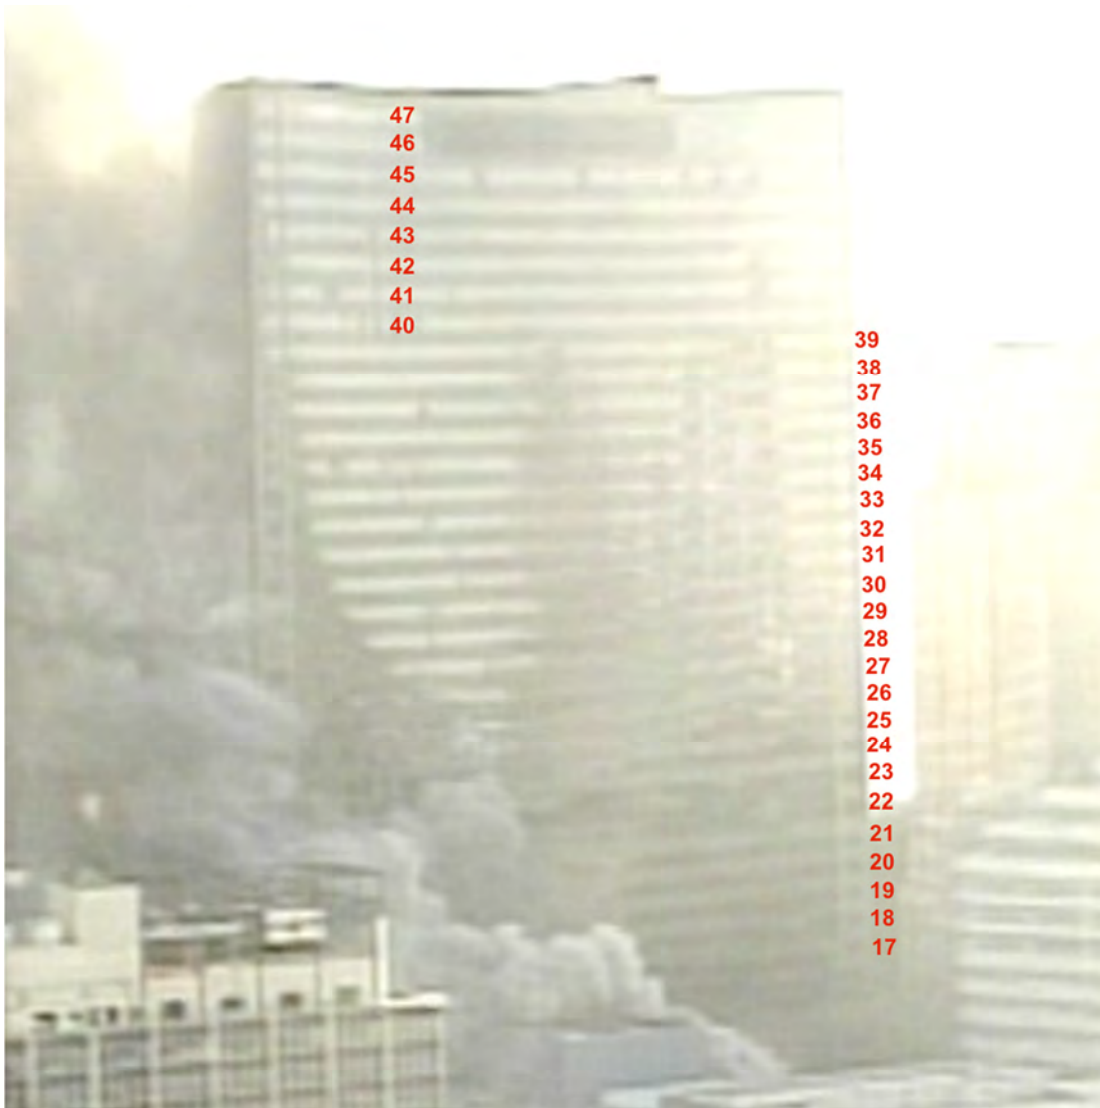
12 to Floor 19; the second was the failure of all columns from Floor 6 to Floor 13. The two simulations were identical in terms of the downward velocity and acceleration of the northwest corner at the top of building. We therefore found that the collapse could have started at various floors. Based on our subsequent review of video footage, we found that Floor 16 is the uppermost floor where the collapse could have initiated, because the video shows Floor 17 to Floor 47 falling uniformly as a unit (see Figure 4.25 below). Although some floors below Floor 17 are somewhat visible in the video, it cannot be determined with confidence that they are falling as a unit with the floors above.

Figure 4.25: Floors 17 to 47 falling uniformly as a unit (CBS).
