**NIST NCSTAR 1**

# **Final Report** on the **Collapse of** **the World Trade Center Towers**

**NIST**

September 2005

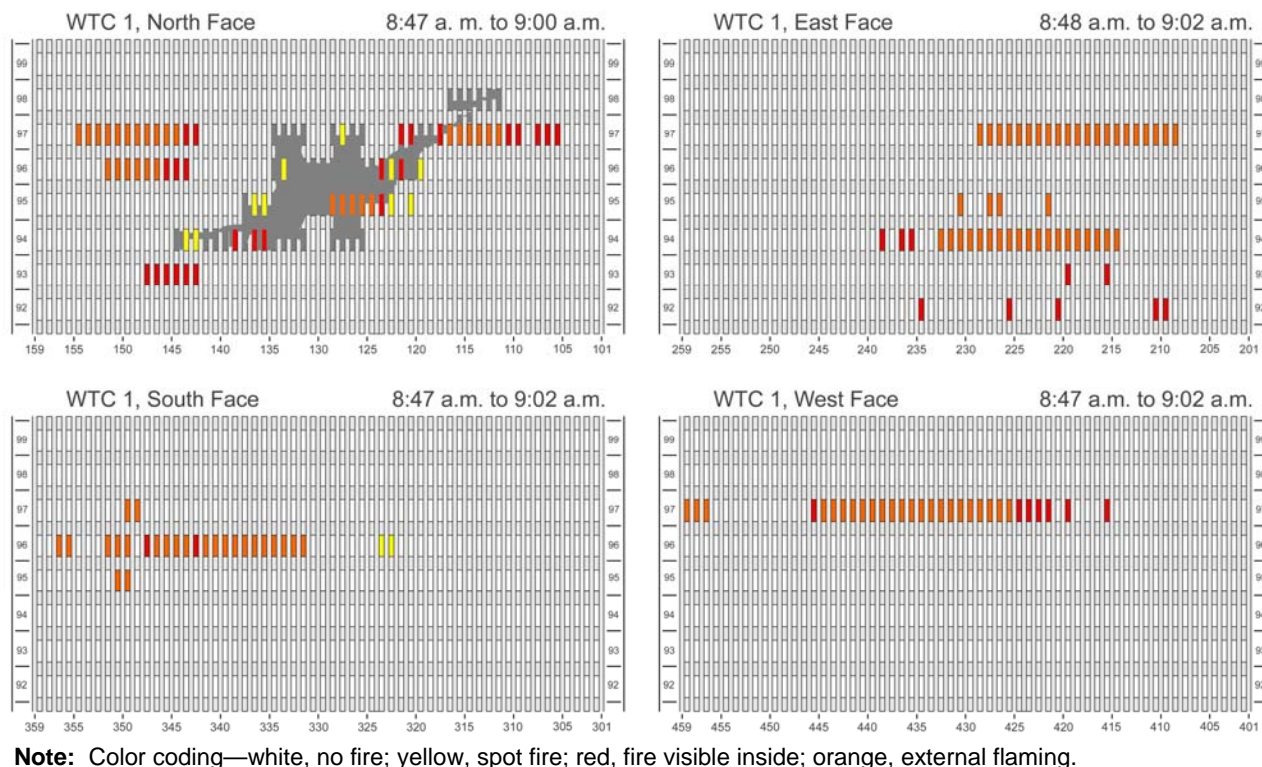
There was no way to fight the fires. The piping providing the water supply to the automatic sprinklers had been broken, and water was flowing down the stairwells. Even had this not happened, the system was designed to supply water to about 8 sprinkler heads at one time, enough to control the flames from as much as 1,500 ft<sup>2</sup> of burning material. The water supply was likely sufficient to control fires up to triple that size. The fires, however, had already grown far larger than that.

**Figure 2-5. Representation of exterior views of the fires on the four faces of WTC 1 from 8:47 a.m. to about 9:02 a.m.**

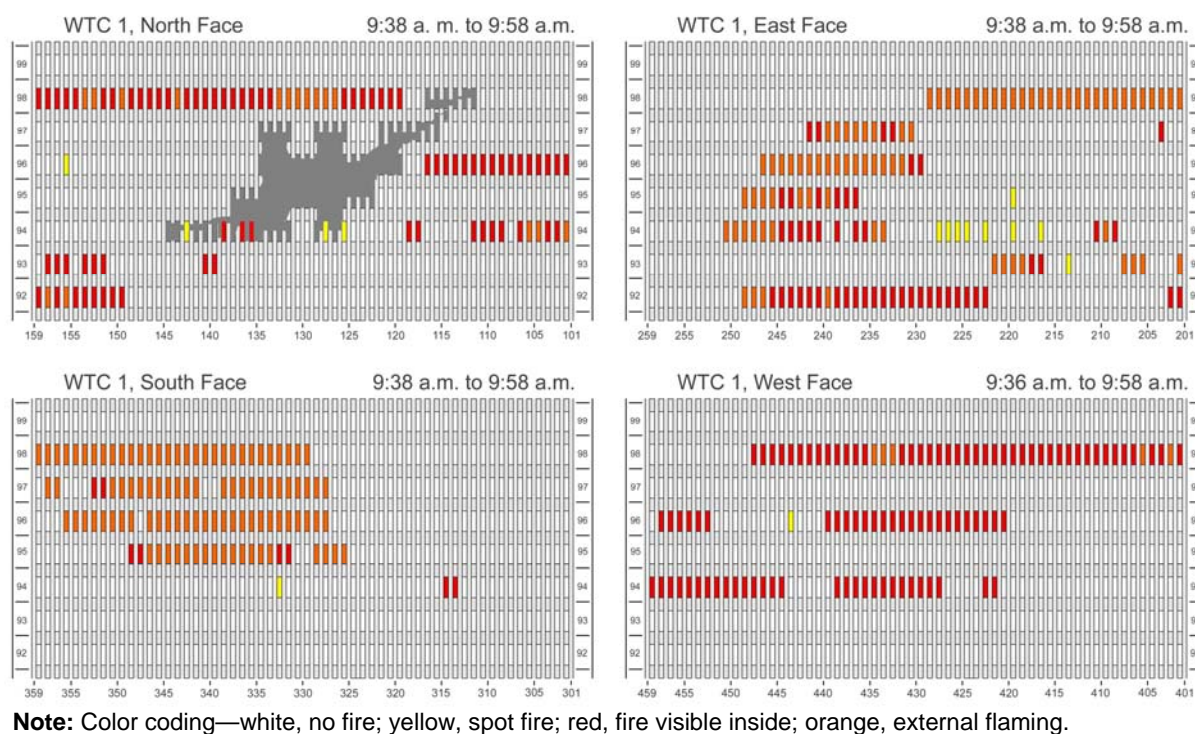
Seventy-five minutes after the impact, approaching 10:00 a.m., the fire on the 97<sup>th</sup> floor had begun to burn itself out, but the fire on the 94<sup>th</sup> floor had intensified and filled much of the north half of the floor (Figure 2–7). Starting about 9:30 a.m., there were vigorous fires on nearly the full perimeter of the 98<sup>th</sup> floor. There was still almost no burning on the 99<sup>th</sup> floor or above.

**Figure 2–7. Representation of exterior views of the fires on the four faces of WTC 1 from about 9:38 a.m. to 9:58 a.m.**

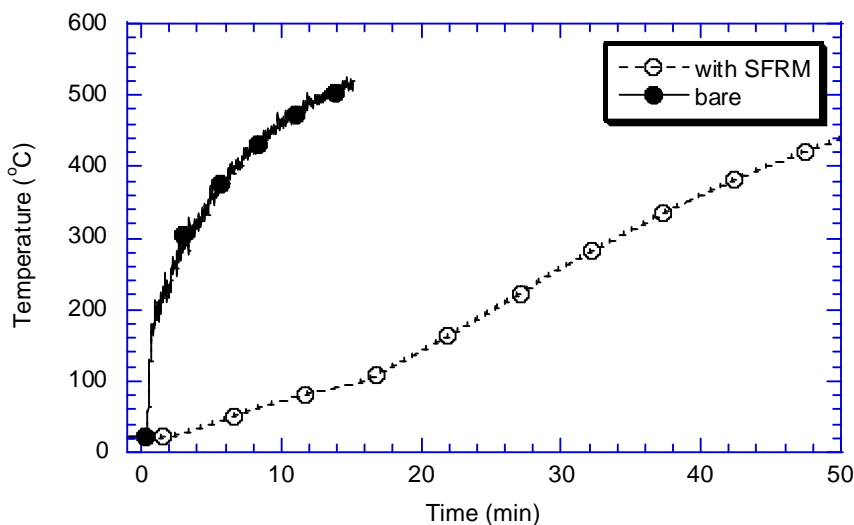
The perimeter columns, floors, and core columns were immersed in these hot gases and began to weaken. Where the insulation was dislodged, the temperature of the steel rose rapidly, in contrast to steel members where insulation was intact (Figure 2–8). The heaviest core columns with damaged insulation heated slowly, as the absorbed heat was dissipated through their massive cross sections. The temperatures of the lighter columns and the floor slabs rose more quickly, and those of the stripped trusses even more so.

**Figure 2–8. Steel surface temperatures on the bottom chords of fire-exposed trusses, uninsulated and insulated with  $\frac{3}{4}$  in. of BLAZE-SHIELD DC/F.**

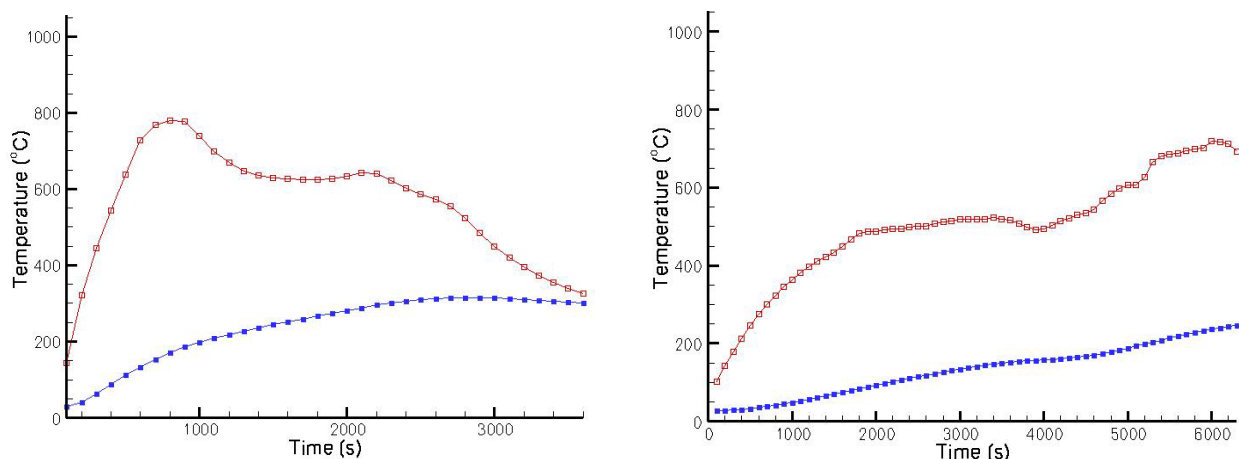
**Figure 2–10. Simulated temperatures of two adjacent trusses (left) and two adjacent perimeter columns (right) exposed to the fires in WTC 1.**

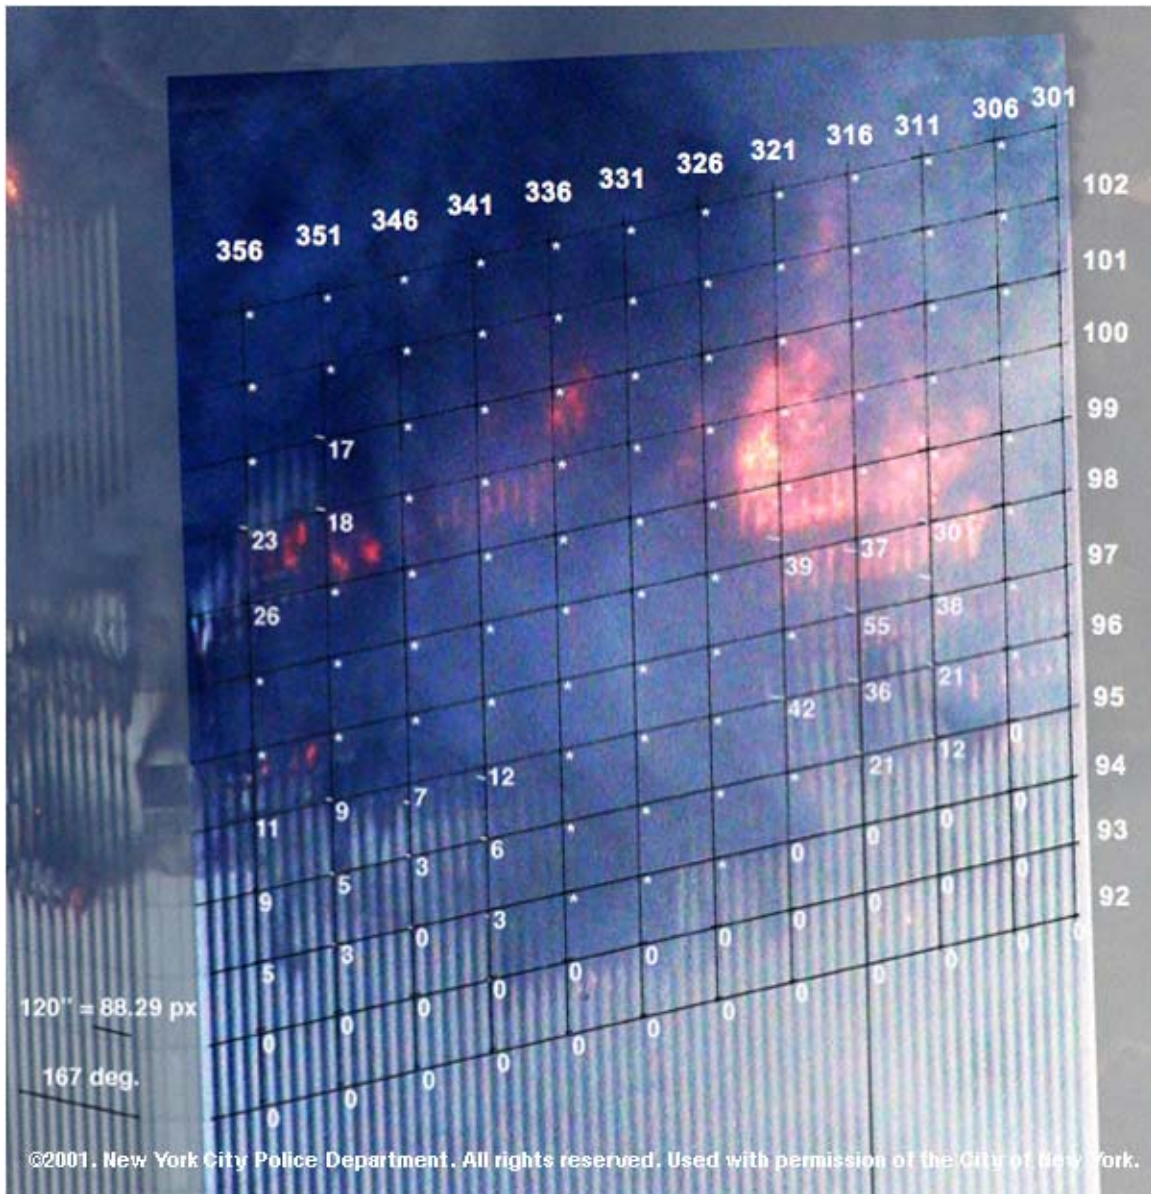
The sagging of the floors had increased. Although the floors on the north side of the tower had sagged first, they contracted due to cooling when the fires moved toward the south. Now, the south side floors had sagged to the point where the south perimeter columns bowed inward (Figure 2–12). By 10:23 a.m., the south exterior wall had bowed inward as much as 55 in.

**Figure 2–12. South face of WTC 1 at 10:23 a.m., showing inward buckling (in inches) of perimeter columns.**

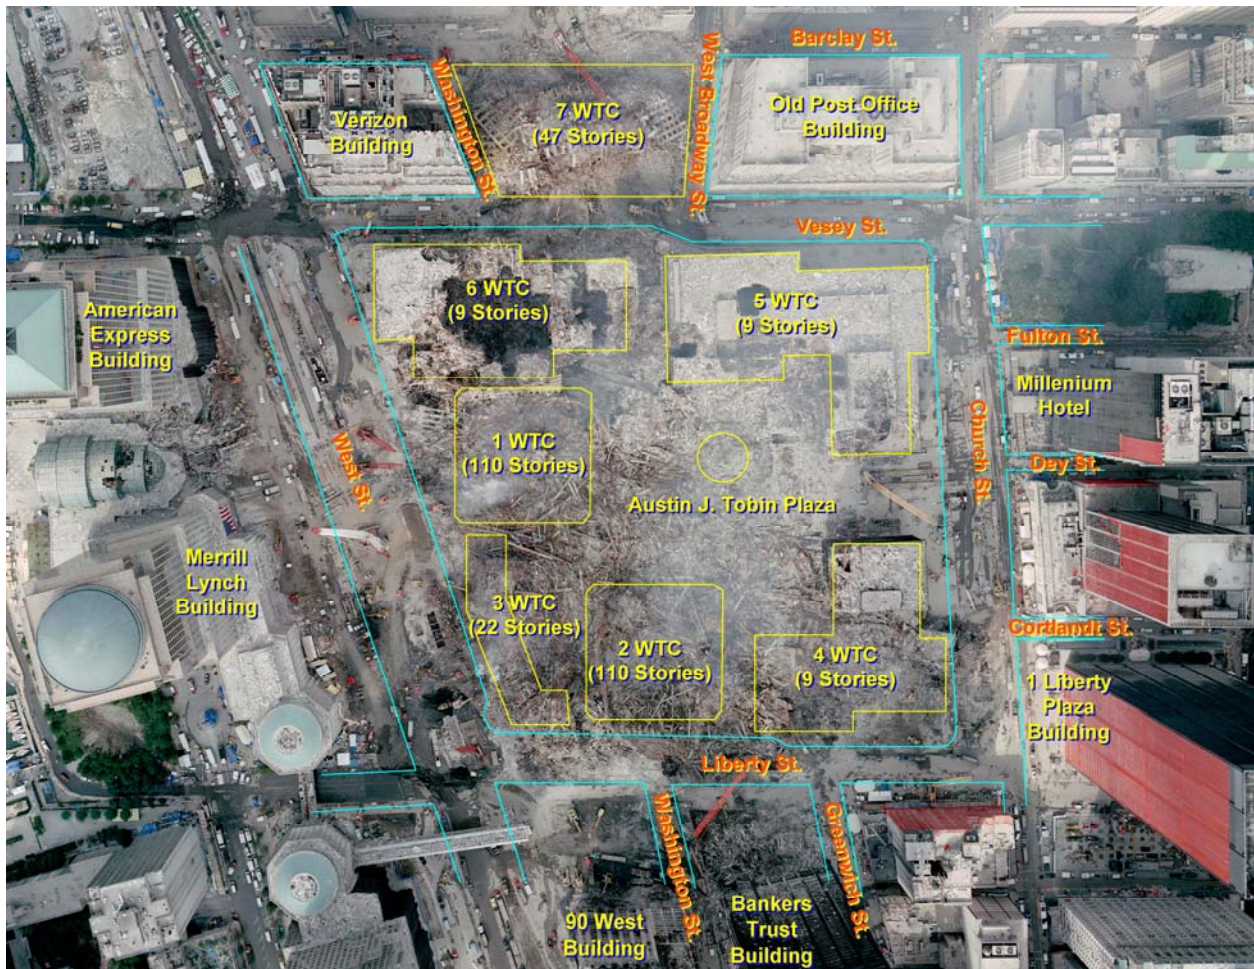
By sunset on September 11, 2001, all seven buildings on the World Trade Center (WTC) site lay in ruins (Figure 4–1). Table 4–1 compiles the likely locations of the decedents.

Figure 4–1. The WTC site on September 17, 2001.

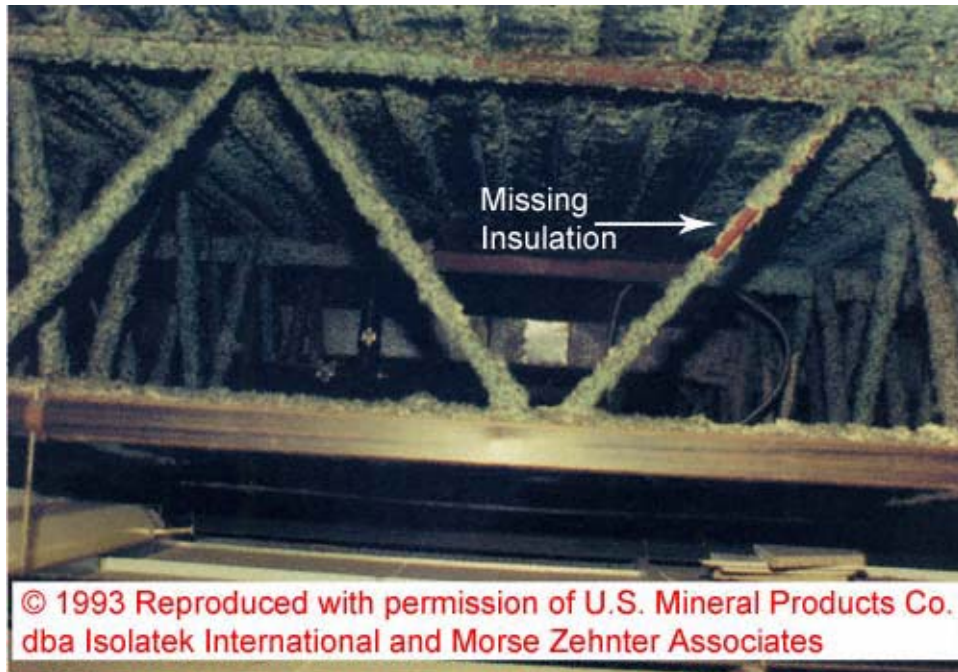
In 1994, The Port Authority measured the SFRM thickness on trusses on floors 23 and 24 of WTC 1. In all, average thicknesses were reported for 32 locations, and the overall average thickness was found to be 0.74 in. NIST performed a further evaluation of the SFRM thickness using photographs taken in the 1990s of floor trusses on (non-upgraded) floors 22, 23, and 27 of WTC 1 (Figure 5–5). By measuring dimensions on the photographs, NIST estimated the insulation thicknesses on the diagonal web members of trusses. (The thickness of chord member insulation could not be measured.) The average thickness and standard deviation of web members was 0.6 in. ± 0.3 in. on the main trusses, 0.4 in. ± 0.25 in. on the bridging trusses, and 0.4 in. ± 0.2 in. on the diagonal struts. These numbers indicated that there were areas where the coating thickness was less than the specified 0.5 in.

**Figure 5–5. Irregularity of coating thickness and gaps in coverage on SFRM-coated bridging trusses.**

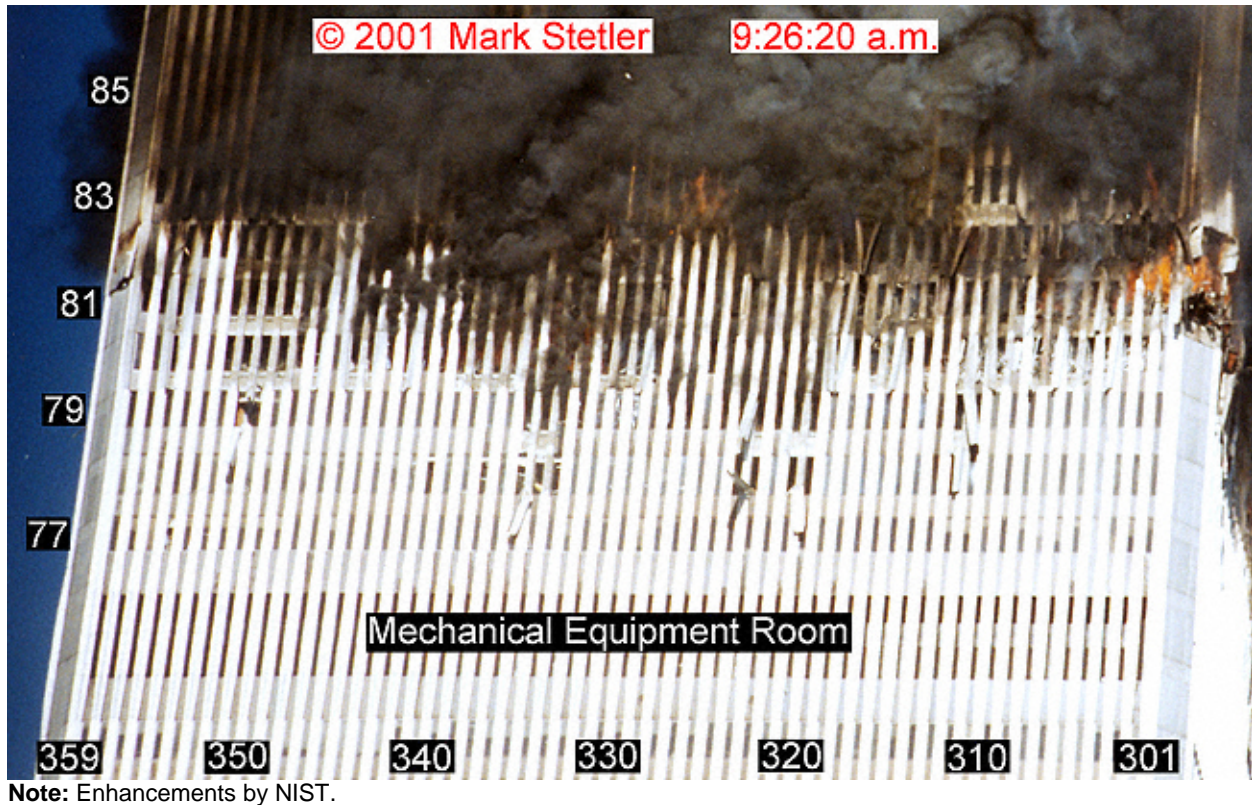
As an example of information that was extracted, Figure 6–1 shows an enhanced image of the east face of WTC 2. Figure 6–2 expands a section of interest. The amount of detail available is evident. For instance, large piles of debris are present on the north side of the tower on the 80<sup>th</sup> and 81<sup>st</sup> floors, and locations where fires are visible or where missing windows are easily identified. Many details of each frame were important in tracking the evolution of the fires and the damage to the buildings.

**Figure 6–1. 9:26:20 a.m. showing the east face of WTC 2.**

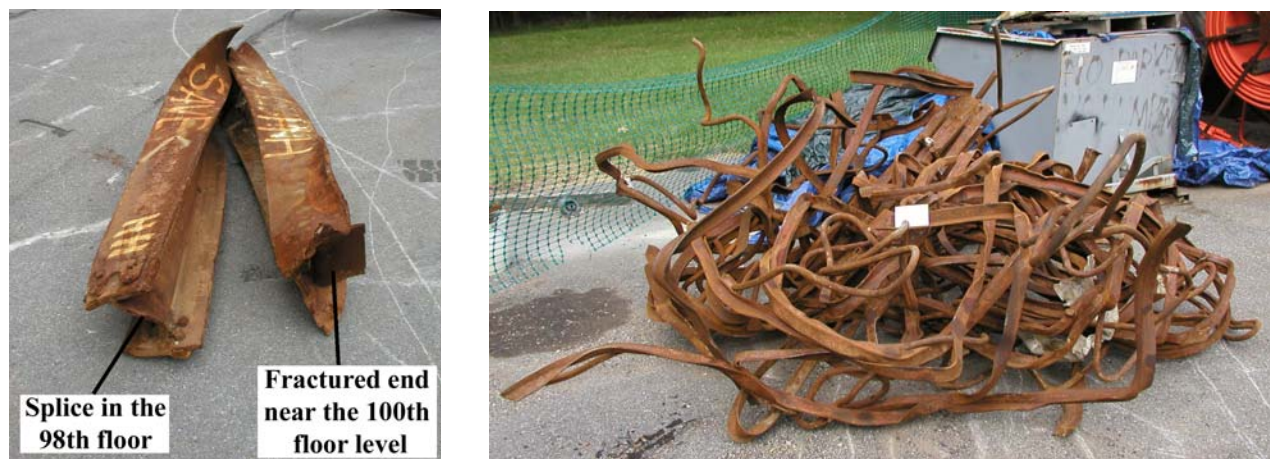
**Figure 6–3. Examples of a WTC 1 core column (left) and truss material (right).**

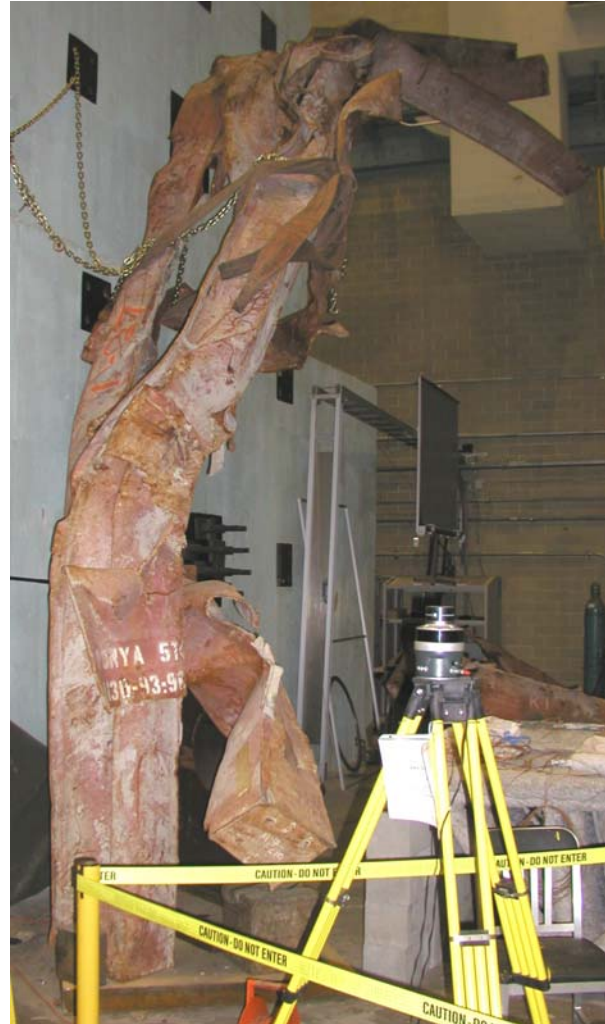
**Figure 6–5. WTC 1 exterior panel hit by the nose of the aircraft.**

For two of the five exterior panels from the impact zone of WTC 1, the general shape and appearance of the recovered pieces matched photographs taken just before the building collapse. Thus, NIST was able to attribute the observed damage to the aircraft impact. NIST also made determinations regarding the connections between structural steel elements:

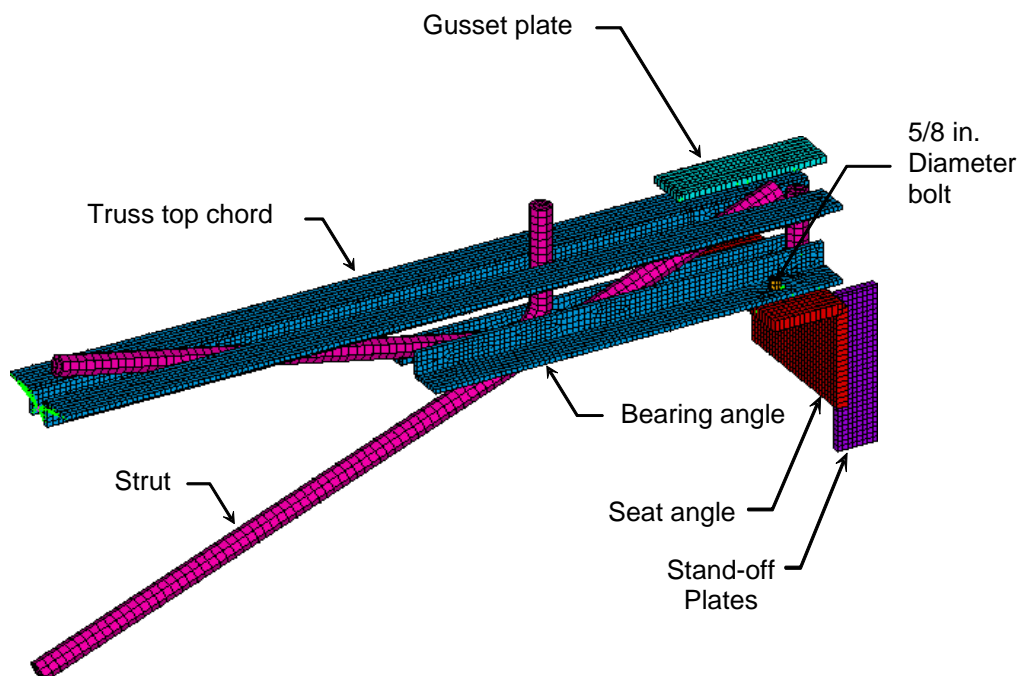
- **Truss seats.** Figure 6–10 shows how an exterior seat connection was represented in the finite element structural model. The component analysis determined that failure could occur at the bolted connection between the bearing angle and the seat angle, and the truss could slip off the seat. Truss seat connection failure from vertical loads was found to be unlikely, since the needed increase in vertical load was unreasonable for temperatures near 600 °C to 700 °C.
- **Knuckles.** The “knuckle” was formed by the extension of the truss diagonals into the concrete slab and provided for composite action of the steel truss and concrete slab. A model was developed to predict the knuckle performance when the truss and concrete slab acted compositely.

**Figure 6–10. Finite element model of an exterior truss seat.**

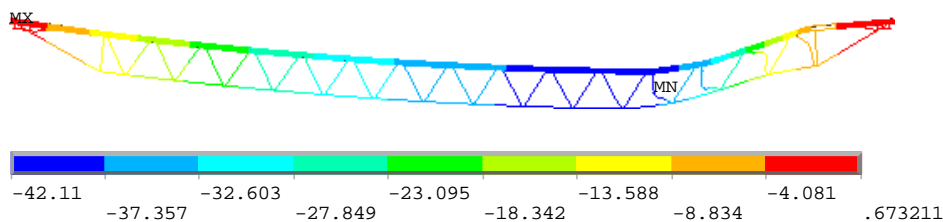
- Single composite truss and concrete slab section. A floor section was modeled to investigate failure modes and sequences of failures under combined gravity and thermal loads. The floor section was heated to 700 °C (with a linear thermal gradient through the slab thickness from 700 °C to 300 °C at the top surface of the slab) over a period of 30 min. Initially the thermal expansion of the floor pushed the columns outward, but with increased temperatures, the floor sagged and the columns were pulled inward. Knuckle failure was found to occur mainly at the ends of the trusses and had little effect on the deflection of the floor system. Figure 6–11 shows that the diagonals at the core (right) end of the truss buckled and caused an increase in the floor system deflection, ultimately reaching approximately 42 in. Two possible failure modes were identified for the floor-truss section: sagging of the floor and loss of truss seat support.

**Figure 6–11. Vertical displacement at 700 °C.**

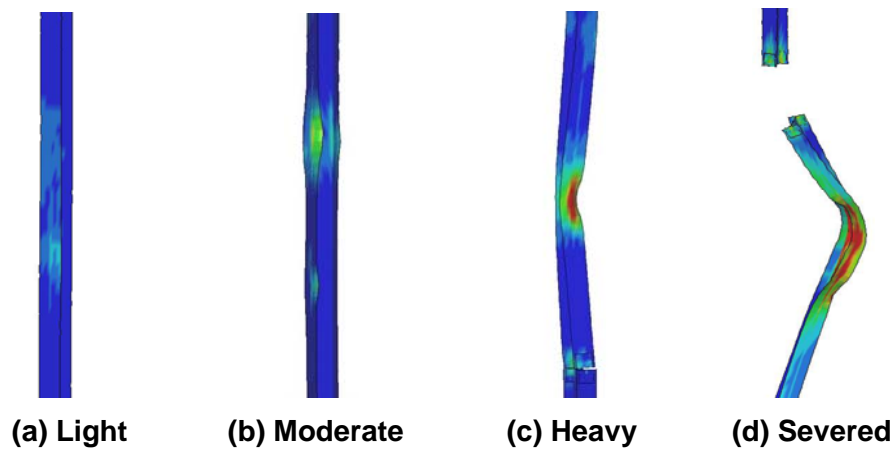
- Lightly damaged column: column impacted, but without significant structural deformation;
- Moderately damaged column: visible local distortion, but no deformation of the column centerline;
- Heavily damaged column: Permanent deflection of the column centerline; and
- Failed column: Column severed.

Figure 6–19. Column damage levels.

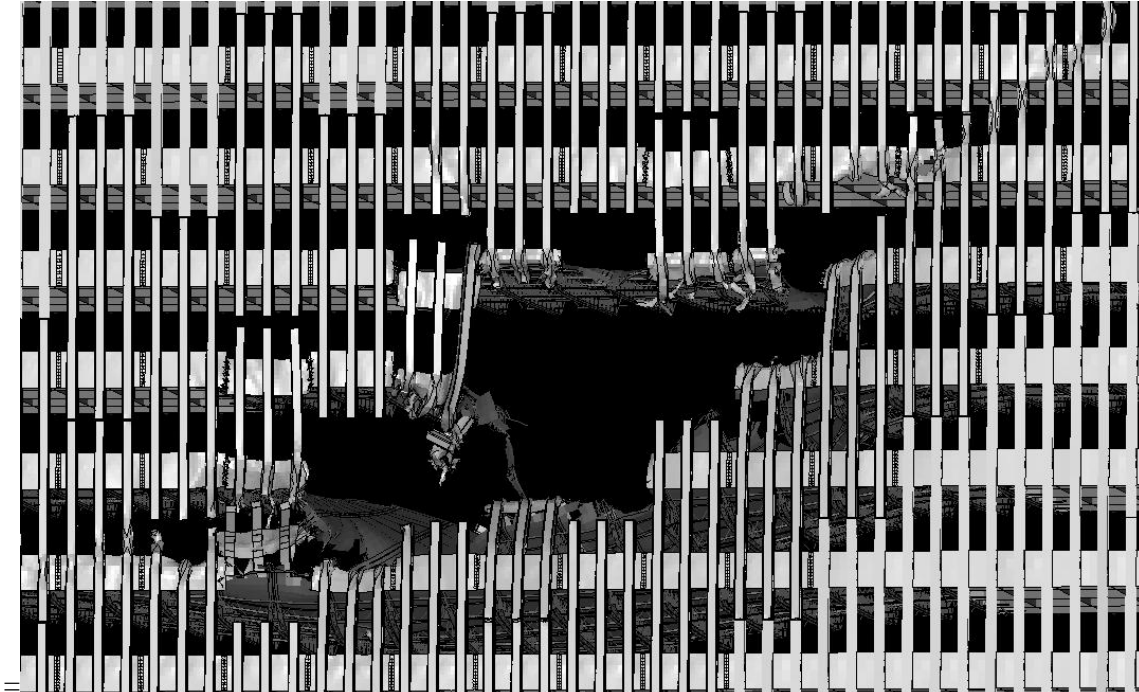
Figure 6–26. Observed and Case A calculated damage to the north face of WTC 1.

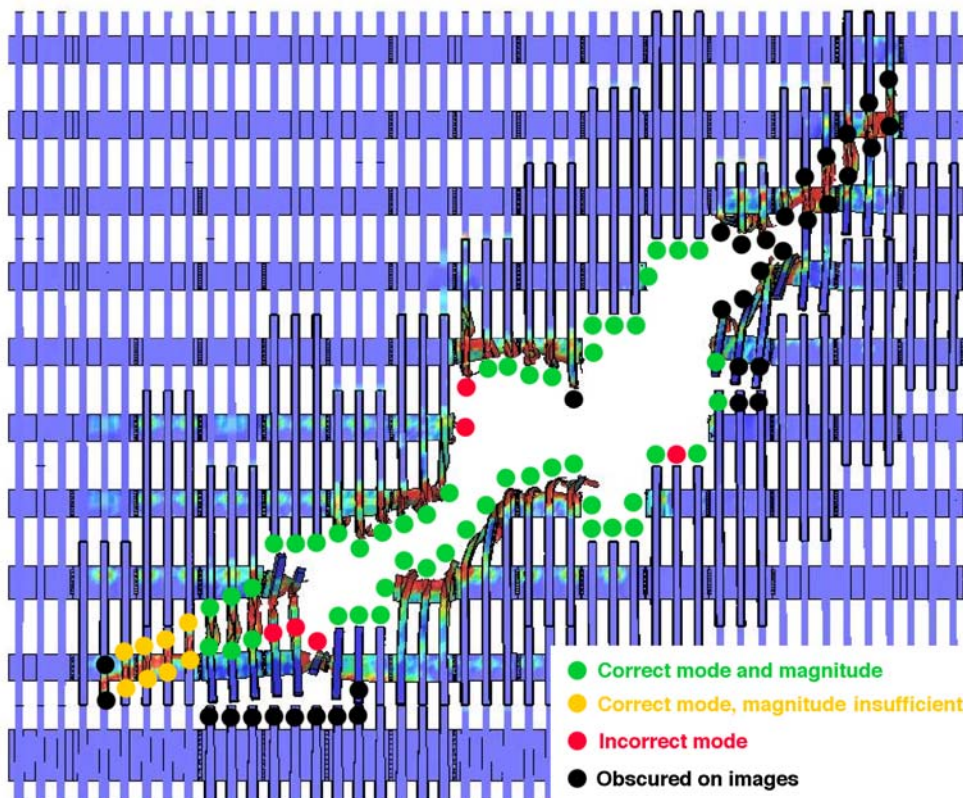
Figure 6–28. Schematic of observed damage (above) and Case C calculated damage (right) to the south face of WTC 2.

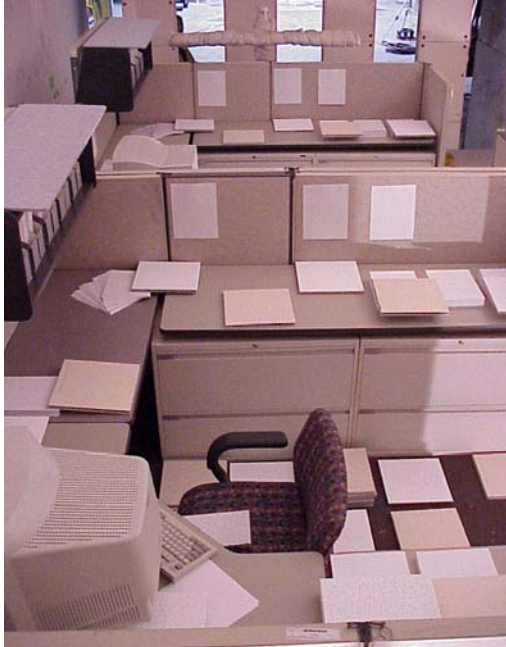
The second series was a preamble to the modeling of the actual WTC fires. Arrays of three WTC workstations were burned in a 35.5 ft by 23 ft by 11 ft high compartment (Figure 6–32). The tests examined the effects of the type of workstation, the presence of jet fuel, and the presence of fallen inert material on the burning surfaces. In one of the tests, the workstations were rubblized (Figure 6–33). Figure 6–34 depicts the intensity of the test fires. Figure 6–35 shows the measured and predicted heat release rate data from one of the tests in which there was no jet fuel nor inert material present.

**Figure 6–32. Interior view of a three-workstation fire test.**

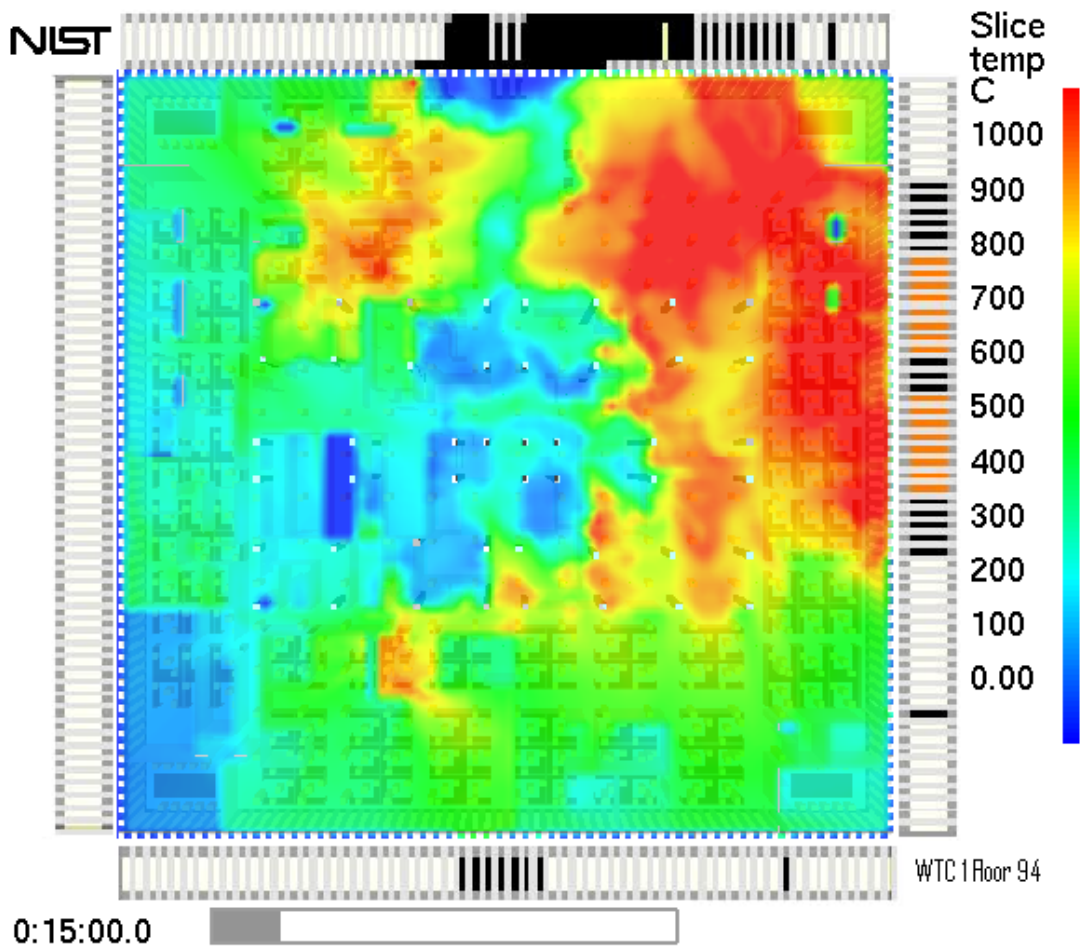
Figure 6–36. Upper layer temperatures on the 94<sup>th</sup> floor of WTC 1, 15 min after impact.

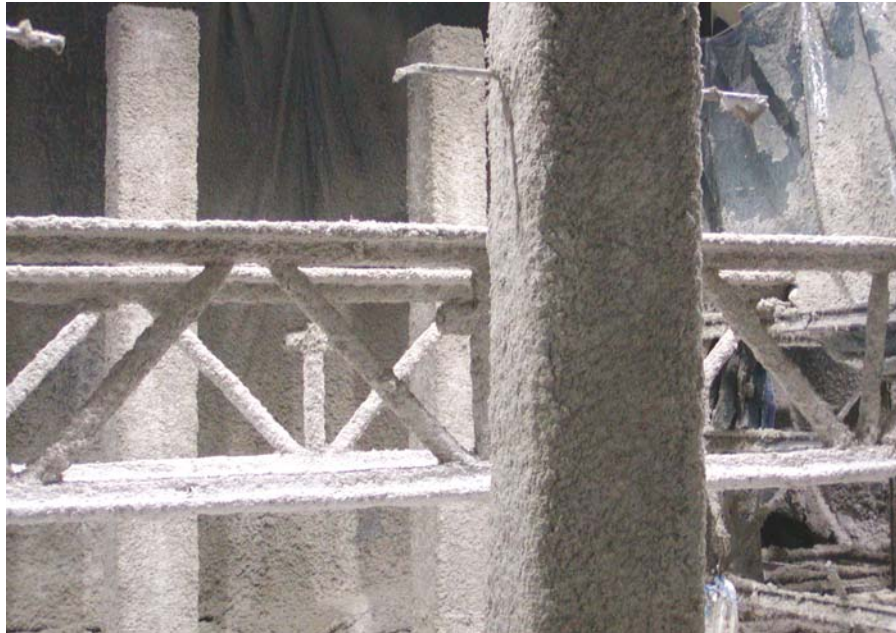
experienced applicator, who took considerable care to apply an even coating of the specified thickness. As such, the insulated test subjects represent a best case in terms of thickness and uniformity. Figure 6–42 shows some of the coated components.

Figure 6-42. SFRM-coated steel components prior to a test.

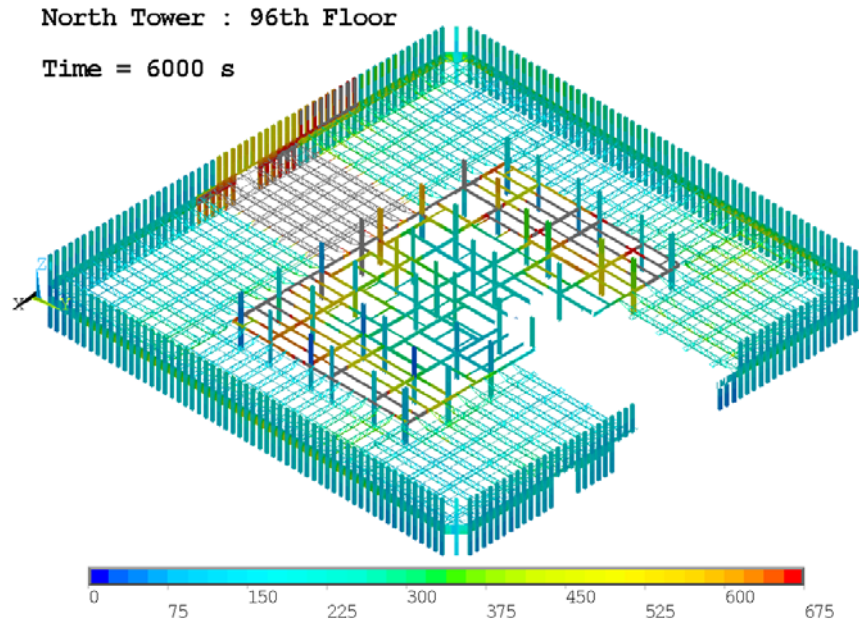
For ease of visualization, two graphic representations were developed. Figure 6–46 shows an example of the temperature map for the 96<sup>th</sup> floor of WTC 1. Severed columns and broken floor segments are not shown. Figure 6–47 shows a similar map for the 81<sup>st</sup> floor of WTC 2.

**Figure 6–46. Temperatures (°C) on the columns and trusses of the 96<sup>th</sup> floor of WTC 1 at 6,000 s after aircraft impact, Case B.**

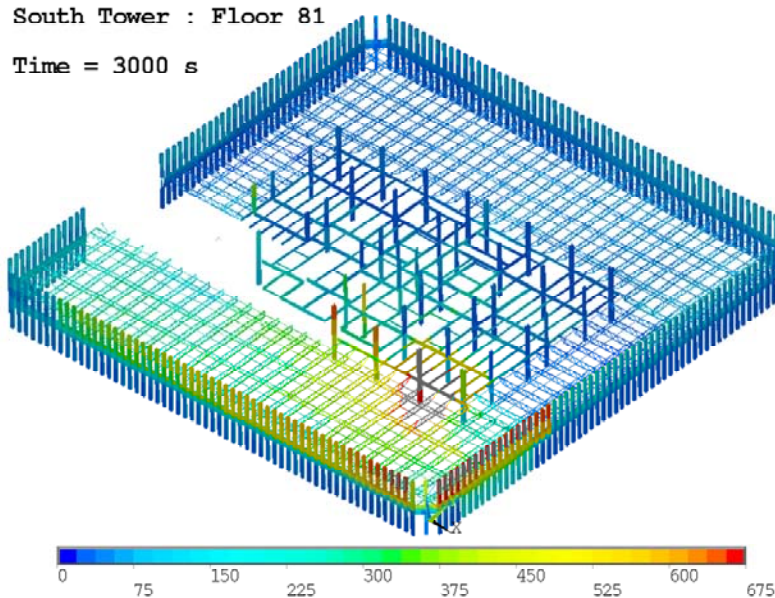
**Figure 6–47. Temperatures (°C) on the columns and trusses of the 81<sup>st</sup> floor of WTC 2 at 3,000 s after aircraft impact, Case D.**

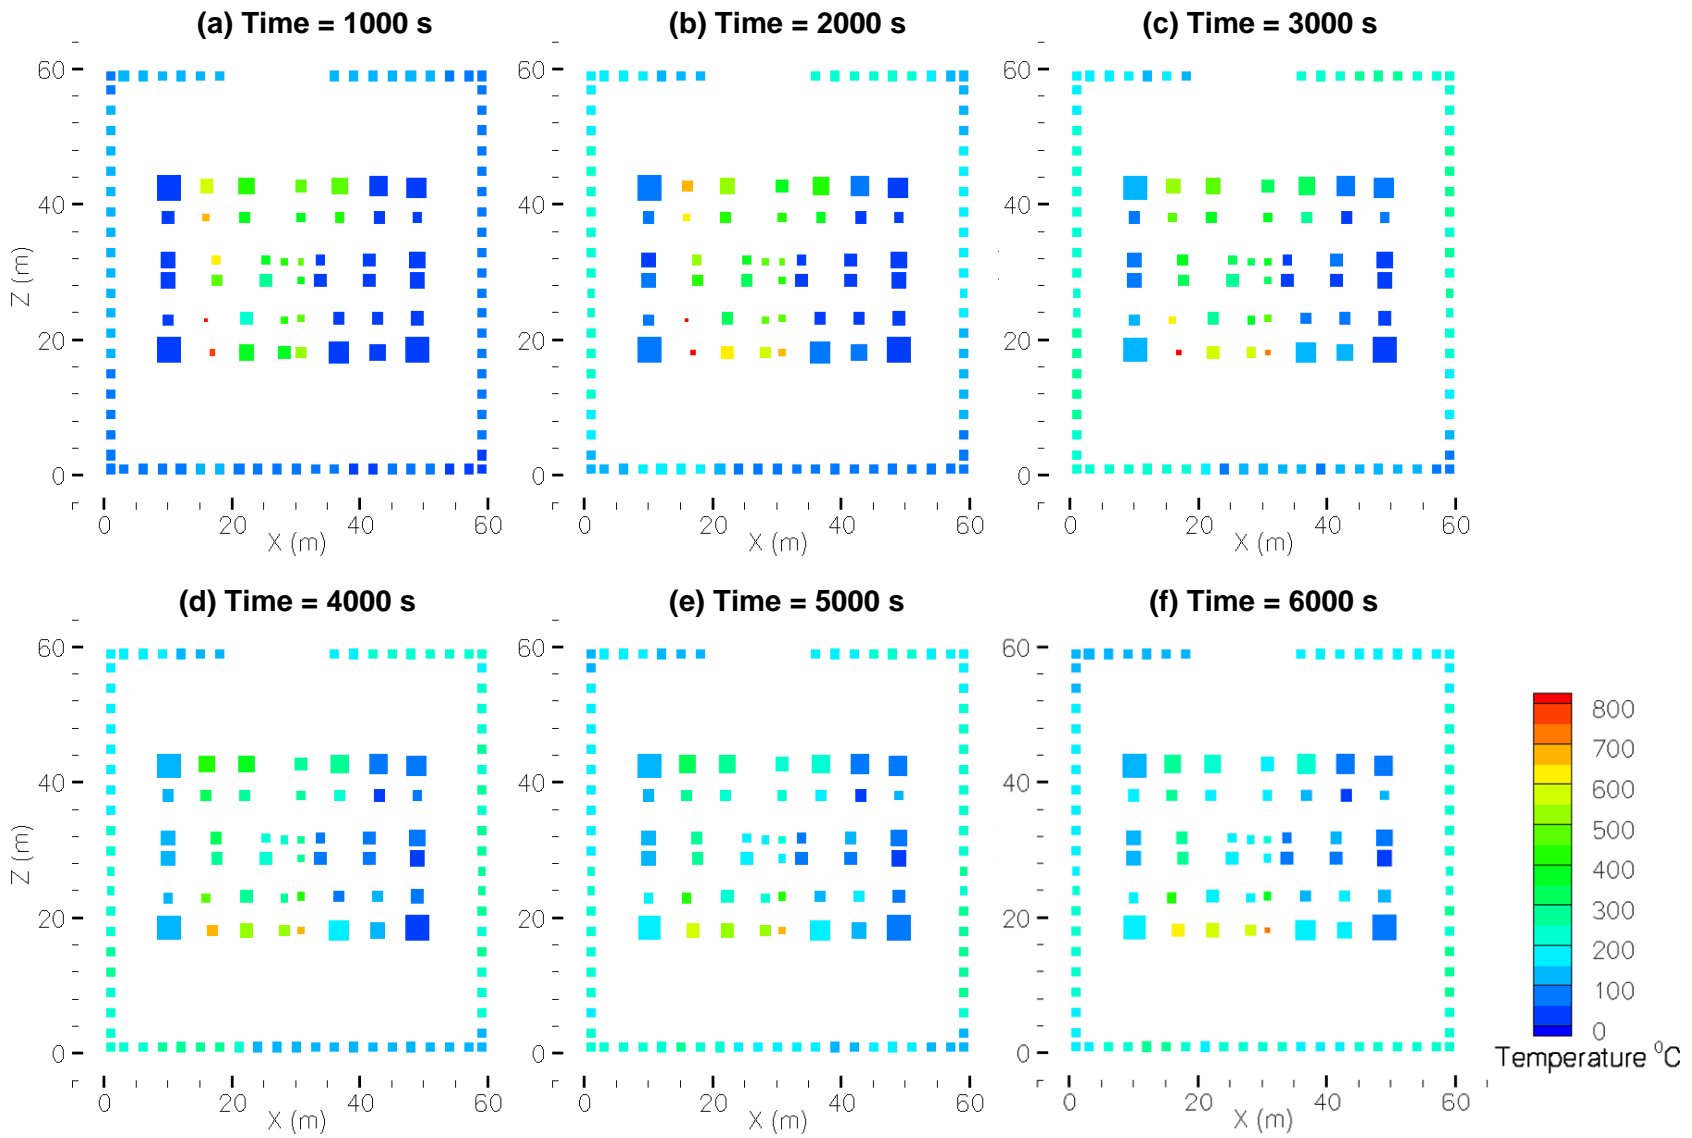
A third visualization tool was animation of the evolving temperatures of the columns. Frames from an example, again of the 96<sup>th</sup> floor of WTC 1, Case A, are shown in Figure 6–48. The size of the square representing a column represents its yield strength. Columns may have been heated when the fire was nearby and then cooled after the local combustibles were consumed.

Figure 6-48. Frames from animation of the thermal response of columns on the 96<sup>th</sup> floor of WTC 1, Case A.
