ALUMINIUM INSIGHT

February 2011

MOLTEN ALUMINIUM / WATER EXPLOSIONS RISKS AND PREVENTION

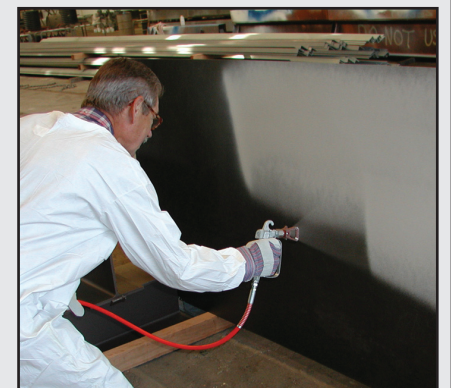
Wise Chem coatings applied to aluminium production equipment and material surfaces

involves the pit beneath tilting furnaces and the hydraulic cylinders that tilt the furnace. Only the bottom 36 in of the pit requires coating but the appearance is enhanced if completely covered. This improves housekeeping and does eliminate a potential explosion site. One coating will last for years.

The coating is effective at inhibiting rust formation on exposed steel parts. Wise Chem coatings develop excellent adhesion to damp surfaces, which allows casting pits to be coated without waiting for the walls to fully dry, thus minimizing down time.
