11-4403-CV

United States Court of Appeals
for the
Second Circuit

JOINT APPENDIX
Volume 13 of 16 (Pages JA-3321 to JA-3616)

In re: September 11 Property Damage and Business Loss Litigation

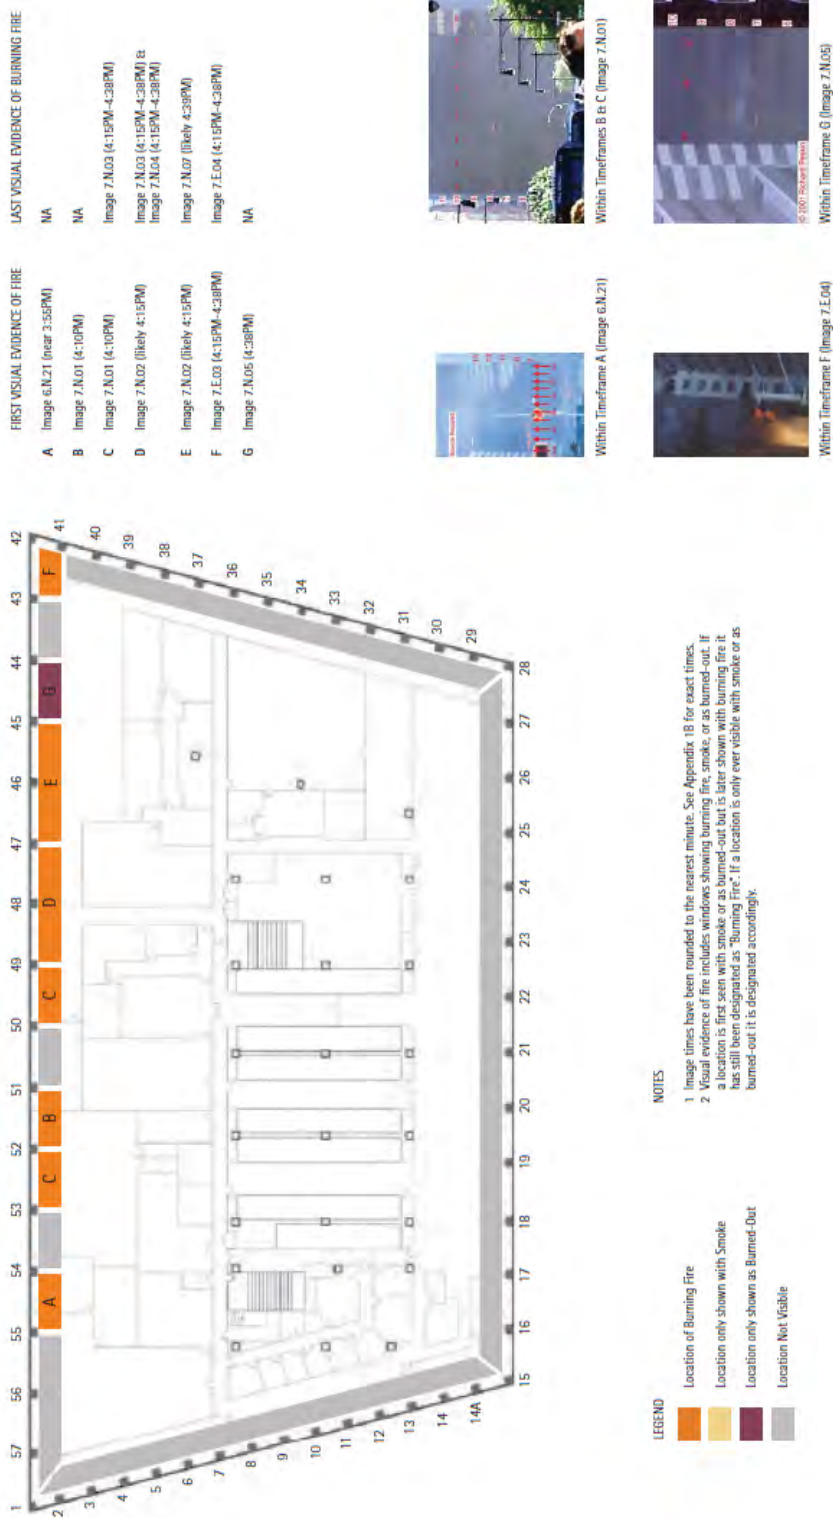
Figures 13 and 14, prepared by GNA, summarize the photographic evidence of the fires on the 9th and 12th floors, respectively. The GNA analysis shows that fire on the 9th floor progressed clockwise from west to east along the north façade. The first visual evidence of fire occurs at approximately 3:55 PM and the last visual evidence of burning fire occurs at approximately 4:38 PM on this floor. The fire on the 12th floor progressed counter-clockwise, with the first visual evidence of fire on the east façade occurring at approximately 2:00 PM and the last visual evidence of burning occurring in the northwest corner of the building at about 5:00 PM. This photographic evidence generally shows the presence of active burning in any one location on Floors 9 and 12 for a period of less than 30 minutes, a period consistent with the durations demonstrated in the workstation fire tests referenced above.

Figure 13. Planometric diagram of fire progression for the 9th floor (source: GNA report – Exhibit B of this report).

The FDS simulation of the 12th floor fire effects is based on the observed window breakage sequence for the 12th floor. As noted in Figures 13 and 14, the fire in the northeast quadrant on the 9th floor occurred later than the fire on the 12th floor in this area. The fire on the 9th floor

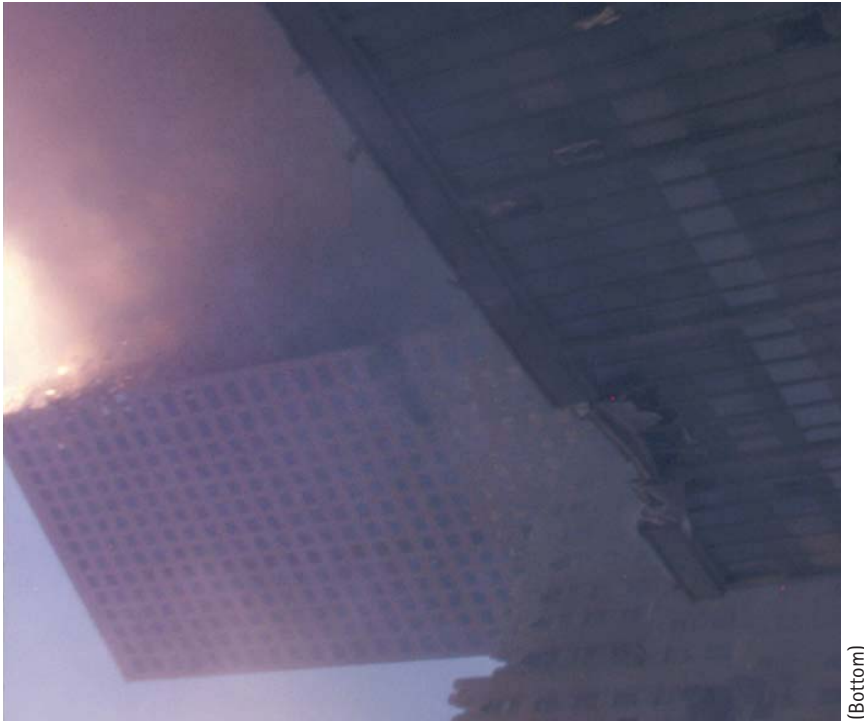
Image 2.W.01 Southwest corner, approximately 10:30AM-12:30PM

West Facade - The only available visual evidence of fire during this time period occurs on the west facade. The earliest images show windows on level 29 already burned-out, indicating that a fire had burned soon after WTC1's collapse in this location.

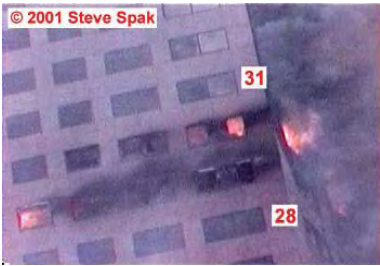
Image 3.W.12

West Facade - Visual evidence of the west facade during this time period shows that fires burned on levels 29 and 30 but burned-out by the end of the hour. Smoke and fire were visible on floor 22 throughout the hour. The earliest images of level 19 show windows already burned-out, indicating that a fire may have burned soon after WTC1's collapse in this location. Lastly, in the second half of the hour smoke became visible on level 18.

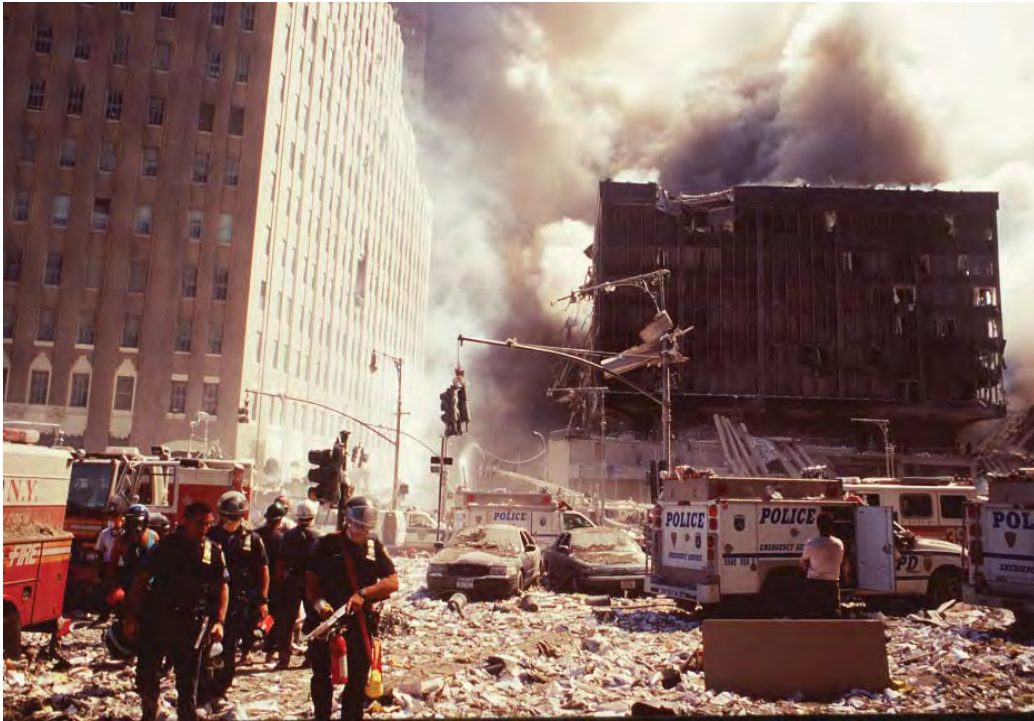
Image 3.W.01 West facade, approximately 12:10PM-12:25PM

Image 3.W.01 with columns and floor levels overlaid

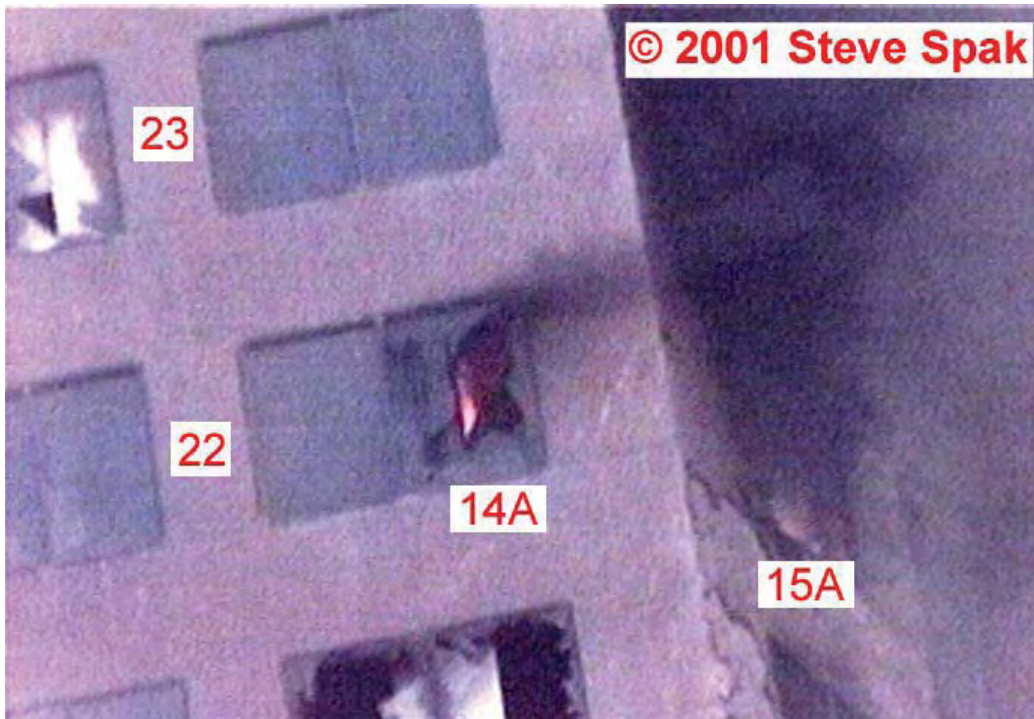
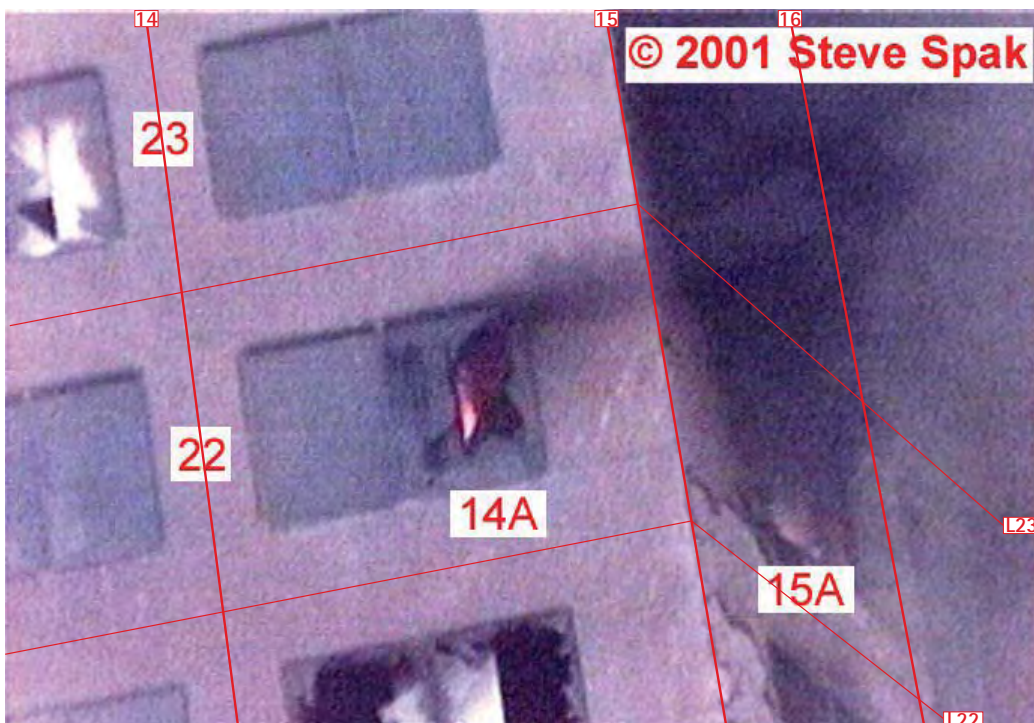
Image 3.W.02 Southwest corner, 12:10PM-12:25PM

Image 3.W.02 with columns and floor levels overlaid

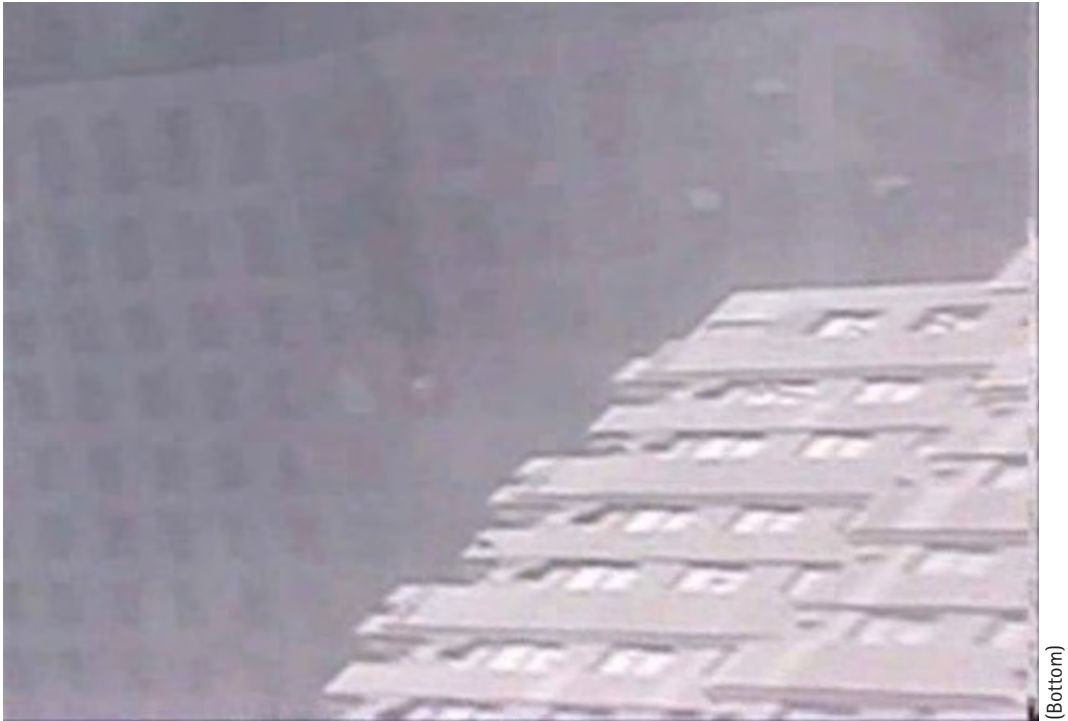
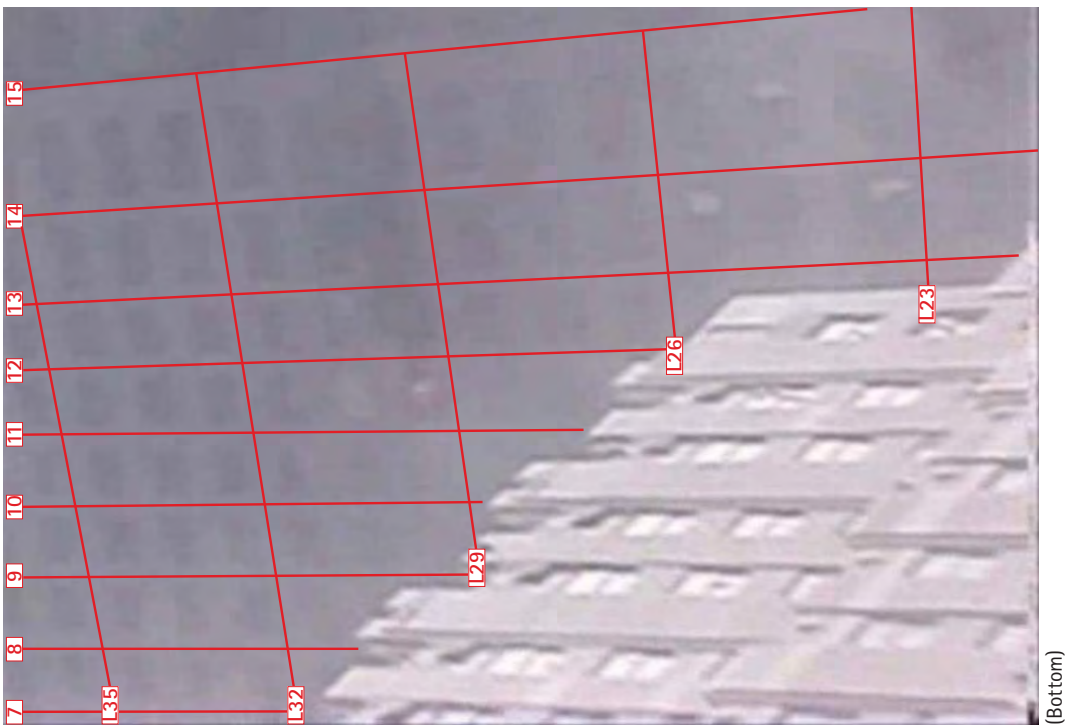
Image 3.W.03 West facade, approximately 12:10PM-12:27PM

Image 3.W.03 with columns and floor levels overlaid

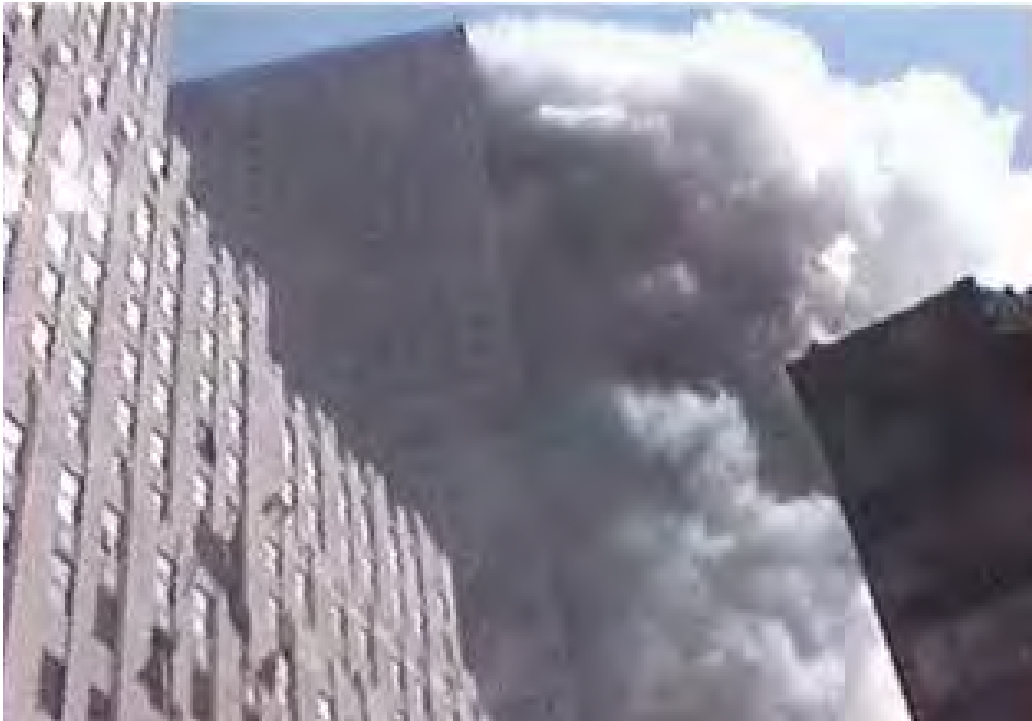
Image 3.W.04 West facade, approximately 12:10PM-12:28PM

Image 3.W.04 with columns and floor levels overlaid

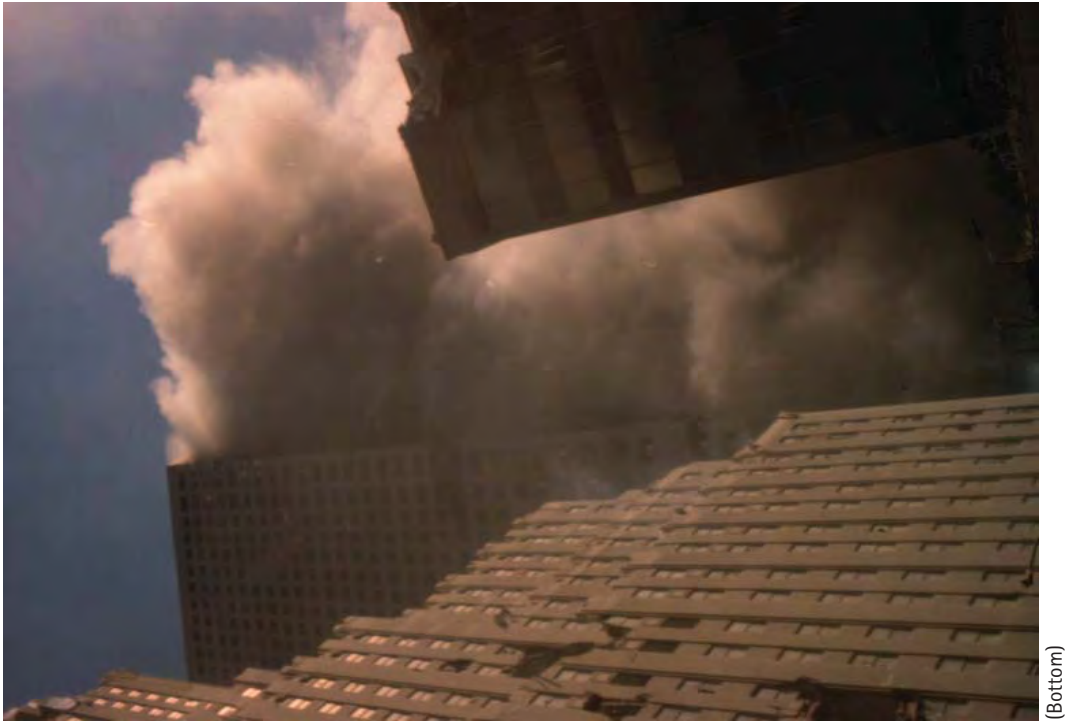
Image 3.W.05 Southwest corner, approximately 12:10PM-12:28PM

Image 3.W.05 with columns and floor levels overlaid

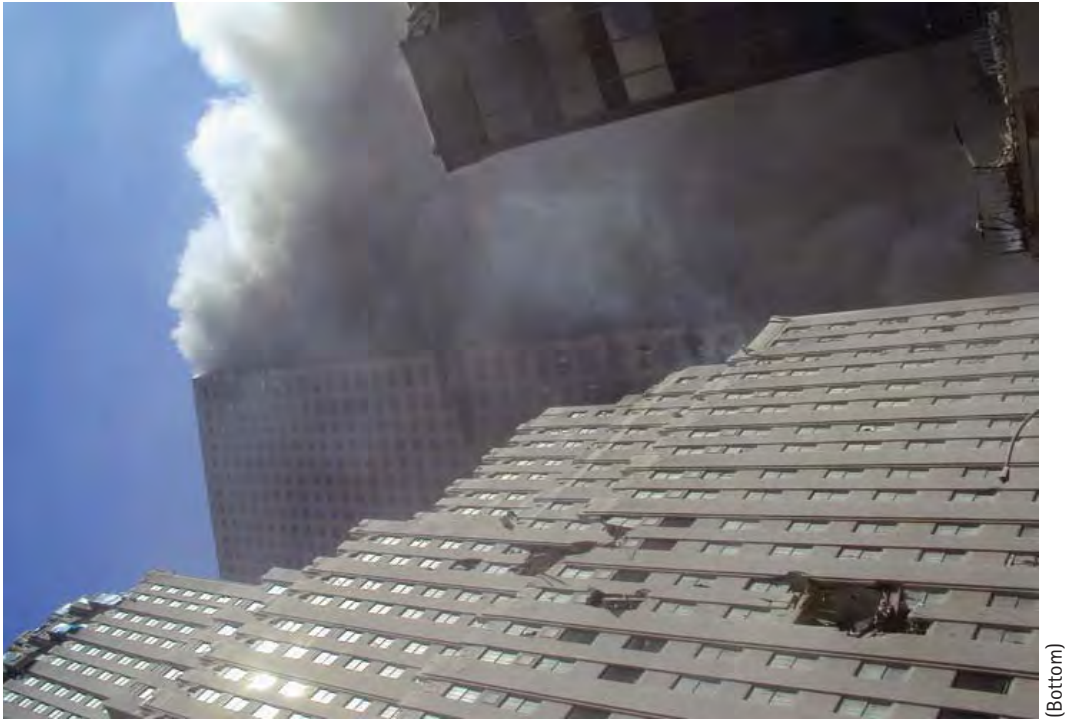
Image 3.W.06 West facade, 12:27:17PM +/-1s

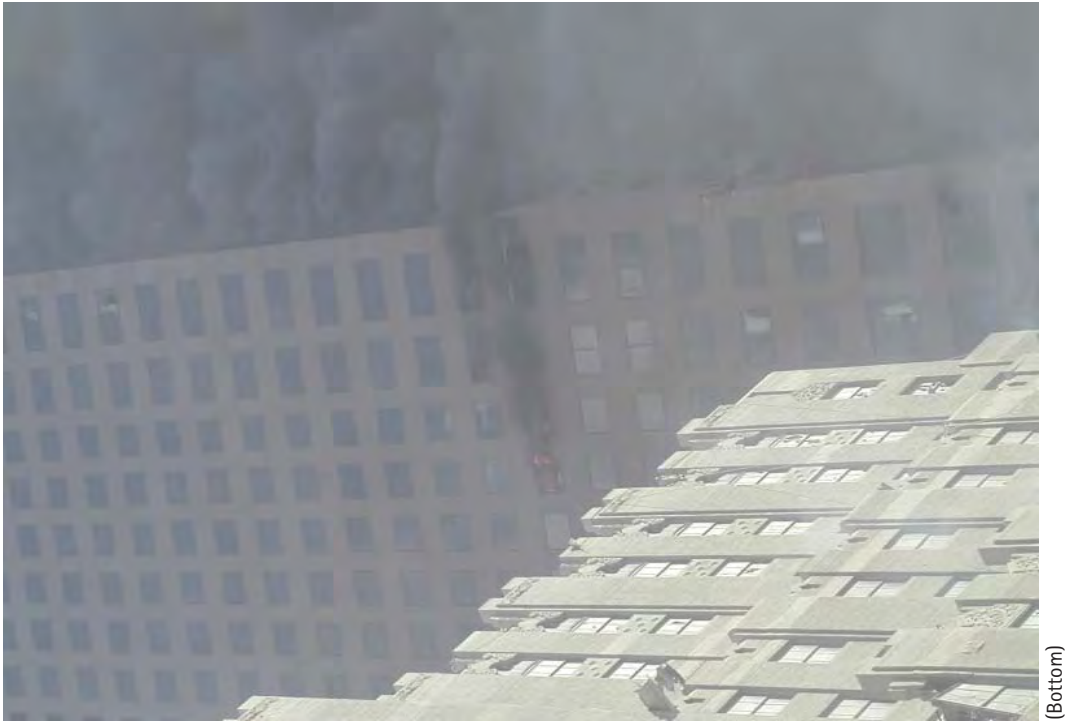
Image 3.W.07 Southwest corner, 12:27:30PM +/-1s

Image 3.W.07 with columns and floor levels overlaid

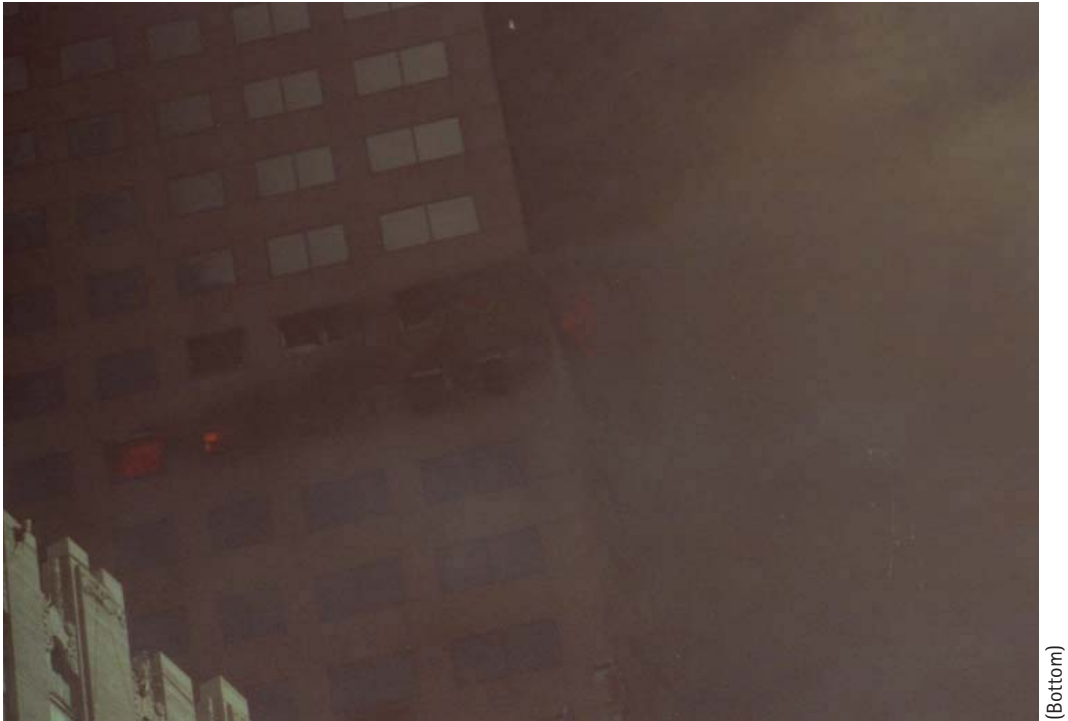
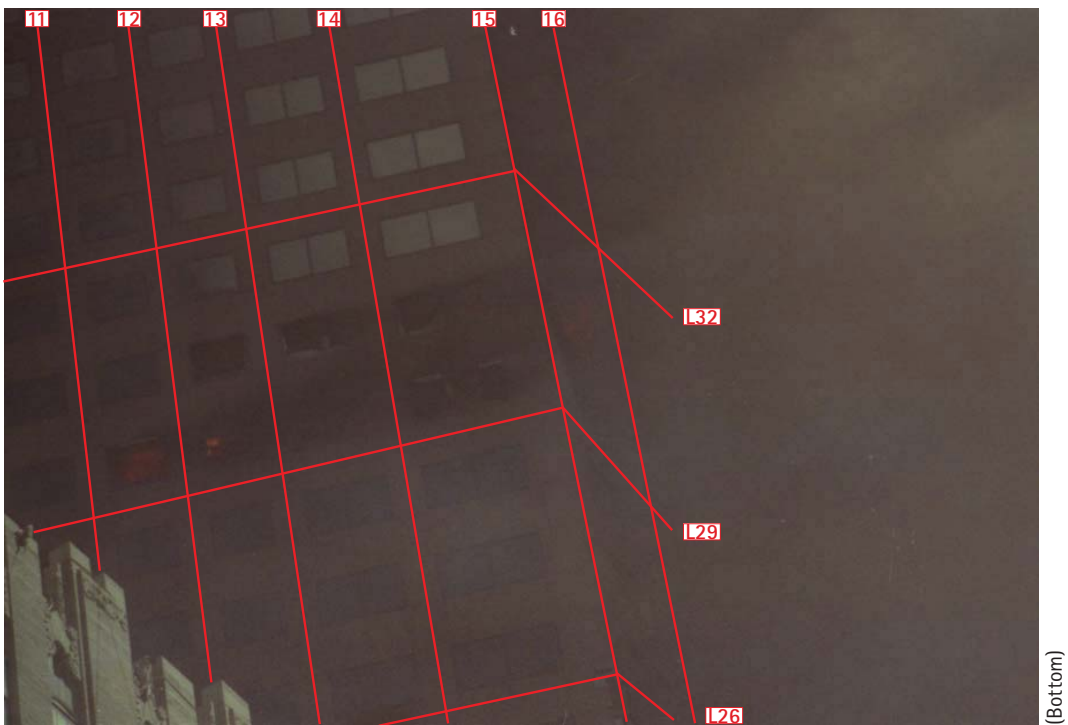
Image 3.W.08 Southwest corner, approximately 12:27PM-12:28PM

Image 3.W.08 with columns and floor levels overlaid

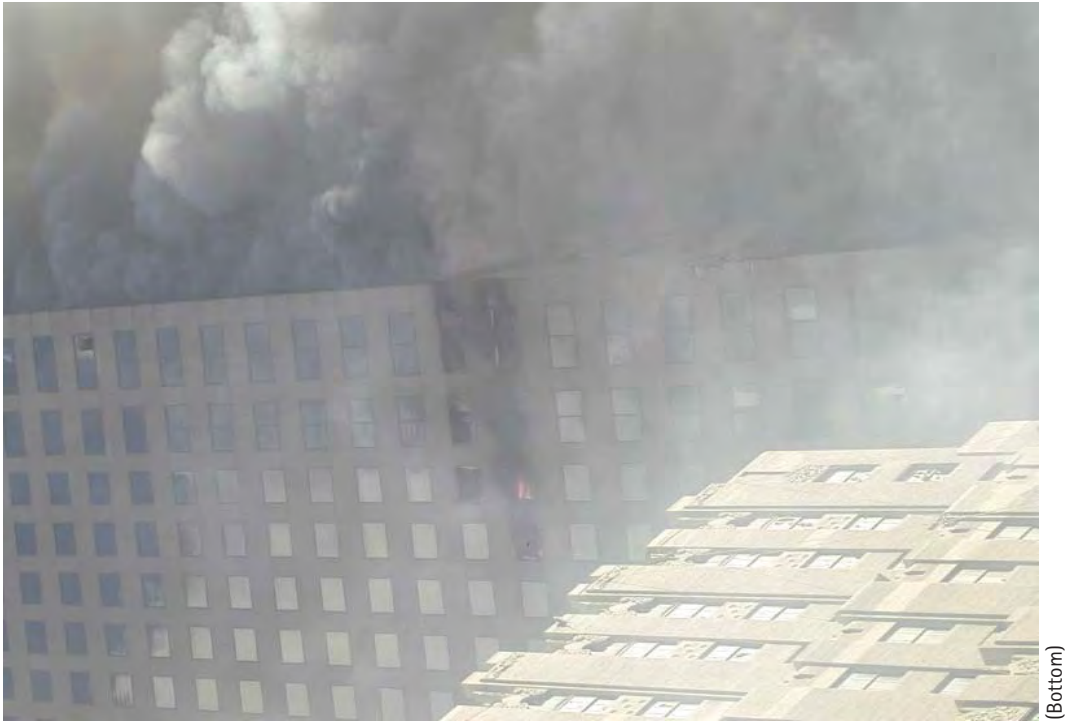
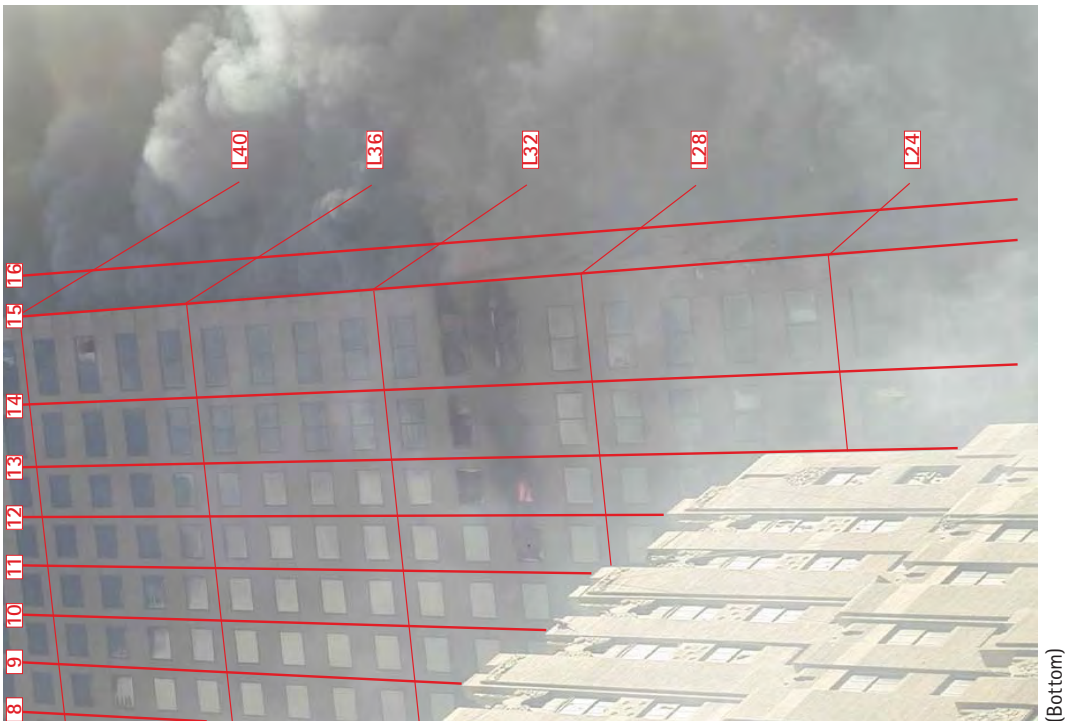
Image 3.W.09 Southwest corner, 12:28:40PM +/-1s

Image 3.W.09 with columns and floor levels overlaid

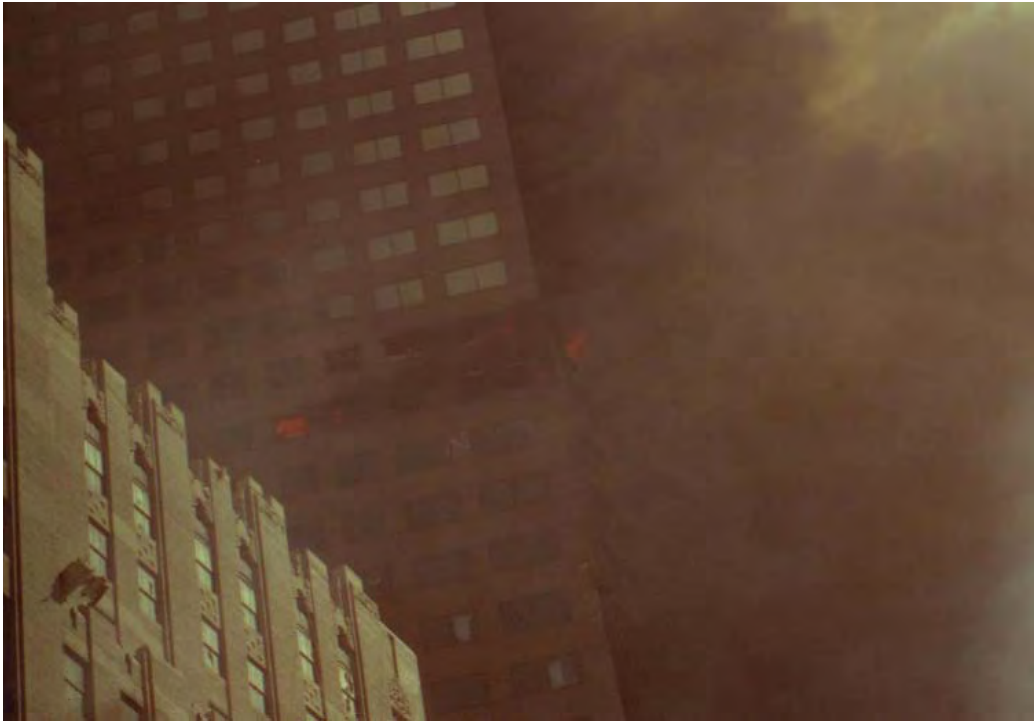
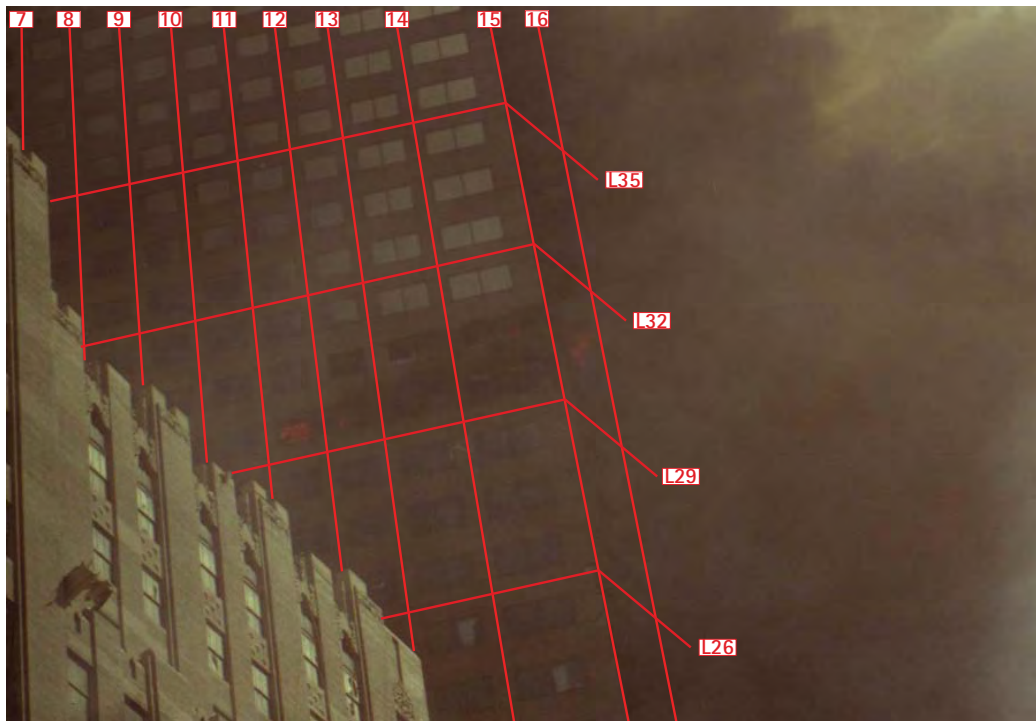
Image 3.W.10 Southwest corner, approximately 12:28PM-12:31PM

Image 3.W.10 with columns and floor levels overlaid

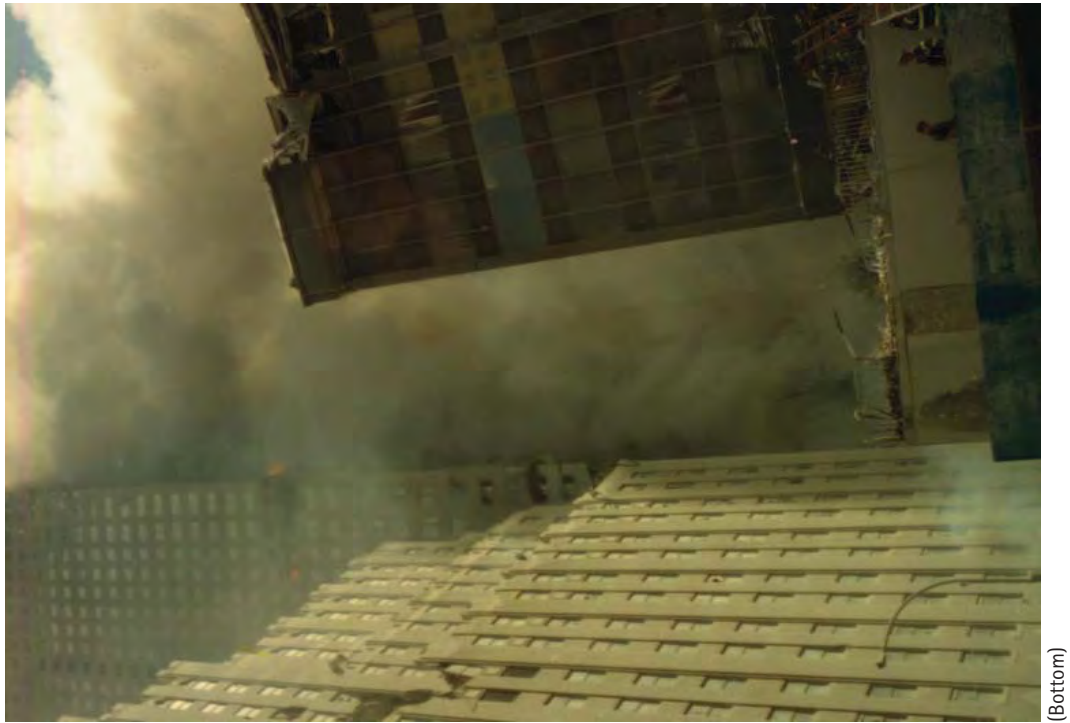
Image 3.W.11 Southwest corner, approximately 12:28PM-12:31PM

Image 3.W.11 with columns and floor levels overlaid

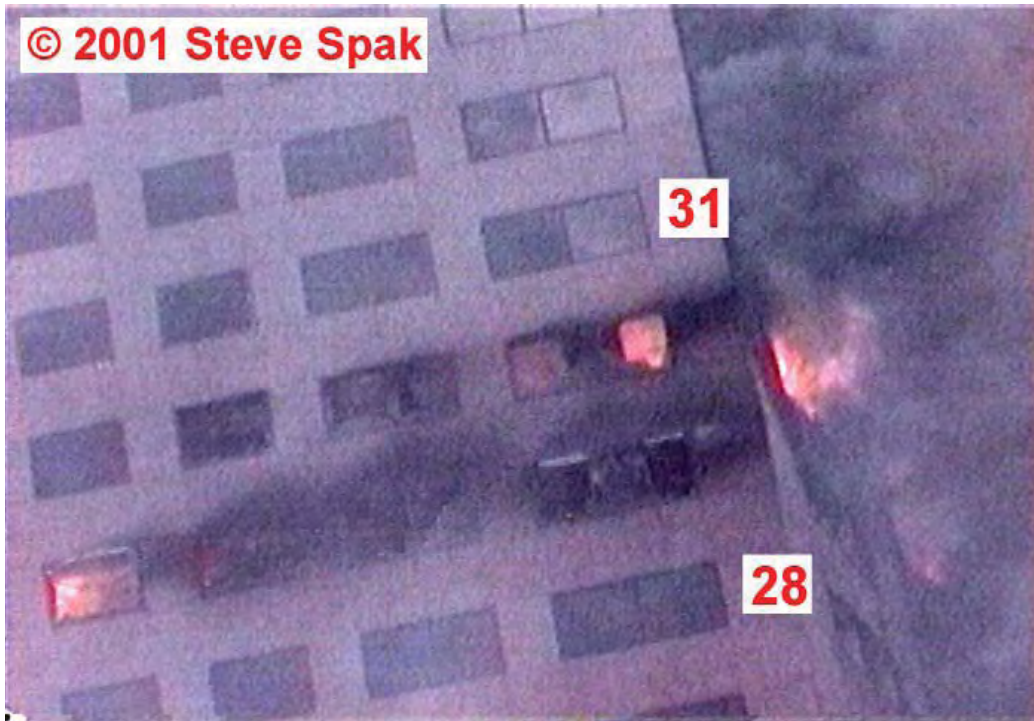
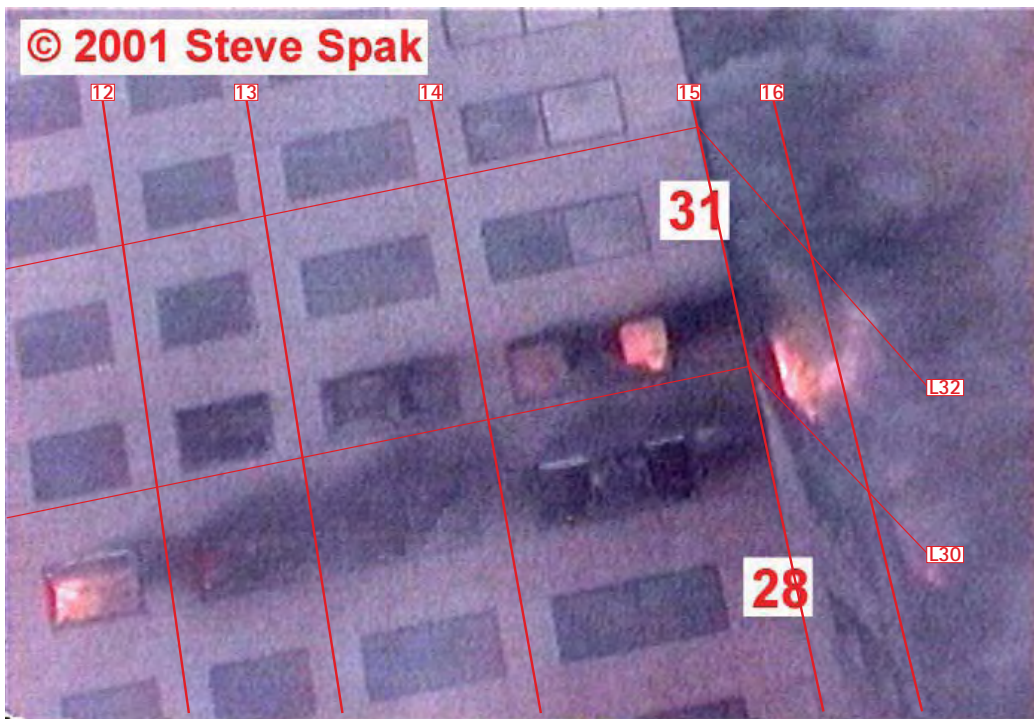
Image 3.W.12 Southwest corner, 12:28PM +/-180S

Image 3.W.12 with columns and floor levels overlaid

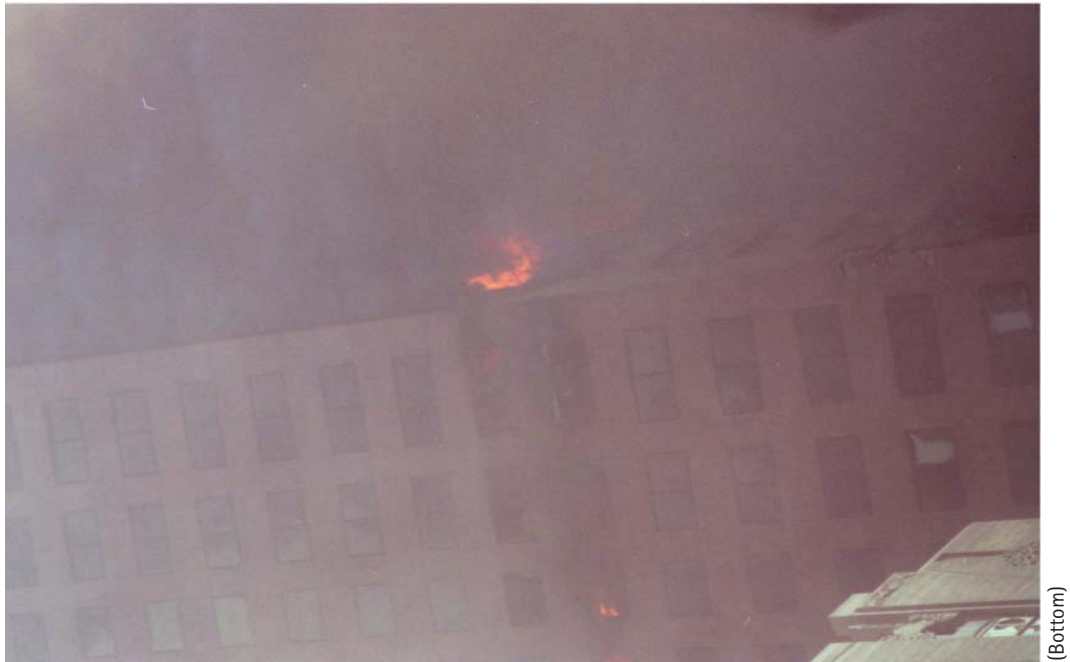
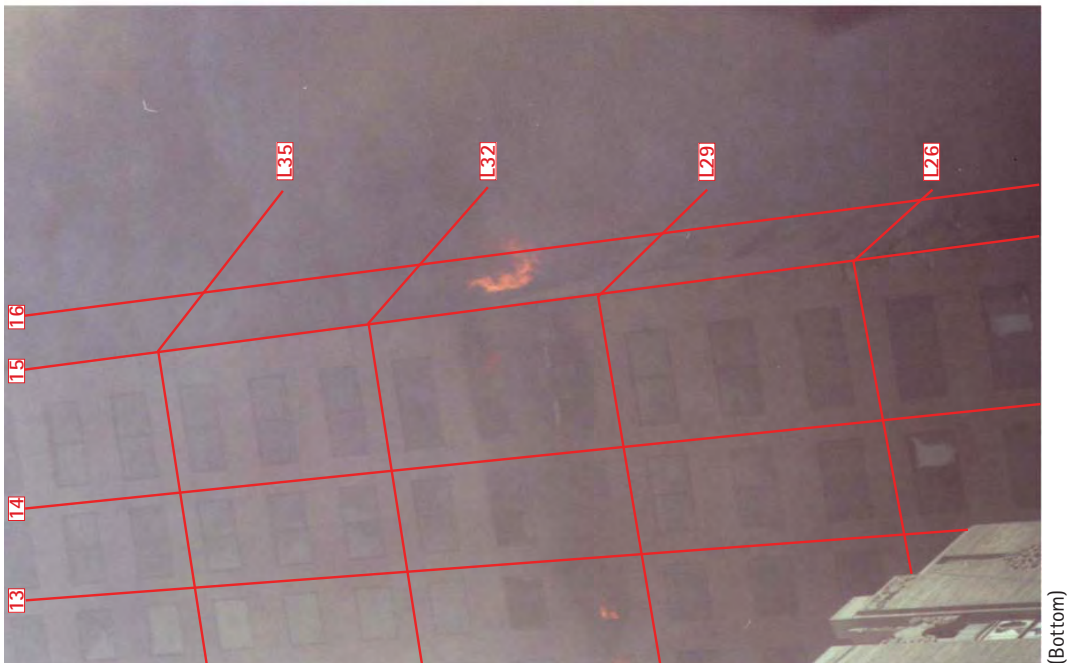
Image 3.W.13 Southwest corner, approximately 12:28PM-12:32PM

Image 3.W.13 with columns and floor levels overlaid

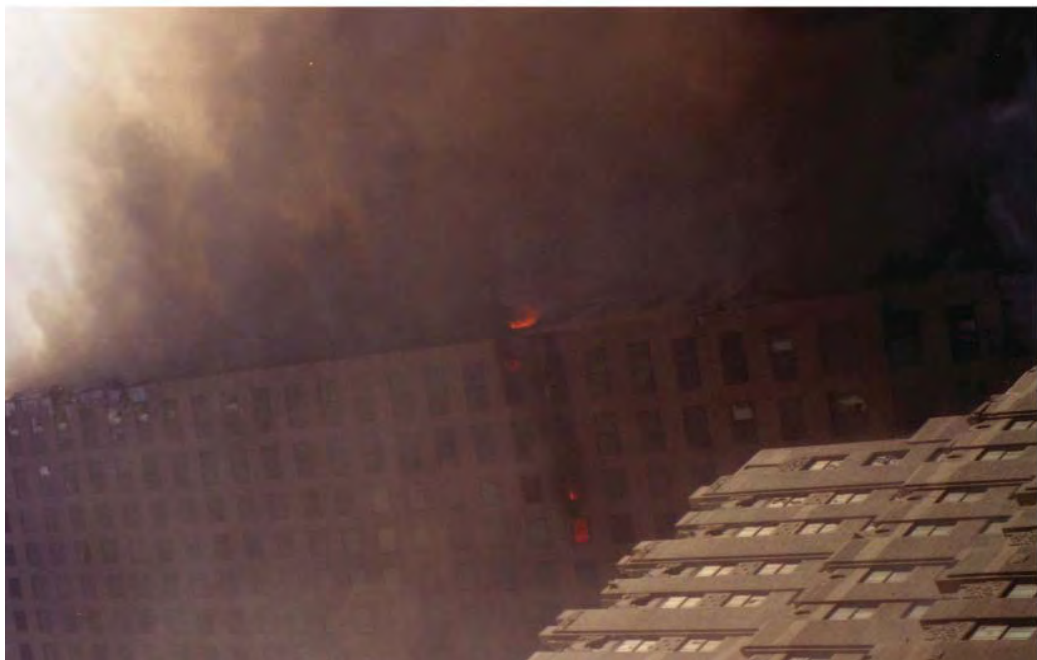
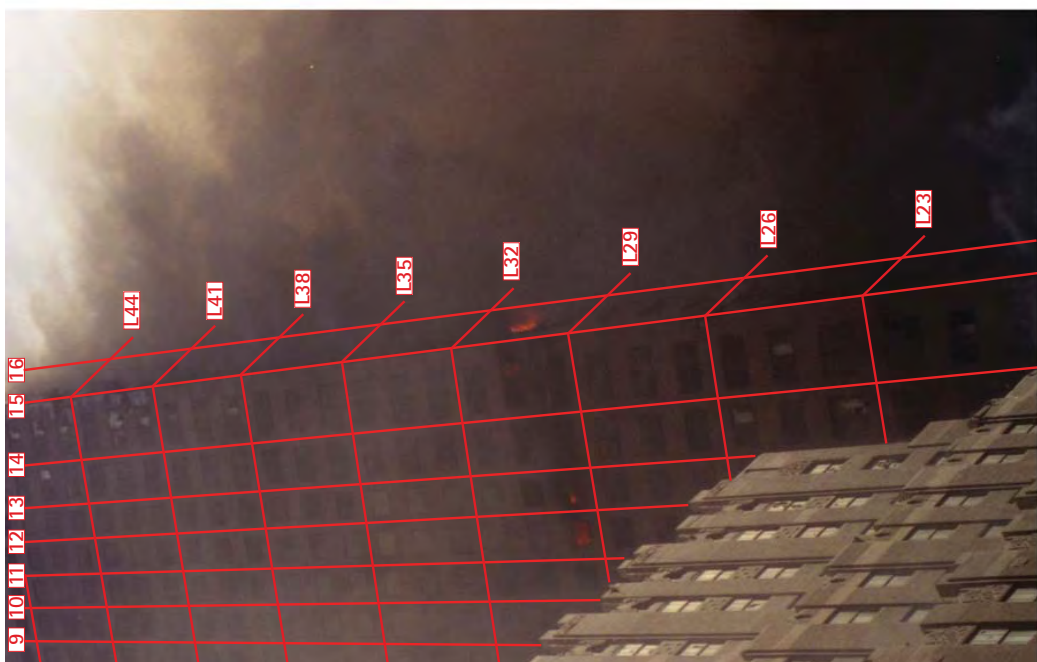
Image 3.W.14 Southwest corner, approximately 12:28PM-12:32PM

Image 3.W.14 with columns and floor levels overlaid

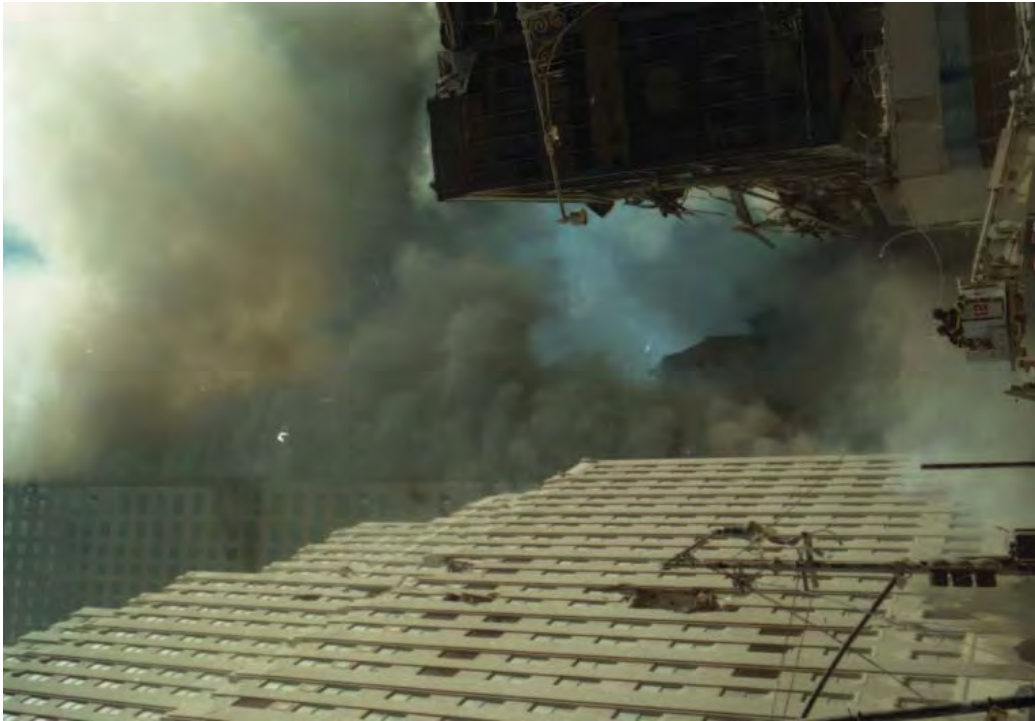
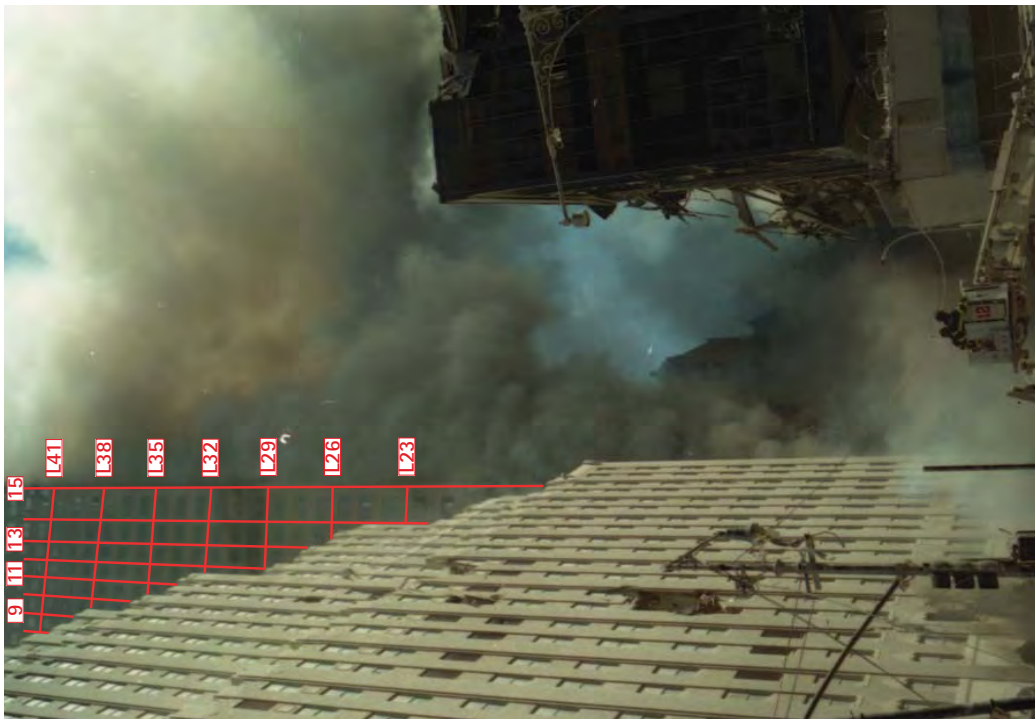
Image 3.W.15 Southwest corner, approximately 12:28PM-12:32PM

Image 3.W.15 with columns and floor levels overlaid

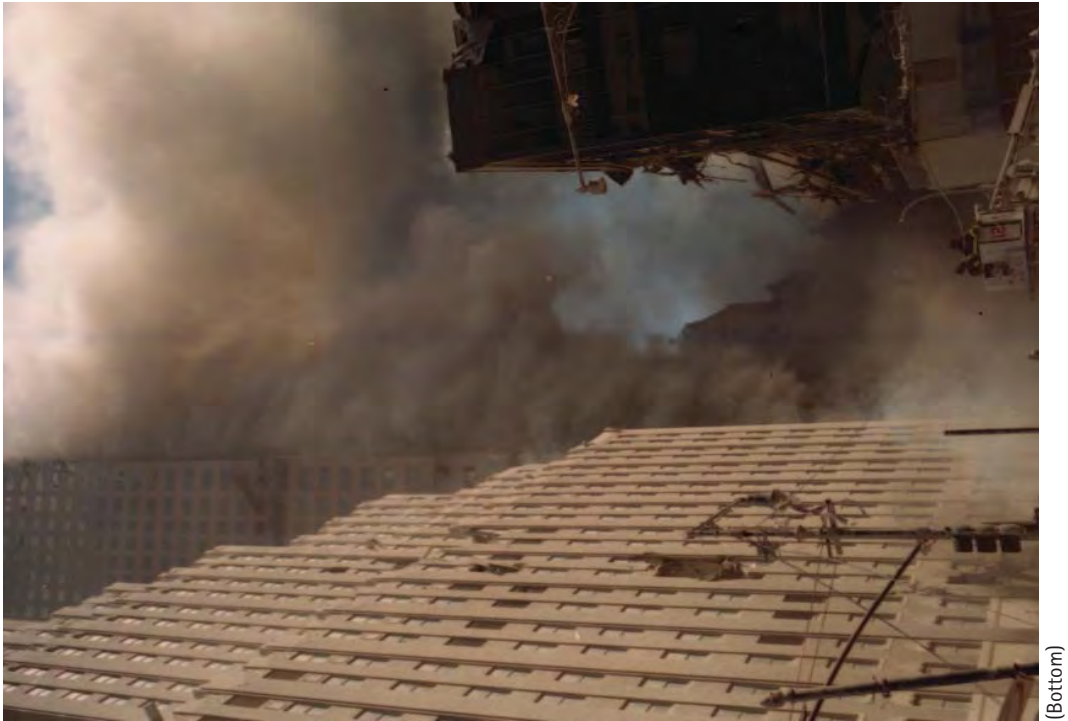
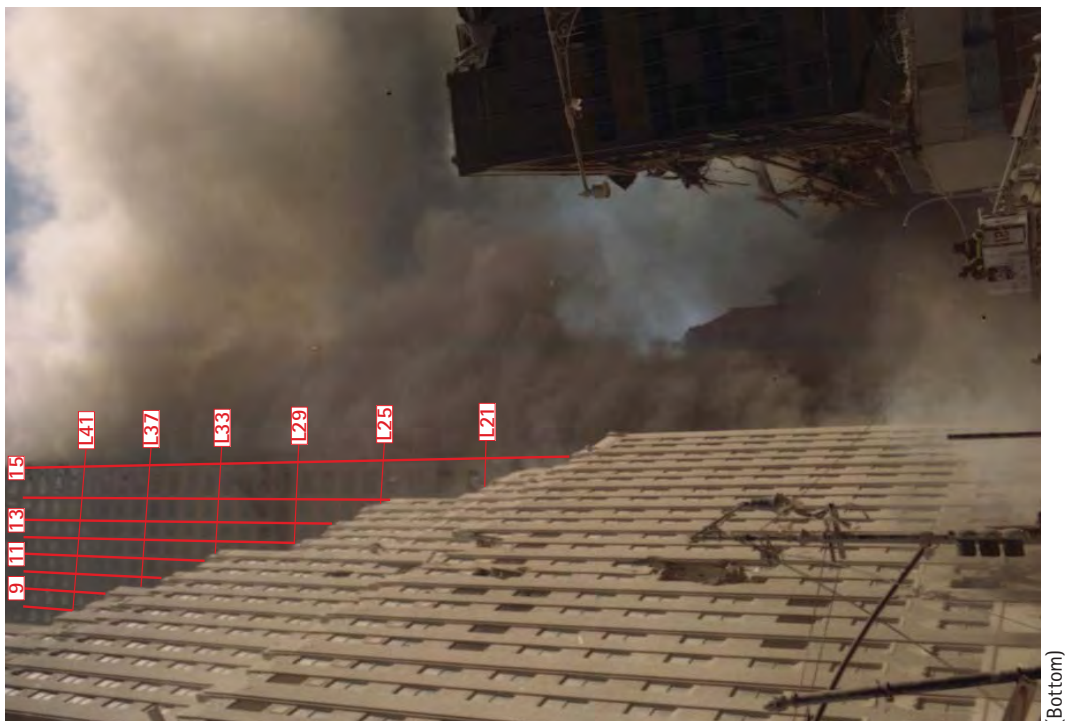
Image 3.W.16 Southwest corner, approximately 12:28PM-12:32PM

Image 3.W.16 with columns and floor levels overlaid
