11-4403-CV

United States Court of Appeals
for the
Second Circuit

JOINT APPENDIX
Volume 13 of 16 (Pages JA-3321 to JA-3616)

In re: September 11 Property Damage and Business Loss Litigation

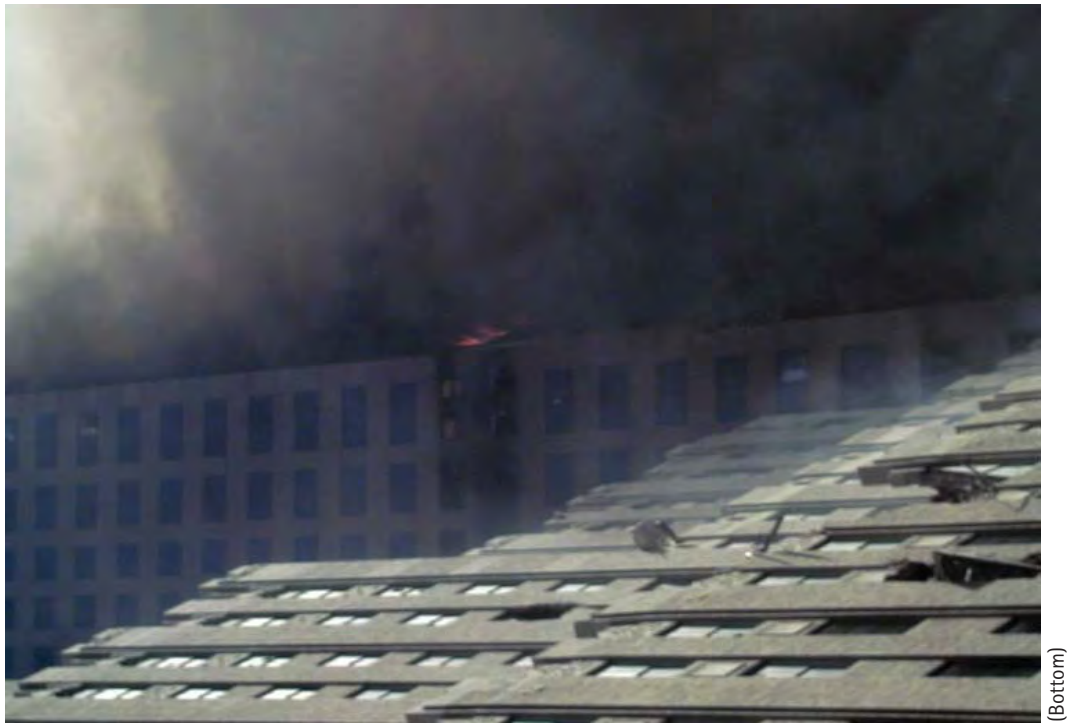
Image 3.W.17 Southwest corner, 12:33:03PM +/-1s

Image 3.W.17 with columns and floor levels overlaid

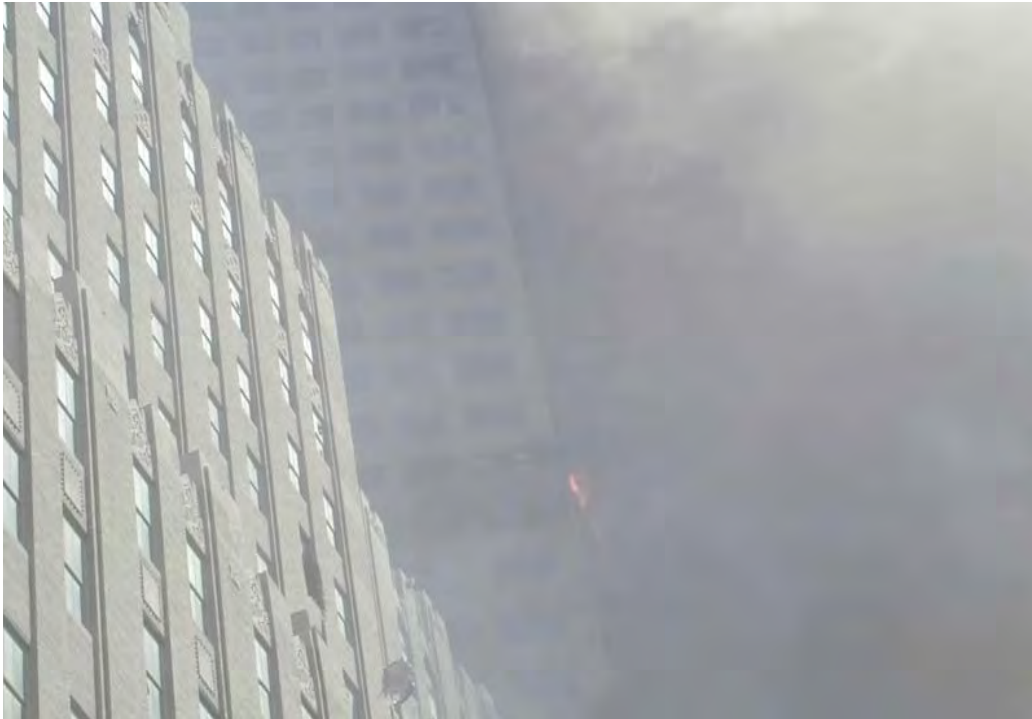
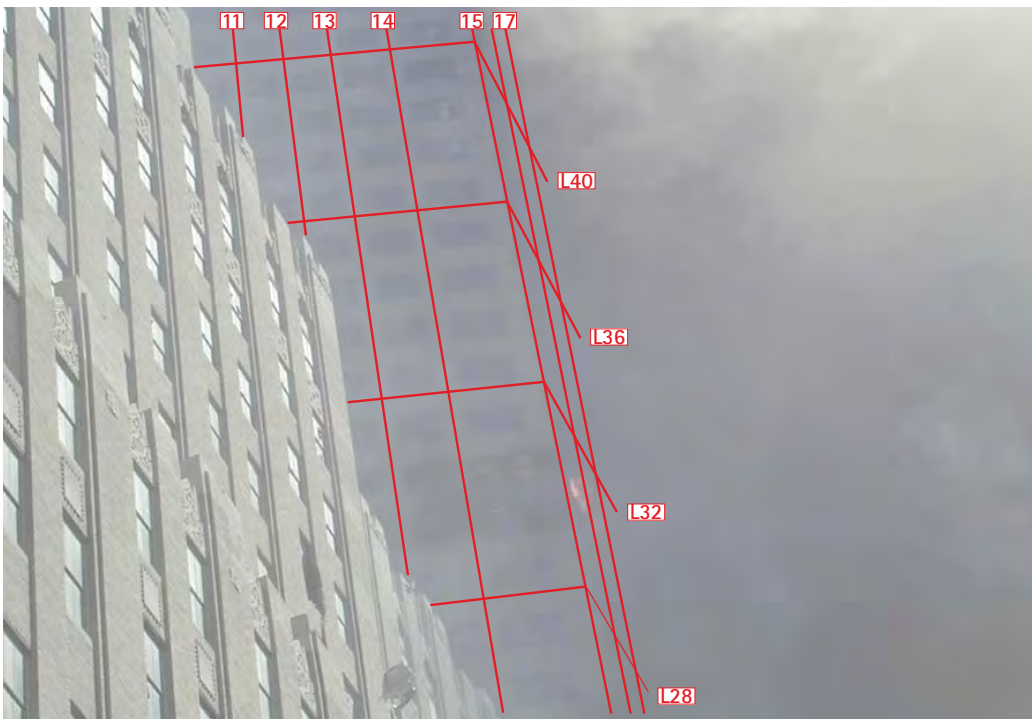
Image 3.W.18 Southwest corner, 12:33:03PM +/-1S

Image 3.W.18 with columns and floor levels overlaid

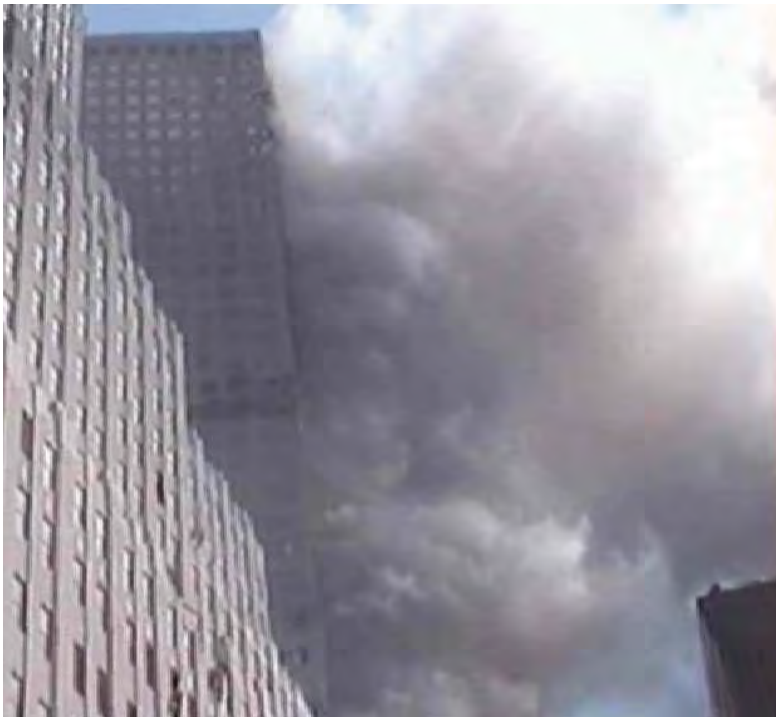
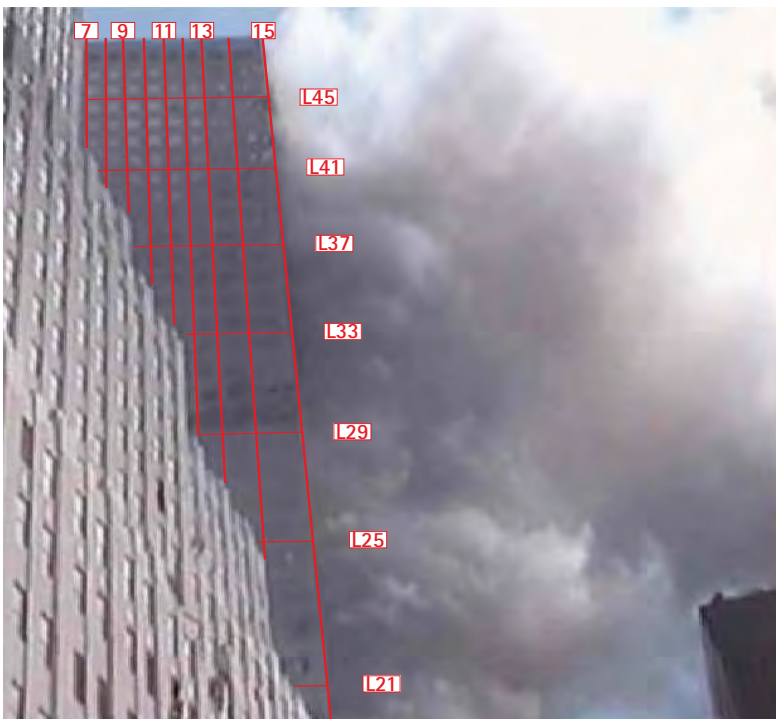
Image 3.W.19 West facade, approximately 12:30PM-1:00PM

Image 3.W.19 with columns and floor levels overlaid

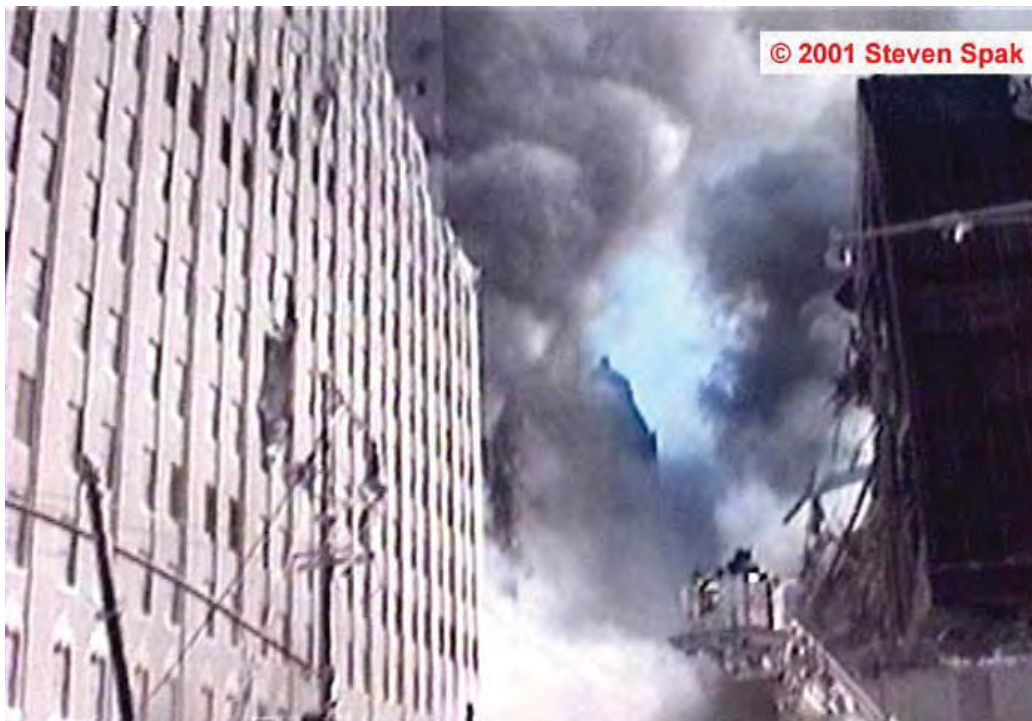
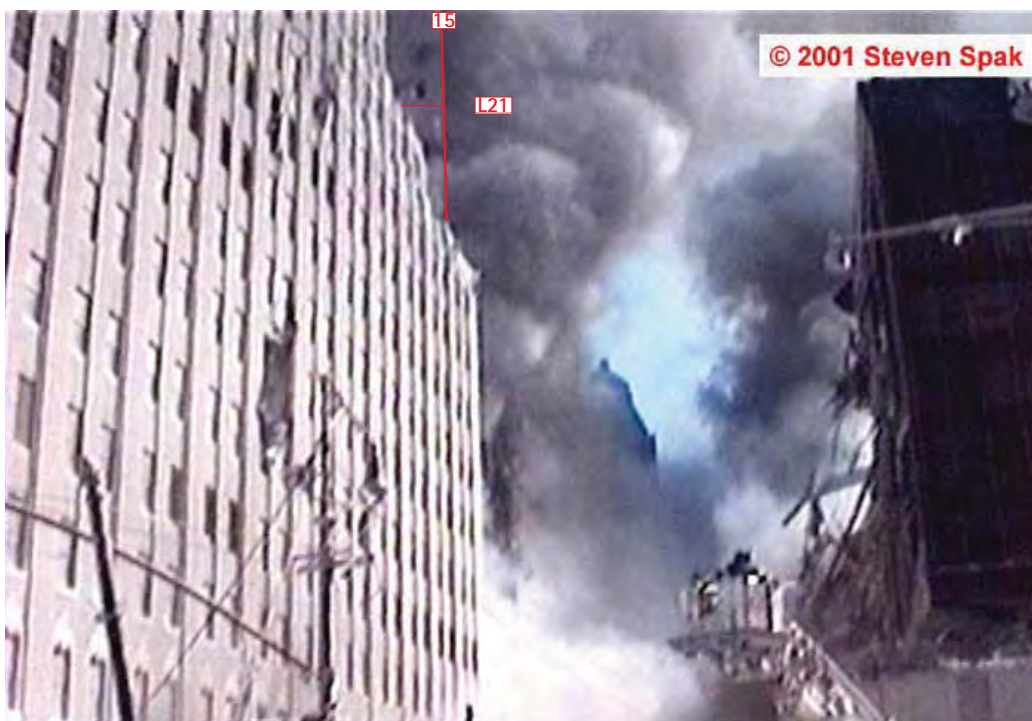
Image 3.W.20 Southwest corner, shortly before 12:46:39PM

Image 3.W.20 with columns and floor levels overlaid

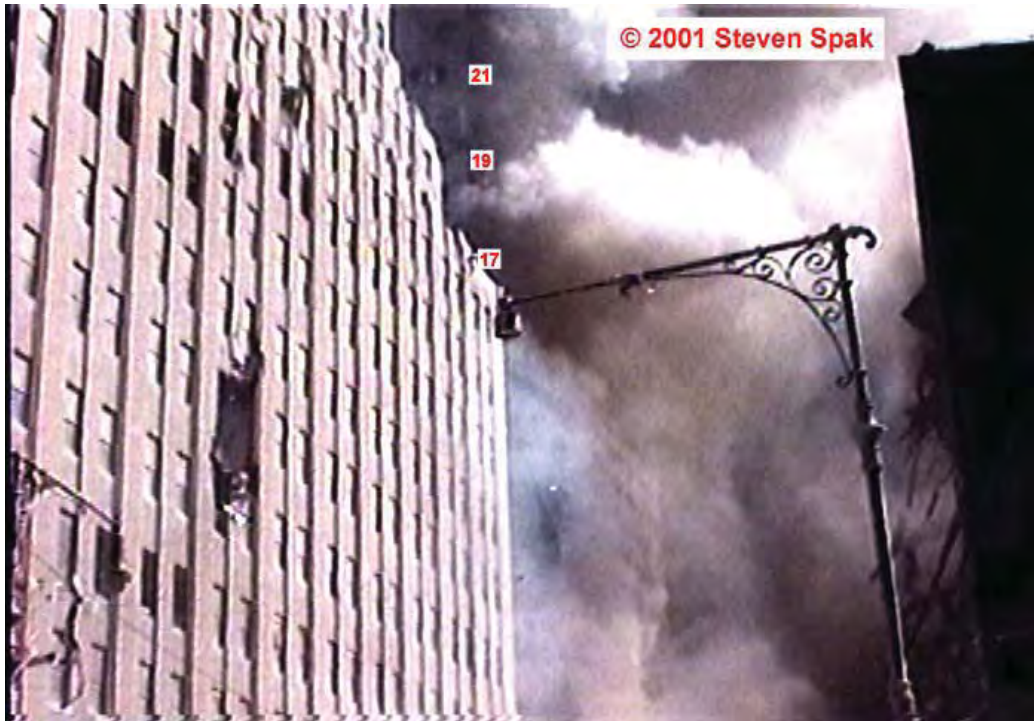
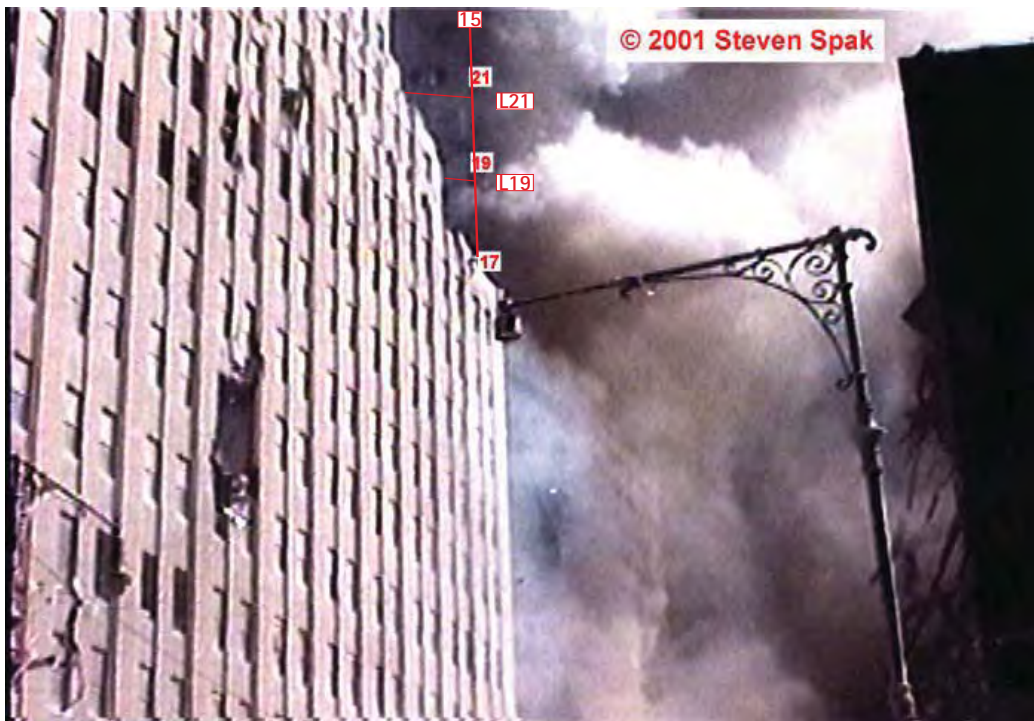
Image 3.W.21 Southwest corner, shortly after 12:30PM

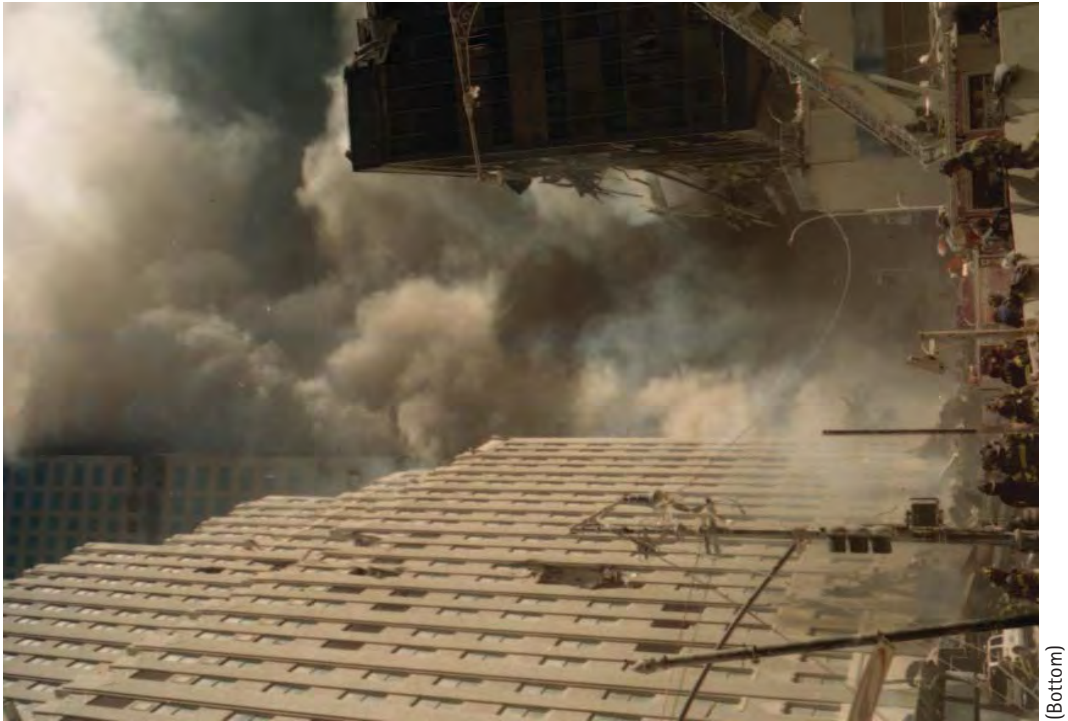
Image 3.W.22 Southwest corner, approximately 12:30PM-1:00PM

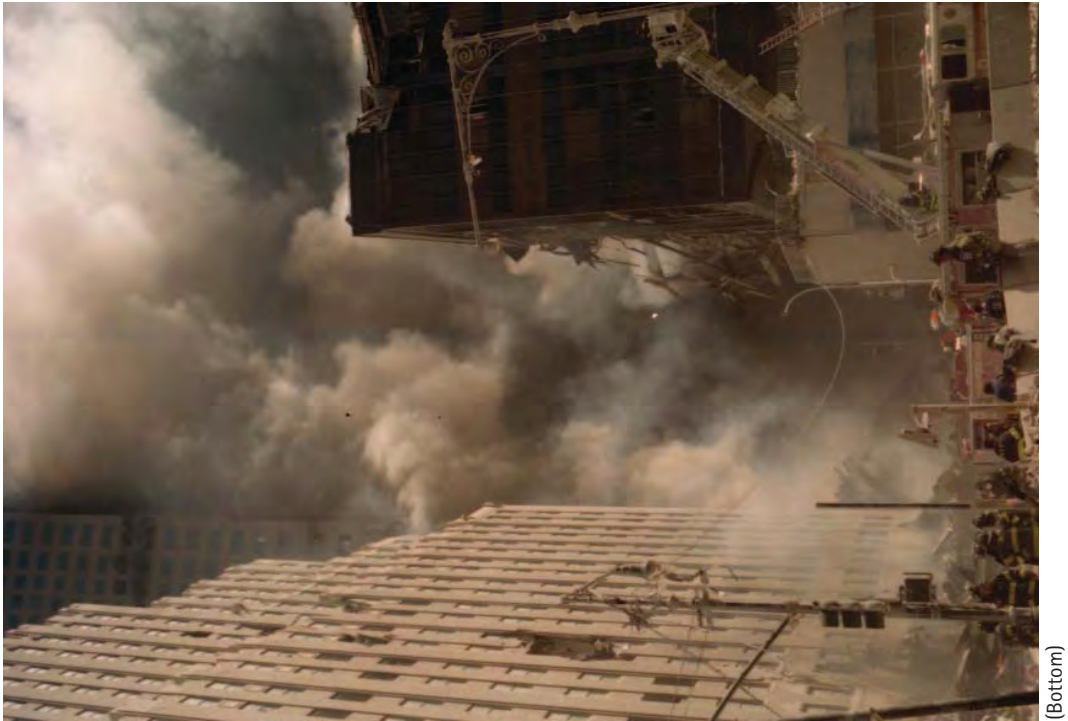
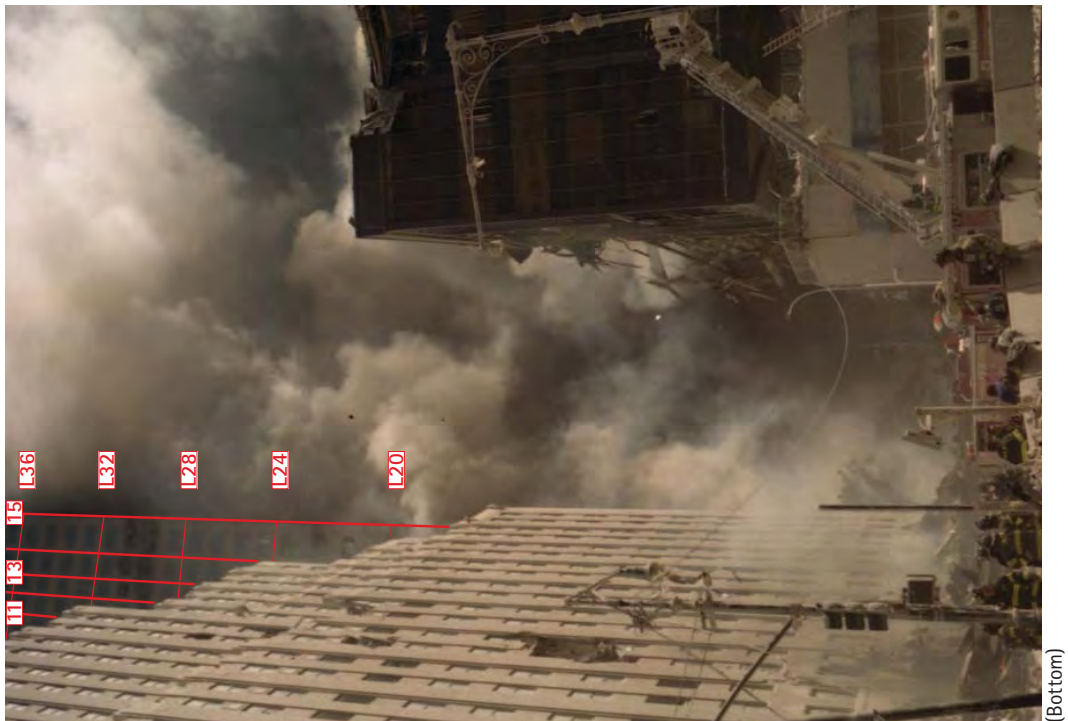
Image 3.W.23 Southwest corner, approximately 12:30PM-1:00PM

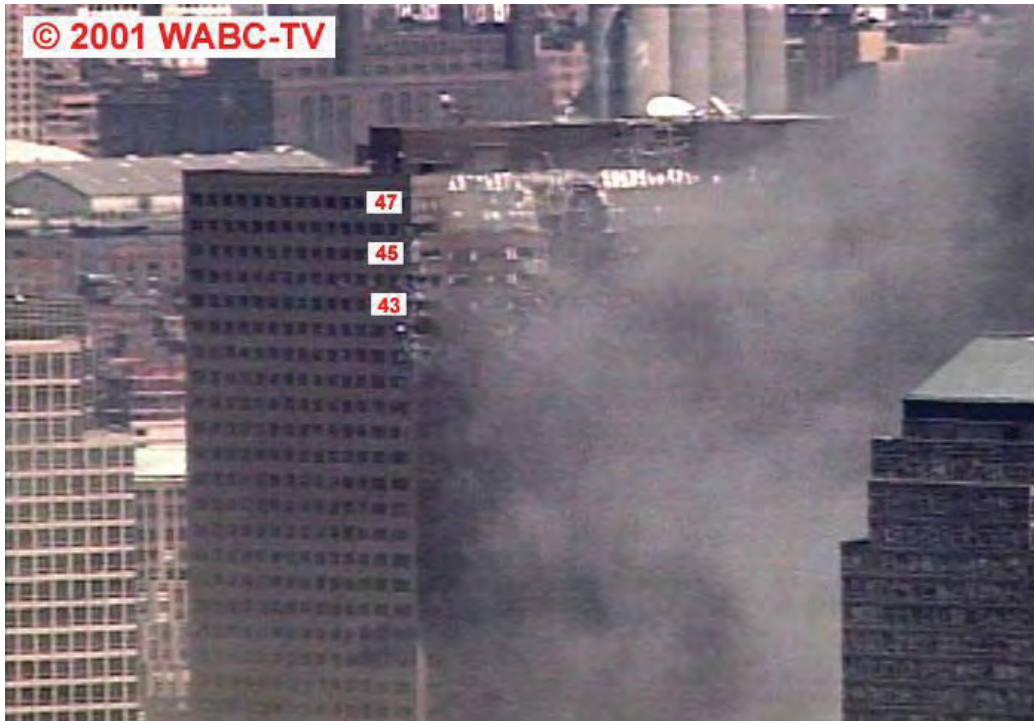
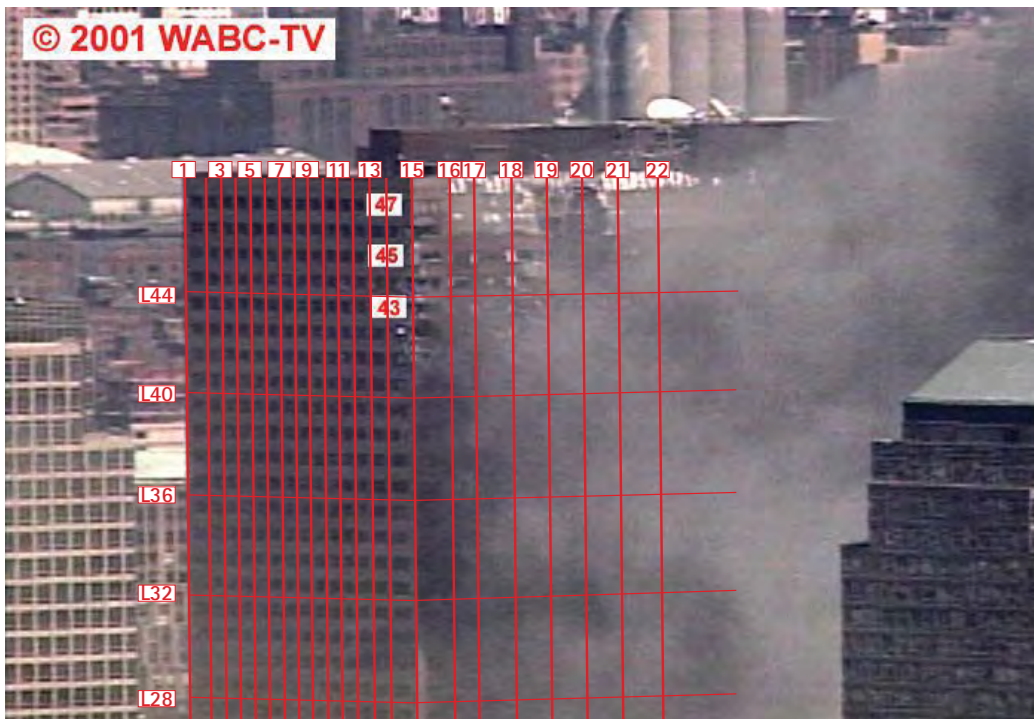
Image 3.W.24 Southwest corner, approximately after 12:40PM

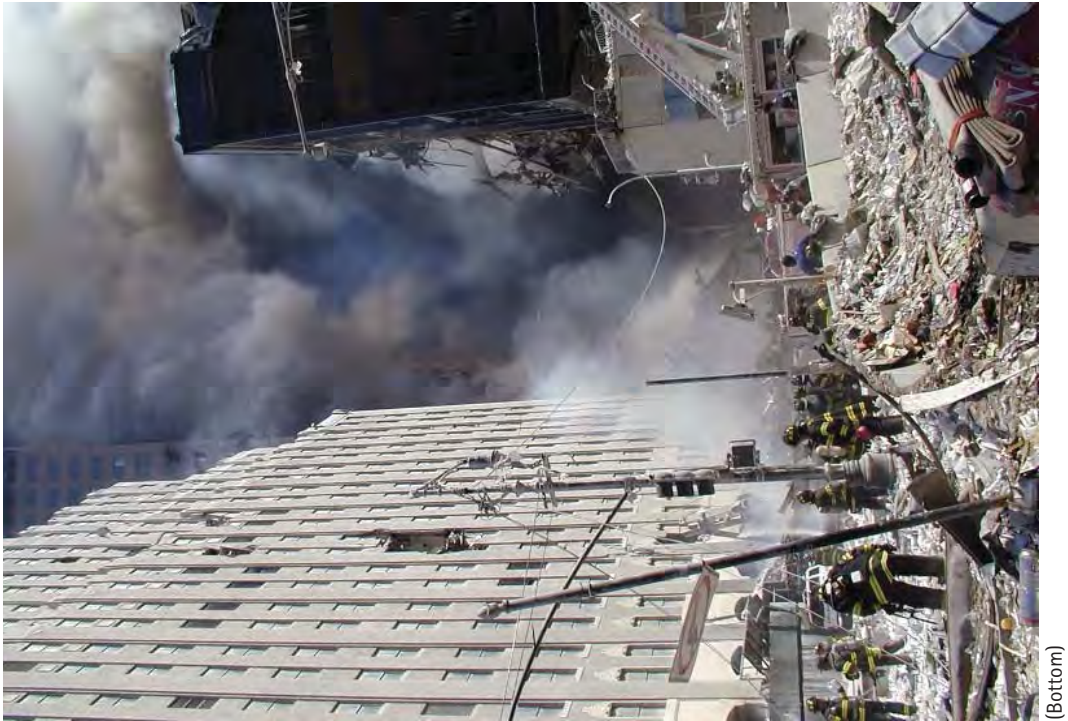
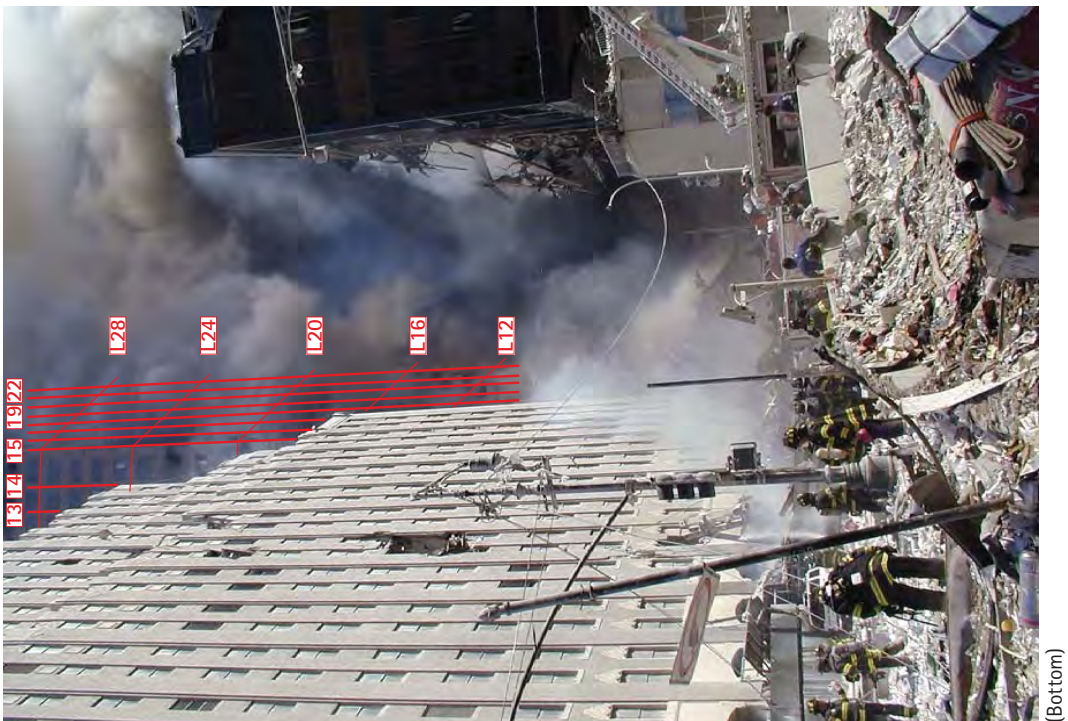
Image 3.W.25 Southwest corner, 12:46:39PM

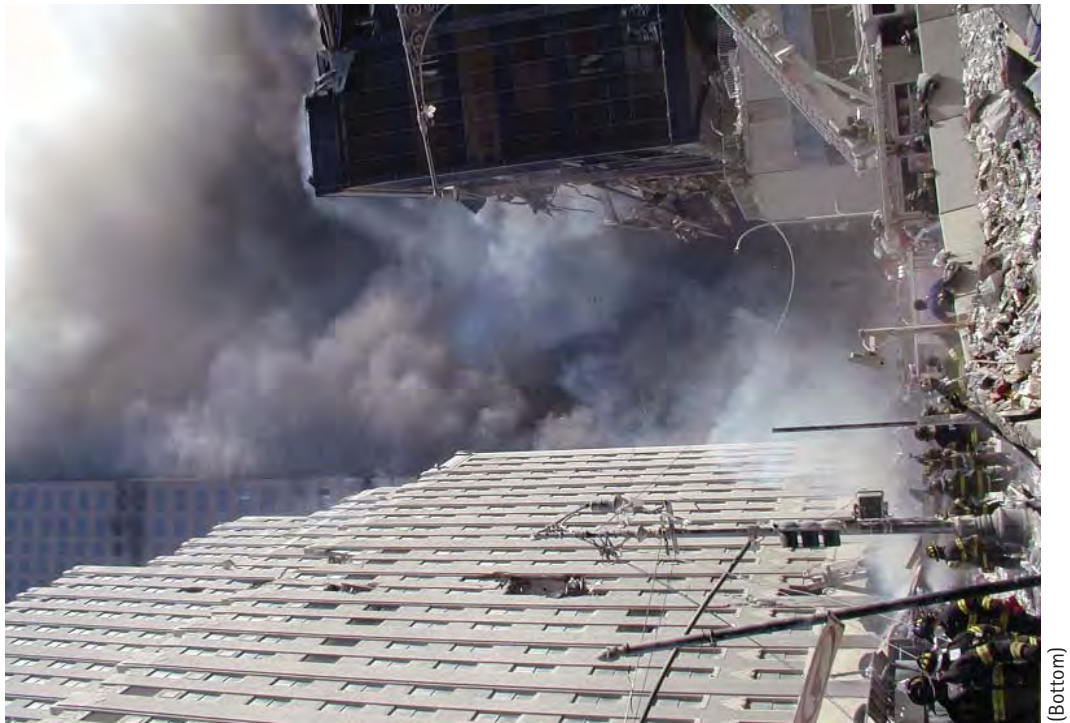
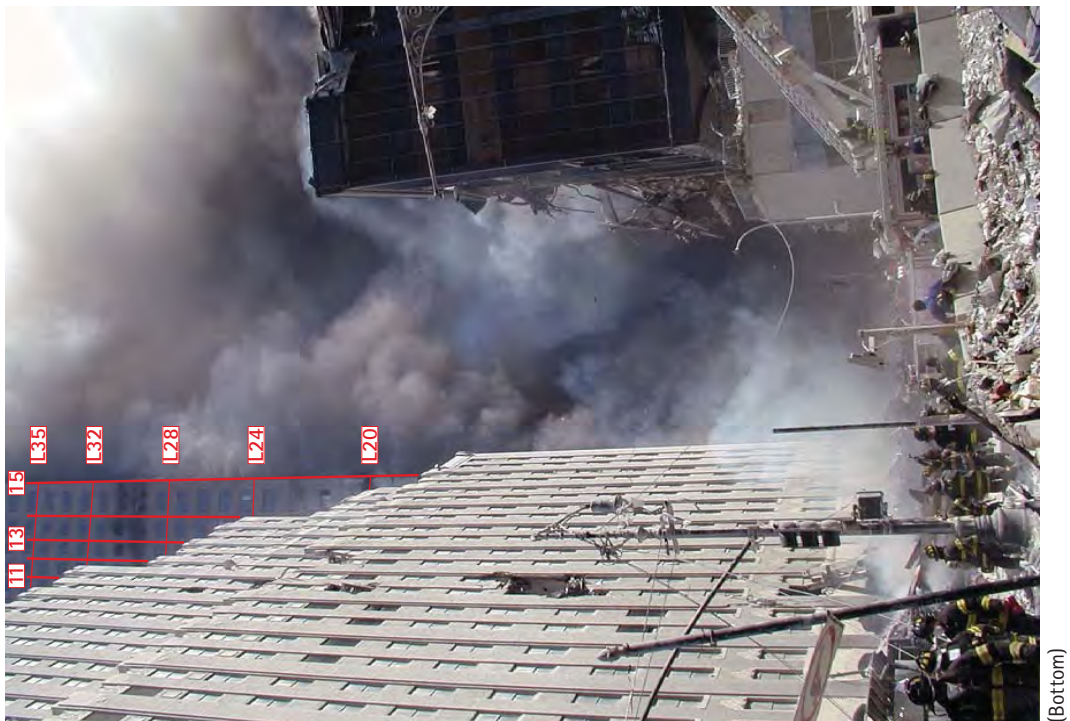
Image 3.W.26 Southwest corner, 12:46:48PM +/-1S

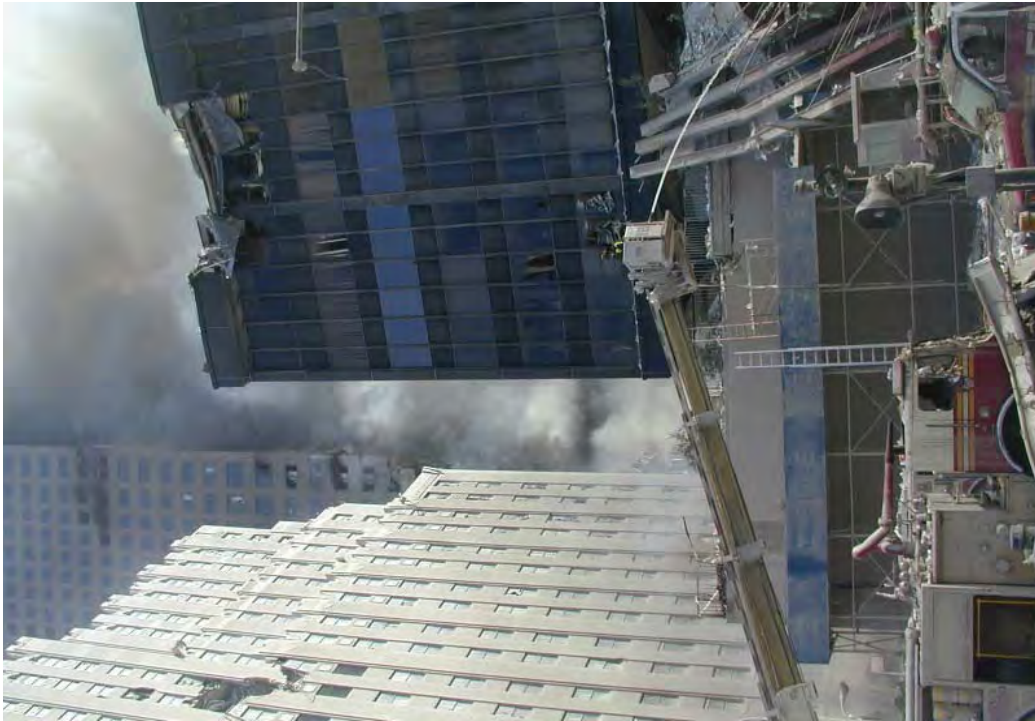
Image 3.W.27 Southwest corner, 12:47:40PM +/-1s

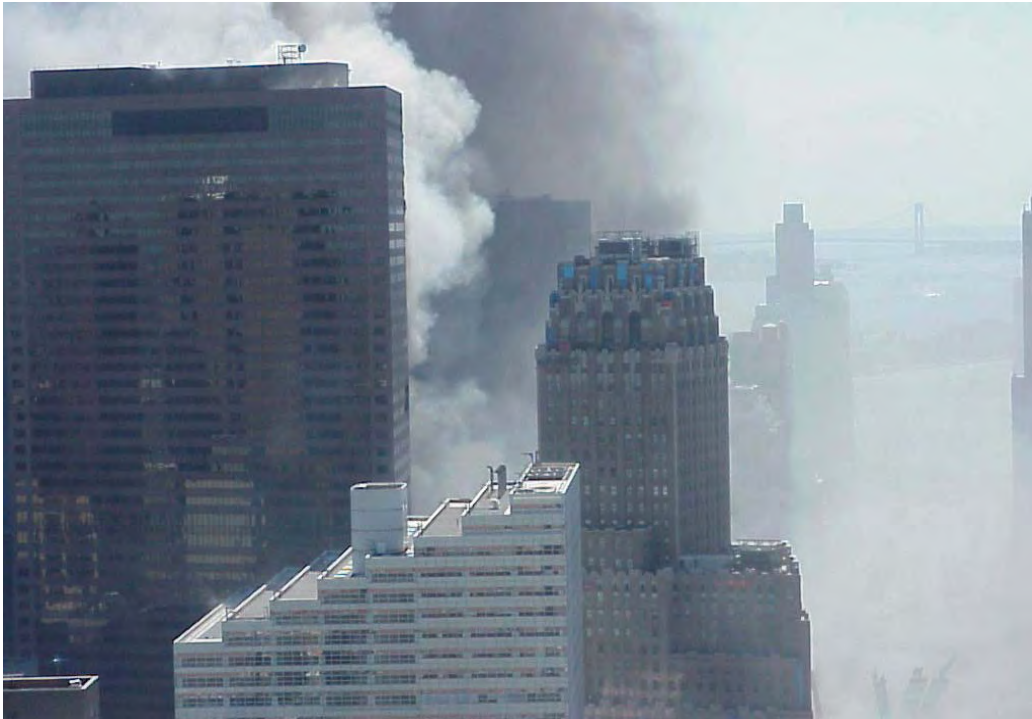
Image 3.W.28 Northwest corner, approximately 12:30PM-2:00PM

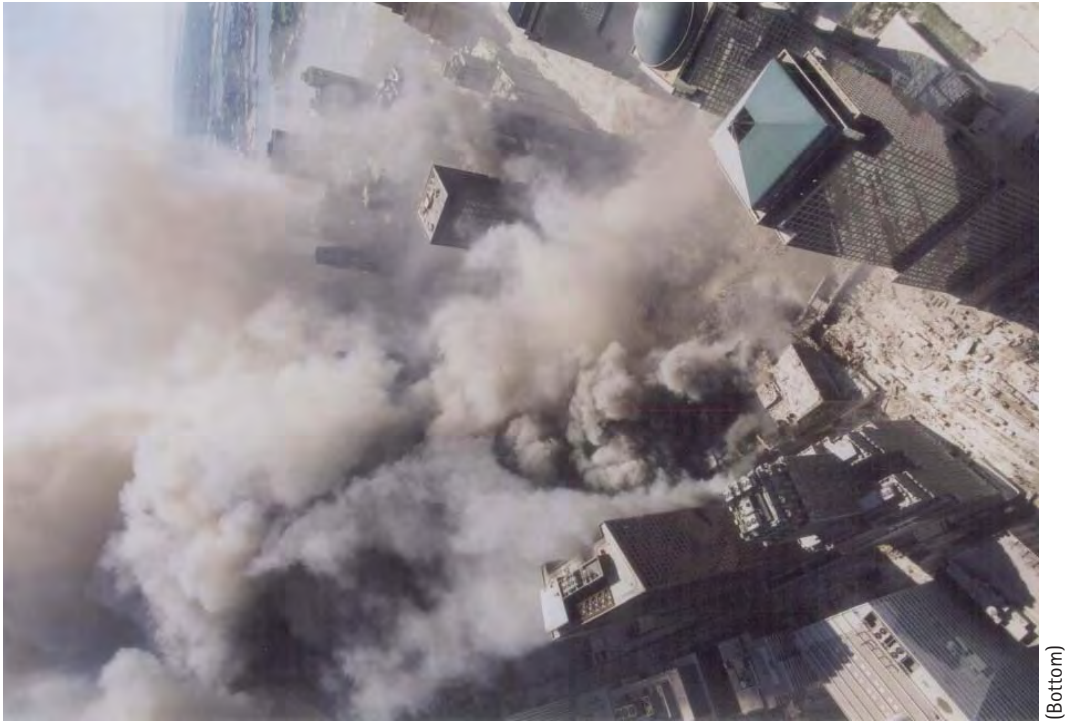
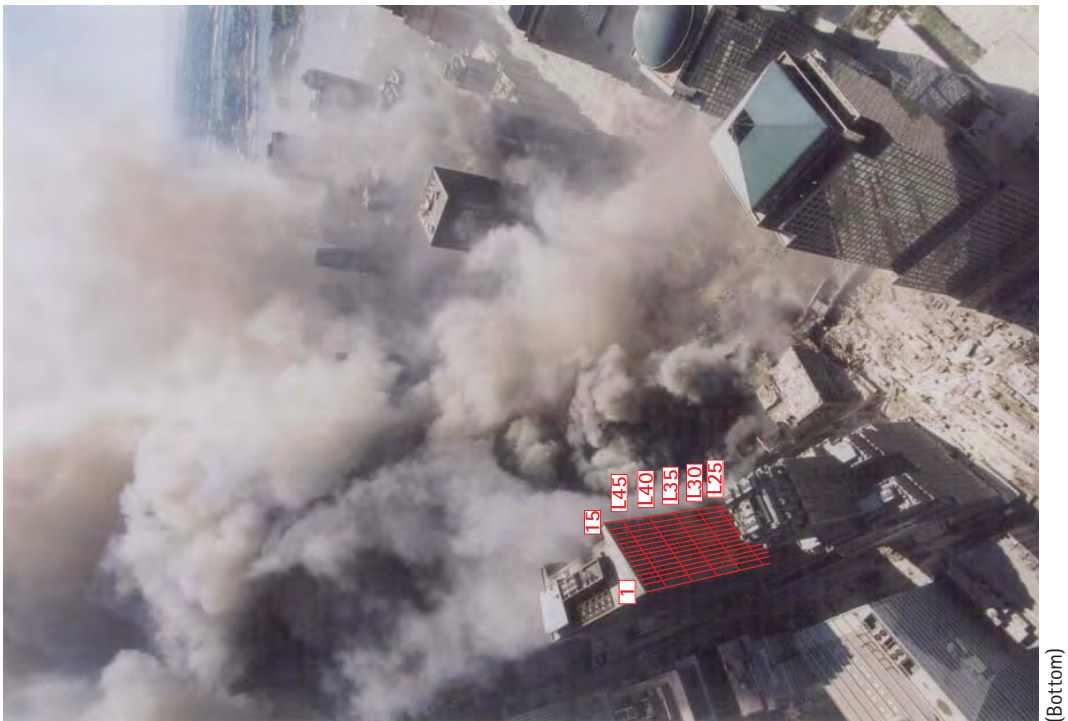
Image 3.W.29 West facade, approximately 12:30PM-2:00PM

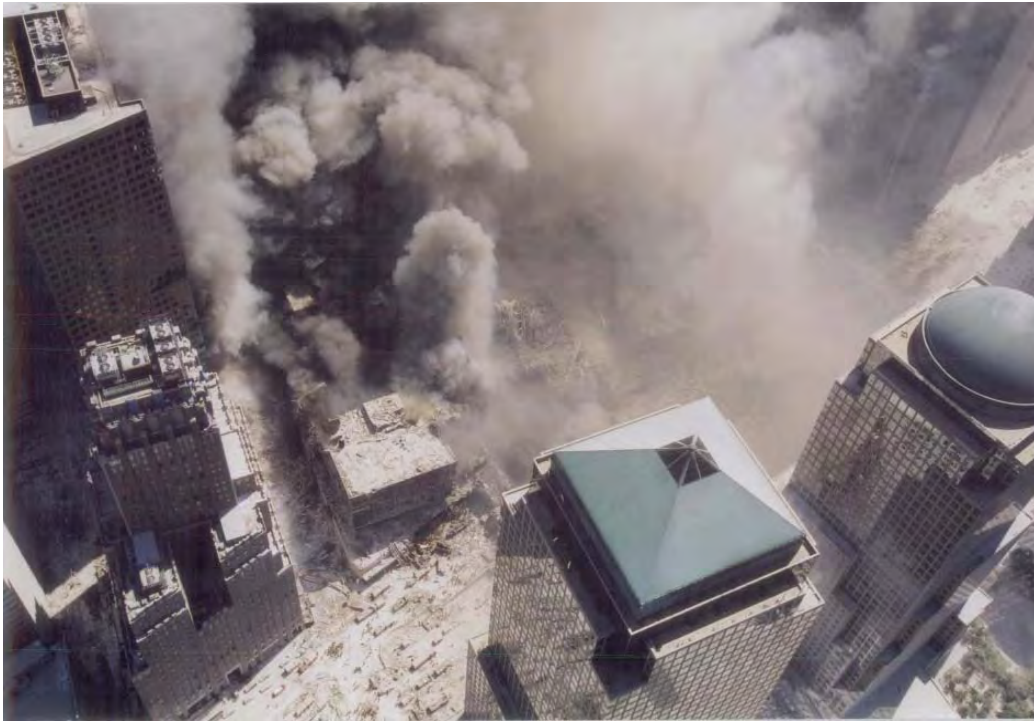
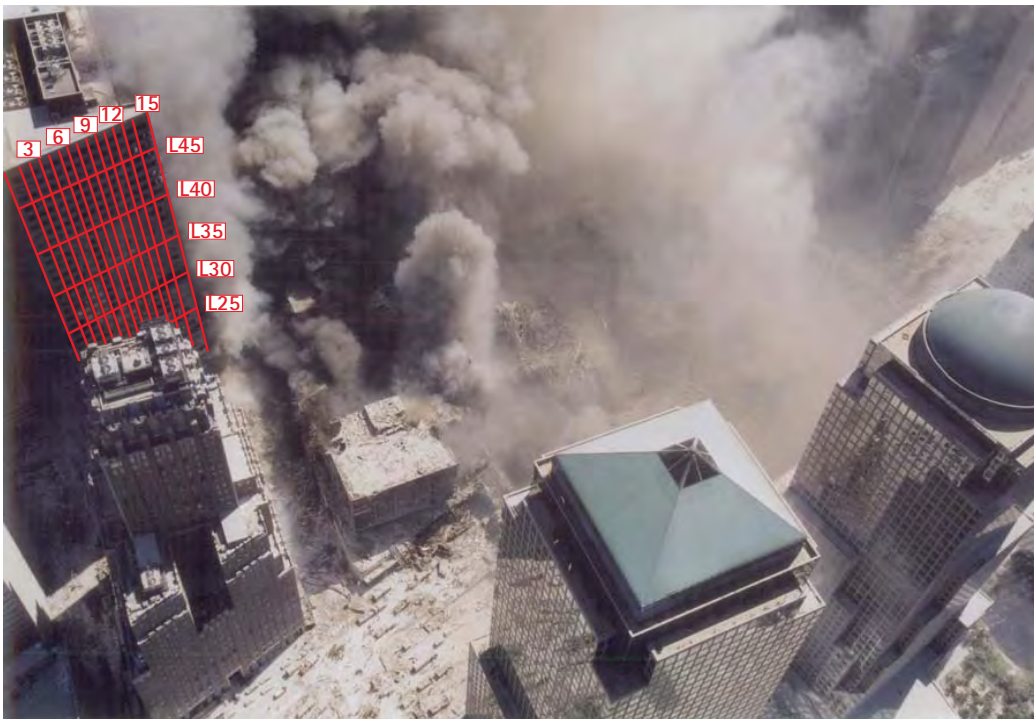
Image 3.W.30 West facade, approximately 12:30PM-2:00PM

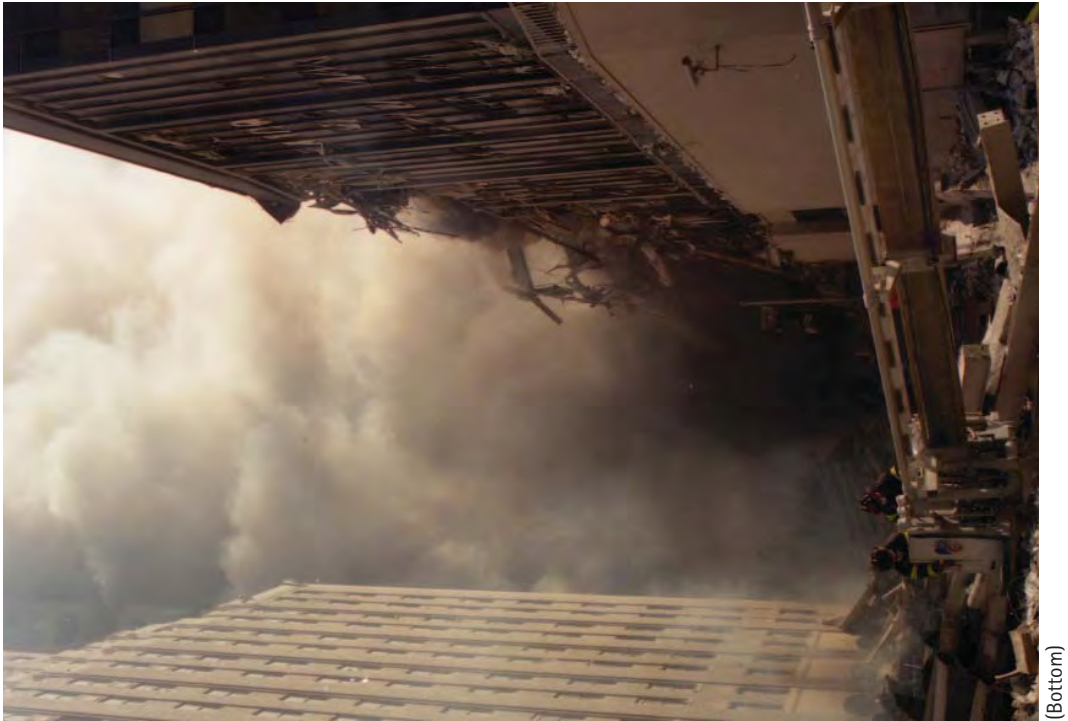
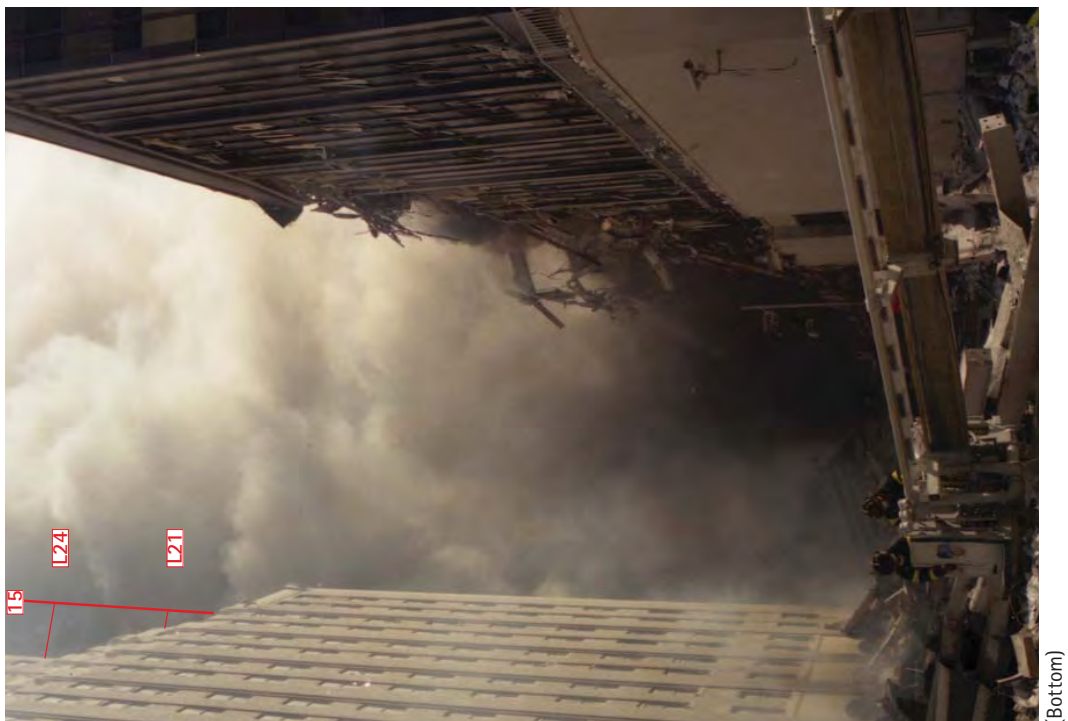
Image 3.W.32 Southwest corner, approximately 12:47PM-1:03PM

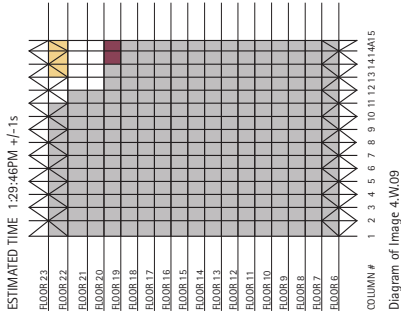
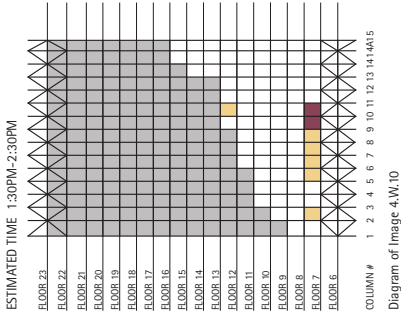
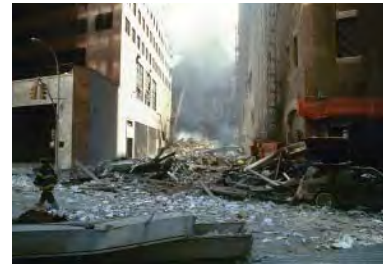
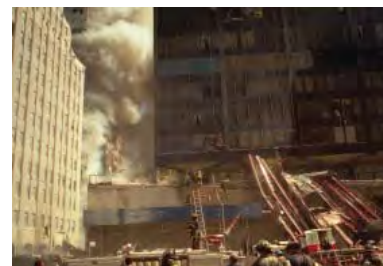
Figure 4.W.02 WTC7 West Facade - Detailed Fire Progression from 1PM to 2PM

West Facade – During this time period, visual evidence shows that an additional window on level 22 broke and both windows are shown with smoke until they burned-out at the end of the hour. Smoke continued to stream from level 18, while smoke also became visible on levels 17 and 12. Additionally, both smoke and burn stains appeared at floor 7.

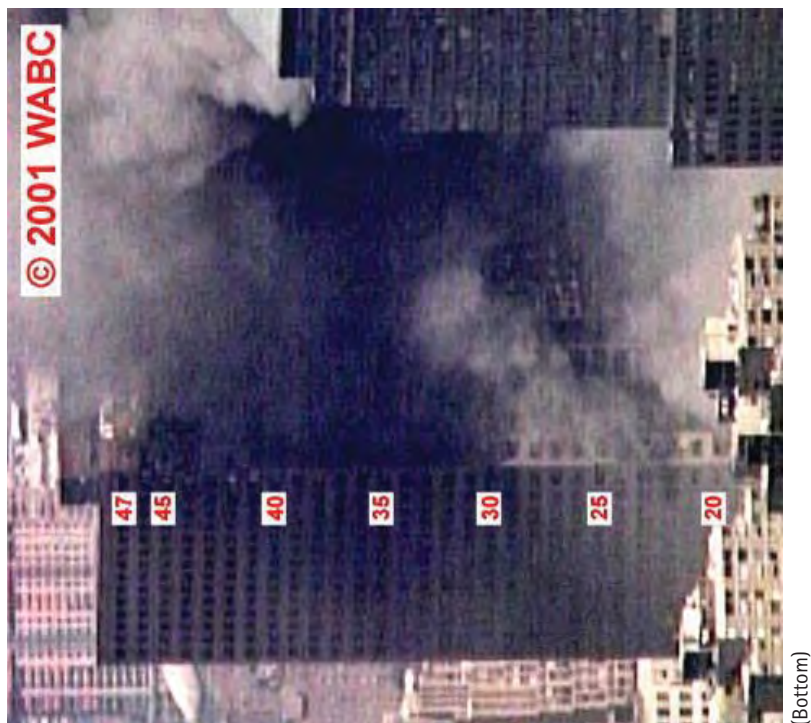
Image 4.W.01 Southwest corner, around 1:00PM

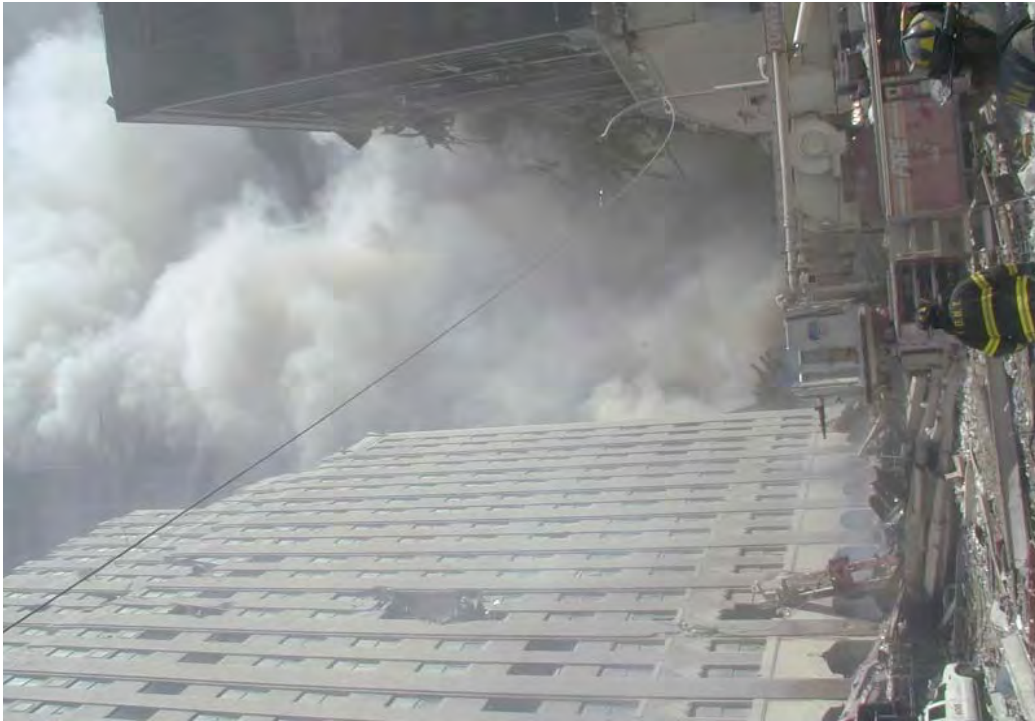
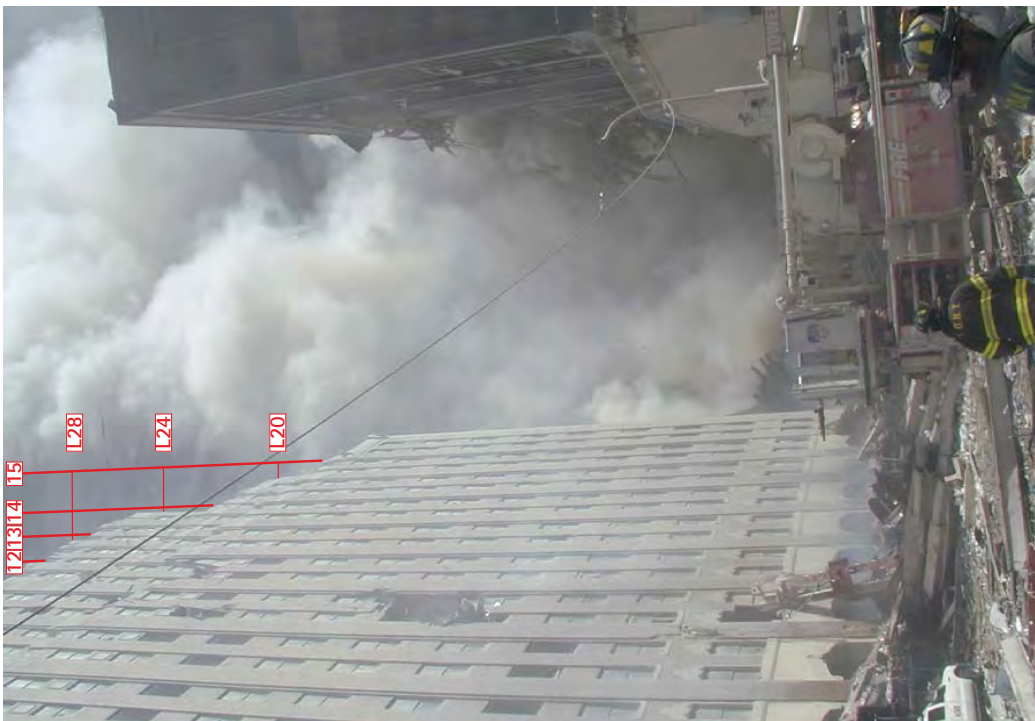
Image 4.W.02 Southwest corner, 1:03:44PM +/-1s
