11-4403-CV

United States Court of Appeals
for the
Second Circuit

JOINT APPENDIX
Volume 13 of 16 (Pages JA-3321 to JA-3616)

In re: September 11 Property Damage and Business Loss Litigation

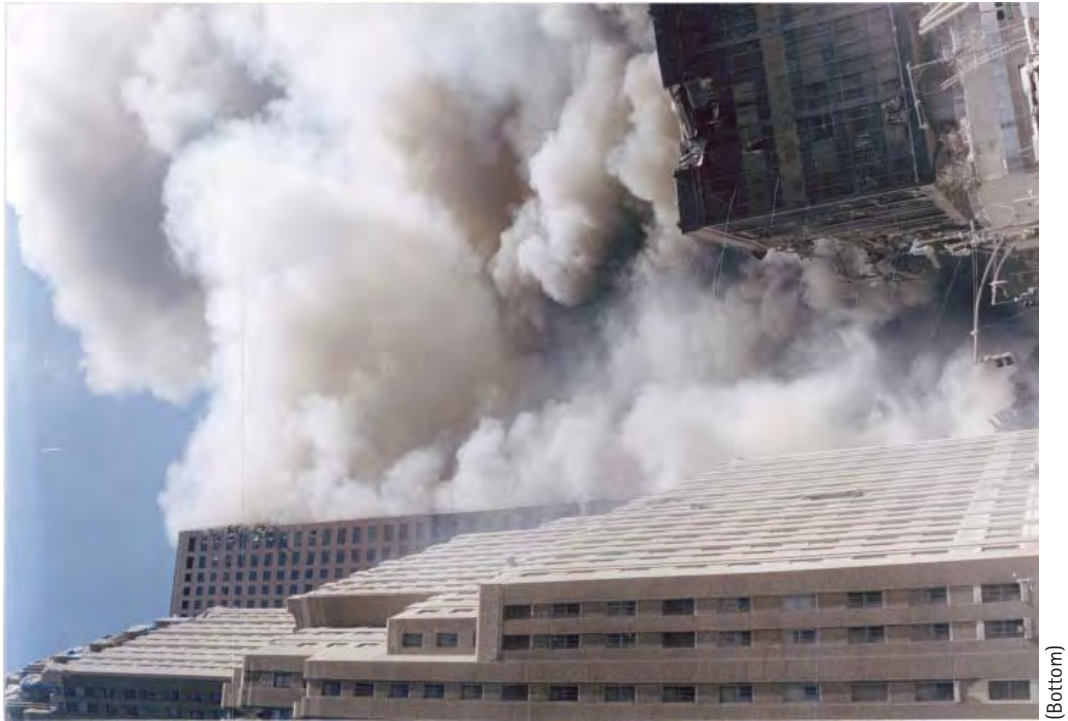
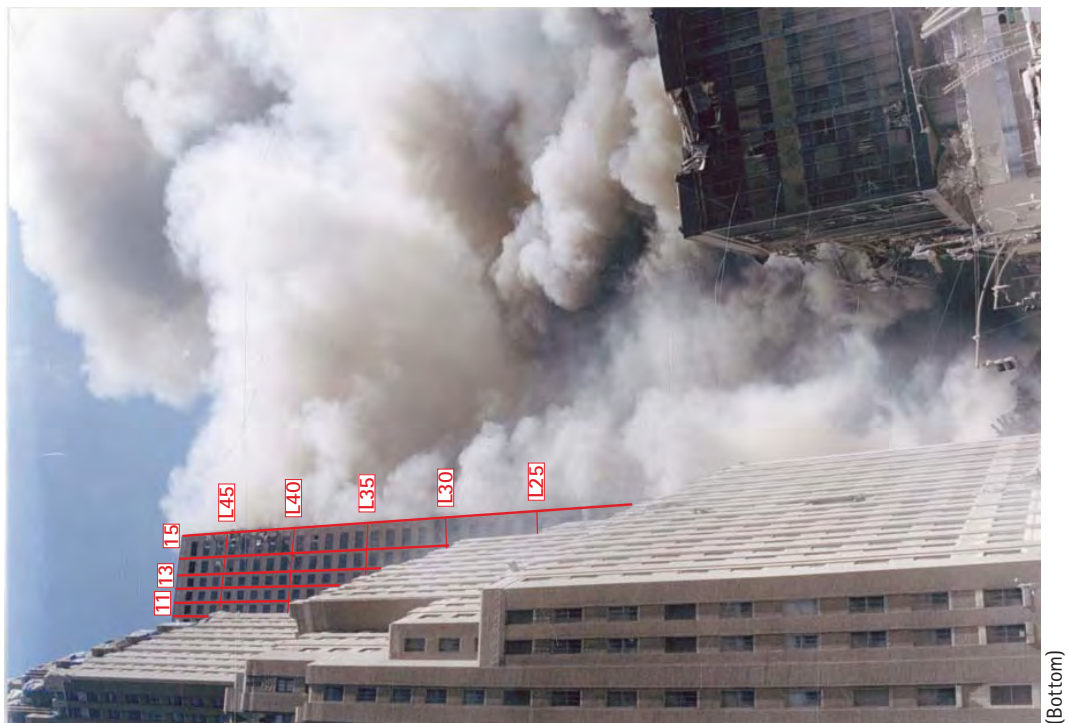
Image 4.W.03 West facade, approximately 1:00PM-1:45PM

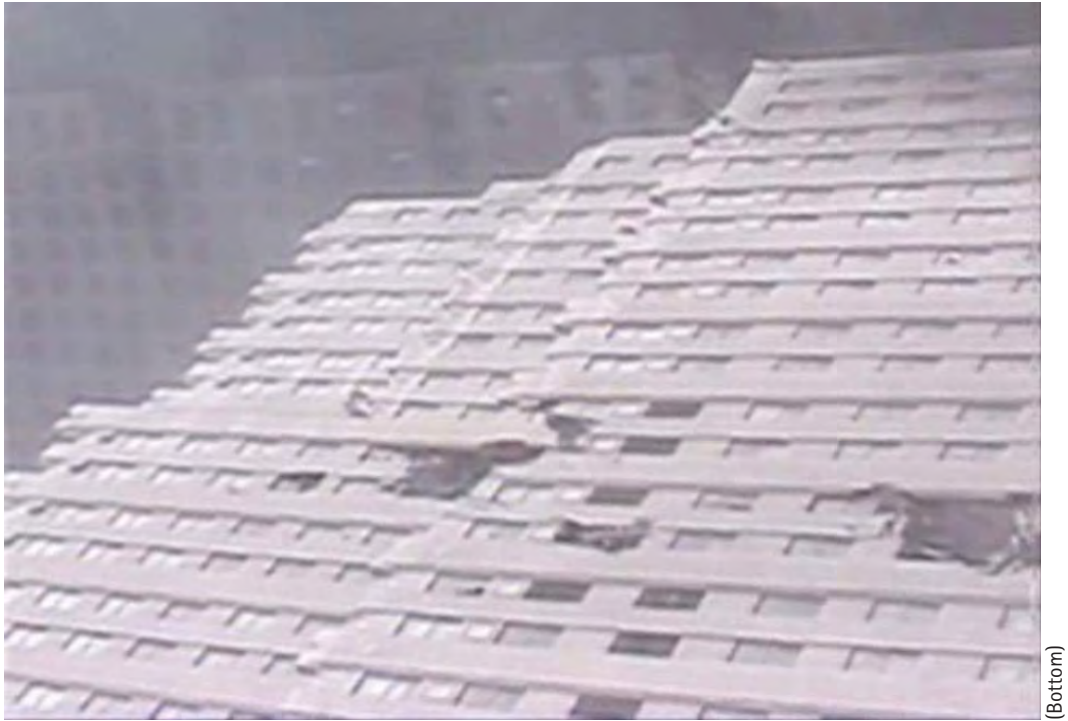
Image 4.W.04 West facade, approximately 1:00PM-2:00PM

West Facade – During this time period, visual evidence shows that an additional window on level 22 broke and both windows are shown with smoke until they burned-out at the end of the hour. Smoke continued to stream from level 18, while smoke also became visible on levels 17 and 12. Additionally, both smoke and burn stains appeared at floor 7.

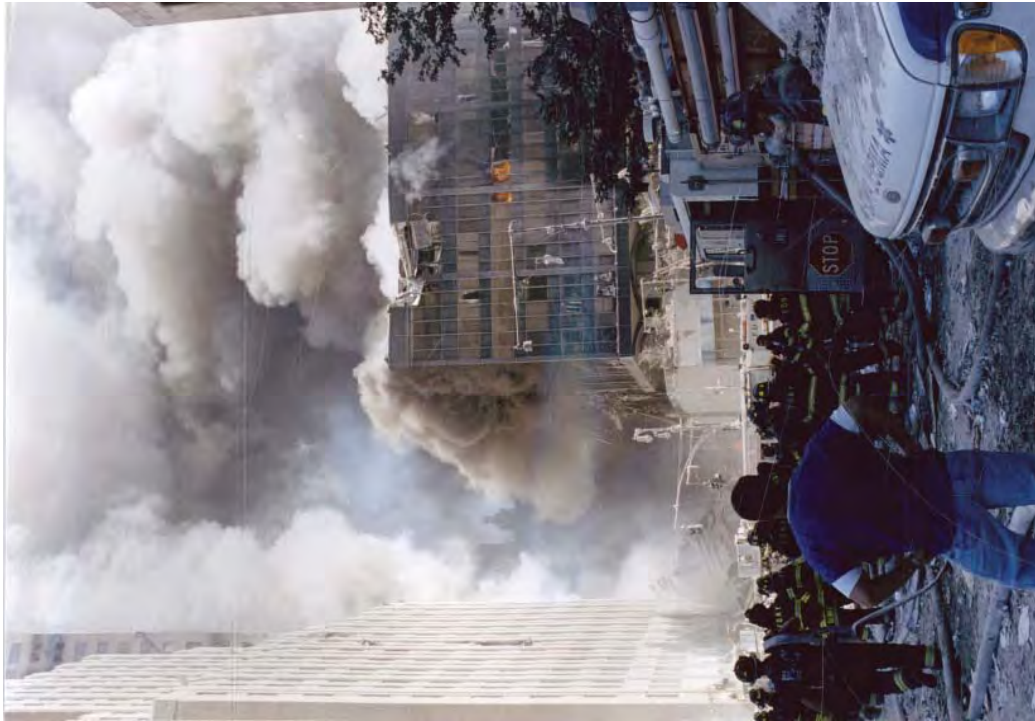
Image 4.W.24 West facade, approximately 1:30PM-2:00PM

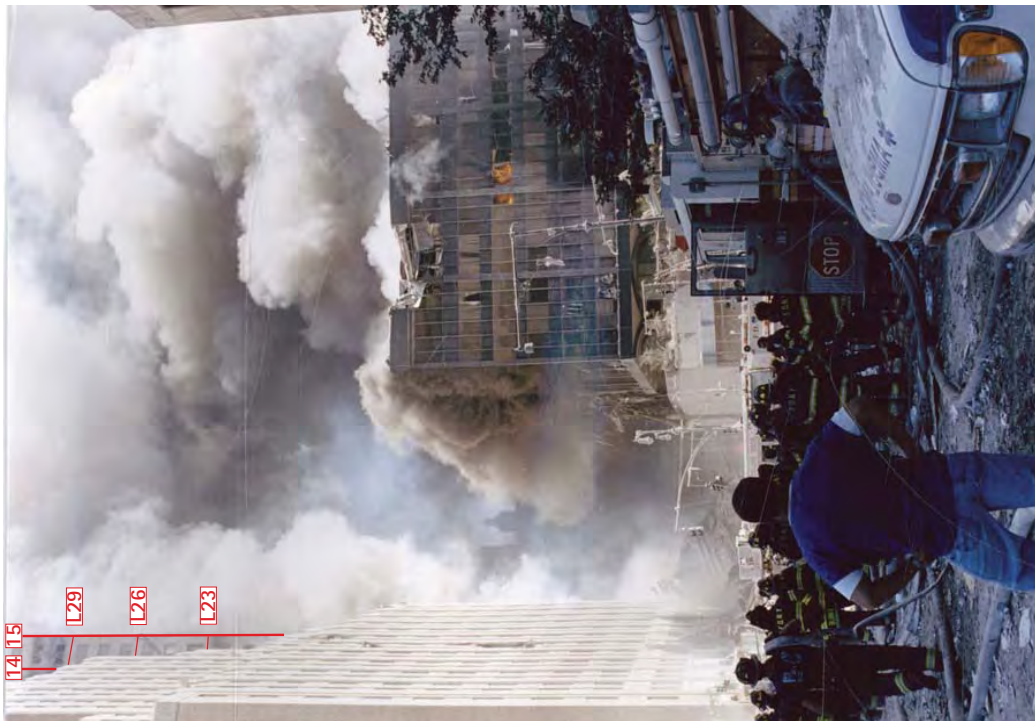
Image 4.W.24 with columns and floor levels overlaid

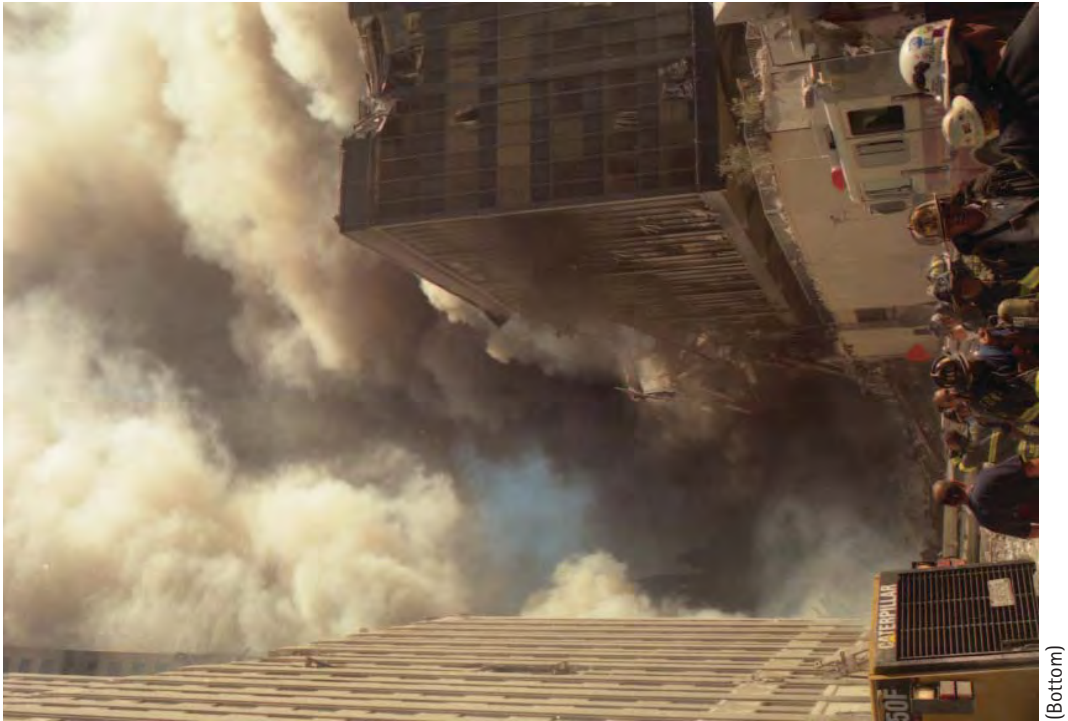
Image 4.W.25 West facade, approximately 1:00PM-2:00PM

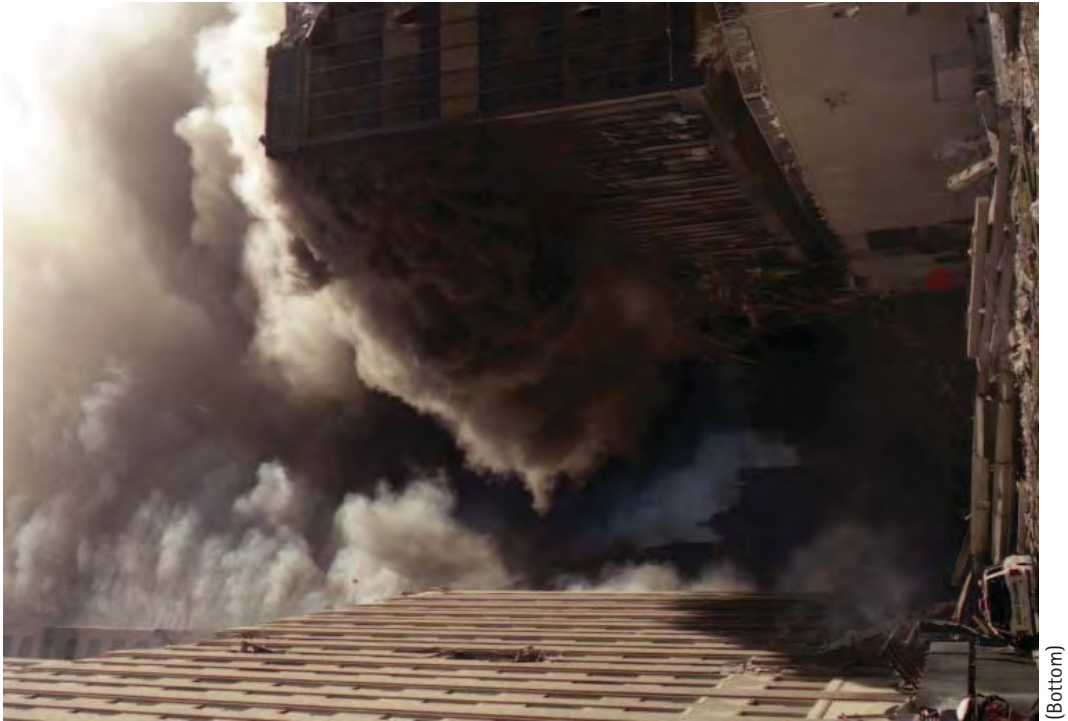
Image 4.W.26 West facade, approximately 1:00PM -2:00PM

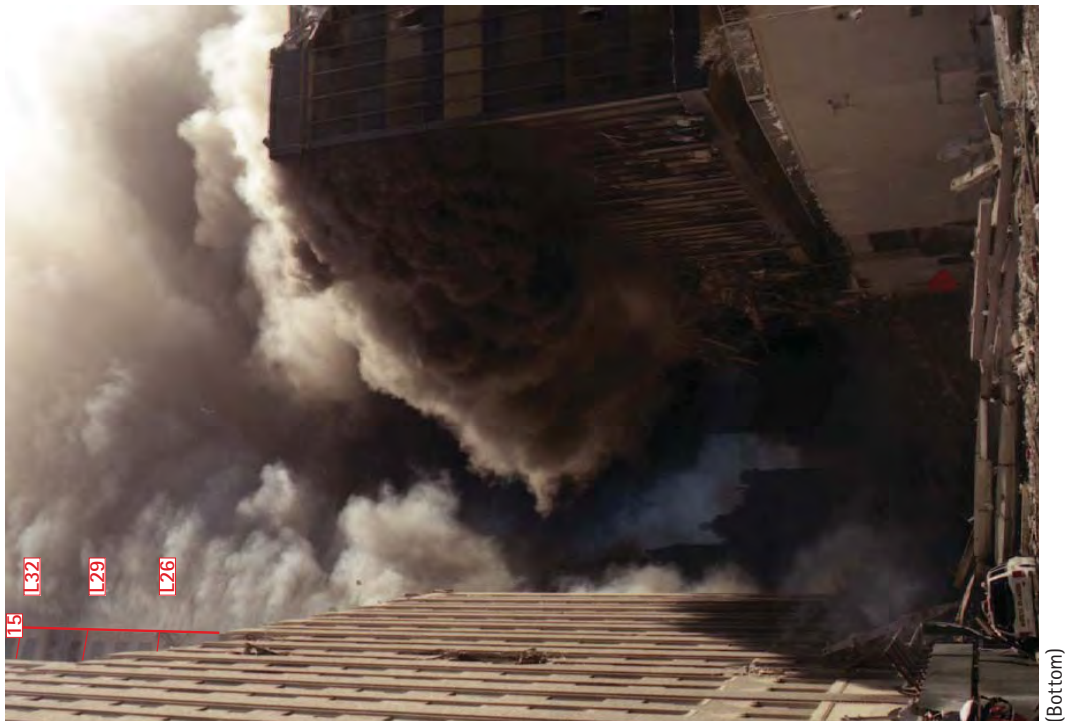
Image 4.W.26 with columns and floor levels overlaid

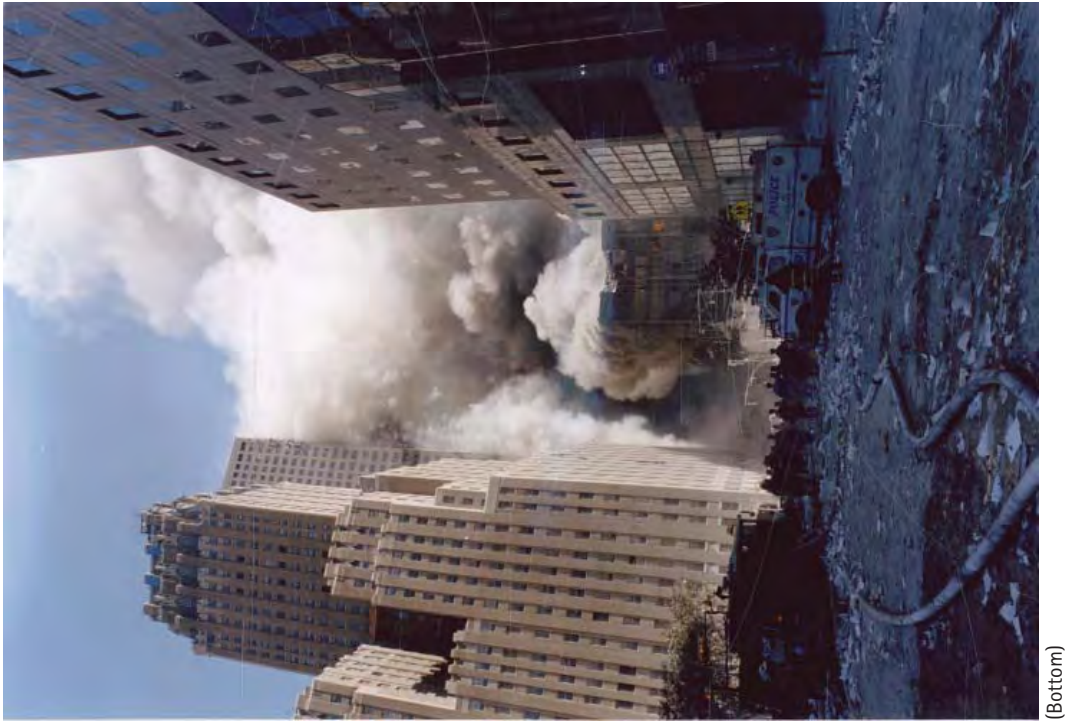
Image 4.W.27 West facade, approximately 1:30PM-2:00PM

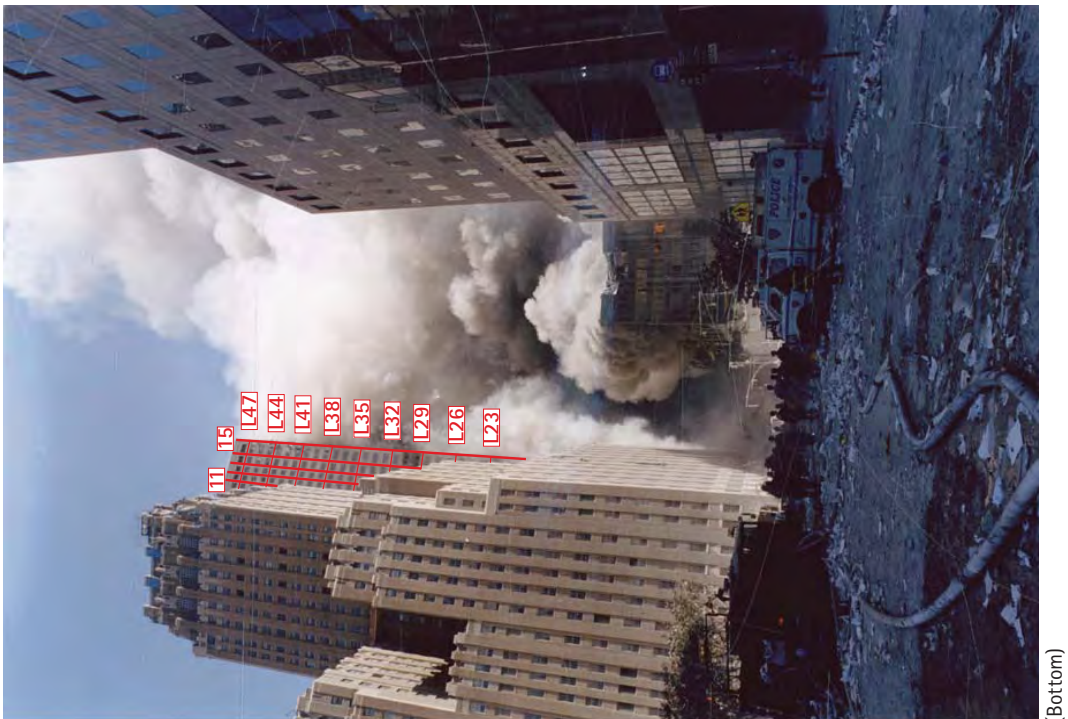
Image 4.W.27 with columns and floor levels overlaid

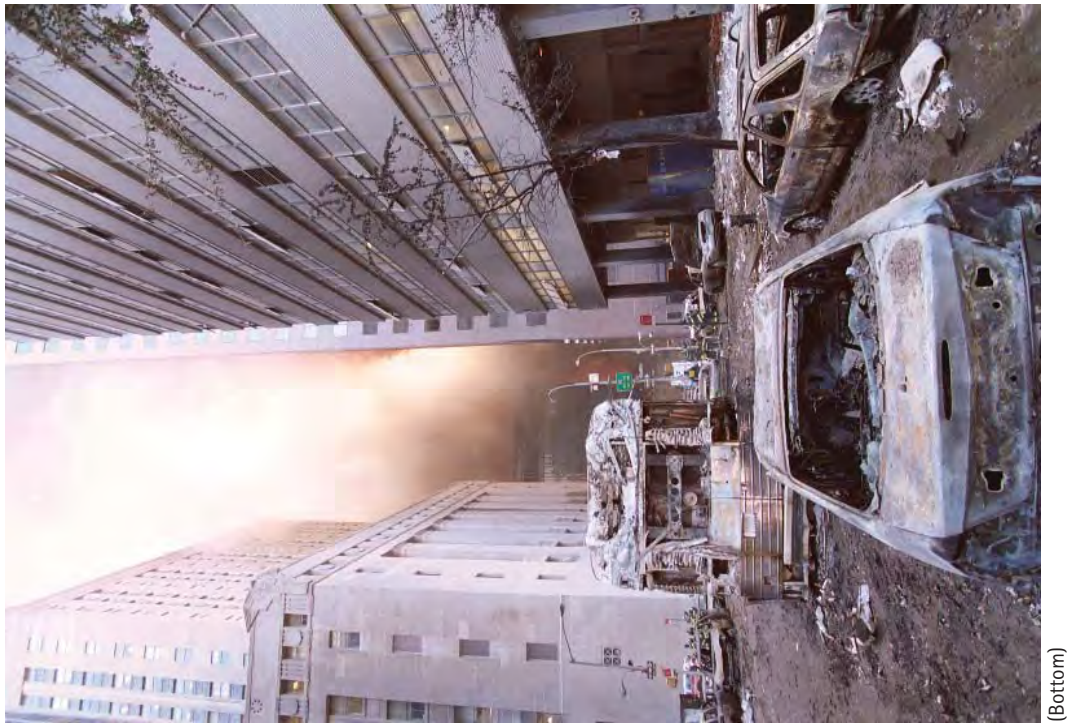
Image 5.E.01 Northeast corner, approximately 2:00PM-2:28PM

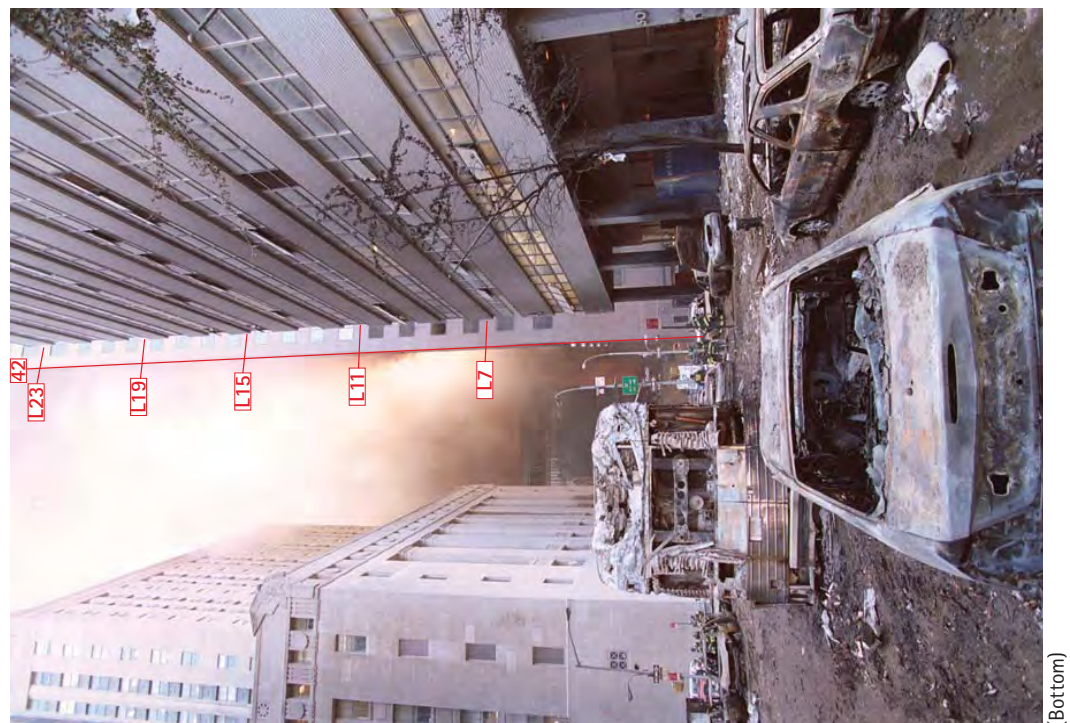
Image 5.E.01 with columns and floor levels overlaid

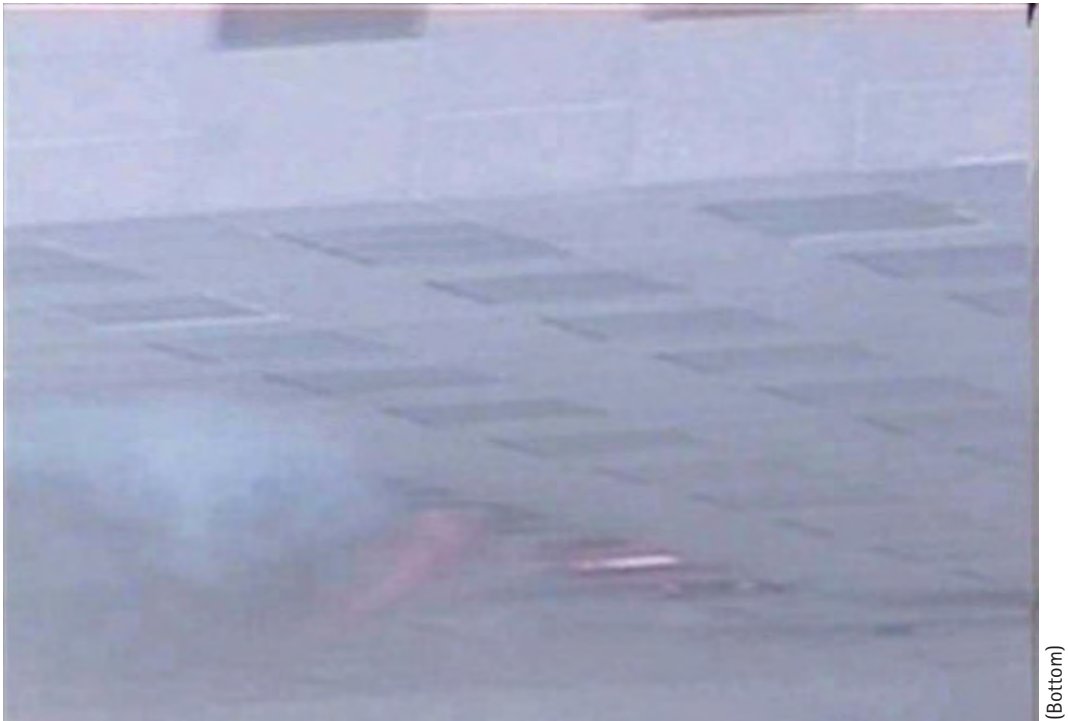
Image 5.E.02 Northeast corner, approximately 2:00PM-2:08PM

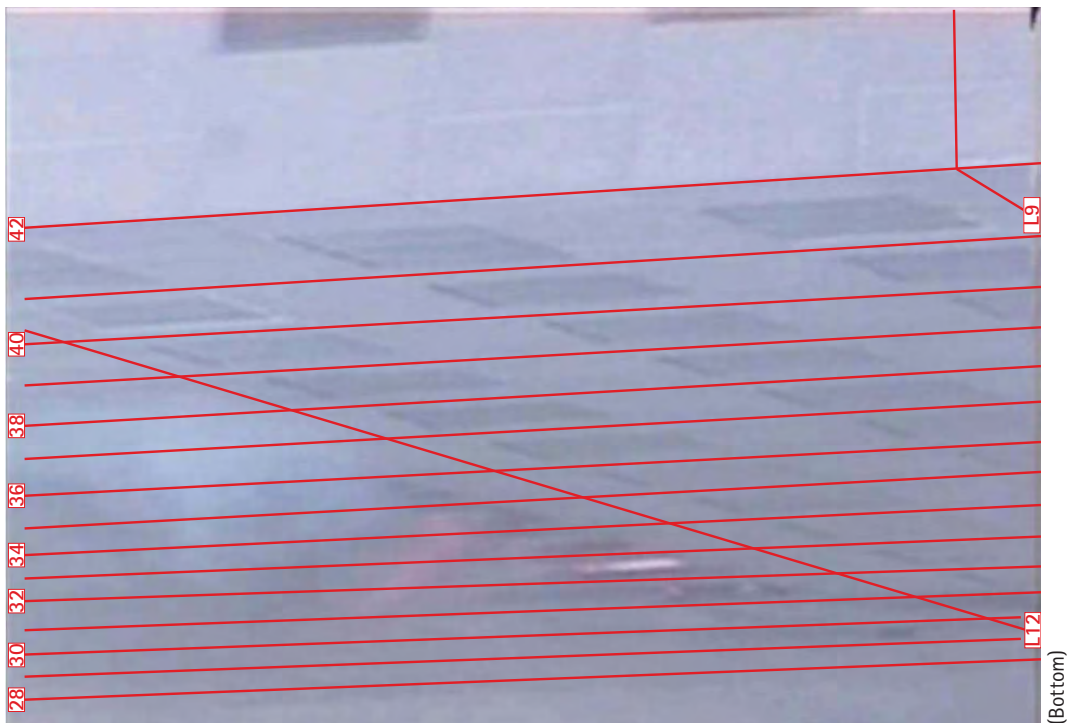
Image 5.E.02 with columns and floor levels overlaid

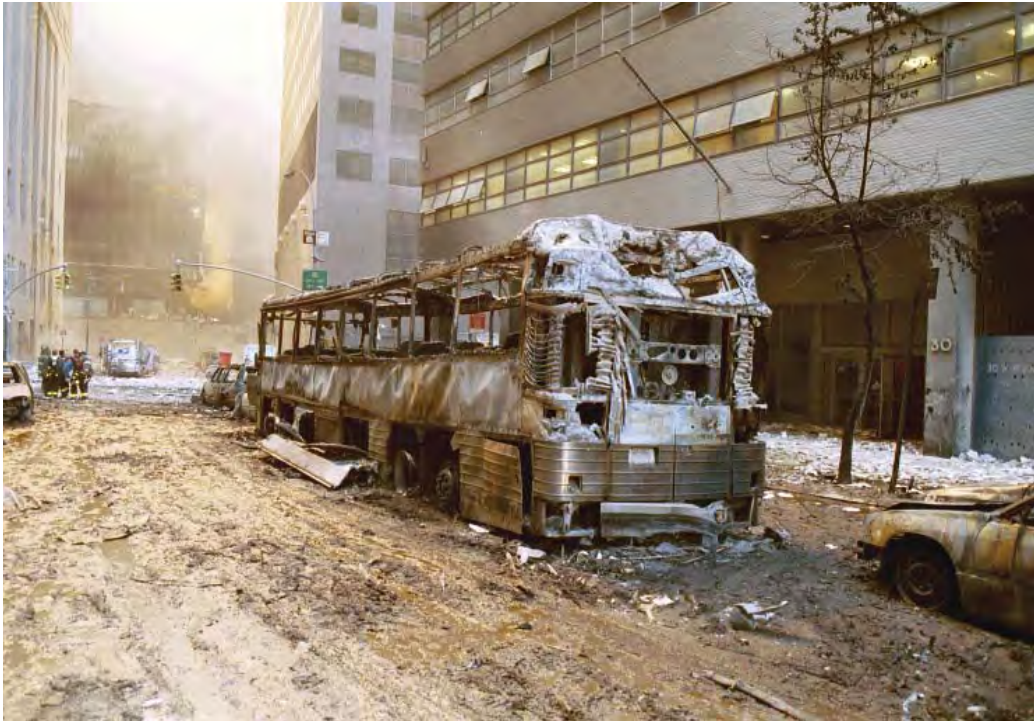
Image 5.E.03 Northeast corner, approximately 2:00PM-2:08PM

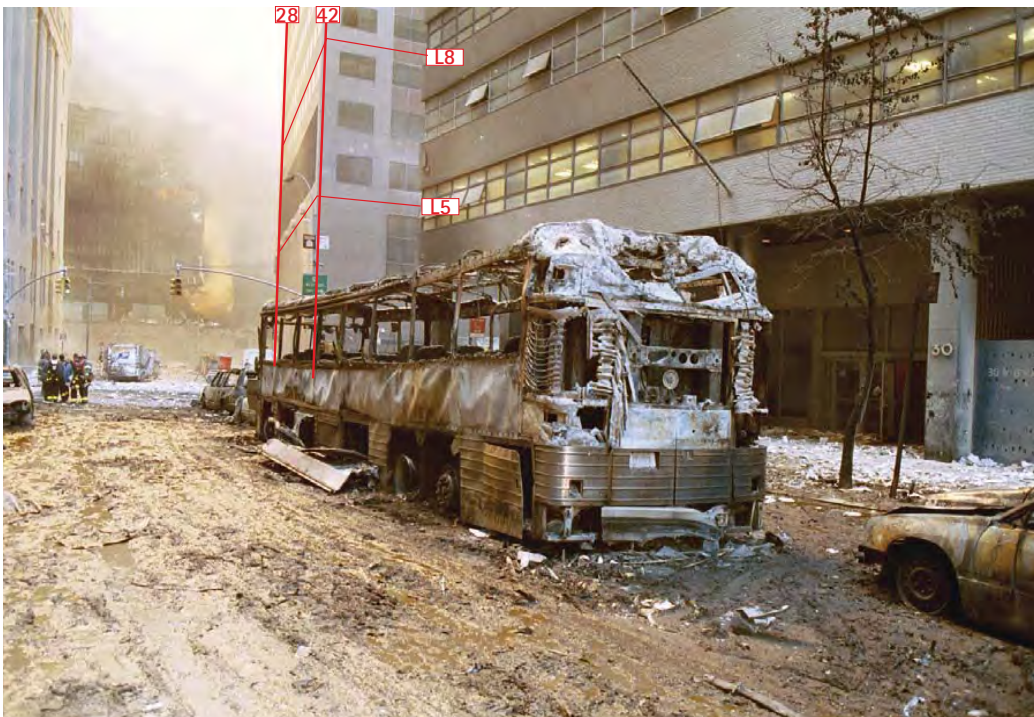
Image 5.E.03 with columns and floor levels overlaid

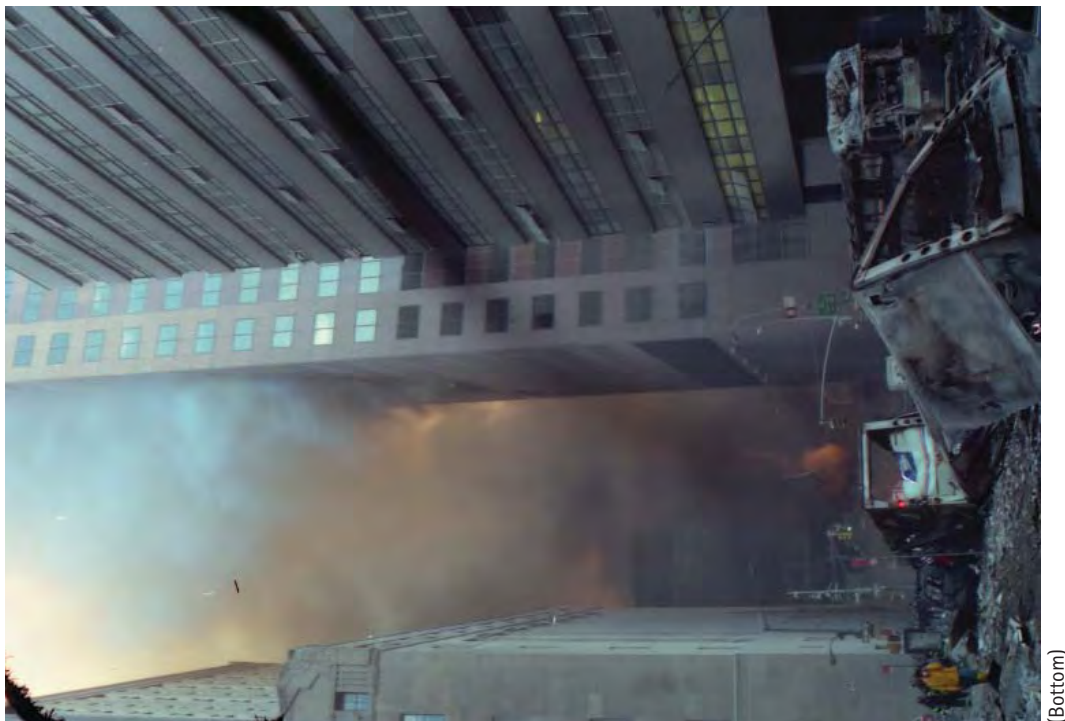
Image 5.E.04 Northeast corner, approximately 2:00PM-2:08PM

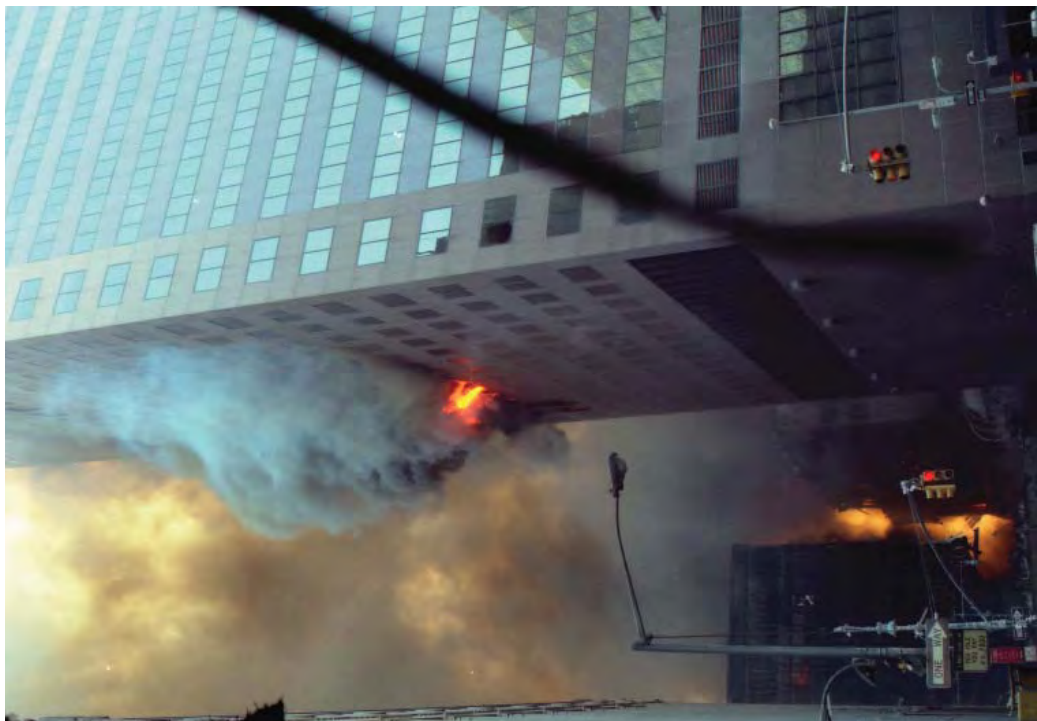
Image 5.E.05 Northeast corner, approximately 2:00PM-2:08PM

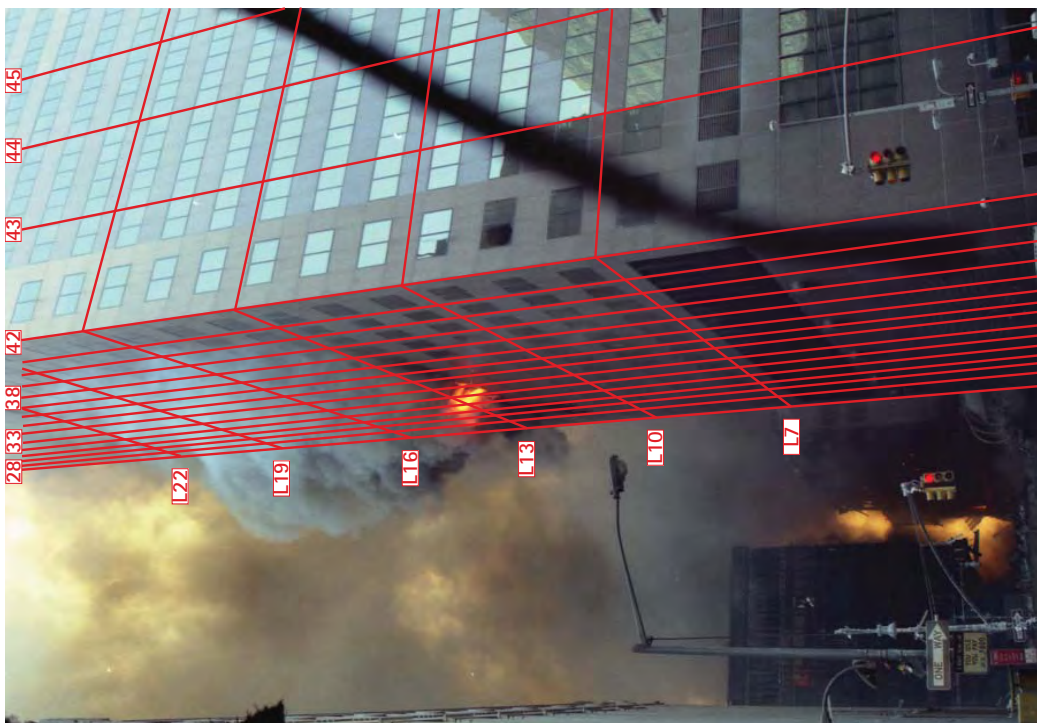
Image 5.E.05 with columns and floor levels overlaid

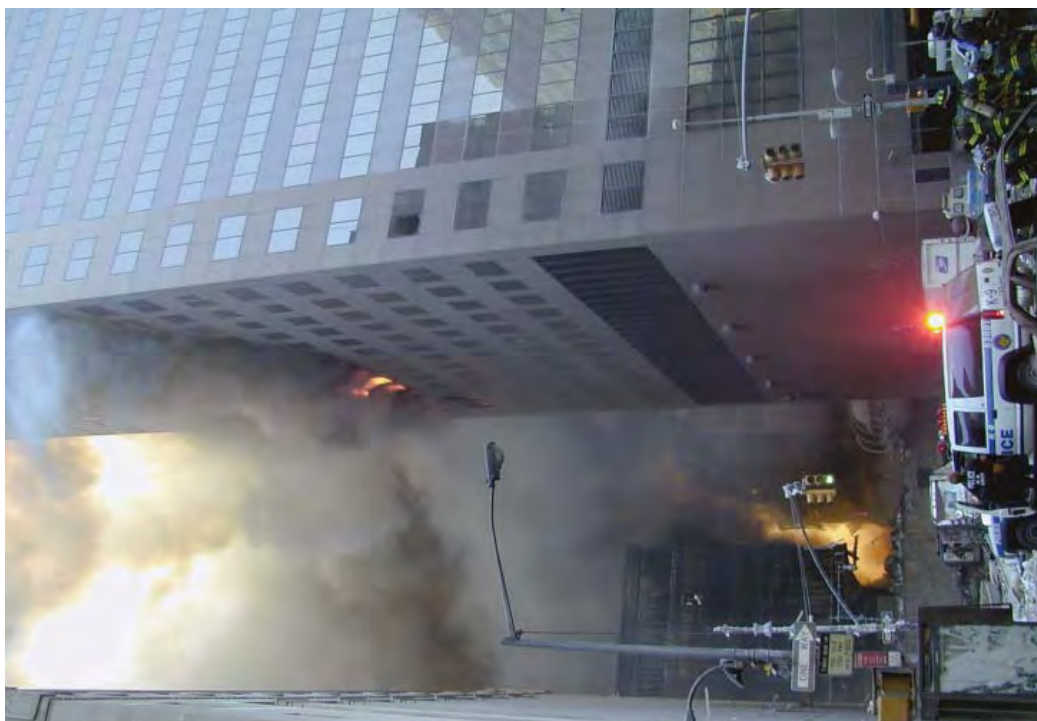
Image 5.E.06 Northeast corner, approximately 2:00PM-2:08PM

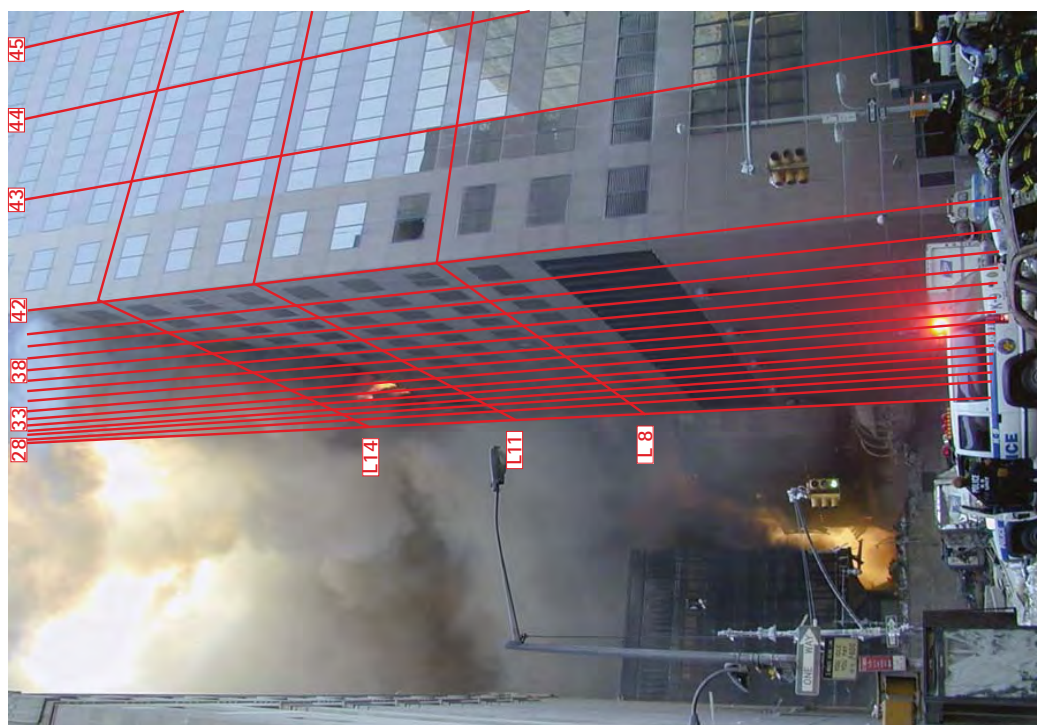
Image 5.E.06 with columns and floor levels overlaid

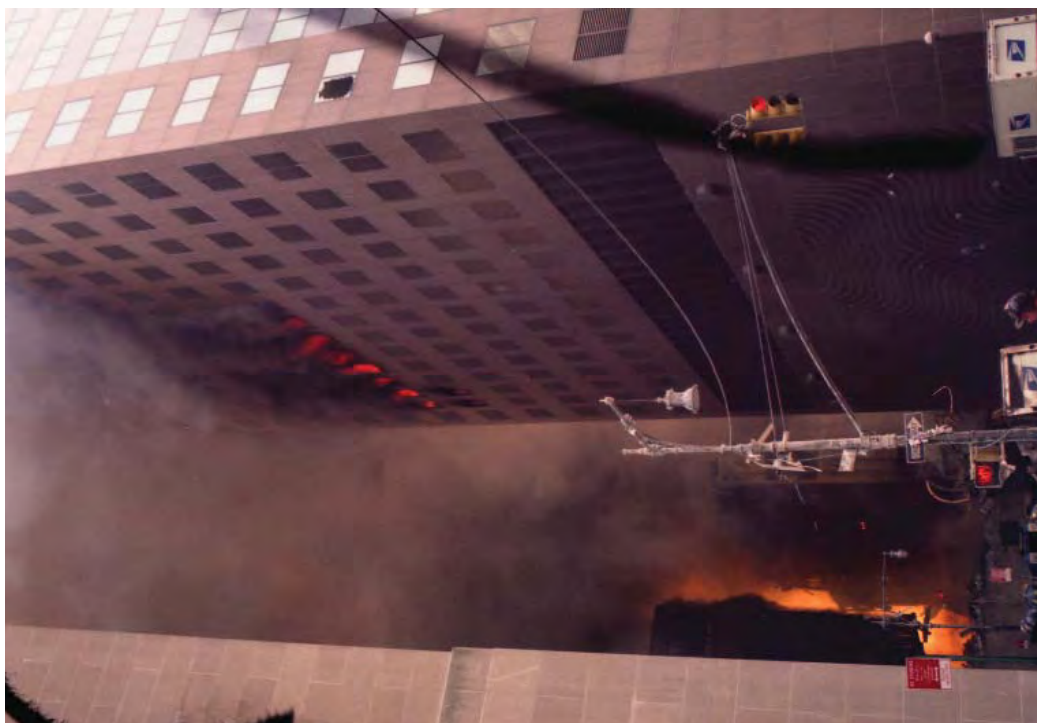
Image 5.E.07 Northeast corner, approximately 2:00PM-2:08PM

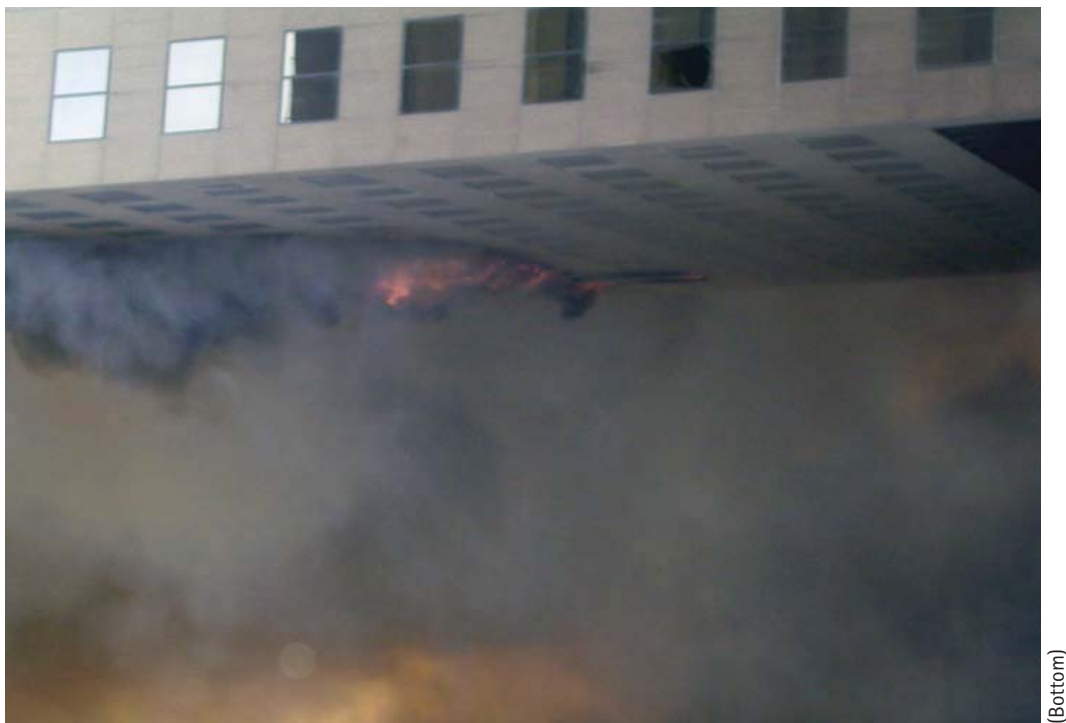
Image 5.E.08 Northeast corner, 2:08:28PM +/-1S

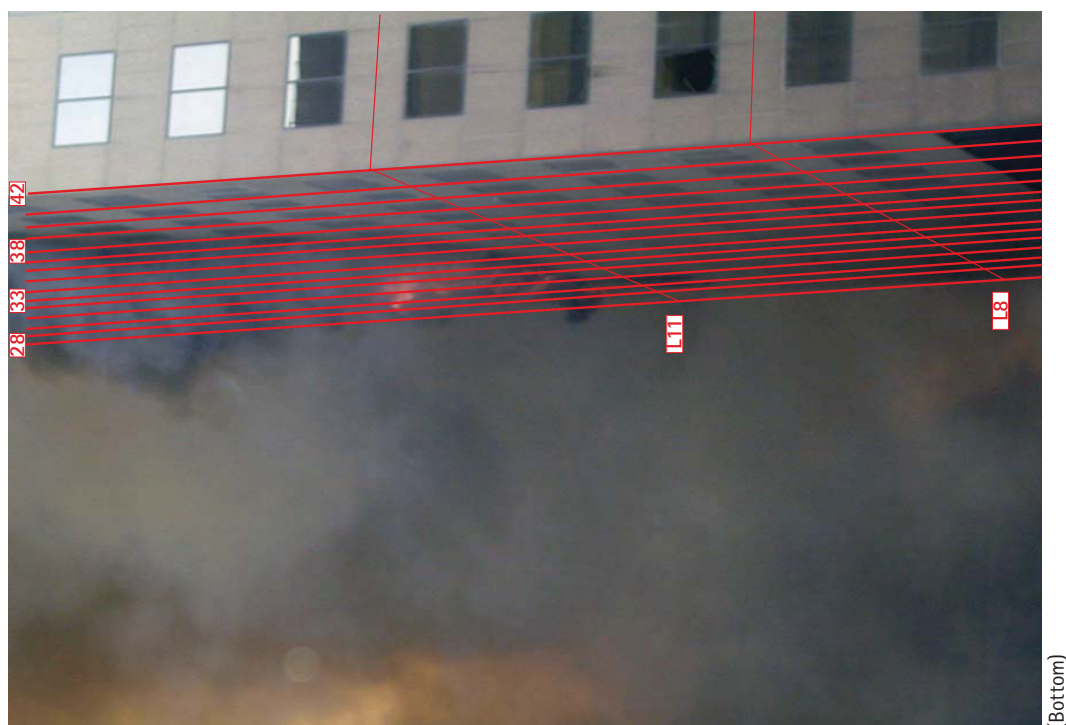
Image 5.E.08 with columns and floor levels overlaid

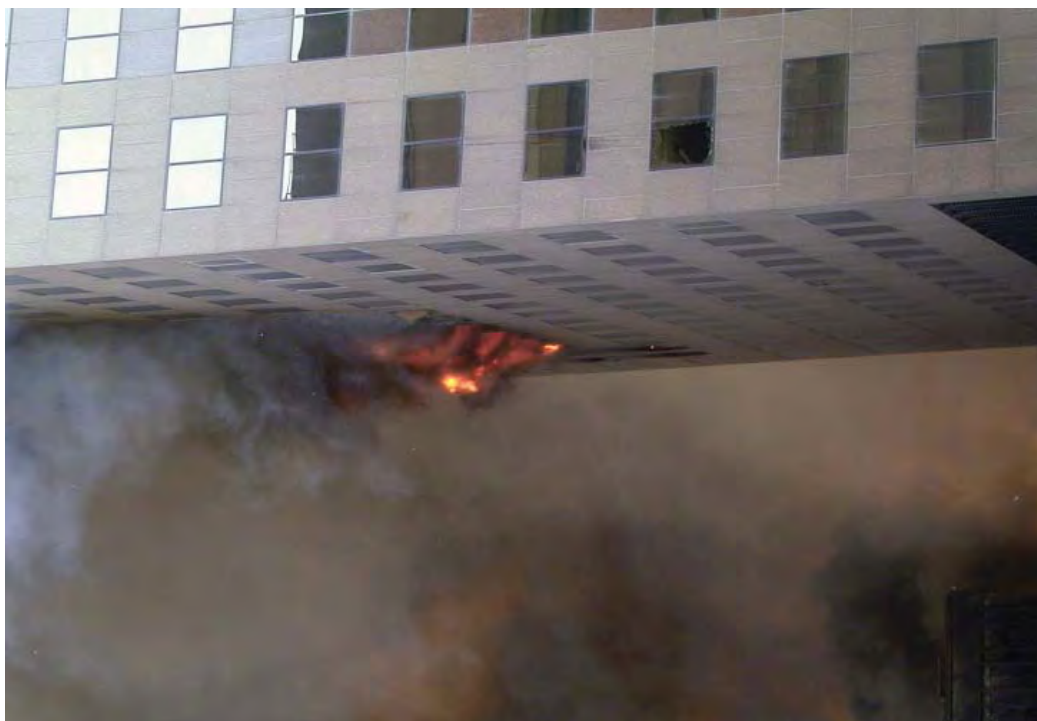
Image 5.E.09 Northeast corner, 2:08:45PM +/-1S

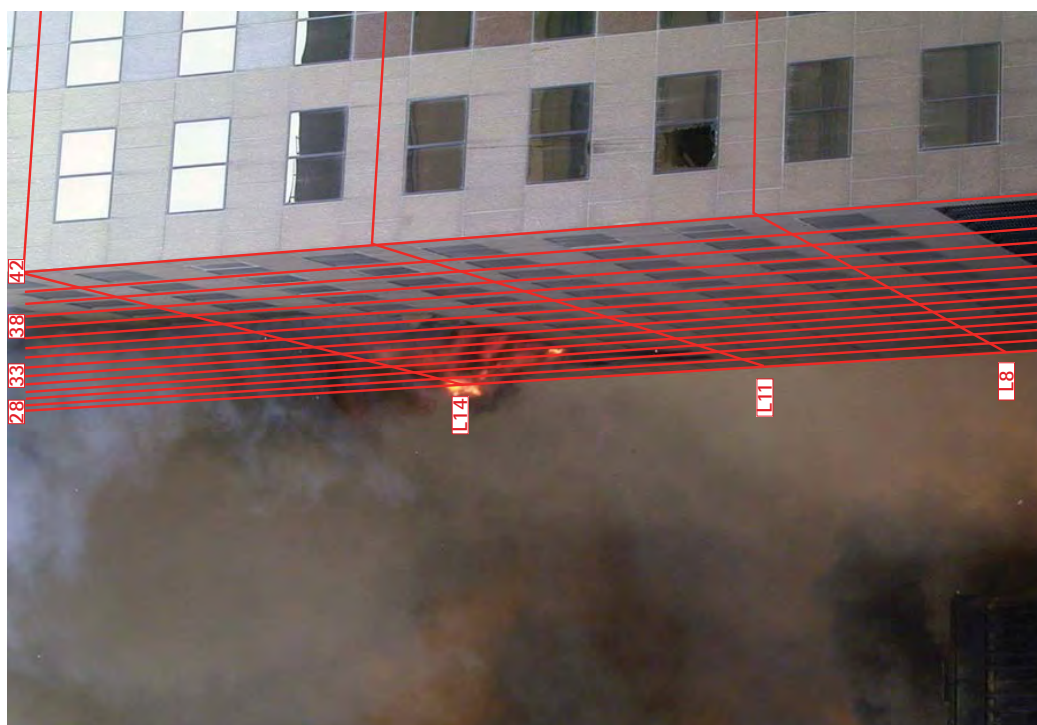
Image 5.E.09 with columns and floor levels overlaid

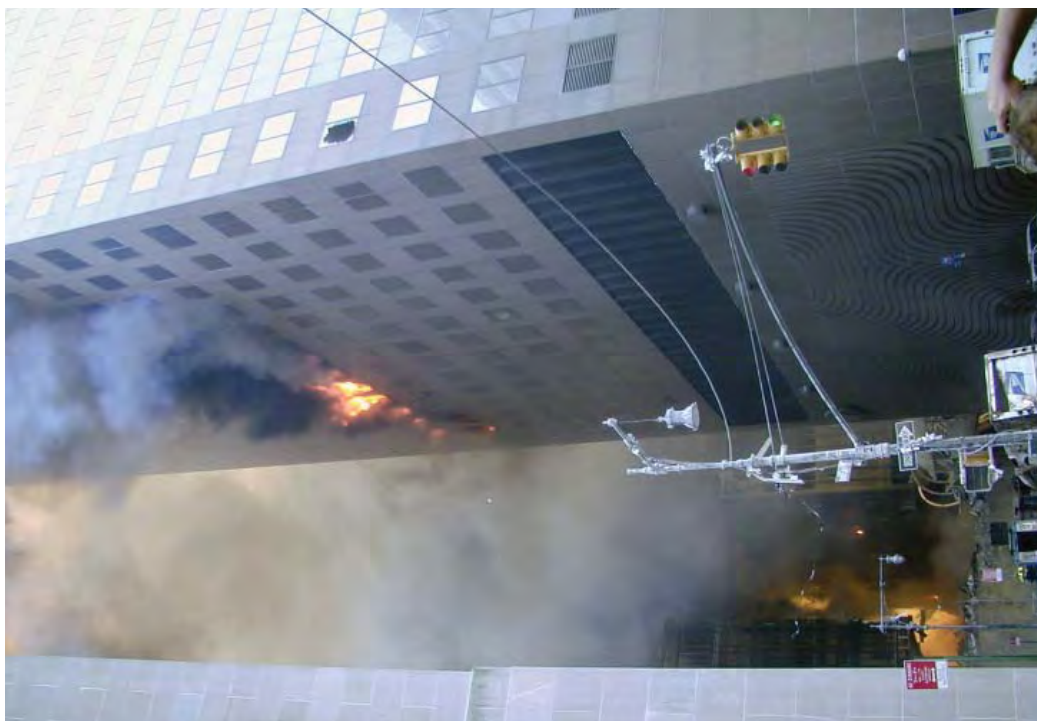
Image 5.E.10 Northeast corner, 2:09:54PM +/-1S

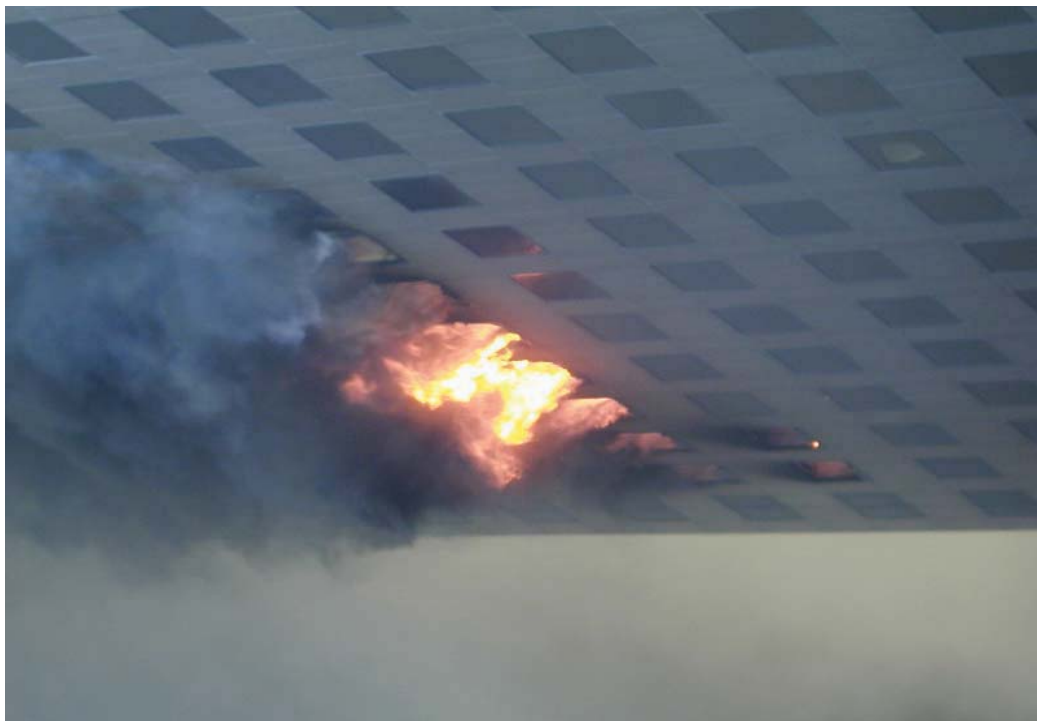
Image 5.E.11 East facade, 2:10:56PM +/-1S

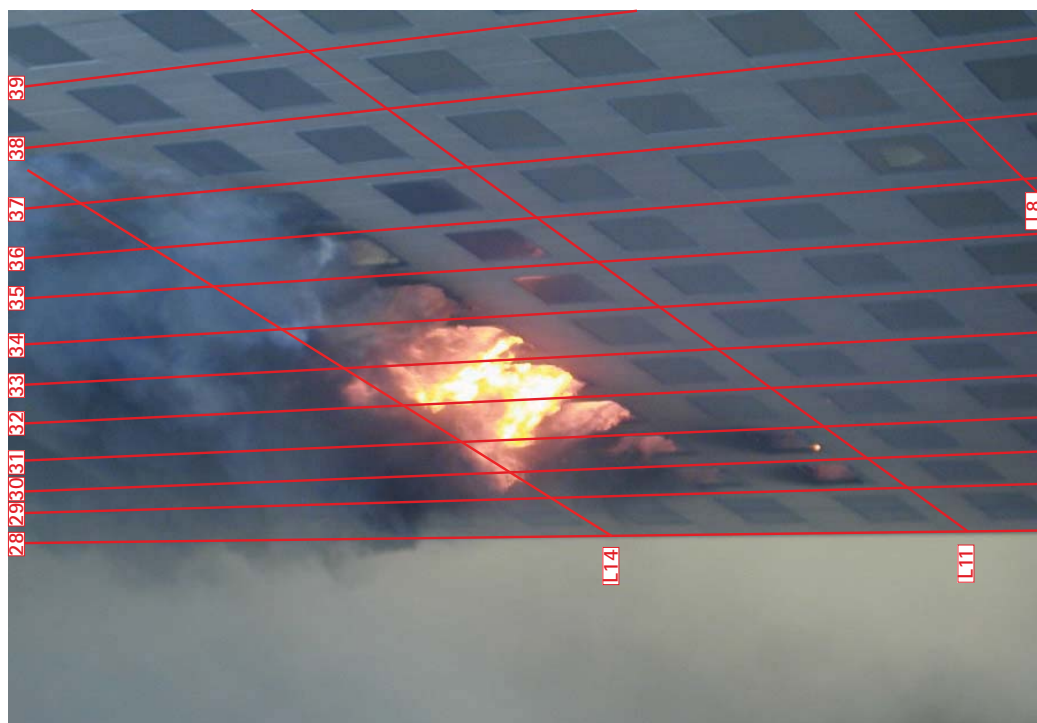
Image 5.E.11 with columns and floor levels overlaid

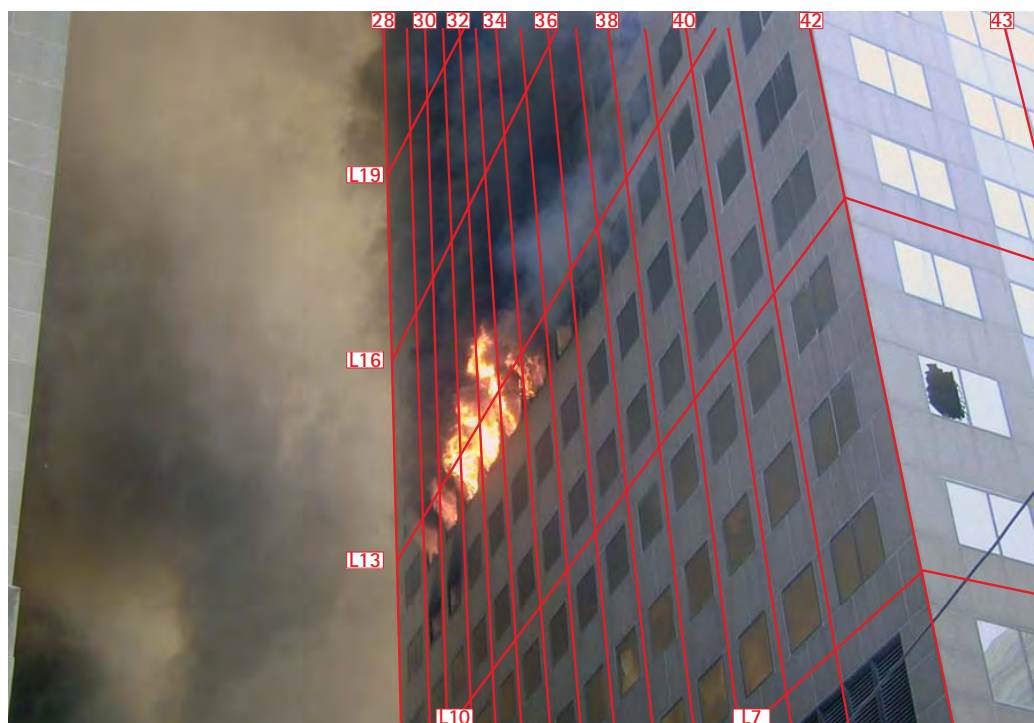
Image 5.E.12 with columns and floor levels overlaid
