11-4403-CV

United States Court of Appeals
for the
Second Circuit

JOINT APPENDIX
Volume 13 of 16 (Pages JA-3321 to JA-3616)

In re: September 11 Property Damage and Business Loss Litigation

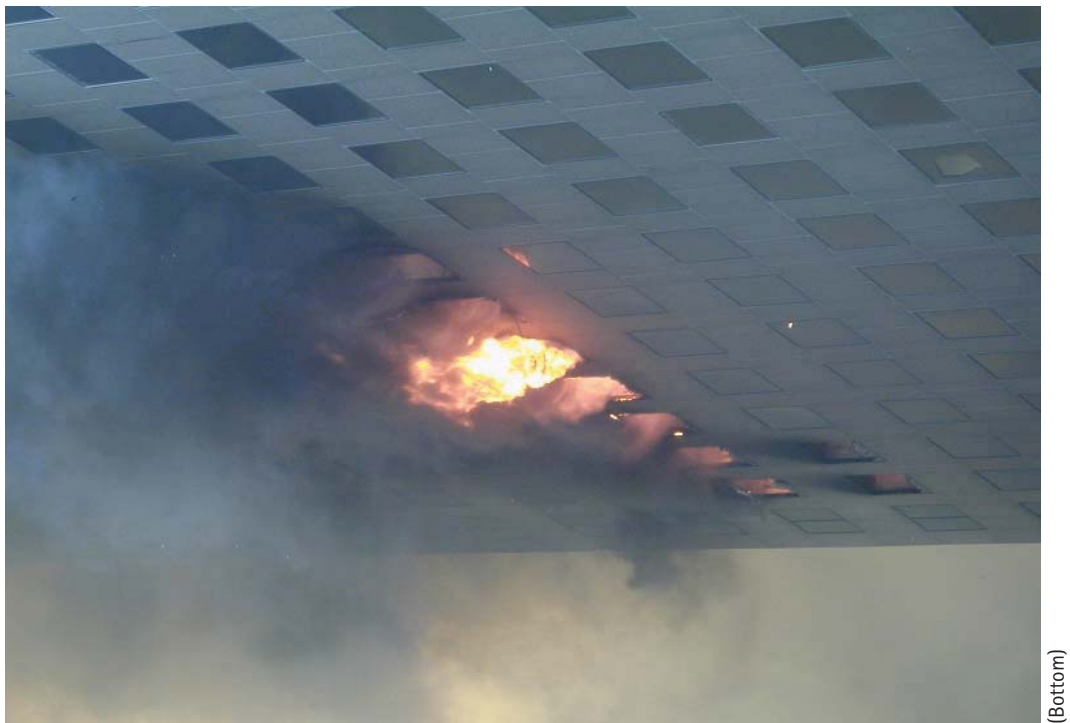
Image 5.E.14 East facade, 2:11:26PM +/-1S

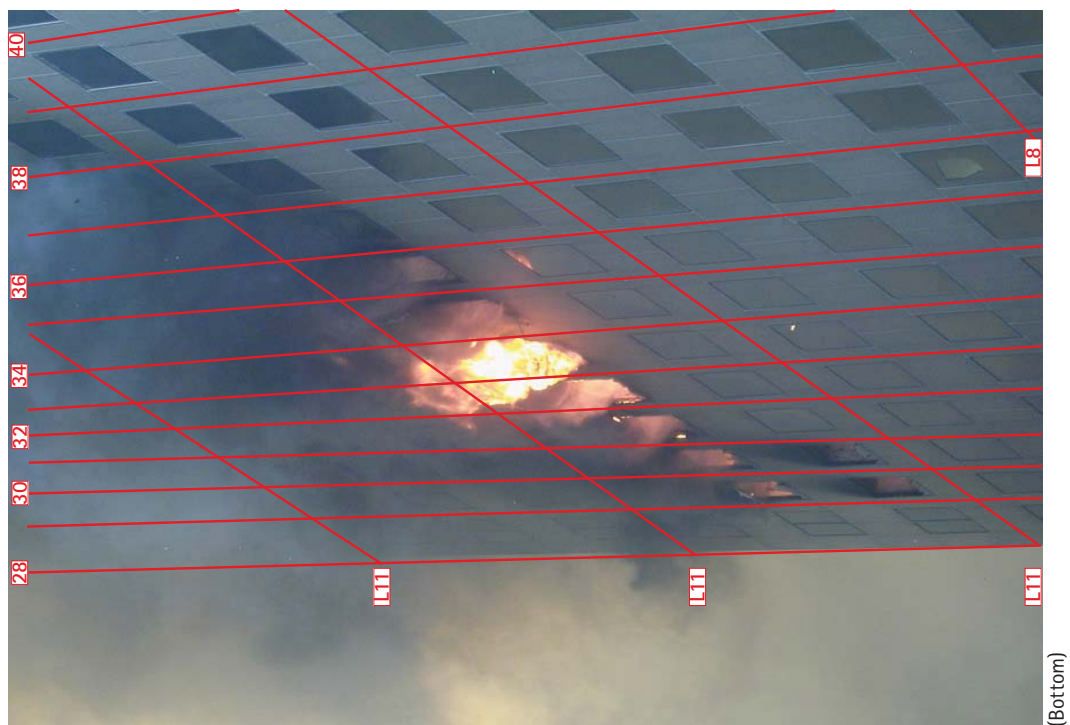
Image 5.E.14 with columns and floor levels overlaid

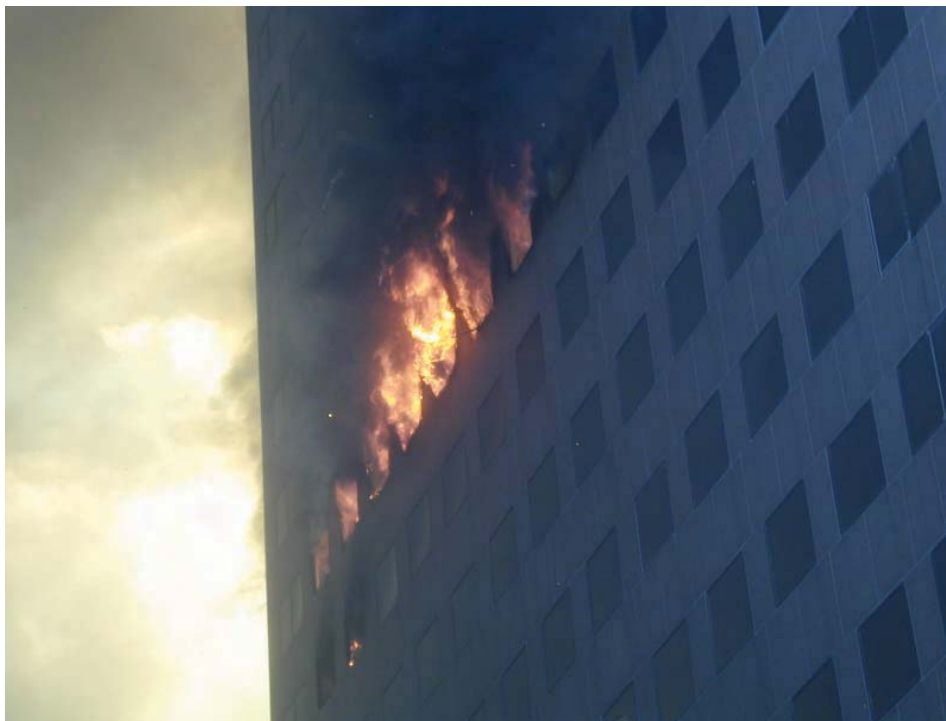
Image 5.E.15 East facade, 2:12:57PM +/-1S

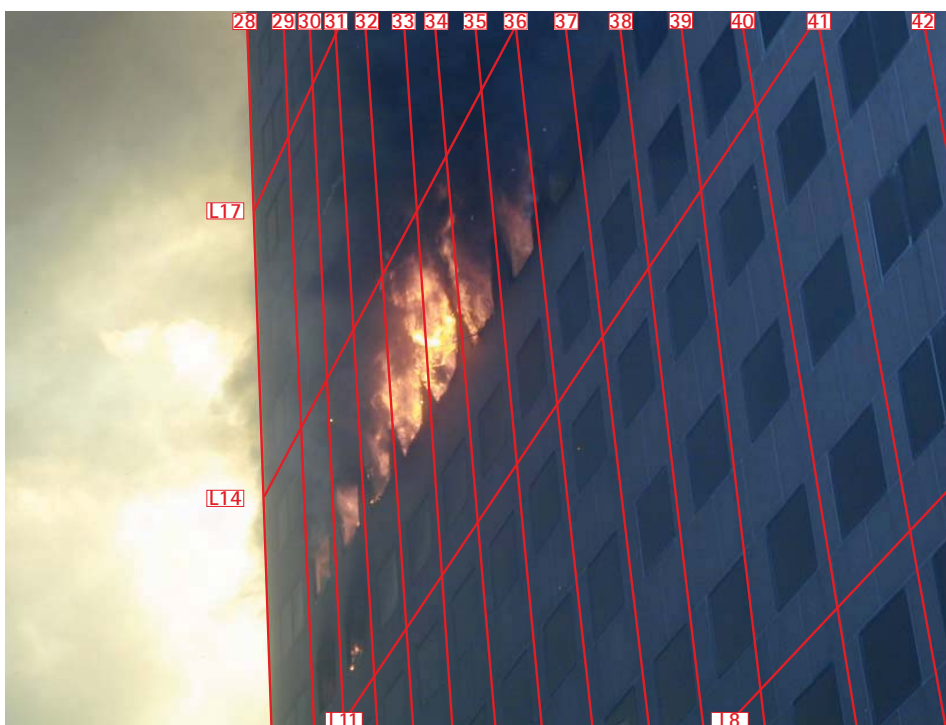
Image 5.E.15 with columns and floor levels overlaid

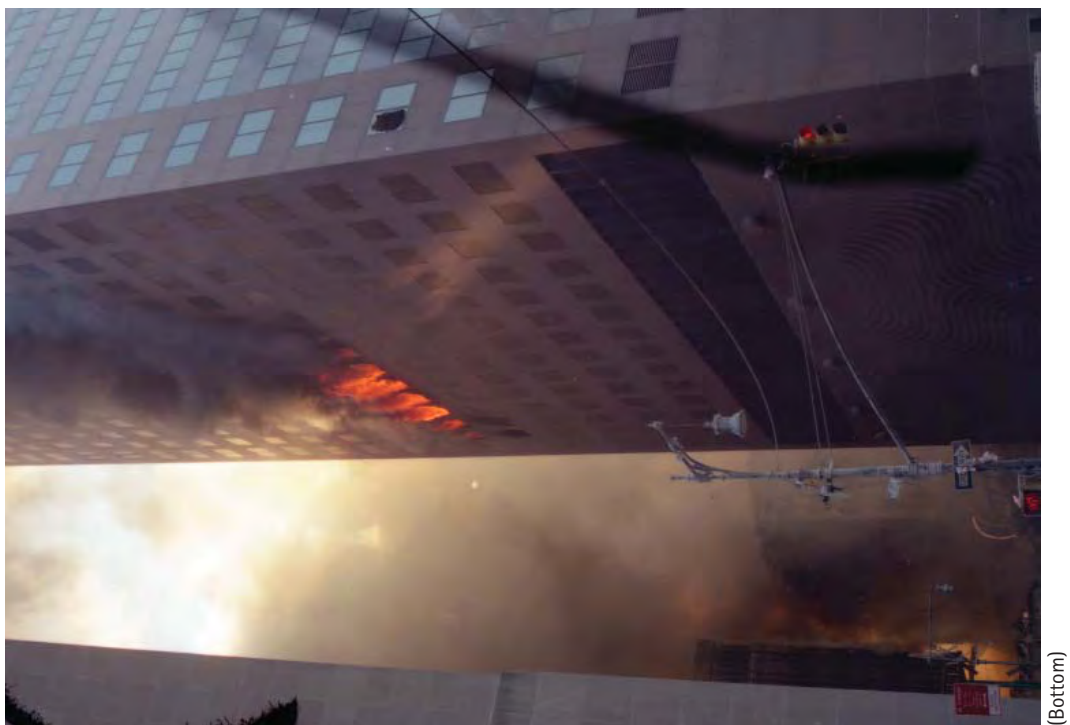
Image 5.E.16 Northeast corner, approximately 2:08PM-2:13PM

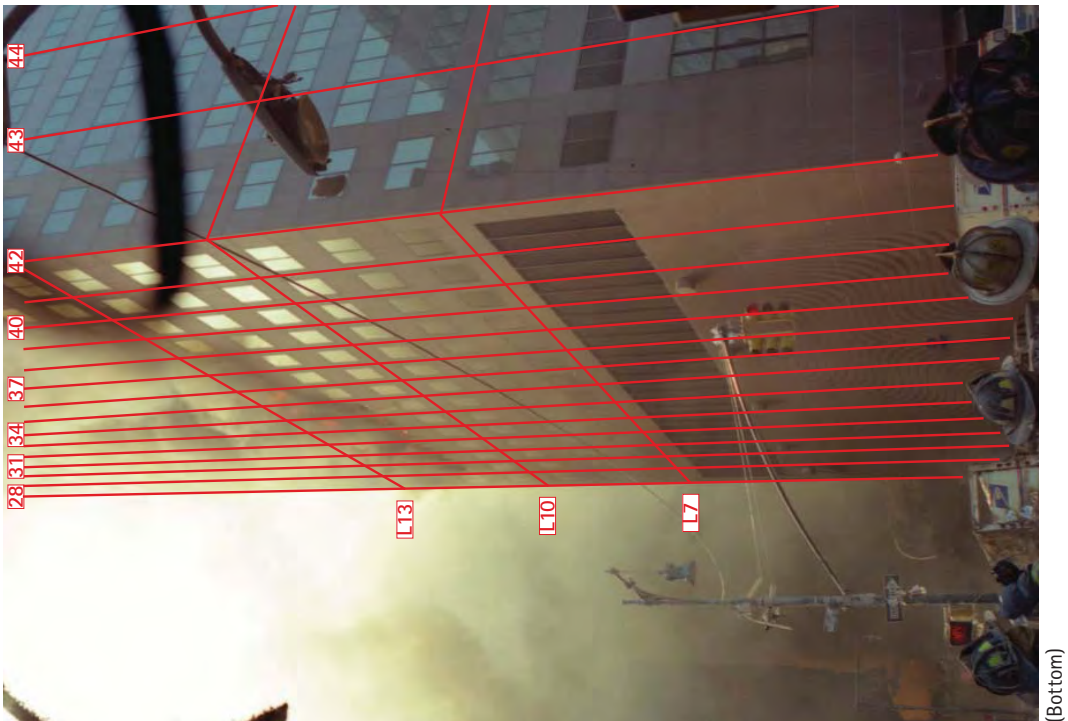
Image 5.E.36 Northeast corner, approximately 2:15PM-2:28PM

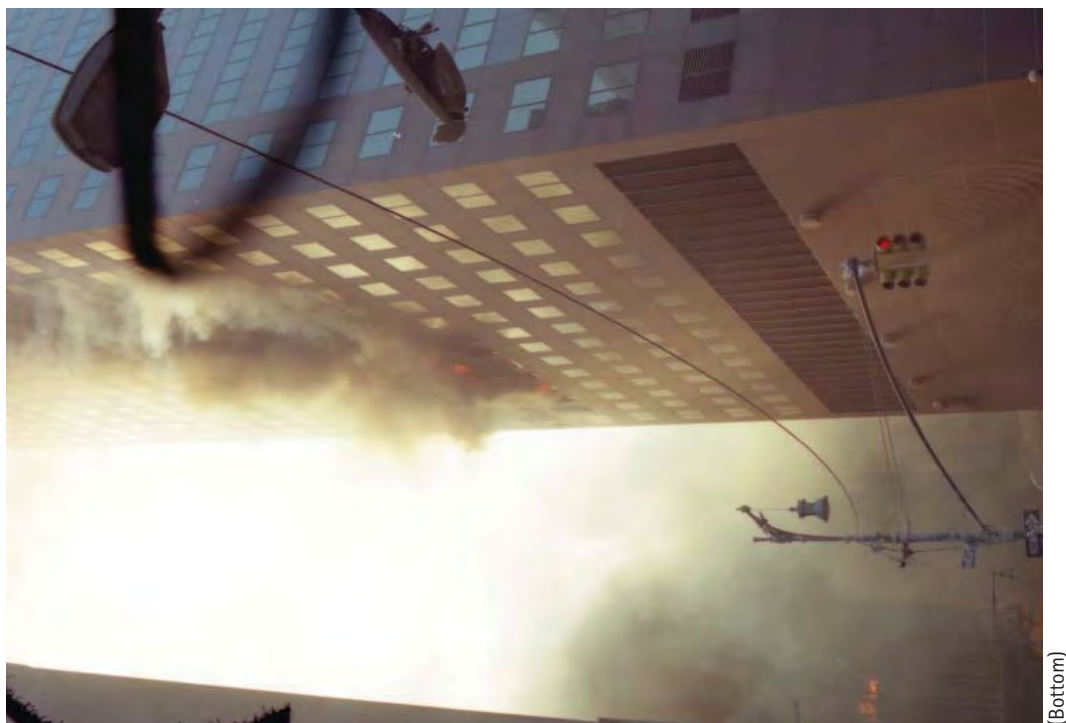
Image 5.E.38 Northeast corner, approximately 2:15PM-2:28PM

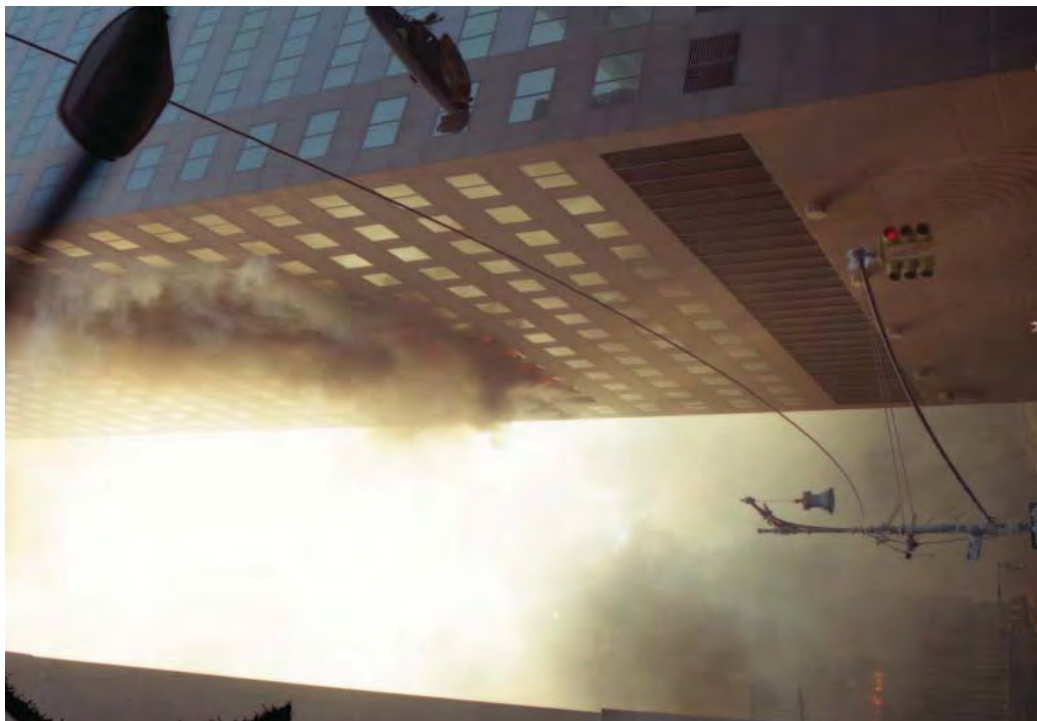
Image 5.E.39 Northeast corner, approximately 2:15PM-2:28PM

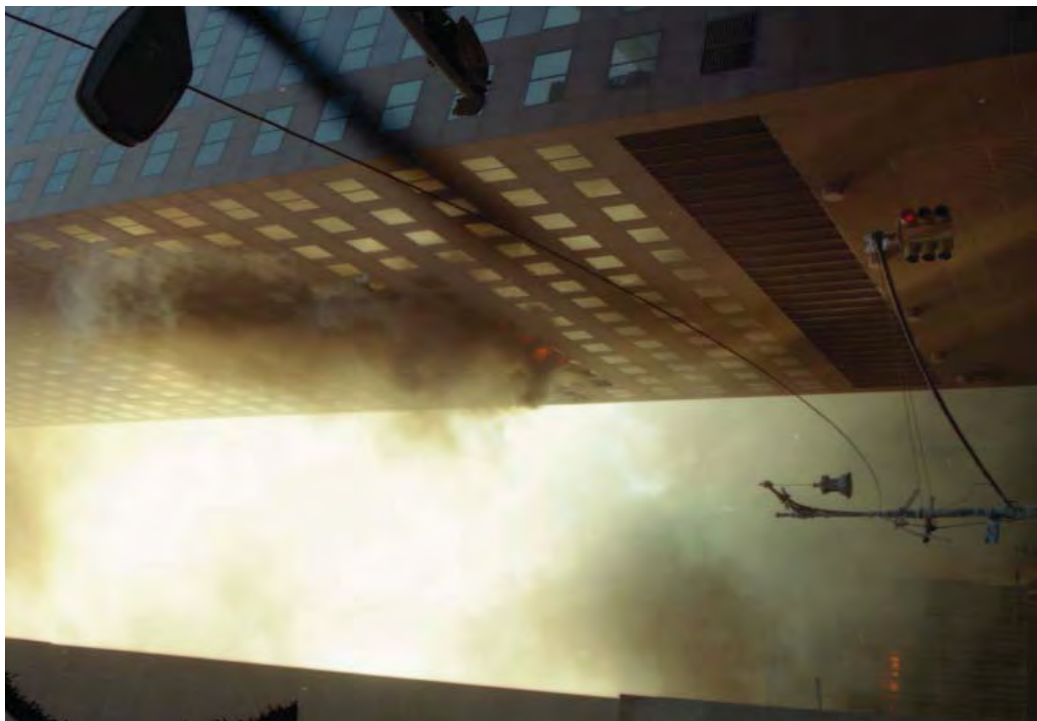
Image 5.E.40 Northeast corner, approximately 2:15PM-2:28PM

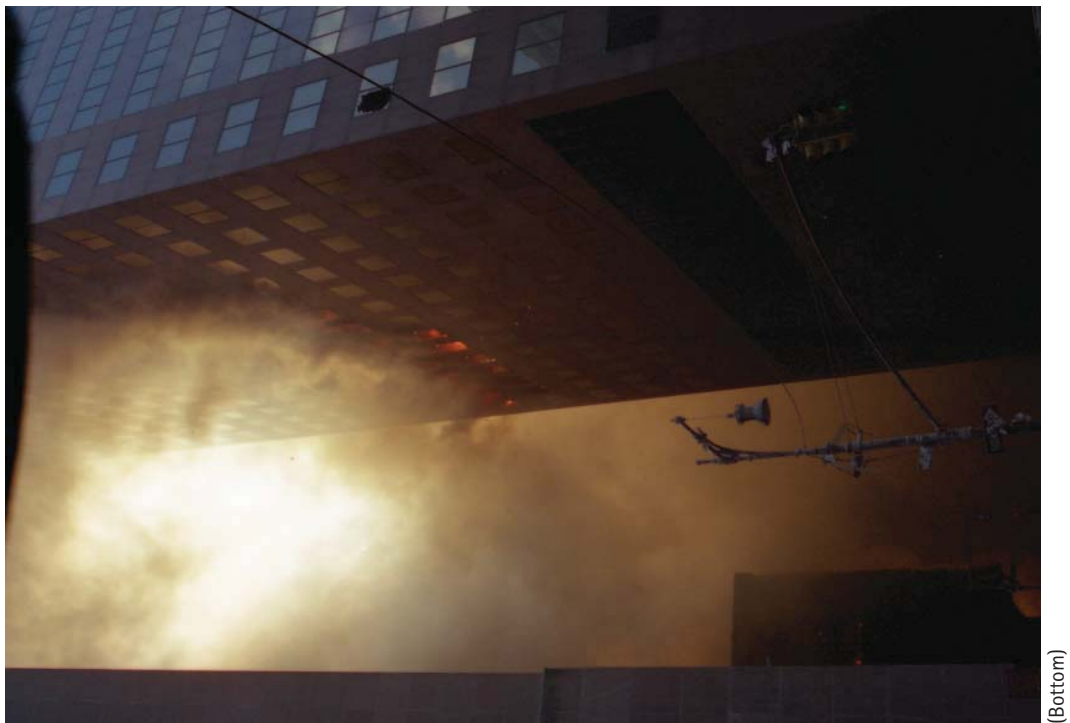
Image 5.E.41 Northeast corner, approximately 2:15PM-2:28PM

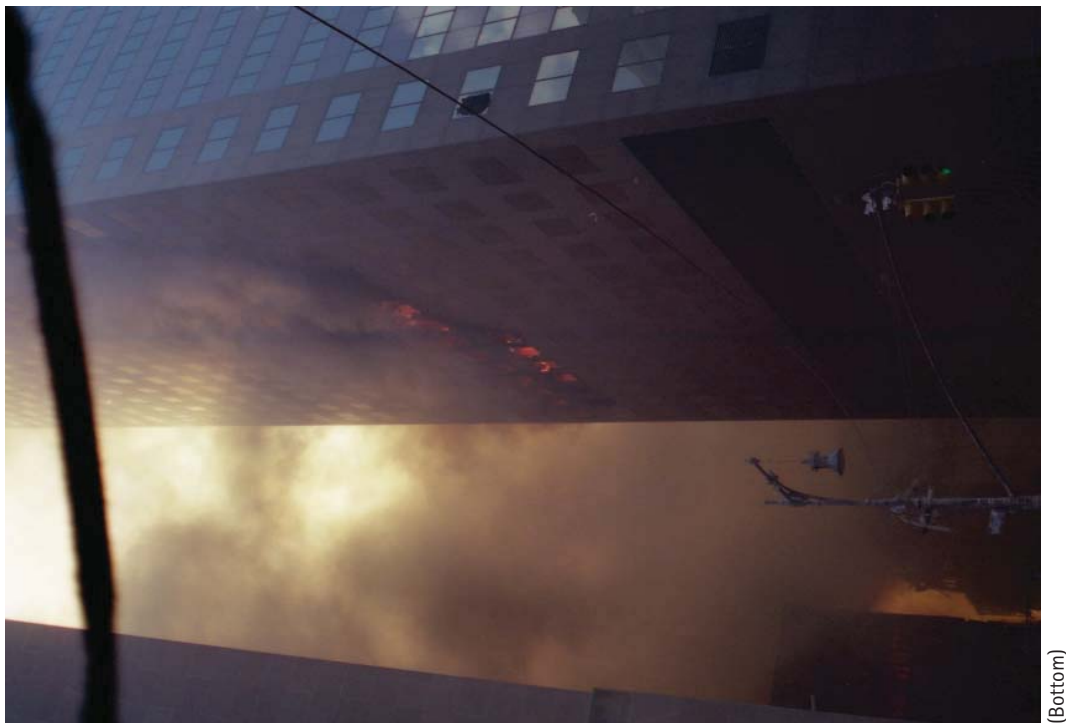
Image 5.E.42 Northeast corner, approximately 2:15PM-2:28PM

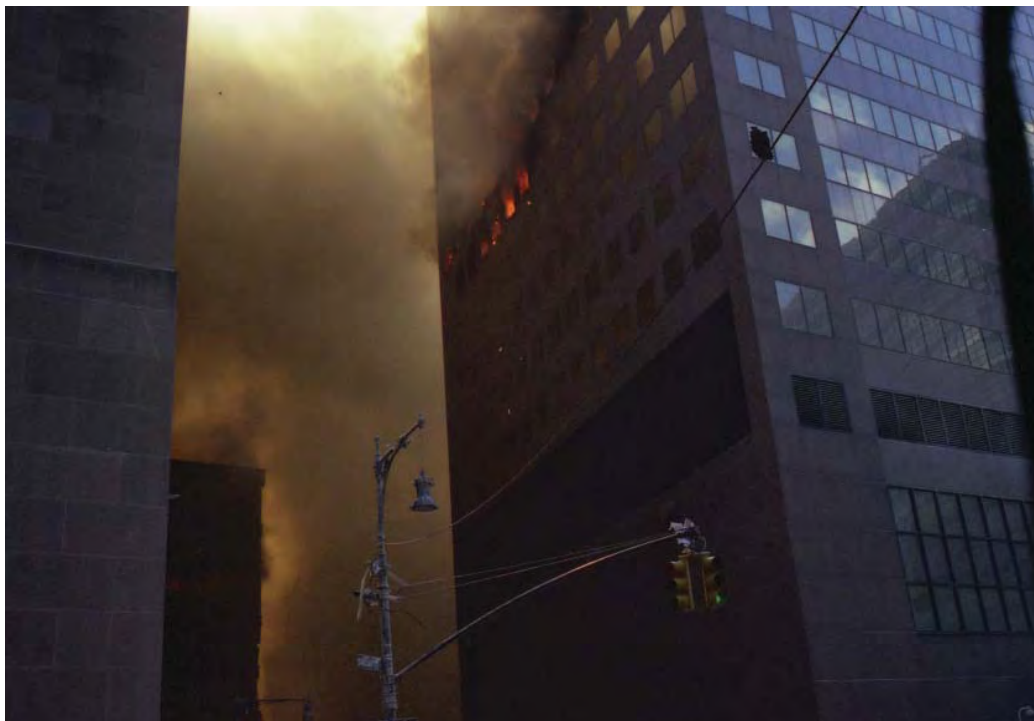
Image 5.E.43 Northeast corner, approximately 2:15PM-2:28PM

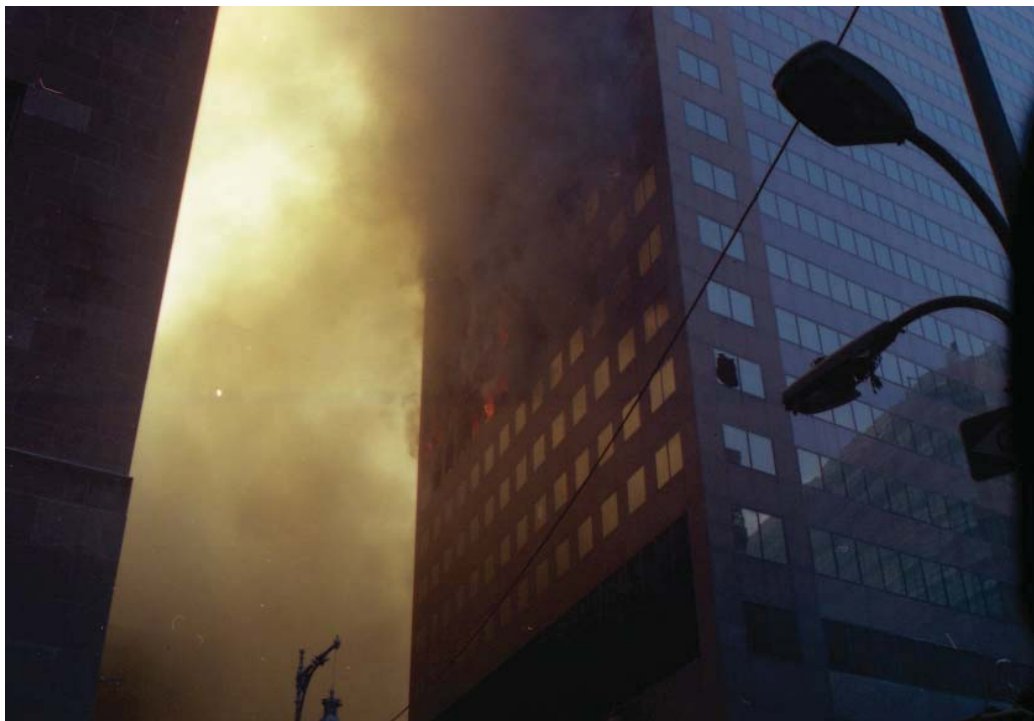
Image 5.E.44 Northeast corner, approximately 2:15PM-2:28PM

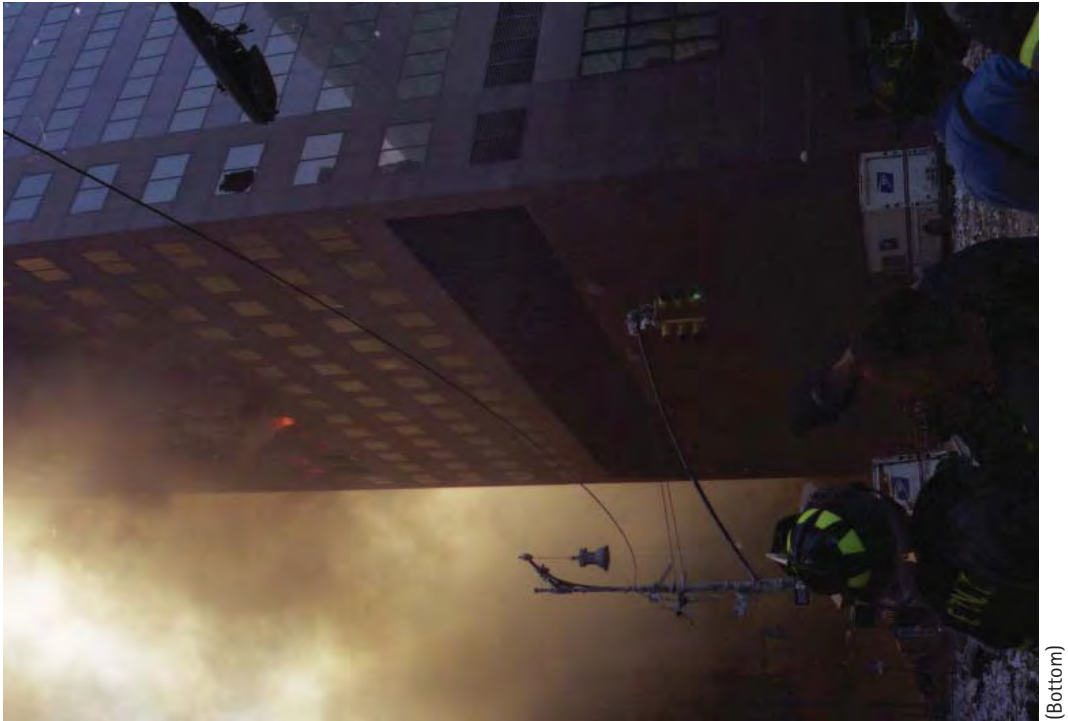
Image 5.E.45 Northeast corner, approximately 2:15PM-2:28PM

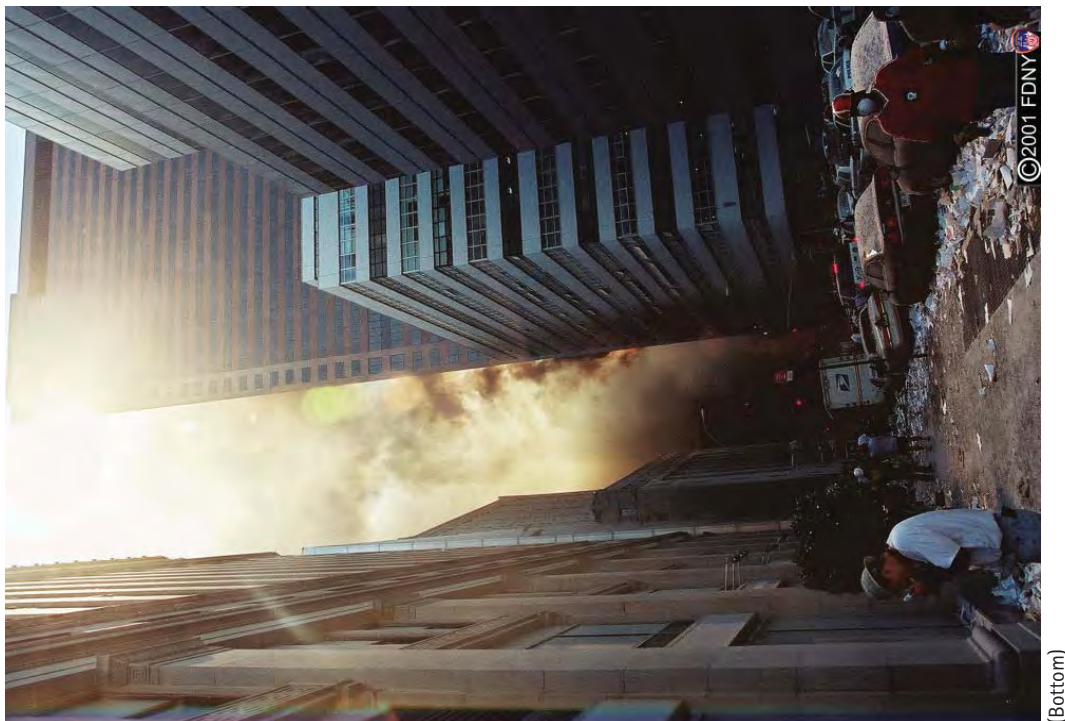
Image 5.E.46 Northeast corner, approximately 2:00PM-3:00PM

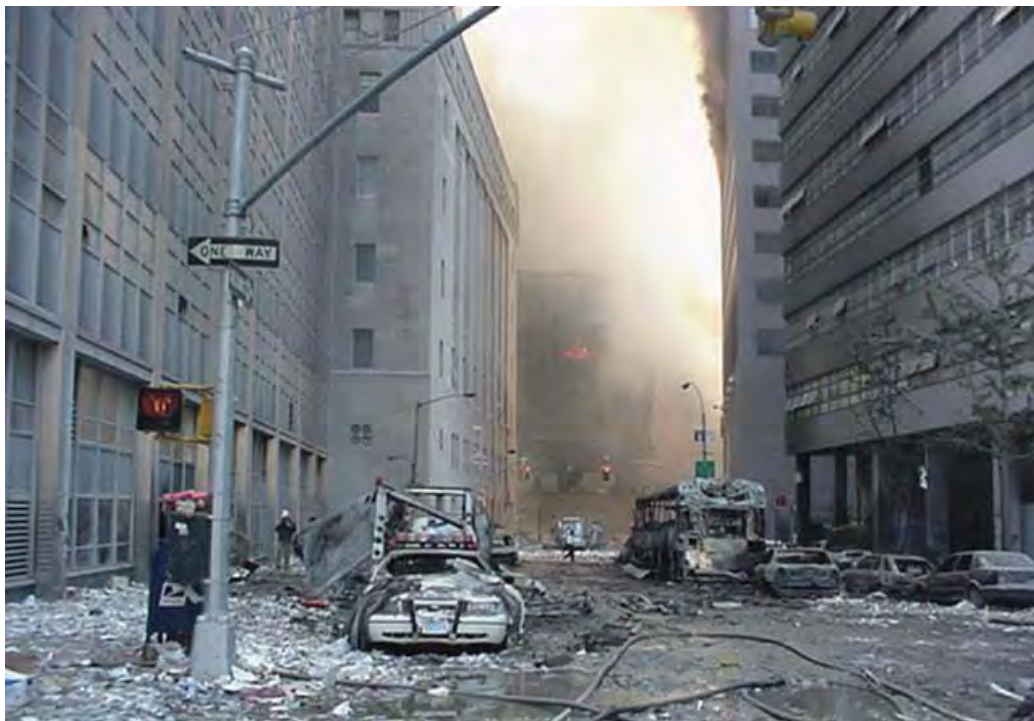
Image 5.E.48 Northeast corner, approximately 2:00PM-3:00PM

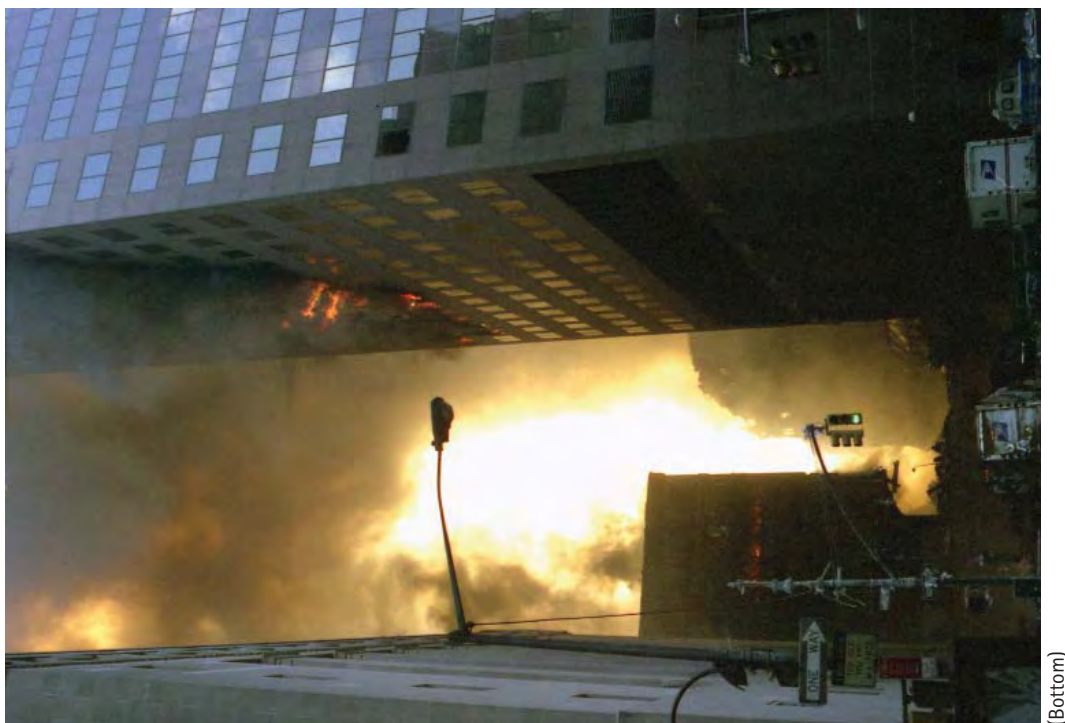
Image 5.E.49 Northeast corner, approximately 2:15PM-2:28PM

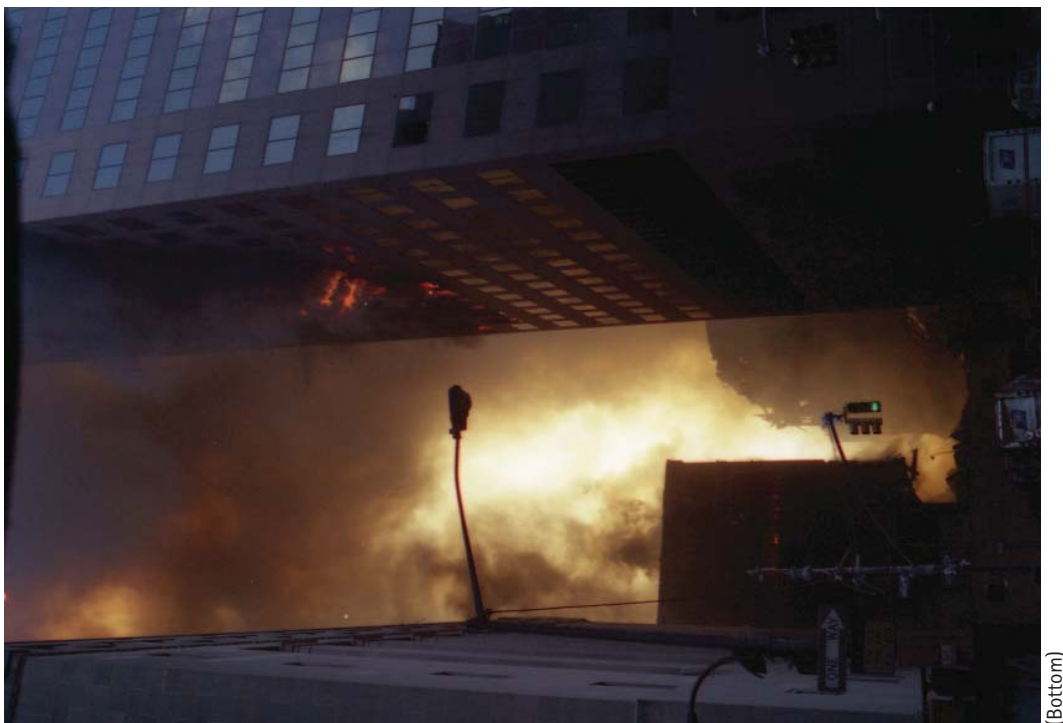
Image 5.E.50 Northeast corner, approximately 2:15PM-2:28PM

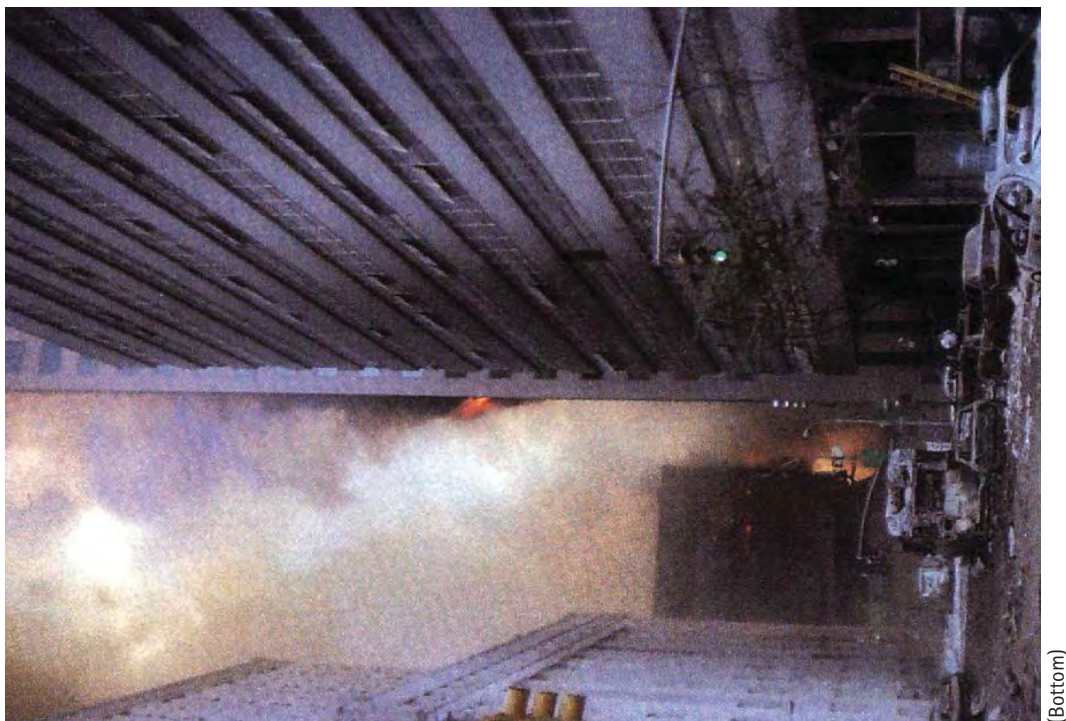
Image 5.E.51 Northeast corner, approximately 2:00PM-3:00PM

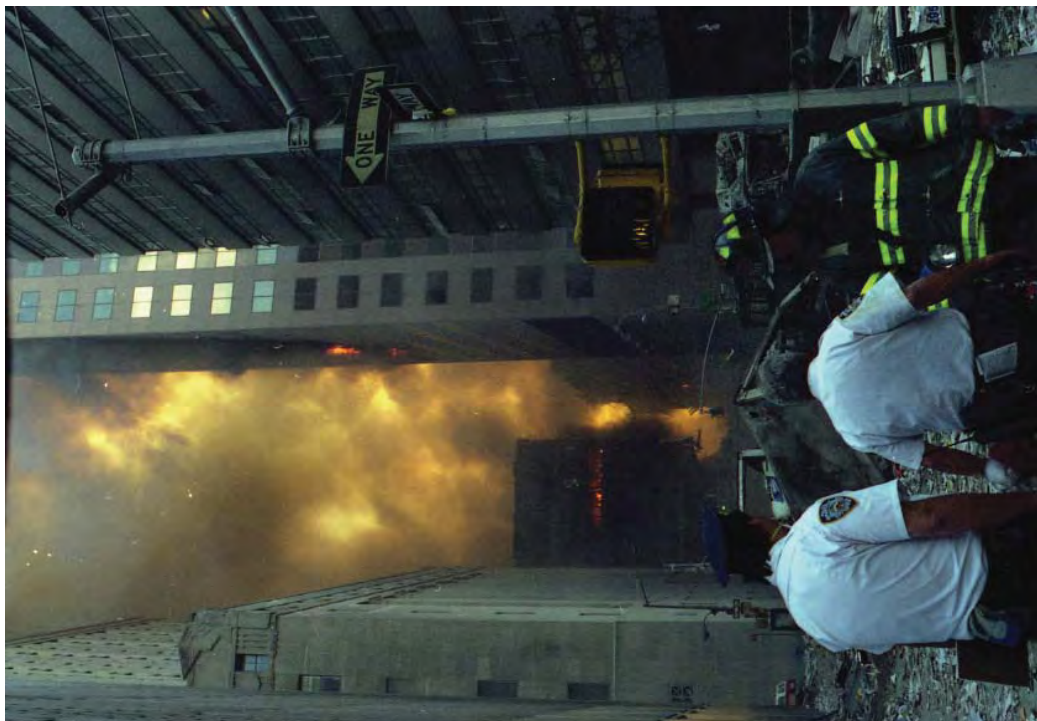
Image 5.E.52 Northeast corner, approximately 2:15PM-2:28PM

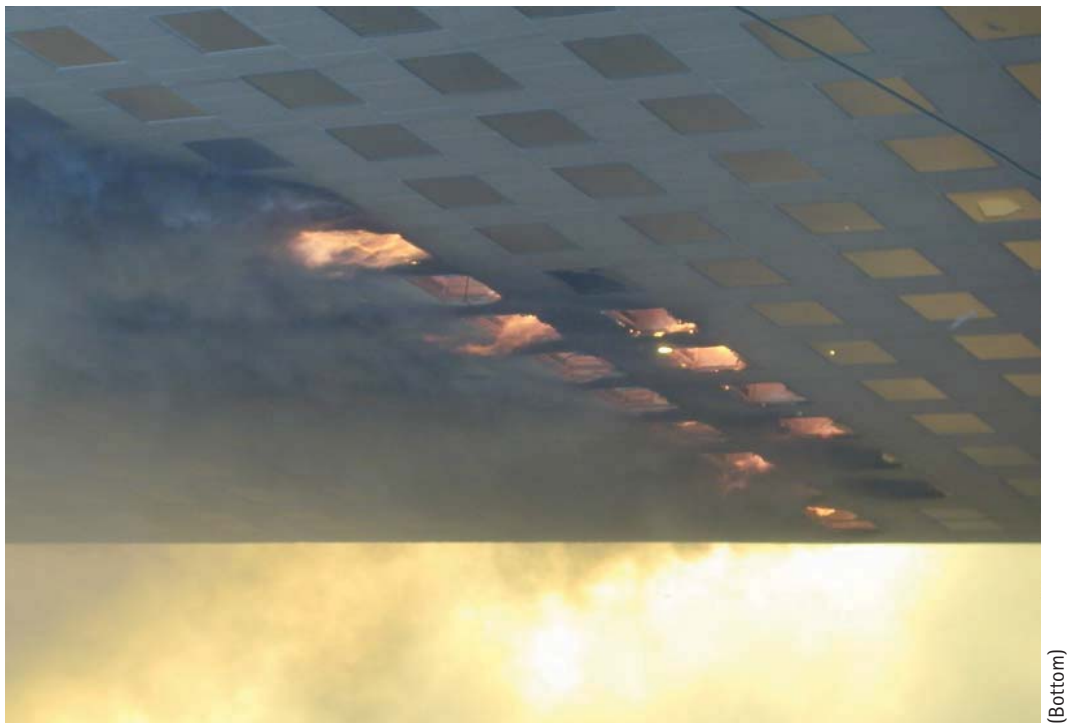
Image 5.E.53 East facade, 2:28:43PM +/-1S

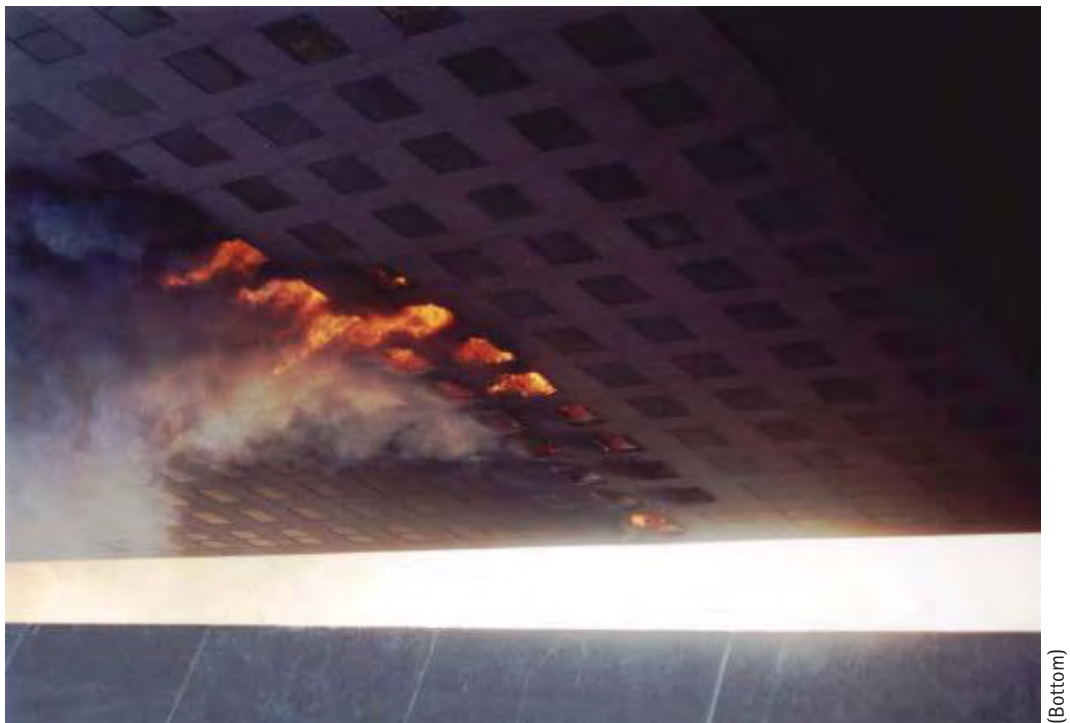
Image 5.E.54 East facade, approximately 2:28PM-3:10PM

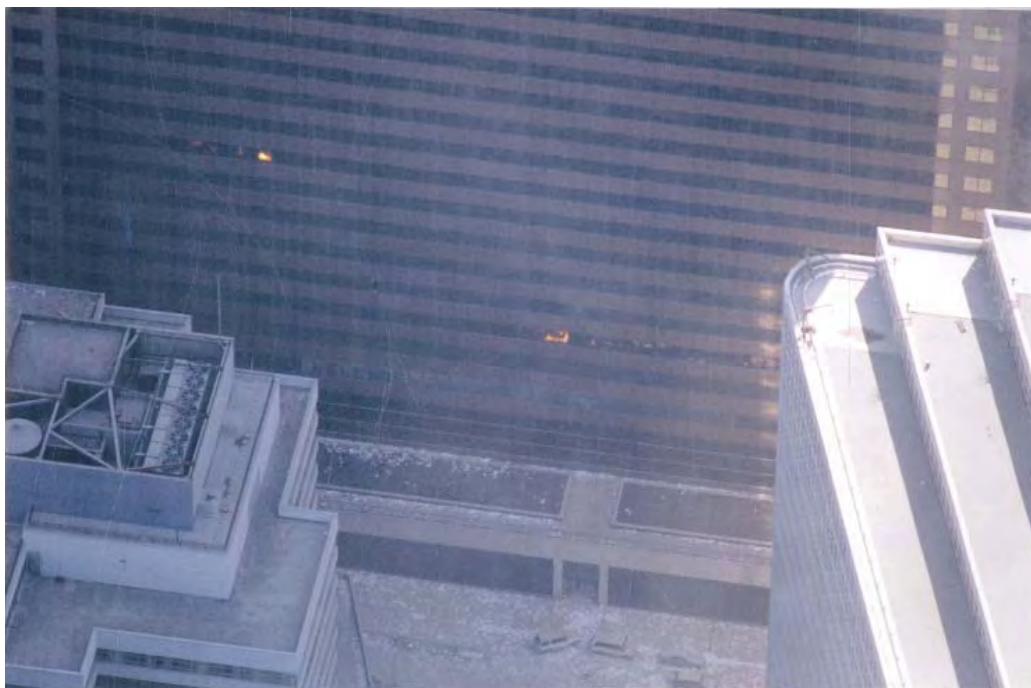
North Facade – During this time period, visual evidence shows that fires were burning on levels 7 and 12 at the end of the hour. Also, a photograph shows that at the middle of the hour windows had already burned-out on level 7 near the northwest corner.

Image 5.N.01 North facade, 2:57PM +/-300S

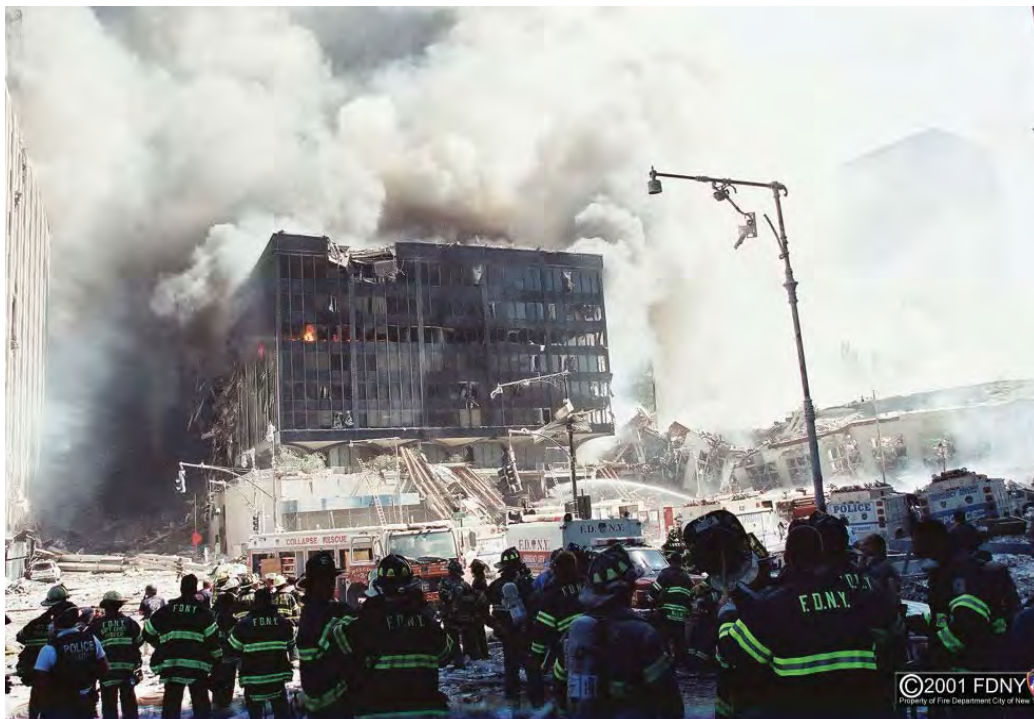
West Facade – Photographs during this time period show that smoke is once again present on levels 17 and 18. Similarly, smoke is visible at new locations on floors 7, 17, and 18. By the end of the hour many of these windows have subsequently burned-out along with an additional window on level 30.

Image 5.W.01 West facade, approximately 2:00PM-3:00PM

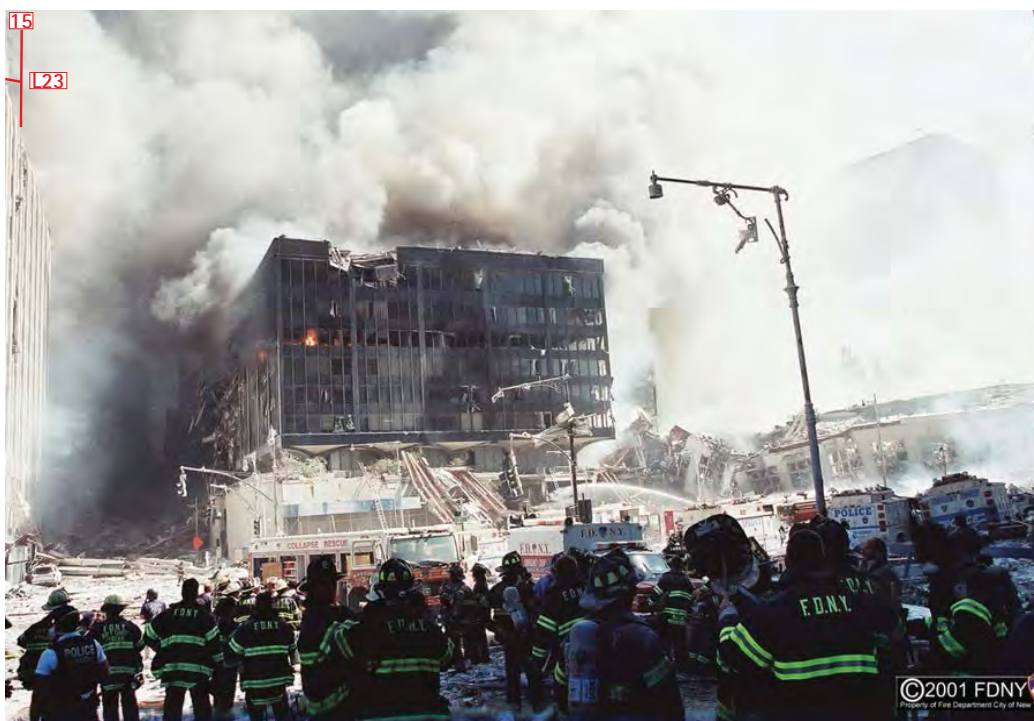
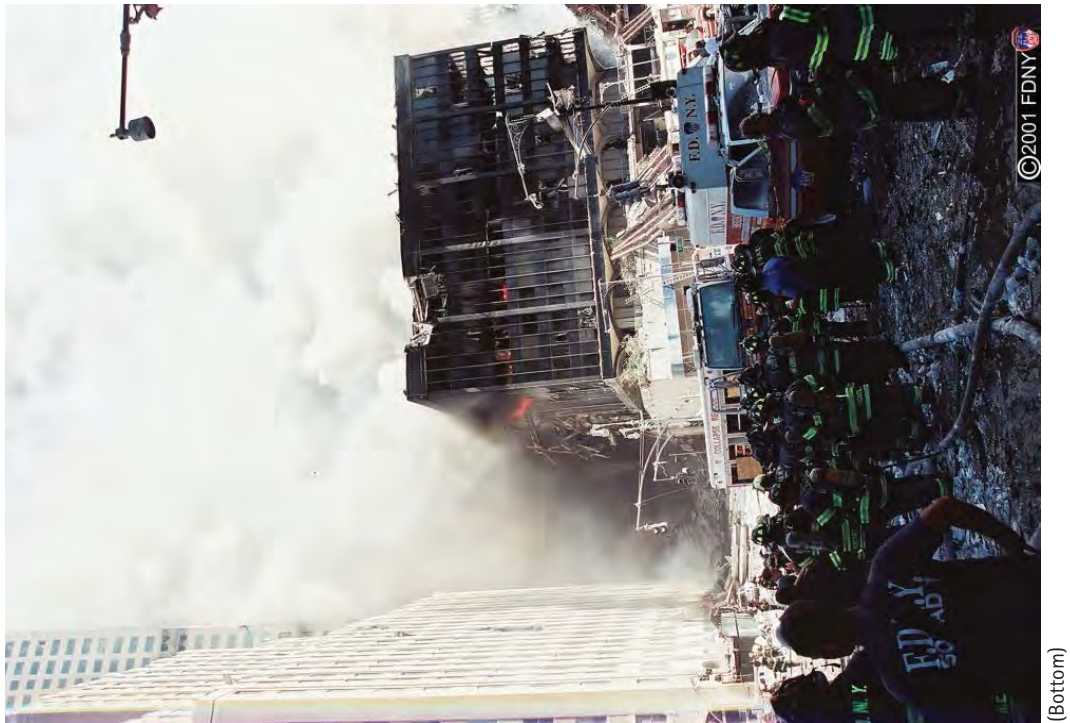
Image 5.W.01 with columns and floor levels overlaid

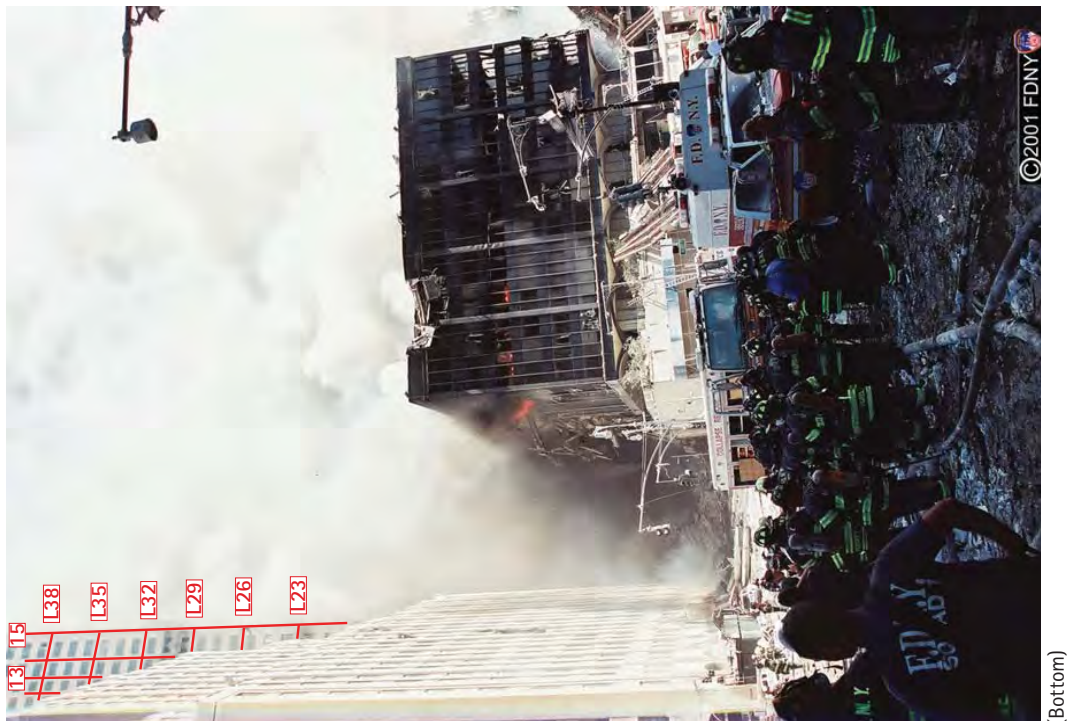
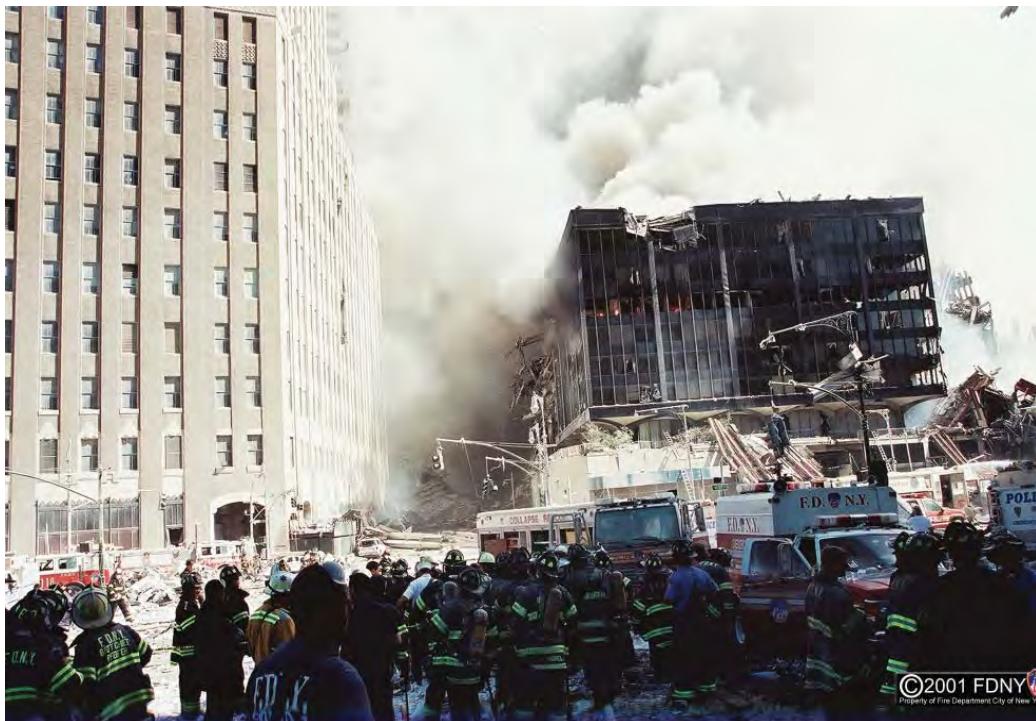
Image 5.W.02 West facade, approximately 2:00PM-3:00PM

Image 5.W.02 with columns and floor levels overlaid

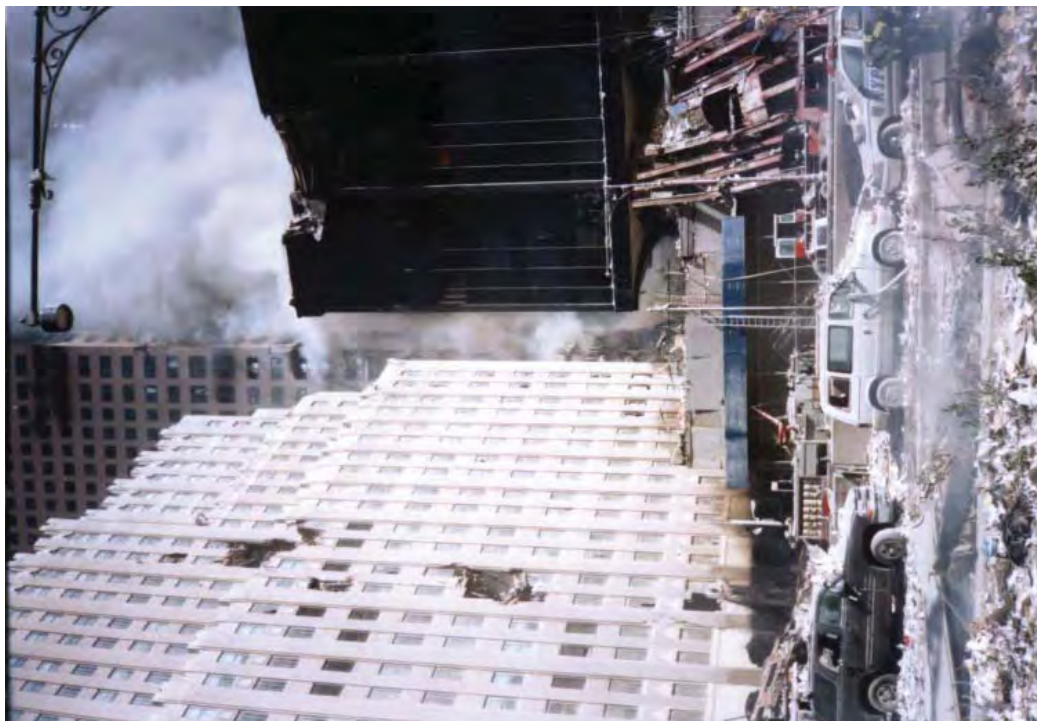
Image 5.W.03 West facade, approximately 2:00PM-3:00PM

Image 5.W.03 with columns and floor levels overlaid

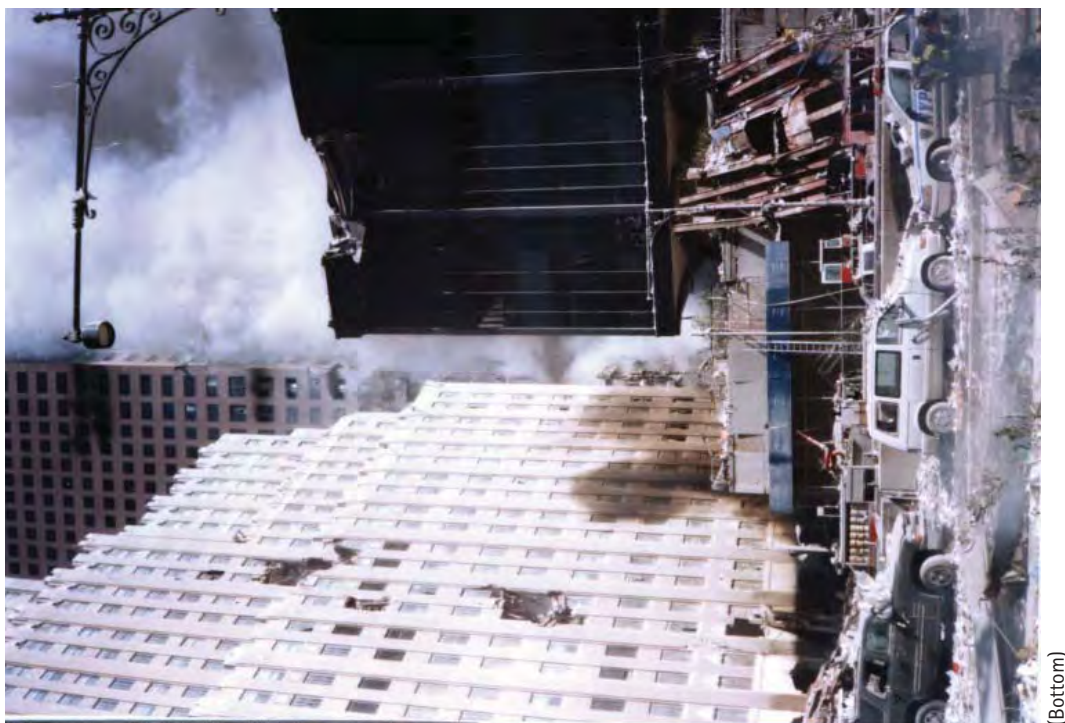
Image 5.W.04 Southwest corner, approximately 2:00PM-3:00PM

Image 5.W.04 with columns and floor levels overlaid
