11-4403-CV

United States Court of Appeals
for the
Second Circuit

JOINT APPENDIX
Volume 13 of 16 (Pages JA-3321 to JA-3616)

In re: September 11 Property Damage and Business Loss Litigation

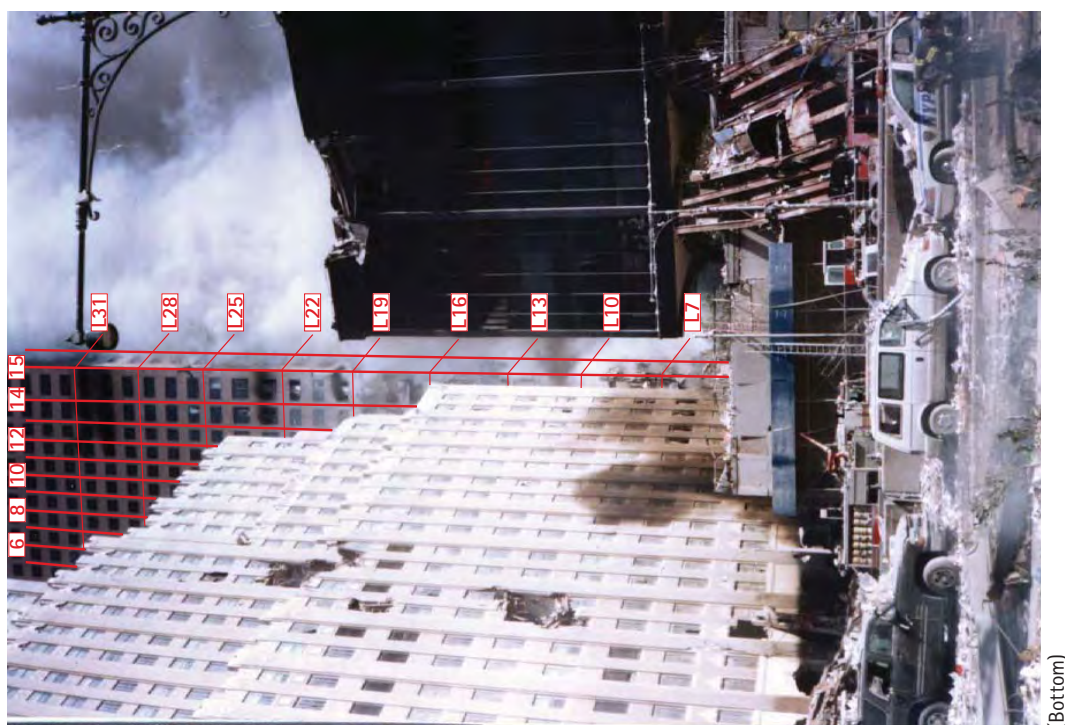
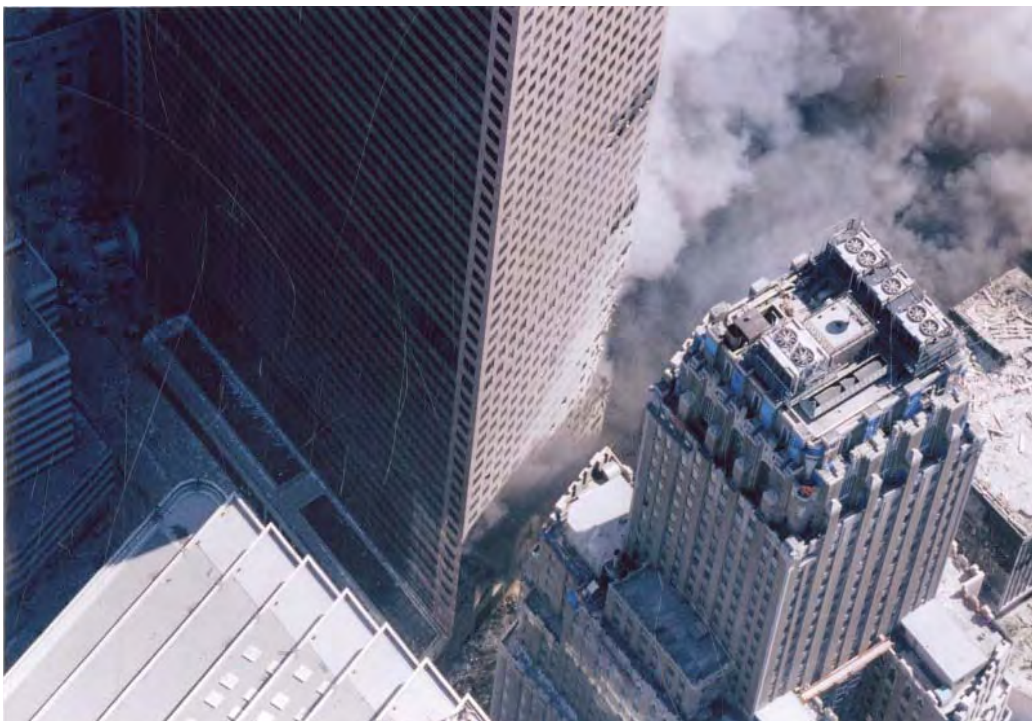
Image 5.W.05 Southwest corner, approximately 2:00PM-3:00PM

Image 5.W.05 with columns and floor levels overlaid

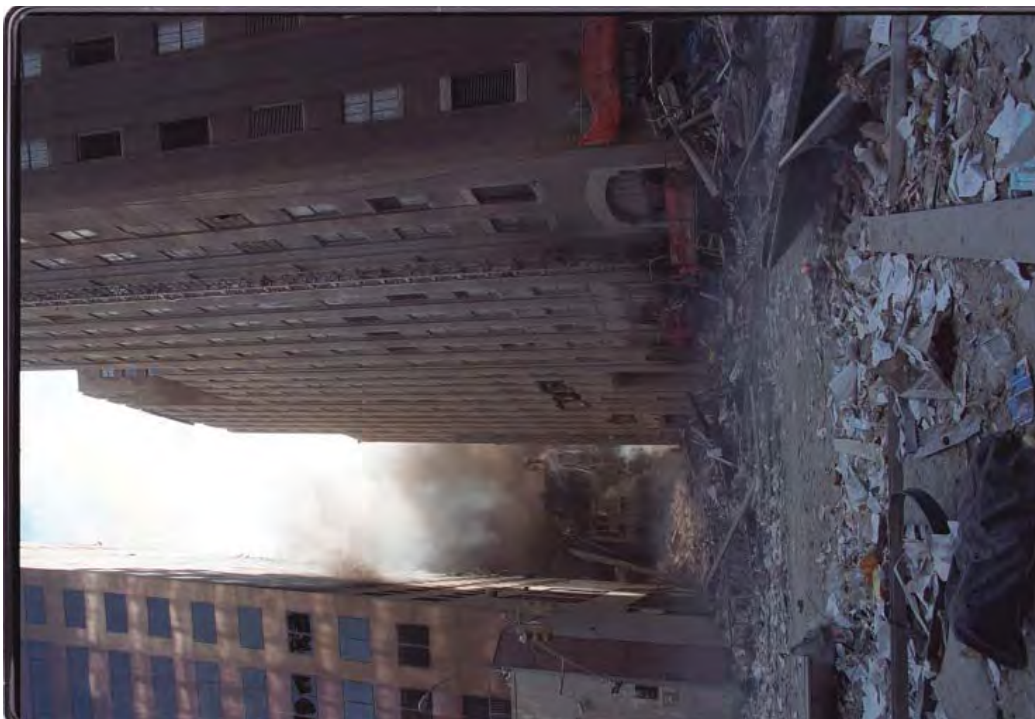
Image 5.W.06 Northwest corner, 2:15PM-2:45PM

Image 5.W.06 with columns and floor levels overlaid

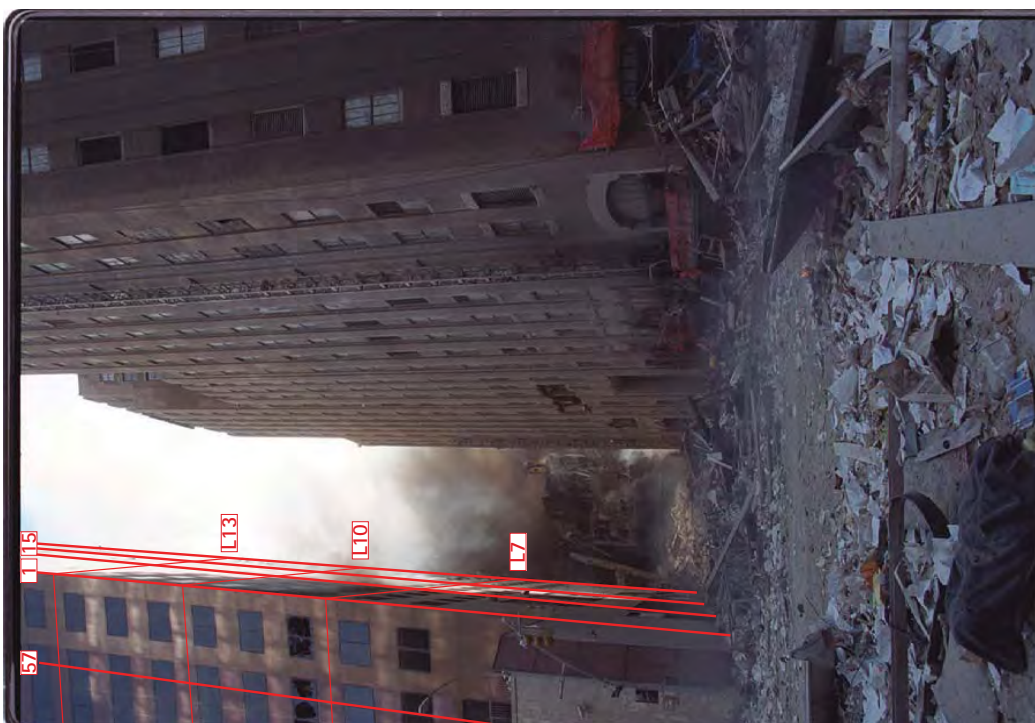
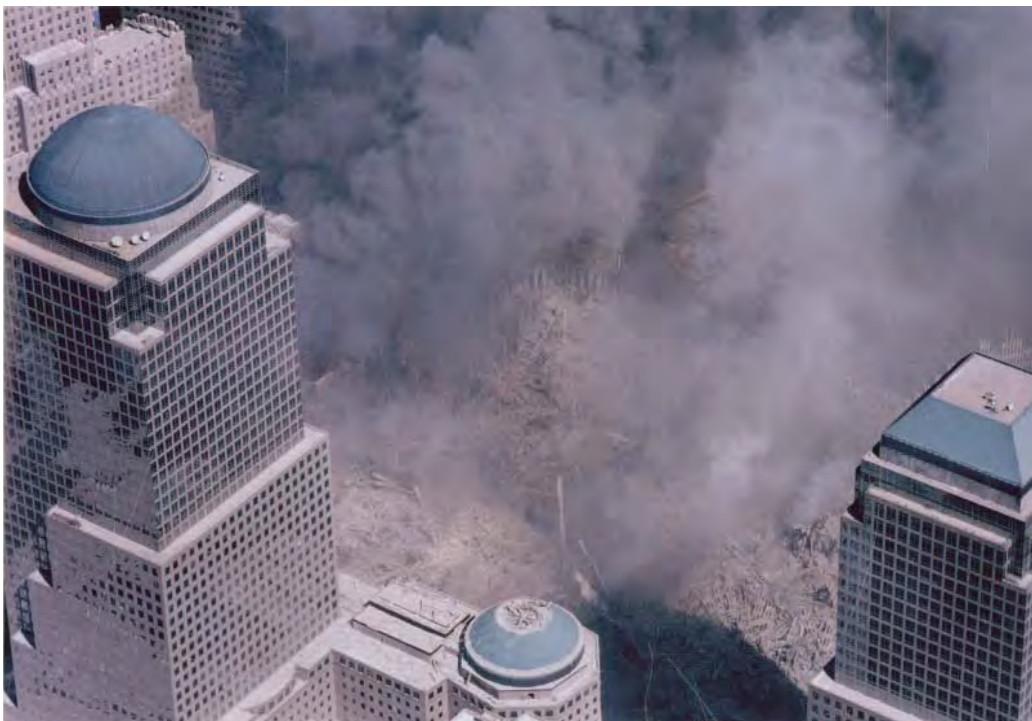
Image 5.W.07 Northwest corner, 2:21:10PM

Image 5.W.07 with columns and floor levels overlaid

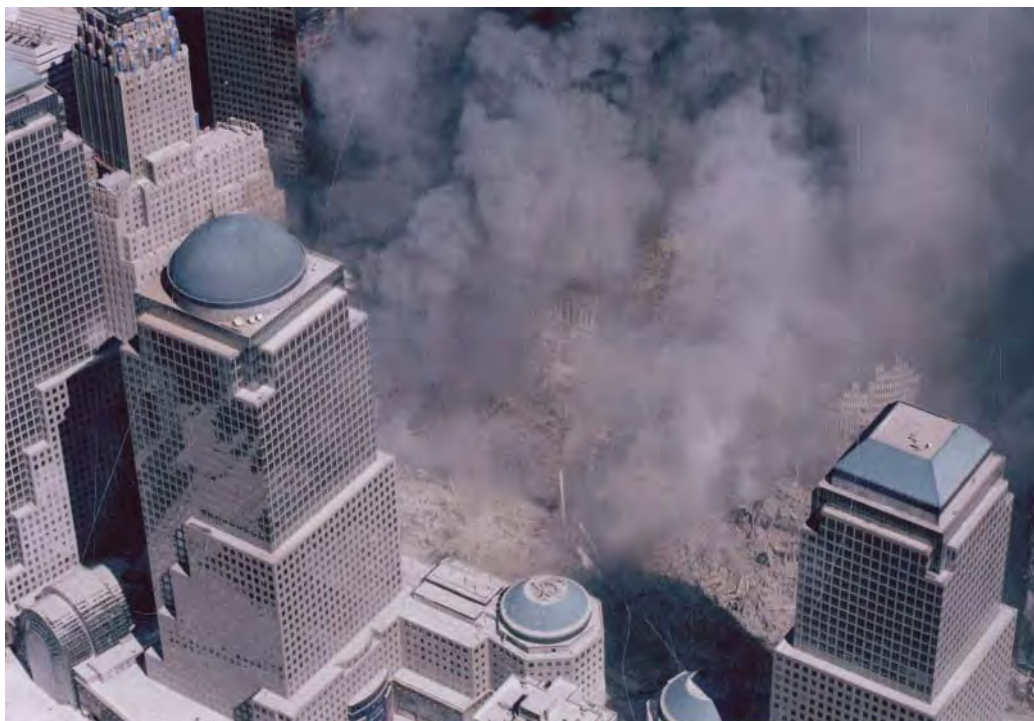
Image 5.W.08 Southwest corner, approximately 2:00PM-3:30PM

Image 5.W.08 with columns and floor levels overlaid

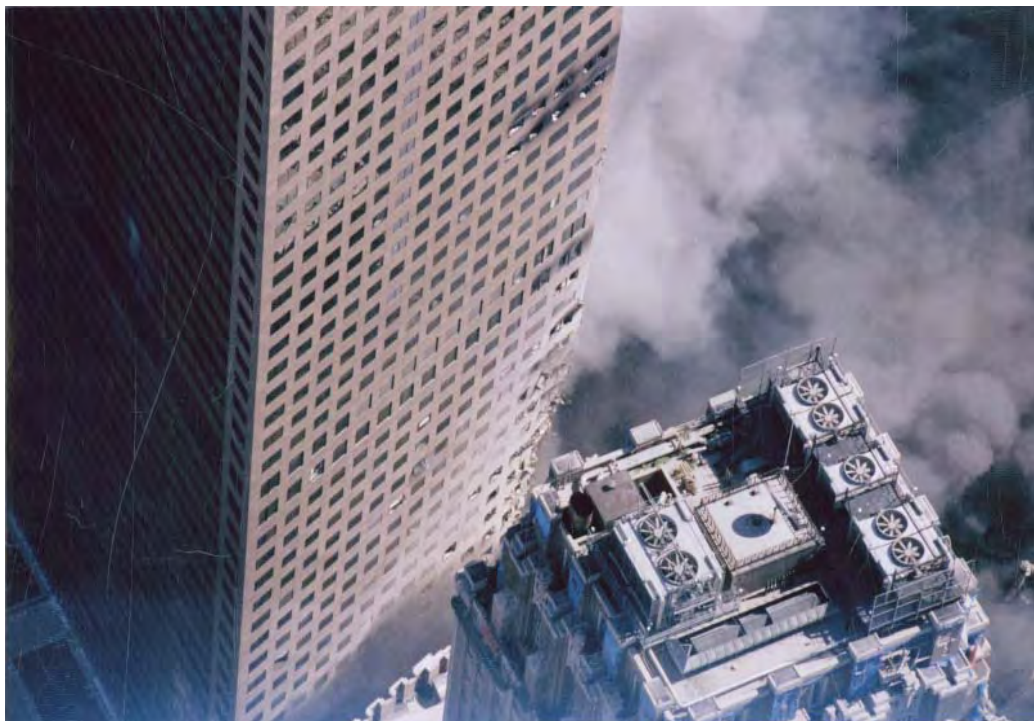
Image 5.W.09 Southwest corner, approximately 2:00PM-3:30PM

Image 5.W.09 with columns and floor levels overlaid

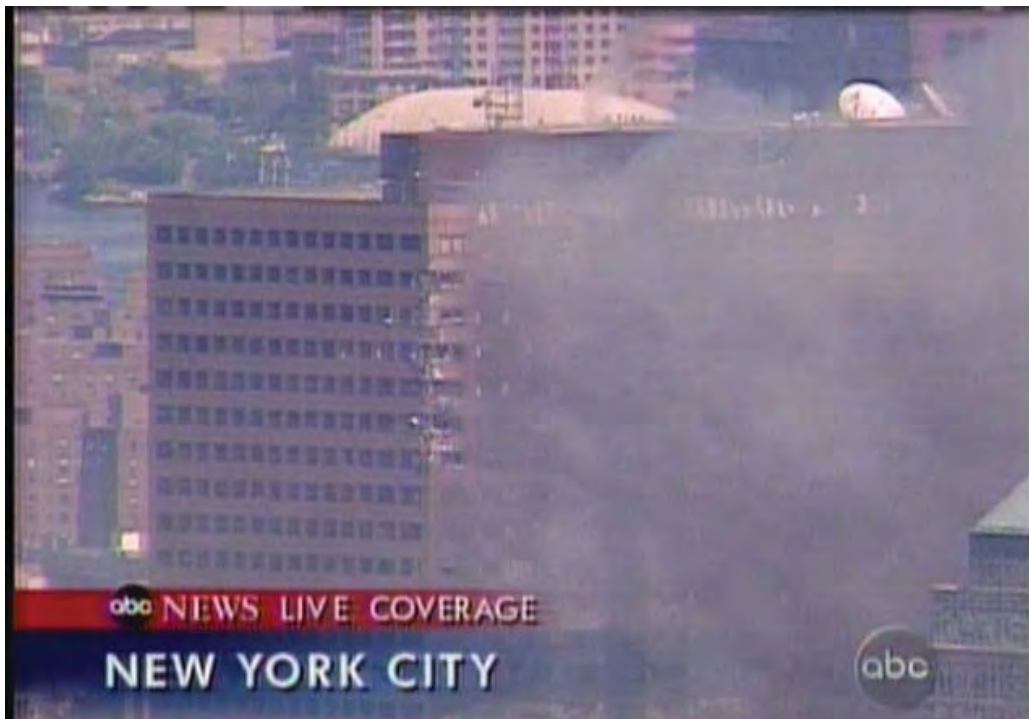
Image 5.W.10 Northwest corner, 2:30PM-3:00PM

Image 5.W.10 with columns and floor levels overlaid

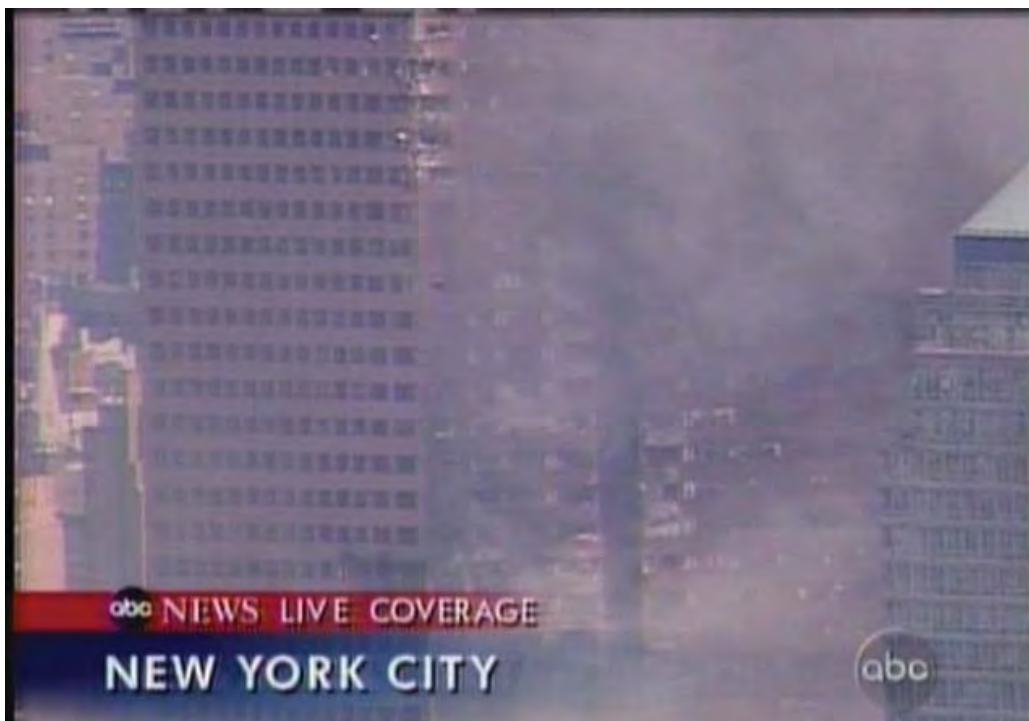
Image 5.S.01 Southwest corner, approximately after 2:00PM

Image 5.S.01 with columns and floor levels overlaid

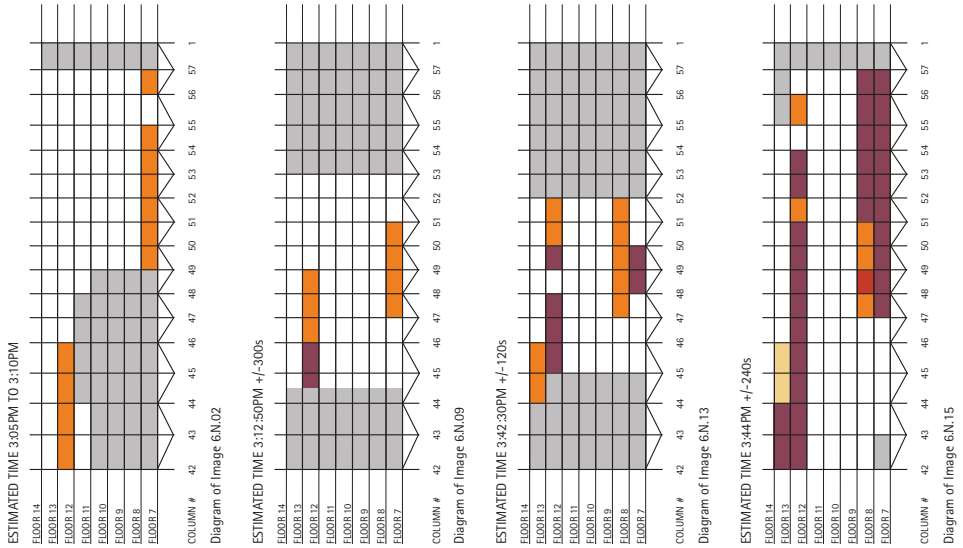
Figures 6.N.02, 6.N.03, 6.W.02, 6.W.03, and 6.W.04 on pages 205 to 209 depict a series of sequential images showing the progression of fire in particular areas of the north and west façades during this time increment. While the full elevation diagrams represent the condition of each facade at the end of the time period, the detail elevation mappings illustrate how fire traveled or altered throughout the hour in a specific area. Debris damage has been omitted from these diagrams for clarity.

Figure 6.N.02 WTC7 North Facade - Detailed Fire Progression from 3PM to 4PM

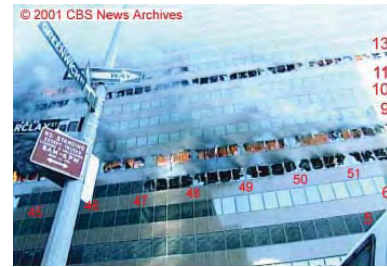
Diagram of Image 6.N.19

ESTIMATED TIME 3:51PM TO 3:58PM

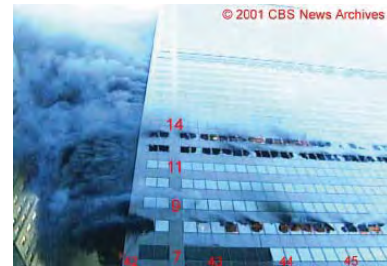
Diagram of Image 6.N.22

ESTIMATED TIME 3:53PM TO 4:02PM

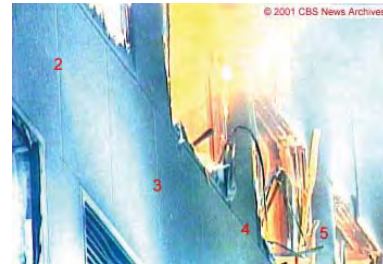
Diagram of Image 6.W.32

ESTIMATED TIME 3:41:30PM +/-300s

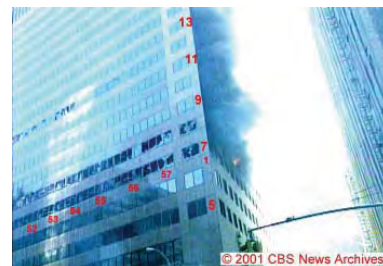
Diagram of Image 6.N.14

ESTIMATED TIME 3:42PM +/-300s

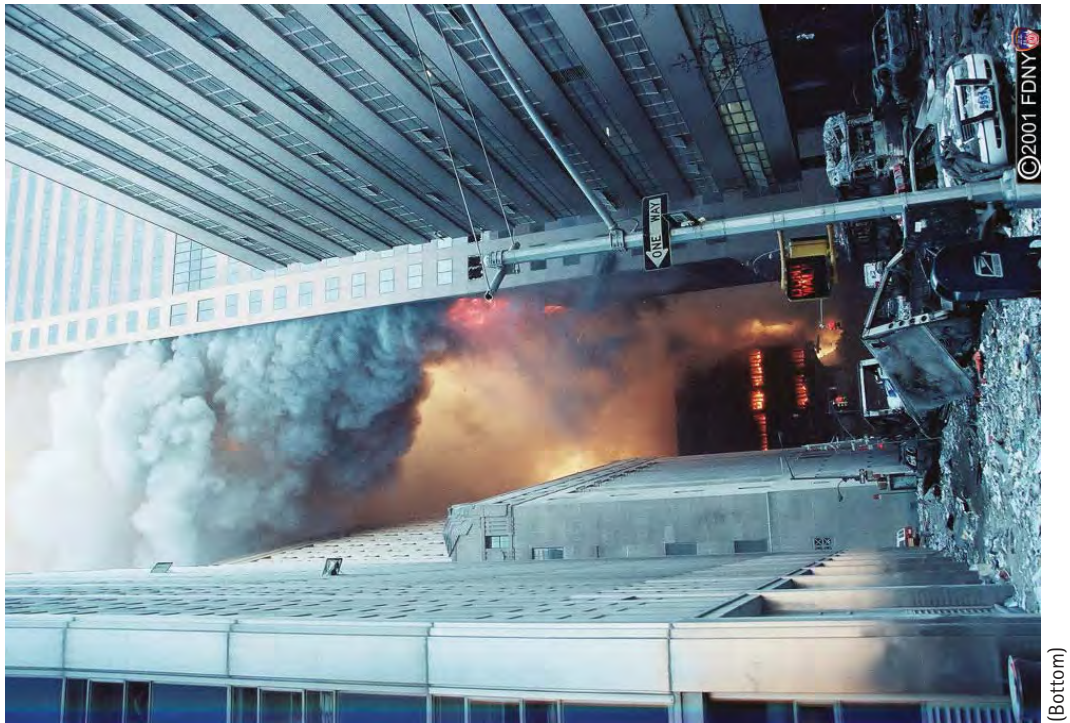
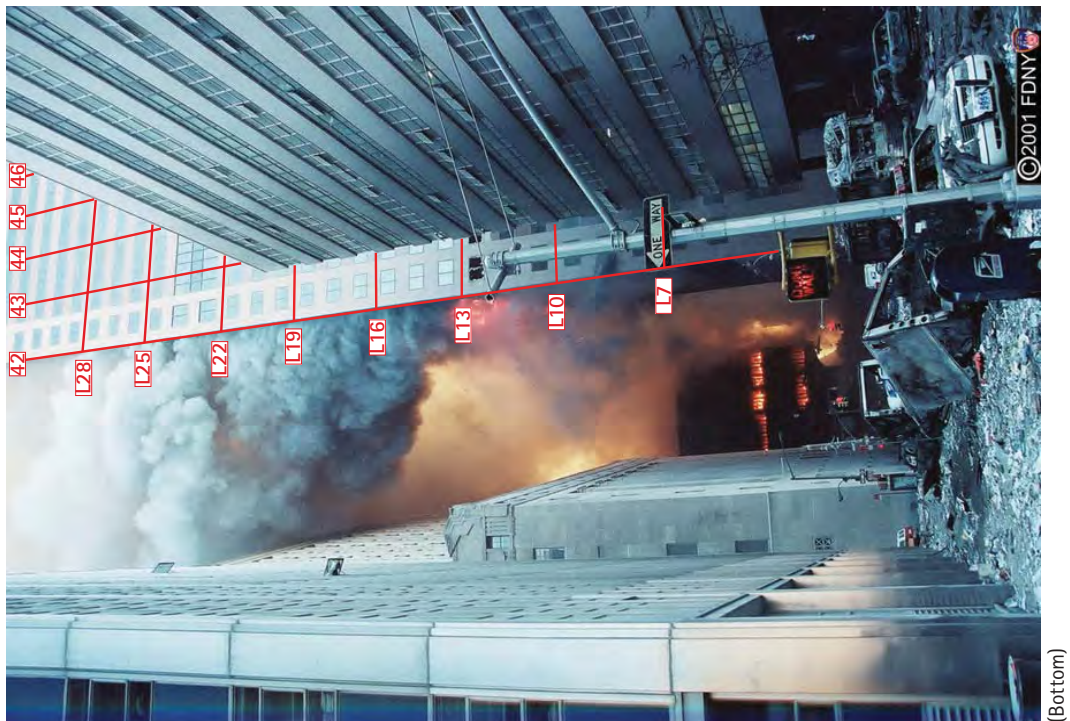
Image 6.E.01 Northeast corner, approximately 3:20PM-3:40PM

Image 6.E.01 with columns and floor levels overlaid

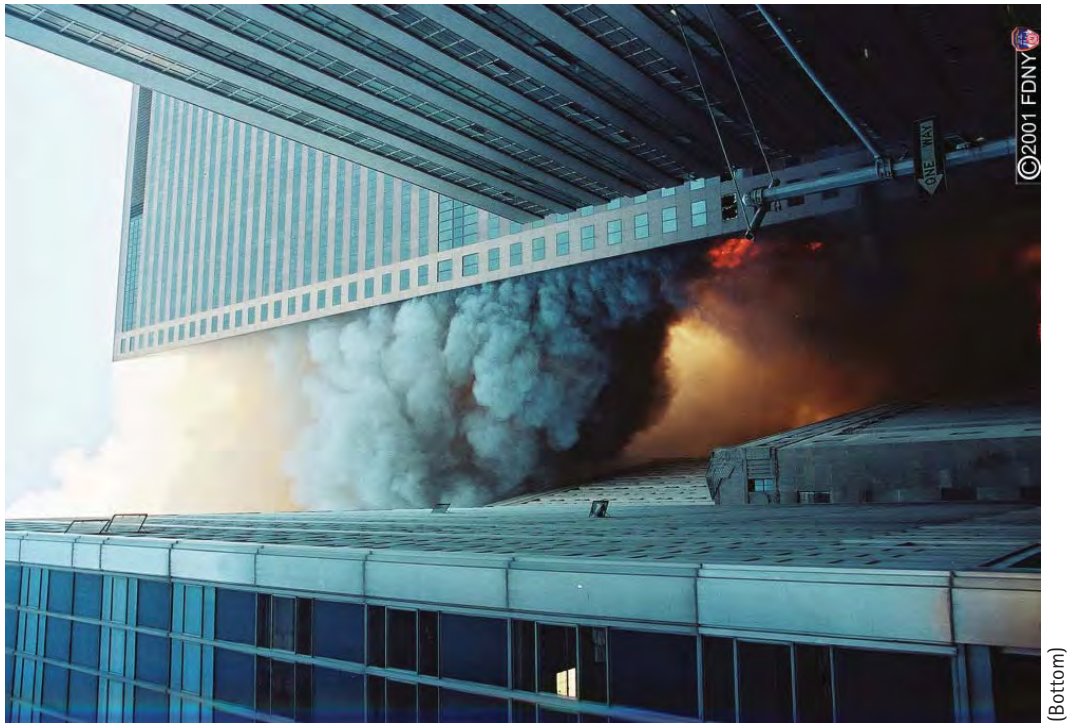
Image 6.E.02 Northeast corner, likely 3:20PM-3:40PM

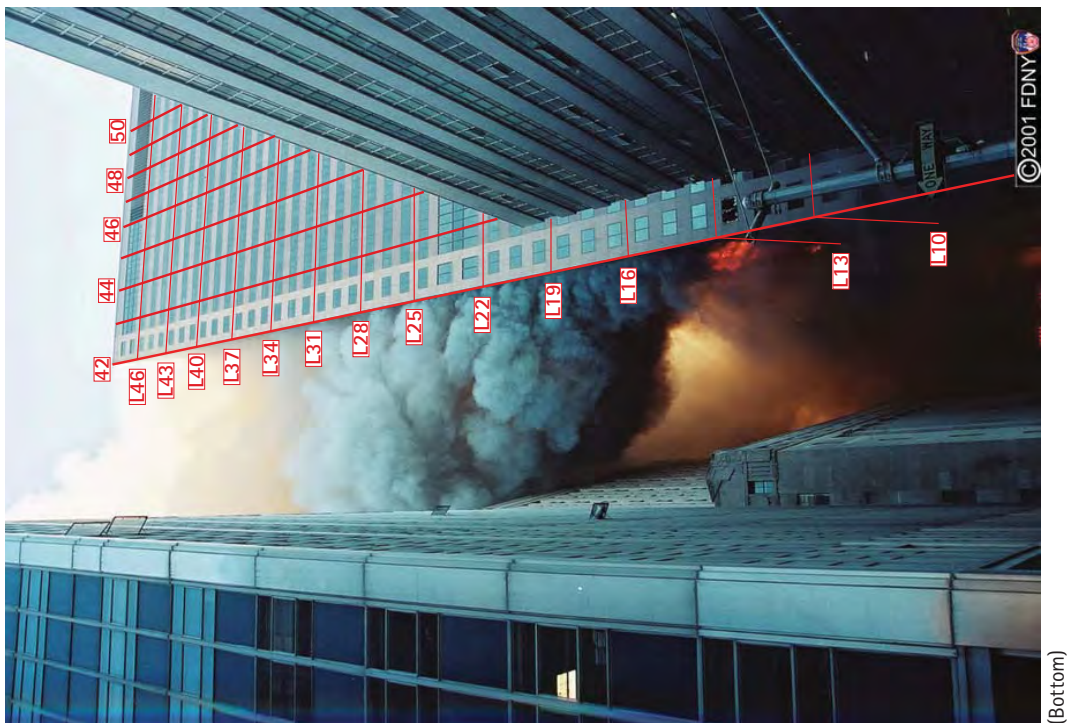
Image 6.E.02 with columns and floor levels overlaid

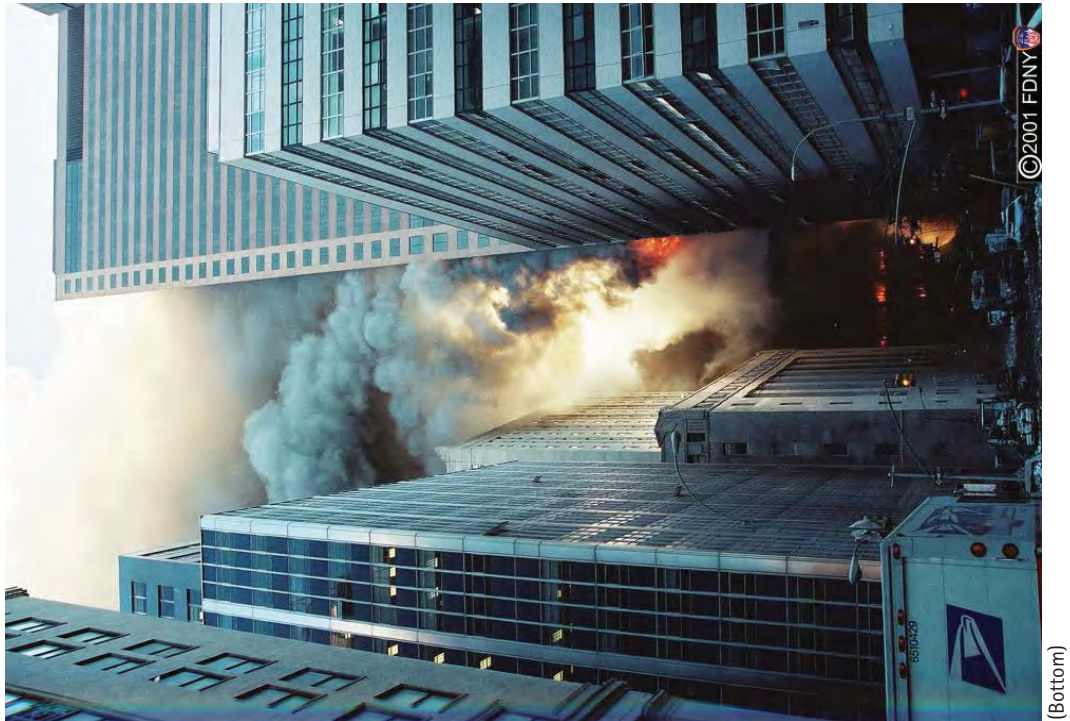
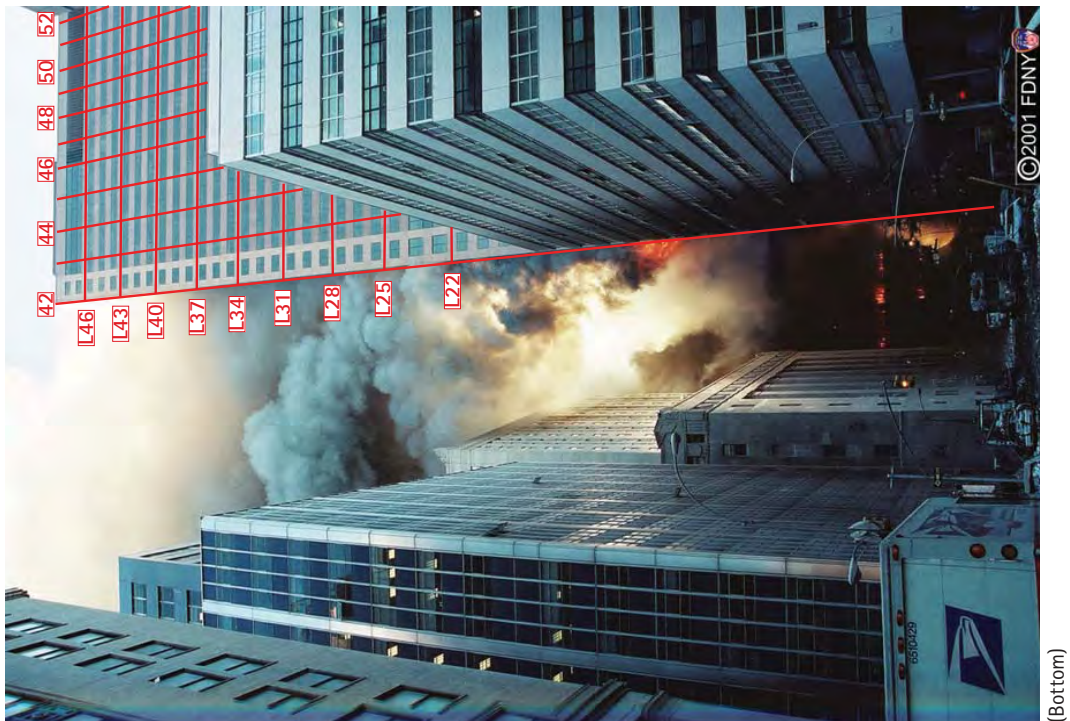
Image 6.E.03 Northeast corner, approximately 3:20PM-3:40PM

Image 6.E.03 with columns and floor levels overlaid

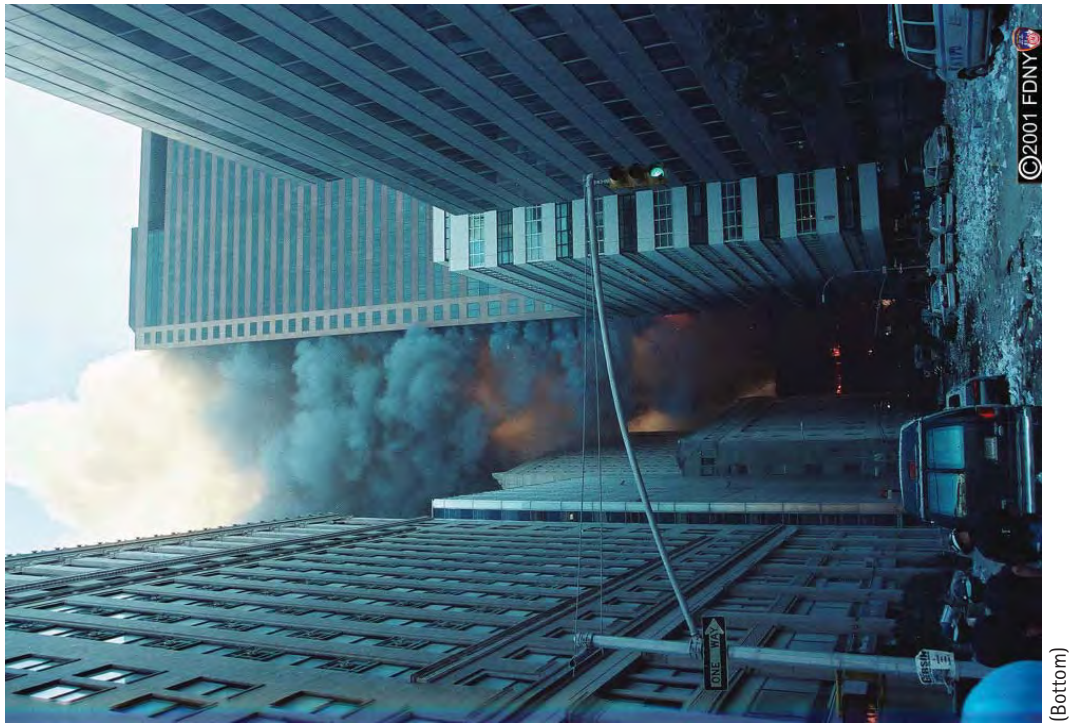
Image 6.E.04 Northeast corner, approximately 3:20PM-3:40PM

Image 6.E.04 with columns and floor levels overlaid

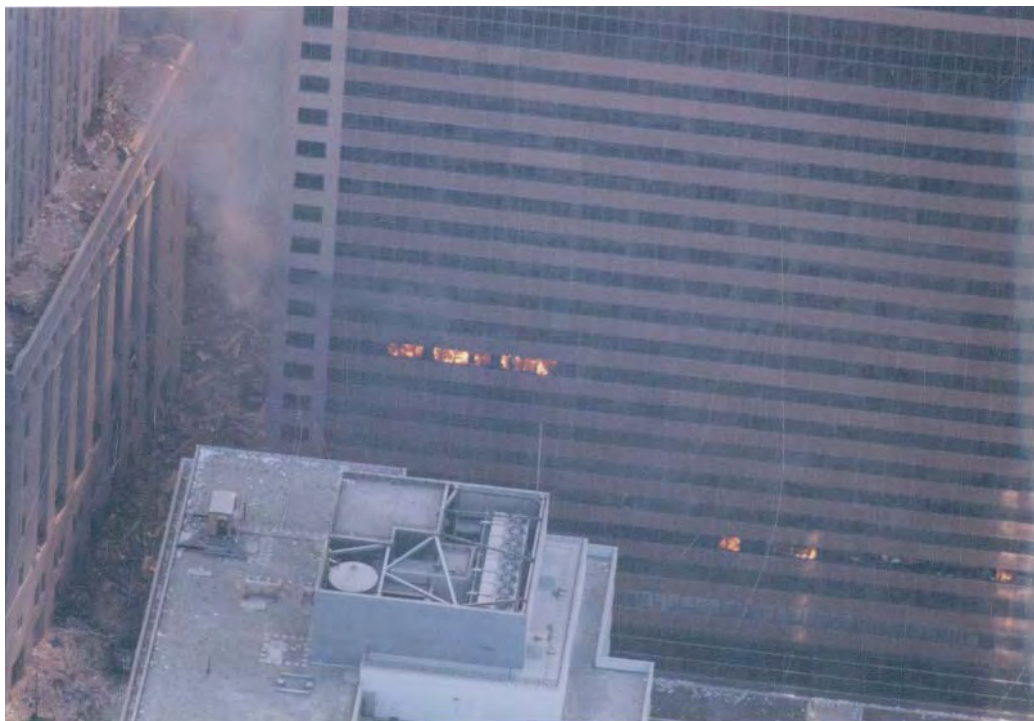
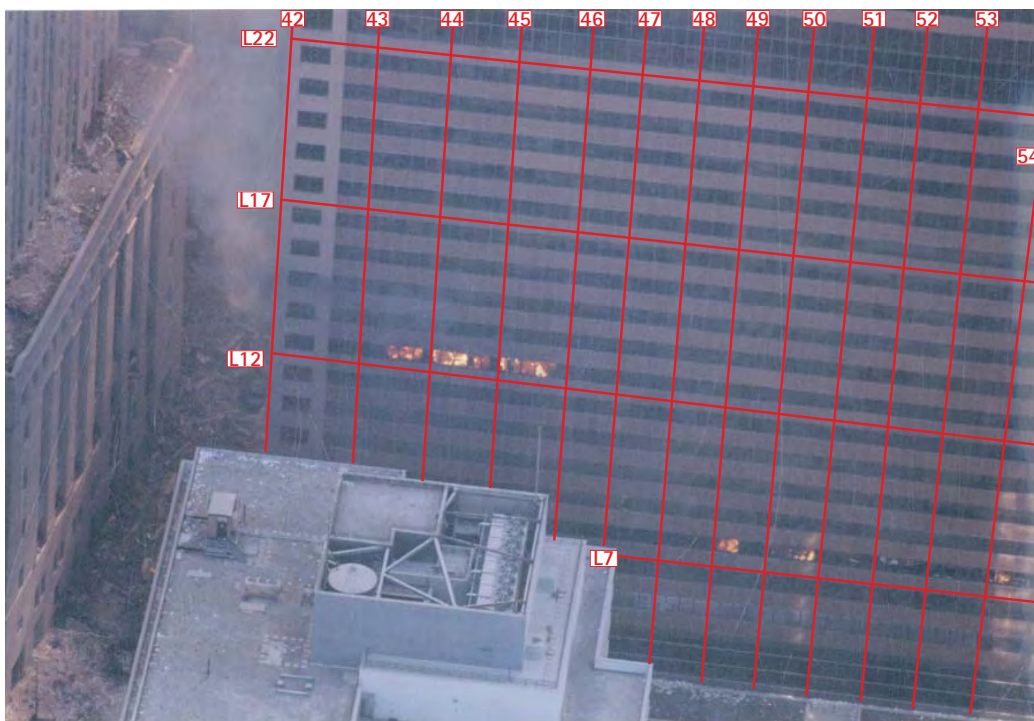
Image 6.N.01 North facade, 3:05PM +/-300S

Image 6.N.01 with columns and floor levels overlaid

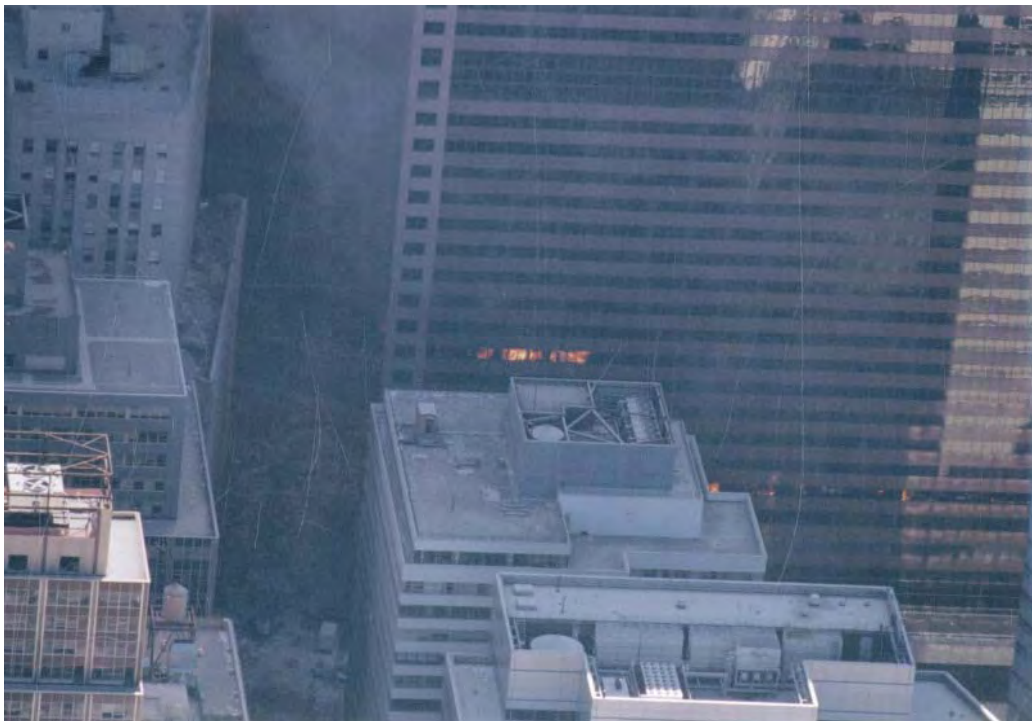
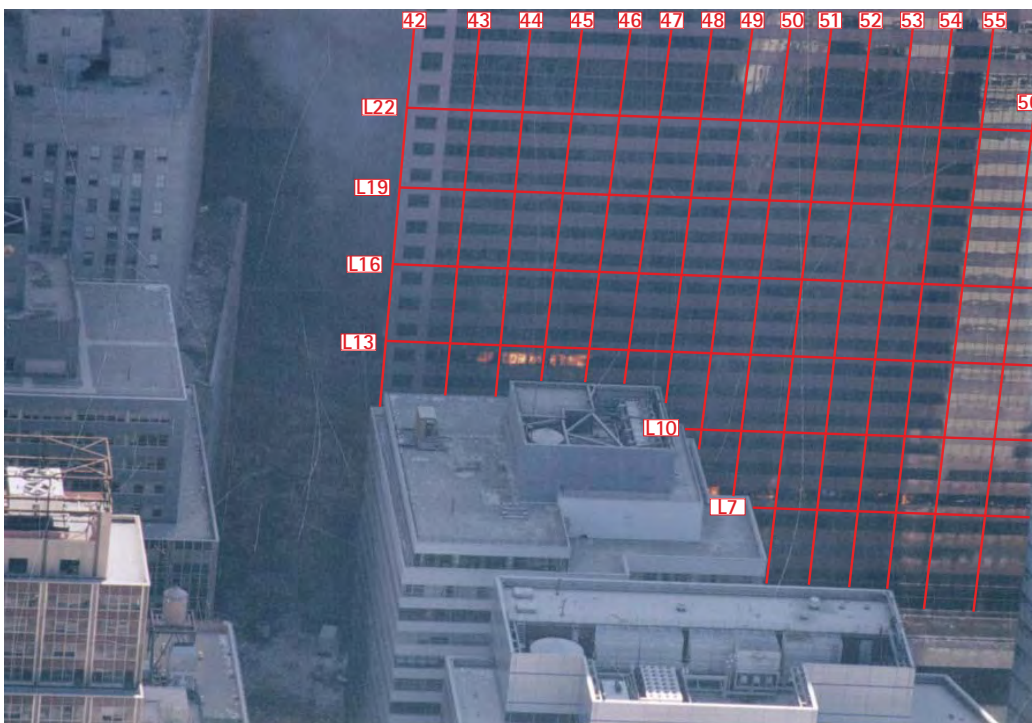
Image 6.N.02 North facade, approximately 3:05PM-3:10PM

Image 6.N.02 with columns and floor levels overlaid

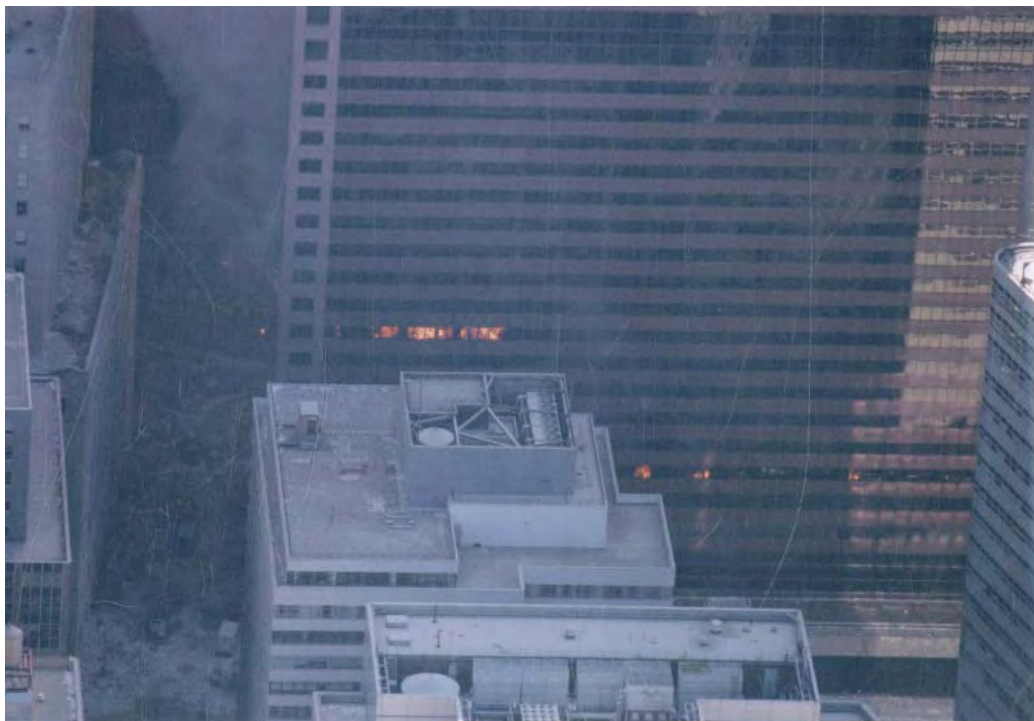
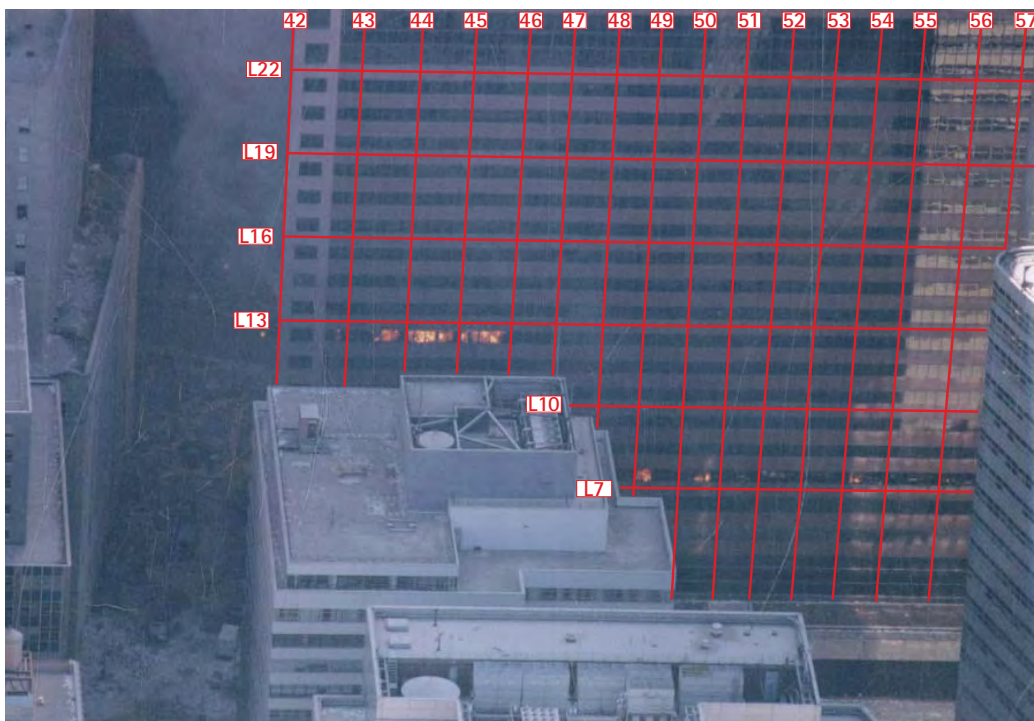
Image 6.N.03 North facade, approximately 3:05PM-3:10PM

Image 6.N.03 with columns and floor levels overlaid

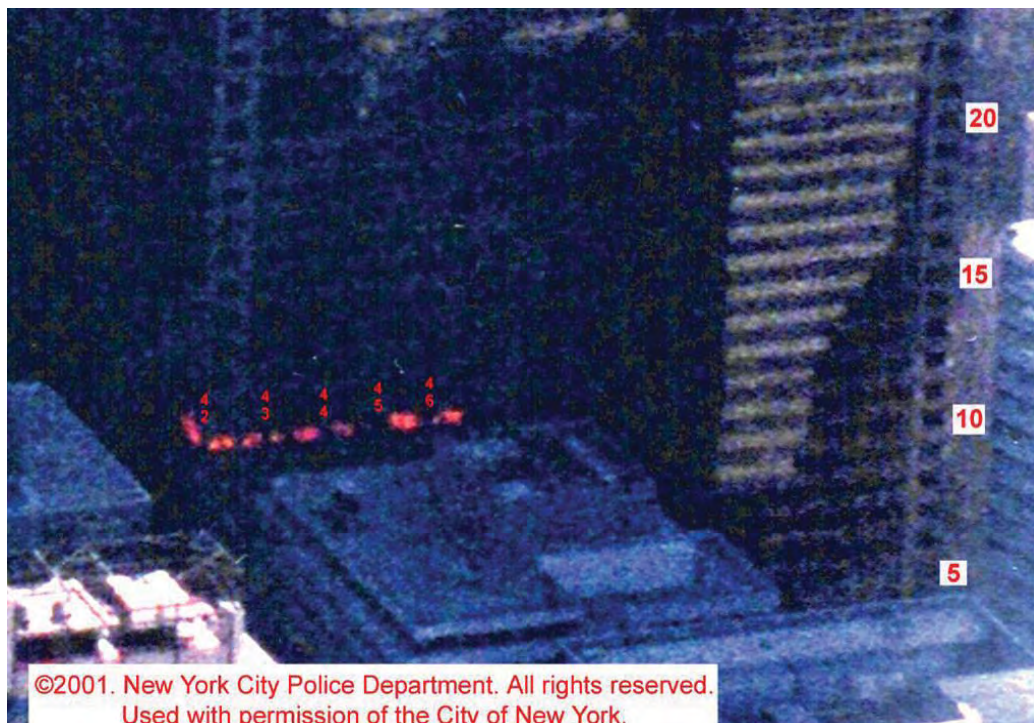
Image 6.N.04 Northeast corner, 3:10PM +/-300S

Image 6.N.04 with columns and floor levels overlaid

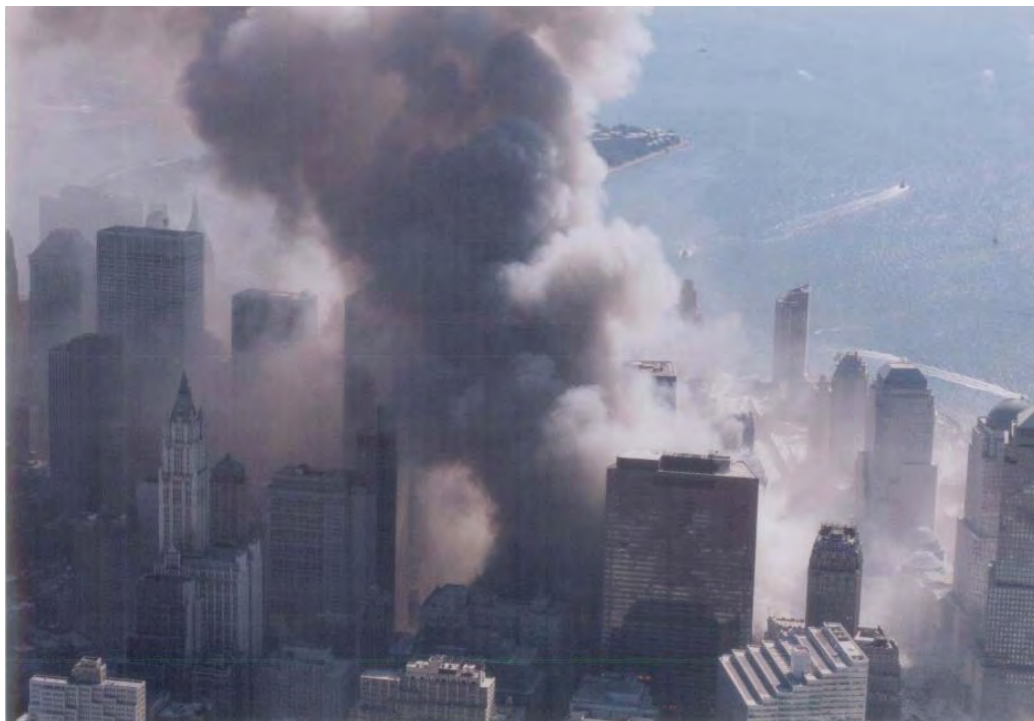
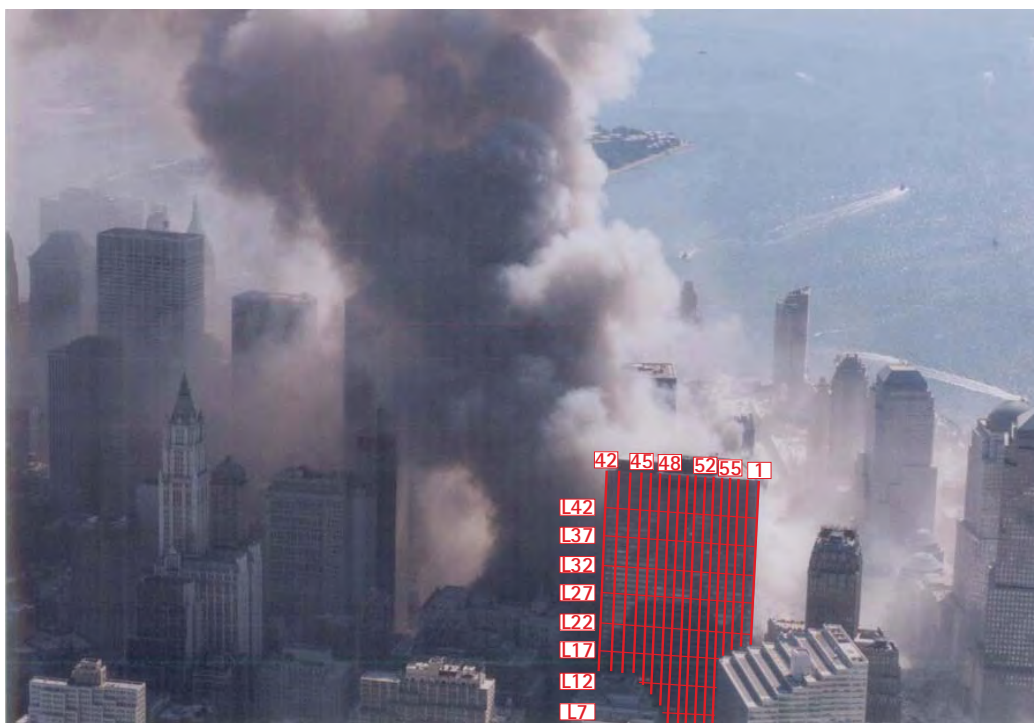
Image 6.N.05 North facade, approximately 3:05PM-3:10PM

Image 6.N.05 with columns and floor levels overlaid

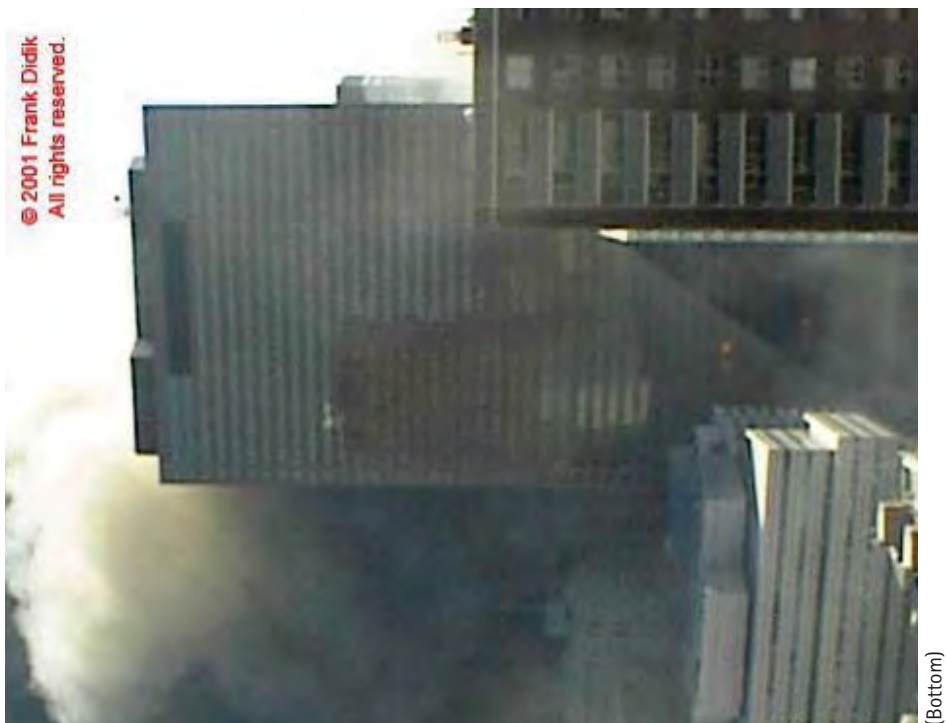
Image 6.N.06 North facade, 3:10:46PM +/-3S

Image 6.N.06 with columns and floor levels overlaid
